RE: **NMED Comments, Updated Closeout Plan and Financial Assurance Proposal, Deming Mill and Tailing Impoundment, GEO Southwest, Ltd., Luna County, New Mexico MMD Permit No. LU009RE**

Field Trip Report
 Mining Environmental Compliance Section (MECS)

Inspection Report
Ground Water Quality Bureau

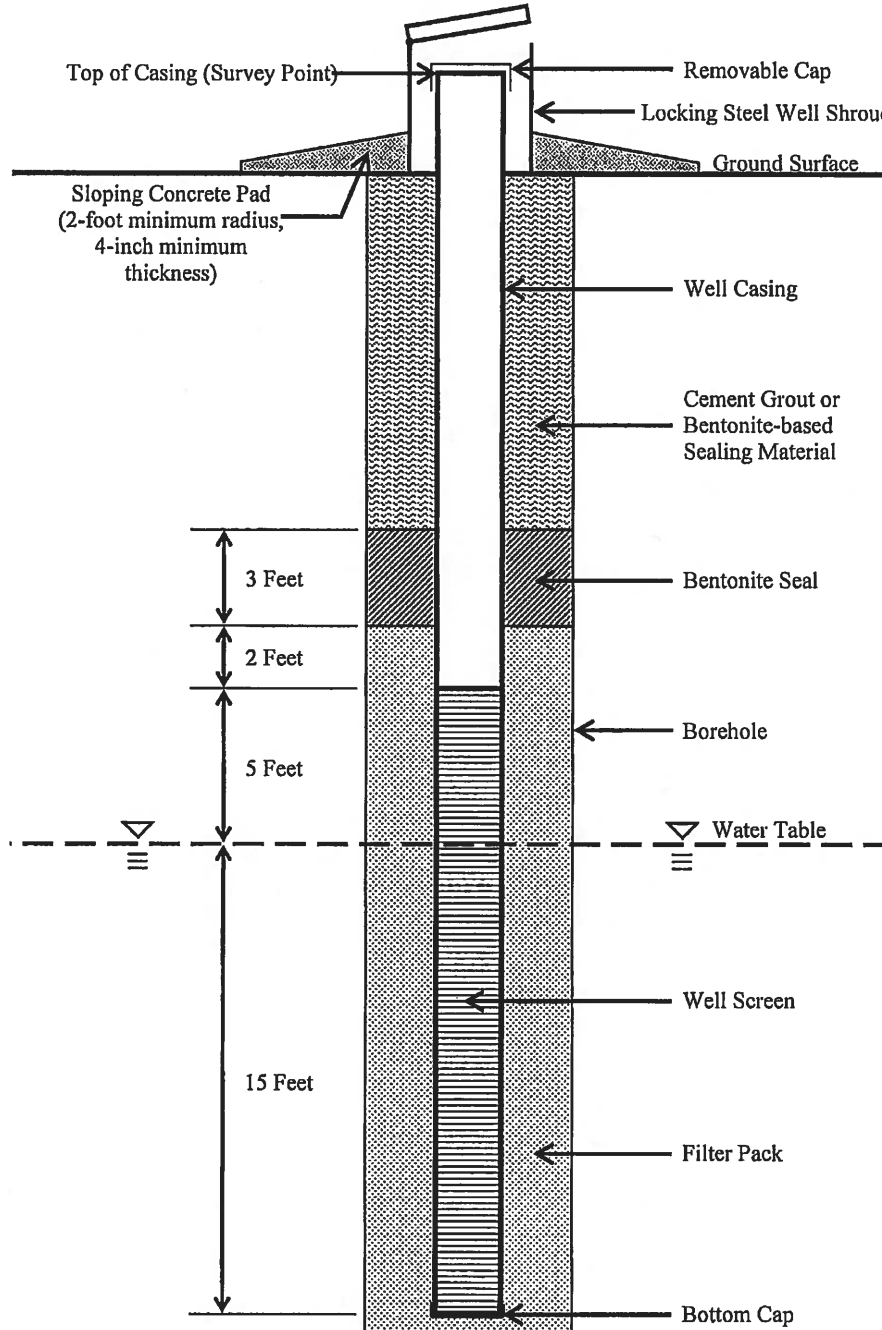
MONITORING WELL SCHEMATIC

Well Specifications (see attached monitoring well schematic):

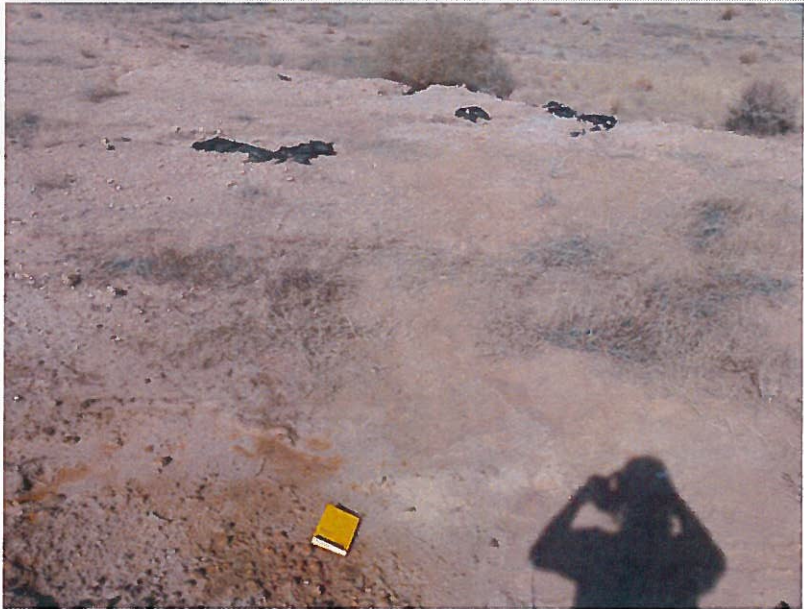
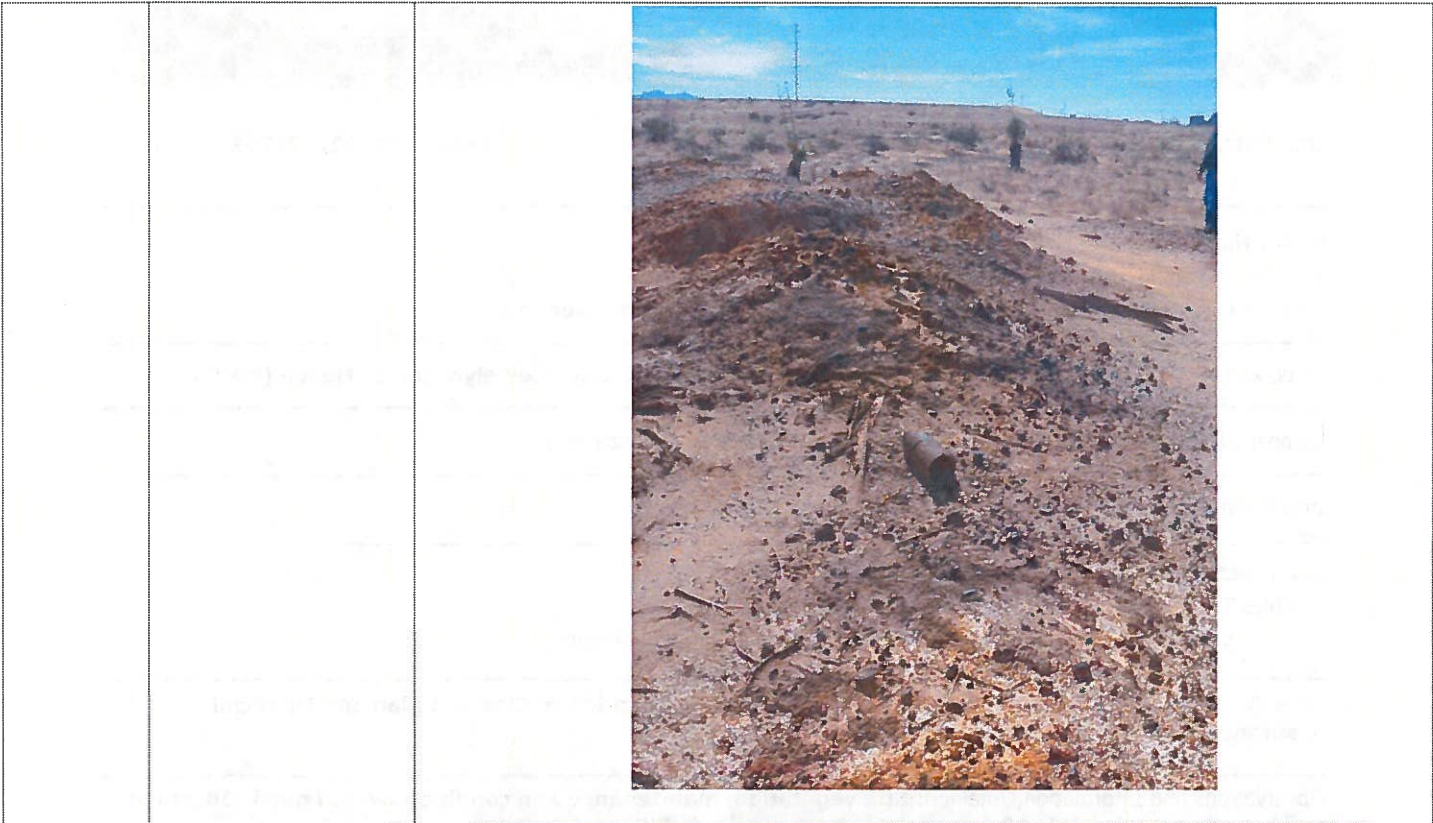
TIME	DESCRIPTION	PHOTO
10:40am	Observed discolored soil, exposed tailings, poor vegetation on area proximal to FMI Cyprus Deming Tailing Facility owned property and Mimbres River.

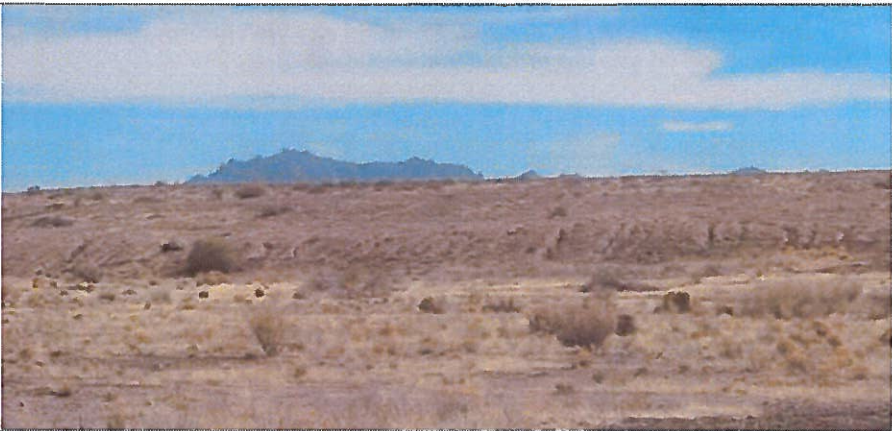
10:45am
Erosion gullies on the one-acre north slope of FMI Cyprus Deming Tailing Facility, on GEO Southwest owned property.

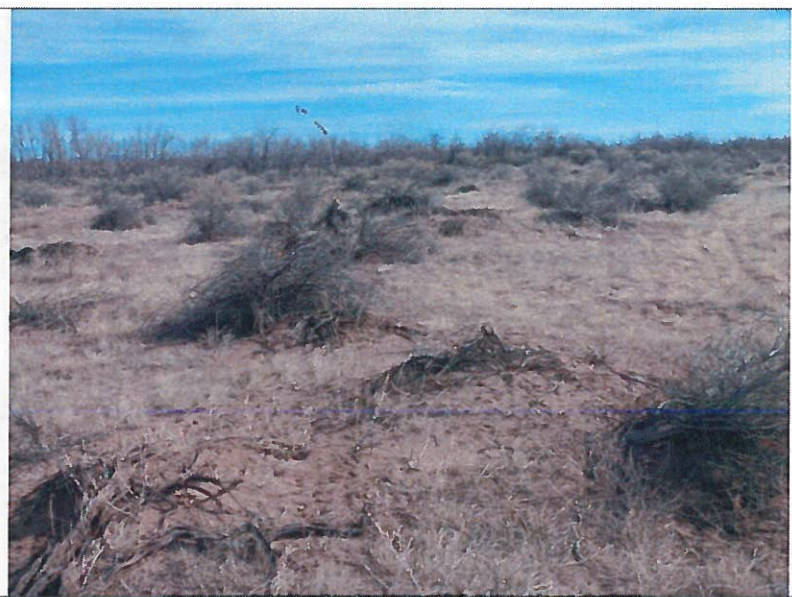
<p>11:00am</p>	<p>Area of acceptable cover and vegetation, closer to Mimbres River than area of concern.</p>

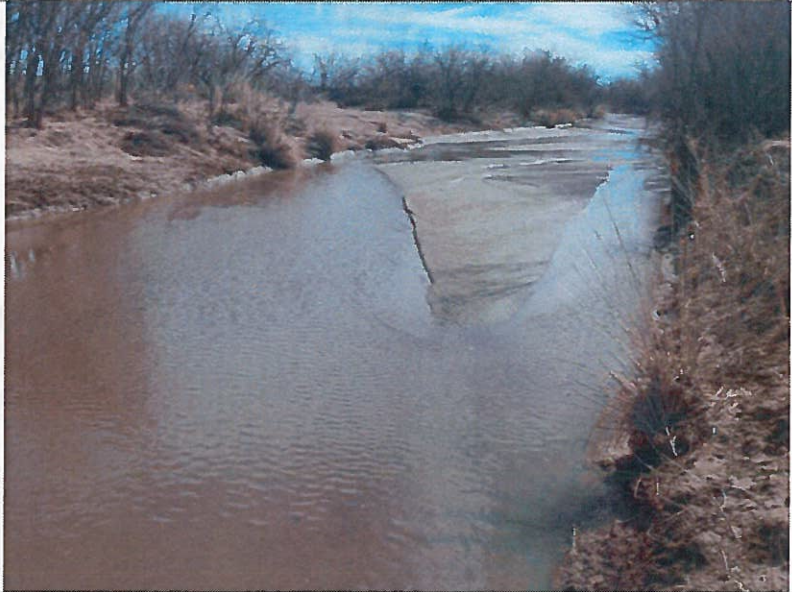
<p>11:15am</p>	<p>Mimbres River with surface flow.</p>

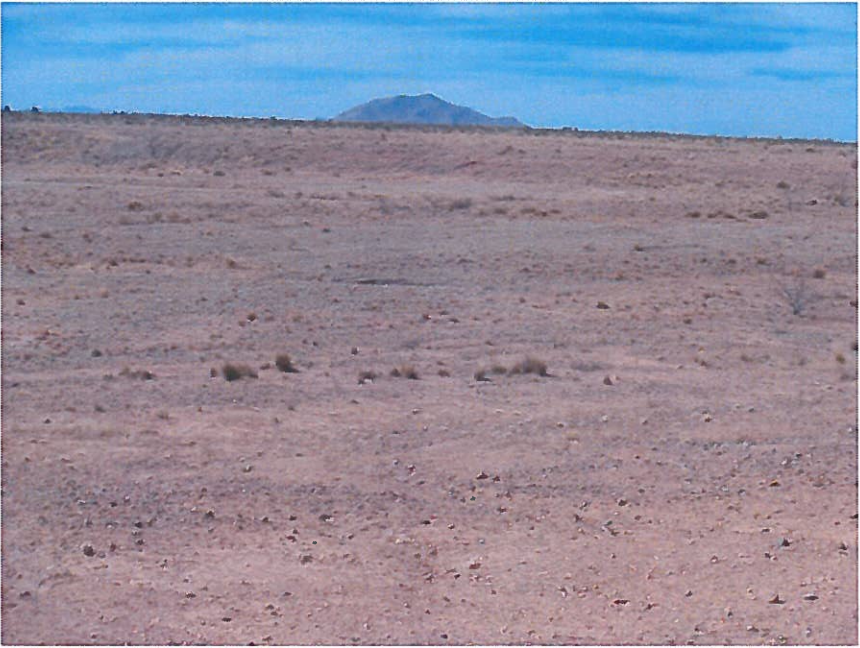
<p>11:30am</p>	<p>Borrow area, minor erosion, adequate vegetation.</p>

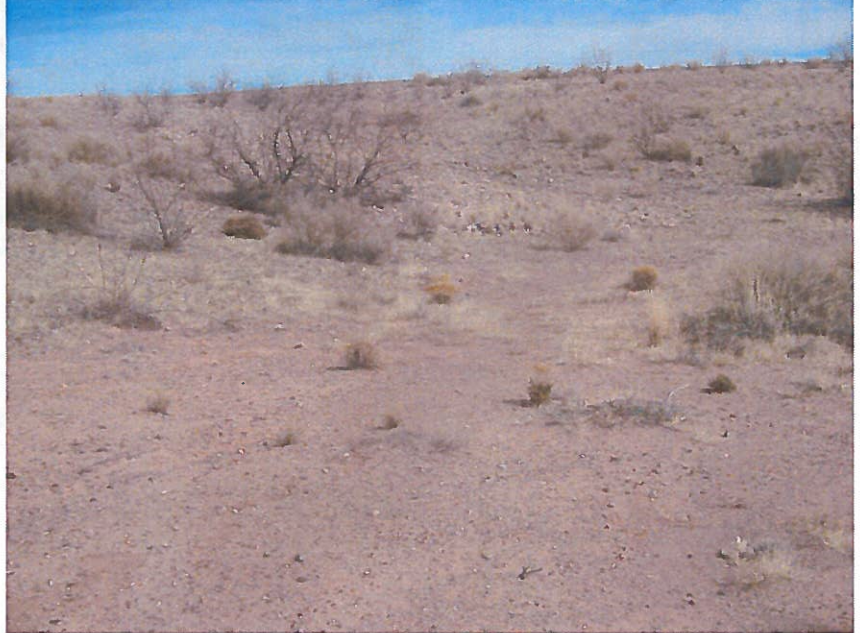
<p>12:00pm</p>	<p>Adequate vegetation observed across impoundment. No erosion issues observed. Variation in soil color on small area of the west side. A field pH test determined it to be neutral.</p>

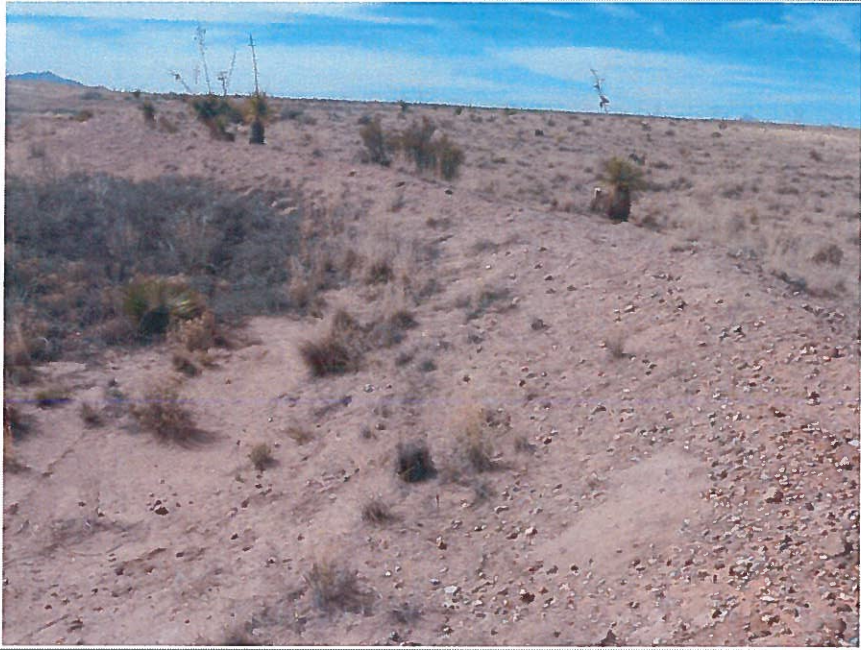
<p>12:30pm</p>	<p>Impoundment perimeter berm, varies from 1-3'</p>

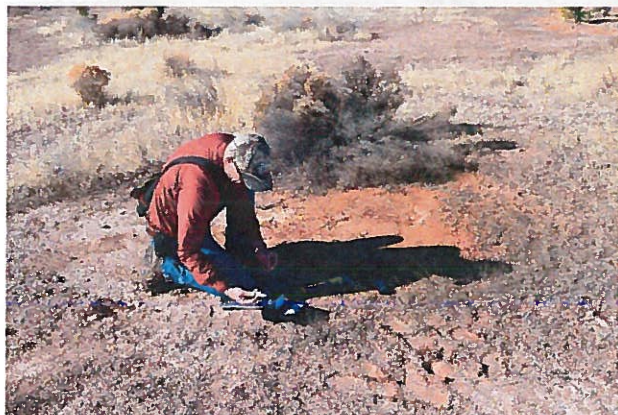
An eroded slope with rills exists adjacent to the FMI-Cyprus Tailings. A small area of tailings (DMS-1) was observed in the East-West swale on the slope. The tailings are orange in color and fine grained. The tailings exhibited acidic conditions with an approximate pH of 4.5 standard units as indicated with the colorimetric pH test kit. Erosional rills were observed at the toe of the slope with orange fine grained tailings exposed. The tailings in two locations (east and west end) exhibited acidic conditions with an approximate pH of 4.5 standard units. The center of this area exhibited a pH of 6.0 standard units. The pH of the black tailings in the area exposed at the toe of the slope exhibited a pH of 7.0 standard units.

DMS	pH	Latitude	Longitude	Notes
DMS 1	4.5	32.28524	-107.78633	Orange colored tailings on slope, swale between BMP berms
DMS 2	6.0	32.28555	-107.78639	Orange colored tailings in erosion gulleys, toe of slope (center)
DMS 3	4.5	32.28571	-107.78688	Orange colored tailings in erosion gulleys, toe of slope (west end)
DMS 4	4.5	32.28567	-107.78590	Orange colored tailings in erosion gulleys, toe of slope (east end)
DMS 5	7.0	32.28560	-107.78602	Black colored tailings in erosion gulleys, toe of slope
DMS 6	7.0	32.28600	-107.78586	Flat area north of slope with little vegetation
DMS 7	4.5	32.28616	-107.78606	Flat area north of slope with little vegetation, orange tailing mixed in.
DMS 8	7.0	32.28649	-107.78594	Native area north of slope with intent vegetation, reference area for DMS 7
DMS 9	7.0	32.28910	-107.78687	Graded area north of slope, east of Peru Mill Rd (northeast corner)
DMS 10	7.0	32.28809	-107.78838	Graded area north of slope, east of Peru Mill Rd (southwest corner)

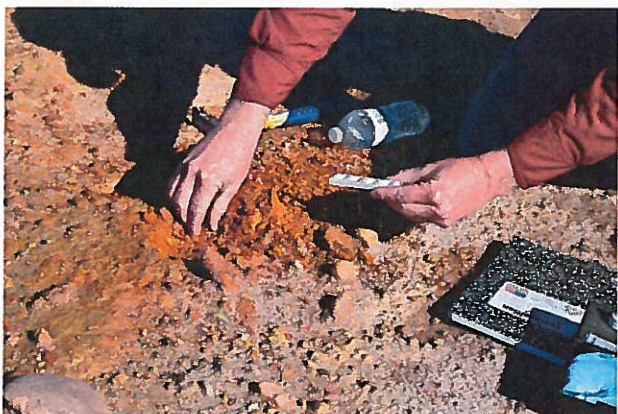
DMS 3

Intermittent areas of tailings were observed at the surface in the area between the eroded slope discussed above and the south bank of the Mimbres River. Vegetation in this area is sparse. Results of colorimetric testing for pH of sites DMS 6 and 7 are in Table 2. A reference area outside the area of intermittent tailings observed at the surface that was well vegetated was photographed and tested for pH. The results are included in Table 2, site DMS 8. In an area east of Peru Mill Road and south of the Mimbres River, partially buried solid waste was observed.

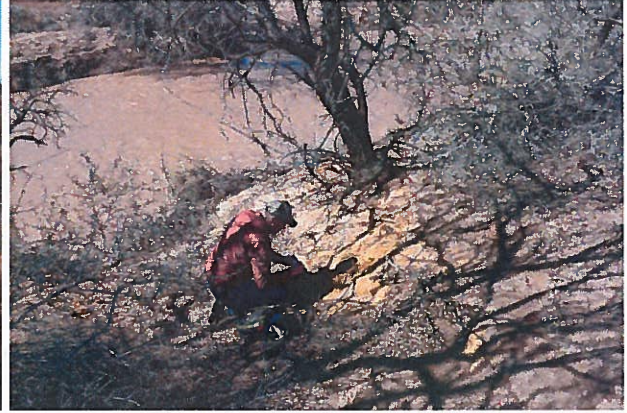
In a drainage that is proximal to the north bank of the Mimbres River, orange colored tailings were observed. See the pH testing results and a photograph of DMS 11 below.

DMS 11	4.5	32.28968	-107.78609	North bank of Mimbres River

There are isolated pockets of tailing on both side of the Mimbres River. Most of the patches are stabilized by deeply rooted vegetation including giant sacaton, willow and soapberry trees and are not subject to erosion except in the largest of flood events. However, there is one location of concern on the north bank of the Mimbres River at approximately lat: 32.2897, long: -107.7863. This location lies at the outer bend of the Mimbres River and is consequently subject to the highest stream velocities and bank stress. There are several erosional channels that have cut through remnant tailings creating a direct discharge into the Mimbres. Tailing erosion is exacerbated by off-highway vehicle "ATV" use which is preventing natural revegetation and stabilization of the tailings. This area is approximately 0.25 acres in size and must be included in the closeout plan either through in-situ stabilization and containment, or by removal and recontouring/revegetation of the streambank.
