RE: Addendum to Roca Honda Mine Baseline Data Report; Permit Nos. MK-025RN, DP-1717

**ROCA HONDA MINE  
BASELINE DATA REPORT  
ADDENDUM**

**July 2018 Addendum 1**

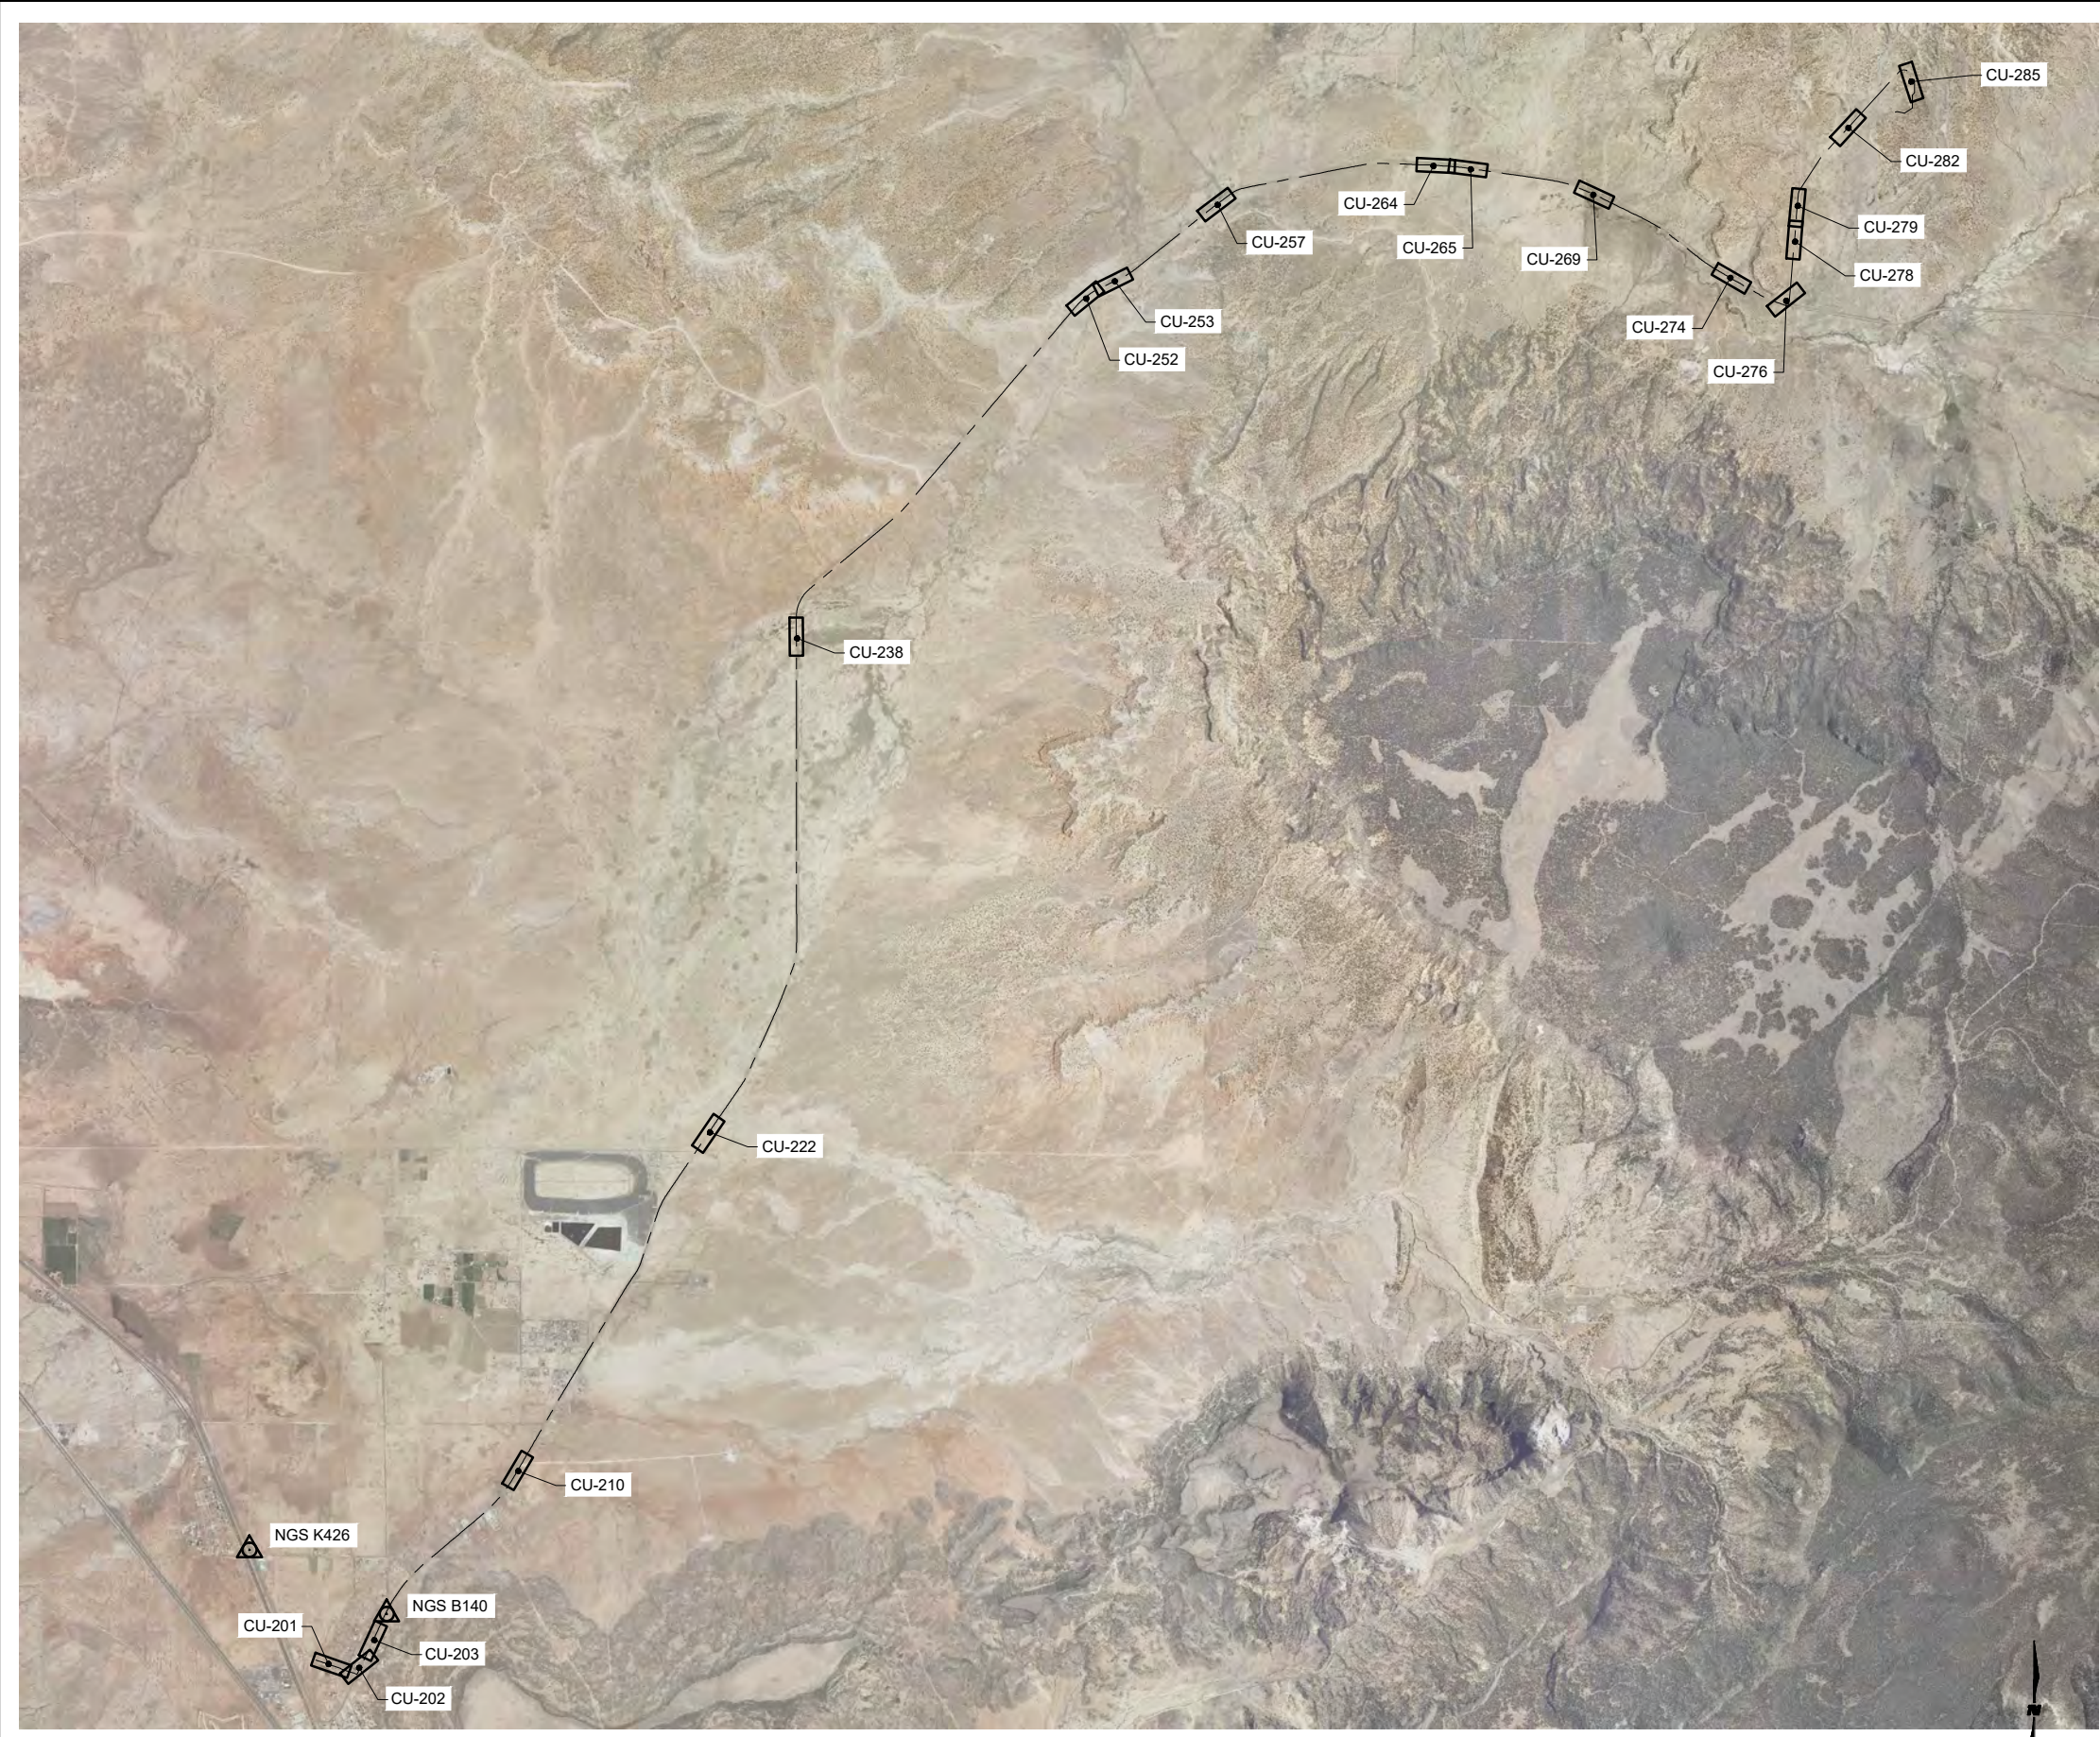
**A1** PROJECT CONTROL PLAN AND SHEET LAYOUT  
SCALE: 1"=3500'
