Re: **Remedial Action Plan**
American Minerals Inc. Deming Manganese Site,
Permit Nos. LU001RE and DP 1234

**REMEDIAL ACTION PLAN
FORMER DEMING MANGANESE-PROCESSING SITE
OF AMERICAN MINERALS, INC.**

MAY 2018

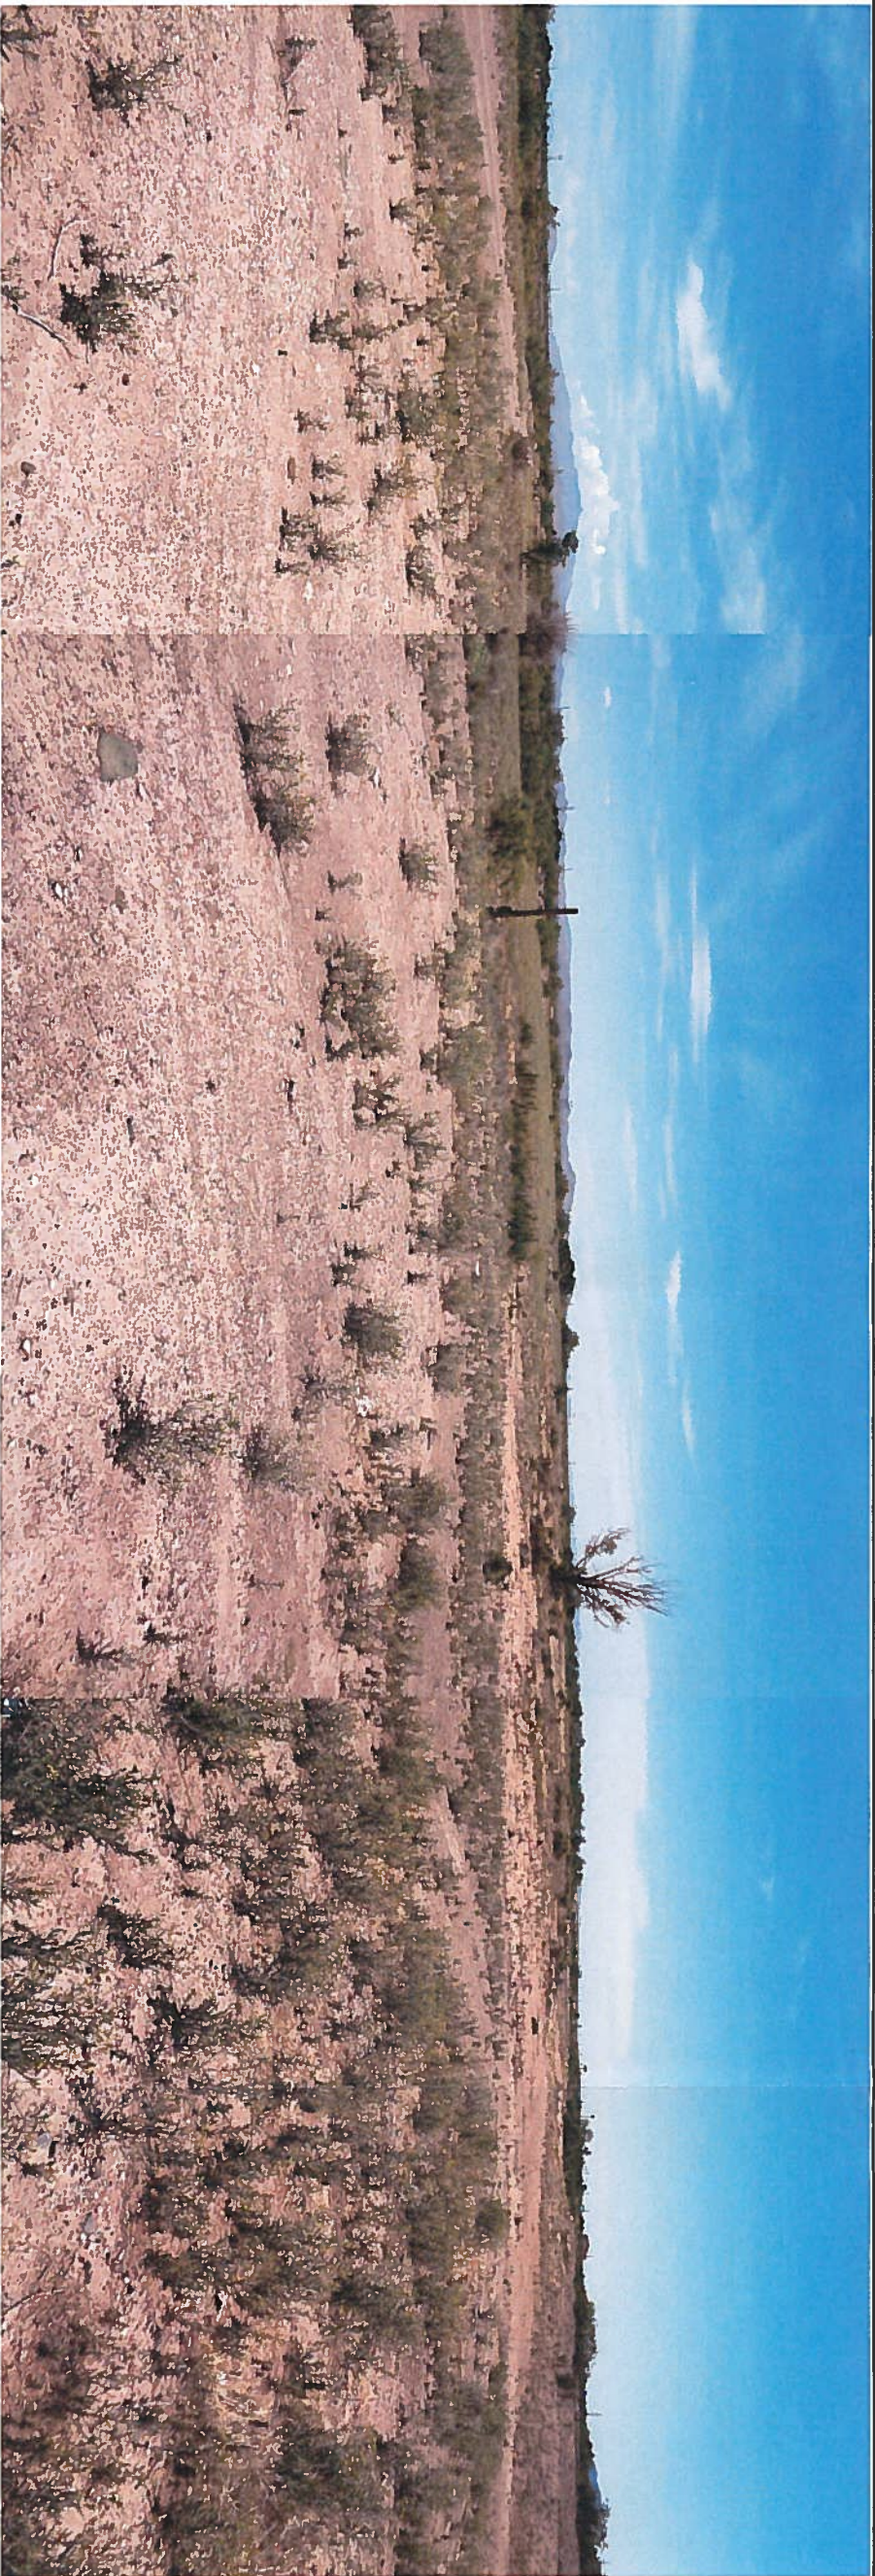
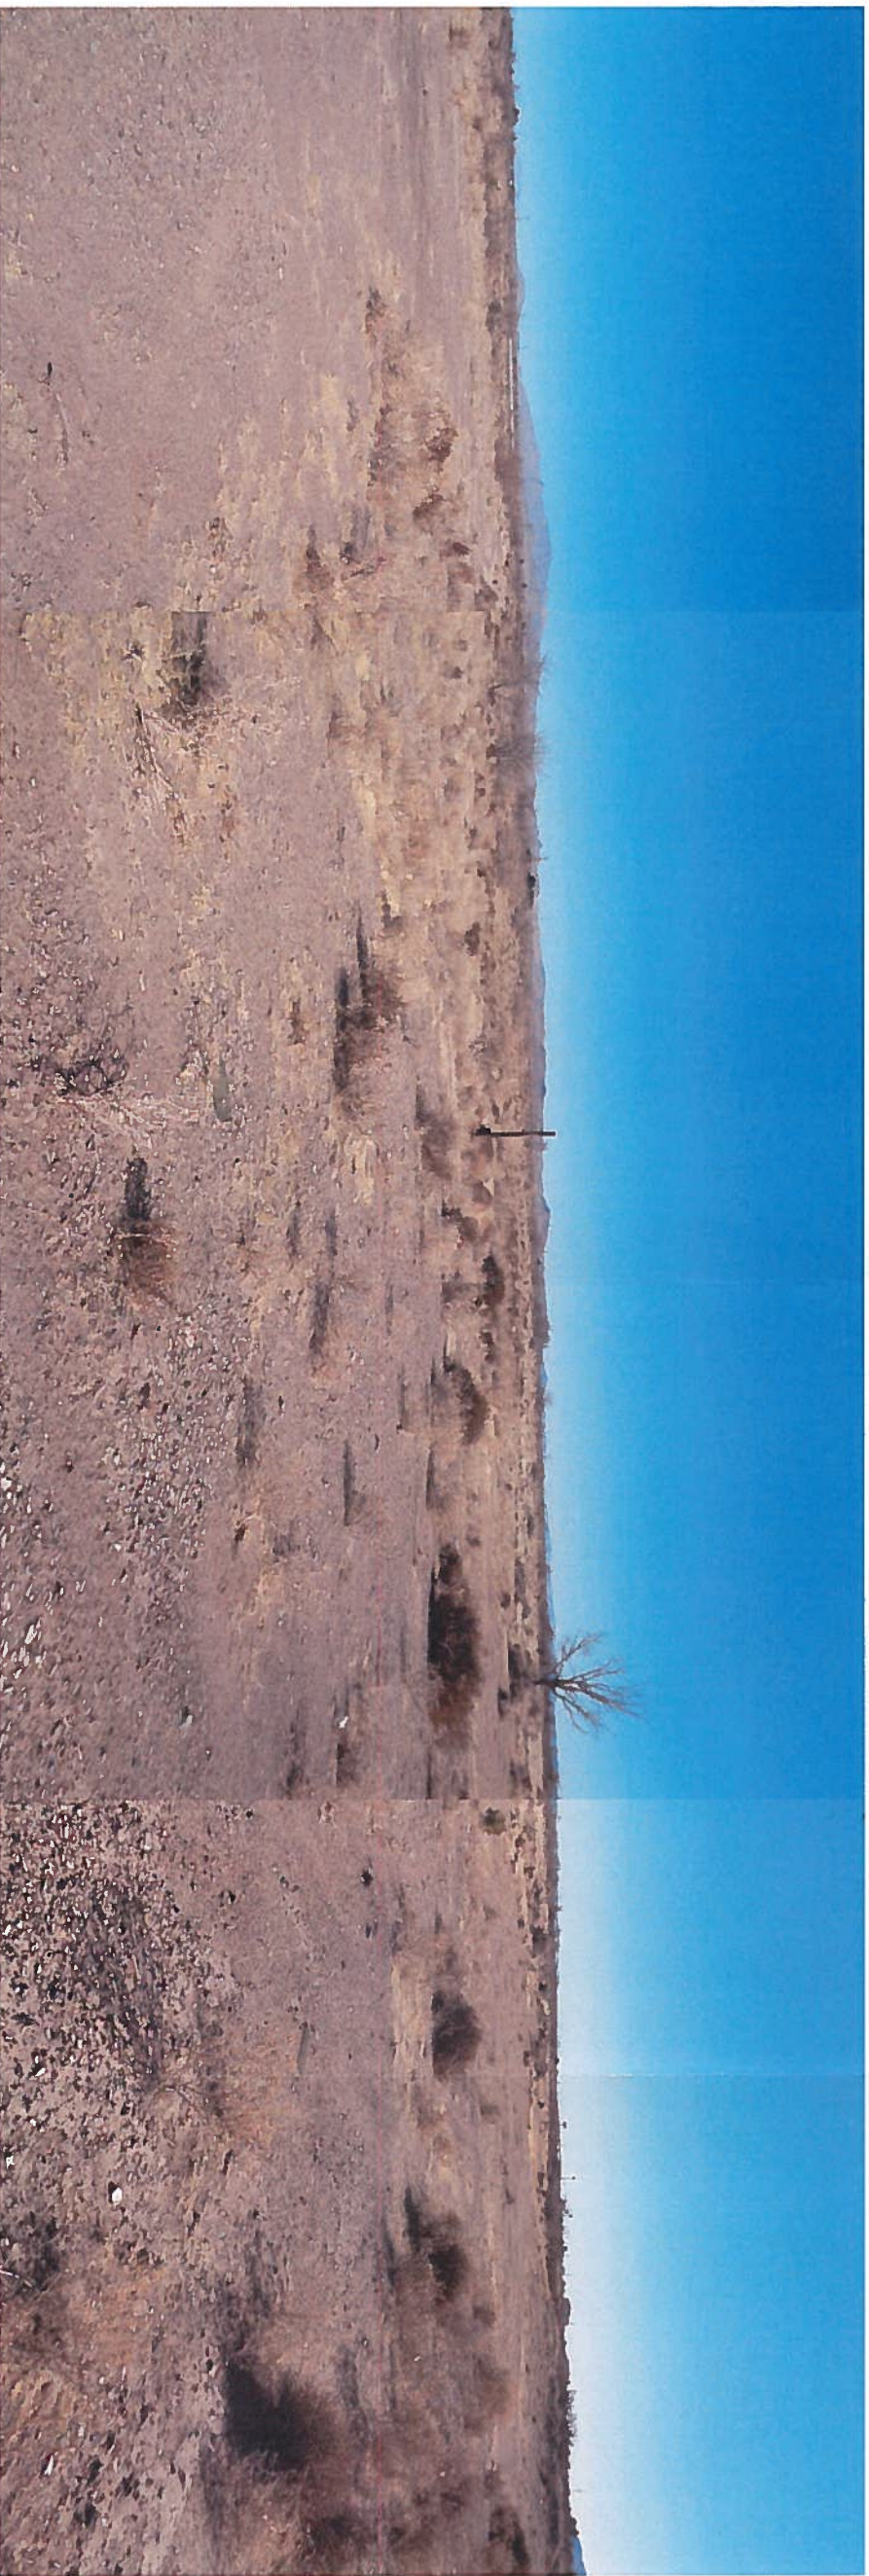
Initially the site developed a good vegetative cover but the drought condition of the past few years has had a significant negative impact. Today the site has a modest growth of grasses and an abundance of invasive weeds. Mesquite bush and other native shrubs are beginning to grow in some areas. The south half of the southwest quarter of the site contains only sparse vegetation. (See attached photographs).

1. Panoramic views across the AMI site taken from the southwest corner where the former processing plant was located. The view is north (left) to east (right). June 8, 2017 (top) and February 8, 2018 (bottom)

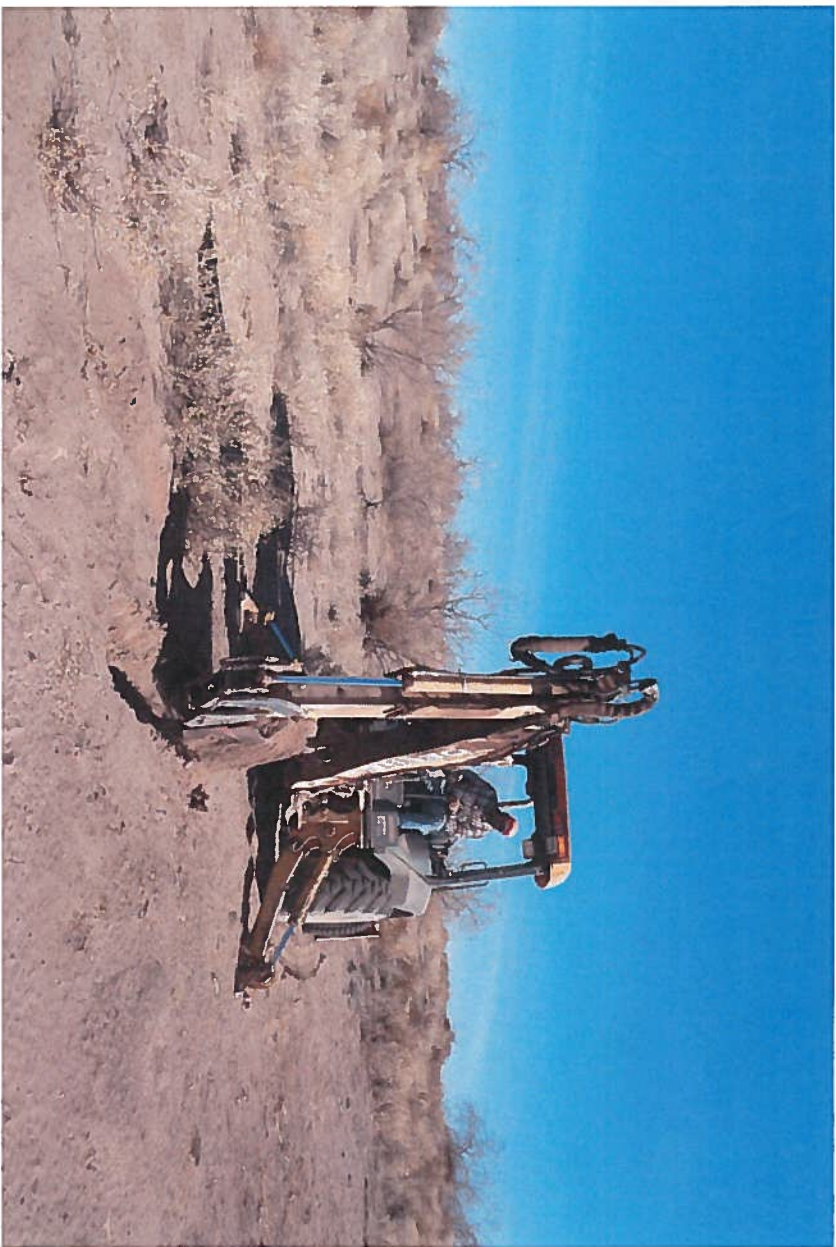
2. Backhoe trench in the northern part of the site.
Excavated to 24 inches with no manganese. (February 9, 2018)

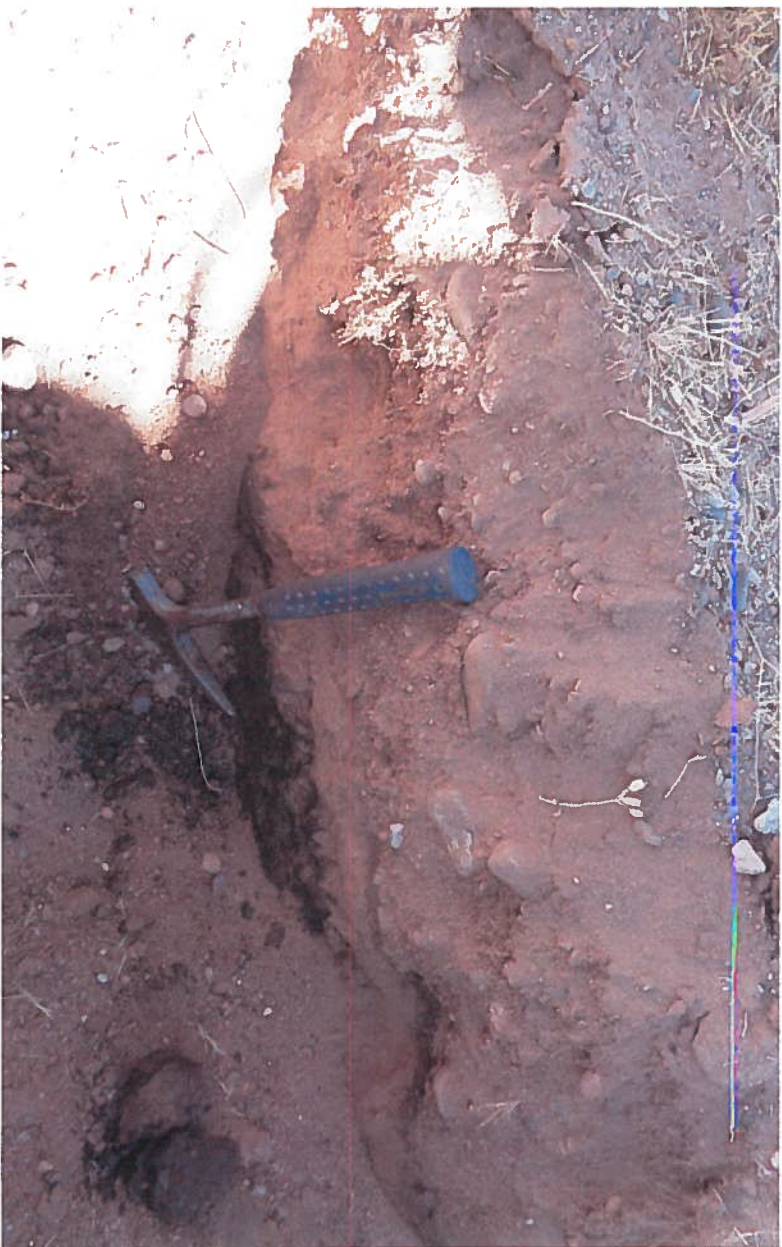
Area 2 - West-side berm. The berm is topped by a dirt access road along the property boundary. The inside (i.e. east side) slope of the berm has a variable cover thickness of 5 to 15 inches. A 6- to 8-inch layer of additional material will be placed on the face of the berm.

3. Backhoe trench along the west side of the site with manganese tailing
showing at a depth of 12 inches. (February 9, 2018)

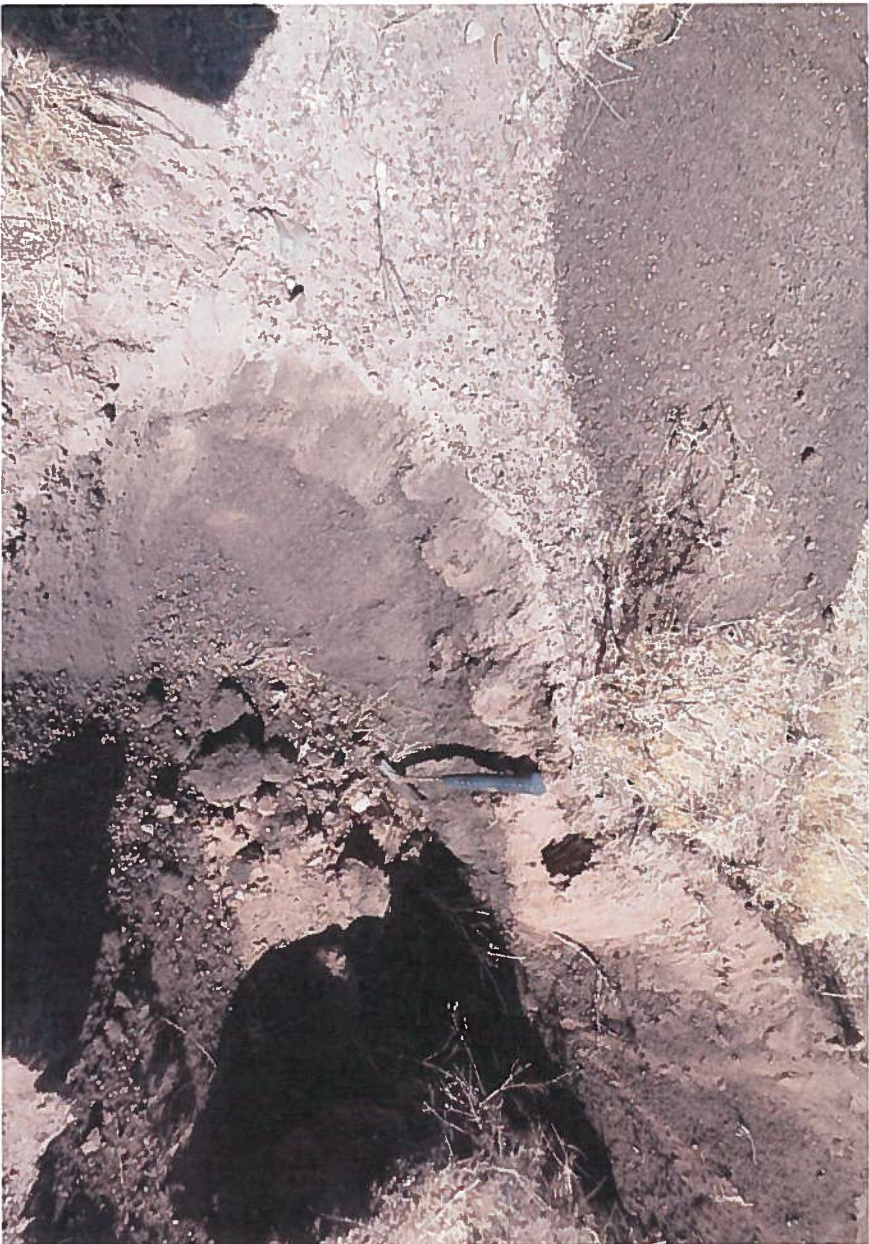
Area 4 - Northeast berm along the Rio Mimbres. A 450-foot length of the berm extending southeasterly from the riprapped overflow channel contains numerous exposures of fine-grained manganese tailing, some of which is 2 and 3 feet thick. Much of the exposed tailing occurs in the steep slope of the berm facing the river bed.

4. Exposed manganese tailing in the northeast berm. (February 9, 2018)

It is proposed to excavate a significant quantity of the tailing to a depth of about 2 feet and remove it to a nearby burial pit situated 200 to 300 feet to the west. As much as 20 to 30 cu. yds. of tailing may require excavation. The excavated areas will be backfilled with clean sand and dirt from the pit, graded and sloped to a lower angle and covered with 2 to 3 inches of coarse gravel. If needed, additional fill dirt will be brought in from off site.

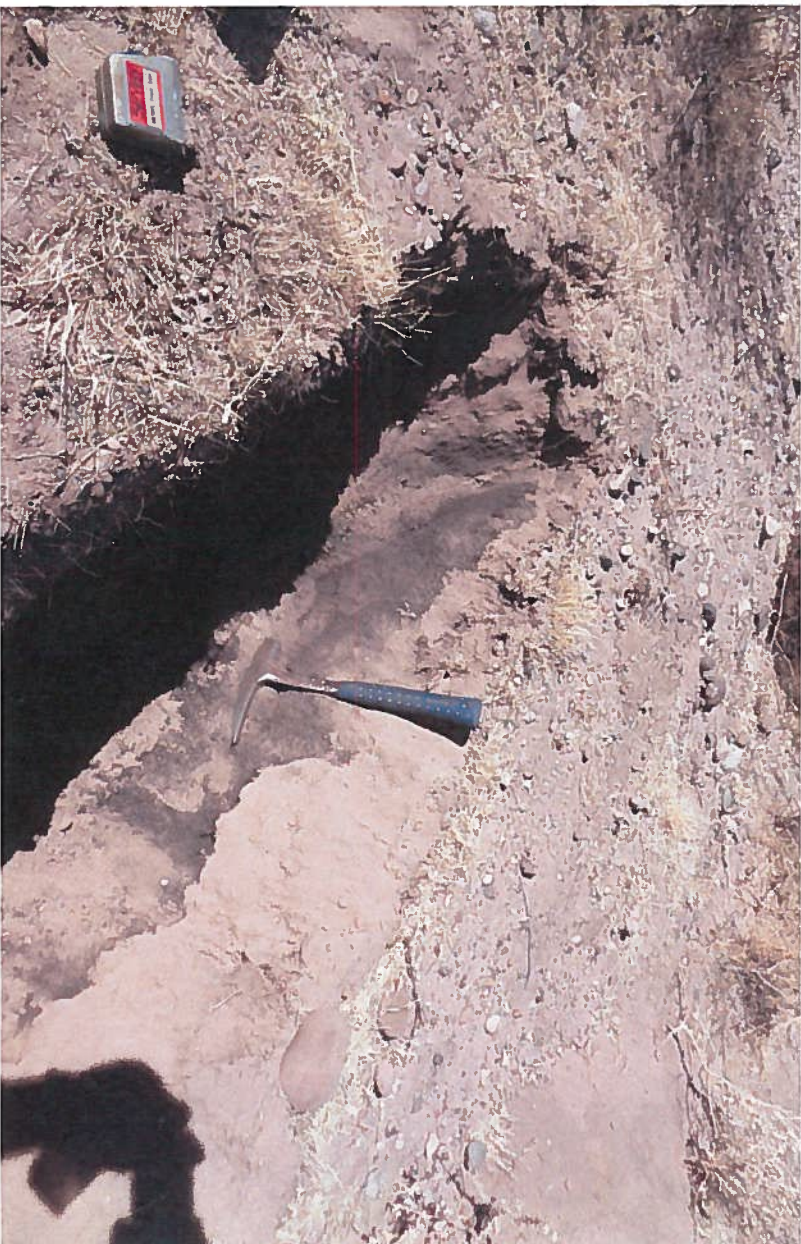
Area 7 - Southeast corner berm. A 280-foot length of the berm and the adjoining inboard area has an inadequate cover thickness. The existing cover depth ranges from 3 to 18 inches. An additional 6 to 8 inches (average) of material will be placed on the area.

5. Backhoe pit in southeast corner showing shallow cover varying from 3 to 12 inches in thickness. (February 9, 2018)

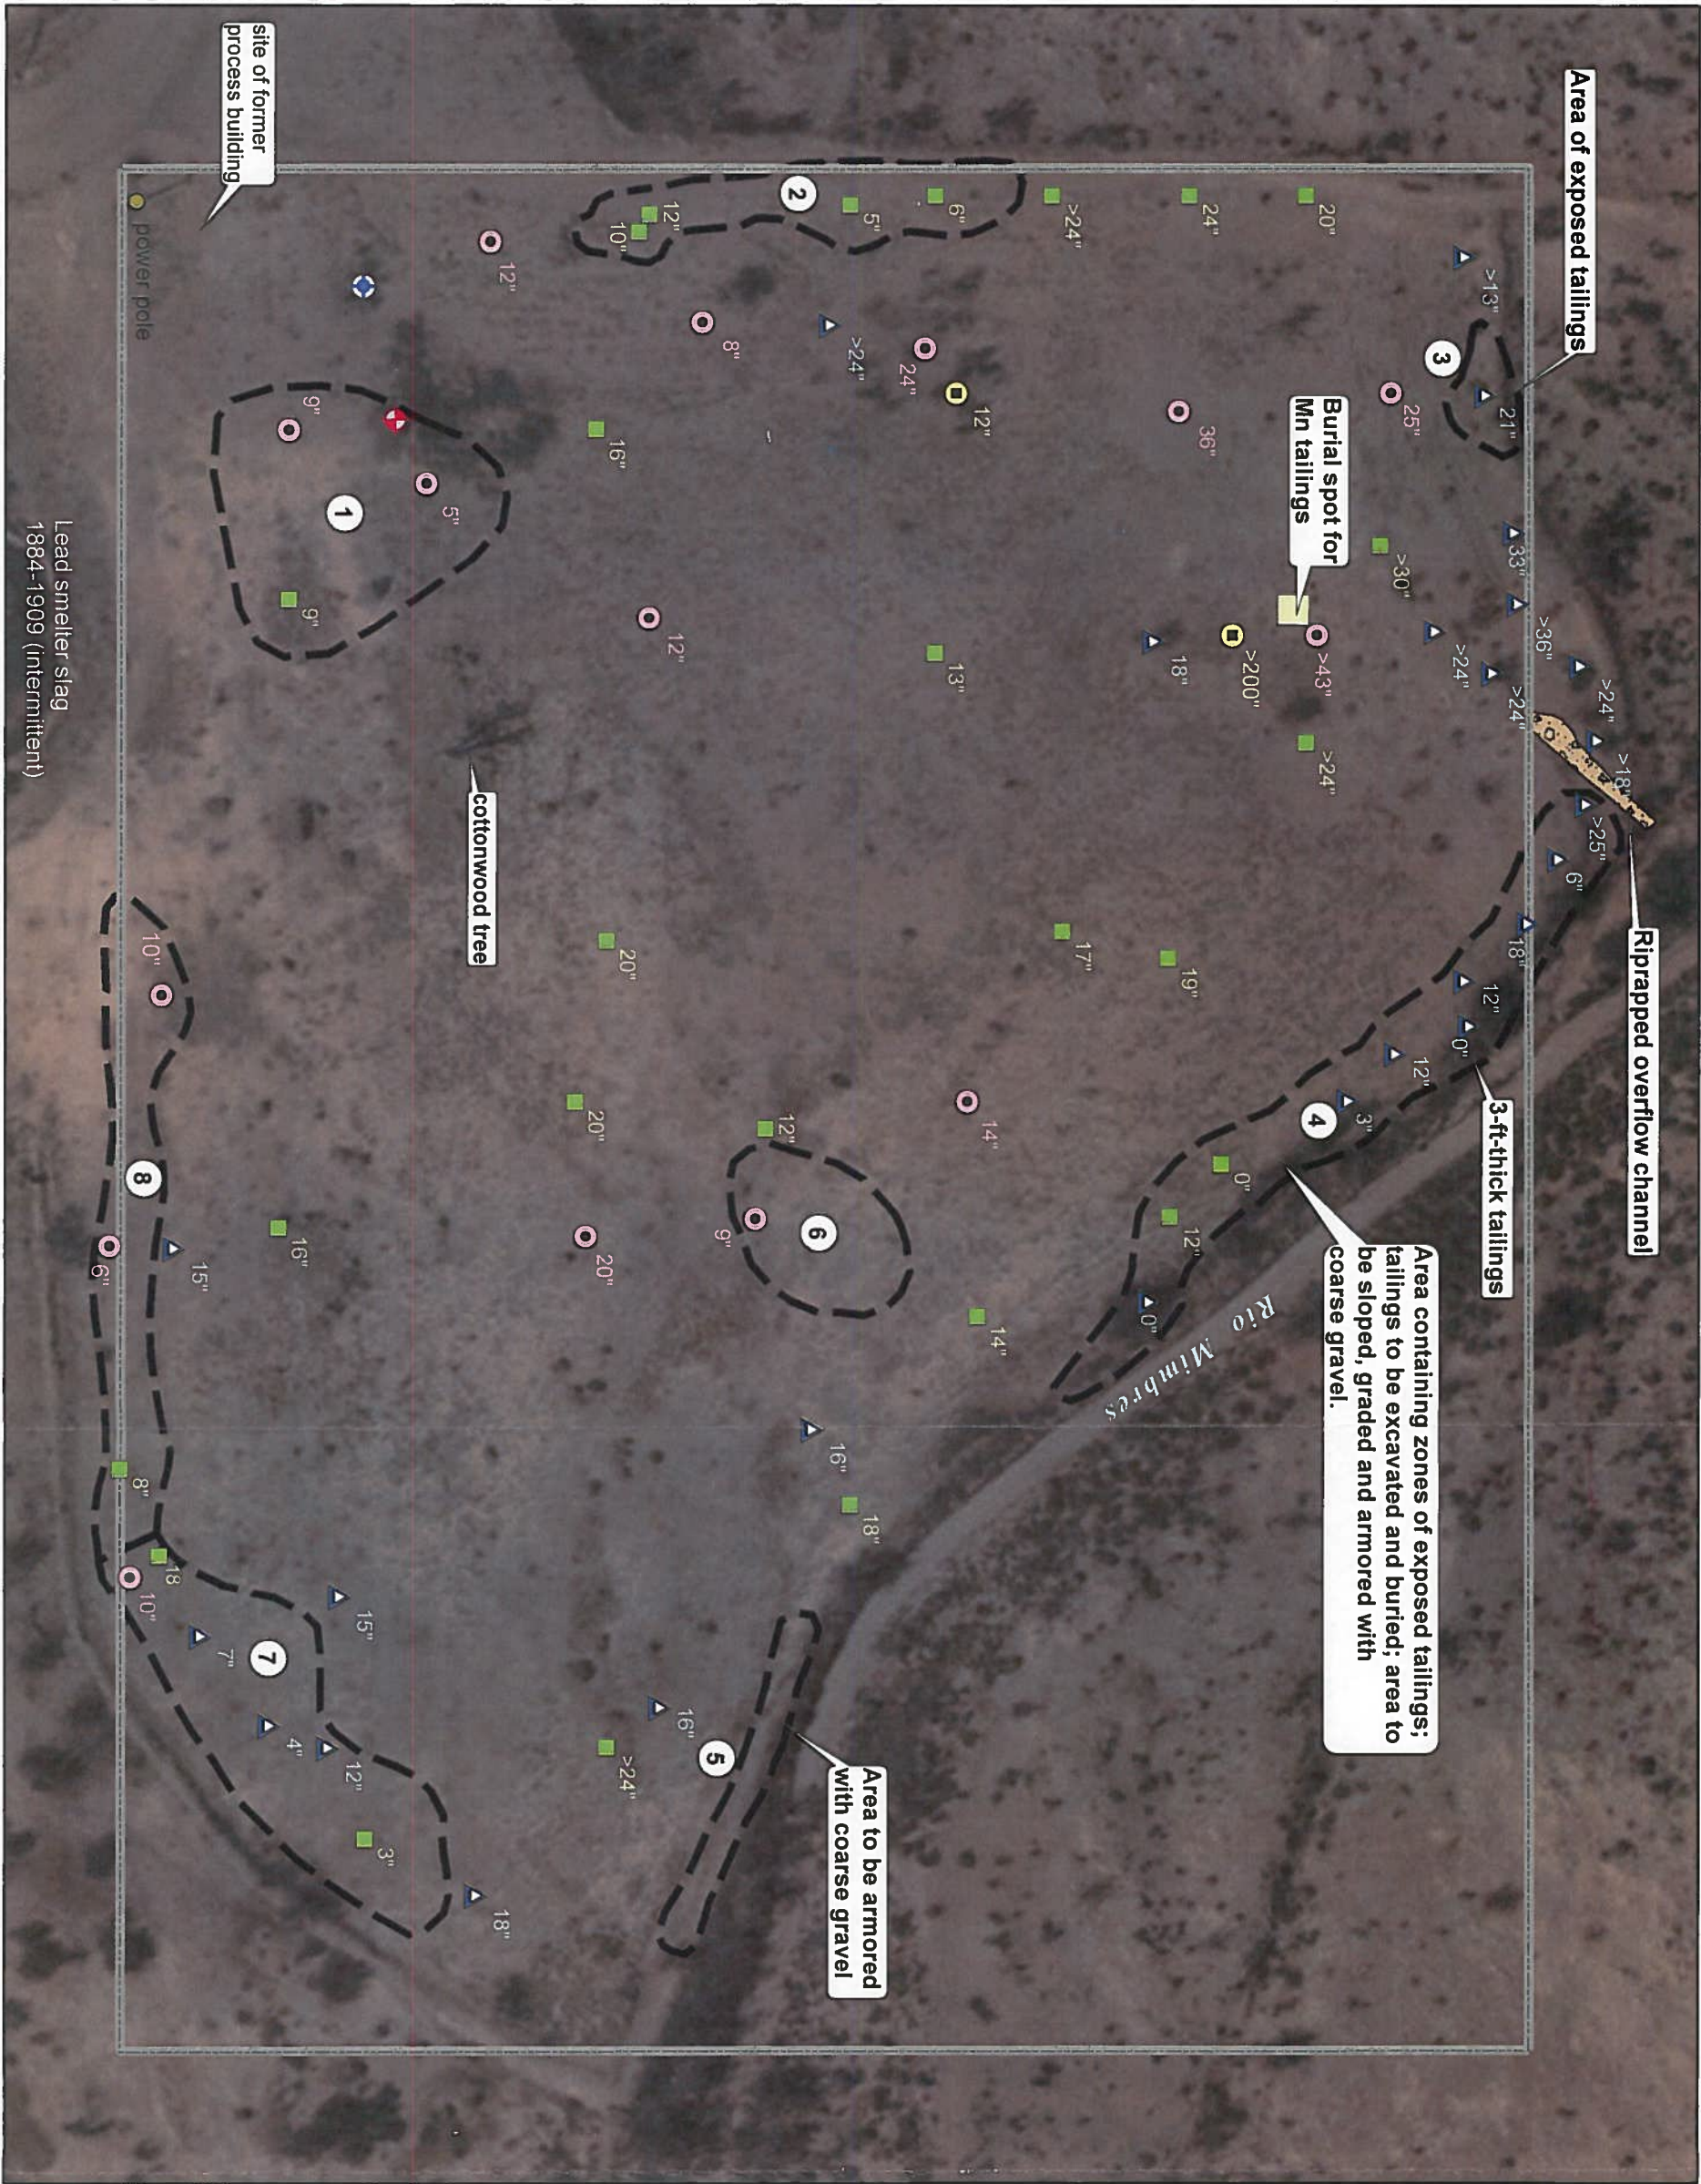
Forty-eight pits were dug around the site. About half of those pits were dug in areas of identified thin cover along the northern berm, the southeast corner, and the western boundary. The attached photo map at a scale of 1 inch equals 100 feet is a site plan showing the location of the backhoe pits (2018) and the hand-auger holes (2015) with the cover thickness in inches. Areas requiring remedial work are outlined.

Eight areas as shown on the accompanying site plan require attention. Most areas typically require an additional six inches of cover material. Area 4 along the Rio Mimbres will require excavation of the exposed fine-grained manganese tailing with subsequent burial in a selected locale in the northwest part of the site.

Aerial photograph of AMI site showing depth of cover over buried manganese tailings and areas requiring remedial work.

The additional cover material will typically comprise a 4-inch thickness of clean fill dirt capped by a 2-inch thickness of medium-to-coarse gravel (minus-2-inch) to act as an armor for protection against wind and water erosion. Each 1,000 sq. ft of area will require 18.5 cu yd of material (12.3 cu yd of fill dirt and 6.2 cu yd of gravel cap). These areas will be seeded with the approved seed mix prior to the onset of the summer rainy season which typically commences in the June-July period and continues through September.

The individual areas are described below. Not all areas require the same treatment and the actual placement of cover will be determined by field testing. An estimated total of 600 to 800 cubic yards of additional material may be needed in order to bring the cover thickness on the site up to the required 12-inch minimum.
