**RE: Revised 2021 CCP update for MMD Permit No. SF002RE, LAC Minerals (USA) LLC Cunningham Hill Mine**

# **CUNNINGHAM HILL MINE RECLAMATION PROJECT CLOSURE/CLOSEOUT PLAN UPDATE**

**EVALUATION OF OPEN PIT  
CLOSURE/CLOSEOUT PLAN AND  
ABATEMENT PLAN 27  
CUNNINGHAM HILL MINE RECLAMATION PROJECT  
SANTA FE, NEW MEXICO**

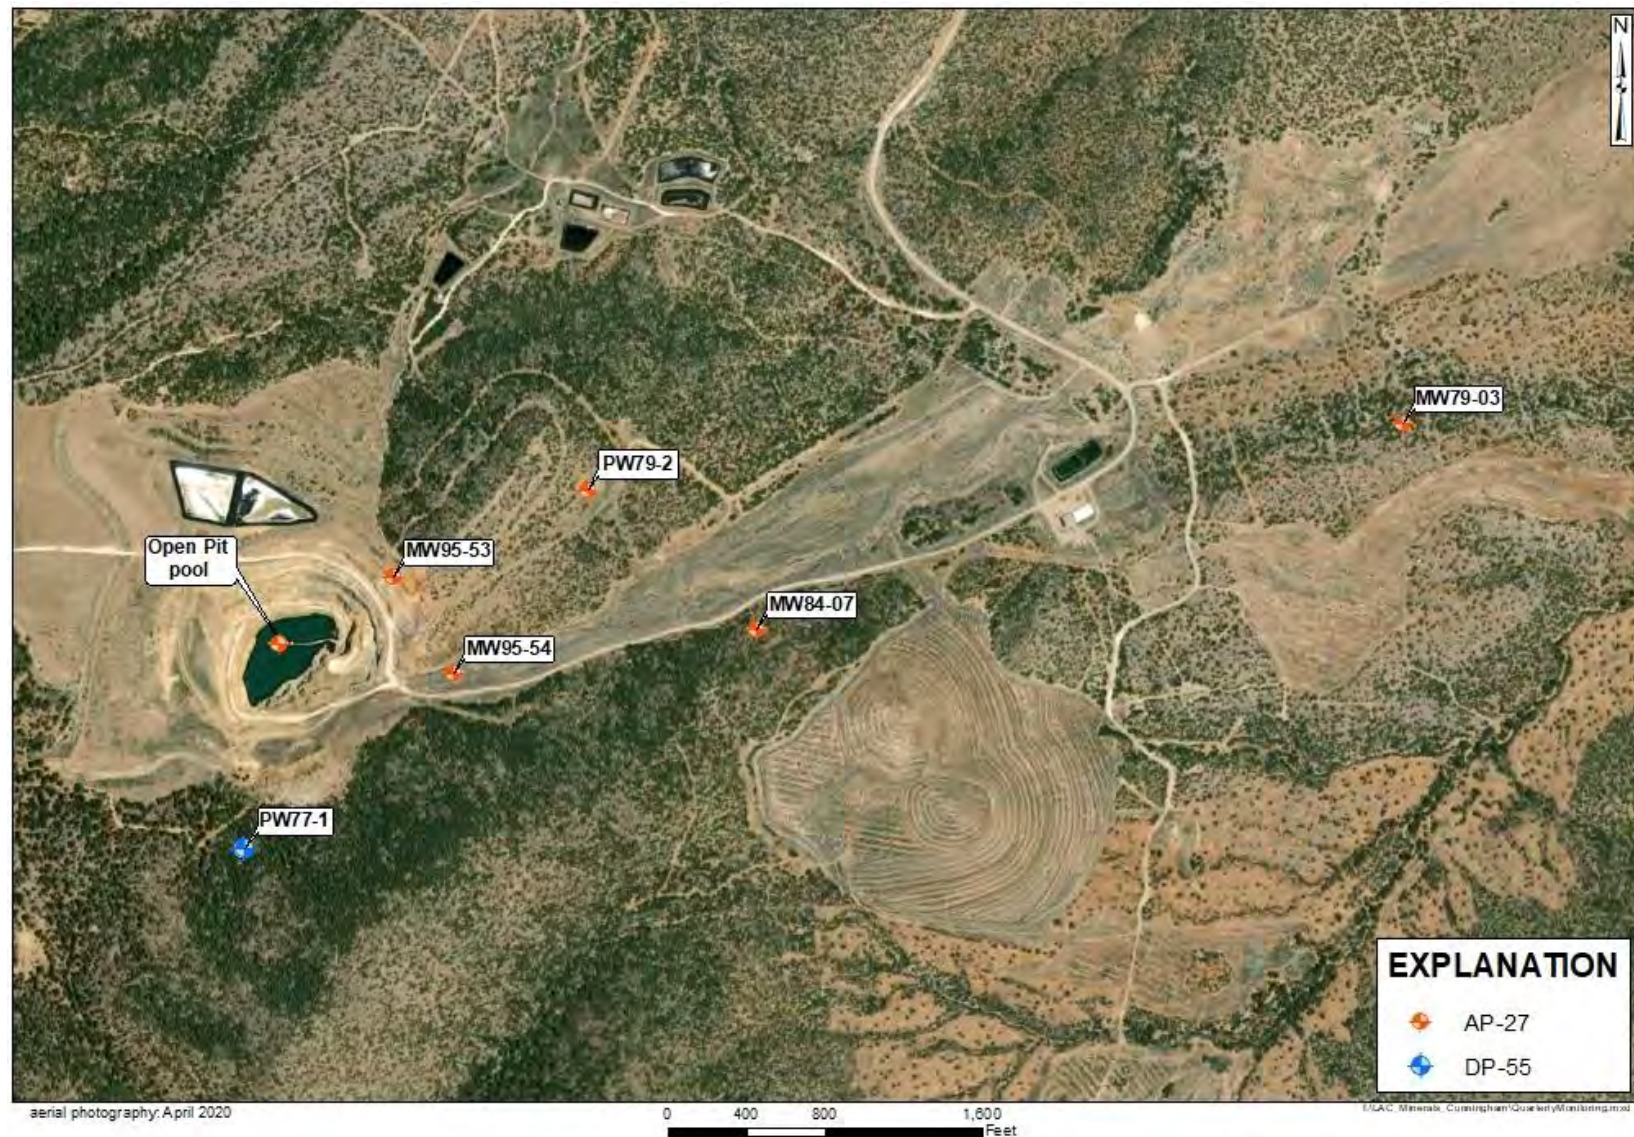
Figure 4. Map showing locations of Open Pit and surrounding monitoring wells, Cunningham Hill Mine Reclamation Project, Santa Fe County, New Mexico.

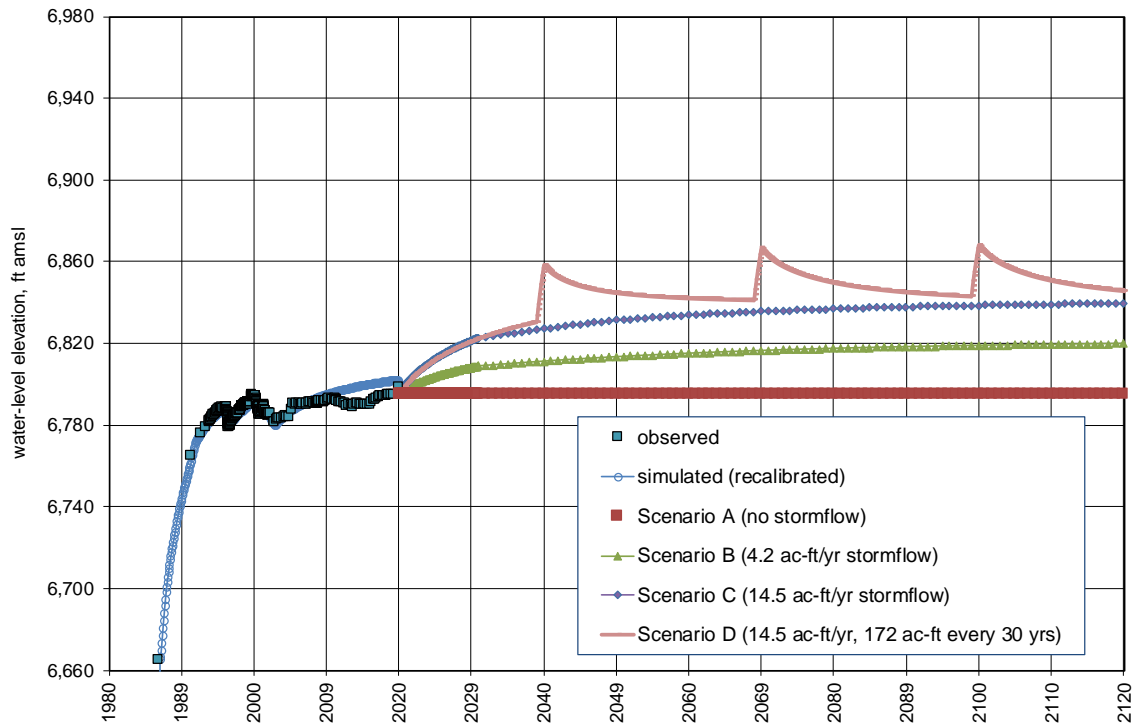
Figure 6. Graph of observed Open Pit water levels, model-calibrated water levels, and model-simulated pit filling scenarios.

The updated and recalibrated groundwater flow model (JSAI, 2011a) was used to evaluate Open Pit filling resulting from the stormwater runoff Scenarios A through C (Fig. 6). Current Open Pit water-level elevation is 6,798.5 feet above mean sea level (ft amsl). The model-predicted steady state Open Pit water level is 6,800 ft amsl, with the potential to rise to 6,840 ft amsl. Regardless of the scenario, near steady-state Open Pit water levels are observed today. The maximum expected Open Pit water level is 6,840 ft amsl (Fig. 6), which would require large stormwater events every 30 years and an average input of 14.5 ac-ft/yr of stormwater over the next 60 to 70 years. The observed rise in Open Pit water levels over the last 4 years has been at an average rate of 2.0 ft/yr (Fig. 7). The last 6 years have shown a 10-ft rise in water levels at PW77-01 (Fig. 7), indicating a change in groundwater recharge up-gradient of the Open Pit.

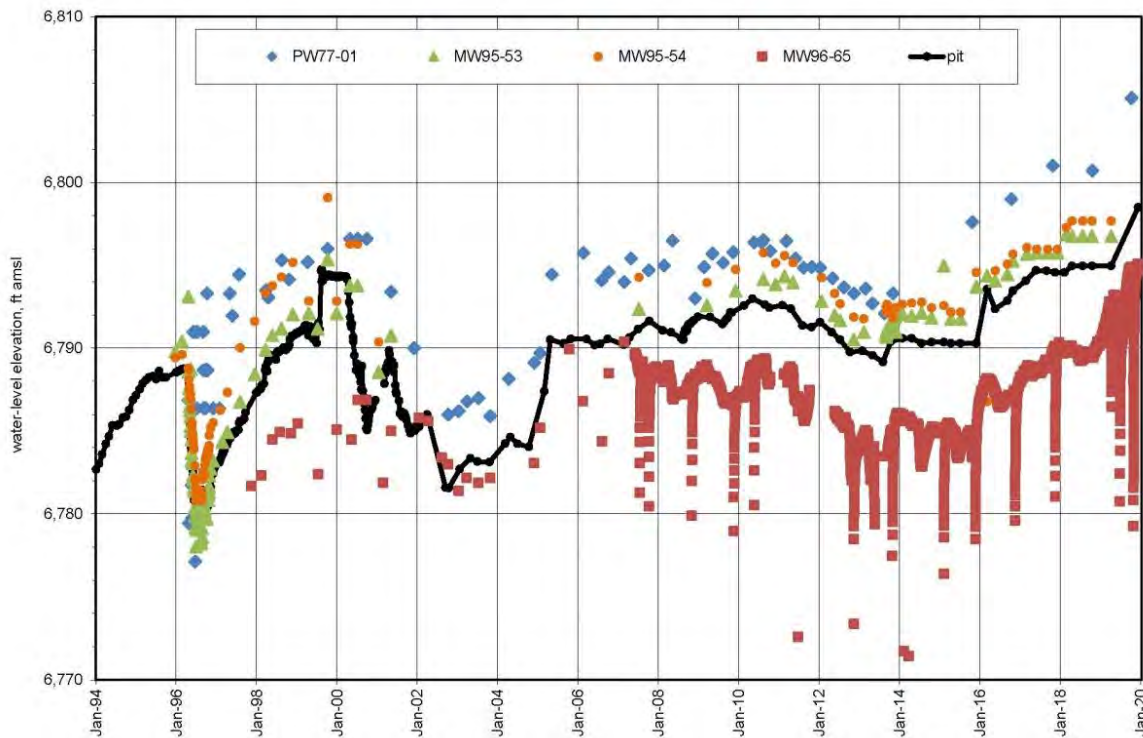
Figure 7. Graph showing observed water levels at the Open Pit and nearby monitoring wells, from 1994 through 2019.

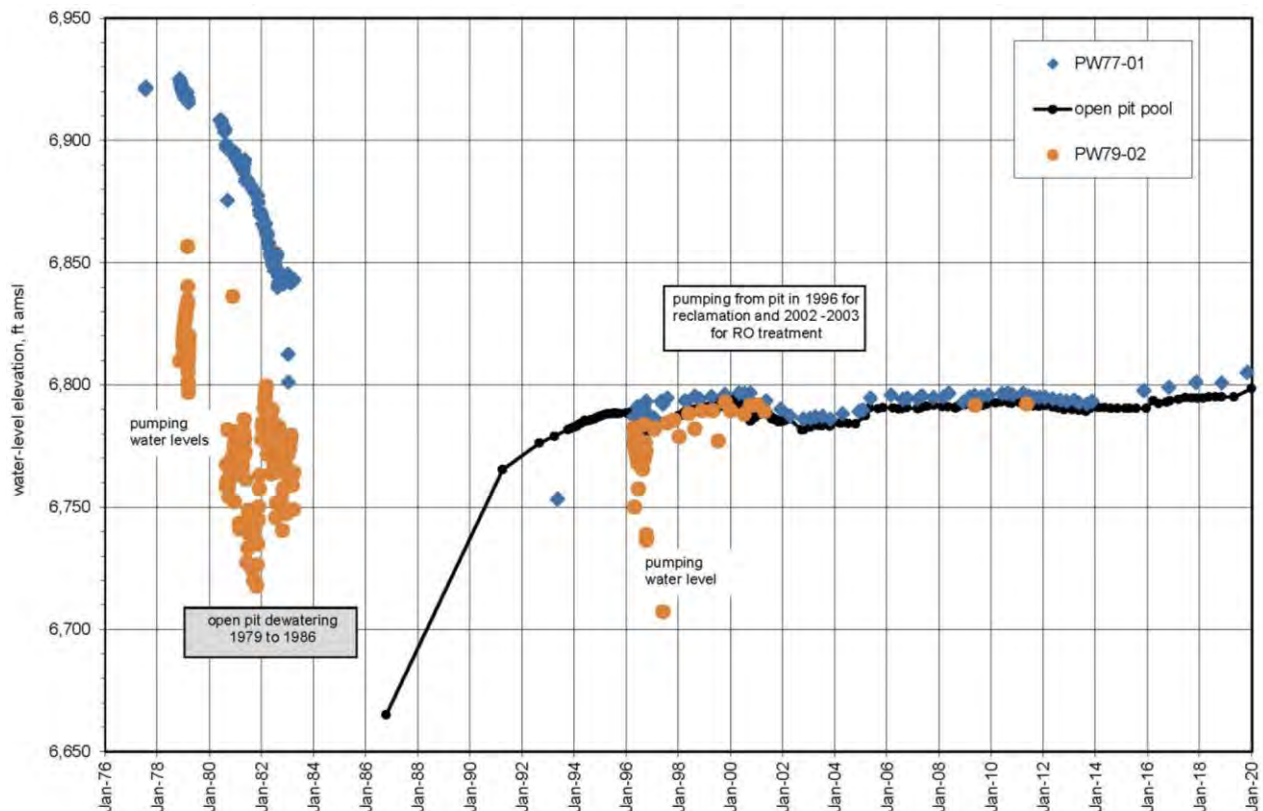
Figure 8. Graph showing observed water levels at the Open Pit and nearby dewatering wells, from 1976 through 2019.

Pre-mining groundwater levels for the Open Pit area ranged from 6,895 to 6,925 ft amsl (Hydro-Geo Consultants, 1994) (Fig. 8). The former up-gradient Open Pit dewatering well, PW77-01, had a water level of 6,920 ft amsl in 1977 (pre-mining), and currently has a water level of 6,805 ft amsl (Fig. 8). Open Pit dewatering wells PW77-01 and PW79-02 are connected to the same fracture system (Golden Fault Zone). PW77-01 is located up-gradient of the Open Pit and PW79-02 is located down-gradient of the Open Pit (Fig. 4). Water-level data from PW77-01 indicate the fracture system connected to the Open Pit has not readily recharged and recovered from dewatering during mining that occurred between 1979 and 1987. Recharge to groundwater system up-gradient of the Open Pit is needed for efficient pit filling with diverted stormwater.

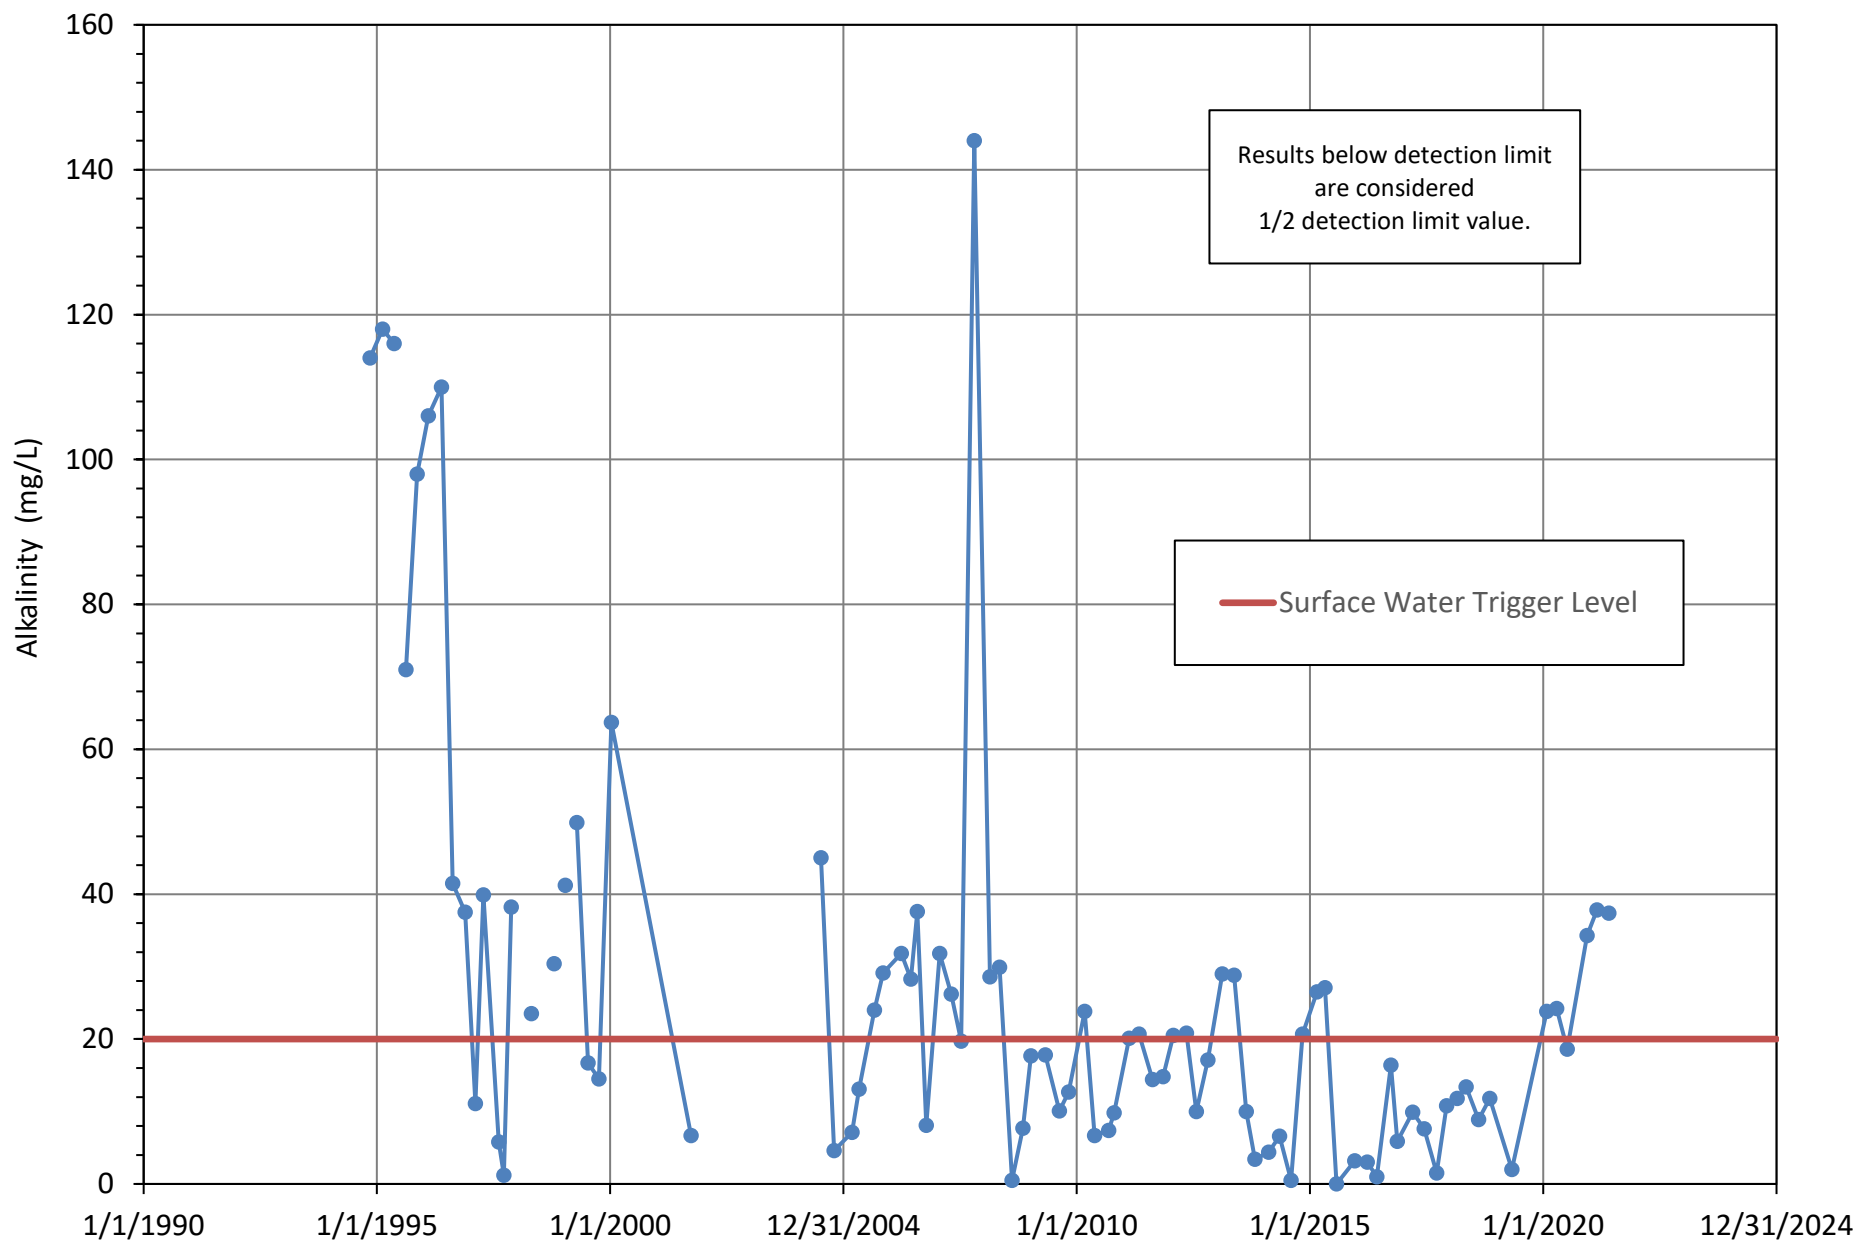
Figure A3. Time-series graph of Alkalinity, 4 ft depth CHMRP Open Pit water body.
