Re: Modification to Tyrone Mine Permit No. GR007RE
Revision 14-1, Request for Approval of Precambrian Granite as a
Reclamation Cover Material and Termination of USNR Test Plot Study

**Modification to Tyrone Mine Permit
No. GR070RE Revision 14-1, Request
for Approval of Precambrian Granite
as a Reclamation Cover Material and
Termination of USNR Test Plot Study
August 2, 2022**

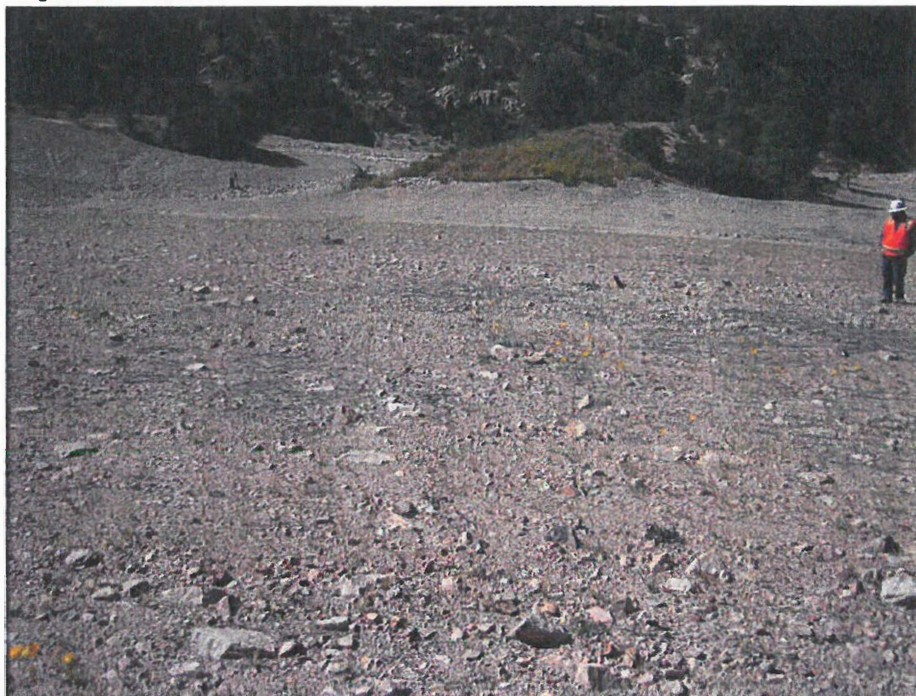
Figure 1. Status of vegetation on the ESMA treatment (October 2016)

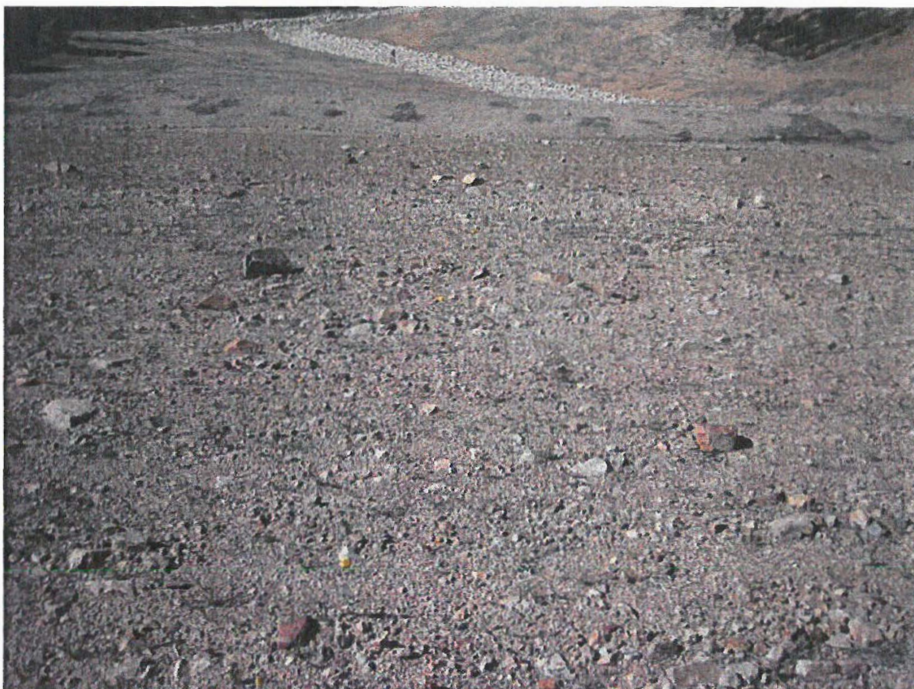
Figure 3. Status of vegetation on the ESMB treatment (October 2016)

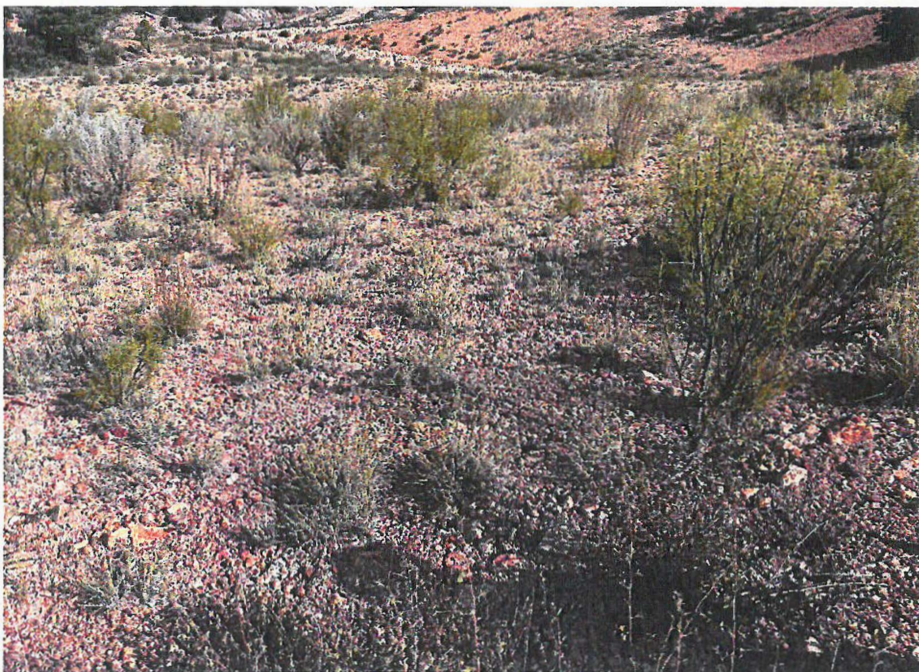
Figure 4. Status of vegetation on the ESMB treatment (July 2022)

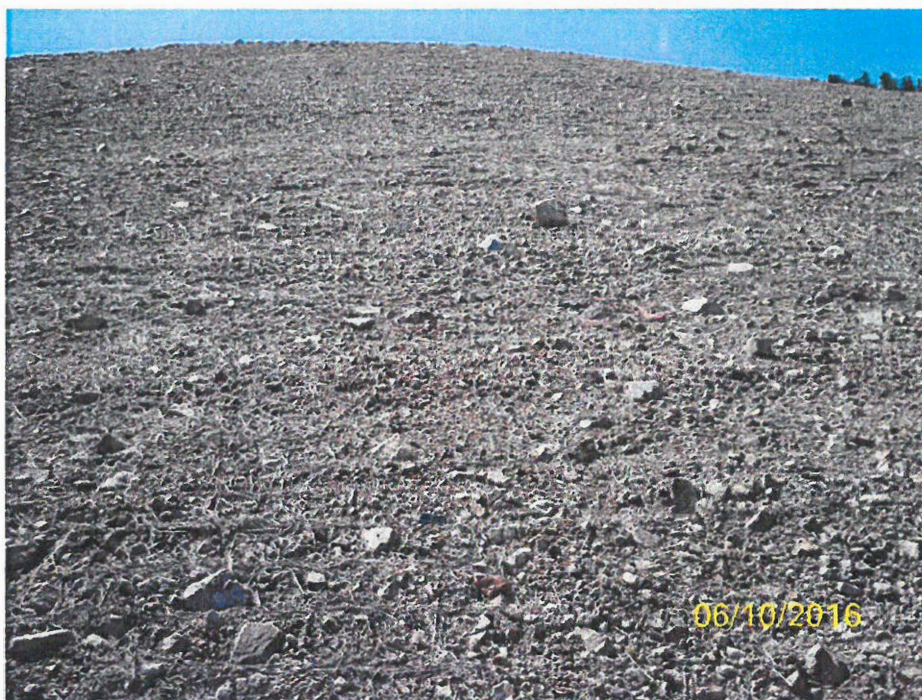
Figure 5. Status of the vegetation on the CSMA treatment (June 2016)

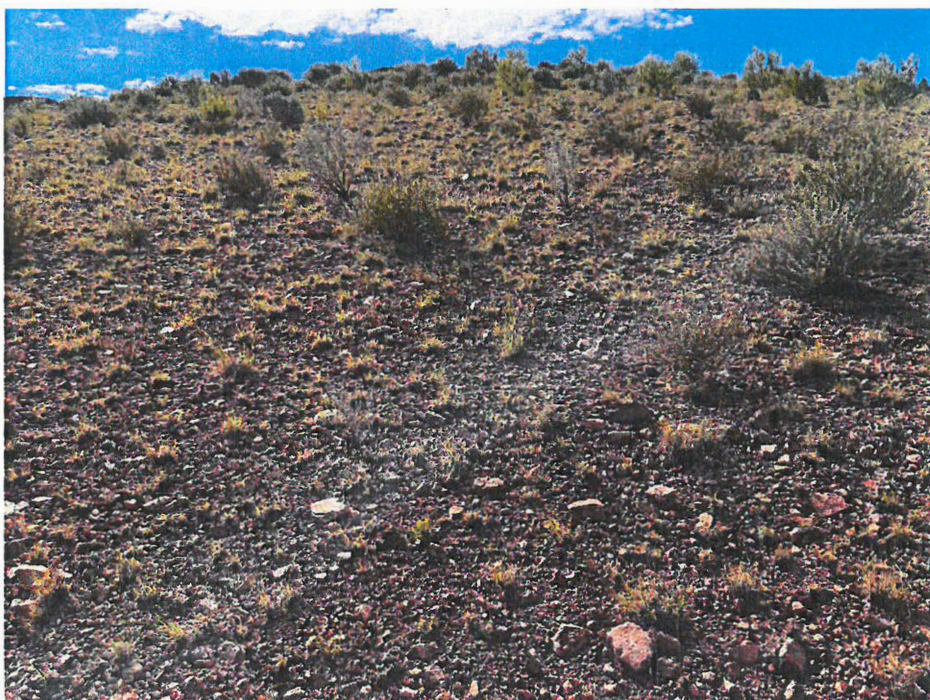
Figure 6. Status of the vegetation on the CSMA treatment (July 2022)

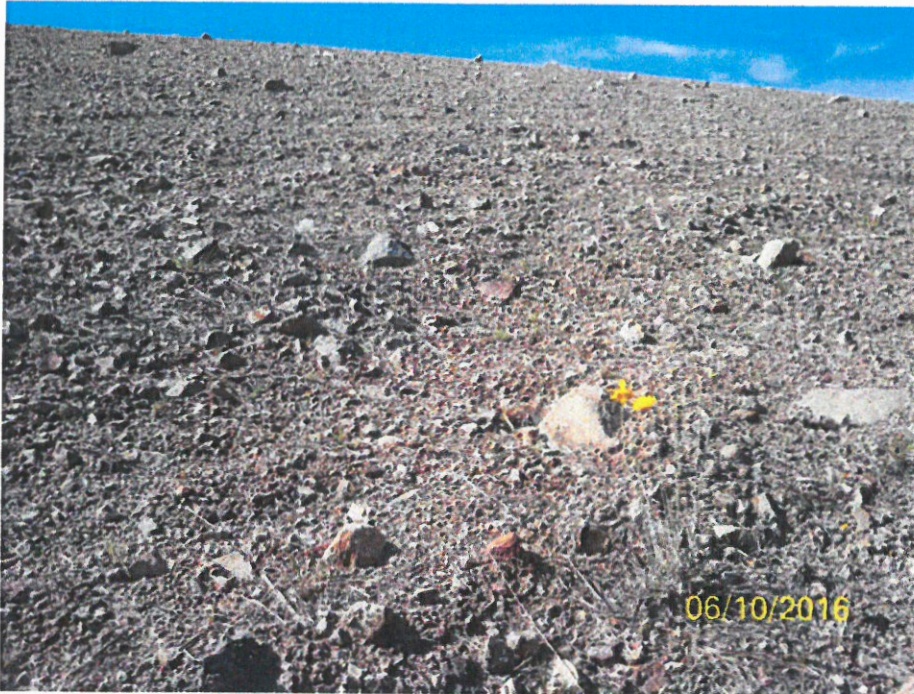
Figure 7. Status of the vegetation on the CSMB treatment (June 2016)

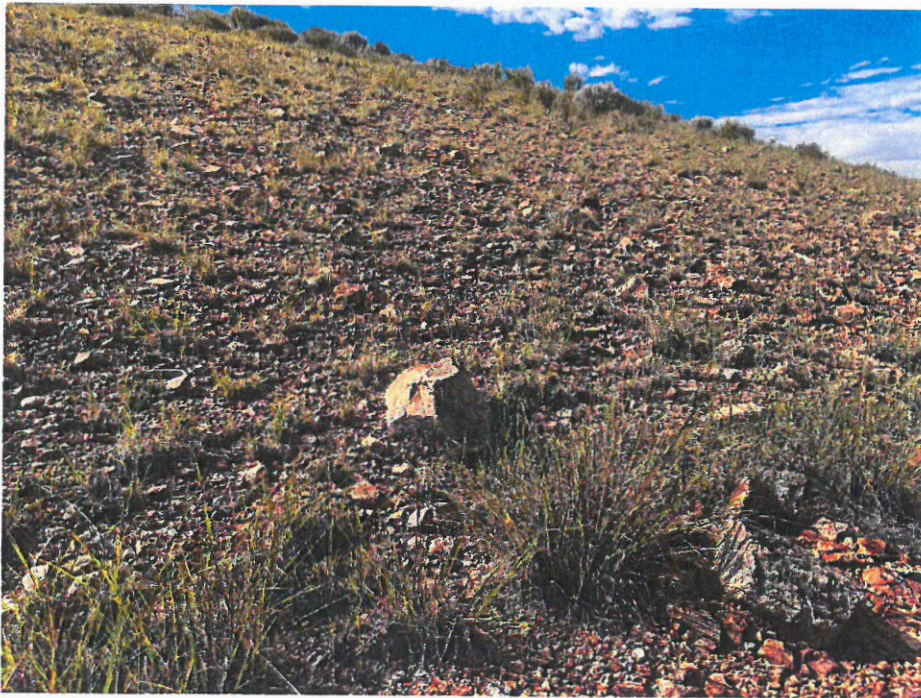
Figure 8. Status of the vegetation on the CSMB treatment (July 2022)

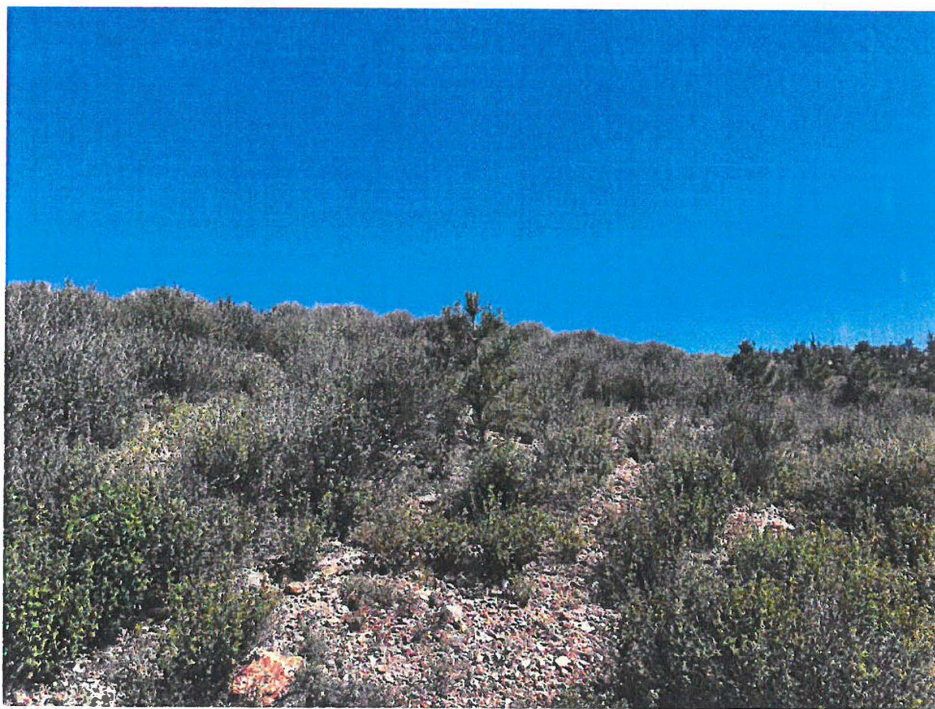
Figure 10. Copper Leach Stockpile reclamation side slope (July 2022)

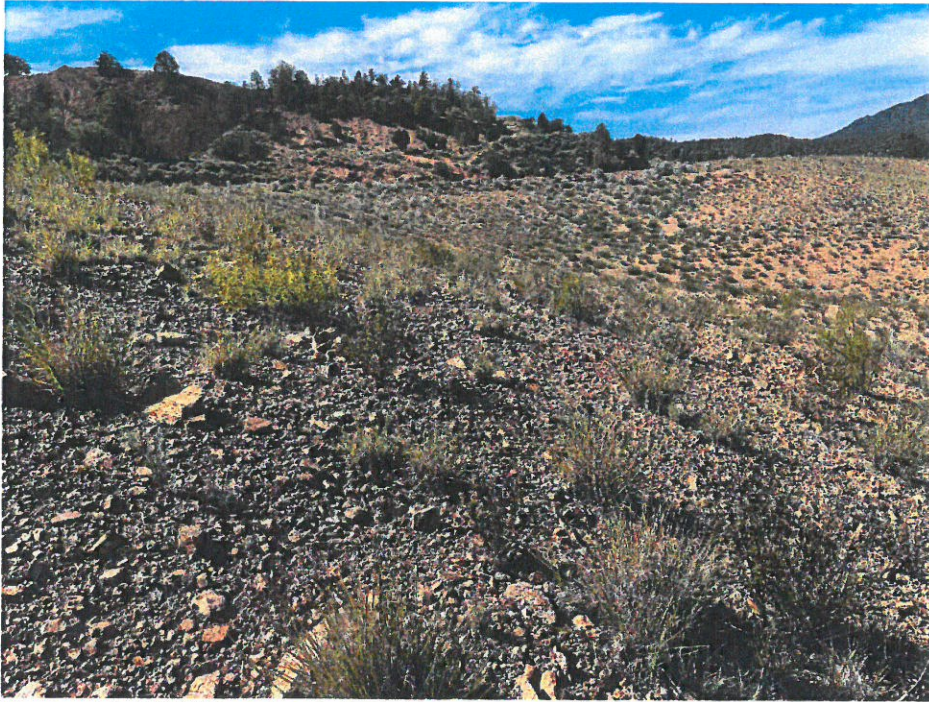
Figure 11. USNR reclamation site upper north facing slope (July 2022)

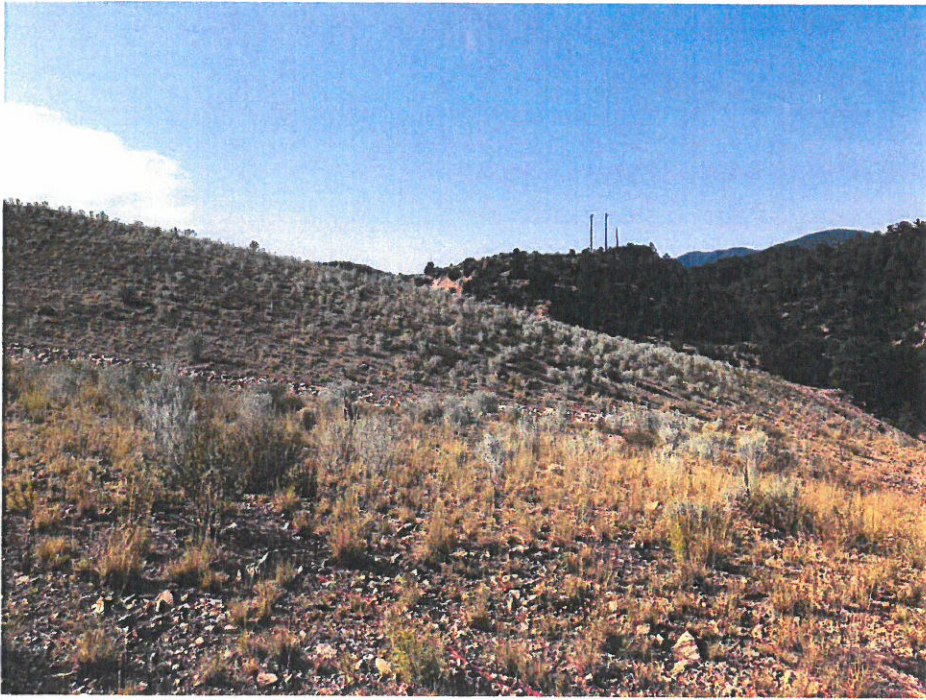
Figure 12. USNR reclamation site, upper south facing slope in foreground (August 2020)
