Closeout Plan Completion Report
South Pit Mine Minimal Impact Operation
Permit No. SA004MN

October 2022

THE ESPANOLA MERCANTILE COMPANY

2021 Reclamation Monitoring Report Copar South Pit Mine

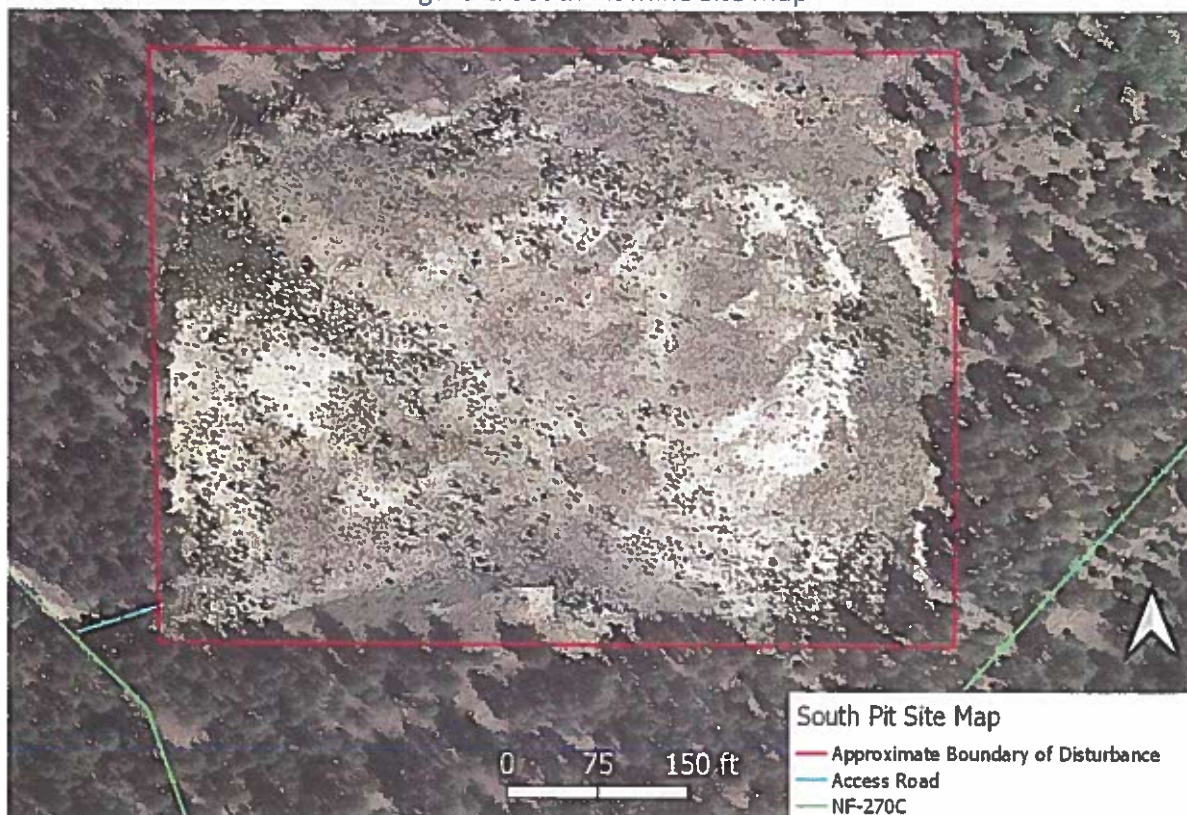
Figure 2. South Pit Mine Site Map

No waste dumps, pits, ponds, plant sites, haul roads, or facilities remain at the South Pit Site.
