The purpose of this letter is to request a permit modification for the Silver Silica Mine, Permit No SF003ME. I am requesting the release of the financial assurance currently required on the permit. I have attached a copy of the Silver Silica Mine Inspection and Survey Report which was conducted in September of 2022.

MINING INSPECTION & VEGETATION SURVEY REPORT

Name of Operator:	Oro Blanco Mining Co. LLC/Beth Chavez		
Name of Mine:	Silver Silica Mine		
Address:	120 Oro Quay Rd. Sandia Park, NM 87047		
Permit Number:	SF003ME		
Commodity:	Silica	<input checked="" type="checkbox"/> SURFACE	<input type="checkbox"/> UNDERGROUND
Date of Inspection:	September 15, 2022		
Time of On-Site Inspection:	9am – 10:45am		
Weather Conditions:	Sunny, ~65°F		
Purpose of Inspection:	Annual		
Lead Inspector:	Carmen Rose		
Present During Inspection:	Oro Blanco Mining Co.: Beth Chavez MMD: Carmen Rose & Linda DeLay		
ENFORCEMENT ACTION TAKEN:	None		
NOTICE OF VIOLATION: #	___	YES: ___	NO: <u>X</u>
CESSATION ORDER:		YES: ___	NO: <u>X</u>
Time: On-Site:	<u>2</u>	Permit Review:	<u>0.5</u> Travel: <u>2</u> Report Writing: <u>1</u>
TOTAL INSPECTION TIME:	<u>5.5</u> HOURS		
NOTE:	<p>Site Access: Continue sou

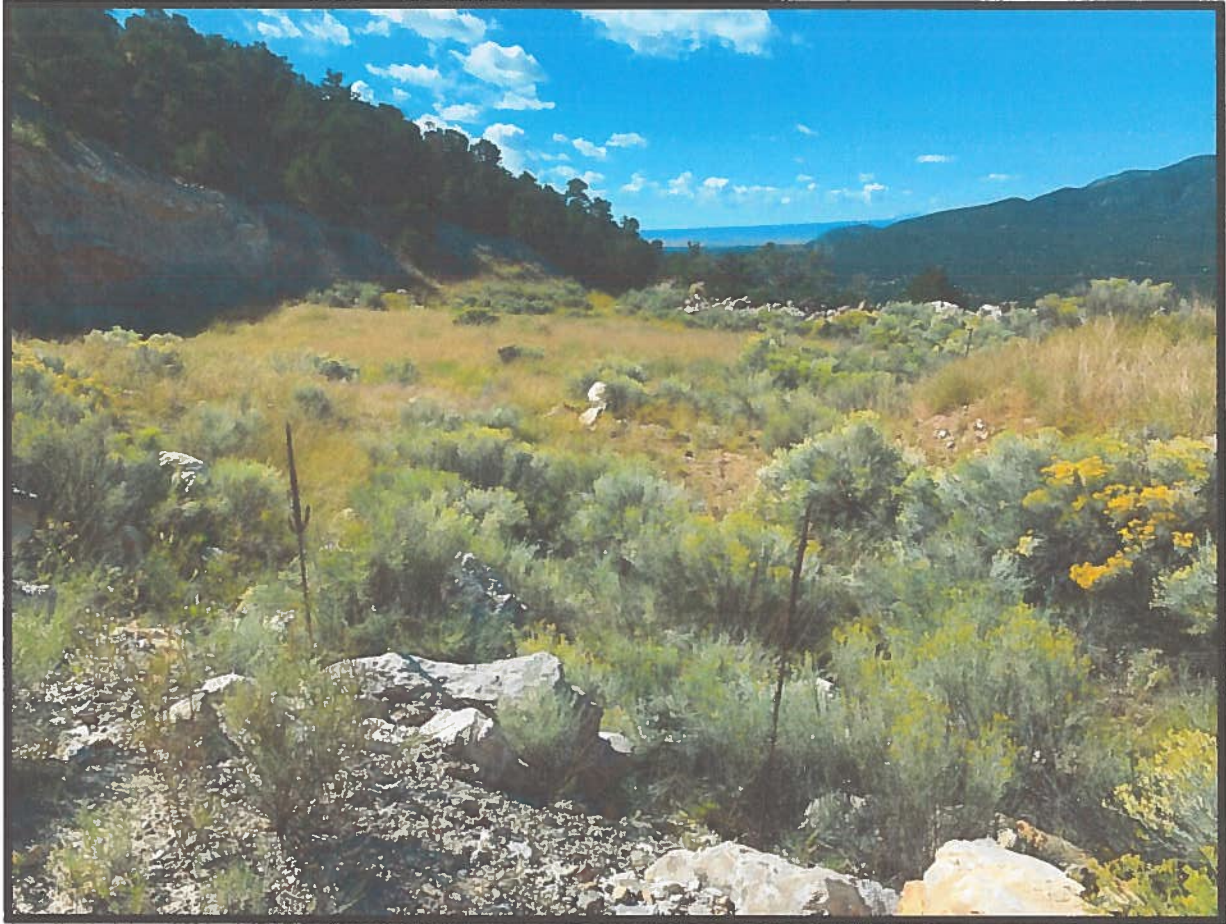
unit to record the exact acreage that was reclaimed. Boulders and/or earthen berms were established along the perimeter of the reclamation with an opening at the southern tip to allow discharge of stormwater onto native undisturbed ground. The reclamation is somewhat domed in the center to discourage ponding. No signs of erosion were found.

Figure 8. Looking south at the reclamation

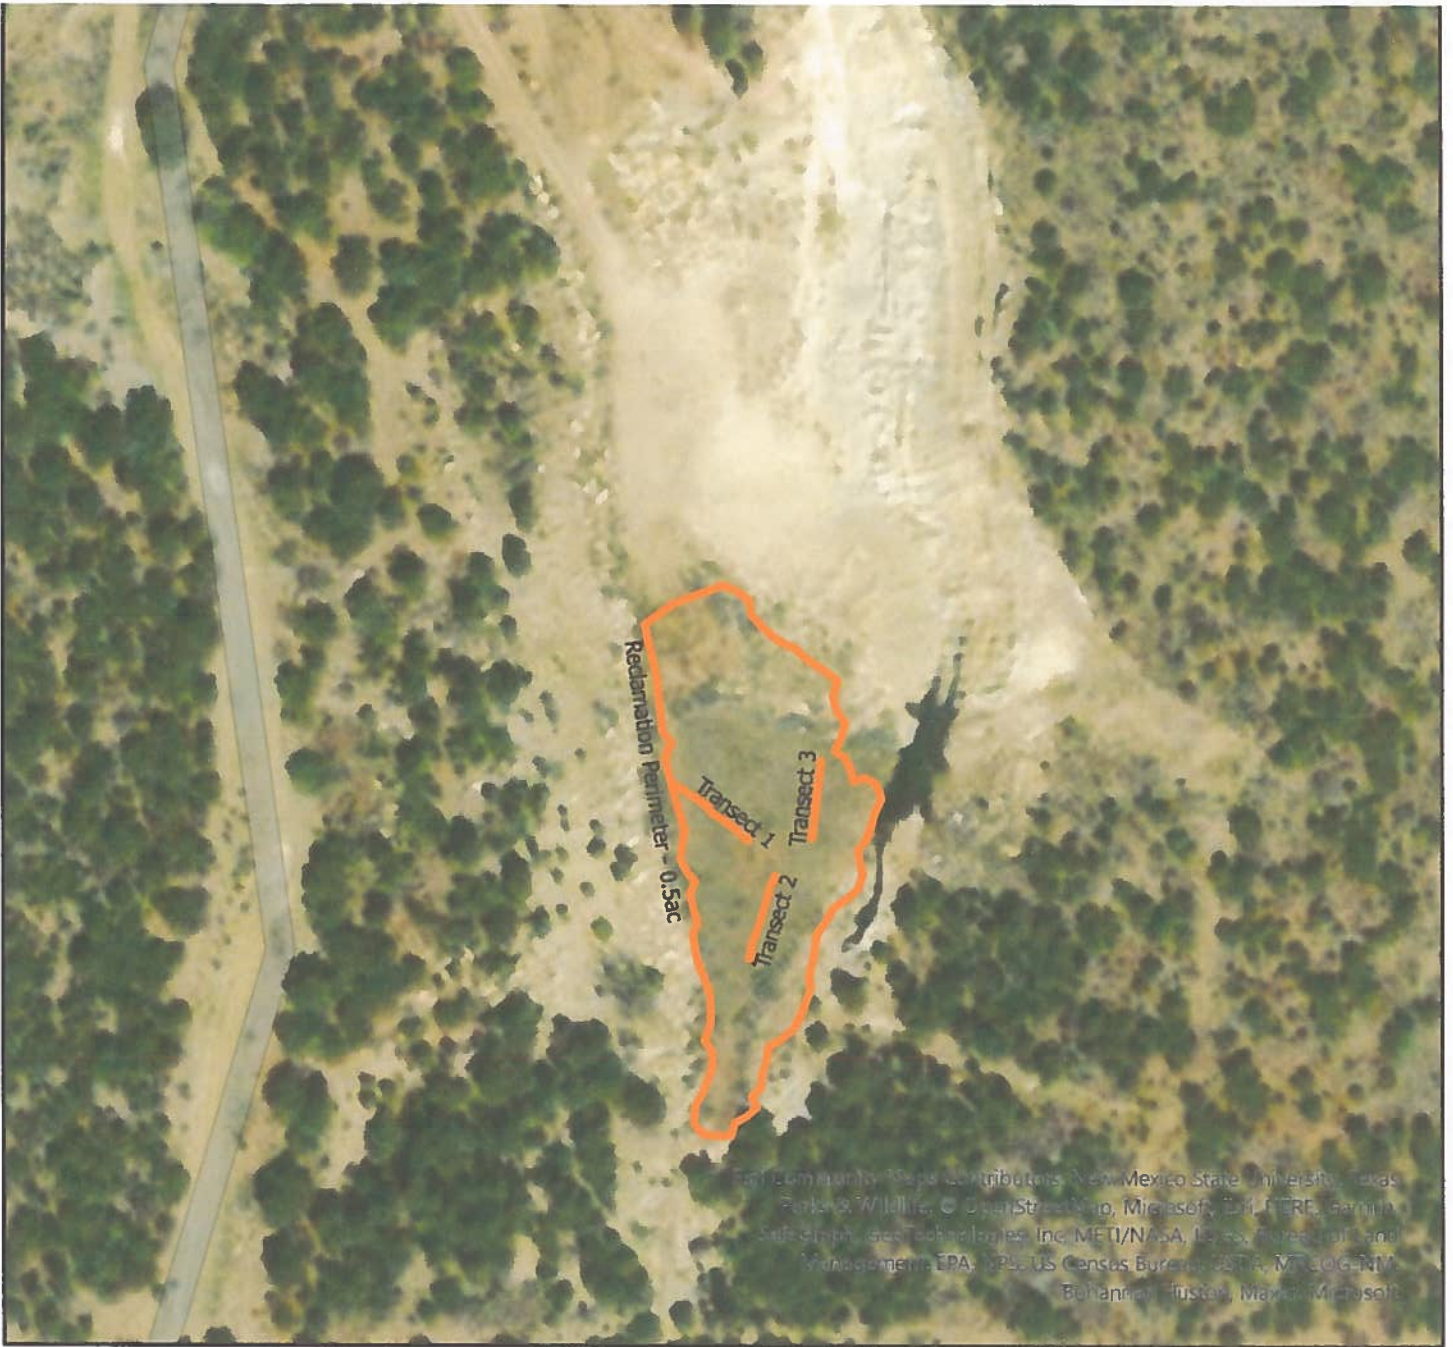
Silver Silica Mine (SF003ME)
 September 15, 2022
 Vegetation Survey Transects
