# MINIMAL IMPACT EXPLORATION OPERATION

## PERMIT APPLICATION

Name: Curiosity Exploration LLC

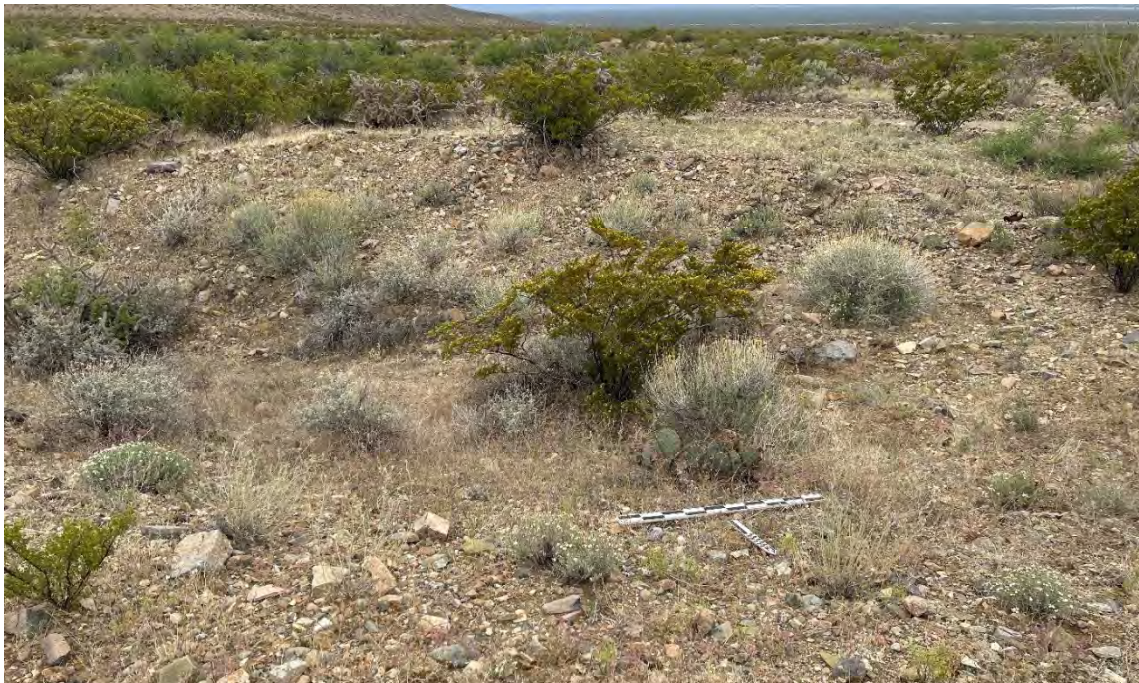
Feature 1 is a large, mechanically excavated prospect pit oriented roughly northwest–southeast (**Photo 3**). The feature is located on the north side of Still Ridge Road. Spoils are piled on the northeast and southwest edges of the feature. A small pit has been excavated in the bottom of the feature pit with a shovel, though it is unclear to what purpose. Artifacts associated with the feature include an oil filter ( $n = 1$ ), steel flat top beverage cans with church key openings ( $n = 2$ ), motor oil cans ( $n = 2$ ), and sanitary food cans ( $n = 2$ ).

**Photo 3.** Feature 1, a prospect pit at LA 208570, view to the southeast

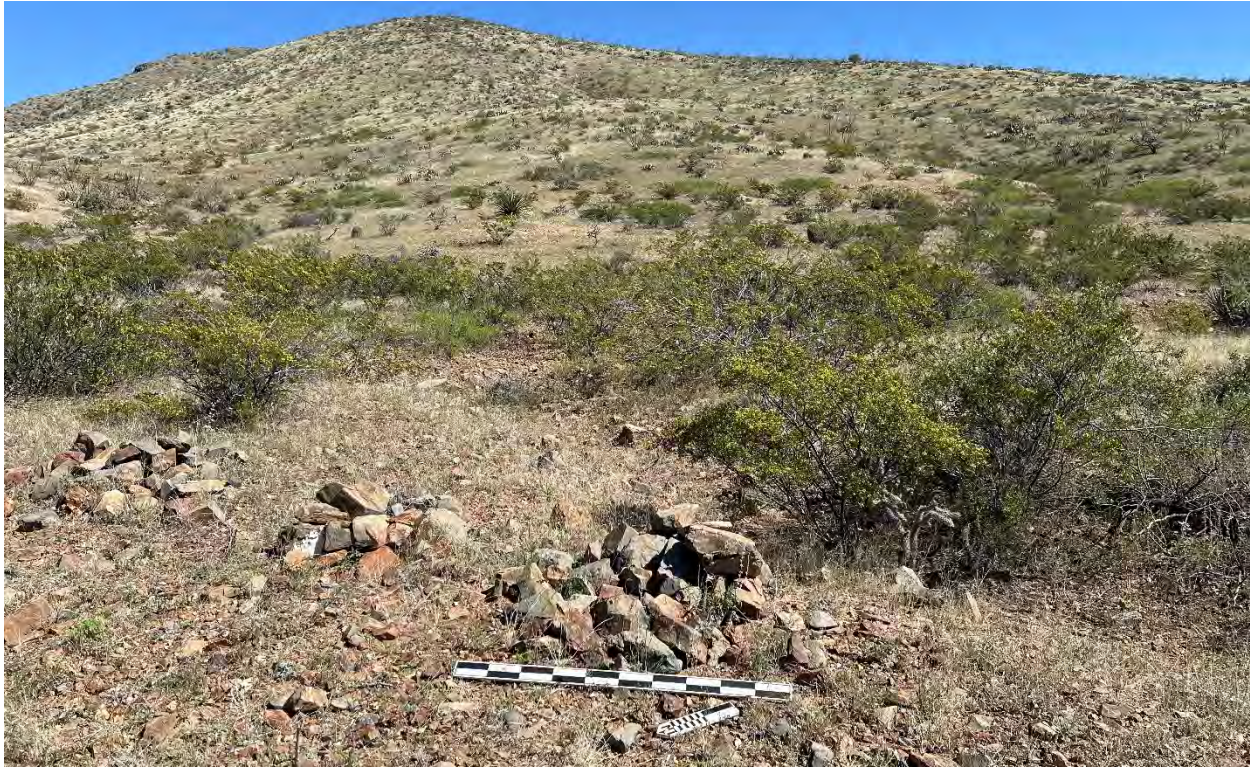
**Photo 5. Features 1 (right), 2 (center) and 3 (left) at LA 208571, view to the southeast**

Feature 3 is a partially collapsed cairn composed of an estimated 40 to 50 rocks (see **Photo 5**). Individual rocks are volcanic in character, likely andesite, and measure up to 30 cm in maximum dimension. A faded Prince Albert hinged lid tobacco tin is present inside the feature, indicating it likely functioned as a claim marker, though no documents were contained within. A small fragment of wood is also present in the feature, likely the remains of a post.

**Material Culture:** The surface assemblage was fully documented. The assemblage consists of hinged lid tobacco tins associated with Features 1 and 3 ( $n = 2$ ). Both cans have faded lithography but are Prince Albert brand with hinged lids, which date from 1913 to 1960 (Rock 1989). The only other artifact present on the site is a sheet of ferrous scrap metal located southeast of the features ( $n = 1$ ).

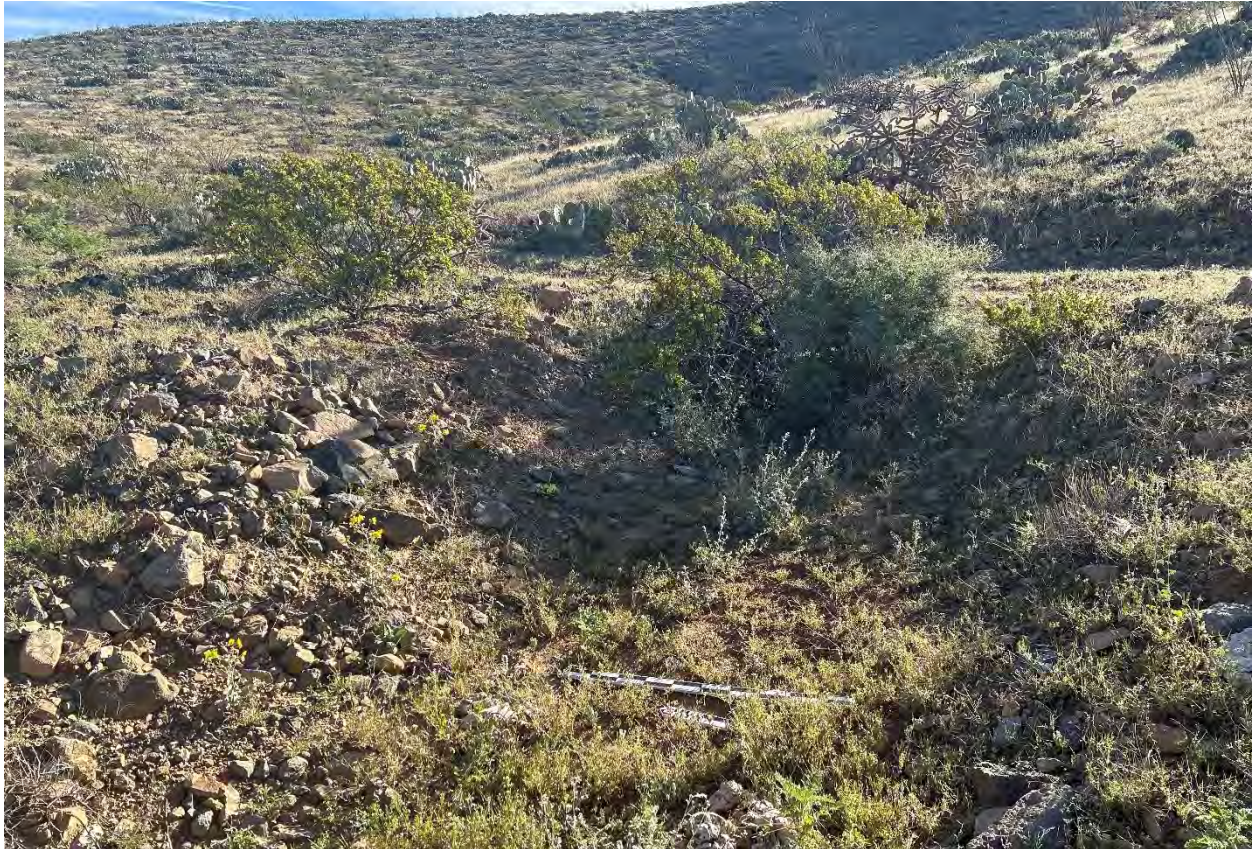
**Photo 7. Feature 1, a prospect pit at LA 208572, two-track at center behind shrubs, view to the northeast**

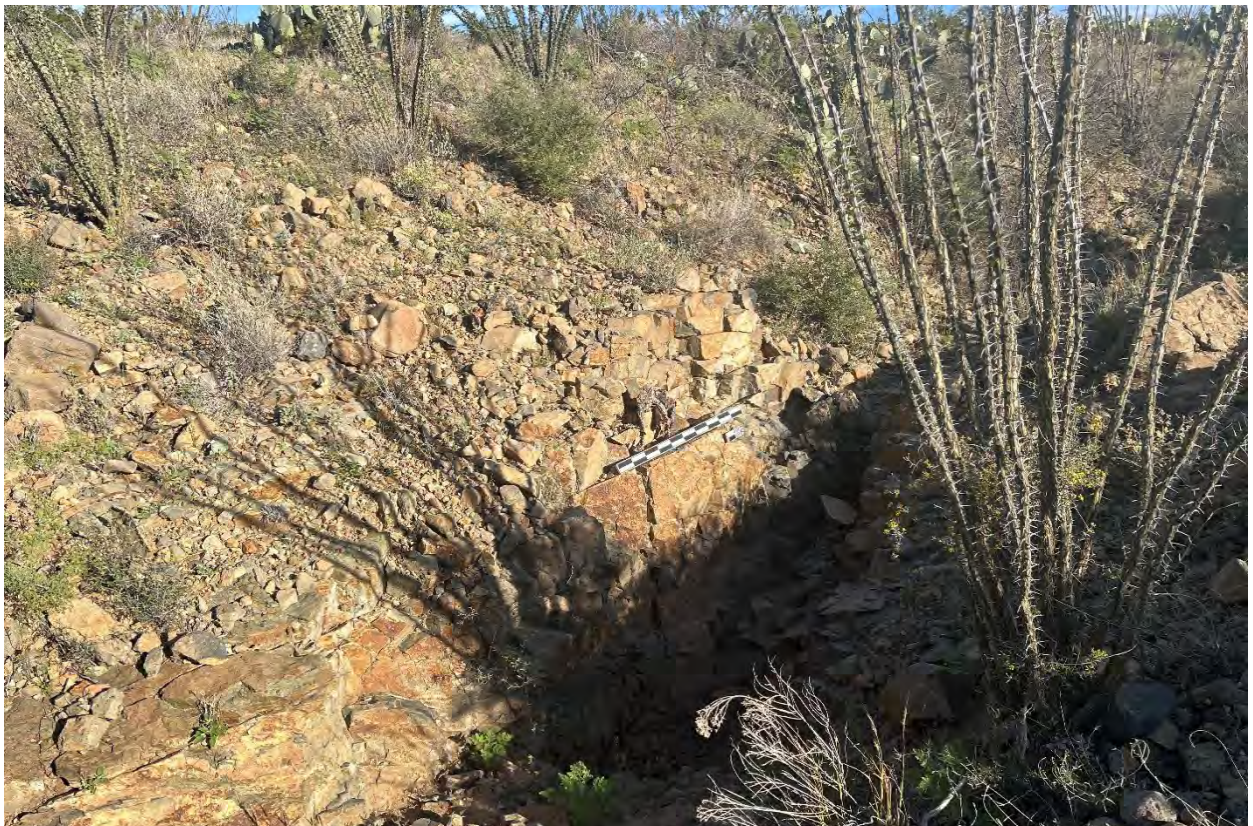
**Photo 8. Feature 2, a mining cut at LA 208572, view to the northwest**

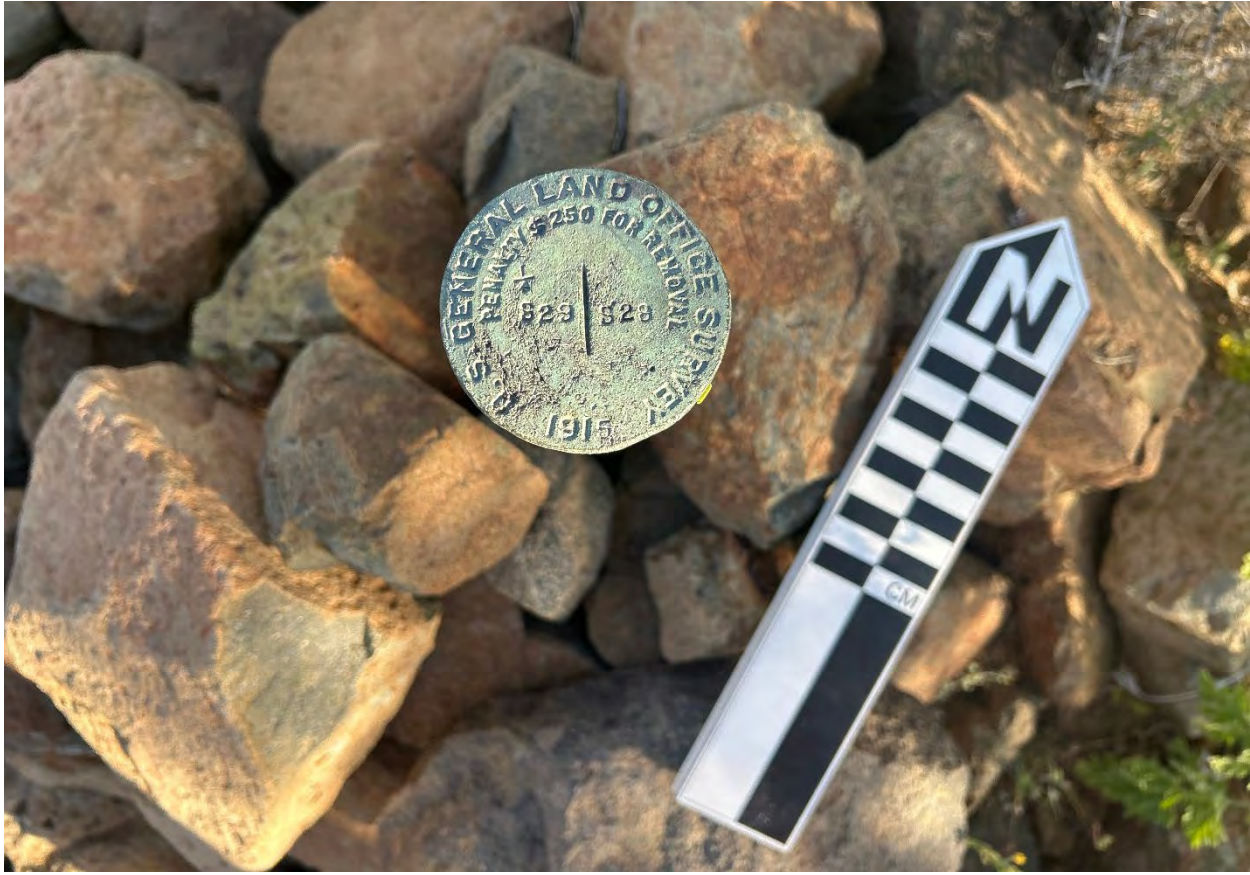
Feature 3 is a cairn composed of an estimated 50+ rocks housing a brass U.S. GLO ¼ section survey marker (**Photo 9**). The feature has partially collapsed and is eroding downslope to the southwest. Individual rocks are volcanic in character, likely andesite or diorite, and measure up to 30 cm in maximum dimension. The survey monument marks the ¼ section at the boundary of Sections 29 and 28 and is dated 1915. No artifacts are present in association.

Photo 9. Feature 3, a U.S. GLO  $\frac{1}{4}$  section marker at site LA 208572, plan view

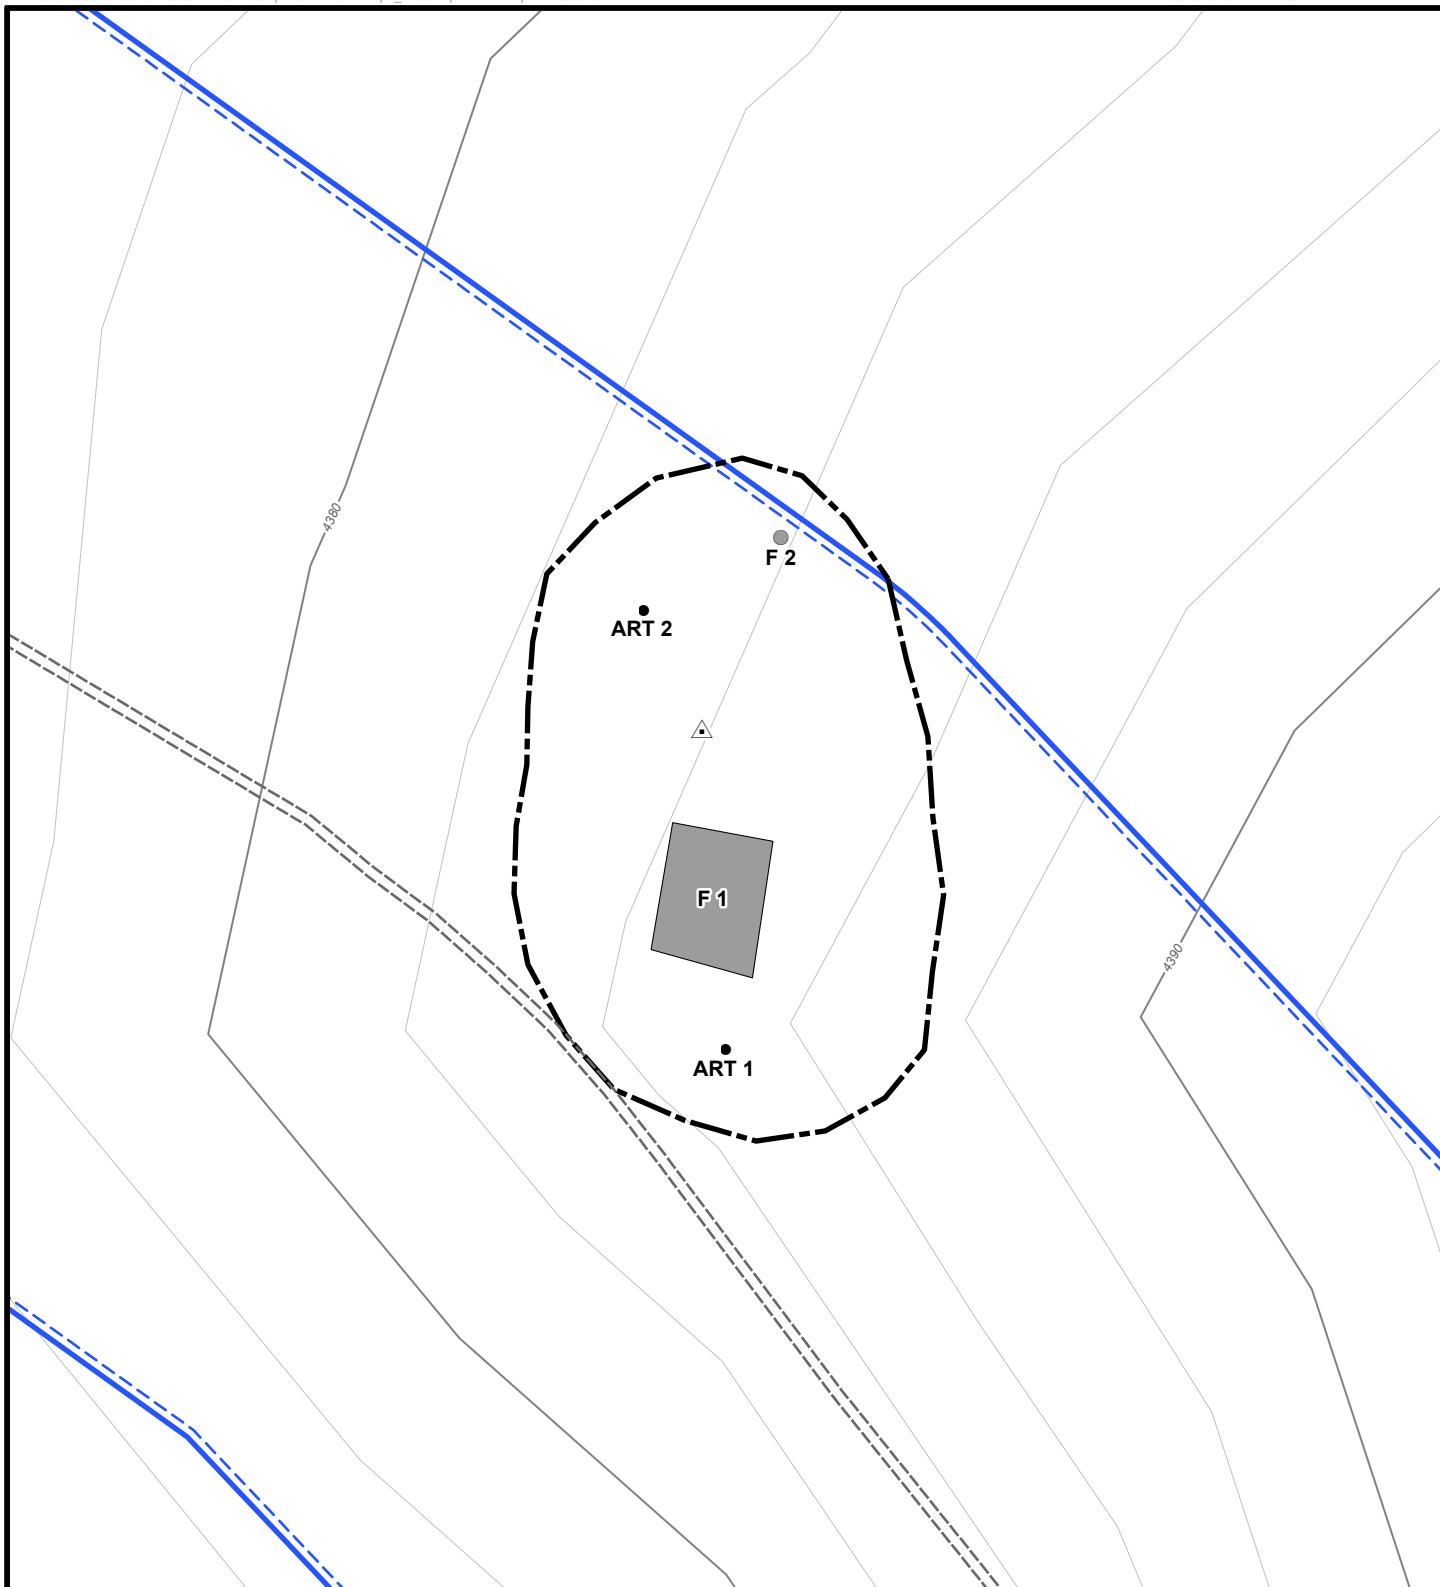
Figure 7. LA 208573 site map

**Site Description:** Site 208573 is a newly identified historic camp site consisting of the remains of a tent pad, a depression of unknown function and a small scatter of cans (see **Photo 10; Figure 7**). Two prehistoric artifacts are also present as non-contributing, underlying isolates.

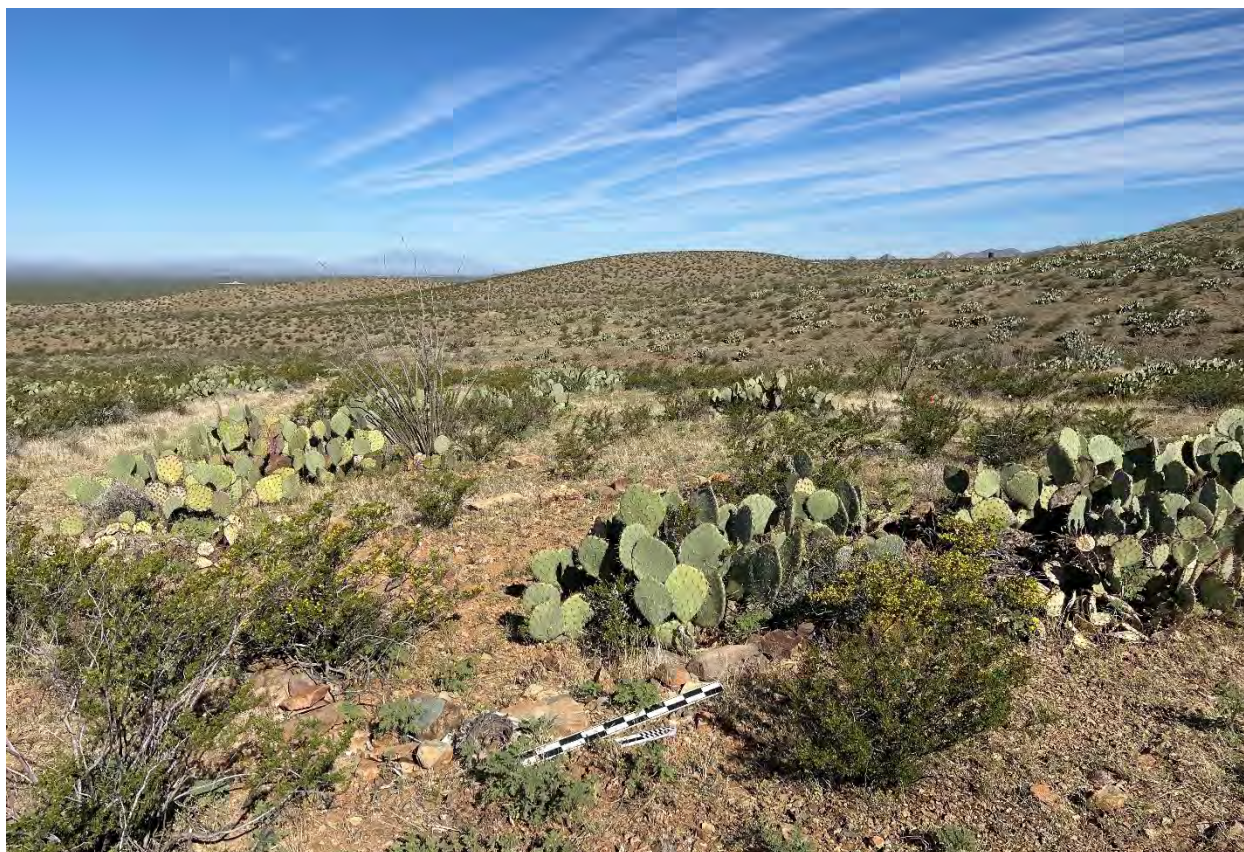
Photo 11. Feature 1, a tent base at LA 208573, view to the northwest

Feature 1 is a rectangular rock alignment representing the outline of a canvas tent platform (**Photo 11**). The stacked rock alignment is formed with locally procured and unmodified volcanic cobbles, likely andesite, though the amount of material is insufficient to represent the remains of a rock walled structure. Likewise, no evidence or remains of any superstructure was observed. The interior surface of the feature appears to have been leveled and all large rocks removed, indicating this likely served as the interior floor of a canvas tent. Much of the feature has been overgrown by prickly pear and creosote. A pack rat midden completely obscures the northeast corner. Small fragments of wooden post are present in association with this midden, likely brought in from a nearby claim marker. The only other associated artifact is a small fragment of cast iron which appears to be from a wood stove.

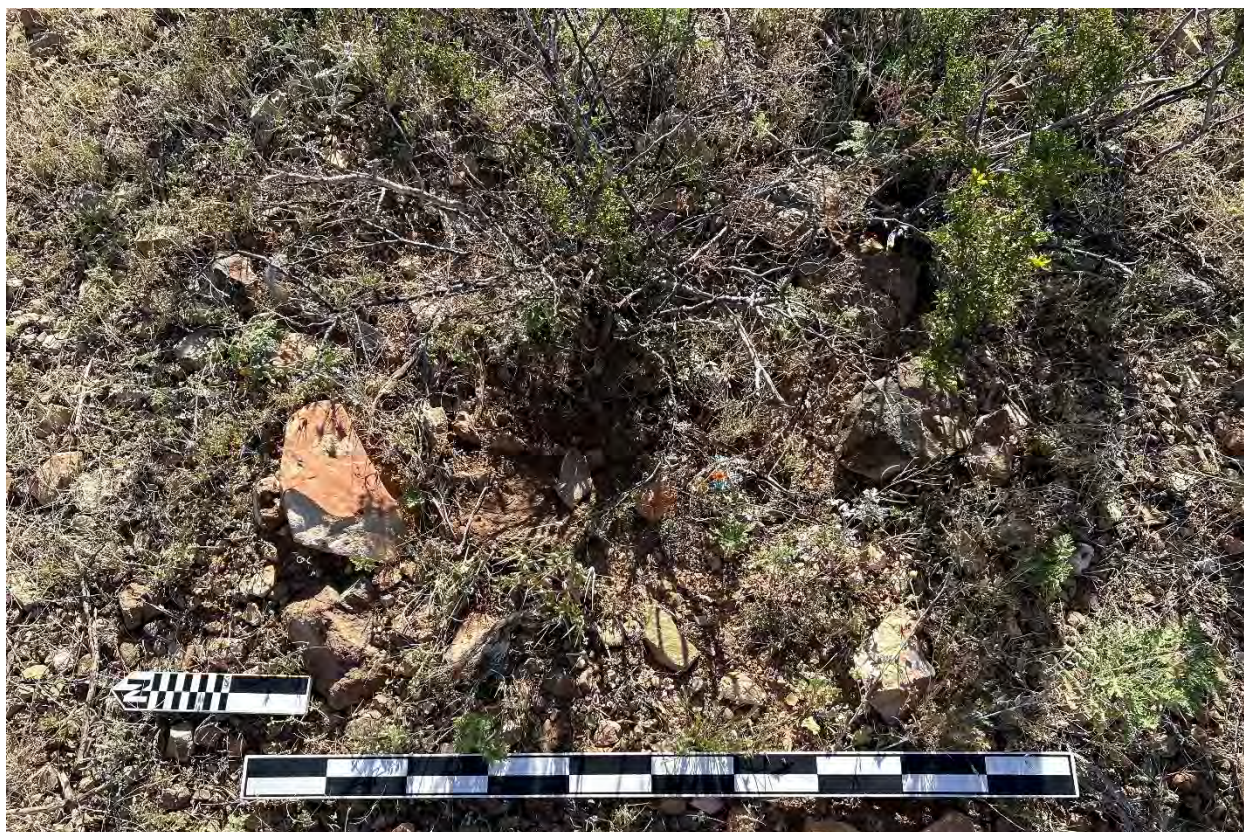
Feature 2 is a shallow, circular depression ringed with rock and of unknown function (**Photo 12**). The interior is overgrown by creosote. No ash/charcoal staining or any other evidence of thermal activity was observed. No artifacts are present in association with the feature. Potentially, the feature represents the remains of a shallow, infilled privy.

Photo 12. Feature 2, a depression at LA 208573, plan view

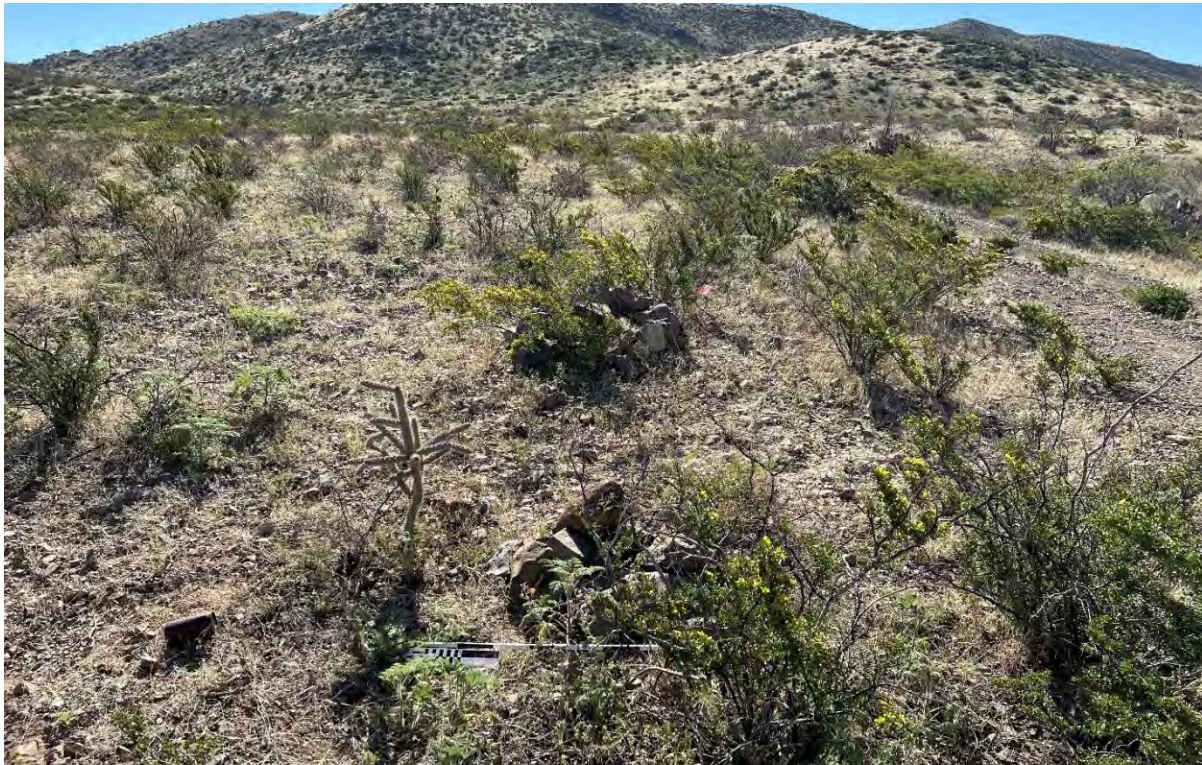
Photo 14. Features 2 (foreground) and 3 (center), cairns at LA 208574, view to the east

Feature 2 is a cairn composed of an estimated 15 locally procured volcanic cobbles (**Photo 14**). The feature is located near the edge of a two-track road approximately 3 m northwest of Feature 3. The feature has partly collapsed and is somewhat overgrown by cholla and various forbs. Associated artifacts include a bimetal pull tab can and a fragment of a wooden stake, though the can may be related to use of the two-track road which runs just west of the feature.

Feature 3 is a cairn composed of an estimated 40 locally procured volcanic cobbles located near the edge of a two-track road, approximately 3 m southeast of Feature 2 (see **Photo 14**). The feature has partially collapsed. Red paint is spattered on some rocks comprising the feature. A small fragment of wooden stake is present in association with the feature.

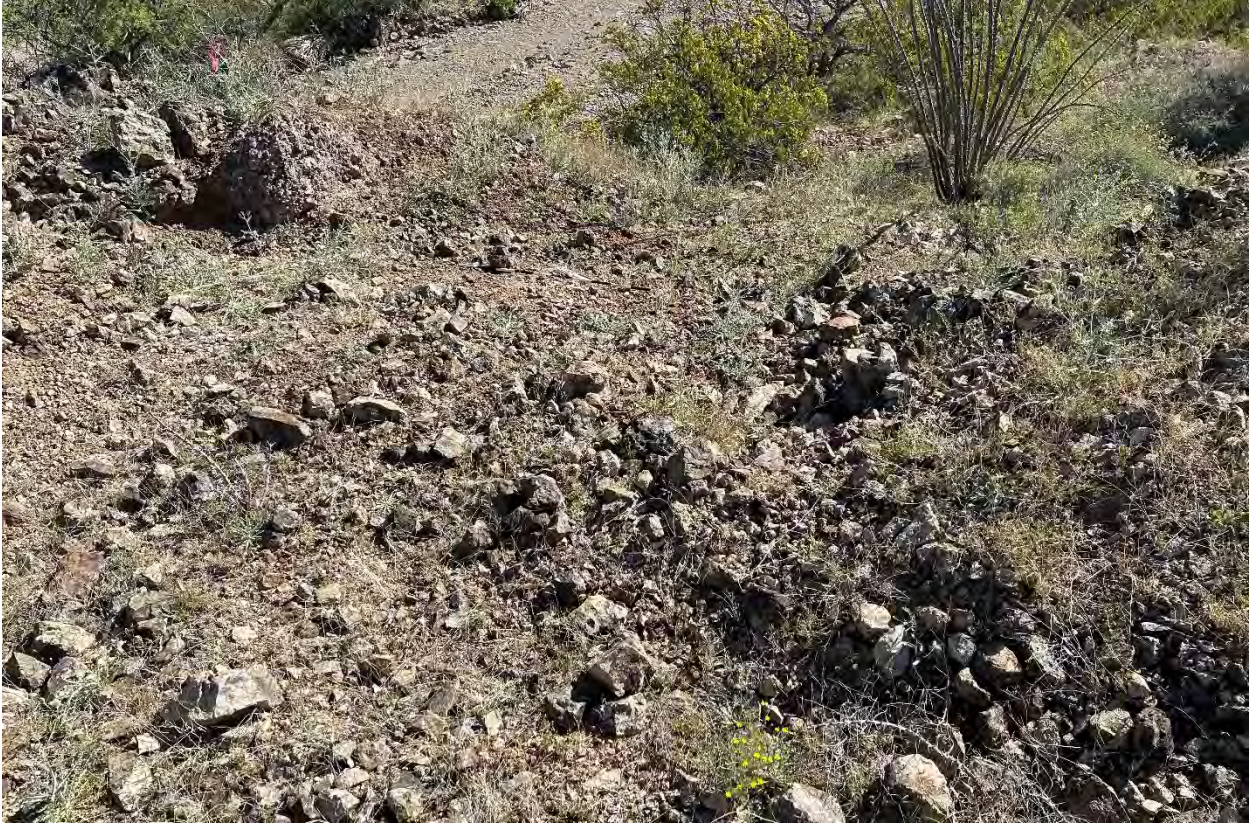
**Photo 16.** Feature 8, mining cut and spoil pile at LA 208574, view to the northeast

Feature 8 is an area disturbed by stepped exploratory mining cuts (**Photo 16**). Three benched areas have been excavated into the northeast face of the landform which opens into the canyon below. The uppermost of these is located just below the top of the landform while the lowest is just above the canyon floor. An associated pile of tailing is primarily located on the south side of the feature. Some of this spoil may be related to Feature 9, which falls within the northern area disturbed by these cuts. The area has been partially overgrown by creosote, ocotillo, along with various grasses and forbs. No artifacts are present in association with the feature.

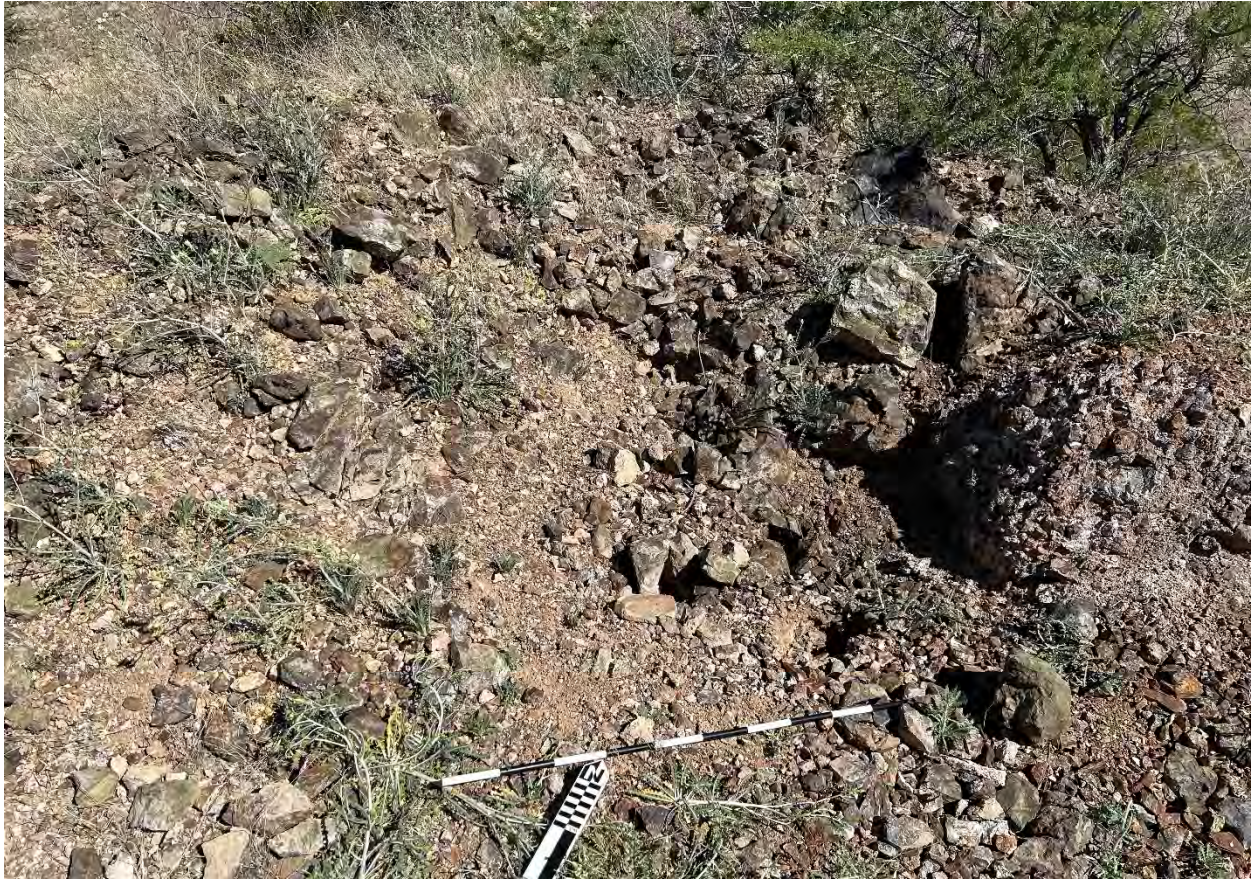
**Photo 17.** Feature 9, infilled shaft at LA 208574, view to the northwest

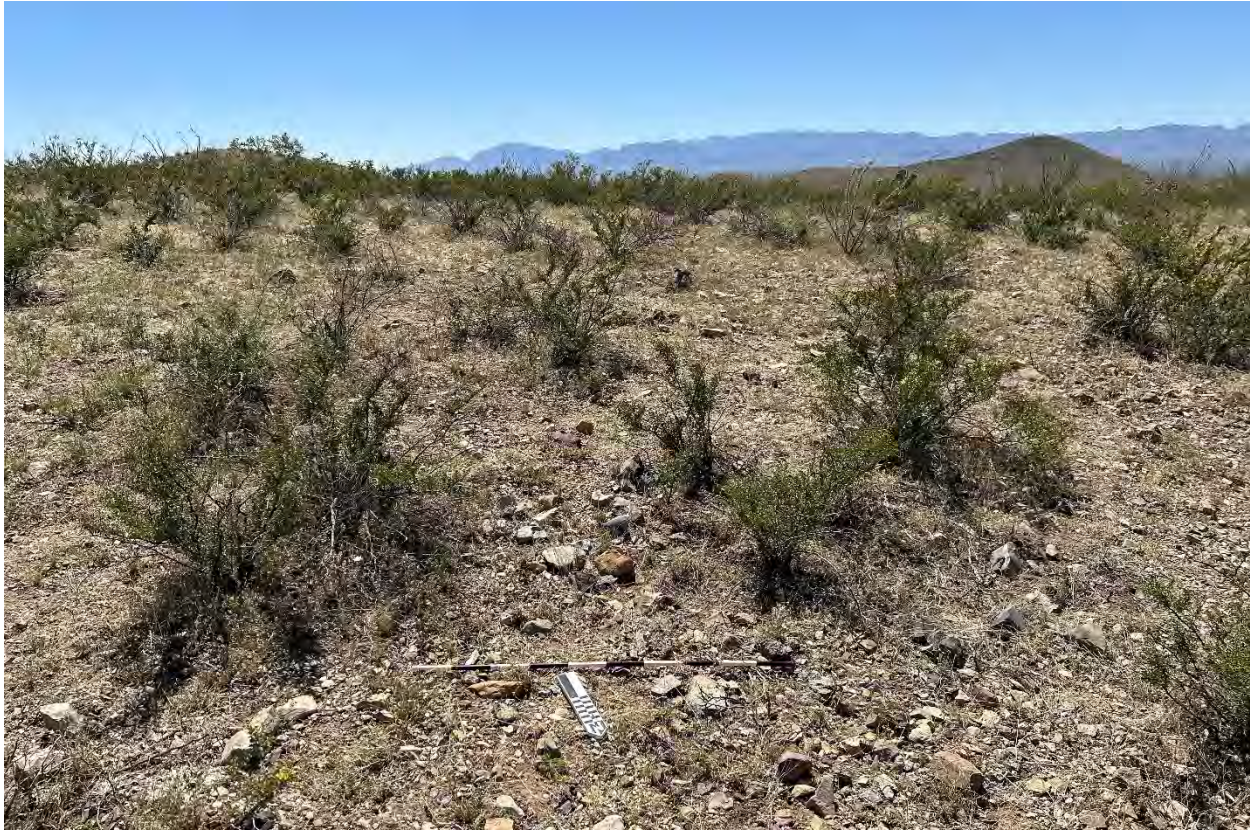
Photo 18. Feature 11, a fire-cracked rock concentration at LA 208574, view to the south

Feature 11 is a concentration of 18 thermally altered cobbles, most likely attributable to the prehistoric component of the site (**Photo 18**). No associated surface staining was observed. The feature has been overgrown by grasses and creosote. It has also been impacted by water erosion and is somewhat dispersed, eroding downslope to the north. Consequently, any potential retained subsurface element is likely to be shallow. Artifacts associated with the feature include a heavily battered 9 × 7 × 6 cm unifacial one-handed rhyolite mano, seemingly utilized as a hammerstone, a fine-grained volcanic chopper with a single working edge which measures 19.5 × 12 × 7 cm, a rhyolite core which retains 26 to 50 percent cortex and measures 9 × 7 × 4 cm, a rhyolite core which retains 26 to 50 percent cortex and measures 7 × 5 × 3 cm, a 2 to 3 cm chert flake with 0 percent cortex, a 1 to 2 cm fine-grained volcanic flake with 0 percent cortex, and two 3 to 4 cm rhyolite flakes with 26 to 50 percent cortex.

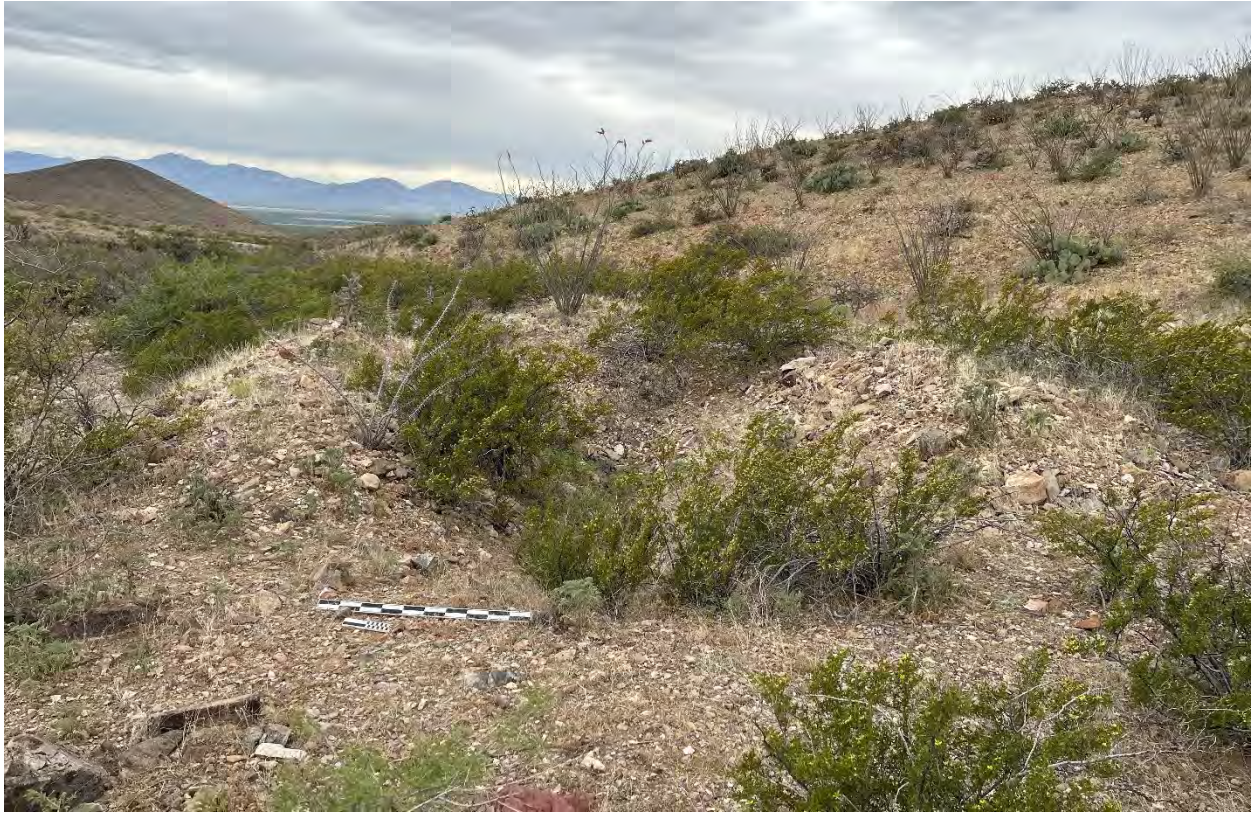
**Photo 24. Feature 1, a prospect pit at LA 208575, view to the west**

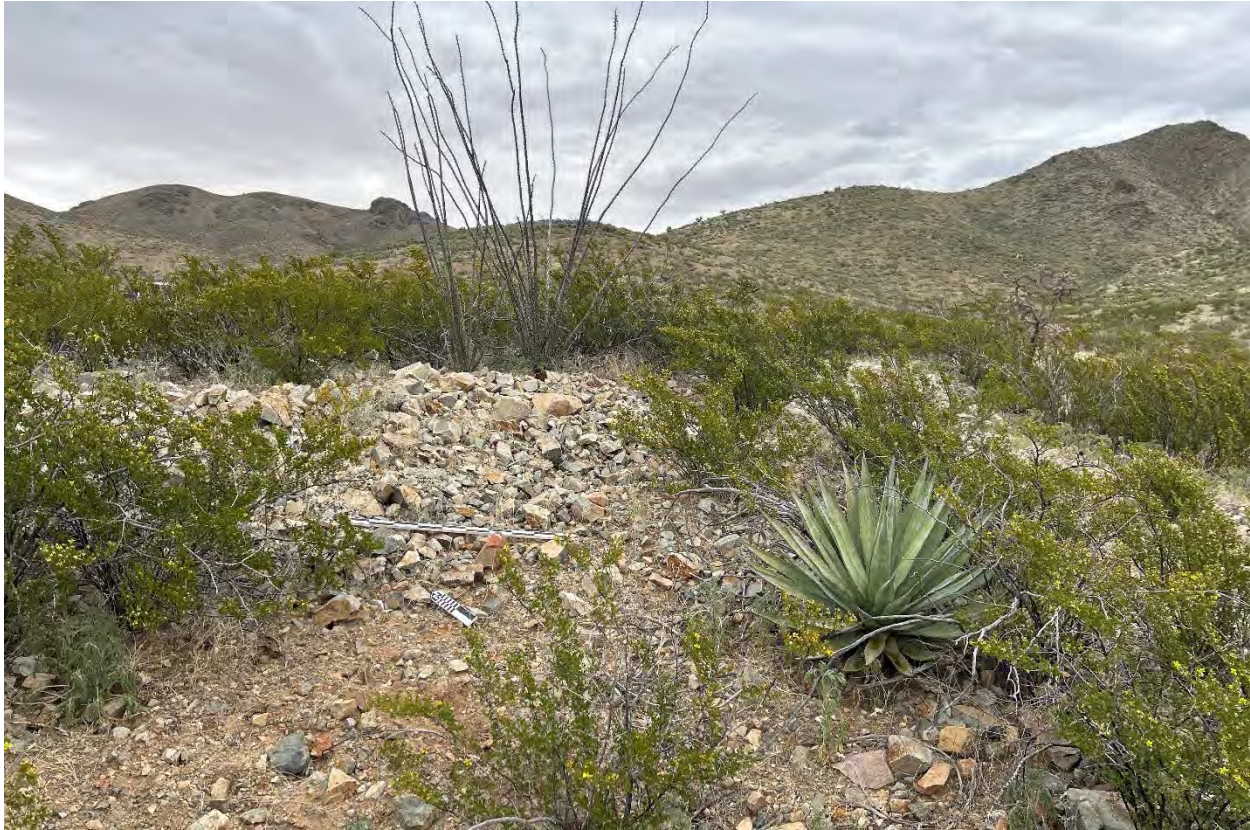
Feature 4 is a mound of tailings, though the source is unclear (**Photo 25**). The feature is located east of Feature 2, though the material present differs from that observed in the exposure of Feature 2. Portions of Feature 4 are somewhat ambiguous as a two-track road runs through the center of the feature. The eastern edge of the feature has formed a pad built up approximately 1 m thick. The feature may represent the remains of an abandoned and infilled shaft, potentially backfilled using material from Feature 2. No clear evidence of an opening exists though the feature is overgrown with dense vegetation primarily consisting of creosote and ocotillo which obscures much of the surface. No artifacts are present in association with the feature, though two modern pull-tab cans are present next to the road north of the feature.

**Photo 25. Feature 4, mine waste at LA 208575, view to the northeast**

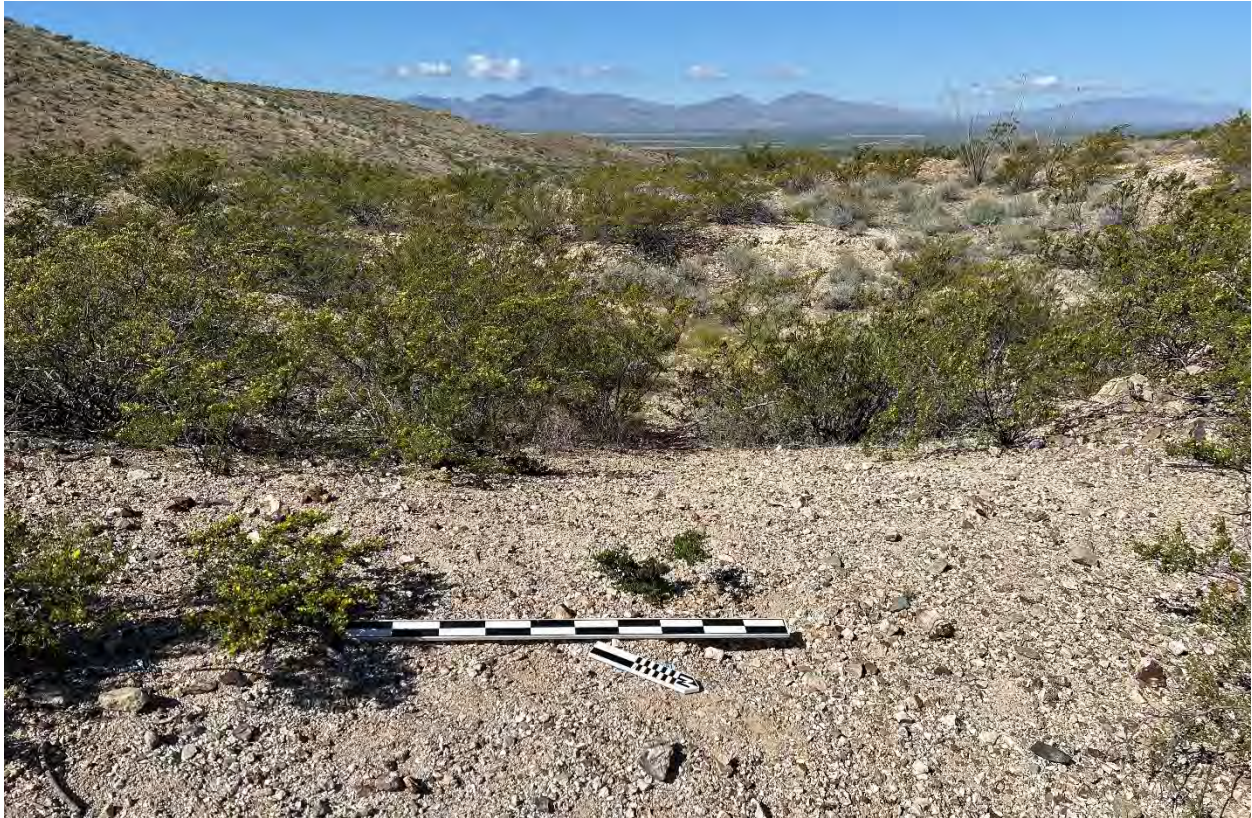
**Photo 27. Feature 1, a prospect pit at LA 208576, view to the southwest**

Feature 2 is a shallow shaft set in conglomerate with a thick limestone matrix overlying volcanic materials consisting of andesite and granite. The feature is located just north of Feature 1 and the southern wall of Feature 2 is shared with Feature 1. The feature is overgrown with vegetation, and the floor is obscured with debris and vegetation. Spoils are primarily located on the north and east sides of the feature. No artifacts are present in association with the feature.

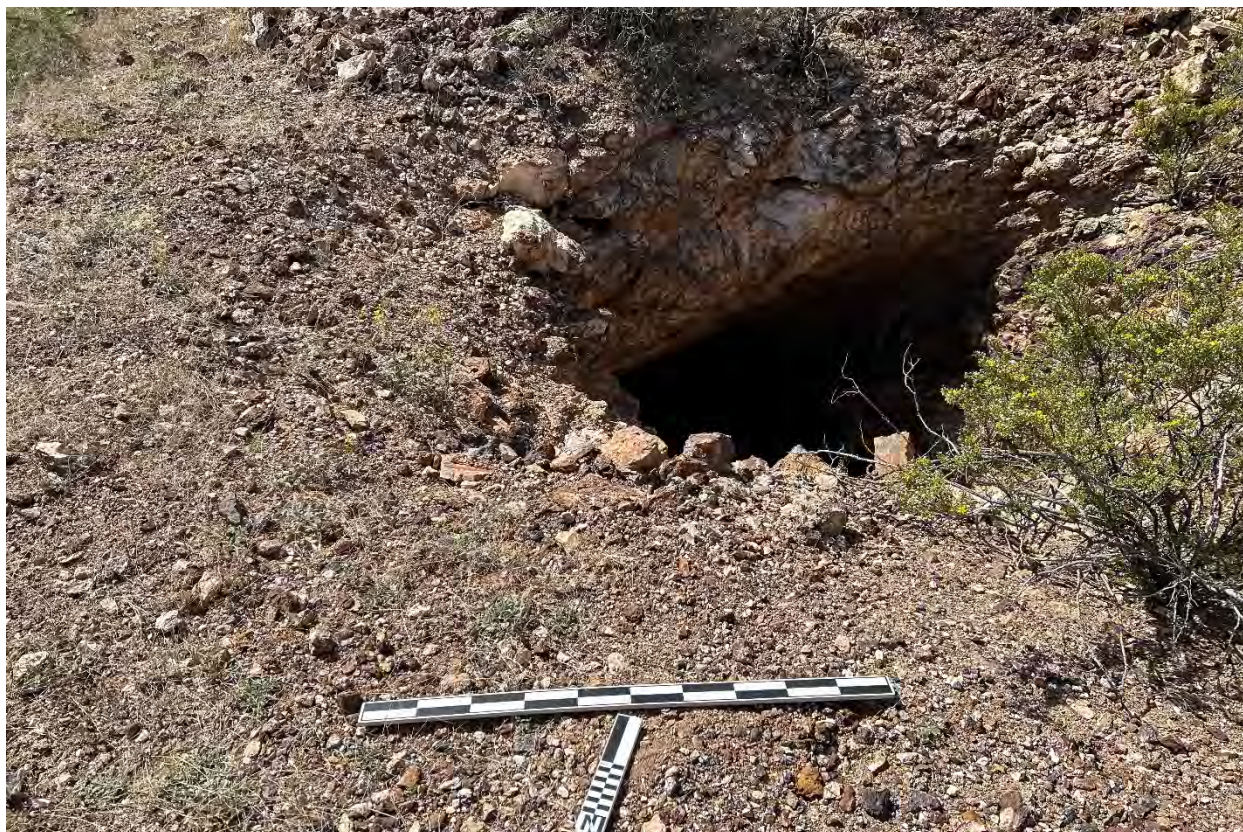
**Photo 29. Feature 4, a mine shaft at LA 208576, view to the south**

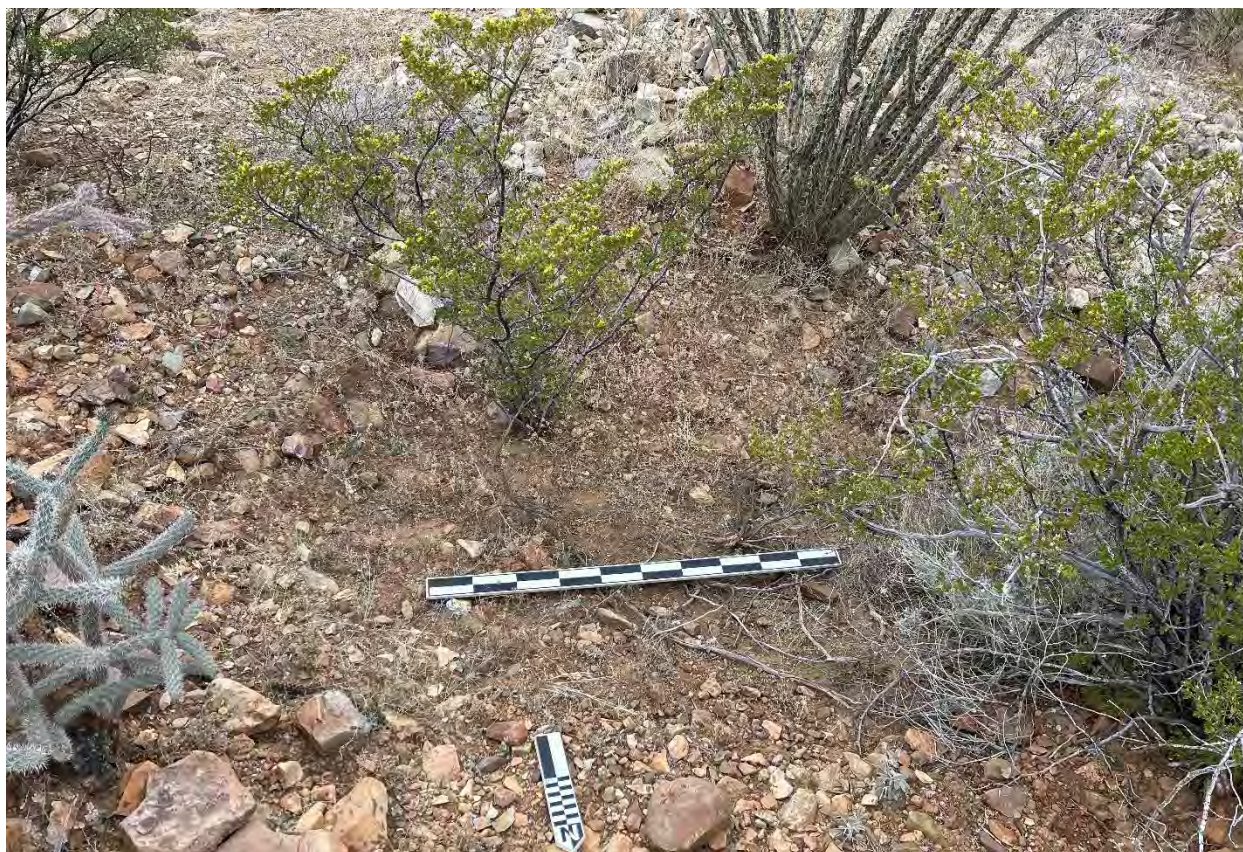
**Photo 34. Feature 1, a prospect pit at LA 208577, view to the south**

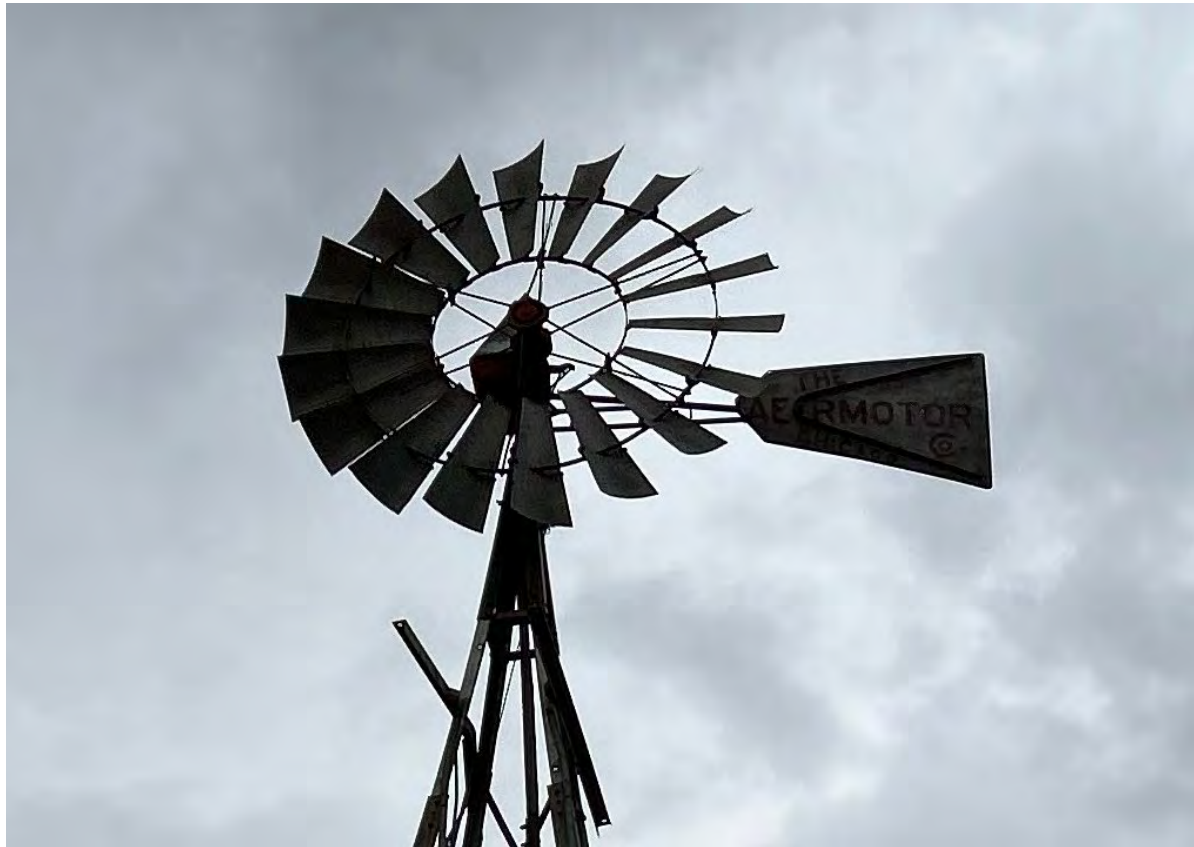
Photo 37. HCPI 57486, a windmill, vane north face, view to the south
