MEMORANDUM

Subject: **NMED Comments, American Minerals, Inc. Deming Jigging Plant,
Request to Change Post Mining Land Use, Luna County, New Mexico,
MMD Permit No. LU001RE, Modification 18-1**

SUBJECT: **Request for Comments, Deming Jigging Plant Site, Request to Change the Post Mining Land Use, Luna County, MMD Permit No. LU001RE**

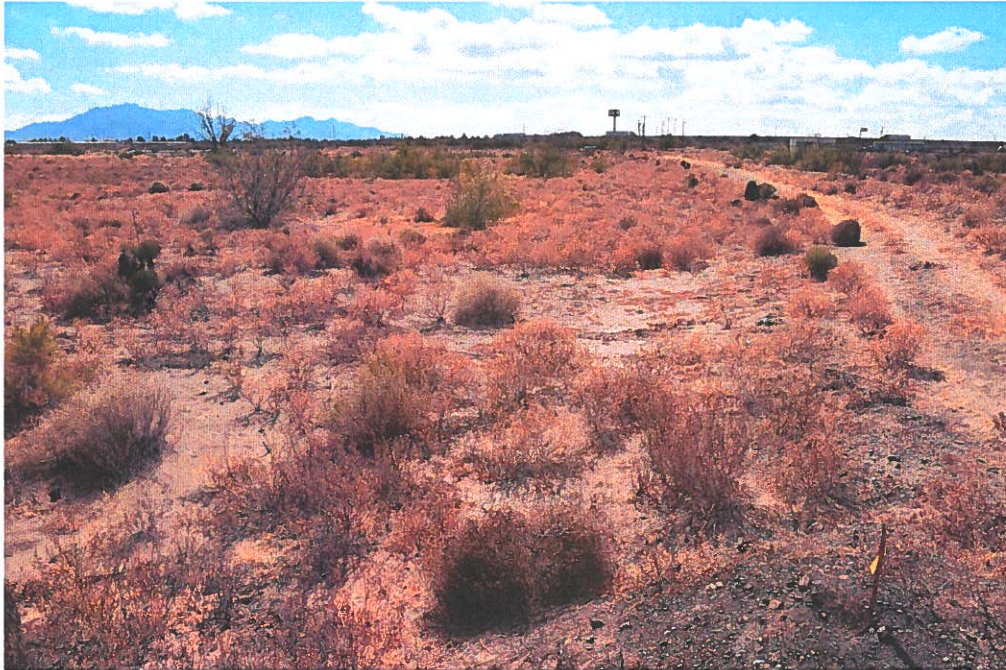
Photo from November 2017, looking across the site from the north. Road on the right marks the western boundary of the reclaimed facility.

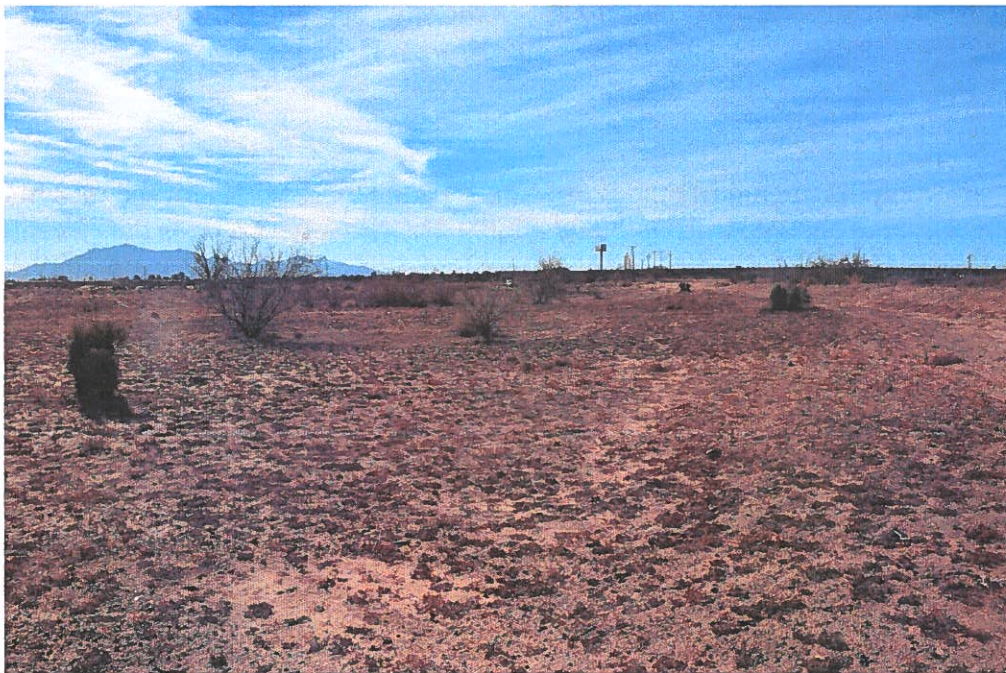
Repeat photo from November 2018. Note additional course grained material placed to armor aeolian sand deposits.

A corrective action plan was submitted to both MECS and MMD and deficiencies noted in the above referenced inspections were corrected from June 19 to July 3, 2018. The corrective actions included addition of approximately 1,000 cubic yards of base course and cobble for armoring and application of additional cover to areas at the Site that had previously been identified. The remediated and disturbed areas were seeded with the approved seed mix.

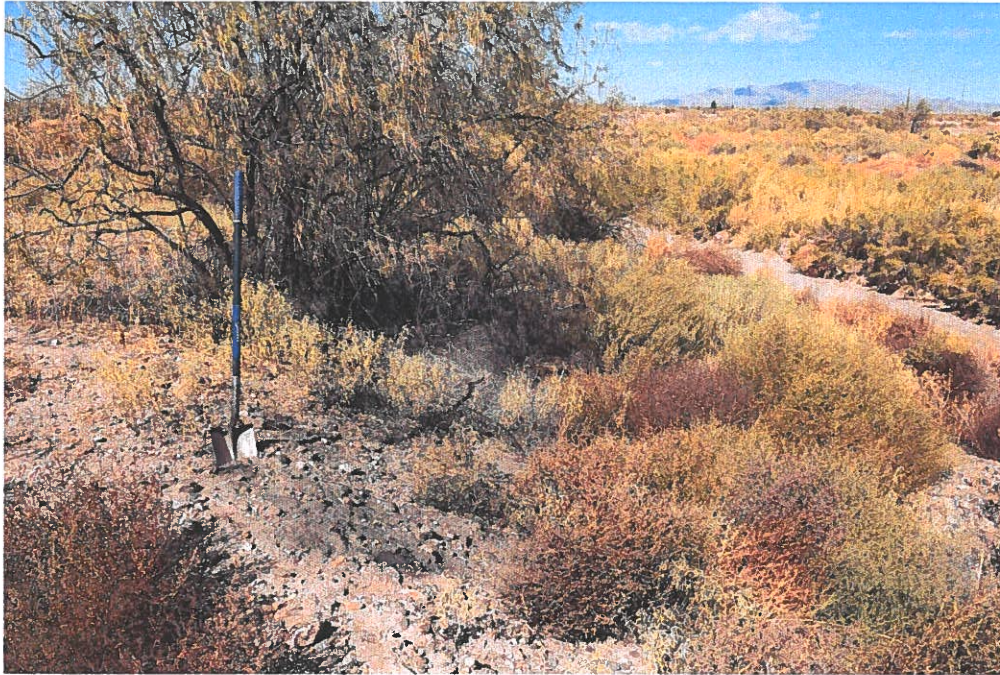
tailing was observed at locations throughout the Site. Exposure of the tailing is due to apparent wind and water erosion of the cover material that was placed during reclamation of the site.

Photo from November 2017. Note Mimbres River channel on right side of photo and exposed dark-colored tailings on berm above the river.

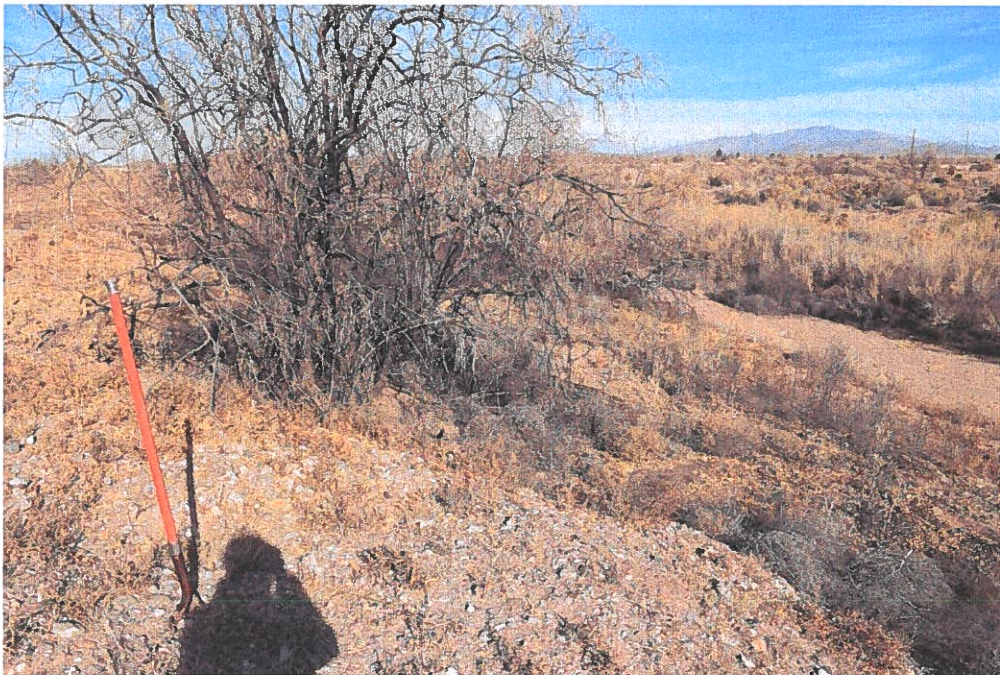
Repeat photo from November 2018. Tailings were removed and buried on the interior of the facility to prevent mobilization into the Mimbres River. Additional cover material was also applied to prevent additional erosion.
