Environmental Assessment: Allison Mine Subsidence Mitigation Project, McKinley County, New Mexico AMLIS Key NM000069-PAD Allison

Parametrix, 2022. Environmental Assessment: Allison Mine Subsidence Mitigation Project, McKinley County, New Mexico AMLIS Key NM000069-PAD Allison. Prepared by Parametrix, Albuquerque, New Mexico. July 2022.

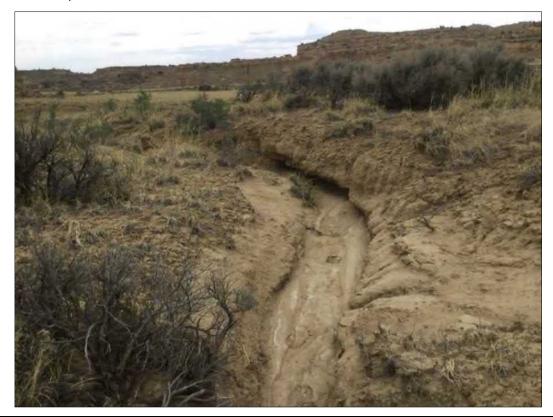
Figure 6-1. The main unnamed waterway that flows north to south through the project area is characterized by sandy bottoms. Photograph taken in May 2018, facing northeast.

On December 20 and 21, 2018, Parametrix senior scientists surveyed the entire Phase IV APE at Allison. During that survey the field crew delineated portions of the main waterway that flows south through the APE (Figure 6-1), and smaller waterways along the eastern and western boundaries of the APE. In addition, an approximate boundary was delineated for one potential wetland located at the southeast end of the APE. Due to frozen ground conditions at the time of the December survey, portions of the main waterways were not mapped in December 2017. In addition, ground conditions precluded the digging of test pits in December, and mapping of waterway and wetland boundaries was refined during field work on May 7 and 8, 2018.

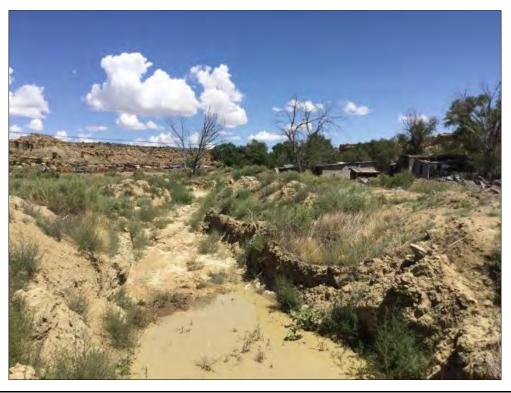
Figure 6-2. The unnamed waterway flowing north to south throughout the project area has been manipulated over the years to convey water away from buildings and structures in Allison.

Portions of the waterways contain linear groupings of bank vegetation with sand bars and vegetated points within the waterway boundaries at the north end of the canyon. In the northern end of the canyon, several tributaries to this waterway converge to form the main channel. As the waterway traverse further south towards Allison however, the drainage widens and deepens, and in some areas, is 10 ft (3.05 m) wide and 6 ft (1.83 m) deep, and flows until just north of the residences located in Allison. At this point the drainage changes significantly due to numerous manipulation of the waterway by Allison residents. A large portion of the channel has been excavated to improve conveyance, resulting in rectangular cross-section about 8-feet (2.43 m) wide and 3-feet (0.91 m) deep (Figure 6-2).

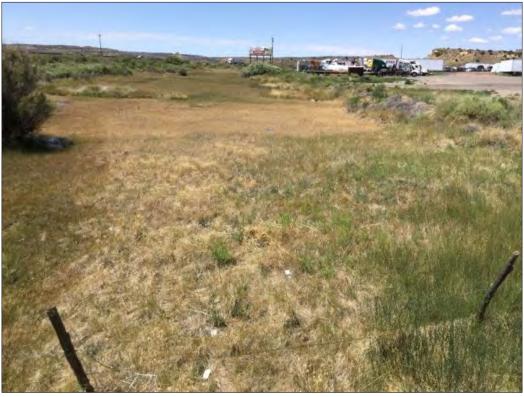
Figure 6-3. Wetland at the southeastern boundary of the Phase IV APE. Photograph taken in July 2018, facing west.

One wetland was mapped in the southeastern corner of the project area in May 2018. This wetland encompasses 1.23 acres (0.50 hectares) and occurs in a broad, shallow swale, connected to the other waterways via culverts under I-40 and the bridge under the Allison access road. The USFWS classification system identifies this wetland as a palustrine emergent system (USFWS 2017b). The wetland is dominated by common spike rush (*Eleocharis palustris*), broadleaf cattails (*Typha latifolia*), and Baltic rush (*Juncus balticus*), with scattered coyote willow *Salix exigua*) [Figure 6-3]. Soil pits were excavated within the wetland in accordance with the methods described in the *Regional Supplement to the Corps of Engineers Wetland Delineation Manual: Arid West Region (Version 2.0)* [USACE 2008], and were consistent with mapped soils but contained depleted matrix colors and prominent redox concentrations typical of hydric soils. For wetland data forms from the May 2018 field work see Appendix C.
