# LA JARA MESA PROJECT

## DRAFT Baseline Data Report

**Project No. 083-9338SI**

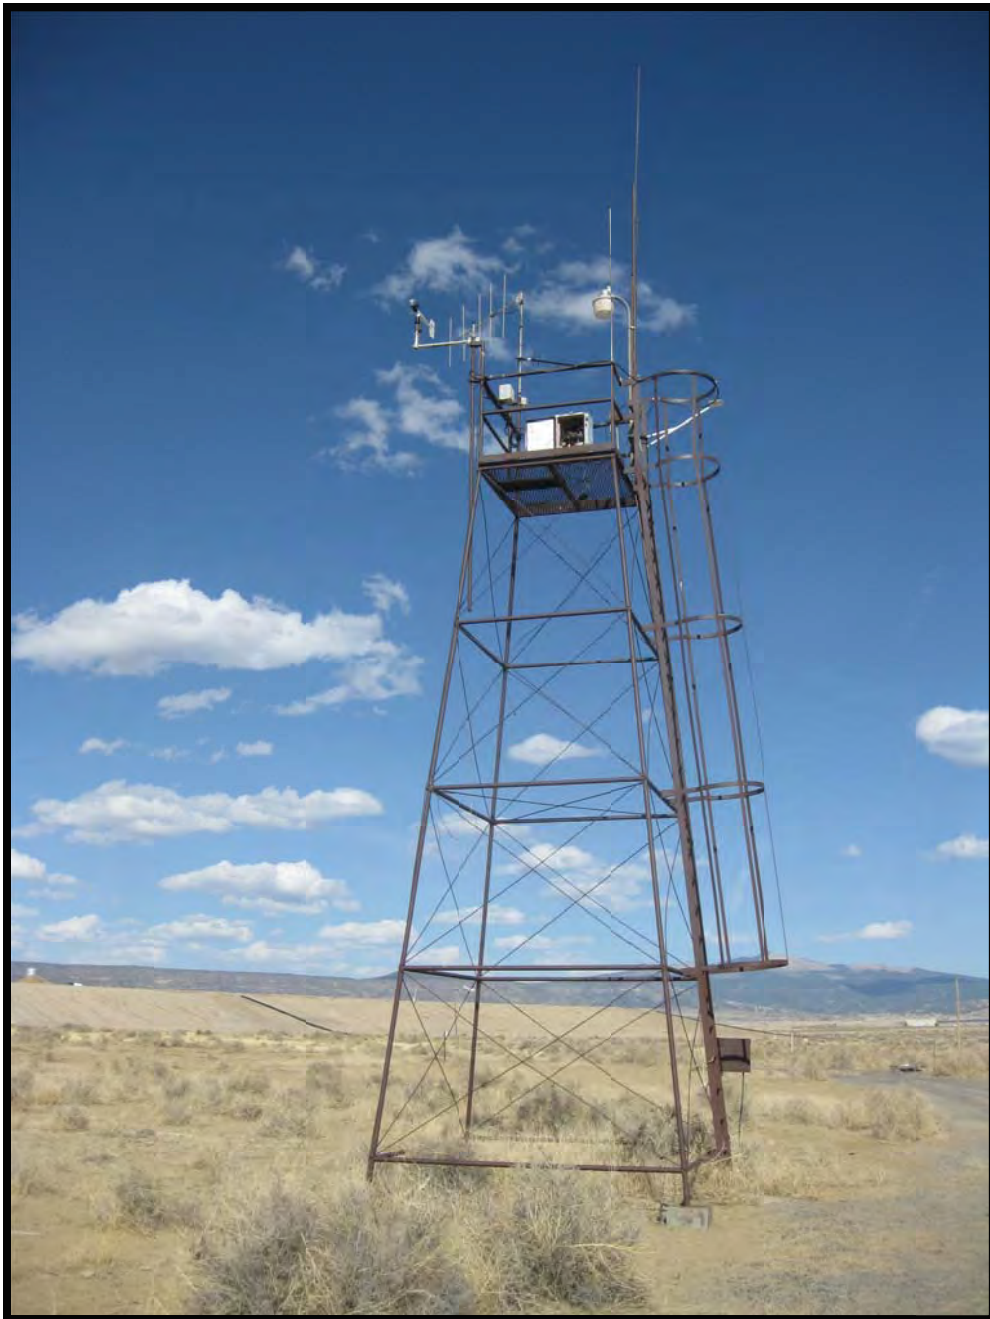
**Figure 1.1 Photograph of Barrick/Homestake Mining Company  
Meteorological Monitoring Station**

The Barrick/Homestake Mining Company station is equipped to measure horizontal wind speed and wind direction at 10 meters, temperature at 9.5 meters, solar radiation at 9.5 meters, relative humidity at 9.5 meters, precipitation at 0.4 meters, and barometric pressure at 8.8 meters. Table 1-1 summarizes the parameters collected at the monitoring site and the units for each parameter. Figure 1.1 presents a photograph of the meteorological monitoring station.

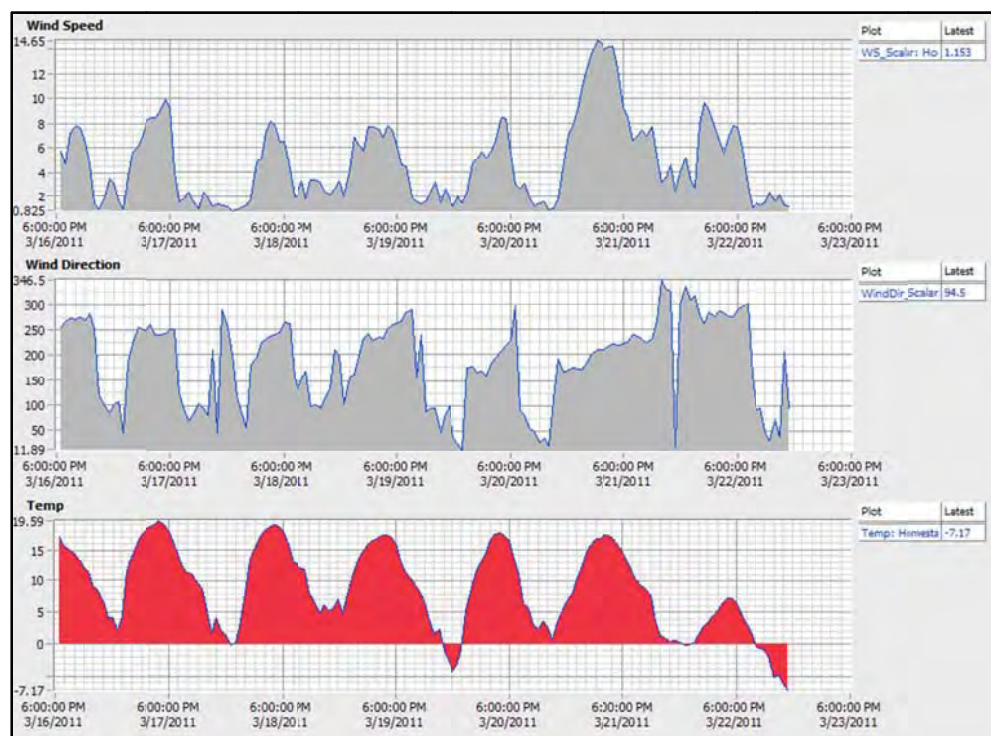
**Figure 3.2 Real-Time Display**

In addition, MSI hosts a password-protected project web-site which is updated daily. The site contains 24-hour meteorological chart graphics, daily minimum, maximums, and averages, quality assurance reports and wind roses. Figures 3.2 and 3.3 present examples of these graphics. By using this approach, data collection percentages are greatly enhanced and MSI meteorologists can quickly note and resolve any potential instrumentation problems.

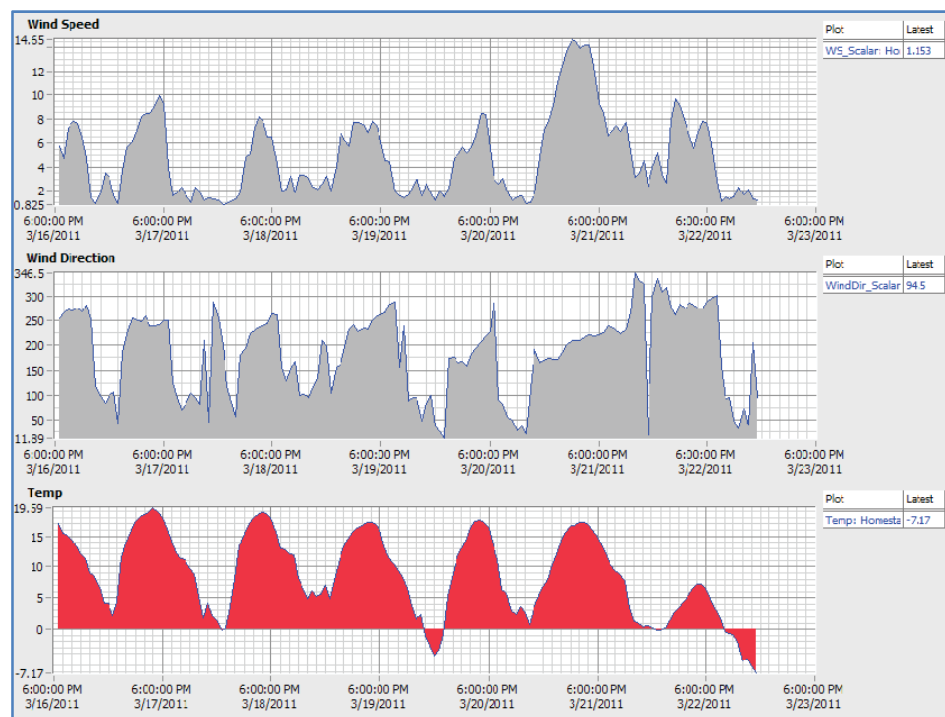
**Figure 3.2 Real-Time Display**

In addition, MSI hosts a password-protected project web-site which is updated daily. The site contains 24-hour meteorological chart graphics, daily minimum, maximums, and averages, quality assurance reports and wind roses. Figures 3.2 and 3.3 present examples of these graphics. By using this approach, data collection percentages are greatly enhanced and MSI meteorologists can quickly note and resolve any potential instrumentation problems.

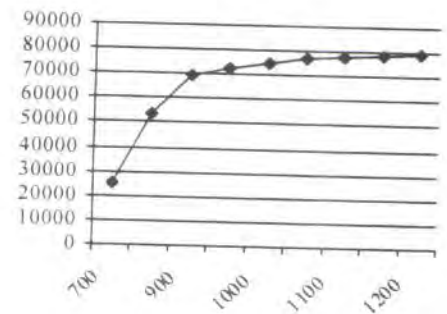
Voltage Plateau

Comments: HV Plateau Scaler Count Time = 1-min. Recommended HV = 1100

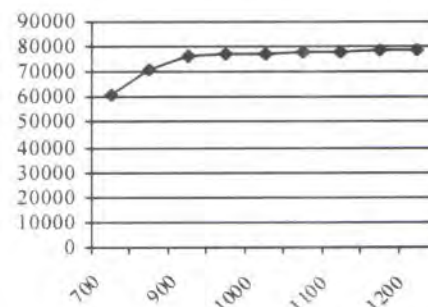
Voltage Plateau

Comments: HV Plateau Scaler Count Time = 1-min. Recommended HV = 1100

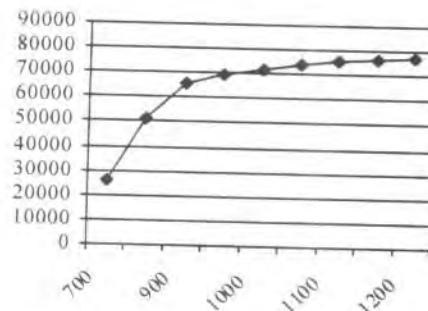
Voltage Plateau

Comments: HV Plateau Scaler Count Time = 1-min. Recommended HV = 1150
