RE: Baseline Data Report Amendment, Copper Flat Mine, Sierra County, New Mexico

COPPER FLAT MINE BASELINE DATA REPORT ADDENDUM

Copper Flat Mine: Addendum to Section 4 (Vegetation) of the Baseline Data Characterization Report

Copper Flat Mine: Addendum to Section 5 (Wildlife) of the Baseline Data Characterization Report

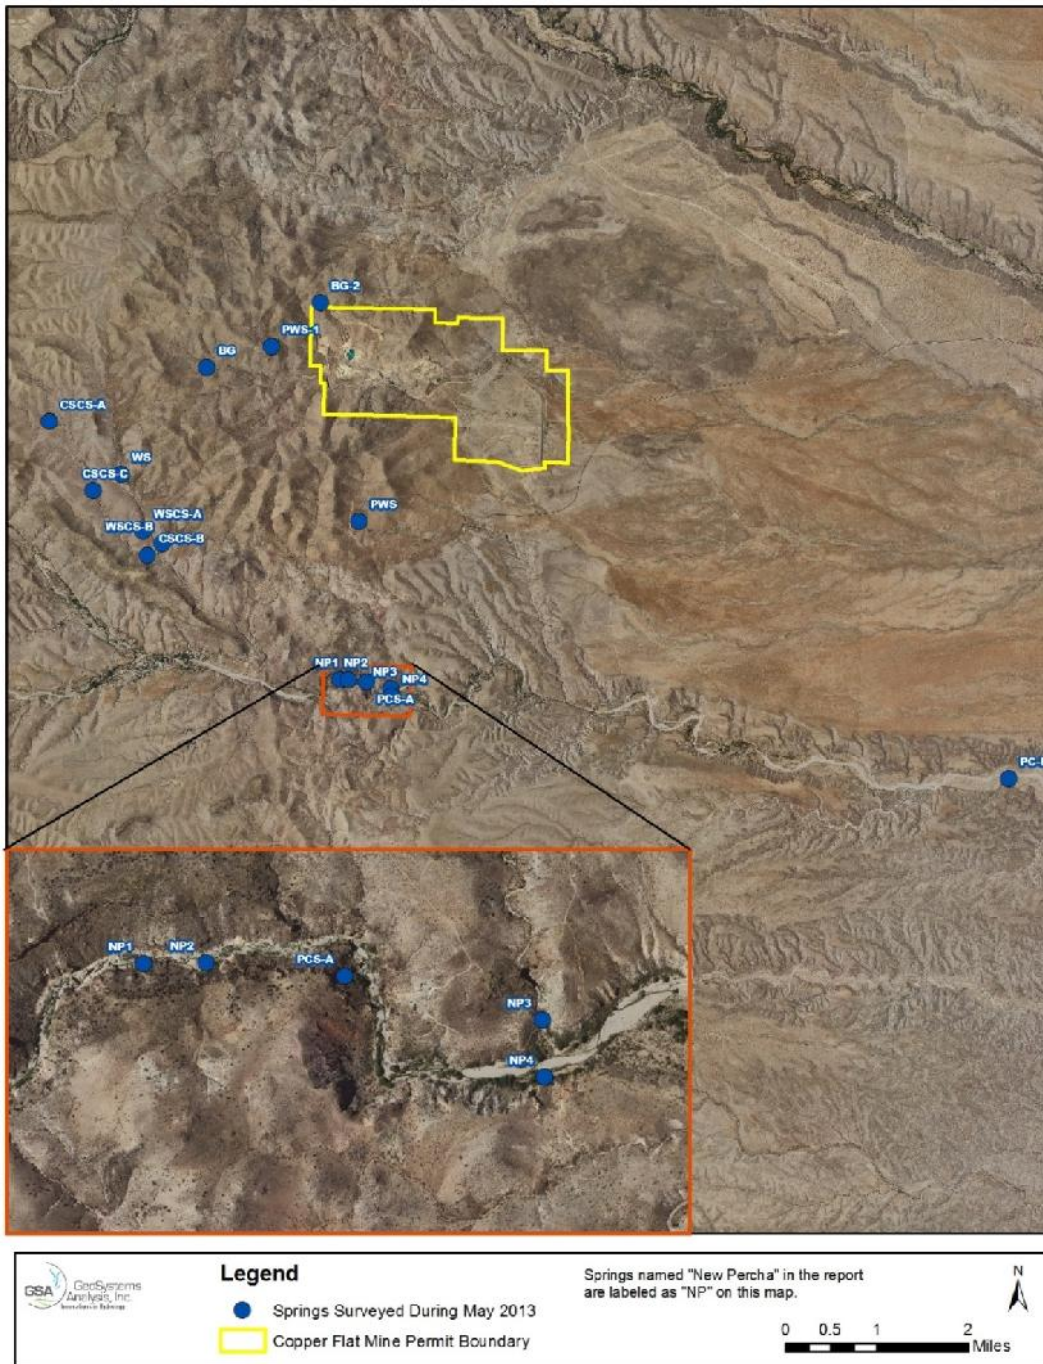
Figure 5A-1. Spring and Seep Survey Locations

Surface water was observed at eight of the sites (Table 5A-1). Water depth was typically not more than a few inches, but deeper water was observed at the two developed springs. Water depth was estimated to be four feet on average in the concrete lined portion of spring WS while PC-E contained about three feet of water in the stock tank. Not surprisingly, the springs with surface water present were also typically vegetated with riparian or wetland plant species. Goodding's willow, cottonwood, and Baccharis were commonly observed at the wet springs. Cattails grew in the open water at one spring (New Percha 2). Spikerush, saltgrass, Bermuda grass, watercress, cloak fern, and bulrush were also sometimes observed growing within the aquatic habitat or in the surrounding moist soil.

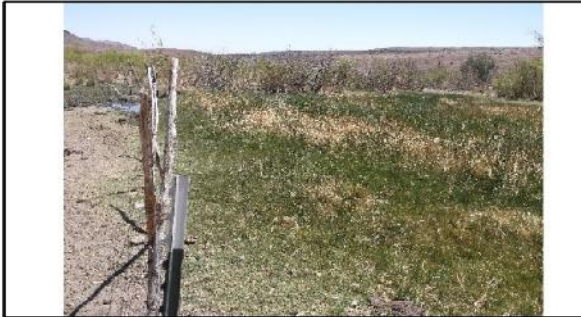
Spring WS, notice difference between grazed and ungrazed sides of fence.

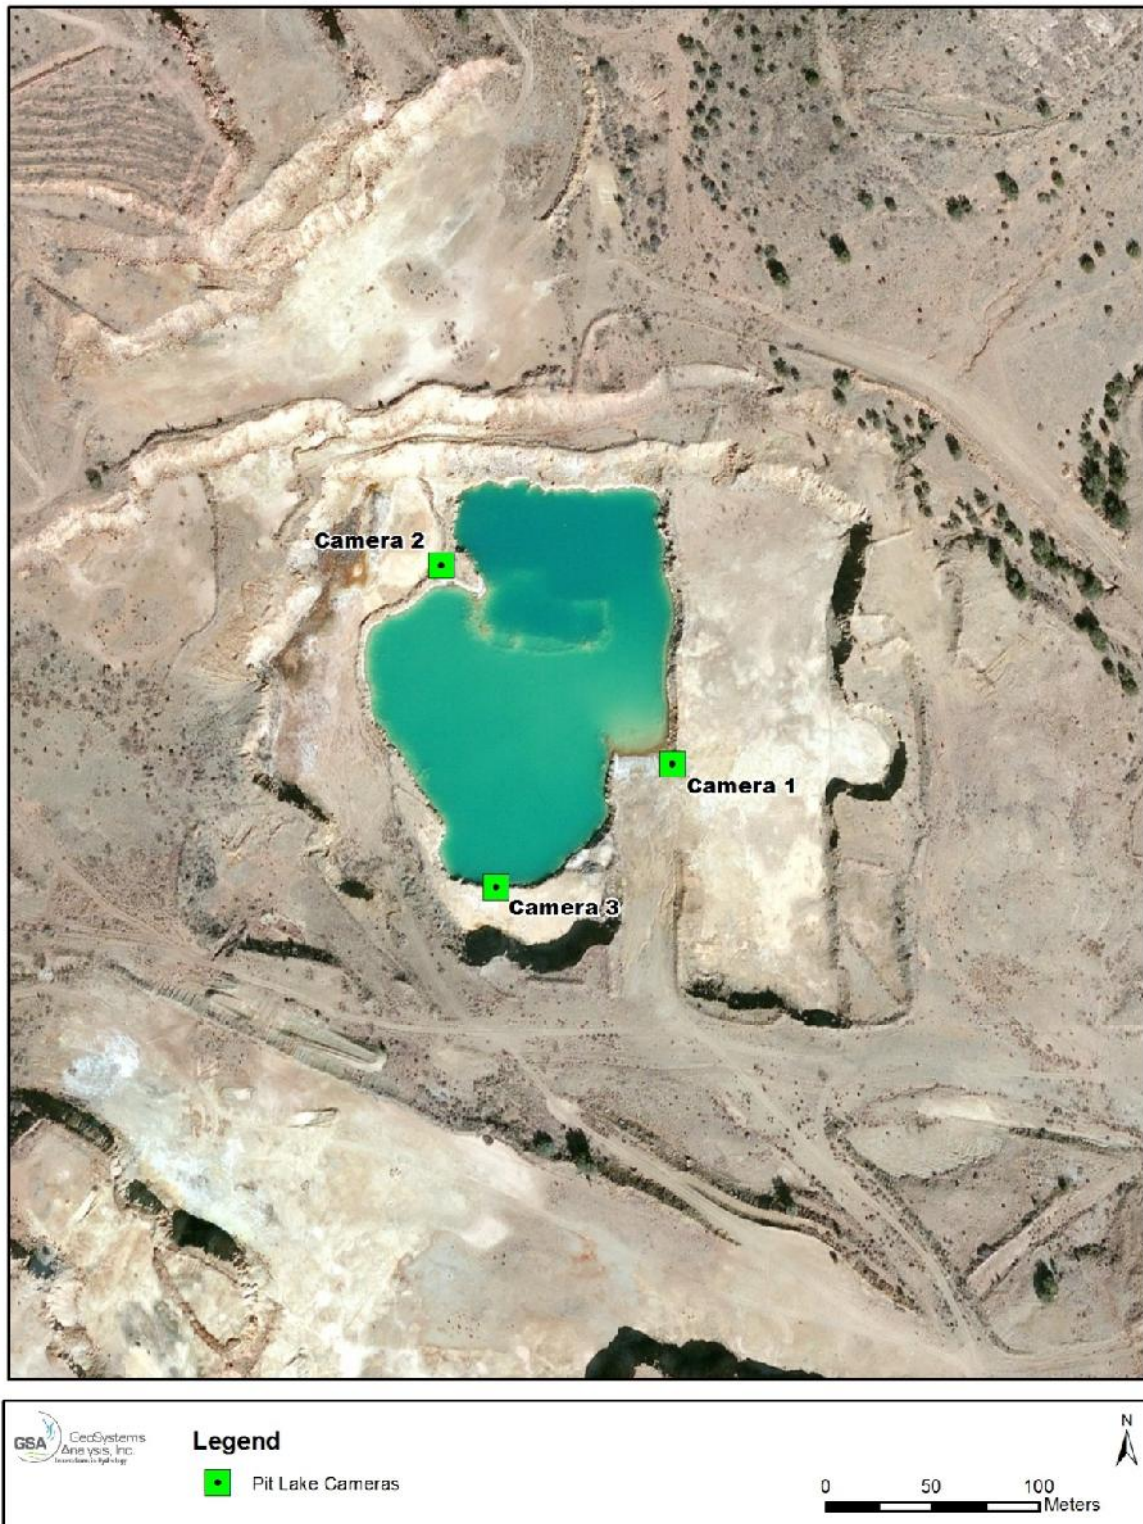
Figure 5A-5. Pit Lake Game Camera Locations

Two 8MP Bushnell Trophy Cam HD game cameras with night vision sensors were installed along the pit lake perimeter in August 2012 and left in place until May 2013. Initially, two cameras were strategically placed in locations where it was possible for mammals to approach the shoreline; much of the lake is surrounded by unstable rock walls, thus the paths selected were predicted to capture ungulate and carnivore use. These cameras also sometimes captured waterfowl use, so a third camera with a direct view of the lake surface was installed on a rock cliff along the lake during early November 2012 in order to directly assess waterfowl activity. Although the specific placement of the third camera did enable supplemental observations between in-person monitoring visits, wave movement on the pit lake sometimes caused falsely triggered photos to overwhelm data storage capacity. Game camera locations are shown in Figure 5A-5. Photos were uploaded from each of the cameras on a regular basis, typically monthly, and batteries were replaced during these visits as necessary.

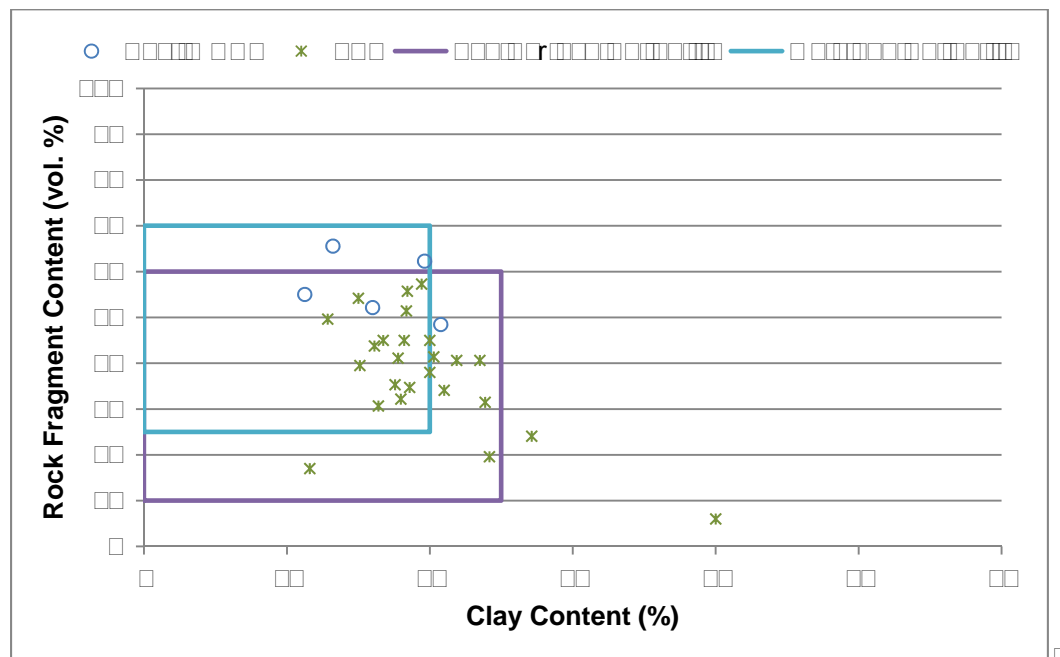
Chart 2: Copper Flat Soils - Weighted Average Clay vs. Rock Fragments

The chart displays the relationship between Clay Content (%) on the x-axis and Rock Fragment Content (vol. %) on the y-axis. The data points are categorized by soil type: Alluvial soils (circles) and Gravelly soils (crosses). A weighted average trend line is shown as a solid line, and a 1:1 relationship line is shown as a dashed line. The trend line indicates that as clay content increases, rock fragment content also tends to increase, but at a lower rate than the 1:1 relationship.

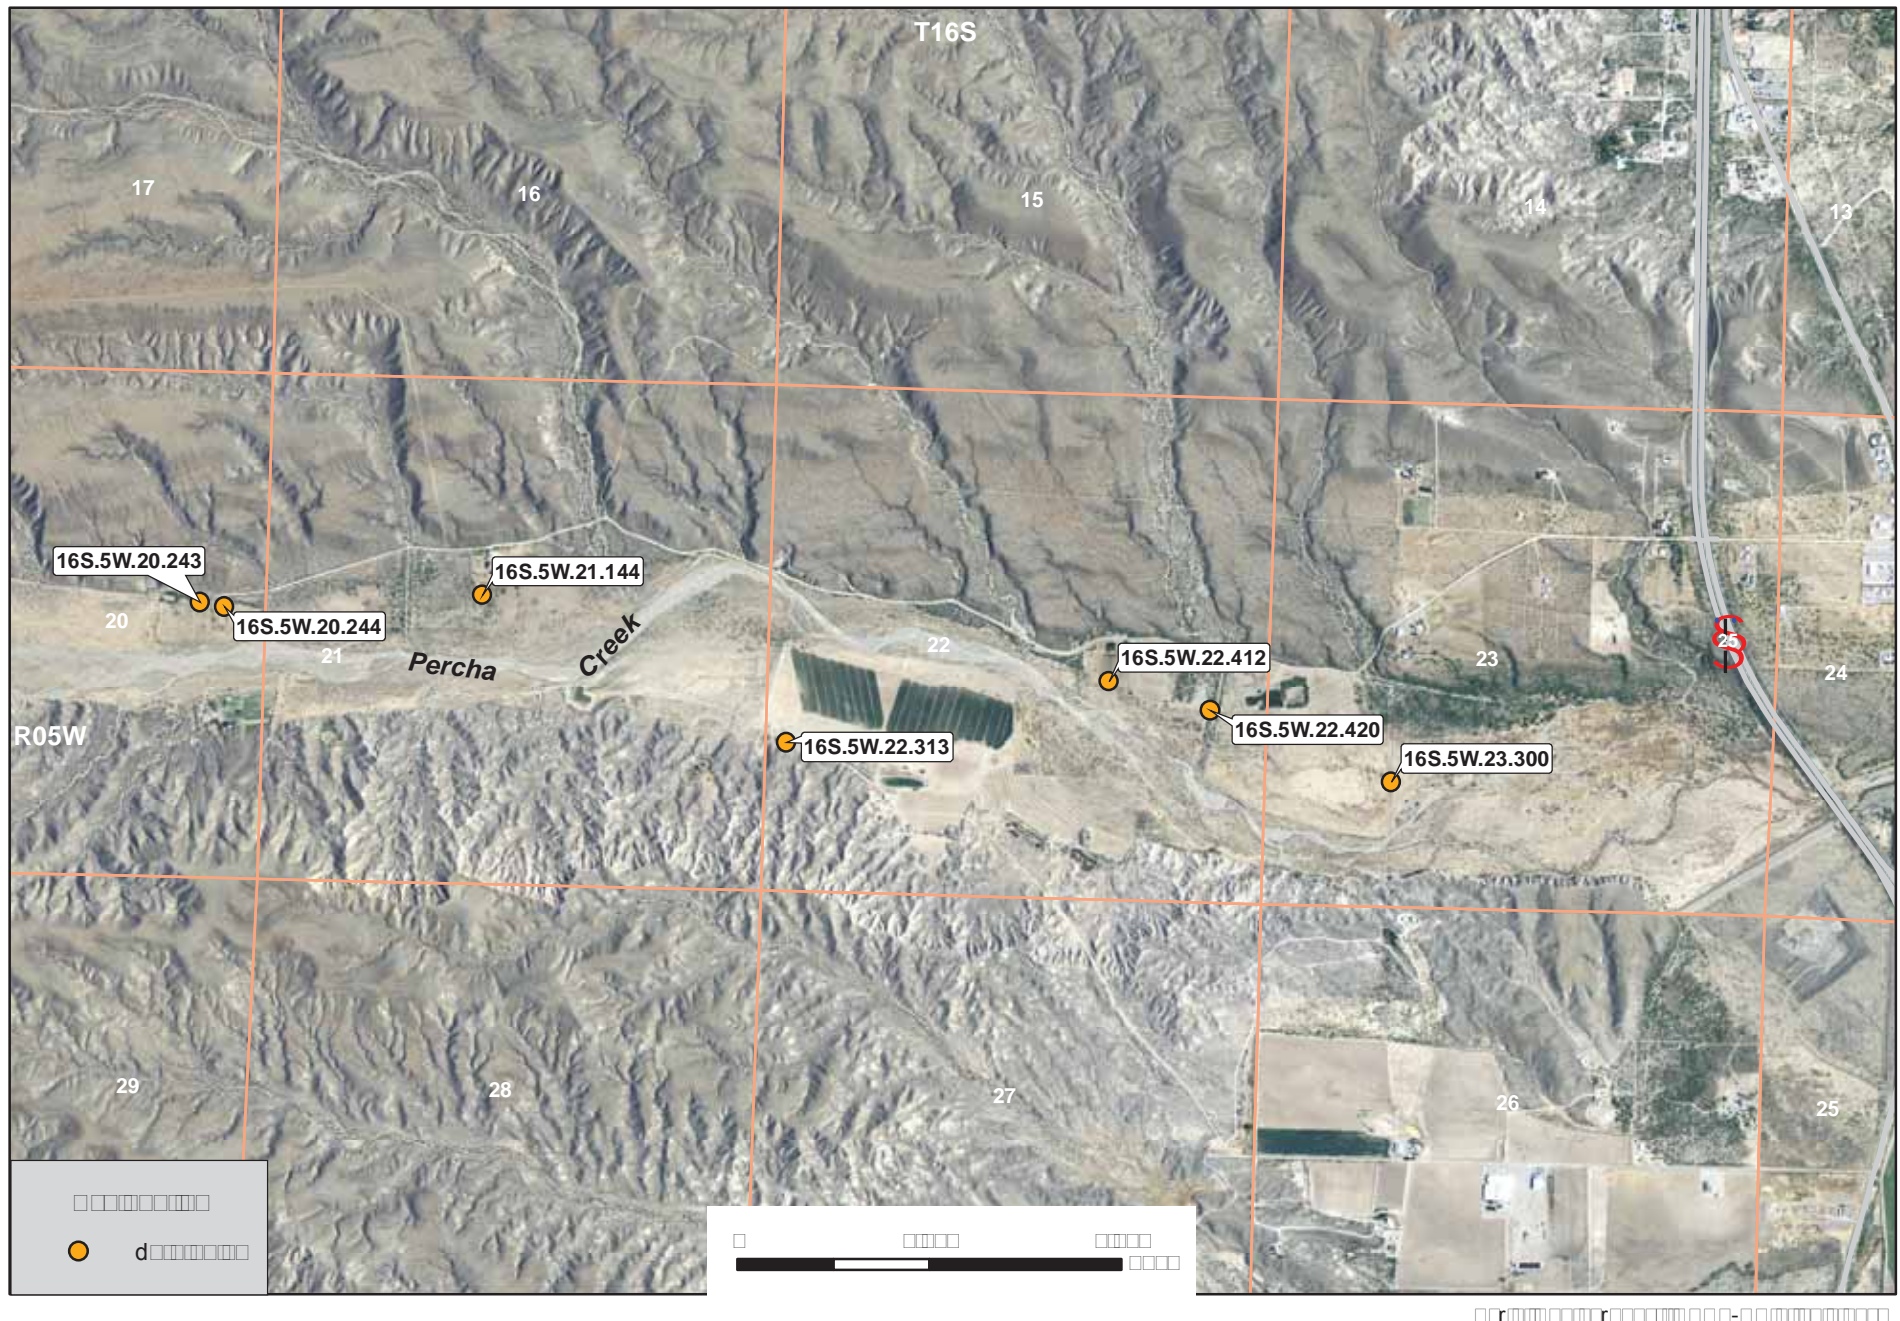
Figure 1. Aerial photograph showing the approximate locations of historical groundwater quality data points along Percha Creek, Sierra County, New Mexico.

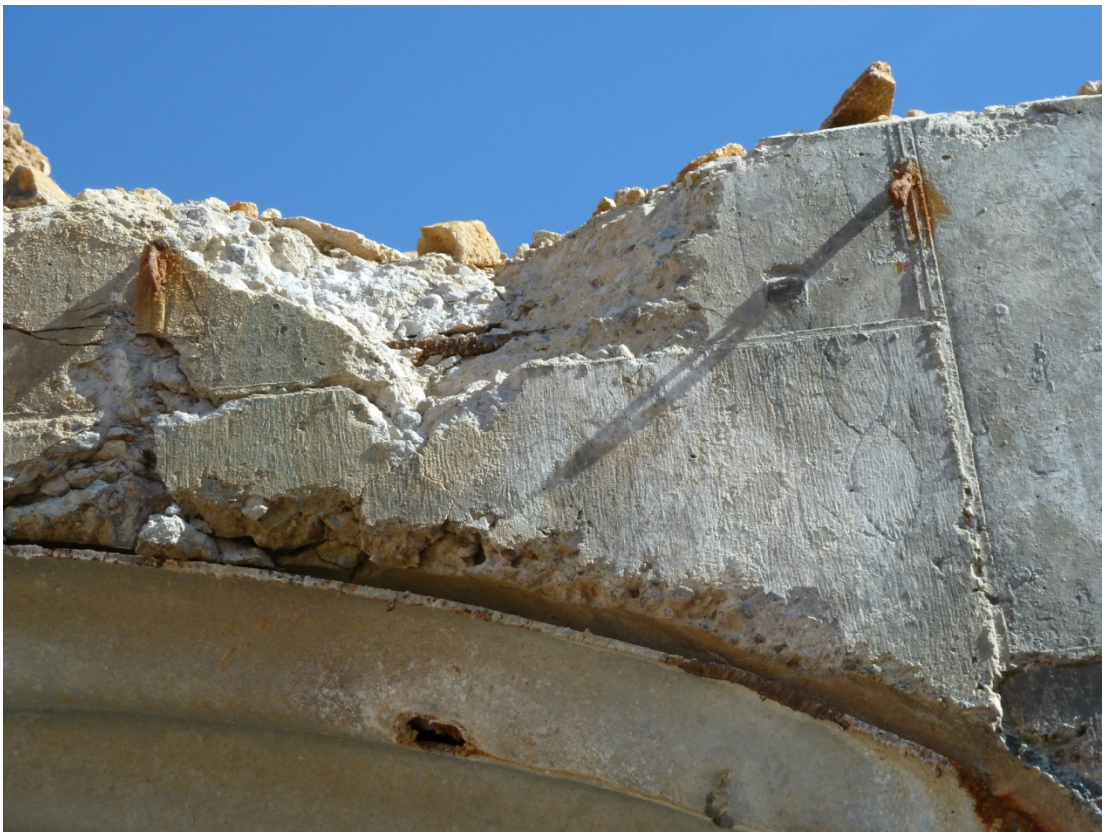
Photo 2 – Damage at Top of Tunnel Entrance

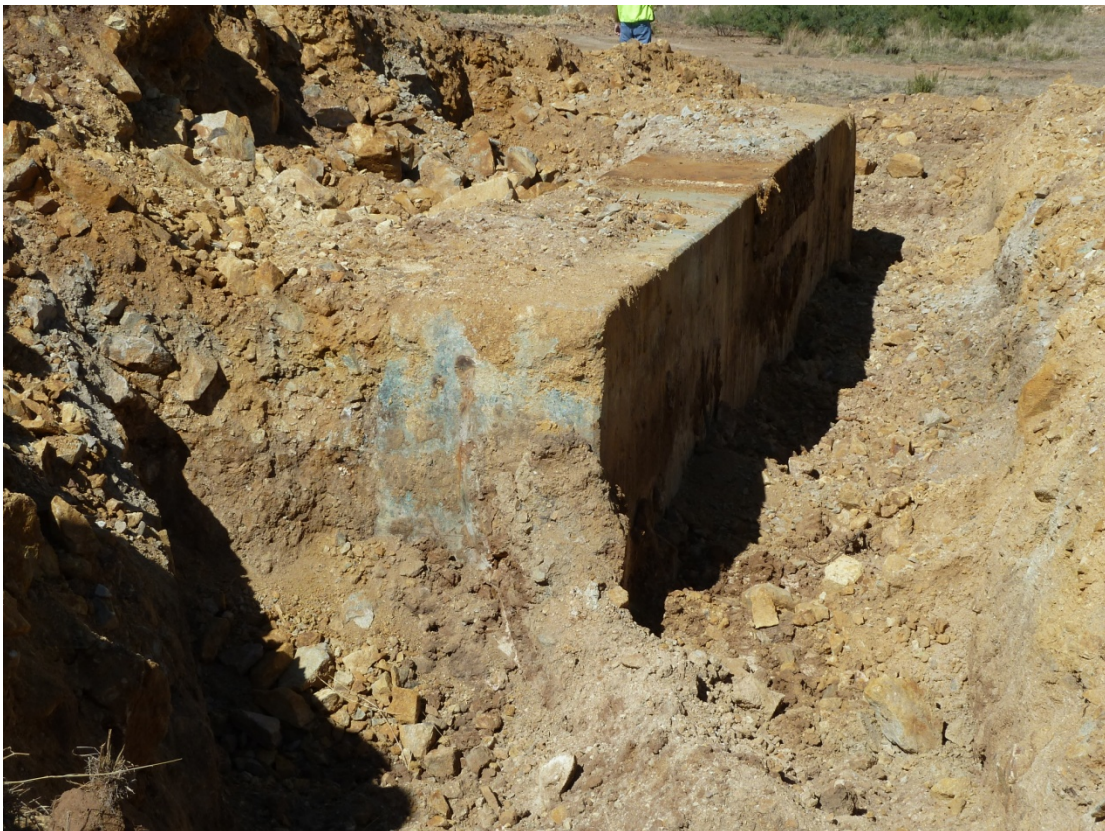
Photo 4 – Primary Crusher Dump Pocket

The main portion of the primary crushing dump station was filled with rock as part of the reclamation. We were not able to go into any of this portion of the crusher, but from the minimal problems we saw on the surface and at the entry to the conveyor tunnel, we are assuming that the crusher concrete should be able to be reused if we install the same type of crusher as it had previously. We are assuming that all the platform steel and stairs were salvaged and will need to be replaced. We are assuming that only the concrete will be reused (Photo 4).

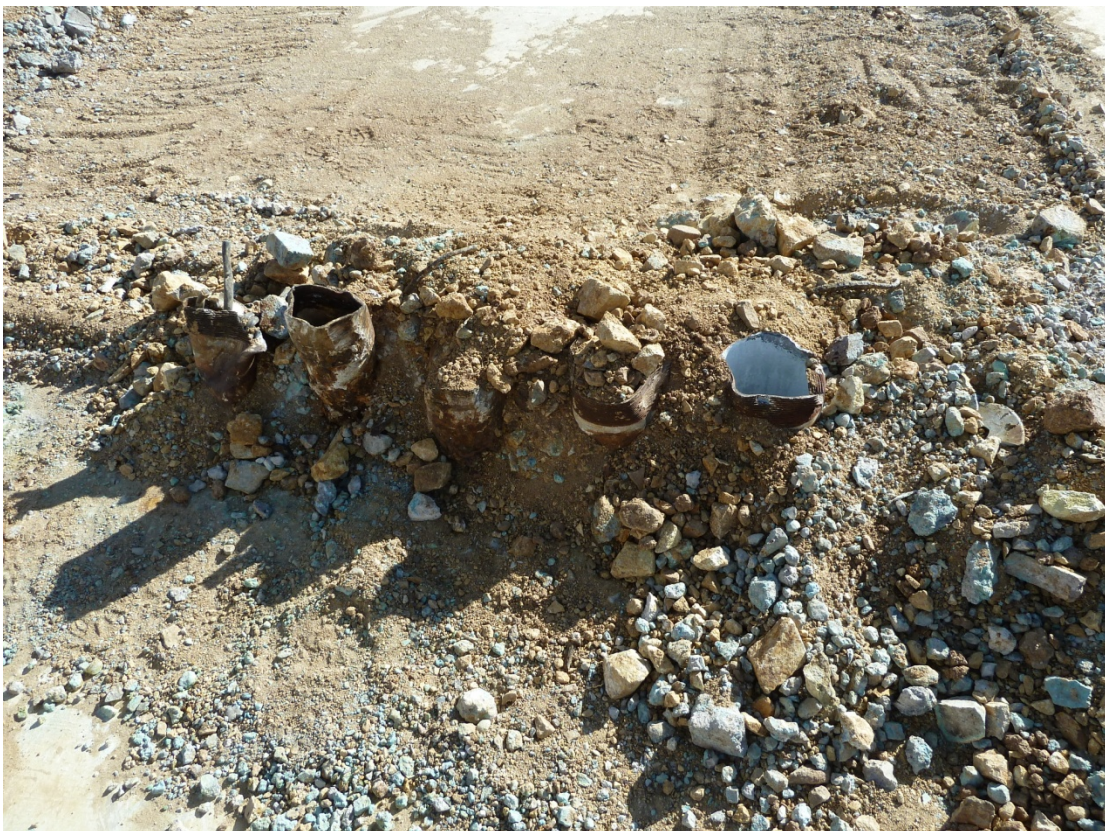
Photo 20 – Underground Utility Floor Penetration

There is potential to reuse portions of the existing underground utilities (Photo 20). All electrical lines after the substation were in concrete-encased duct banks. The duct banks were not exposed and the utility pull boxes were not available for inspection. One vault was open at the surface, and if emptied of the dirt, might indicate that the duct banks can be reused. The fire water and the process water systems are also buried, so they might also be able to be used, but at this time, we are assuming that they will be replaced. The tailings feed line was removed and needs to be replaced. The decant towers on the tailings pond are still in place and exposed and may be reusable, depending on the tailings placement method chosen.

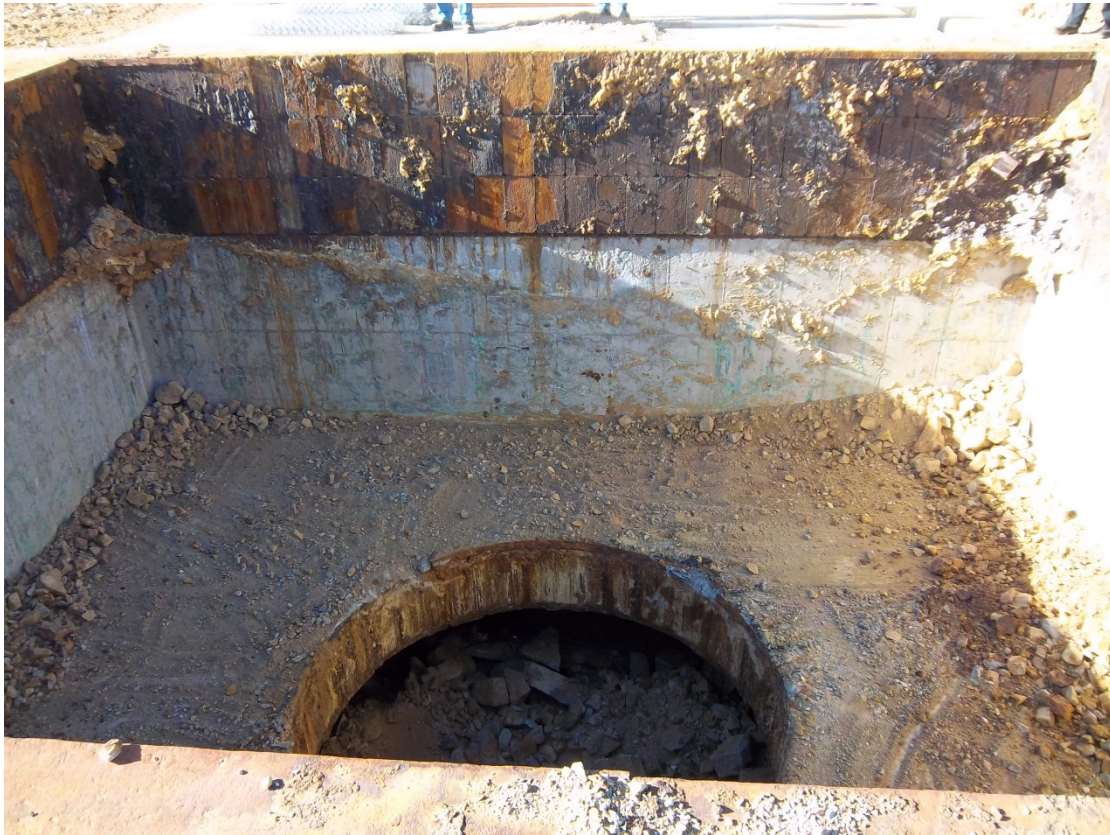
Photo 1 – Primary Crusher - Excavation Progress on Crushing Side

The Primary Crusher had been excavated to the Dump Pocket drawhole at 5551'-0" level (See Photo 1 and Ref. Quintana Dwg. 71-5401). The maintenance side had been excavated to about the 5531'-7" level (See Photo 2). The exposed concrete was visually evaluated for, structural damage, design deficiencies, construction deficiencies, and any structural deterioration occurring during the period of being buried. Concrete surfaces were visually inspected for cracks, spalling, exposed rebar, and signs of any chemical deterioration. Embedded items were also examined for corrosion and signs of deterioration. The concrete surfaces appeared to be in good conditions with some greenish-blue discolorations at the surface (See Photo 3). Embedded items around the openings and Dump Pocket liner plates were observed to have experienced significant corrosion and loss of material (See Photo 4). CMU block walls for the Electrical Room at the 5549'-4 ¾ level had been pushed over exposing wall reinforcing. Also, the elevator framing and structural steel remains were still in place with significant damage (See Photos 5 & 6). No observations were made of the Surge Pocket or levels below, because backfill material had not been excavated to these levels.

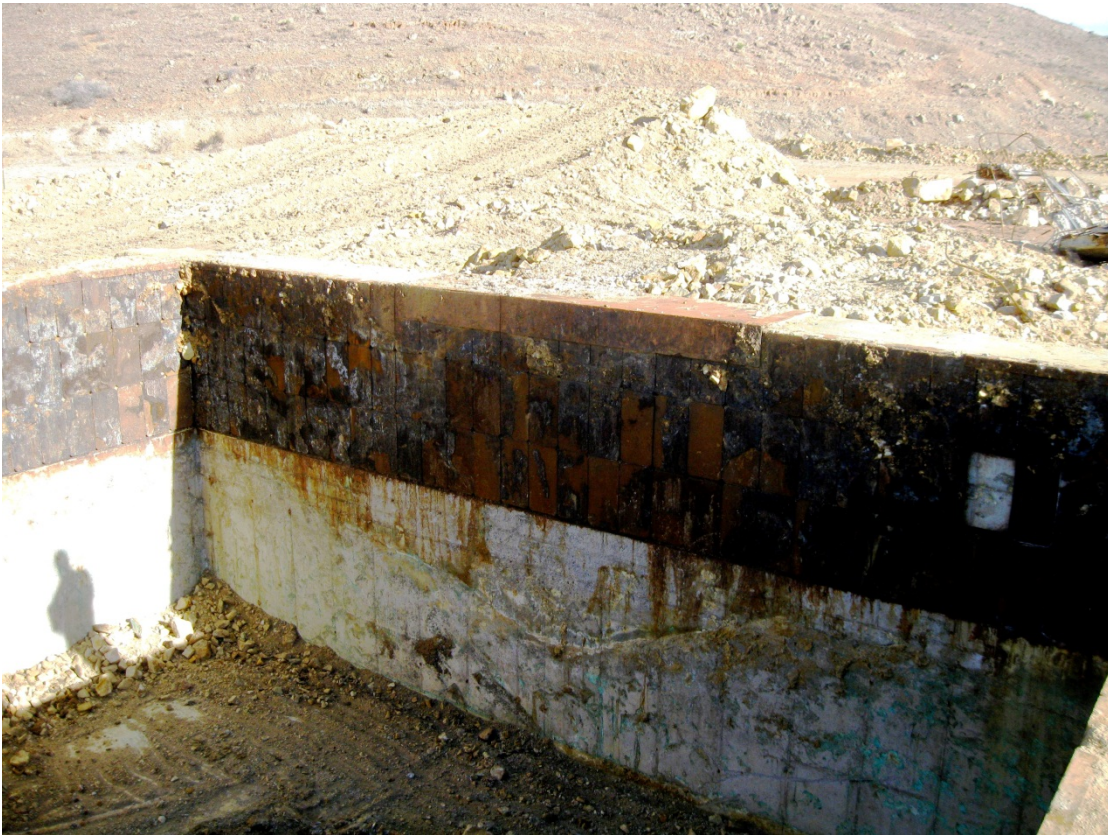
Photo 3 – Primary Crusher – Greenish-blue Discoloration at Wall Surface

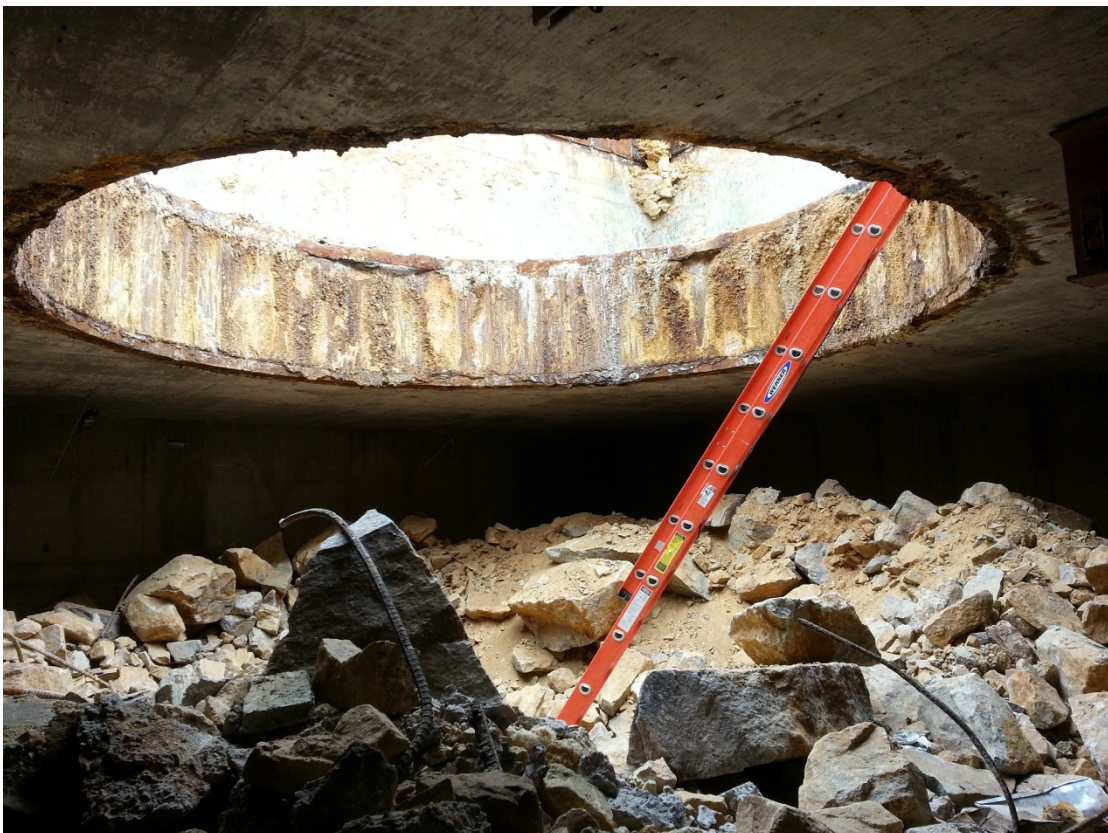
Photo 4 – Primary Crusher – Corrosion on Embedded Items

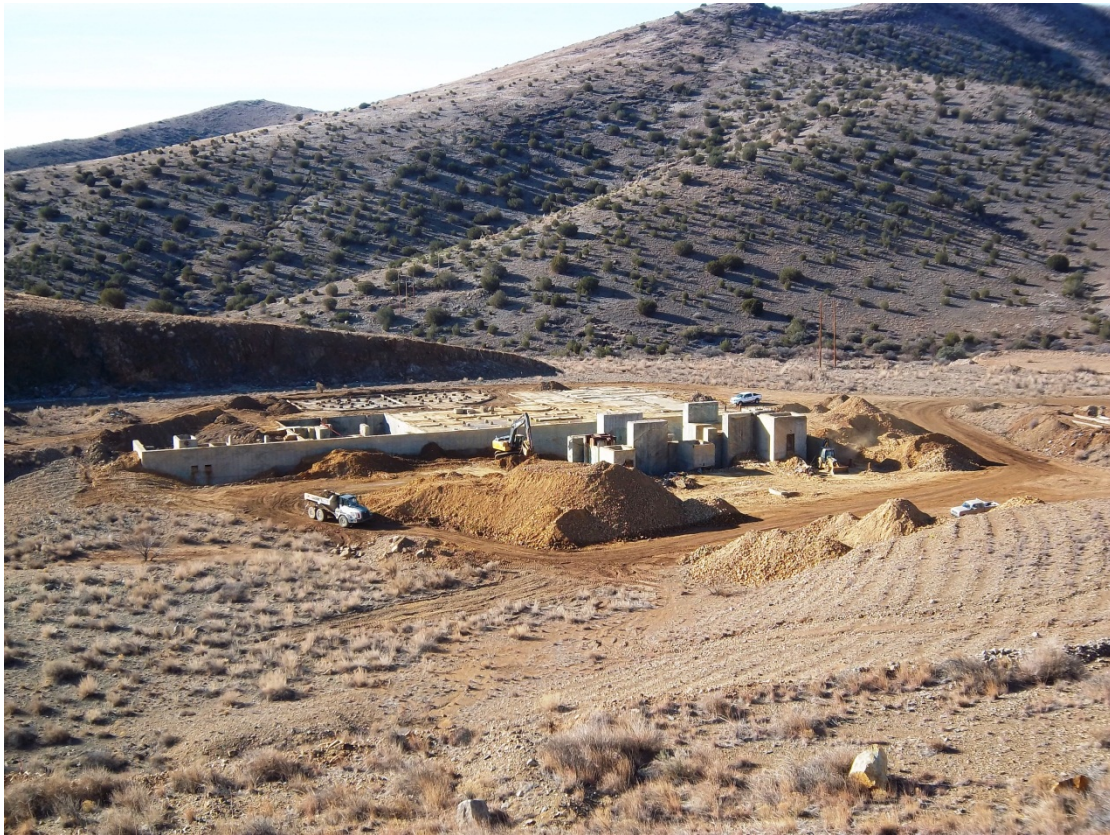
Photo 7 – Concentrator – Excavation Progress

The existing Flotation, Grinding and Regrind Area foundations were visually inspected using the same criteria defined for the Primary Crusher. The majority of the overburden had been excavated with the exception of the Grinding Area containment slab, but the Mill Piers were able to be inspected (See Photo 7 and Ref. Quintana Dwg. 90-5402). The interior piers in the Flotation Area and building piers had significant signs of distress that occurred during excavation operations (See Photo 8). Anchor bolts and embedded items showed significant signs of corrosion and spalling (See Photos 9 thru 11). Retaining walls and slabs all appeared to be in accordance with the design documents. The floor slabs had signs of distress and may not be water-tight, if needed to provide containment.

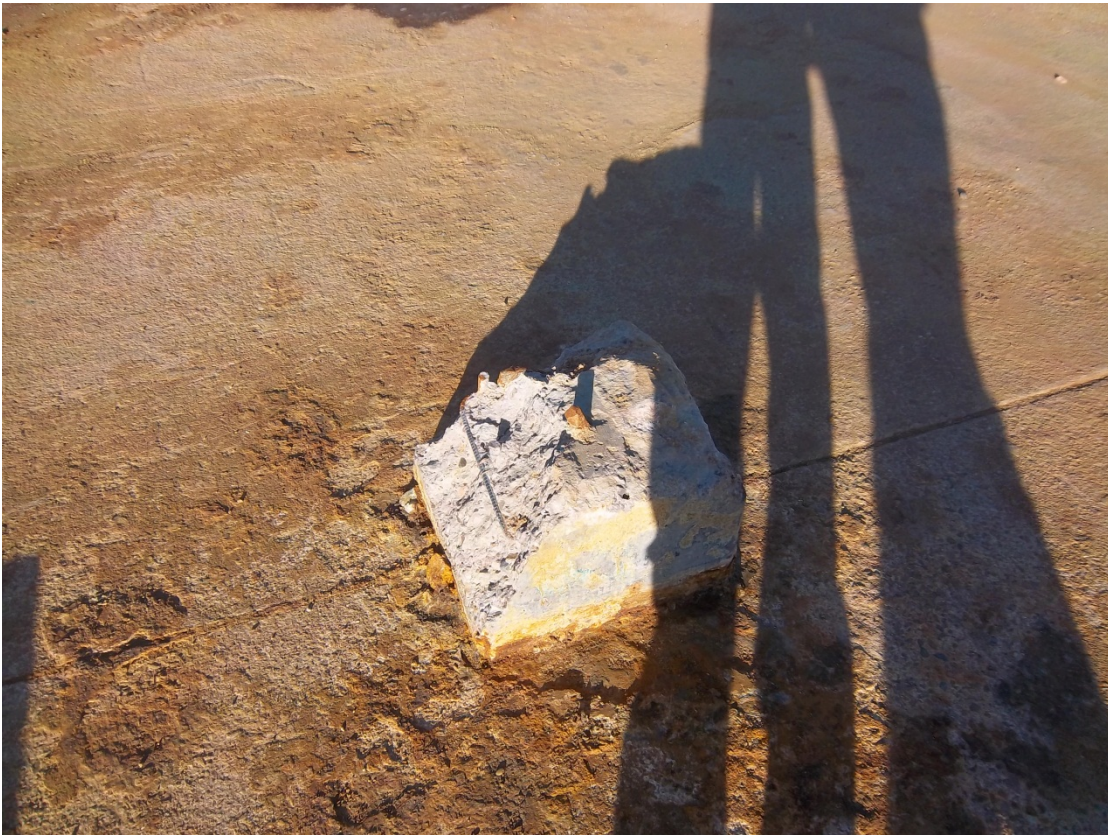
Photo 9 – Flotation Area – Spalled Concrete with Exposed Rebar and Corroded Anchor

Concrete piers that are to be reused should be saw-cut down and a new pier and anchors should be doweled into the pier below where footings below are to be reused. A further investigation should be performed to identify concrete surfaces that will require repairs where excessive deterioration is present. The design criteria for the floor slab should further investigated and the existing design should be further evaluated to satisfy all conditions, including future wheel loads and loads from floor jacks. Local strengthening of the floor slab may be considered to preserve the majority of the existing foundations in the case where new loads are in excess of the existing floor slab's load bearing capacity.

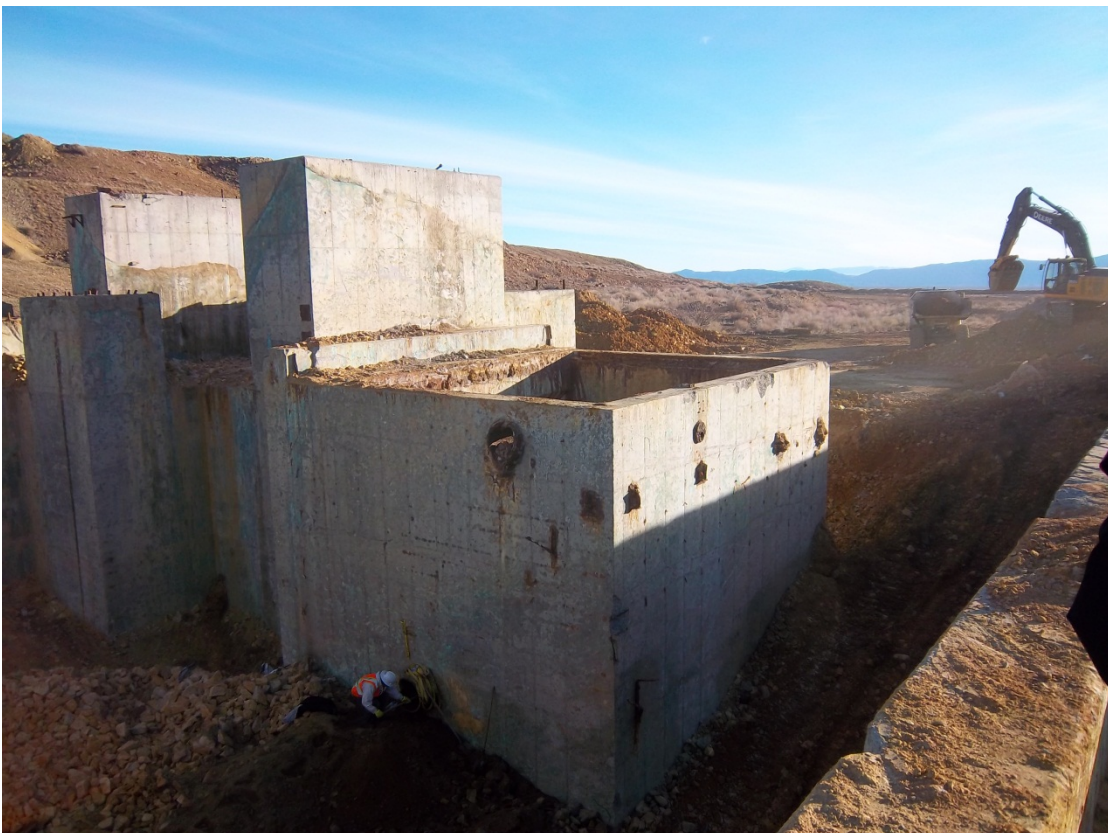
Photo 10 – Grinding Area – Corroded Embeds at Sump Box

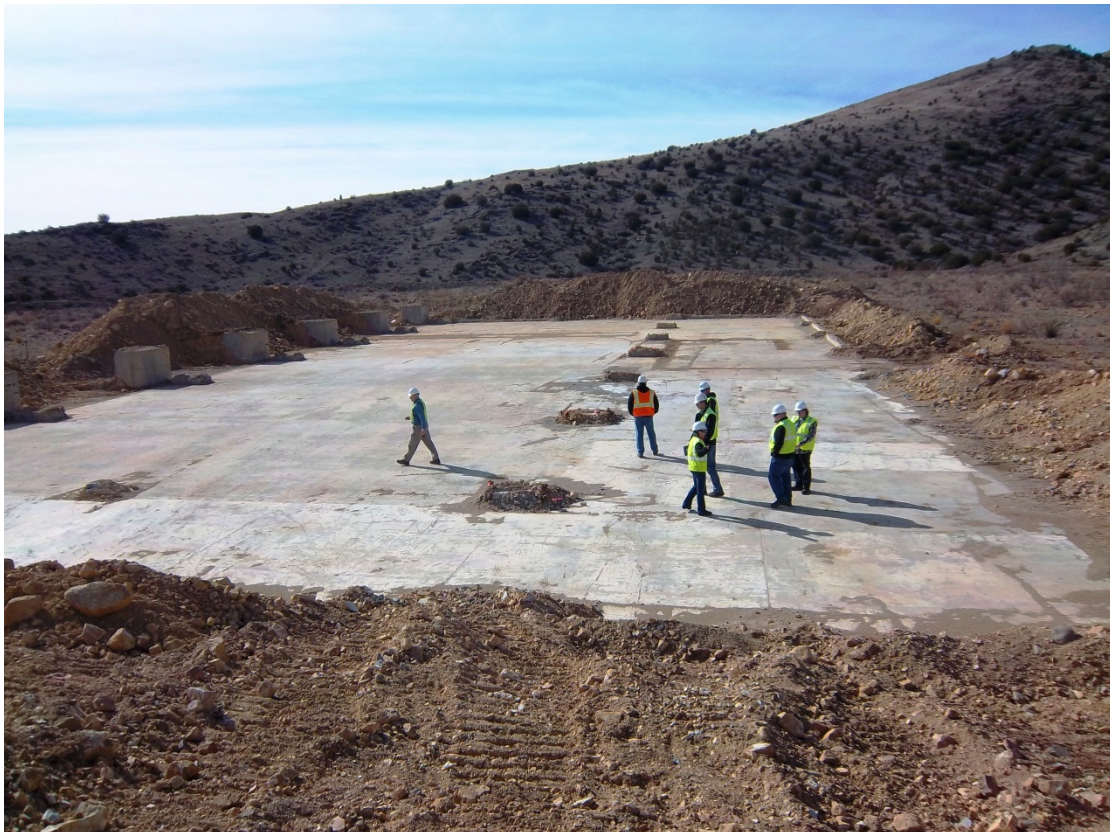
Photo 12 – Truck Shop – Excavation Progress

The existing Truck Shop foundations were visually inspected (See Photo 12) using the aforementioned criteria. Building piers had severe damage and edge distances for the anchor bolts were well below the accepted minimums which have added to the extent of spalled concrete (See Photo 13). Flooring embeds in the electrical trench were severely corroded (See Photo 14).

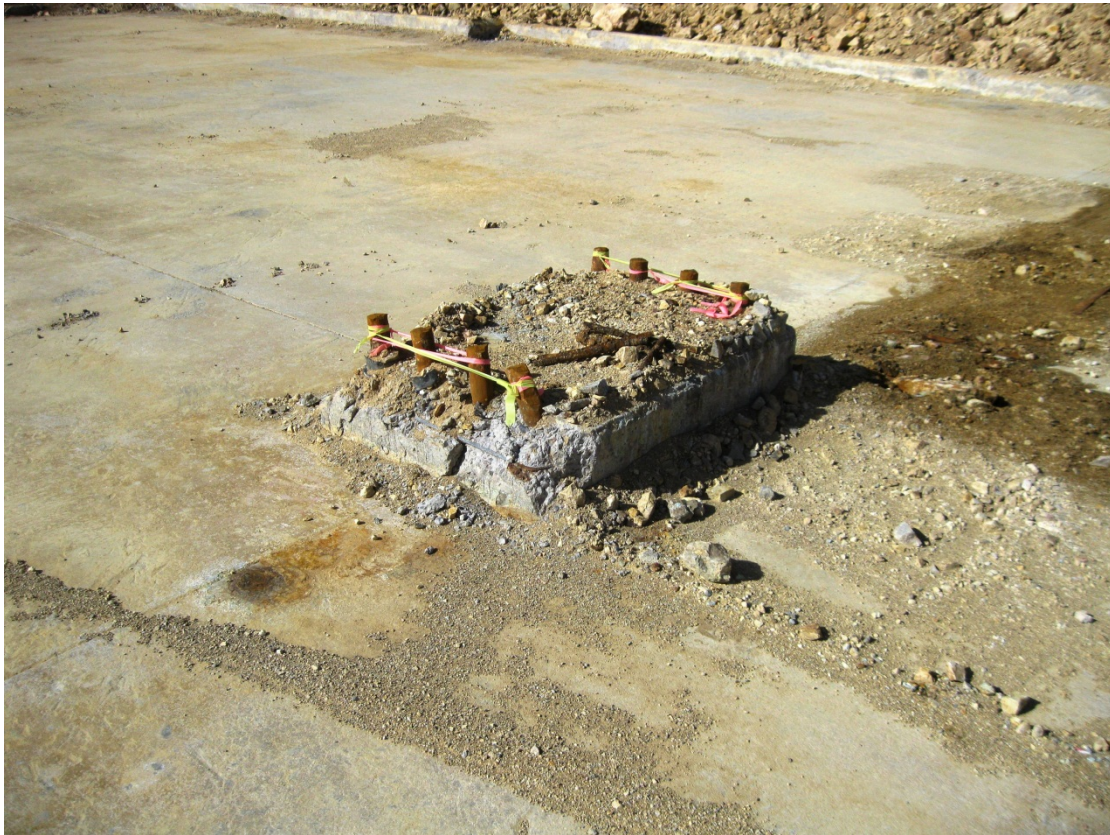
Photo 13 – Truck Shop – Spalled Concrete, Exposed Rebar and Corroded Anchors at Interior Concrete Pier

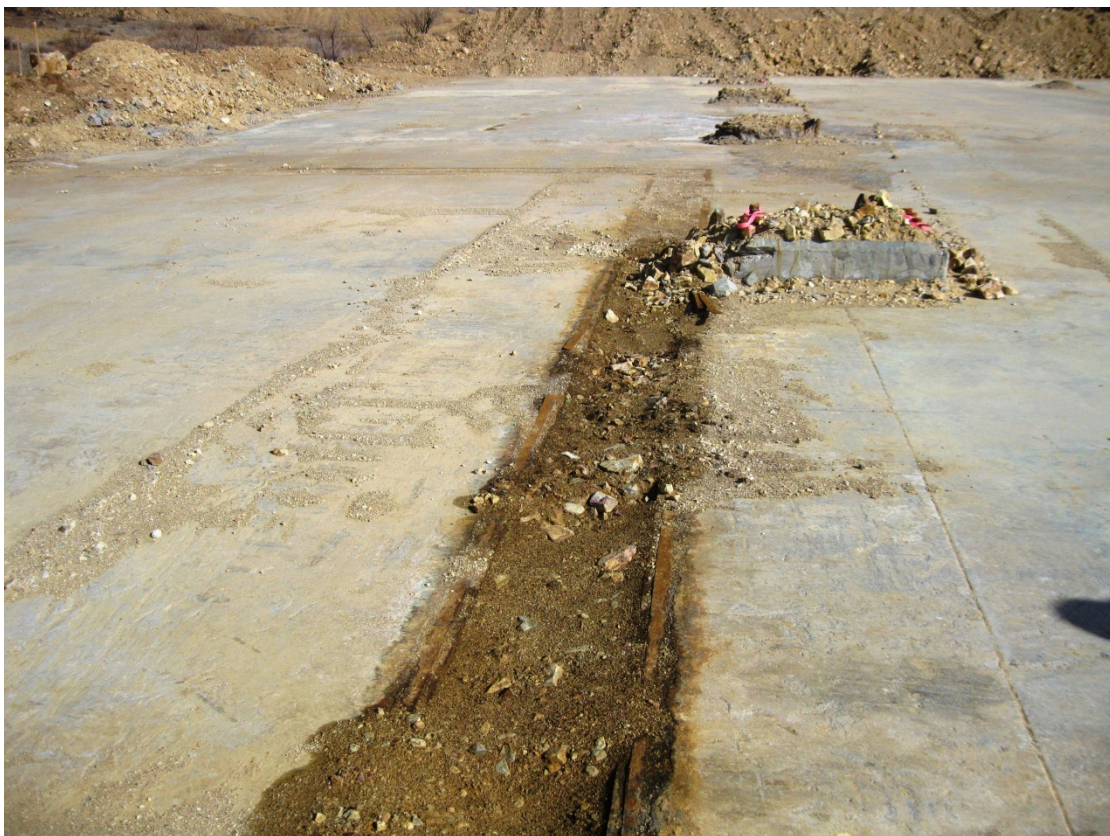
Photo 14 – Truck Shop – Corroded Electrical Trench Embed Angle
