The Swastika Mine and Dutchman Canyon Reclamation Project

Raton, New Mexico

Project Background

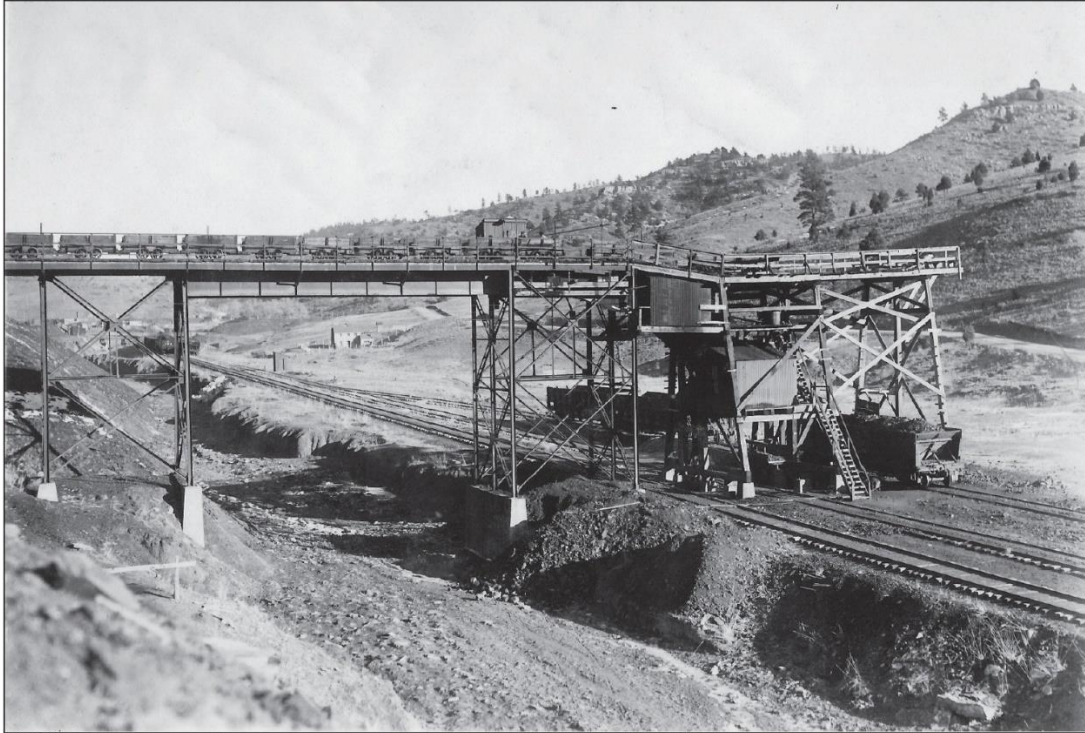
The Dillon Canyon stream channel adjacent to the Swastika Mine was straightened to accommodate mining operations as shown in this historic photograph of the tippie. Later the railroad tracks were removed and the road was rerouted to its current straight alignment atop the east stream bank. Straightening stream channels shortens the flow path, which increases the slope of the channel bottom. Increased slope means faster flow. Faster flows erode the banks and channel bottom.

Notice the lack of trees on the hillside having been harvested by the mining operation and coal camp residents.

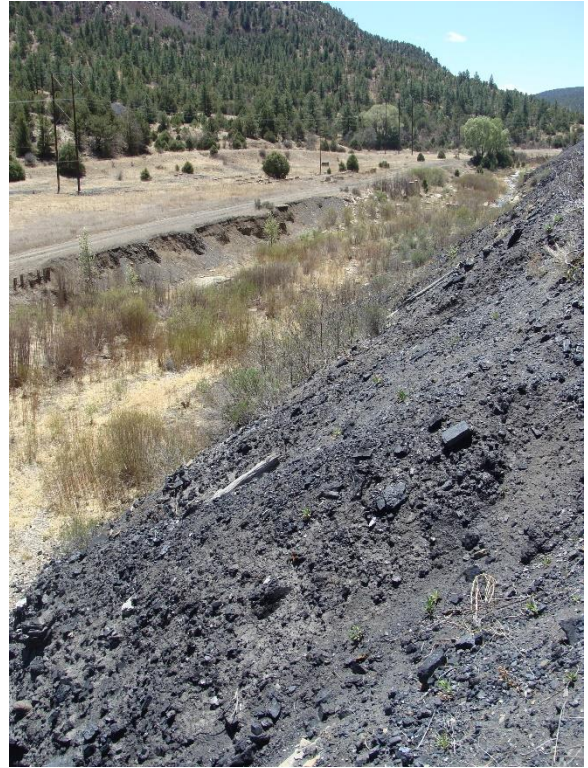
Coal gob pile left on the hillside with adjacent straightened stream at the base. The gob material was not terribly acidic (pH 4.2) but did degrade the quality of the adjacent stream channel.

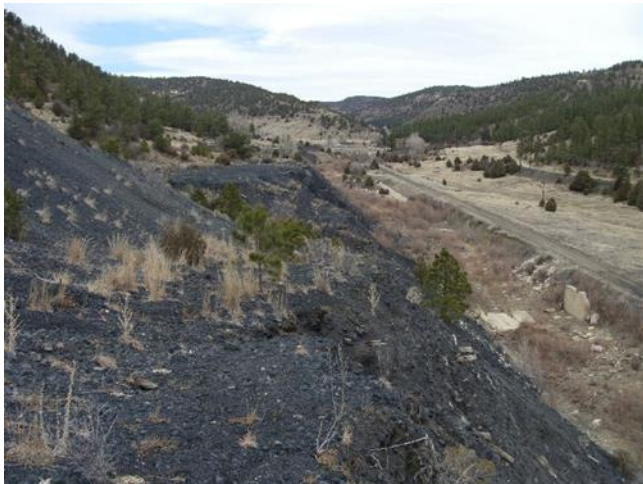
The road is the location of the old rail line and is prohibiting the stream from adding any sinuosity.

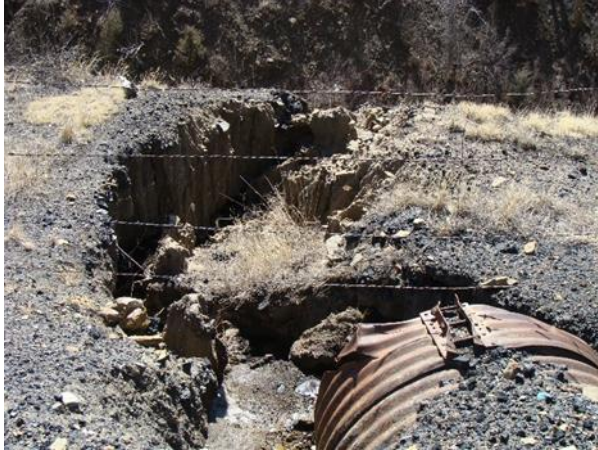
A dilapidated culvert conveying the overflow from ponds at the Dutchman Canyon mine site into a nearby stream channel.

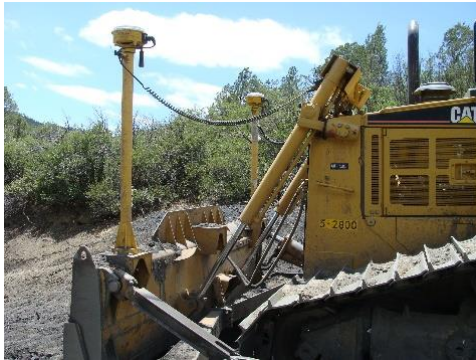
Equipment was enabled with GPS to provide the topography designed by the engineer.

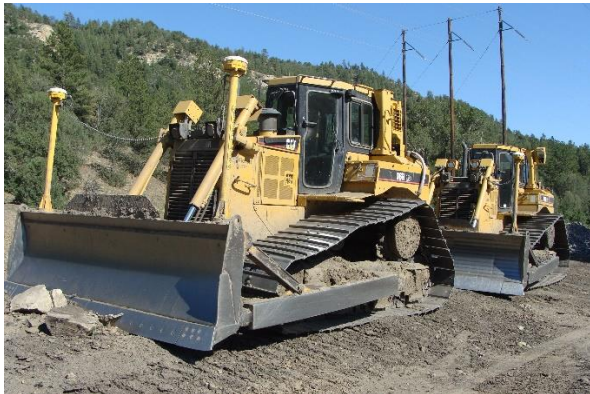
GPS-enabled equipment allowed the operators to follow the engineering plans as drawn. This was relatively new even for a big construction company like Kiewit in 2012 when the project took place. Traditional survey staking was not necessary.

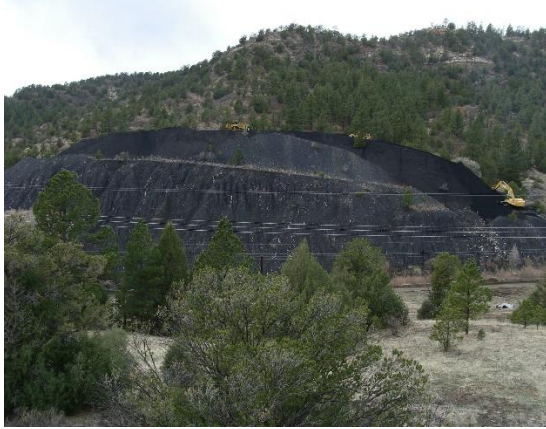
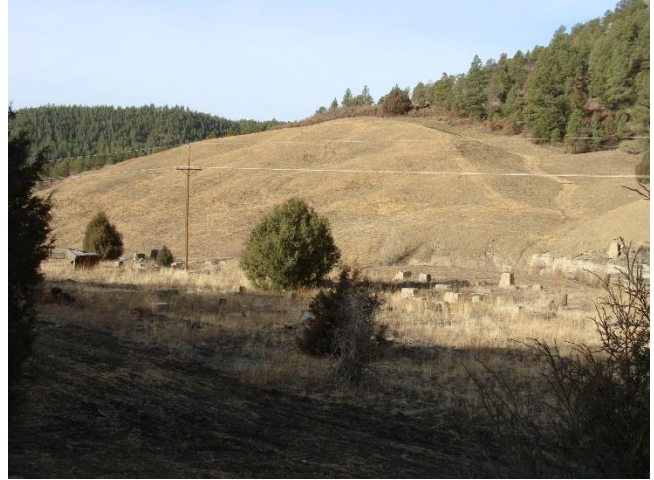
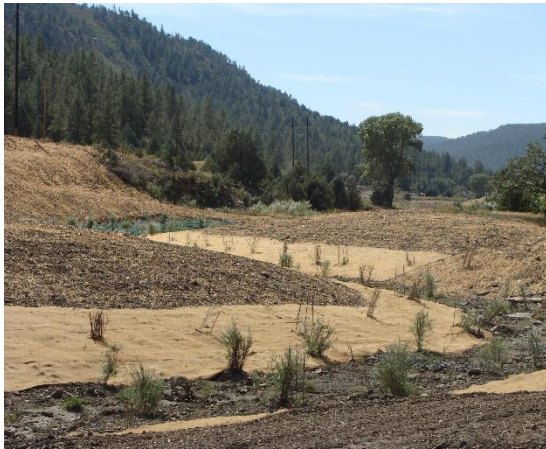
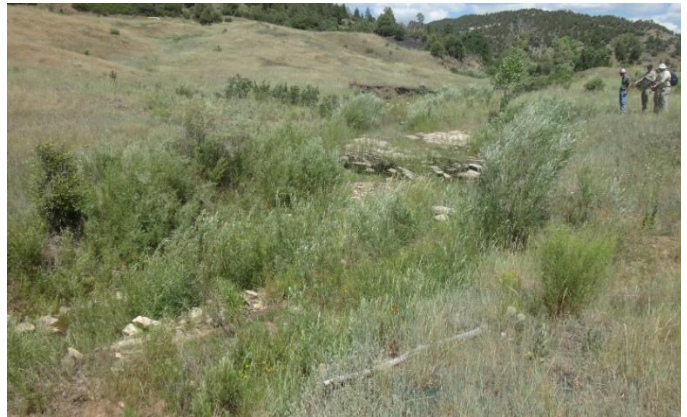
Clockwise from top left: Gob Pile 3 during construction; Gob Pile 3 after reclamation; Dillon Canyon channel in 2019; Dillon Canyon channel immediately after construction

Geomorphic reclamation of hillsides blends in perfectly with the surrounding terrain. See the photos included to for a good illustration. Water running down the hillside from above the project was conveyed through the project site as a natural channel or swale would do.

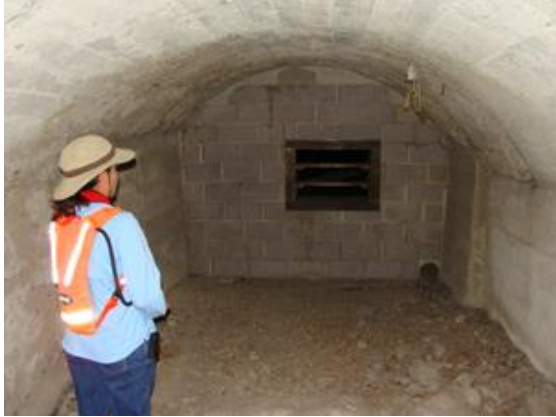
Concrete block bulkhead with bat gate centered in the middle.

A concrete block bulkhead with bat gate was constructed in an open adit and steel grate was constructed above a water well left over from the residential community. Steep slopes on the various gob piles were also graded out to more walkable terrain.

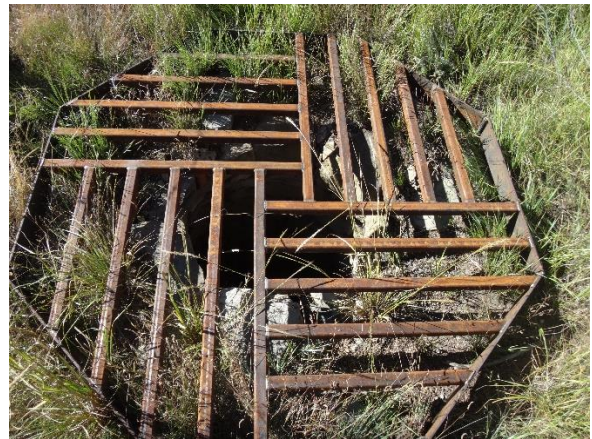
Steel grate placed over rock-lined 25-ft deep mining community water well.

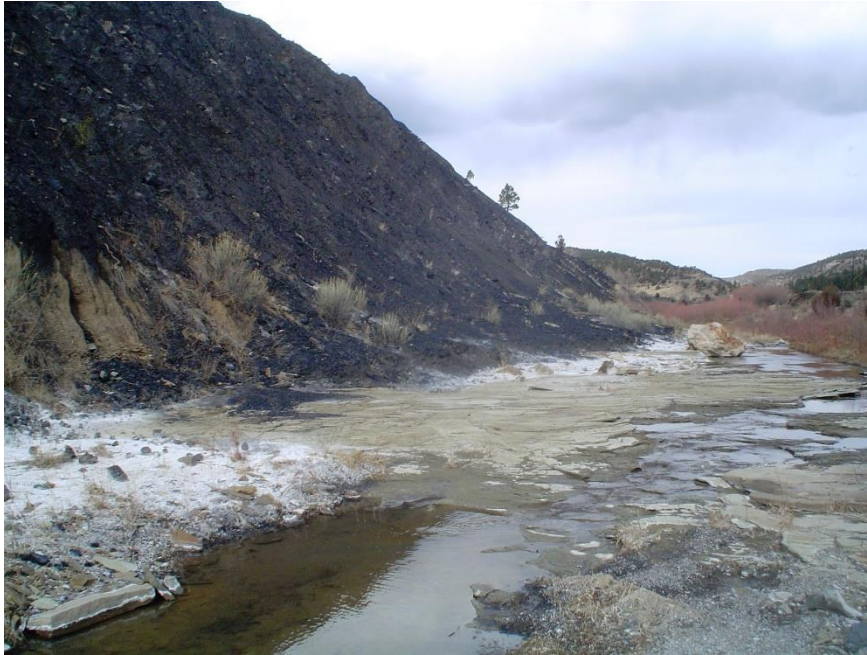
Gob Pile 3 before construction took place.

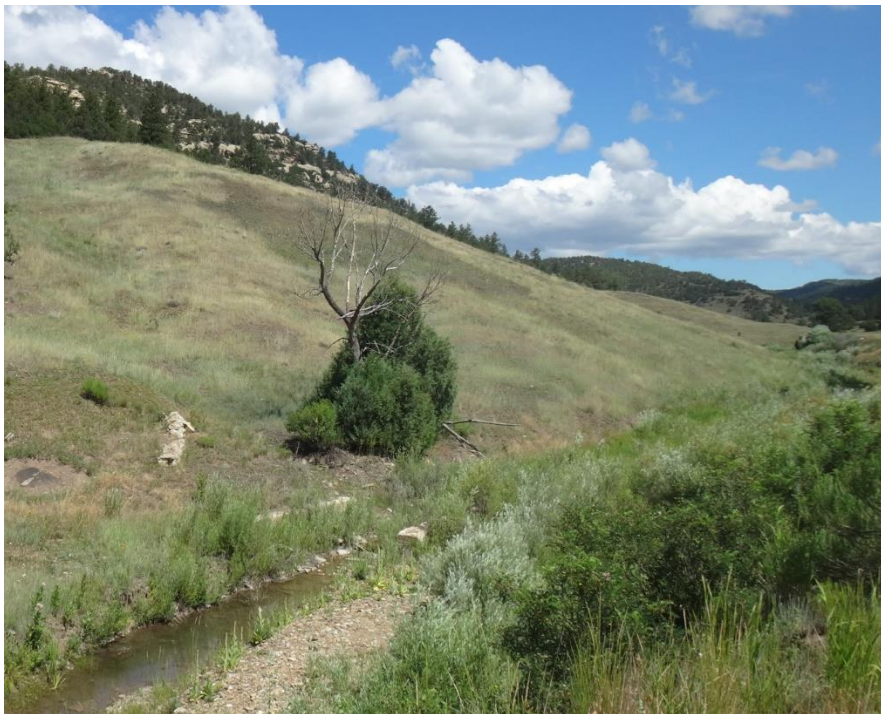
Gob Pile 3 in 2019.

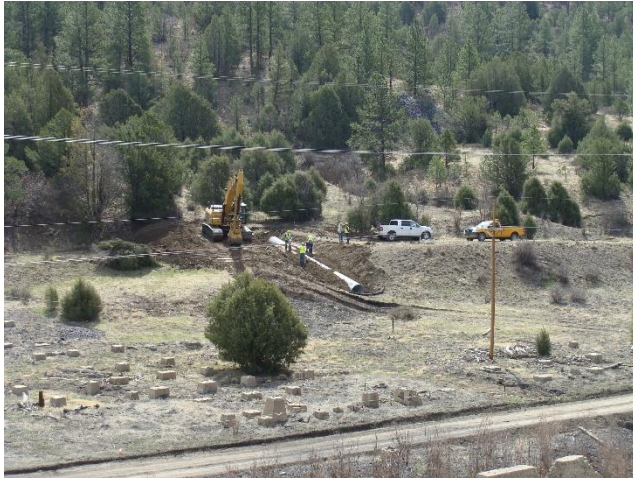
Culvert being placed on the new road route. The route was actually the old route created during the mining era. Note the preserved archaeological features in the foreground.

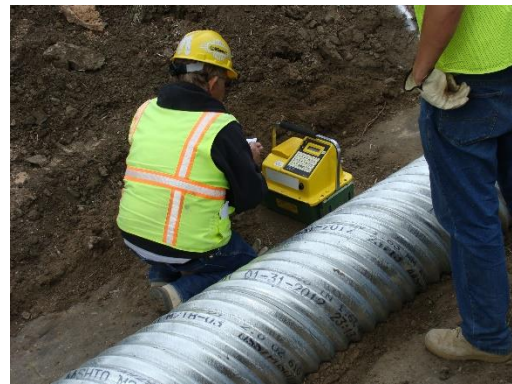
Compaction tests being conducted at the site of a culvert installation.

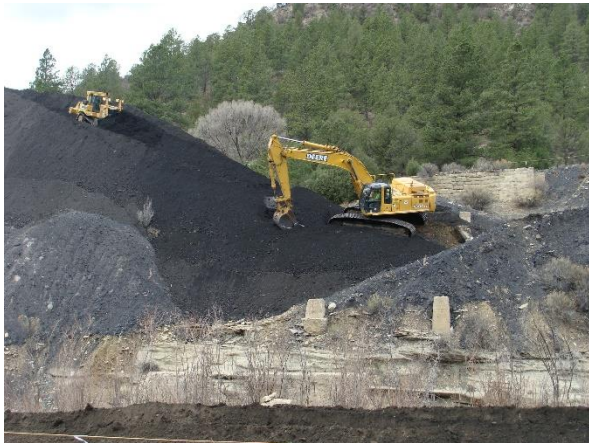
Gob regrading occurring near archaeological features. Great care was shown not to affect the pre-existing structures and artifacts.

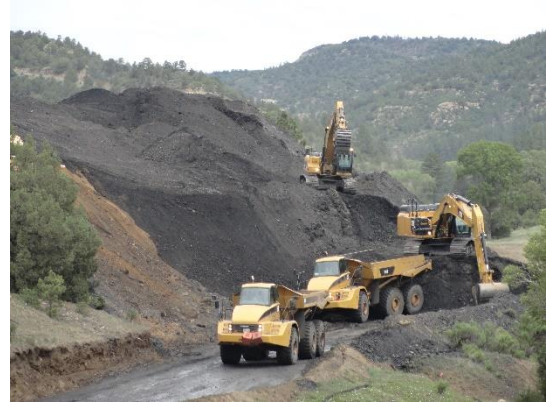
Gob Pile 3 being reduced in size by excavating and transporting the material to borrow area repositories.

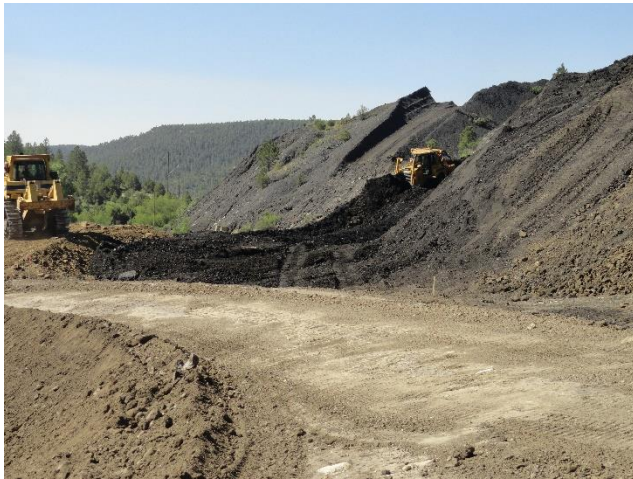
Gob pile being regraded to a lesser slope.

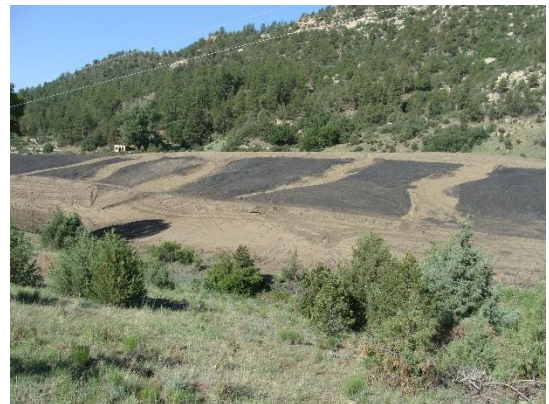
Regraded gob pile with clean growth material at the locations of drainage channels.

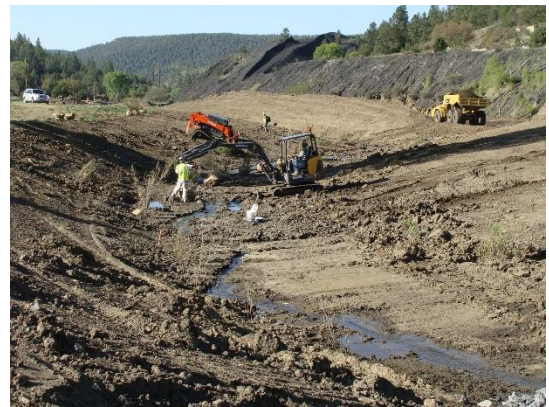
The channel along a reclaimed gob pile towards the end of construction.

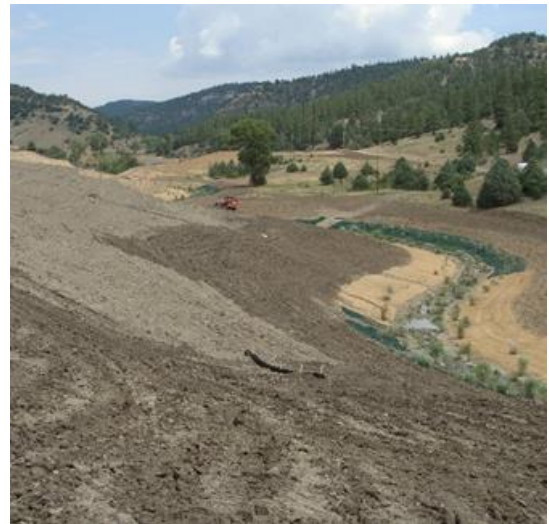
Newly planted vegetation and erosion protective fabric planted on the sides of the channel.

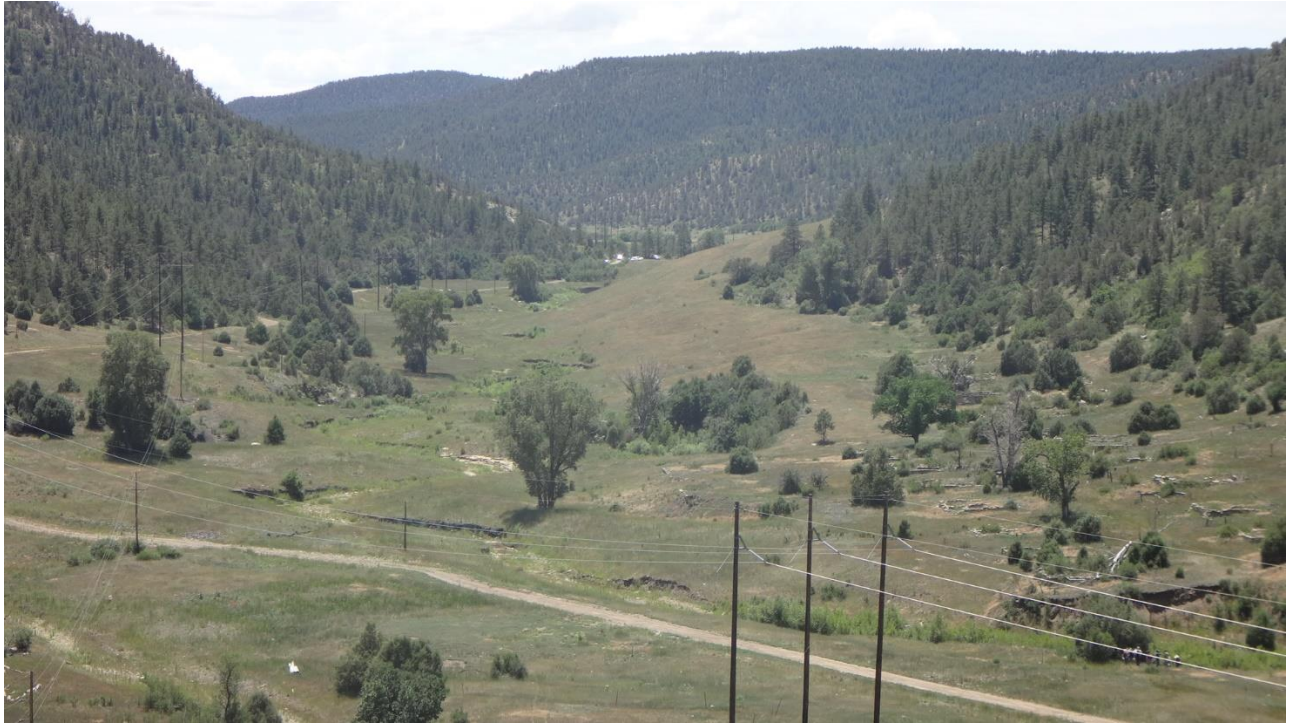
View of the reclaimed Dillon Canyon in 2019.
