Subject: Modification Application for Reference Area for Reclamation Success Criteria at GCC Rio Grande Tijeras Mine and Mill (Permit No. BE001RE)

Reclamation Monitoring Plan

Tijeras Mine & Mill

2021 Reclamation Monitoring Report GCC Tijeras Mine and Mill

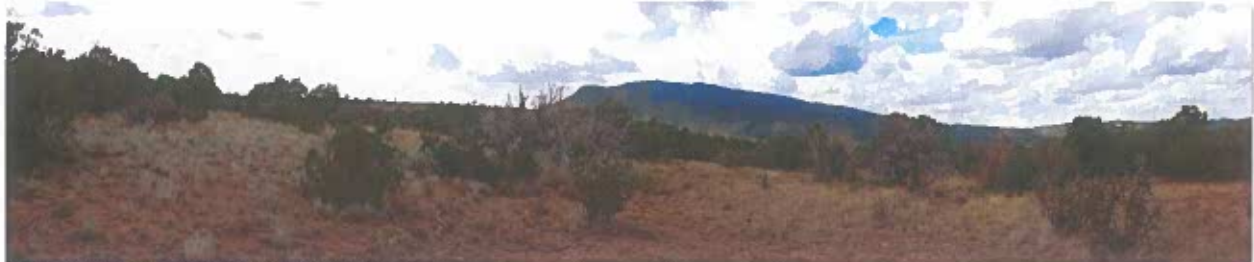
Photograph 1 . Panoramic photograph of proposed reference area

In order to provide a more reasonable measure of revegetation success for reclamation at the Tijeras Mine and Mill, GCC Rio Grande proposes to establish an approximately 1-acre reference area east of Quarry 357 (Appendix A – Map A-1). The reference area captures the pre-disturbance variation in slope, aspect, and surface soils to adequately represent disturbed and planned areas of disturbance in the quarry (Appendix A – Map A-2). Additionally, the reference area captures early-successional grassland stages of the mountain shrub vegetation community (dominated by piñon pine [*Pinus edulis*] and juniper [*Juniperus monosperma*]), which would only be expected after several decades of vegetation establishment after reclamation. Species within the proposed reference area include blue grama (*Bouteloua gracilis*), side-oats grama (*B. curtipendula*), black grama (*B. eriopoda*), hairy grama (*B. hirsuta*), bush muhly (*Muhlenbergia porteri*), sand dropseed (*Sporobolus cryptandrus*),

mountain mahogany (*Cercocarpus montanus*), snakeweed (*Gutierrezia sarothrae*), cholla (*Cylindropuntia* sp.), prickly pear (*Opuntia* sp.), and yucca (*Yucca* sp.).

Upon approval, the reference area would be marked on the vegetation map, permanently marked in the field, and would be properly managed in a manner similar to non-affected lands adjacent to the permit area. Monitoring transects within the reference area would be established after the first round of monitoring which is anticipated to occur in Fall 2020; the number of transects (sampling adequacy) will be determined after collecting a set of preliminary samples, testing the data for normality, and calculating the Cochran formula for sample adequacy. The reference area would be monitored at least every two years during the liability period to ensure that markings are visible and that the area continues to be managed in a manner similar to non-affected adjacent lands. The condition and management of the reference area would be described in any subsequent monitoring reports.
