Re: Submittal of Response to Comments and Addendum to
Tyrone Stage 1 Abatement Plan Proposal, DP-1341 Condition 34

Addendum to the Tyrone Mine Facility Stage 1 Abatement Plan Proposal

**Phelps Dodge Tyrone, Inc.
Tyrone, New Mexico**

Daniel B. Stephens & Associates, Inc.

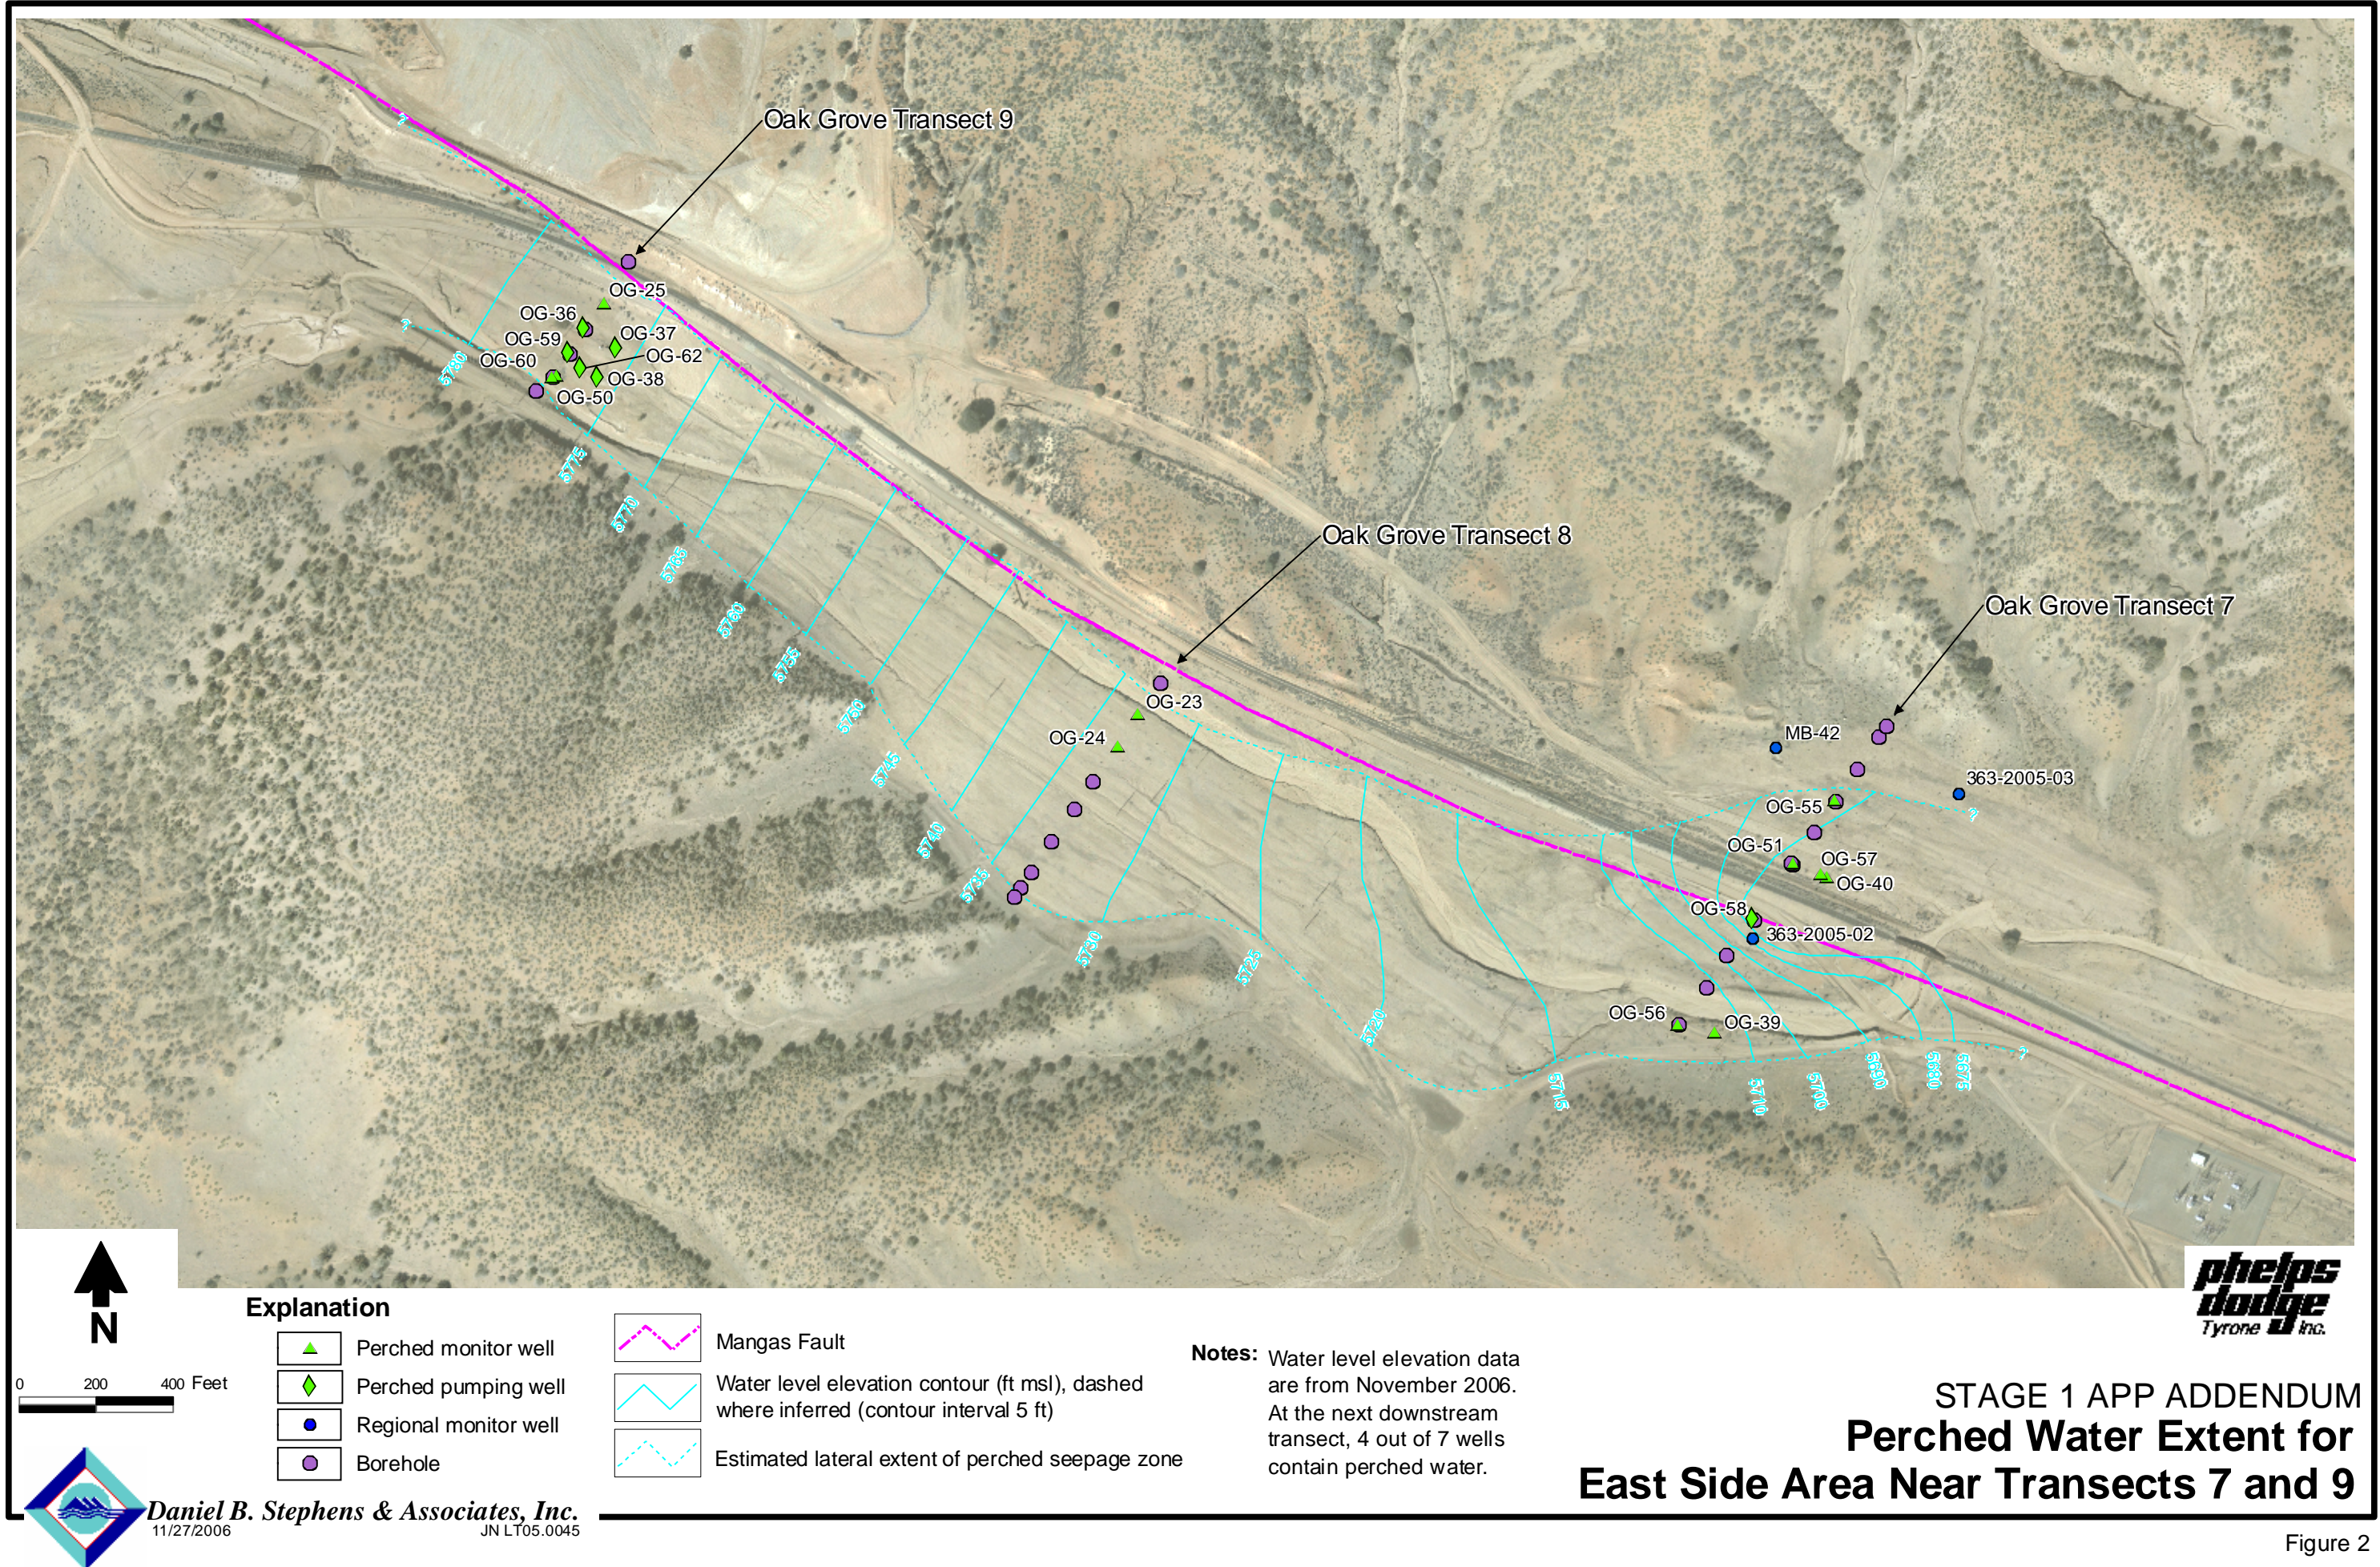
Figure 2 is a map of Lower Oak Grove Wash from Transects 7 to 9 showing all existing monitoring (perched and regional) and pumping wells, soil borings, and November 2006 perched water elevations. Two regional groundwater wells installed in 2005 near Transect 7 (363-2005-02 and 363-2005-03) are also shown in Figure 2. Figure 3 is a cross section of Transect 7, which crosses the Mangas Fault; this figure shows perched and regional wells along the transect and the vertical extent of perched water in November 2006. Approximately 25 feet of perched water occurs above the alluvium/Gila Conglomerate contact in the area near the southwest end of Transect 7. Perched well OG-51, screened only in Gila Conglomerate, is currently dry. The two regional wells installed in 2005 have pH values near 7, TDS concentrations just below 600 milligrams per liter (mg/L), and no exceedances of water quality

NMED (2006, Specific Comment No. 7) stated a concern that the lateral extent of groundwater contamination may not be well defined in this area. Although the comment refers to Oak Grove well Transect 9, it is PDTI's understanding from conversations with NMED that the concern is really focused on Transect 7 (Figure 2). Due to unsafe drilling conditions (overhead power lines in the area), an additional boring southwest of perched well OG-56, at the southwest end of Transect 7, was not completed (DBS&A, 1997). The lateral extent of perched water, however, can be inferred from the upstream Transect 8 (along wells OG-23 and OG-24), as shown in Figure 7 of the February 1997 No. 1A stockpile seepage investigation progress report (DBS&A, 1997). The estimated lateral extent of perched water in Figure 2 is consistent with the lateral extent determined at Transect 8 through drilling. PDTI believes that the lateral (cross-gradient) extent of contaminated water in this area is adequately defined based on the available transects of wells and borings, as illustrated in Figures 2 and 3.

Note in Figure 2 that the delineated lateral extent of perched water in the downgradient direction (i.e., along Oak Grove Wash) is not closed, as it has been shown in some previous East Side perched zone maps submitted by PDTI. This is because water levels measured during November 2006 indicate that saturated conditions occur in the alluvium at four of the seven monitor wells in the next downgradient well transect (Transect 6, not shown on Figure 2). PDTI is currently in the process of acquiring and installing continuous water level recorders in two perched zone monitor wells in Oak Grove Wash to better monitor transient changes in perched zone water levels. One recorder will be installed in Oak Grove Transect 3, located about 2,400 feet southeast of Transect 6, and the other in Transect 1, located just upstream of the confluence of Oak Grove Wash and Brick Kiln Gulch. This activity was proposed under Section 3.4.4. of the Stage 1 APP. PDTI is also in the process of considering additional measures that can be implemented to capture and reduce the extent of contaminated alluvial water in Lower Oak Grove Wash.

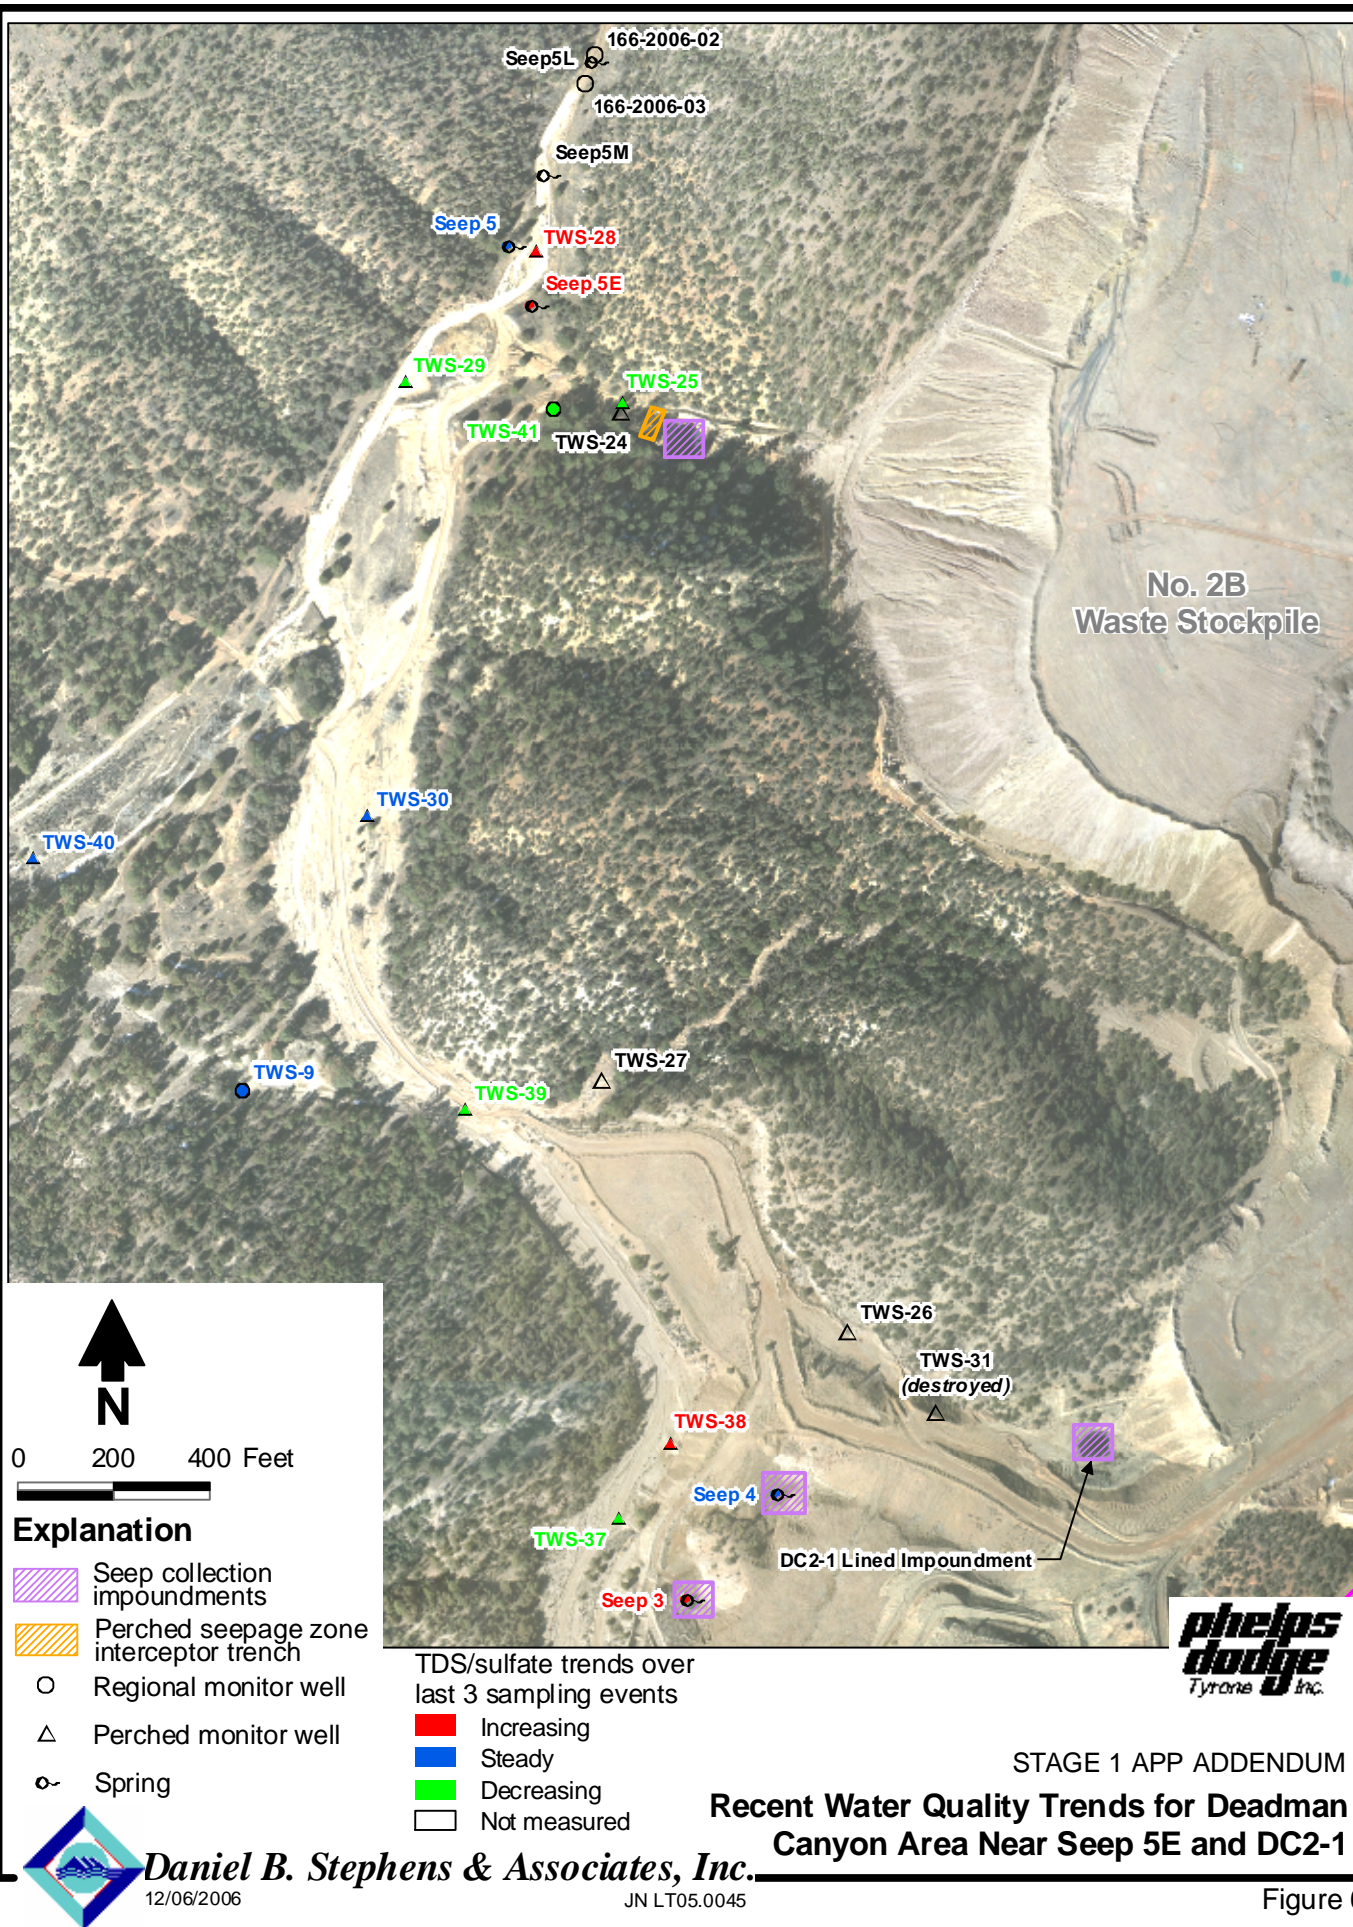
Figure 6 shows the locations of existing perched and regional wells, springs, and seep collection impoundments west of the No. 2B Stockpile. No data are available for 2005 and 2006 to determine recent water quality trends for TDS and sulfate downgradient of the DC2-1 lined impoundment at well TWS-26. Well TWS-31, which was closest to the impoundment, was destroyed (Figure 6). TWS-26, currently dry, is a shallow well with the bottom of screen at 17 feet below ground surface, similar to destroyed well TWS-31 (bottom of screen 18.72 feet deep). As noted above, additional groundwater quality investigation in Deadman Canyon is proposed in the APP CPT work plan (including groundwater sampling of well TWS-26, if it contains water). PDTI proposes to assess the need for additional monitor wells in Deadman Canyon, including replacement of TWS-31, once this investigation is complete.

Regional groundwater quality in the vicinity of that portion of Deadman Canyon discussed above, as evidenced by monitoring wells TWS-8, TWS-9 and TWS-41 (Figures 1 and 6), meets groundwater quality standards. Farther to the north, well TWS-19 at the north end of the Deadman Canyon narrows, exceeds water quality standards for copper and manganese (Figure 9). This well was added back in the DP-166 sampling regimen based on a recommendation made in the Stage 1 APP (DBS&A, 2004).

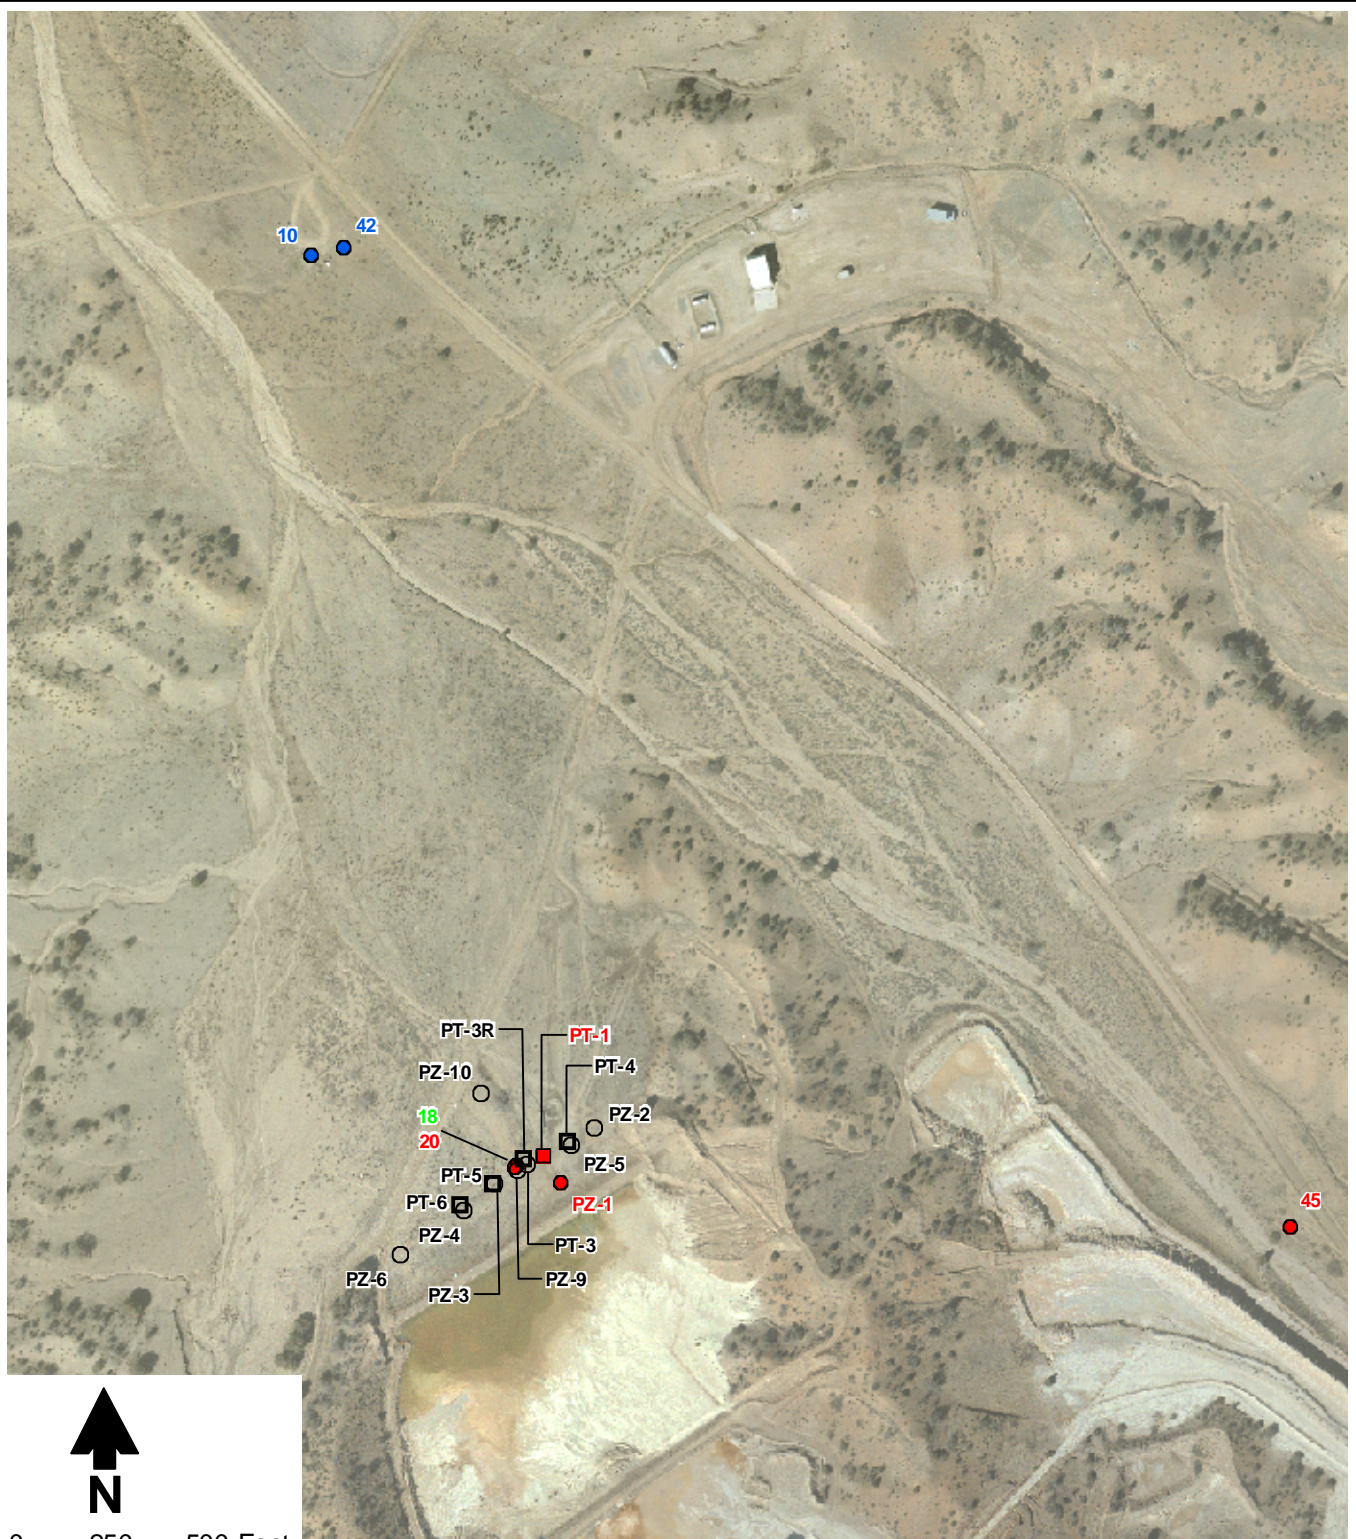
Figure 10

P-203 (Canyon 11) is a pumping well with a total depth of 245 feet and screened interval from 225 to 245 feet, and P-196 (Canyon 7) is a pumping well with a total depth of 170 feet and screened interval from 150 to 170 feet. These wells are both screened in Gila Conglomerate and sampled annually. TDS and sulfate concentrations have steadily increased over the past

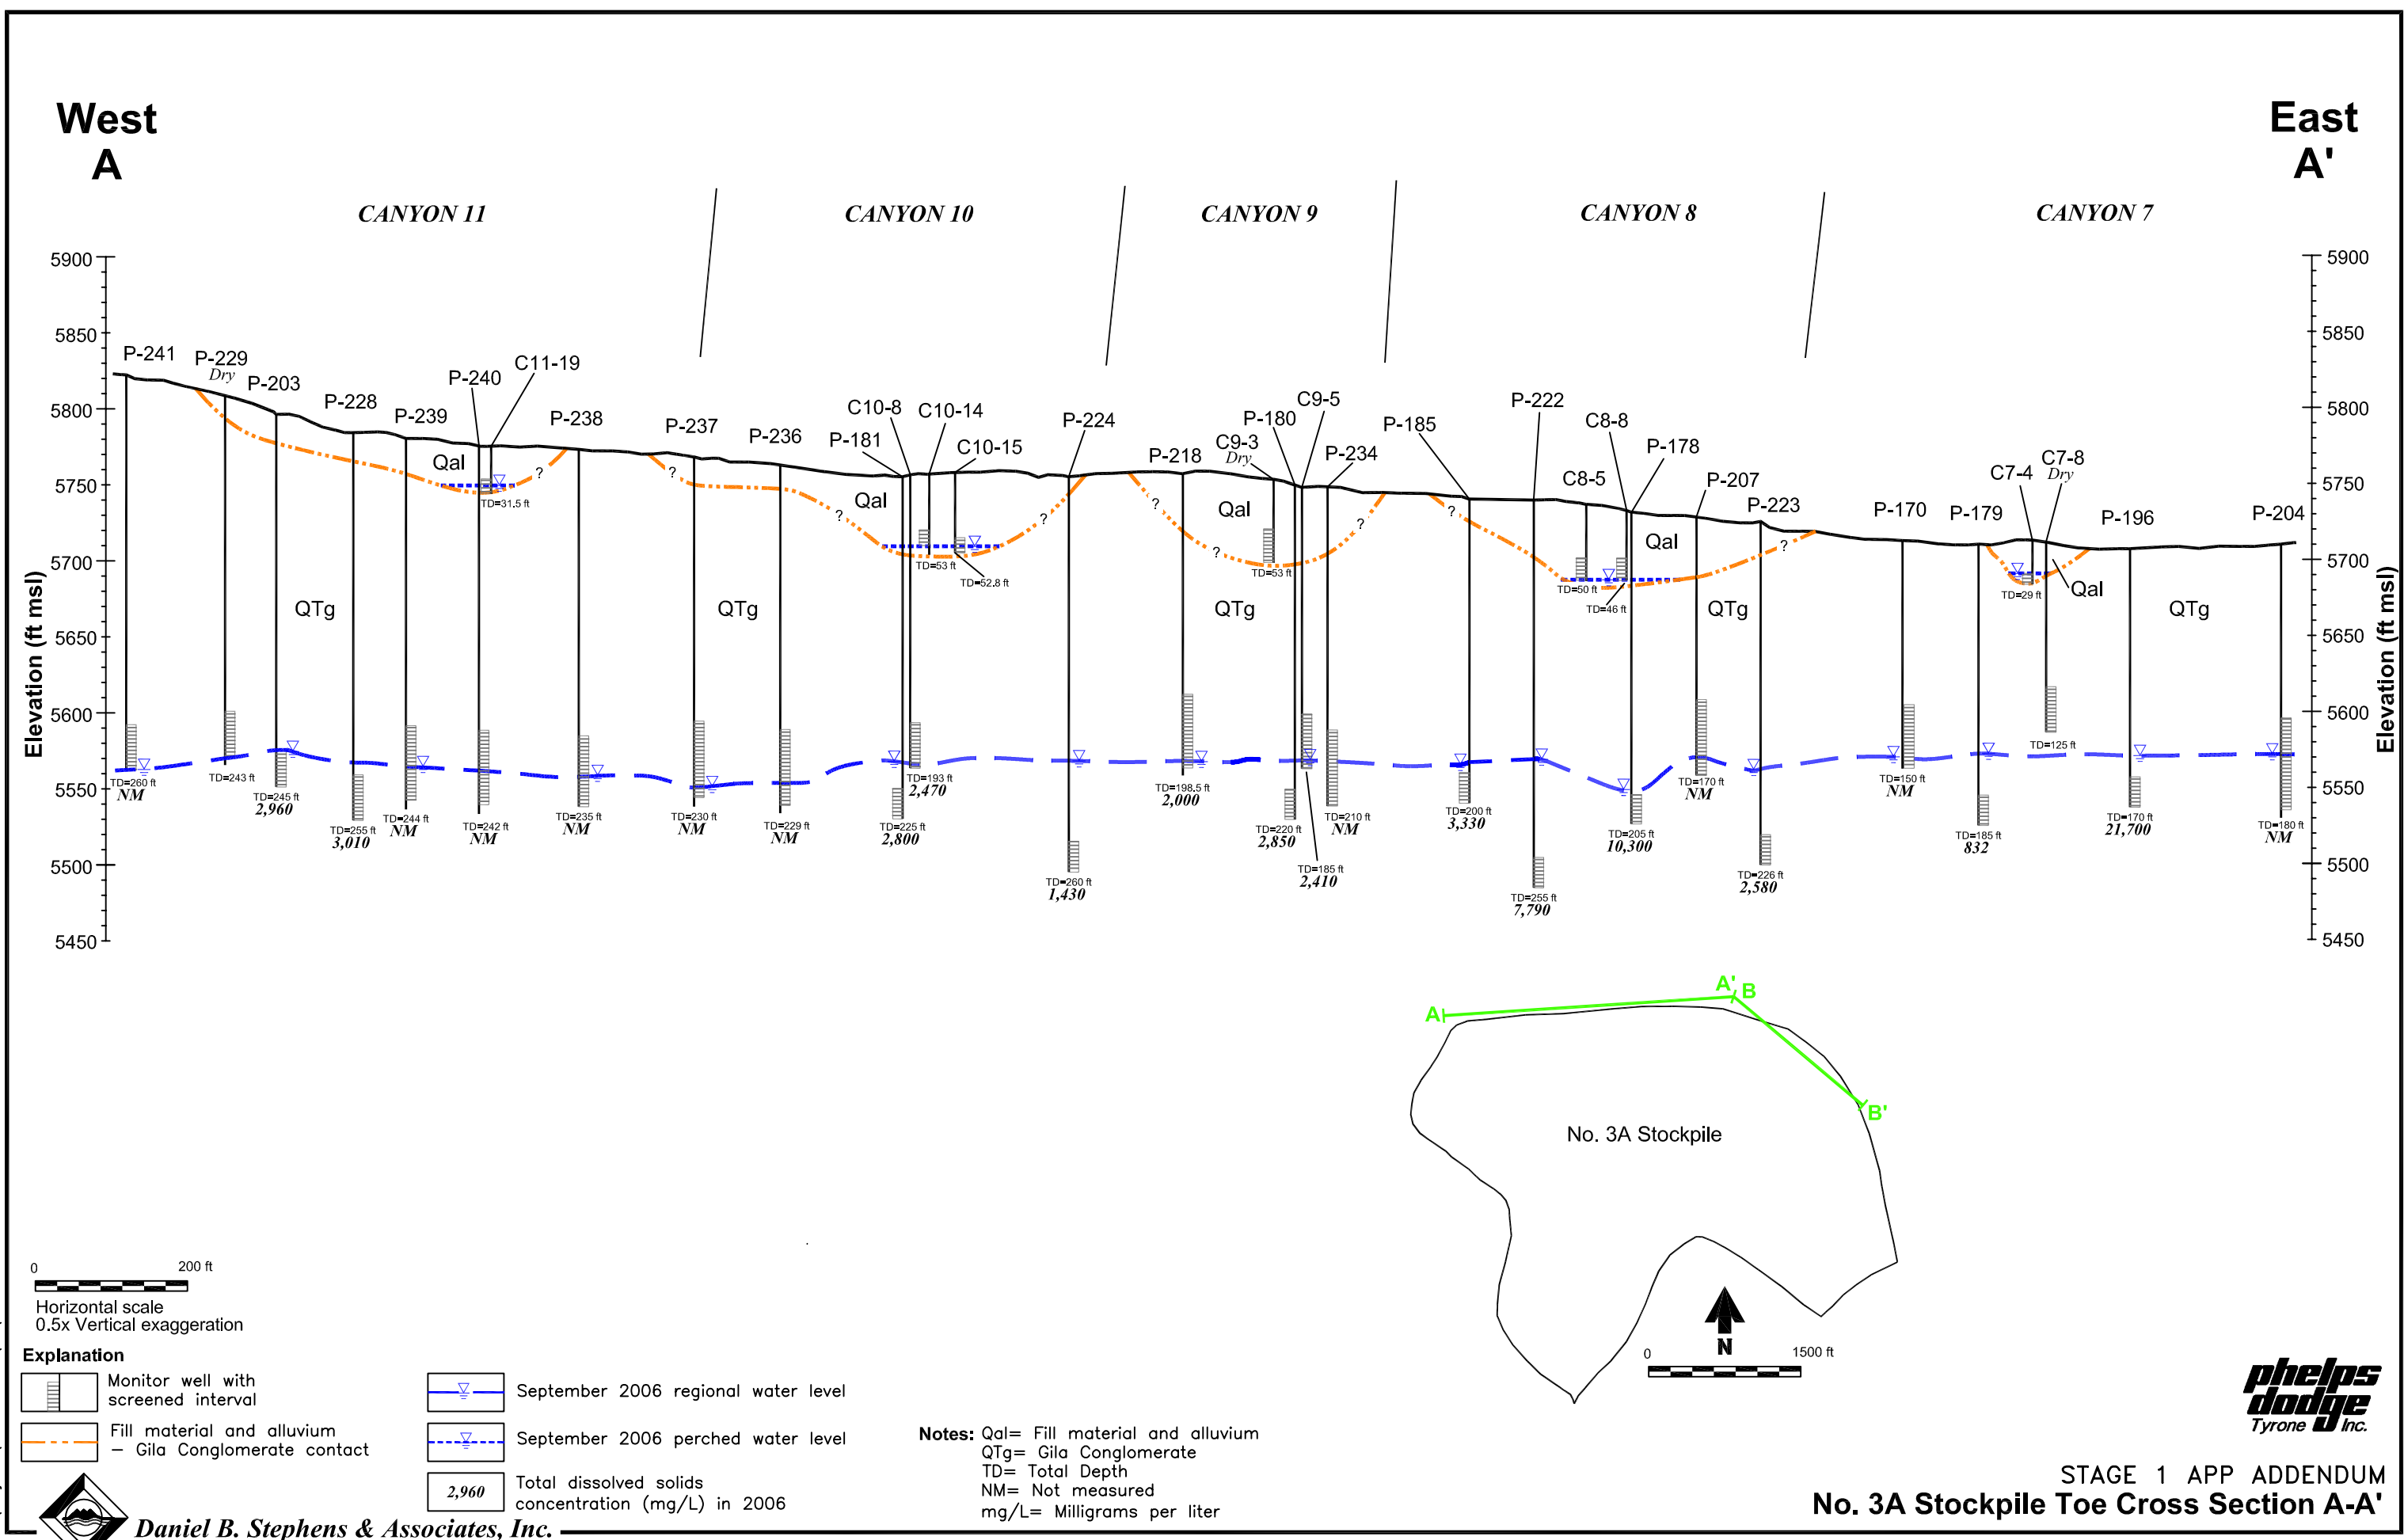
Figure 13 is a cross section along the toe of the No. 3A stockpile from Canyon 11 to Canyon 7, and Figure 14 is a cross section from Canyon 6 to Canyon 4. These figures show perched and regional wells with screened intervals, the vertical and horizontal extent of perched water in the canyons, the regional water table, and TDS concentration at regional wells where available. At some locations, higher TDS concentrations are found in shallower wells screened near the top of the regional water table and beneath the perched seepage zones, suggesting vertical migration of contaminants from the perched seepage zones to the regional aquifer. This observation is consistent with previous investigation findings at the No. 3A stockpile that indicate regional seepage pathways are spatially related to the natural drainages beneath the stockpile. The result of this seepage has been a progressive degradation in water quality along the toe of the stockpile from the Canyon 4 through the Canyon 11 areas.

Overall, the vertical extent of impacts in the regional aquifer near the toe of the No. 3A stockpile is not well defined. A large number of wells will be installed, and a large number of existing wells will be plugged and abandoned as part of stockpile regrading and reclamation. As part of these activities, PDTI plans to evaluate the vertical extent of impacted water in the vicinity of the
