**Re: DP-1341, Condition 84,
Update to the 2001 Assessment of No. 3 Tailing Pond Reclaim Area**

**DP-1341, CONDITION 84, UPDATE TO THE 2001
ASSESSMENT OF THE NO. 3 TAILING POND
RECLAIM AREA**

Submitted by:
Golder Associates Inc.
4910 Alameda Blvd., Suite A
Albuquerque, NM 87113

April 29, 2005

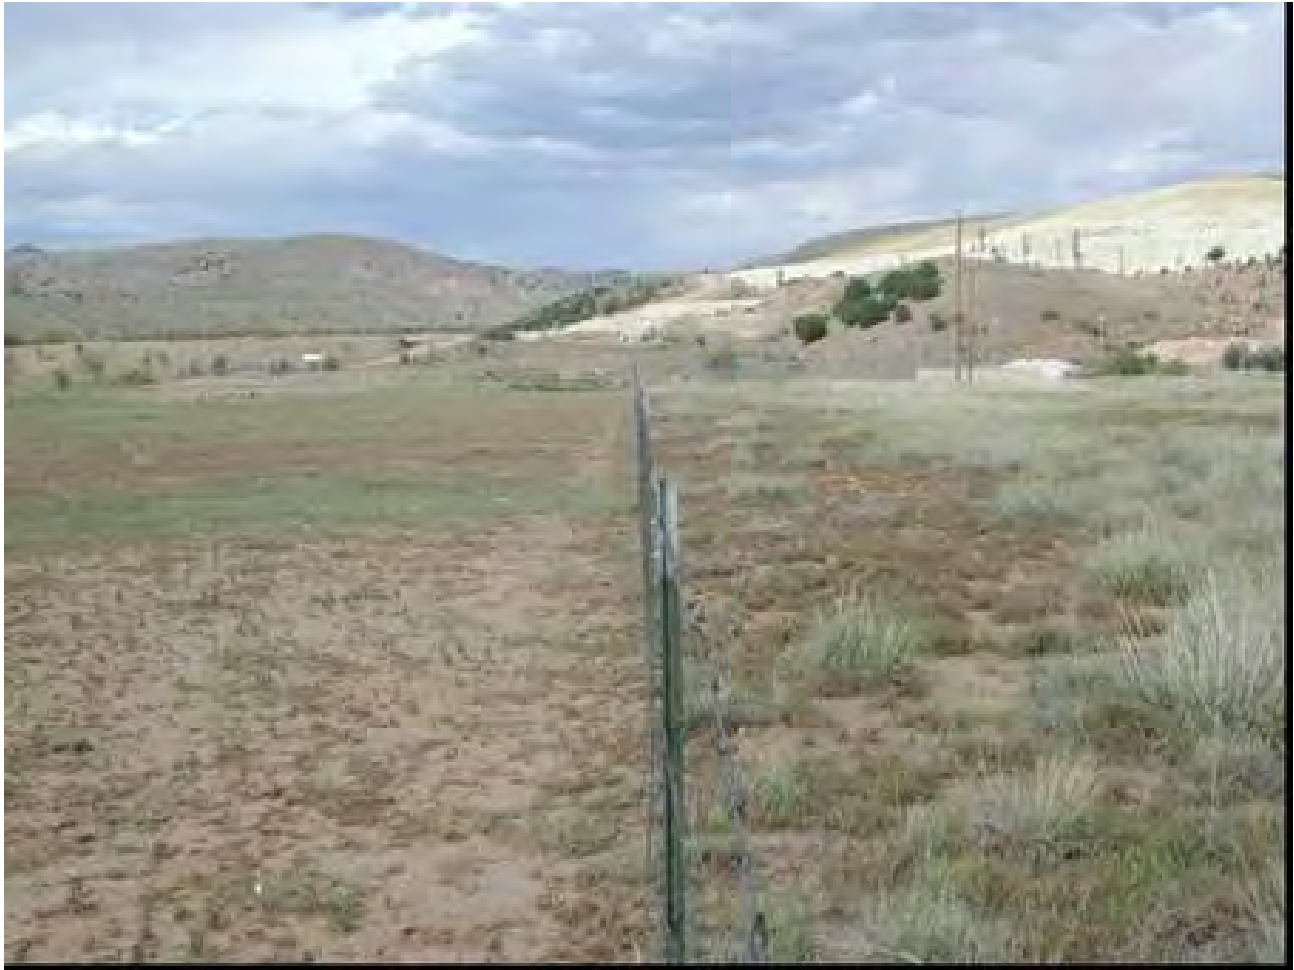
FIGURE 3
RESPONSE OF VEGETATION COVER TO GRAZING. PHOTO OF FENCE LINE ON THE
ORIGINAL NORTHERN ENCLOSURE ON THE SOUTH MAIN REPOSITORY. GRAZING HAS
BEEN EXCLUDED ON THE RIGHT OF THE FENCE.

The rangelands in the Mangas Valley, including the repositories, were actively managed for livestock production. The repositories were not fenced, and livestock had access to the original repository areas. Range utilization varied by repository, but was similar to surrounding native pastures and generally ranged from 60 to 100 percent at the time of the assessment. Overall range condition on both the repositories and adjacent native stands could be characterized as fair, but ranged from poor to good. The range condition on the repository areas with coarse-textured surface soils was similar to the surrounding undisturbed lands. Lands that are grazed generally have lower amounts of canopy cover because the annual biomass is removed by the grazing animals (Figure 3). In addition, grazing may result in shifts in species composition. Thus, the climate and management were less than optimal with respect to promoting vegetation performance. These factors should be considered in assessing the inherent capacity of the soil cover system in this region.

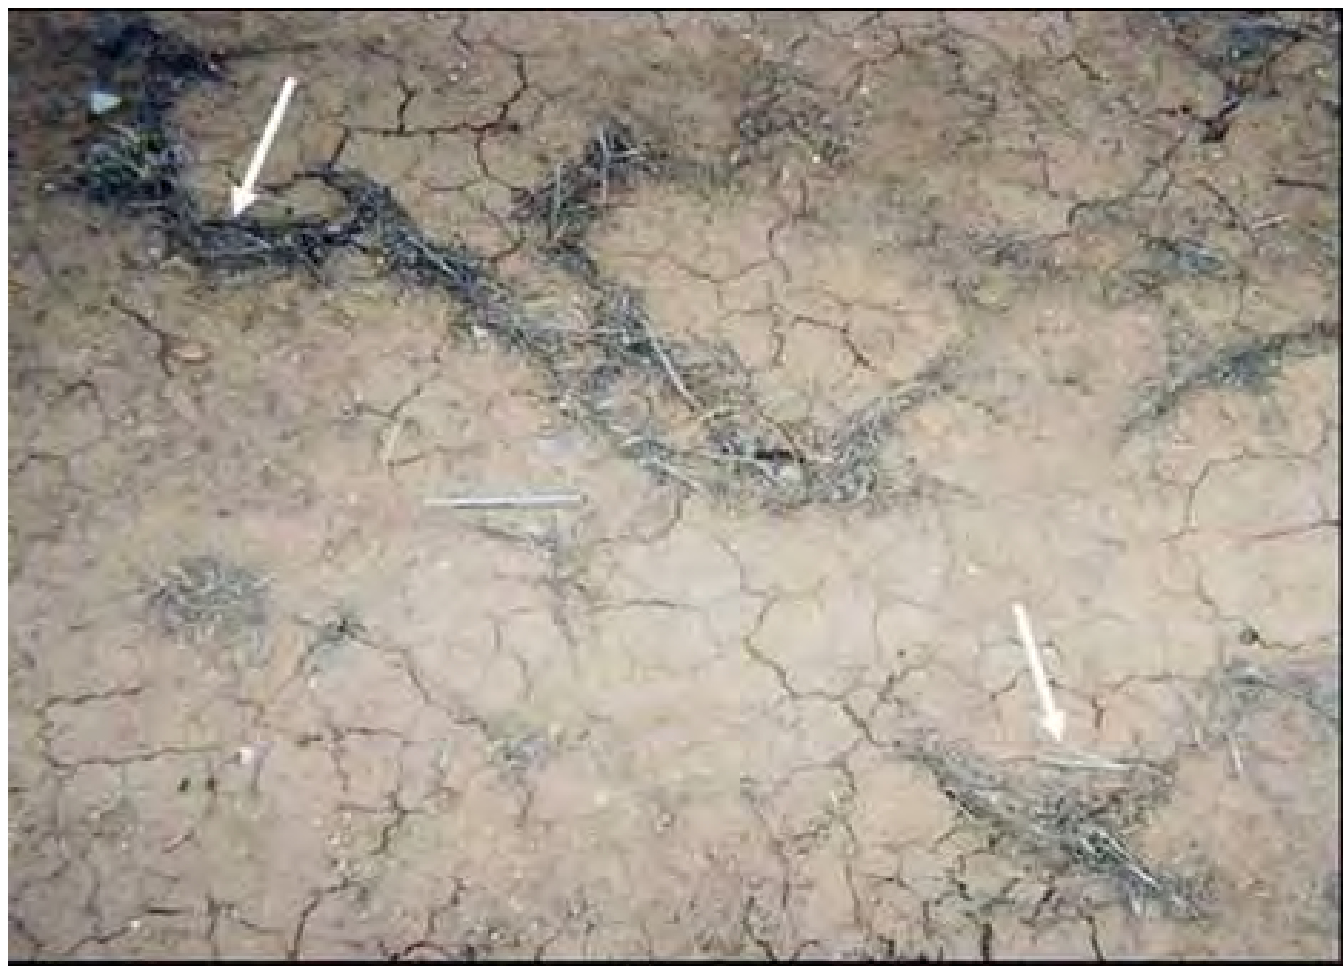
FIGURE 4
SURFACE CRUSTS ON A FINE-TEXTURED COVER SOIL (SILT LOAM). NOTE THE DEBRIS DAMS (ARROWS) INDICATING OVERLAND FLOW AND DEPOSITION OF LITTER. PEN JUST LEFT OF CENTER FOR SCALE.

Surface crusts (2- to 5-mm thick) were commonly observed on the medium and fine-textured soil (Figure 4). Surface crusts reduce the amount of water that infiltrates into the soil during high intensity rainstorms, thereby reducing available soil water and consequent plant performance. Reduced infiltration on the crusted soils increases runoff and erosion. Thus, surface crusting, sheet and rill erosion, run-on, and heavy grazing all contributed to poor performance of the covers with finer-textured surface layers.

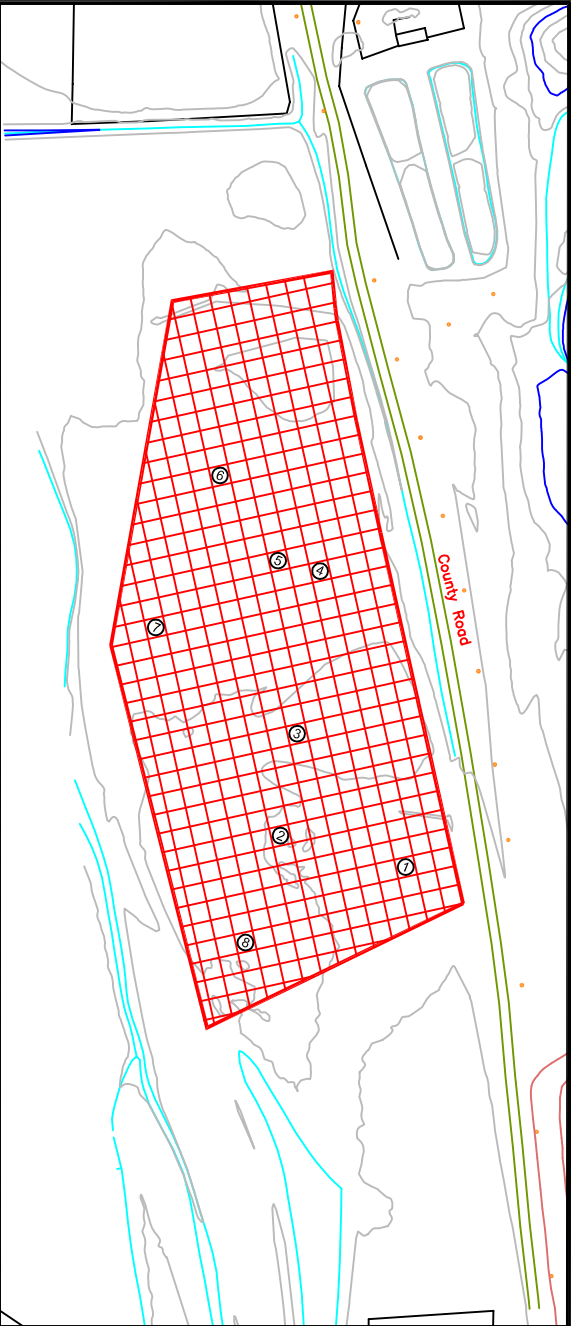
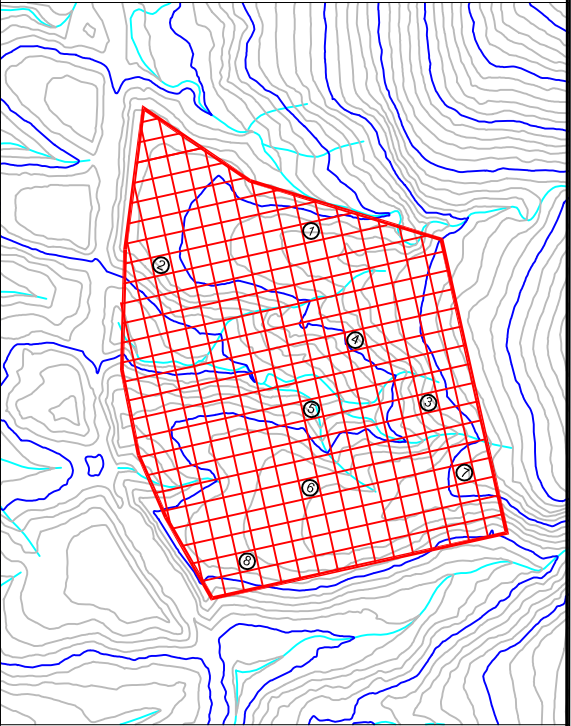
FIGURE 5

VEGETATION PLOTS EXCLUSION AREA
SCALE: 1"=500'

VEGETATION PLOTS TYRONE REFERENCE AREA
SCALE: 1"=500'

Fieldwork was conducted at the end of the growing season, but prior to the first killing frost (October 2004). A systematic random sampling procedure employing a transect/quadrat system was used to select sample sites within the two study areas. A 15.25 meter square grid was imposed over each study area to delineate vegetation sample plots, and random coordinates were used to select plots for vegetation sampling. Originating from the southeastern corner of the selected vegetation plot, a 30-meter (m) transect in a dog-leg pattern was established (DBS&A, 1999). Four 1 square-meter (m^2) quadrats were placed at pre-determined intervals along the transect for quantitative vegetation measurements. A total of eight plots (32 quadrats) were sampled in the Tyrone reference area and eight plots (31 quadrats) were sampled at the repository. Appendix B contains plot and quadrat photos taken at the time of the vegetation assessment in 2004. Soil depths in the sampling area ranged from 15 to 25 inches.

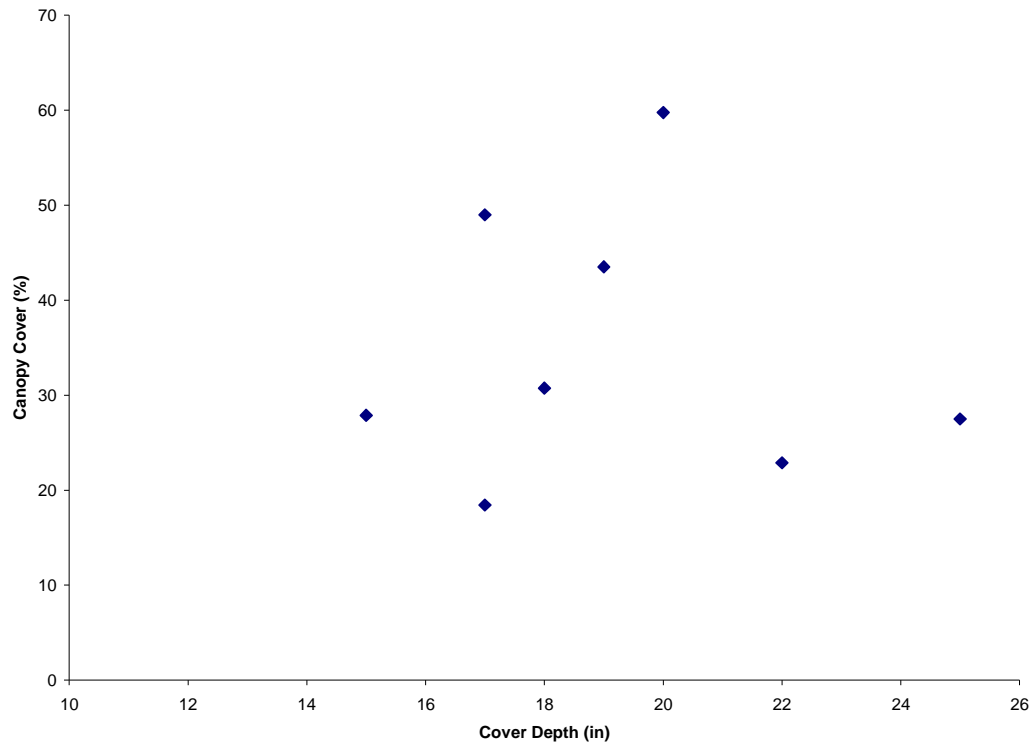
FIGURE 6
RELATIONSHIP BETWEEN COVER THICKNESS AND MEAN PLOT CANOPY COVER. DATA
FROM THE RECLAIMED VEGETATION COMMUNITY IN THE EXCLUSION AREA

The quantitative data confirmed the poor correlation among of vegetation cover and soil cover thickness noted during the qualitative surveys (Section 2.1). Cover thickness in the randomly selected vegetation plots ranged from 15 to 25 inches and no relationship was observed with measured canopy cover (Figure 6).

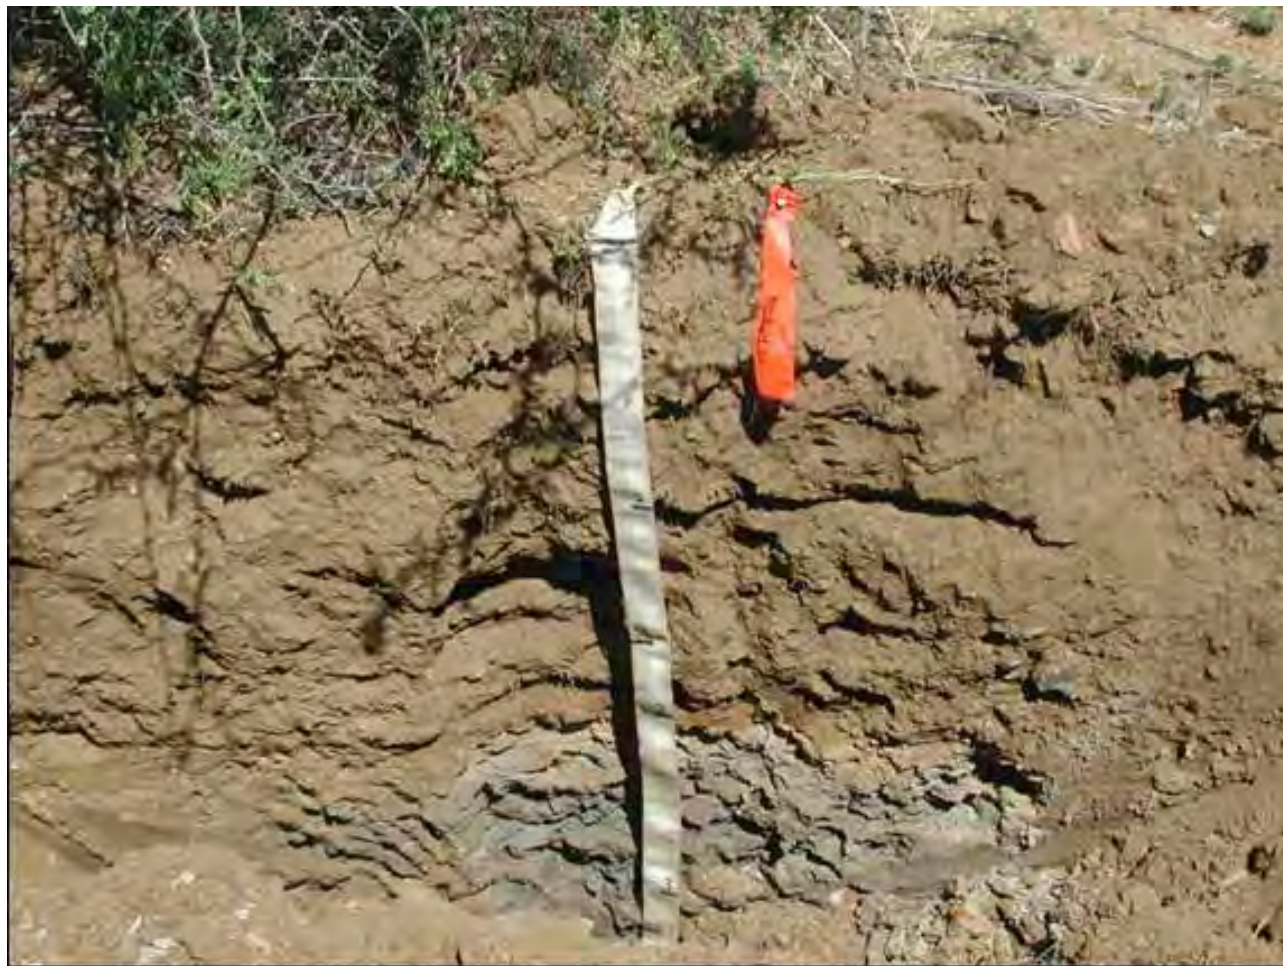
FIGURE 11
COVER SOIL OVER TAILING AT SITE TRT-1. THE TAILING IS EXPOSED IN THE PIT
WALL AT APPROXIMATELY 60 CM BELOW GROUND SURFACE.

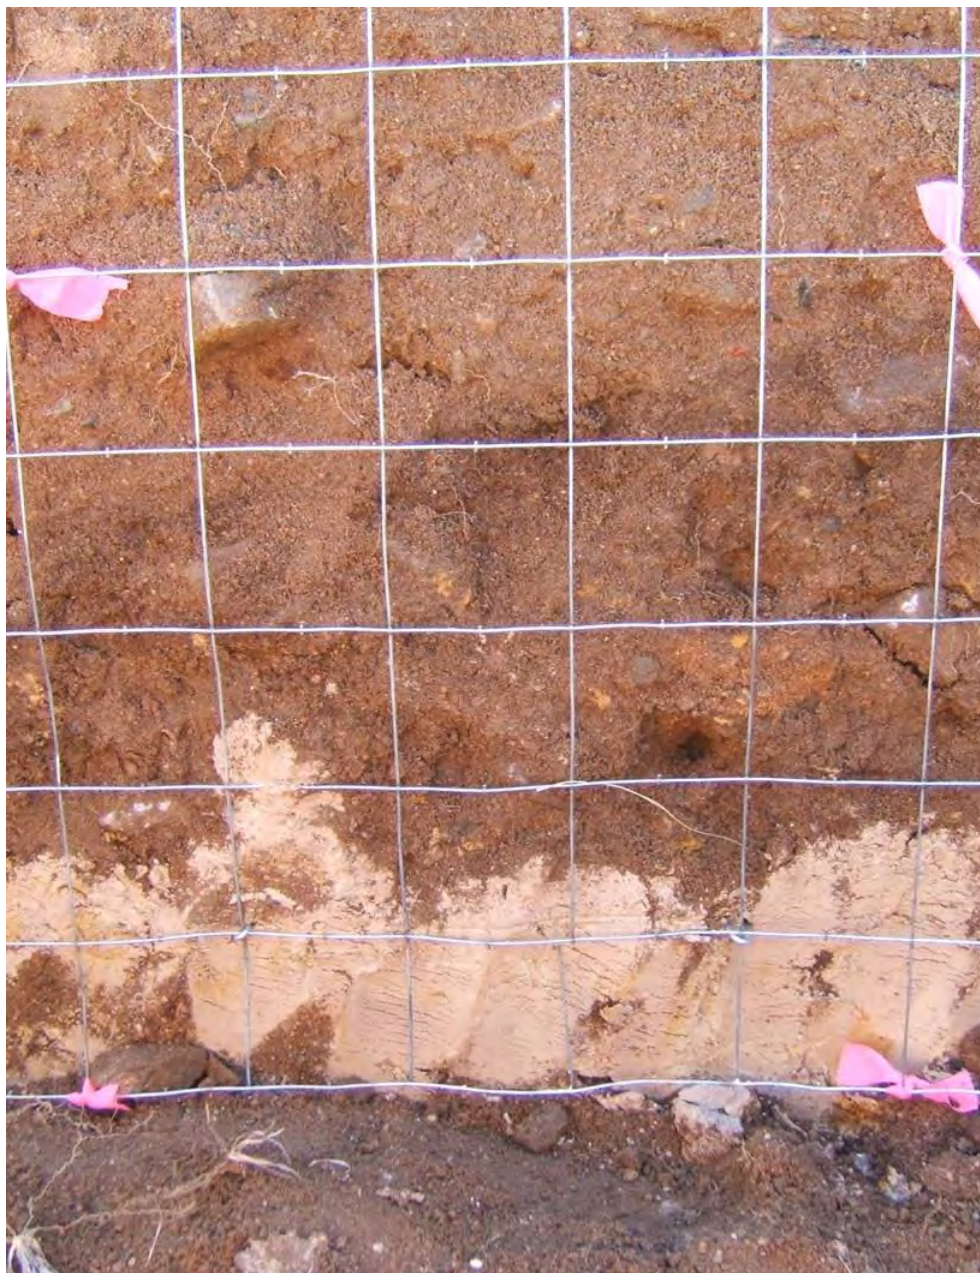
FIGURE 12
TONGUING OF TAILING IN THE BASAL CONTACT ZONE OF THE SOIL COVER.
WIRE MESH GRID SPACING IS 10 CM.

The basal contact zone represents the interface between the cover and tailing. The reduction in pH in the basal contact zone indicates that some process has caused acidification in the lower part of the cover. Oxidation of tailing physically mixed into the lower part of the cover during construction and diffusion are the two primary mechanisms identified that could contribute to acidification of the basal contact zone. Physical mixing is identified as a potential mechanism based on field observations of tonguing and incorporation of tailing in the cover soils (Figure 12). Although none of the profiles sampled showed gross manifestations of mixing, and a 1-inch zone immediately above the tailing contact was excluded, it is impossible to conclude that mixing did not occur at the interface. The chemical data collected from these profiles does not provide conclusive evidence that upward migration is the causative factor for acidification in the basal contact zone. Incorporation of tailing probably explains at least part of the observed decrease in pH. The chemical data are discussed below with respect to the potential for upward migration.

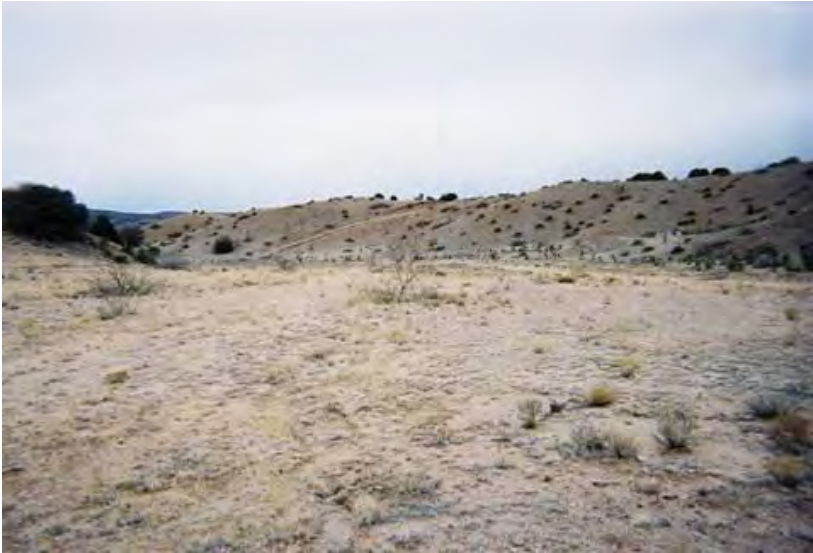
MANGAS EAST

The Mangas East repository occurs below the northwest corner of the No. 3X tailing impoundment. Overall, this repository was in good condition. It is gently sloping with a northwest aspect. The cover soil is generally coarse-textured and plant cover was considered good (25 to 30 percent) over the majority of the area.

There were no upland surface water diversions to prevent runon. Localized erosion features occurred where runon was uncontrolled. Runoff from an access road on the west side of the repository has lead to the formation of a small gully (4 to 5 feet deep) on the western face of the deposit. The arroyo just north of the repository has cut into the slope and exposed a small area of tailing. These erosion features represent about one percent of the area.

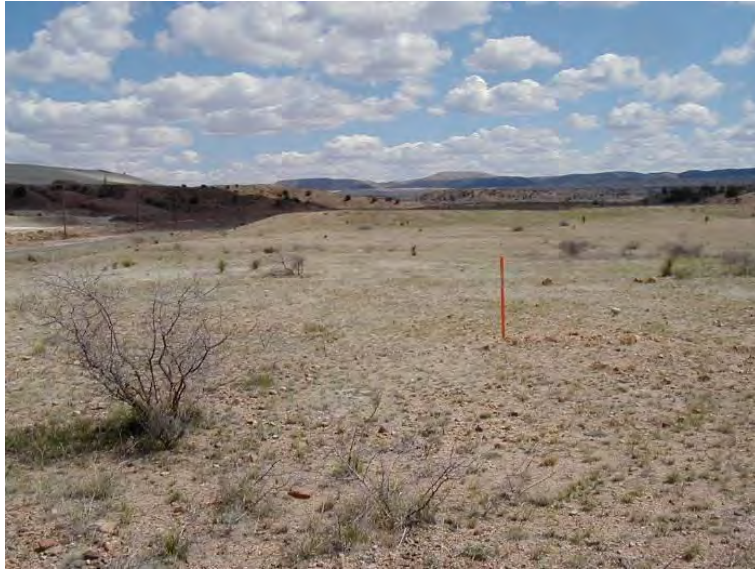
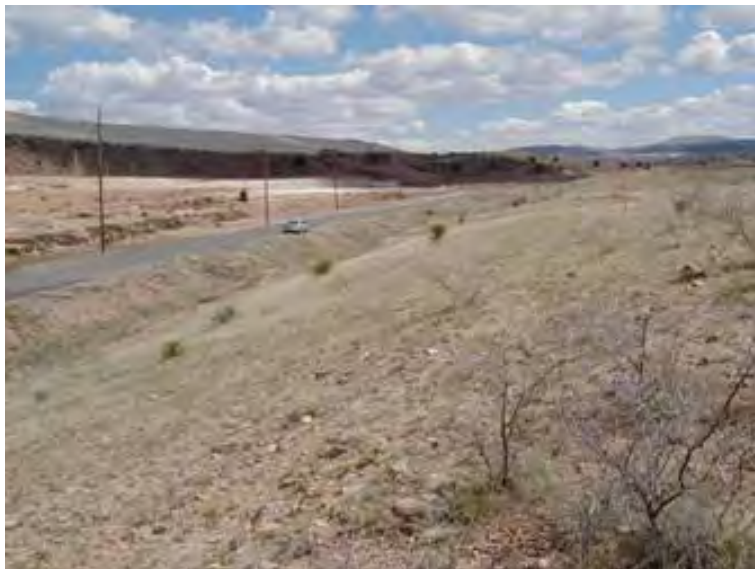
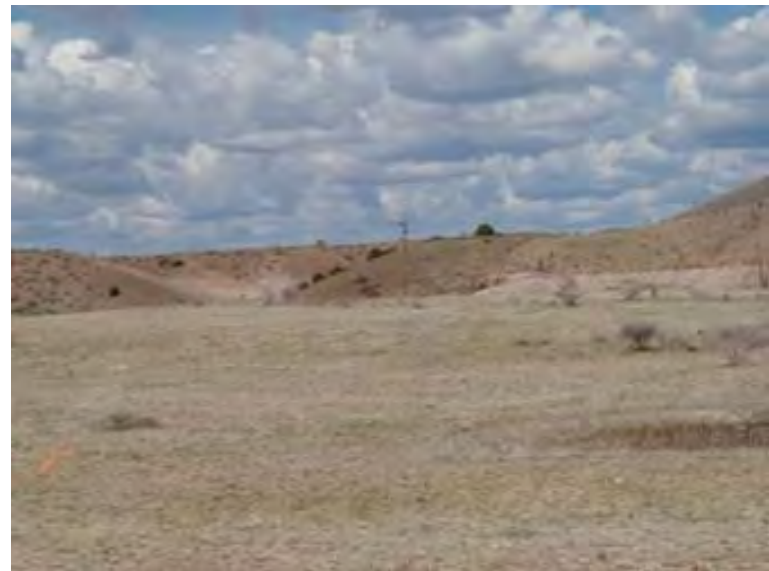
SOUTH MAIN

The South Main 2 (SM-2) repository runs between the Mangas Wash and the Mangas Valley Road for about a mile and a half. Cover soils on the SM-2 are primarily coarse textured with 30 to 70 percent coarse fragments on the surface. Vegetation cover was good (15 to 30 percent) over most of this area and signs of severe erosion were rare and localized.

The repository was gently sloping and slightly undulating (top left). Minor areas of slopes longer runs and steeper gradients occurred near the north end of the repository. Slopes along the road on the northern portion of the repository were stable and well vegetated (bottom left). Slopes on the southern portion of the SM-2 repository were rilled with small areas (25 to 50 square feet) of exposed tailing. Erosion in these areas occurred at slope inflection points, where shallow gradients converged with steeper gradient slopes. Cover thickness in these areas appeared to be shallow. On the western edge, Mangas Wash formed a steep embankment and has cut into a small portion (< 0.5 acre) of the repository.

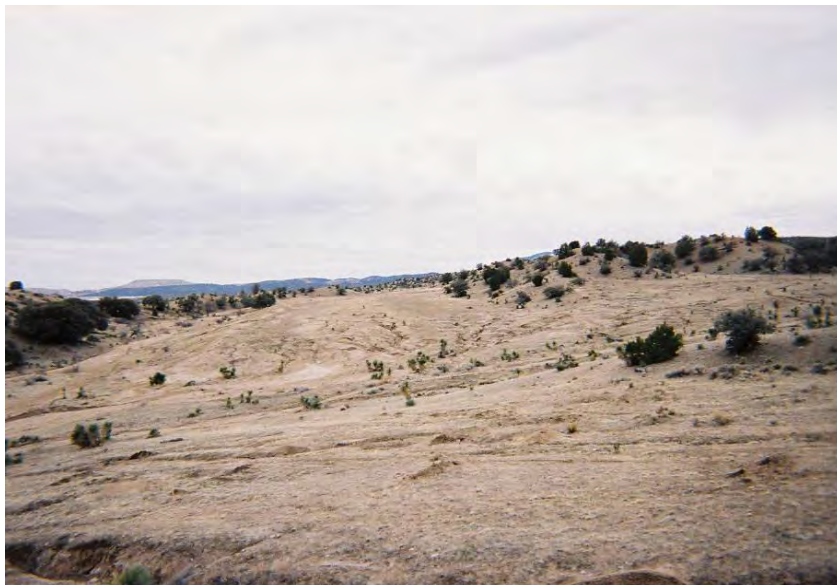
RED ROCK

Five distinct deposits occur in the Red Rock repository; three small fills in upland watersheds and two larger deposits that extend out from native hills. The photo was taken looking south across a small repository towards the larger Red Rock-4 repository. Cover soils were primarily coarse-textured, though there were small areas covered with finer textured materials. All of the repositories deposits were affected to some degree by the runoff from the adjacent upland slopes. Overland flow from the top surfaces of the deposits was also not directed away from the slopes, leading to rill erosion on the side slopes (larger rills on the far repository in center of photo). Vegetative cover was considered good where runoff-related erosion did not occur.

Cover Soil		Vegetation	
Soil Texture	SL 11% clay	Canopy Cover	20-25%
Soil Color	--	Basal Cover	2-3%
Coarse Fragments - Surface	25-30% gravel 0-5% cobble	Shrub Density	5/ac
		Grasses	BOCU, BOER, BOGR
Cover Thickness	--	Shrubs	GUSA, YUEL
Slope	3 to 8%	Forbs	--
		Trees	--
Notes: Lack of upland water diversions has resulted in runoff and rill erosion

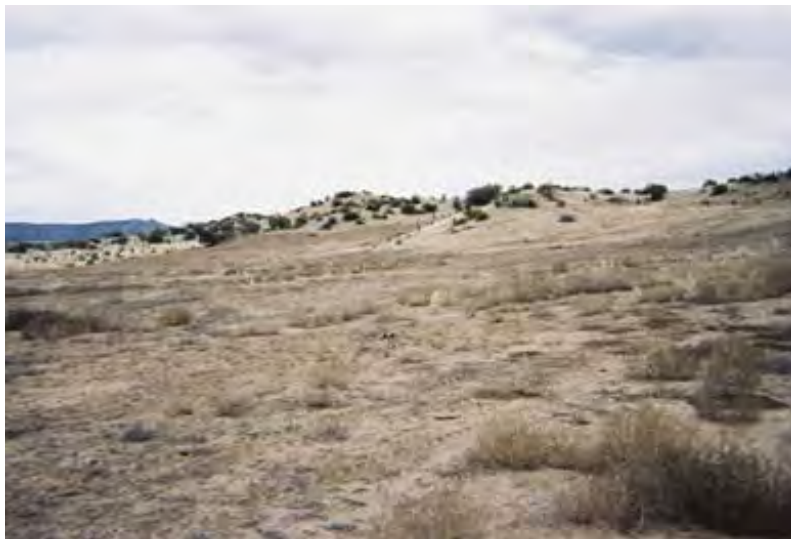
The MS-10 repository consists of three small upland watersheds that were filled with tailing (left). Cover soils were primarily fine-textured, dark-colored soils that developed thin, friable surface crusts. Vegetation performance was generally poor.

Vegetation is sparse on the fine-textured soils, limited to places where water concentrates, such as minor depressions and at the toes of slopes. Annual plants (tumbleweed) appears are dominant; although small patches of western wheatgrass, blue grama, mat muhly and dropseeds were observed. Approximately two acres of coarse texture soils in upland portions of the repository were well vegetated. The contrast in vegetation performance as a function of surface soil texture was apparent at this site.

Cover Soil		Vegetation	
Soil Texture	SiCL, 28% clay	Canopy Cover	<5%
Soil Color	--	Basal Cover	2-3%
Coarse Fragments - Surface	0-5% gravel	Shrub Density	None
		Grasses	AGSM, BOGR, SPFL, MURI
Cover Thickness	12-24"	Shrubs	--
Slope	1-15%	Forbs	KOSC, SAIB, HOGL
		Trees	--
Notes: Surface crust are 1 cm thick and friable. Lack of upland water diversions has resulted in runoff and erosion,

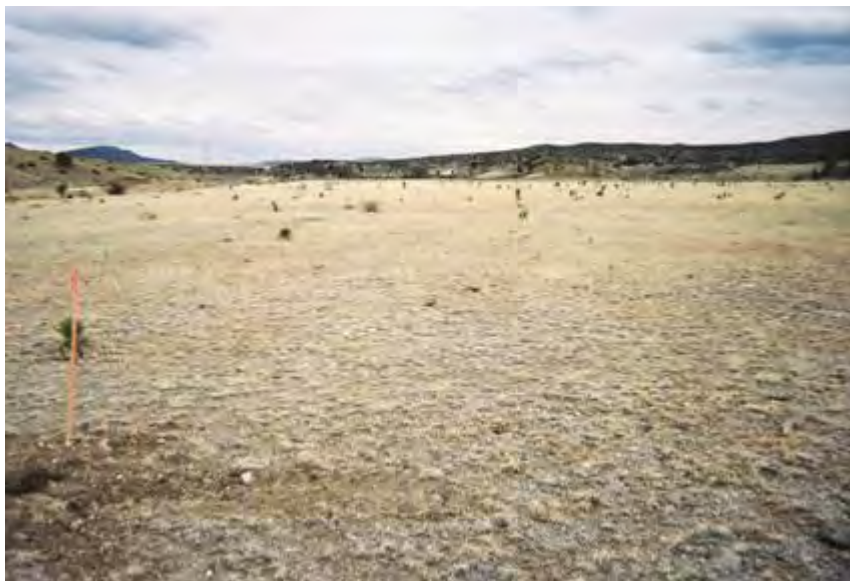
NORTH MAIN

The North Main repository is large deposit near the northern end of the Mangas Valley. The southern half of the repository was primarily covered with coarse-textured soils (left). Plant cover was consistently good on these materials and did not change in response to changes in cover thickness. About three acres of fine-textured cover materials on the southern end also has relatively good plant cover.

The north end of this repository was covered with fine-textured soils and had about 5 percent canopy cover. The vegetation was limited primarily to isolated patches in small depressions and was dominated by grasses. The cover soil was a silt loam or silty clay loam (23 percent clay) with less than 5 percent gravel cover.

Cover Soil		Vegetation	
Soil Texture	CoSL, 18% clay	Canopy Cover	20%
Soil Color	--	Basal Cover	3-4%
Coarse Fragments - Surface	60-70% gravel 5-10% cobble	Shrub Density	25/ac
		Grasses	SPAI, BOCU, BOER, BOGR,
Cover Thickness	--	Shrubs	GUSA, YUEL, MIBI
Slope	2%	Forbs	--
		Trees	--
Notes:

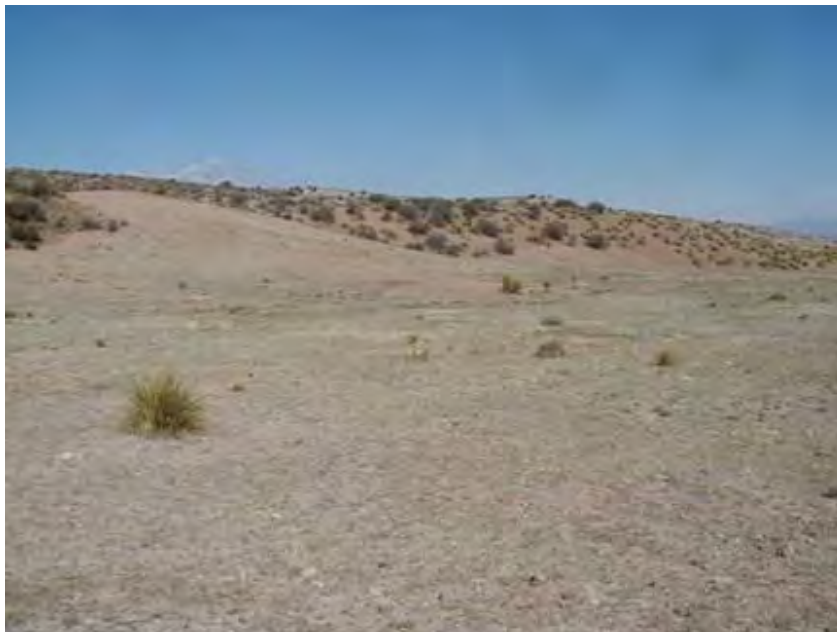
NORTH MAIN-1

The North Main-1 repository was used as a horse pasture. Vegetation cover was fair, considering that it had experienced high use. Canopy cover tended to increase from north to south with more annuals observed in the northern part of the repository. Despite the grazing pressure, the repository demonstrated excellent shrub and forb recruitment including yucca, desert broom, snakeweed, Emory oak, mimosa, globe-mallow, lupines (2-3 species), penstemon, beargrass, black grama, and three awns (2 species).

There were minor runoff/erosion issues associated with the western edge of the repository. These upland areas appear to have been the source for borrow materials and the slopes are lightly vegetated. Sheet flow starts to rill in the central portion of the repository. There are also three areas (about 1/4 acre each) where the cover appears to be affected by the tailing that was mixed with the cover soil during reclamation.

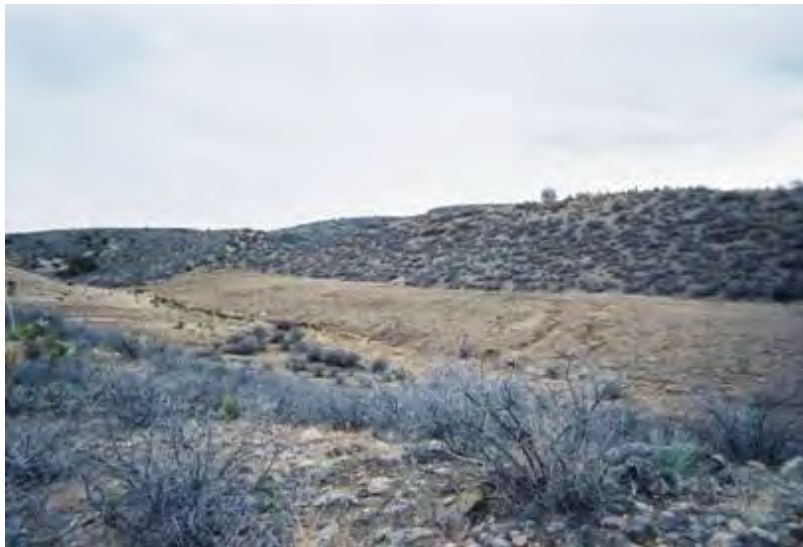
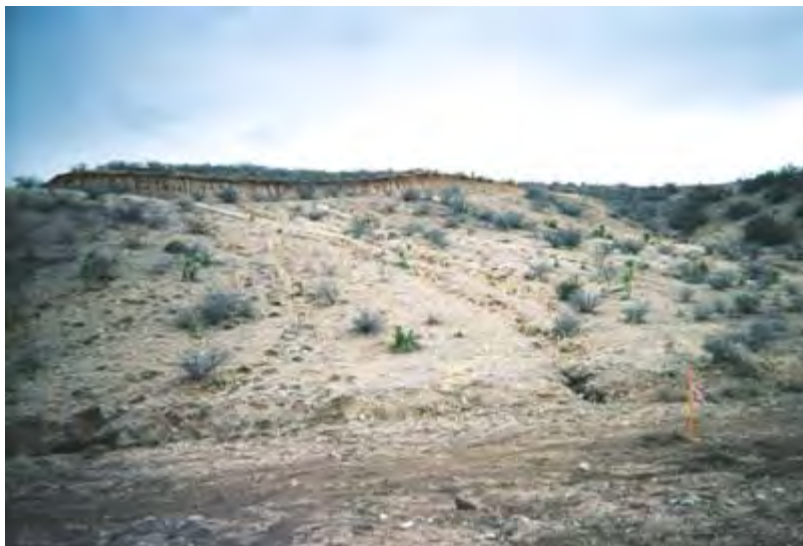
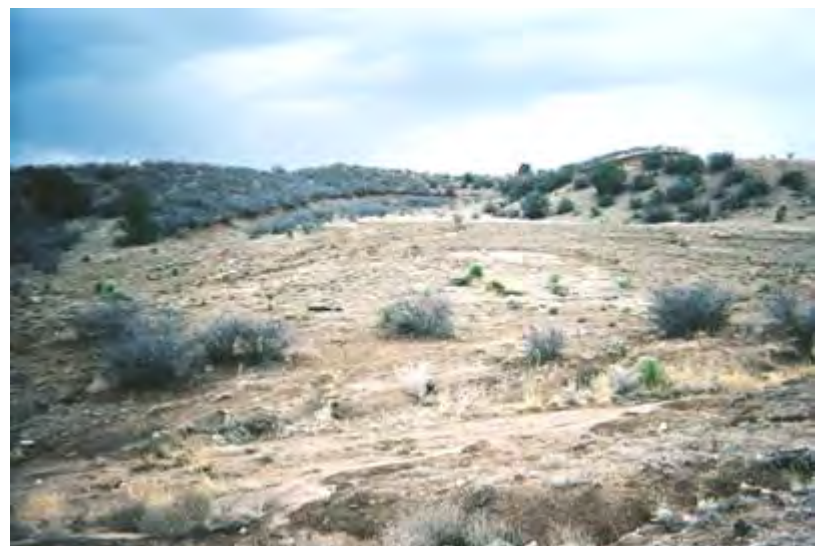
NORTH MAIN-2

The North Main-2 is composed of three small repositories. One is covered by a silty clay loam soil (28 percent clay) with 10 percent fine gravels on the surface (top left). Perennial grass cover was marginal (blue grama primarily; 2 percent basal, 10 percent foliar), especially considering that it appears to have been lightly grazed. Plants were pedestaled 6-10 inches, even on a relatively gentle grade (5 percent). Improper grading and lack of upland surface water diversions has resulted in localized incision and the arroyo on the southern edge has exposed tailing.

Two other small repositories occur to the south (bottom left and bottom right). These repositories were covered with coarse-textured soils and had relatively good plant cover. Rills formed where no upland surface water diversions were installed, otherwise the cover was intact. Slopes range from 15 to 25 percent.

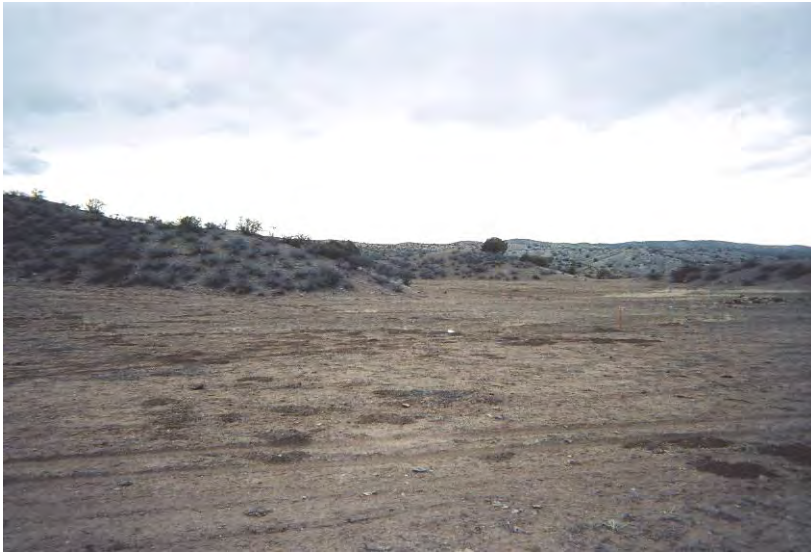
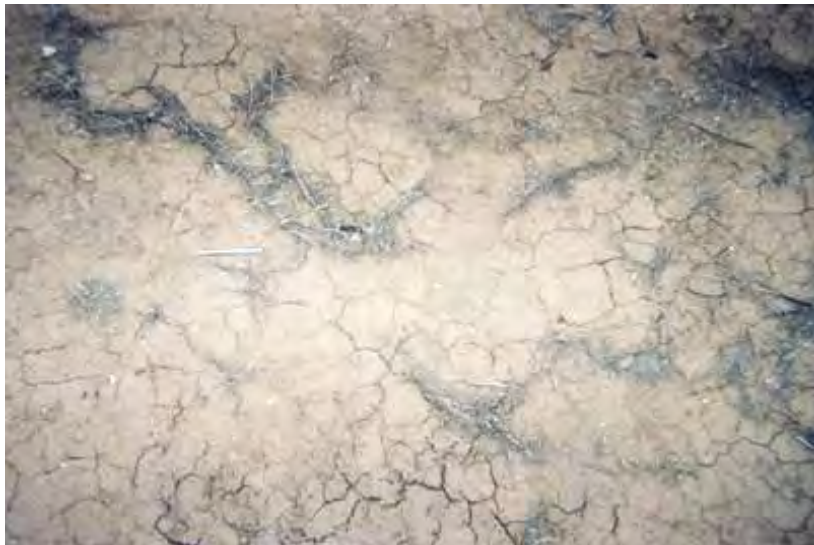
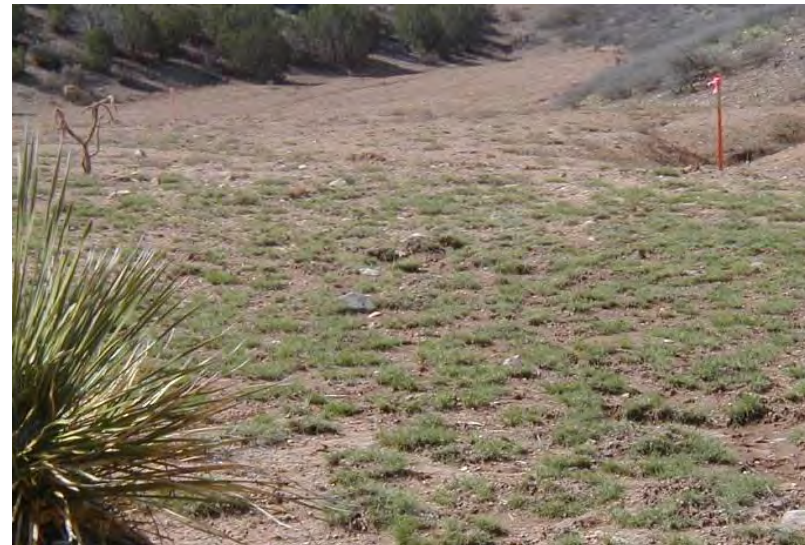
NORTH MAIN-3

The North Main-3 repository was covered entirely with fine-textured soils and was sparsely vegetated (top left). The surface had a friable crust and less than 5 percent gravel. Vegetation was mainly annual weeds, though small patches of blue grama occurred.

There were no upland surface water diversions and runoff was causing minor rilling. There was also evidence of overland flow on the surface with debris dams along the slope (bottom left). In the places where perennial grasses (10 percent cover) had established, 1 to 3 inches high pedestals were evident indicating moderate sheet erosion (bottom right).

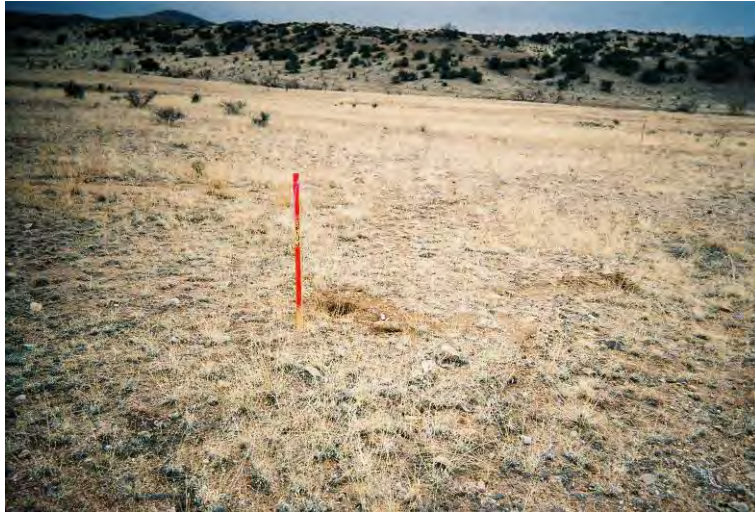
LANEY CANYON

The Laney Canyon repository was composed of two primary deposits separated by an arroyo. Two contrasting soil types were used as cover at this site. The coarser-textured variant supported higher levels of vegetation cover and was generally resilient. The finer-textured variant was poorly vegetated and subject to moderate to severe sheet and rill erosion. Where the finer-textured soils occurred on slopes the erosion was severe and tailing were exposed.

Looking southeast from borehole LC-804. Cover over tailings is 4 inches thick. Cover soil is coarse-textured with 50 percent gravel on the surface. Foliar cover is nearly 25 percent and vegetation shows no signs of physiological stress. Plant diversity is nominal and site dominated by blue, hairy and side-oats gramas, lovegrass and snakeweed. Volunteer acacia, mesquite and yucca occur at about 50 stems per acre, indicating that plant diversity is increasing by natural processes. Plant cover remained fairly uniform as cover soil thickness increased from 4 to 18 and 24 inches thick.

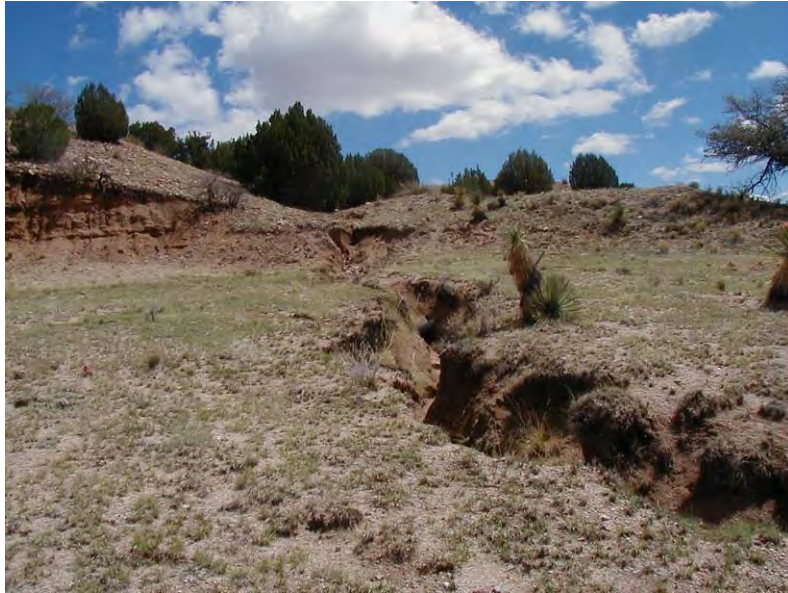
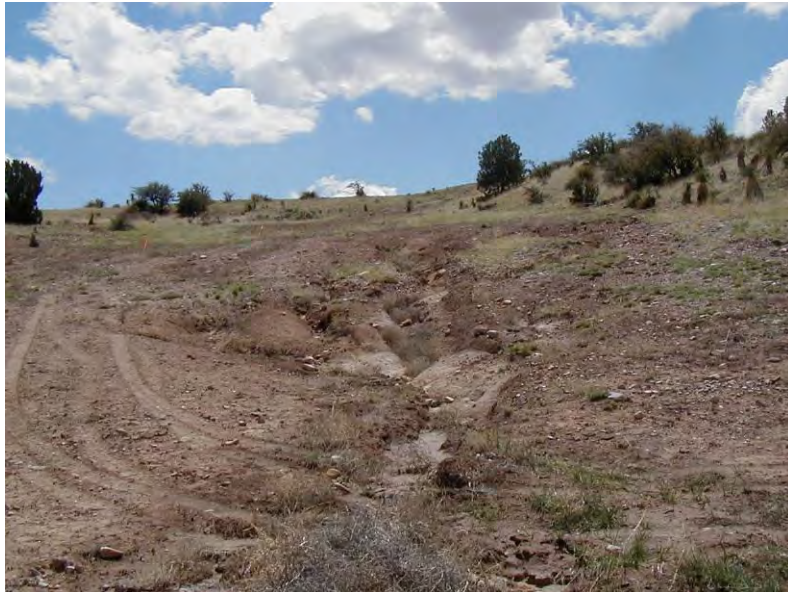
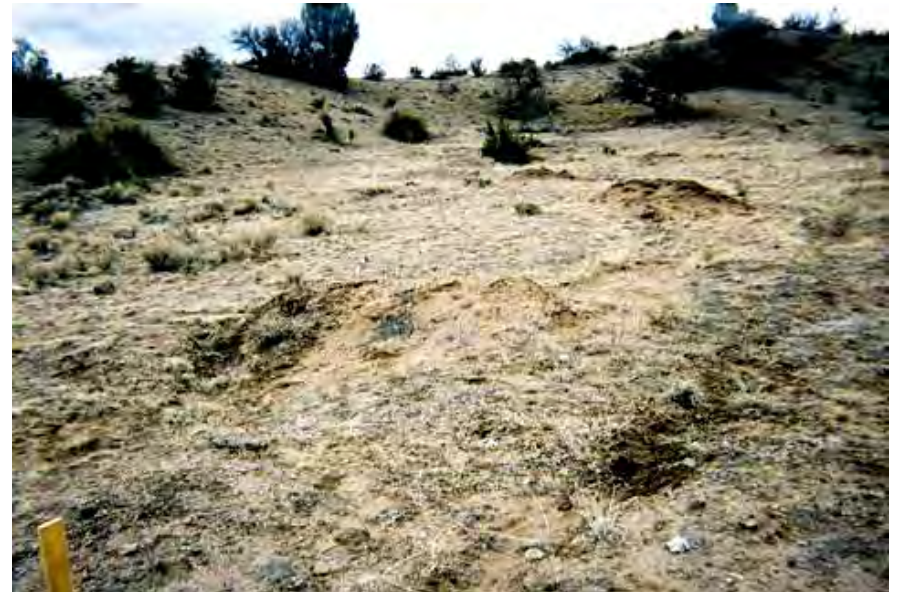
SURFACE WATER CONTROLS

The lack of surface water diversions upgradient of the repositories was the principal cause of rill and gully formation independent of the surface texture of the cover. Uncontrolled runoff from adjacent undisturbed uplands in Mangas Creek repository lead to the formation of this small gully in coarse-textured materials (top left). Tailing was not evident in the cut.

Tailing was exposed in the MS-10 repository (bottom left). Runoff from the fine-textured surface conditions of the cover combined with runoff not diverted from the native uplands to produce this small scalped area.

At the Redrock repository, an attempt to stop rilling caused by upland runoff was made by creating small berms or check dams across small channels (bottom right). These are judged to be ineffective as water circumvents the berms and continues to erode the cover.

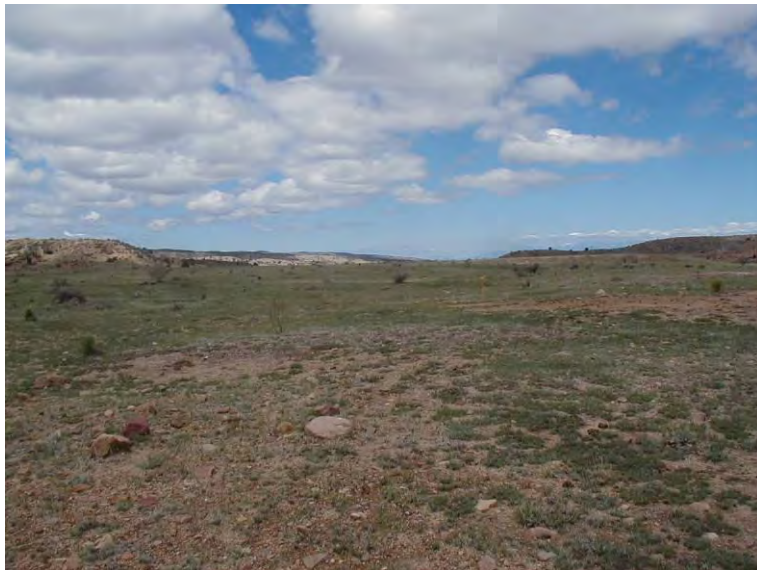
SOIL OBSERVATION (SM2-3768)

Looking north from borehole SM2-3768 across the Exclusion area. Coarse-textured cover thickness is 6 inches thick over tailing at this location. The surface is covered by 60 percent coarse fragments; primarily gravels. Canopy cover is about 20 percent and vegetation shows no signs of physiological stress. Plant diversity is relatively high in the immediate area with several species of volunteer forbs, shrubs and trees. Plant cover increases to about 25 to 30 percent in the slight swale in the background. The increase in canopy cover may be influenced by several factors including surface water runoff, a decrease in rock cover, and an increase in cover thickness from 6 inches to 13 to 16 inches.

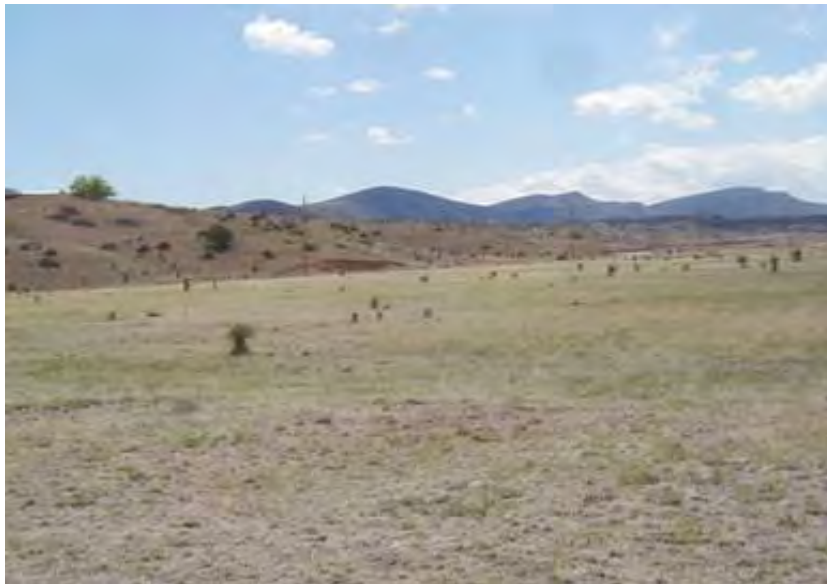
COVER THICKNESS– VEGETATION RESPONSE (MN-146)

The lack of correlation between cover thickness and vegetation cover was apparent at sample point MN-146 in the North Main Repository. The cover was 9 inches thick in the immediate foreground and increased to 12 to 18 inches thick in the background. This site was representative of the response of vegetation to varying cover thickness.

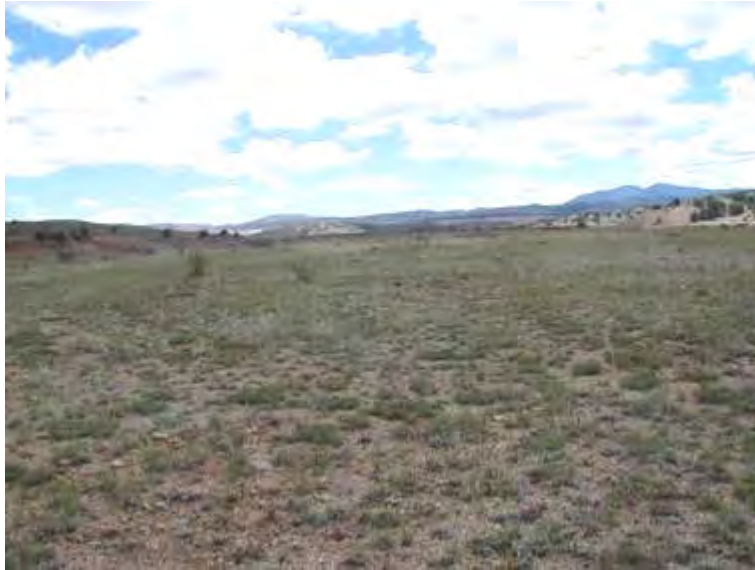
SOIL-VEGETATION OBSERVATION (SM2-3609)

Scattered within the South Main 2 repository are small areas (2-3 acres) where the surface textures are fine sandy loams and loams with less than 10 percent coarse fragments. Sample point SM2-3609 (left) is representative of this variant in cover texture. These soils do not have surface crusts and the vegetative cover is higher than on the soils with higher silt contents.

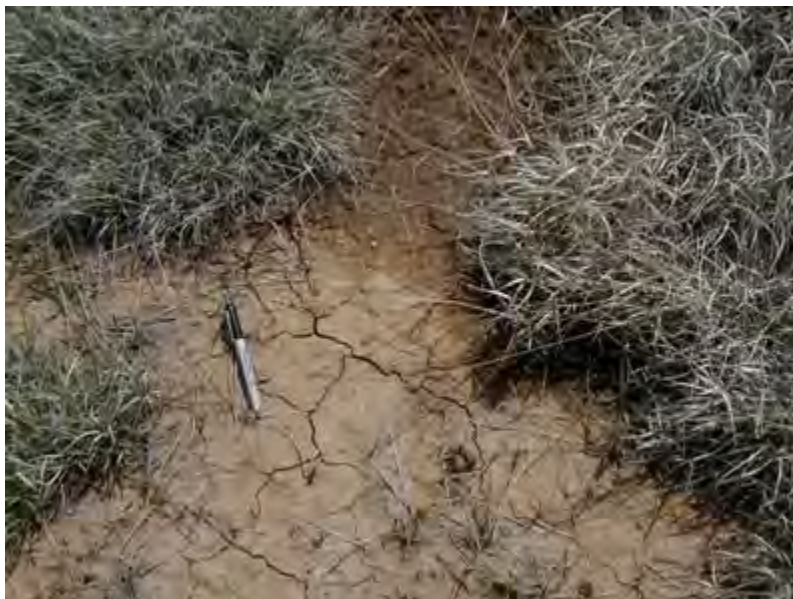
FINE-TEXTURED SOILS IN GRAZING EXCLOSURE

Fine-textured soils generally performed poorly, except where they were grazing was excluded. Surface soil conditions within the northern enclosure on the South Main repository are shown here. The fine-textured cover soil has essentially no coarse fragments and a surface crust is prevalent. Canopy cover is about 30 percent. The area supports a slightly more diverse grass community than is found outside the enclosure. Grasses inside the enclosure include mat muhly, vine mesquite, bottlebrush squirreltail, and western wheatgrass in addition to the gramas. The cool-season species (bottlebrush squirreltail and western wheatgrass) tend to occur rarely outside the enclosure and suggest that cool-season grass may persist with lower grazing pressure.

The area was fenced to exclude livestock, though the date of its installation is unknown. The area provides a indication of the potential performance of this soil to support vegetation. Canopy cover, both live and litter, is markedly better compared to other fine-textured repository covers. There was also no evidence of sheet erosion (i.e. plant pedestaling) .
