**Re: Phelps Dodge Tyrone, Inc., DP-1341, Condition 85,  
Tailing Transport and Deposition Impacts Investigation Report**

**DP-1341 CONDITION 85  
TAILING TRANSPORT AND DEPOSITION  
IMPACTS INVESTIGATION REPORT**

053-2025

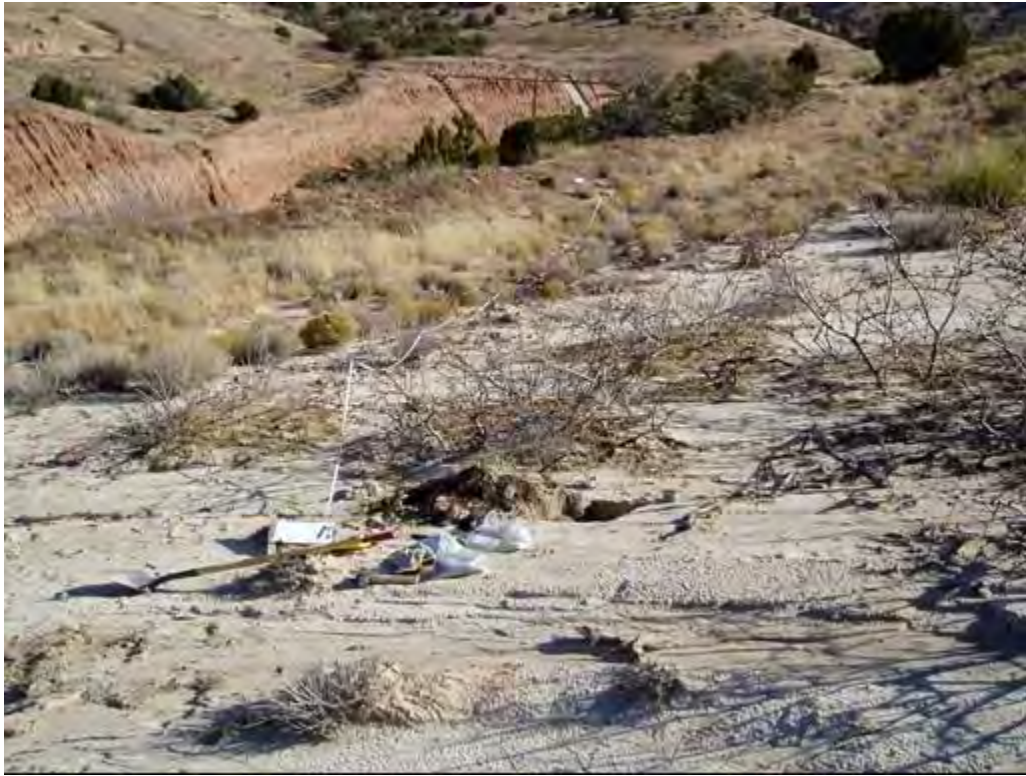
Figure B-1. Thick accumulation area in map unit 10 (Transect 2-T1).

Golder recommends that Tyrone mitigate areas with the more extensive deposits of tailing as part of ongoing tailing reclamation activities. In particular, we recommend mitigation of the areas with the thickest tailing deposits in map units 10 and 20. The tailing coverage in these areas is fairly extensive and impacts to vegetation are apparent. We recommend treating the areas represented by map unit 30 on a case-by-case basis. We don't believe that the areas presented by map unit 40 represent a threat to groundwater and disturbance associated with reclamation of these areas will have limited environmental benefit. We recommend treating the map unit 50 areas on a case by case basis, with particular attention given to mitigating the causative factors leading to the erosion and deposition of the tailing.

In general, we recommend removal of the tailing with minimal soil disturbance. Following tailing removal, the soils should be deeply ripped (at least 12 to 18 inches) to promote mixing with  $\text{CaCO}_3$  containing layers deeper in the soil profile. We recommend at least two ripping passes oriented at perpendicular angles. Seeding and mulching should be conducted using the techniques currently practiced on the tailing dams.

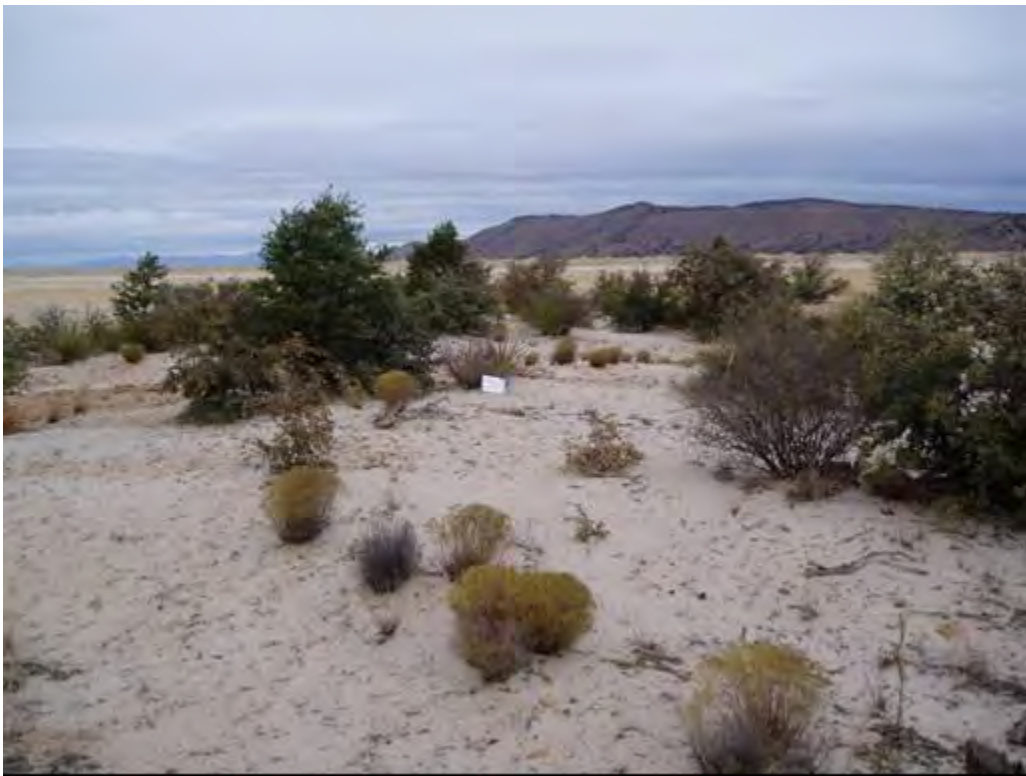
Figure B-2. Inter-dune area in map unit 10 (Transect 3-T3)

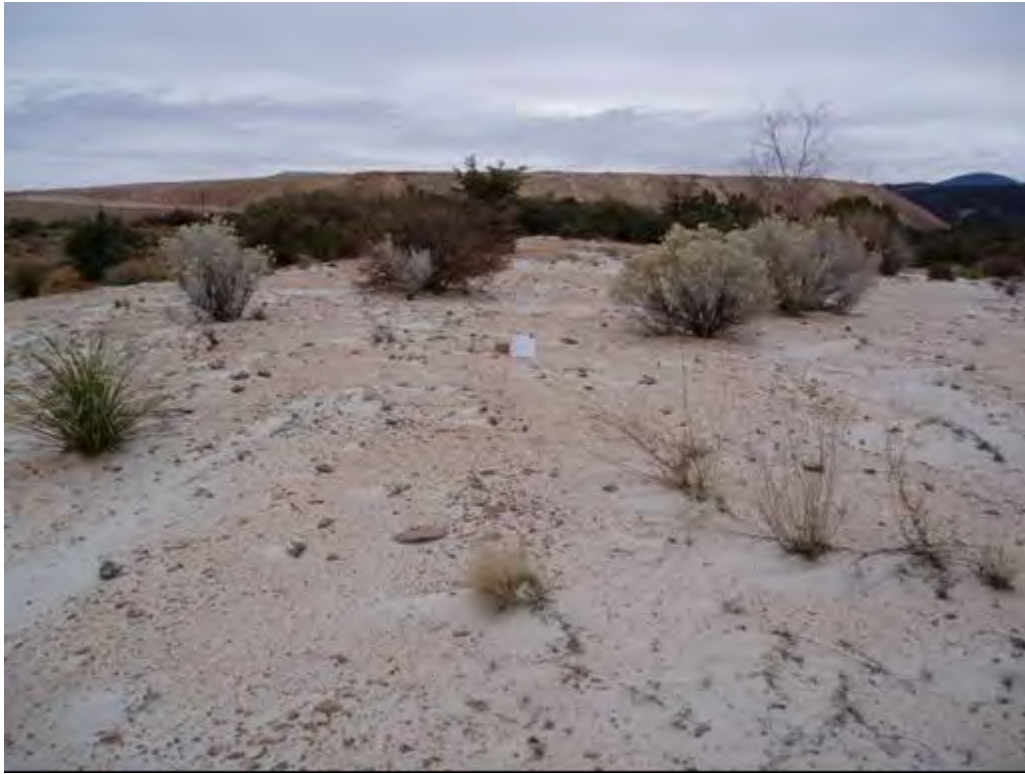
Figure B-3. Wind scoured area in map unit 20 (Transect 3-T1)

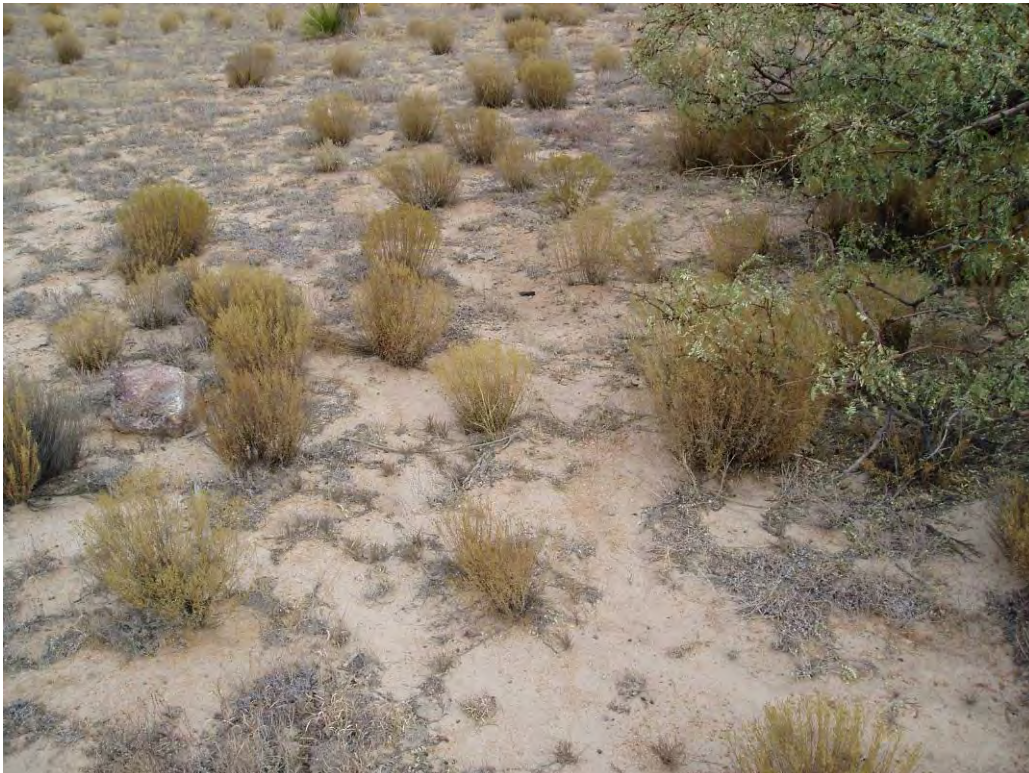
Map Units 30 is represented by areas with 25 to 50 percent cover by tailing. The tailings are usually 0.1 to 1 inches thick in the inter-dune areas. The dunes are 0.2 to 1.5 feet thick and cover less than 10 percent of the area. Figure B-4 shows typical conditions in map unit 30. This map unit occupies about 52 acres. Impacts to vegetation are minimal in this map unit.

Figure B-4. Thin tailing deposits and vegetation in map unit 30 (west of 1A Dam)

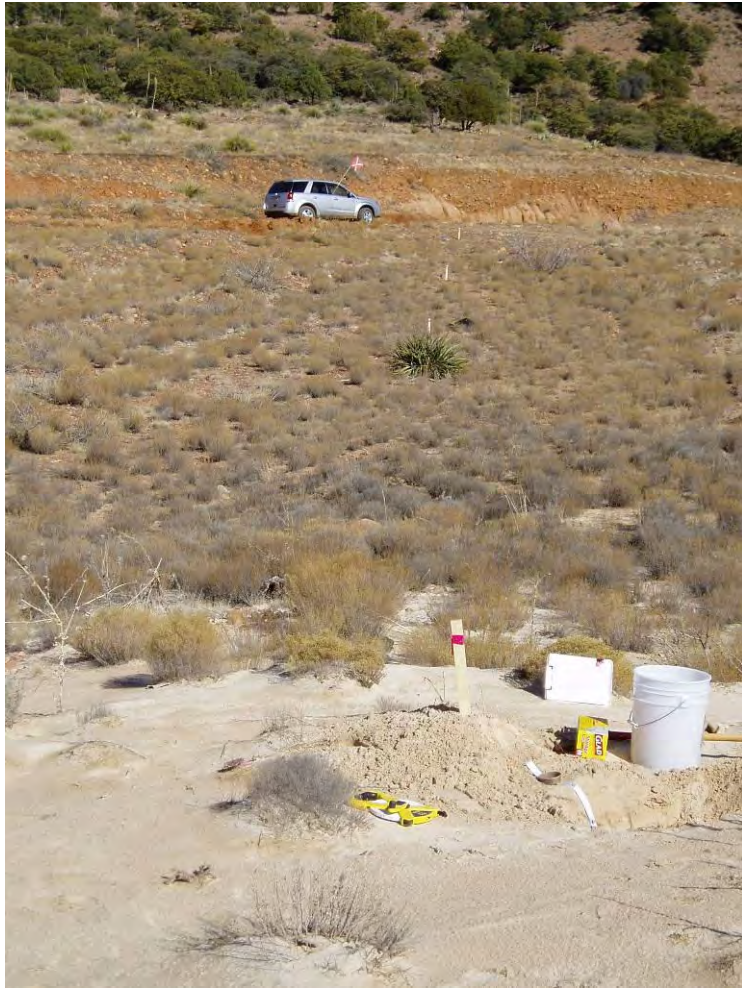
Map Unit 40 is represented by areas with 5 to 25 percent cover by tailing. The tailings are generally 0.1 to 1 inches thick in the inter dune areas. The dunes are 0.5 to 1 feet thick and cover less than 5 percent of the area. Figures B-5 and B-6 illustrate the conditions in map unit 40. This map unit occupies about 47 acres. The vegetation impacts in this map unit are minimal.

Figure B-5. Map unit 10 (foreground) transitioning to map unit 40 (Transect 2-T3). Tailing limit between 2<sup>nd</sup> and 3<sup>rd</sup> stake

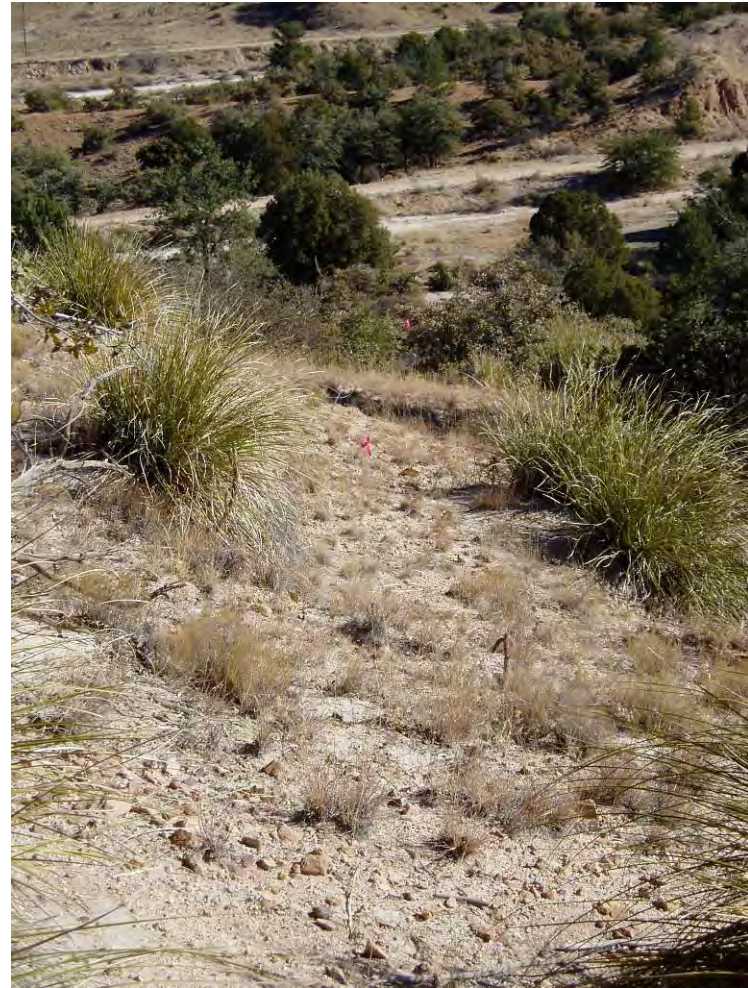
Figure B-6. Typical surface conditions in unit 40 (Transect 1A-T2).

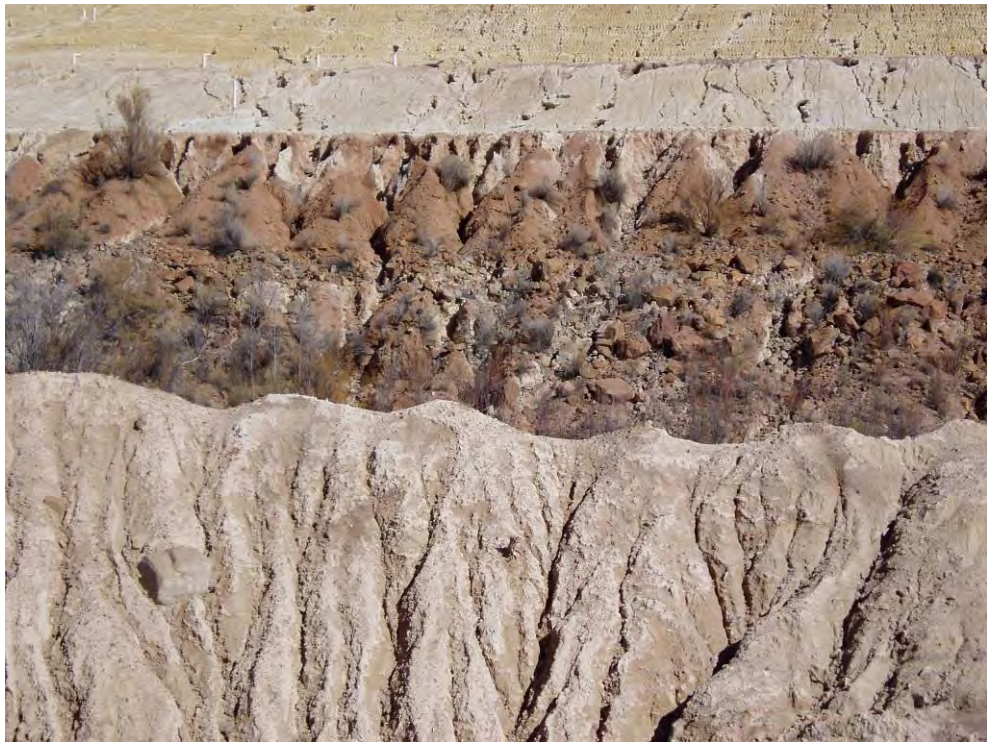
Figure B-7. Water deposited tailing (map unit 50) on the southwest face of the No. 2 starter dam. Tailing in foreground is contained by the catch basins below the starter dam.

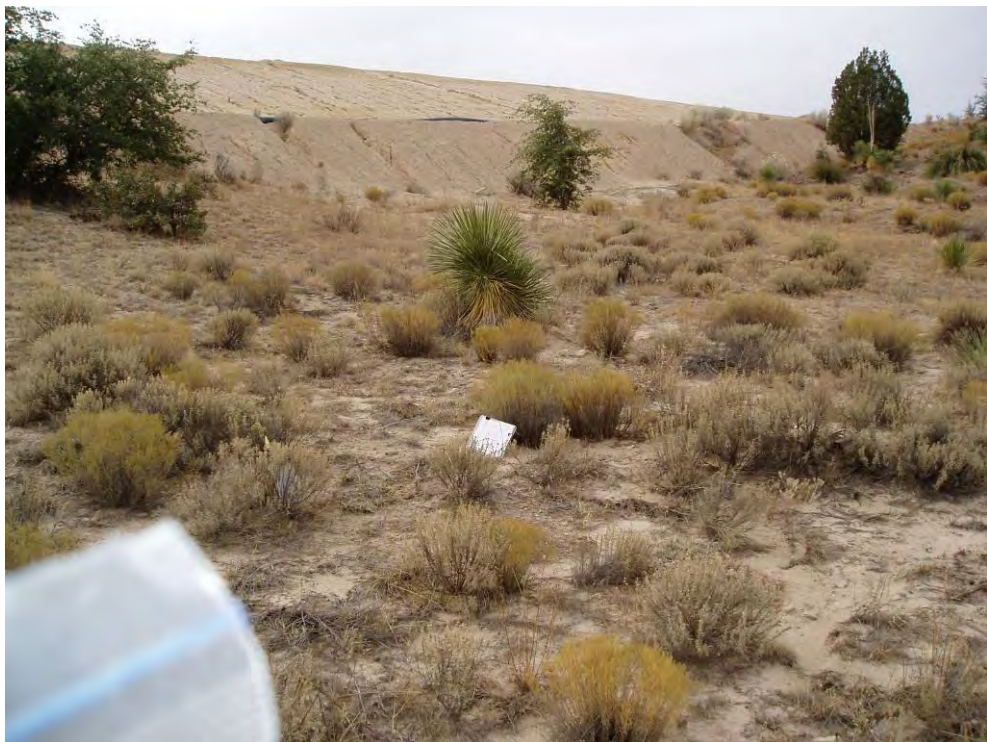
Figure B-8. Water deposited tailing in map unit 50 (NW side of No. 1X Dam)

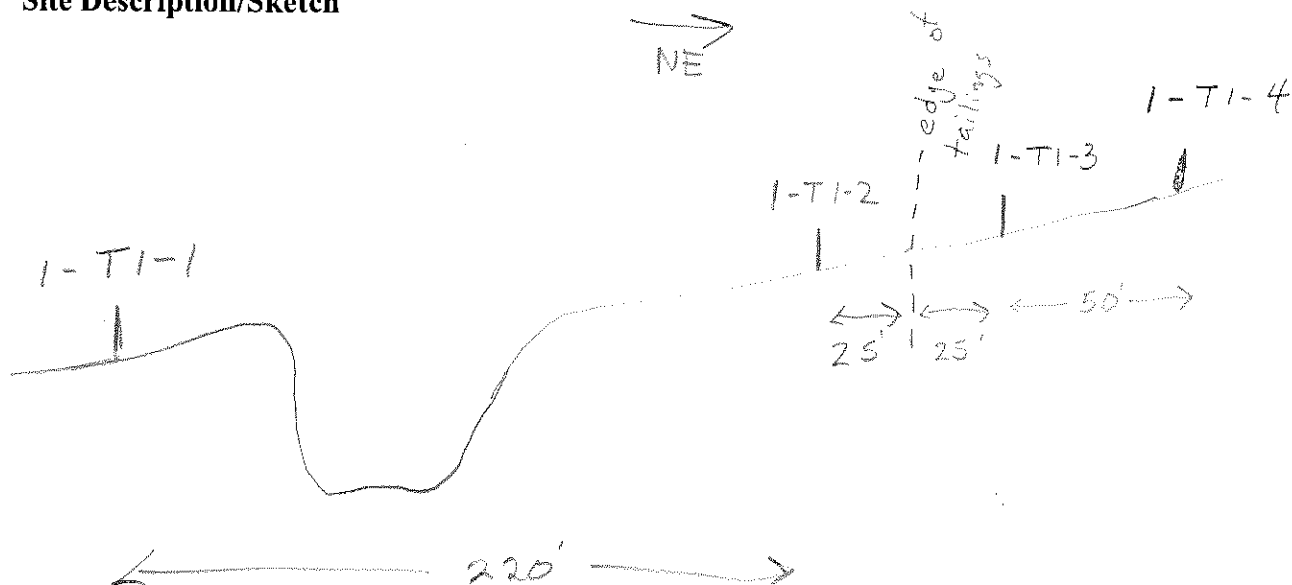
Location: East side of Mangas Rd, east of No. 1  
tailing MU 30, 40

- moved 1-T1-1 to thicker tailings deposit.
- edge of tailings is very subtle.
- edge of tailings defined by pH.

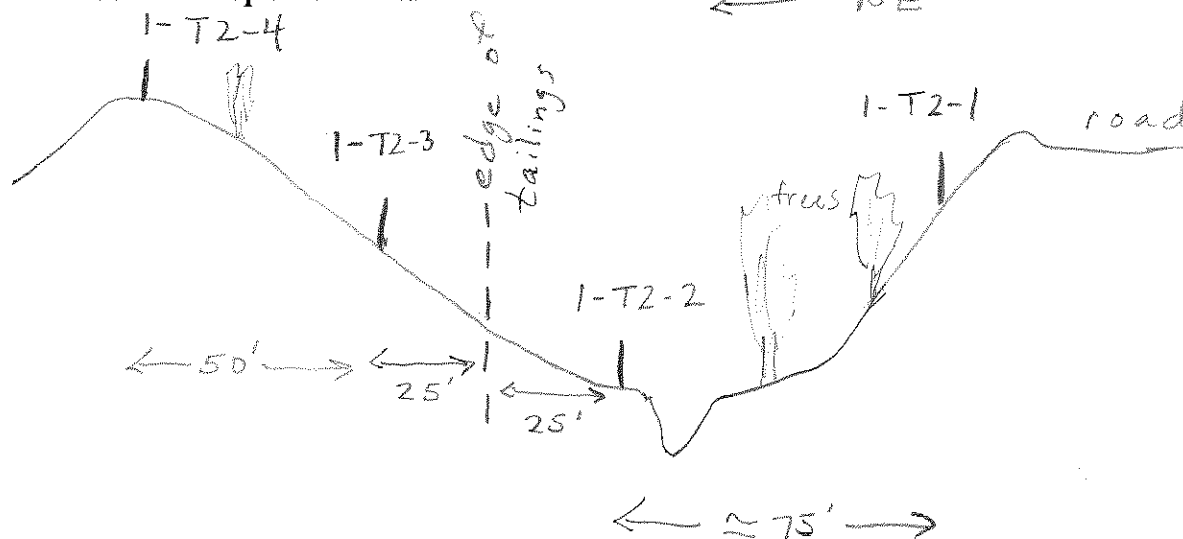
Location: East, in trees, of the SE corner of  
No. 1 tailings M.U. 40

- thin deposit of wind blown tailing  $\frac{1}{4}$  -  $\frac{1}{8}$ " thick.
- tailing edge very subtle, used pH to define limit.

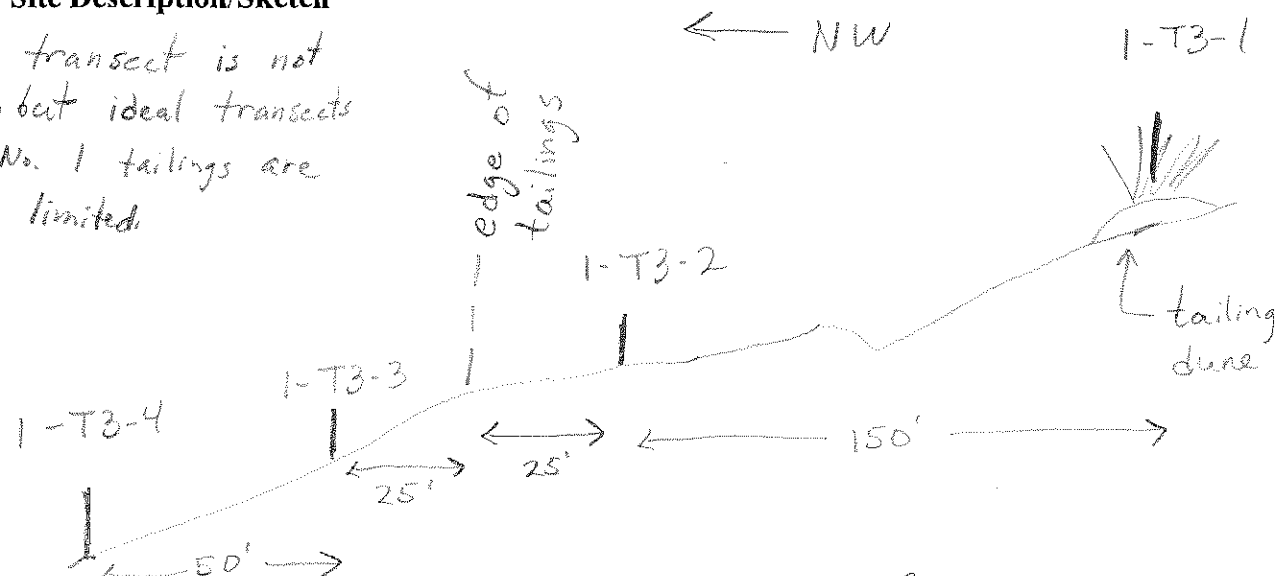
- This transect is not ideal, but ideal transects for No. 1 tailings are very limited.

- tailing edge is very subtle, used pH to define edge.
- transect runs NW/SE to represent dominant wind direction for this deposit.
- Some of these tailings may have been from a slurry line but have been reworked by the wind.
- moved 1-T3-1 150' from 1-T3-2 to capture thicker tailing deposits.

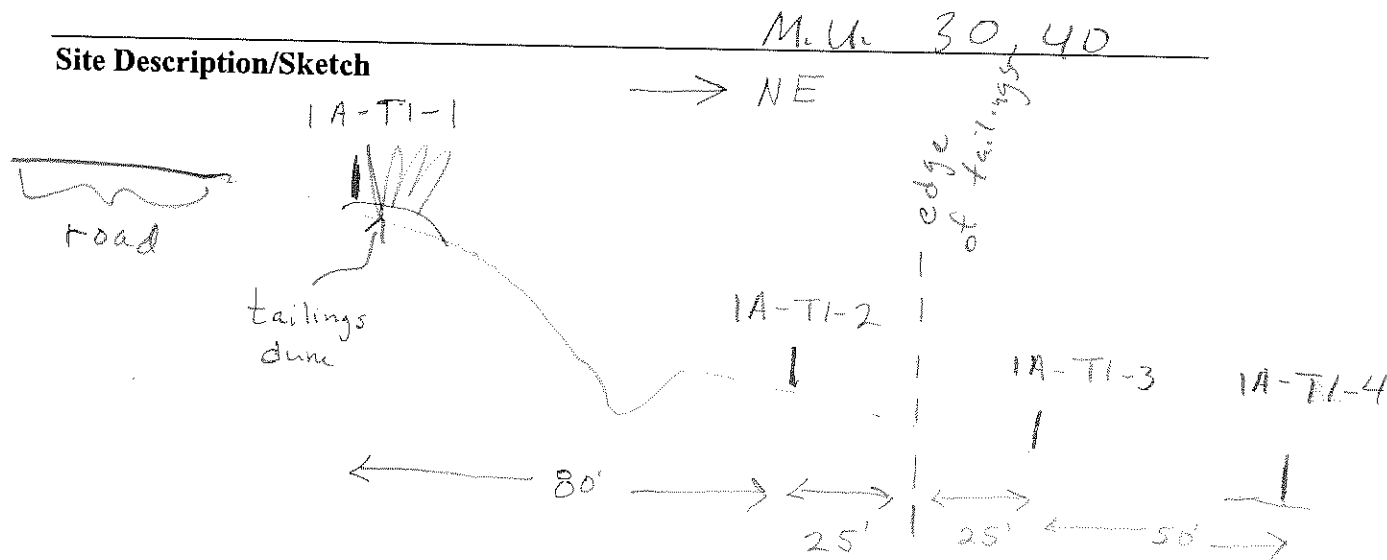
Location: East of NE corner of 1A tailing dam, in trees.

- moved 1A-T1-1 to tailings dune (thicker tailings deposit)
- tailings edge is very subtle, use pH to define edge.
- some light colored fine sand in the non-tailings portion but pH = 6.5
- some tailings along this transect may in part be water deposited.

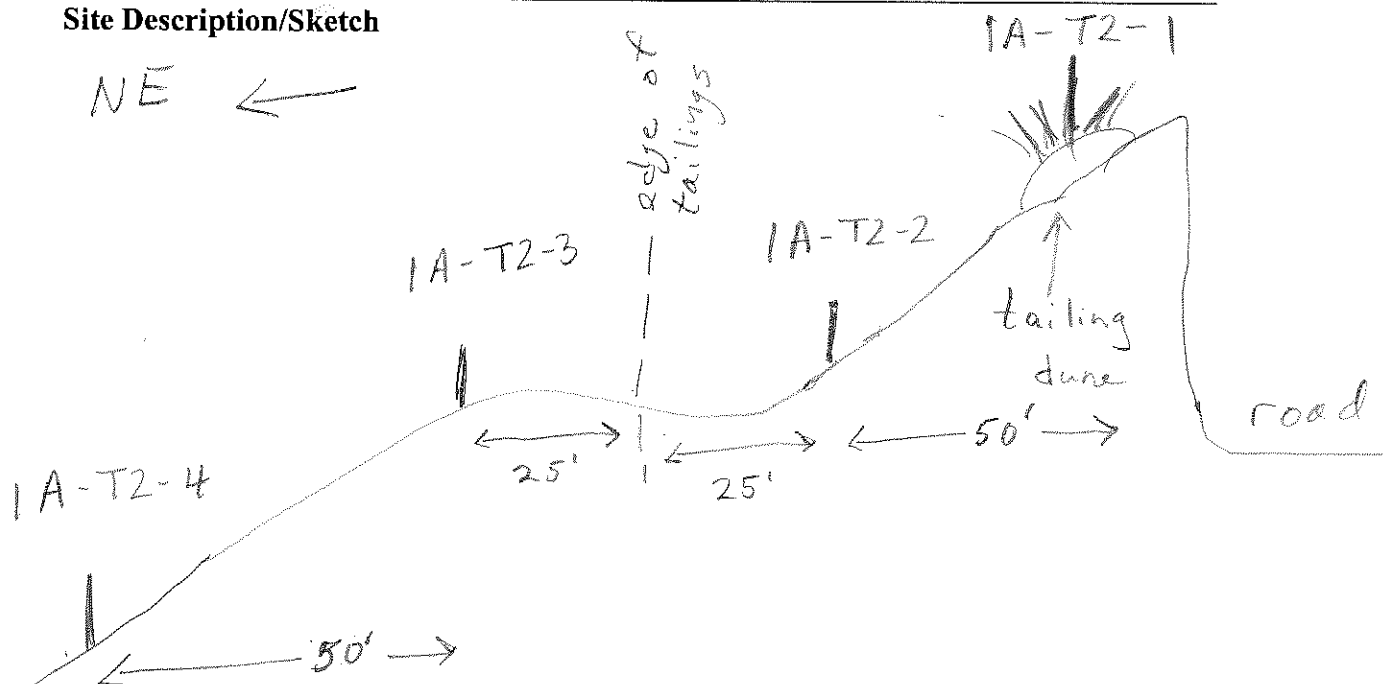
5' NW of 1A-T1 M.U. 30, 40

- edge of tailings is very subtle, used pH to define boundary
- abundant eolian LS, looks like tailings but pH is 6.5-7.0
- dune near 1A-T2-2 pH = 5.0,

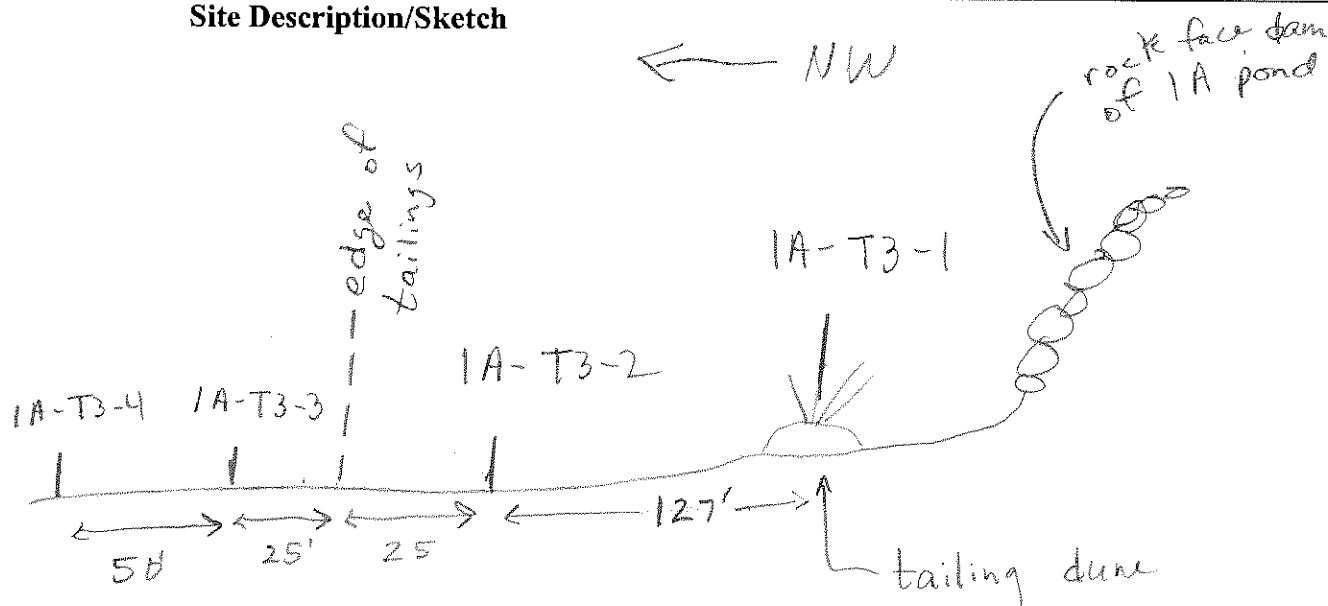
Location: West of SW corner of 1A tailing pond  
M.U. 30,40

- tailing boundary is very subtle, use pH to define edges
- relocated 1A-T3-1 to tailing dune to represent thicker tailing deposit.

\* Orientated transect NW/SE-parallel to dominant wind direction for this wind-blown tailing deposit.

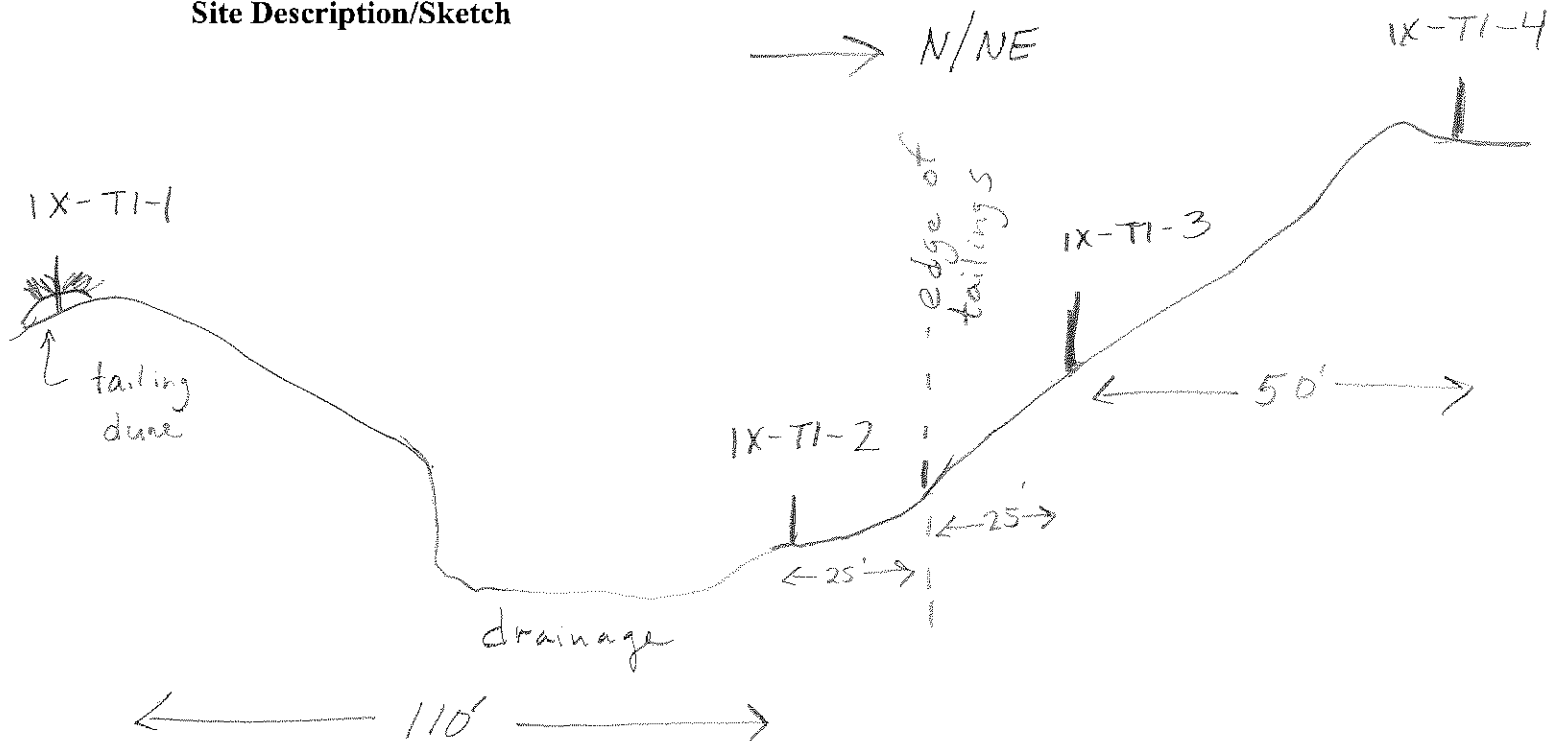
M.U. 30

- moved IX-TI-1 110' from IX-TI-2 to capture thicker deposit of tailing.

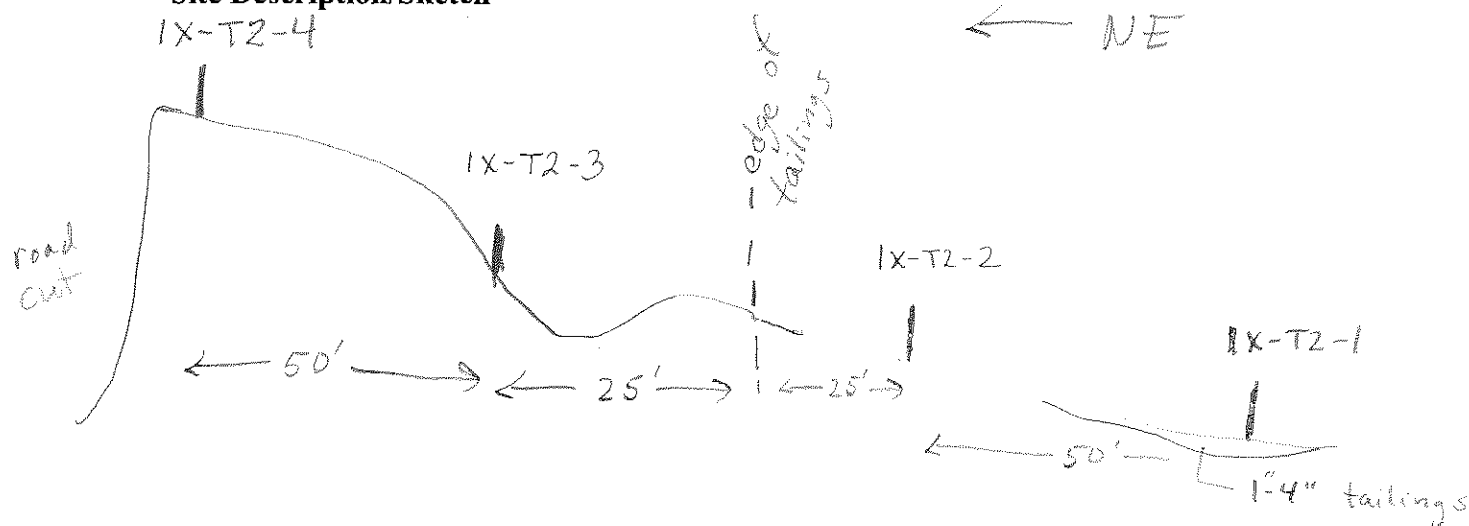
Location: Couple hundred feet N of N side of 1X dam,  
NE of tailing detention pond M.U. 20, 40

- edge of tailings is subtle, used pH to define edge,
- tailing looking material near 1X-T2-3 put pH 6.0
- 1X-T2-2 pockets of 1/8-1/4" tailings mixed in with 35% CF on surface - did not collect

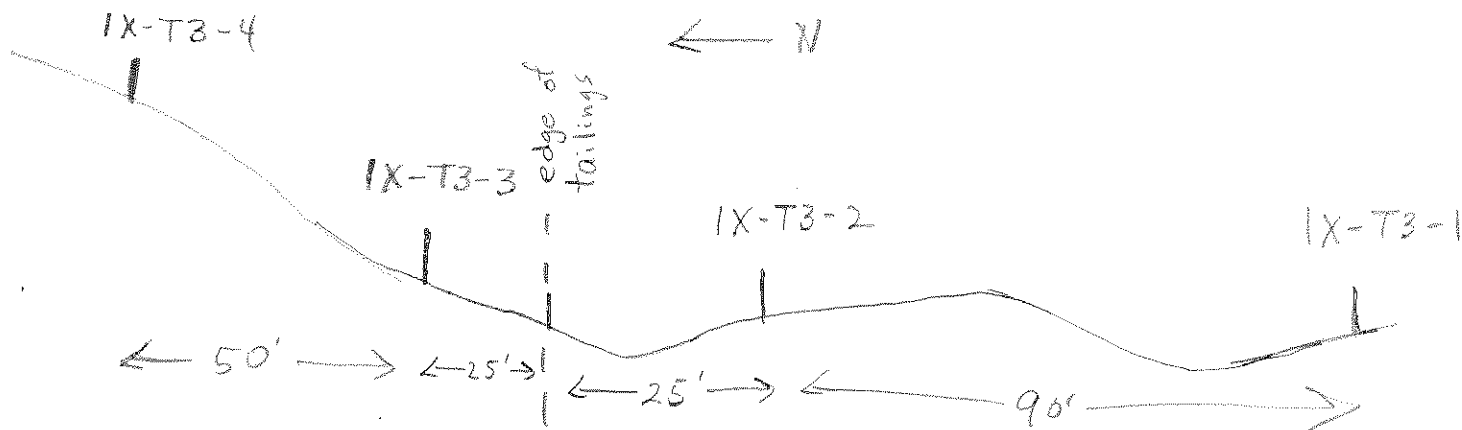
Location: N side of 1X dam. MU 40

- all tailings in this unit are very mixed with eolian soil, slope wash + surface C.F.
- moved 1X-T3-1 90' from 1X-T3-2 to area where it was possible to collect tailings/eolian soil
- transect runs N-S, only orientation that would fit because of road on top of hill + tailing detention pond to the east.
- edge of tailings is very subtle, used pH to define edge. Tailing area pH 4.5, non-tailing area pH = 5.5, Tailings is very mixed with eolian soil.

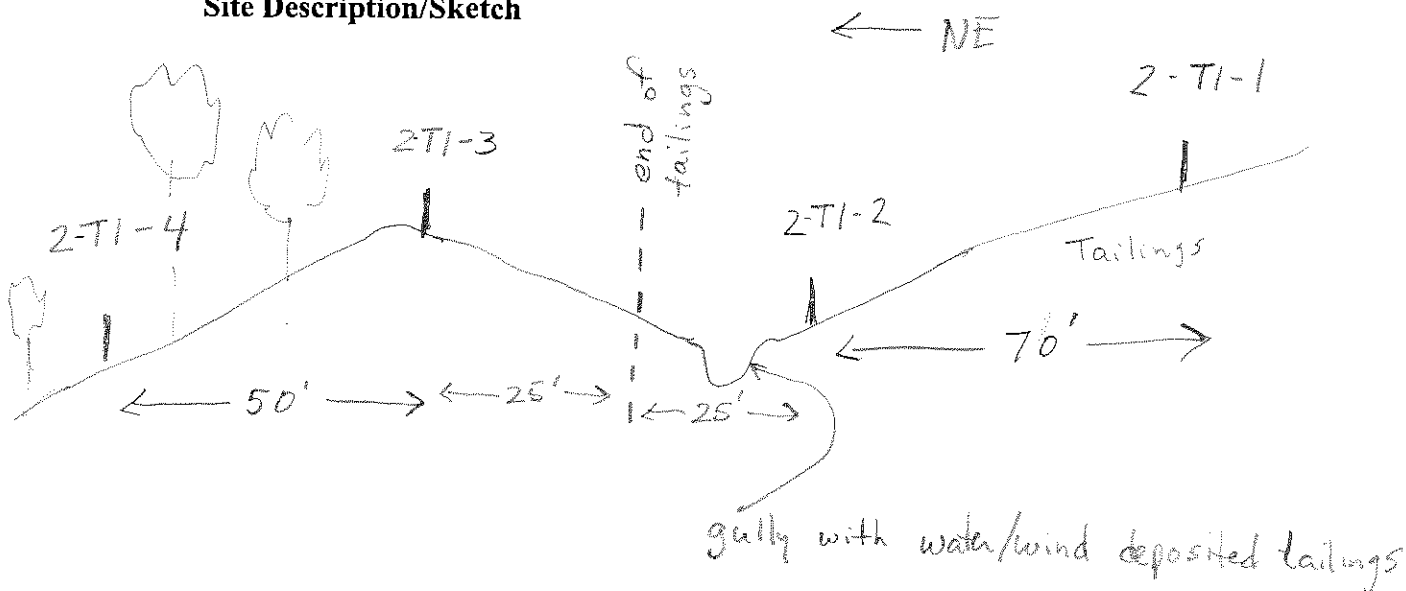
M.U. 10, 20

- soil under oak tree near 2-T1-4 appeared to have some tailings but pH = 7.0
- relocated 2-T1-1 to 95' away from tailings boundary to better represent the avg thickness of tailings
- transect is oblique to tailing deposit.

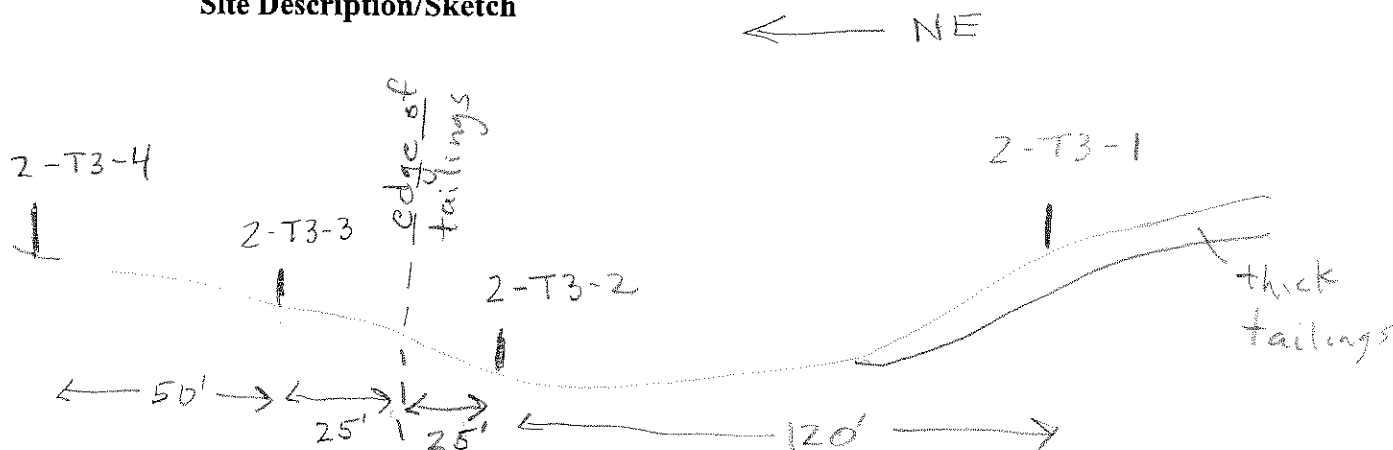
M.U. 10, 30, 40

- moved 2-T3-1 120' away from 2-T3-2 to represent thick tailings deposit.
- tailings edge is very subtle.

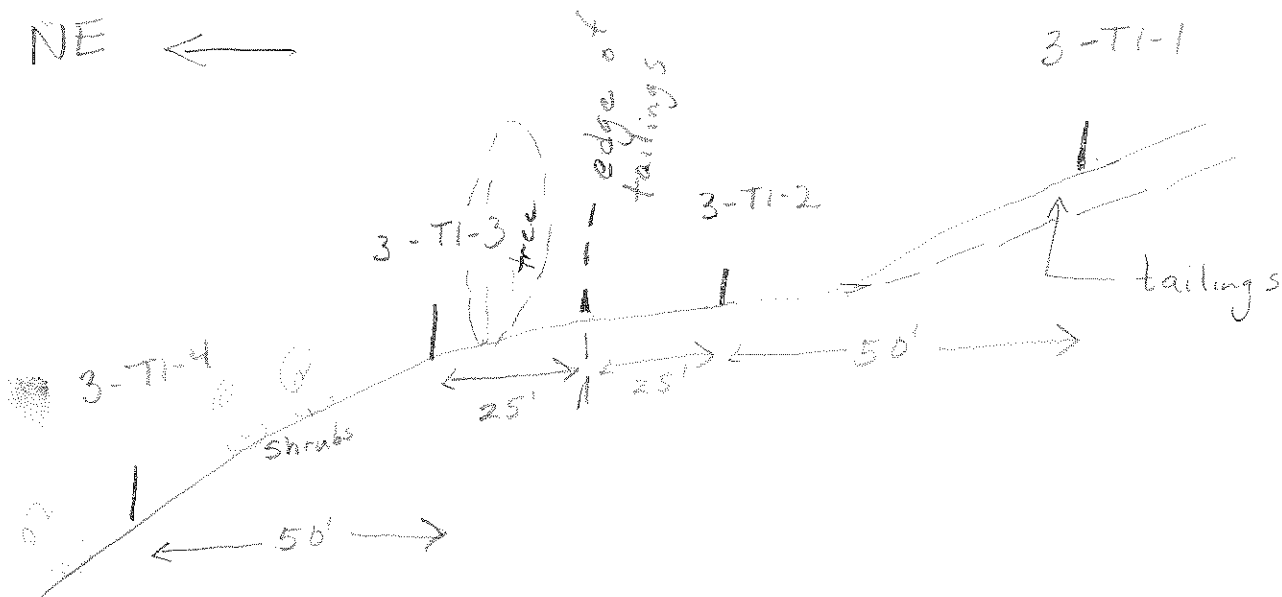
M.U. 10, 30

- used pH kit to define edge of tailings
- $\frac{1}{4}$ " -  $\frac{1}{2}$ " above 3-T1-2S is 55% grl with some eolian soil mixed with minor tailings  $\rightarrow$  did not collect, could not get good sample without mixing with soil below.

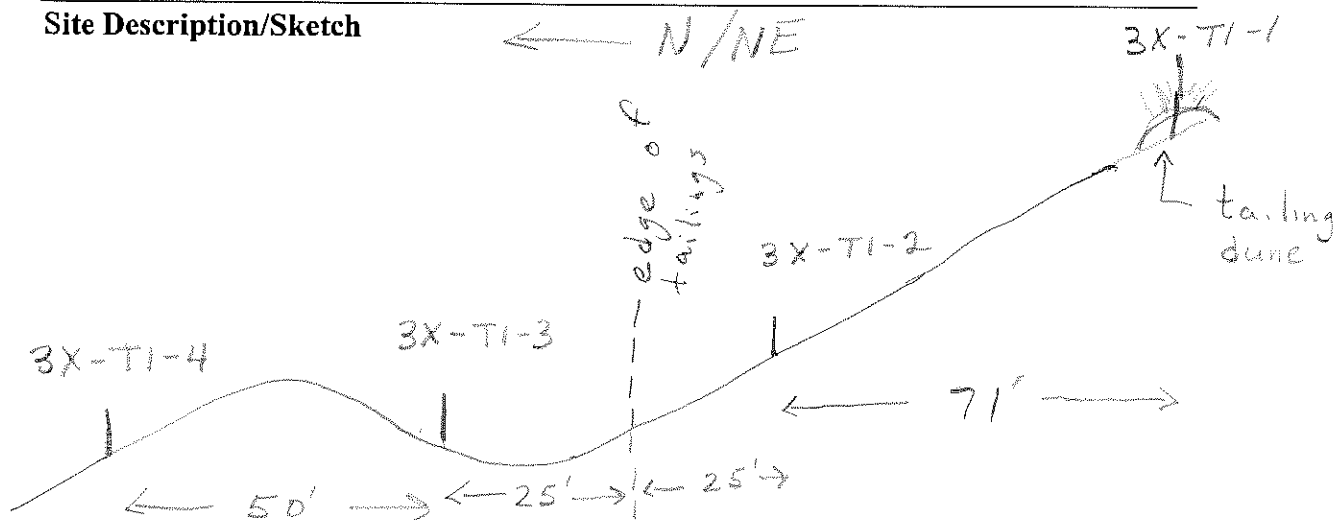
M.U. 40

- checked pH on several shrub-dunes to define tailings boundary,
- transect is oblique to wind-blown tailing deposit, deposit is more
- moved 3X-T1-1 up slope to a tailing dune (Controlled by the hill,
- laid out transect N/NE because it has been reclaimed on the NE side of this wind-blown deposit. N/NE is the only direction that the transect will fit.

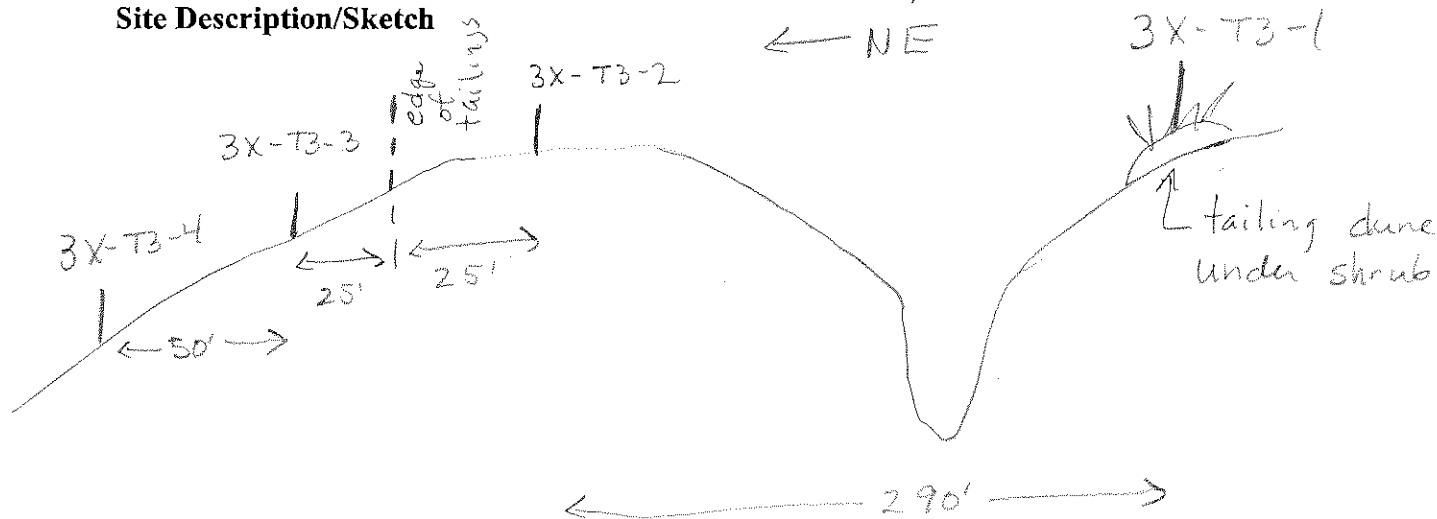
M.U. 40

- moved 3X-T3-1 290' from 3X-T3-2 to an area where it was possible to collect tailing sample.
- edge of tailings is subtle, used pH to define edge.
- 3X-T3-2, minor amt. of tailings mixed in with edian soil + 50% CF. — no tailing sample.
