Kennecott Exploration – Steeple Rock Project - Reclamation Report

In February of 2020, Kennecott Exploration Company completed construction of two exploration drilling sites, permitted as 19PDS-Fr and 19PDS-Ir under the [GR082EM Kennecott Steeplerock Minimal Impact Exploration Permit](#). New access trails leading to both sites, and maintenance on the existing access road were also constructed at the same time.

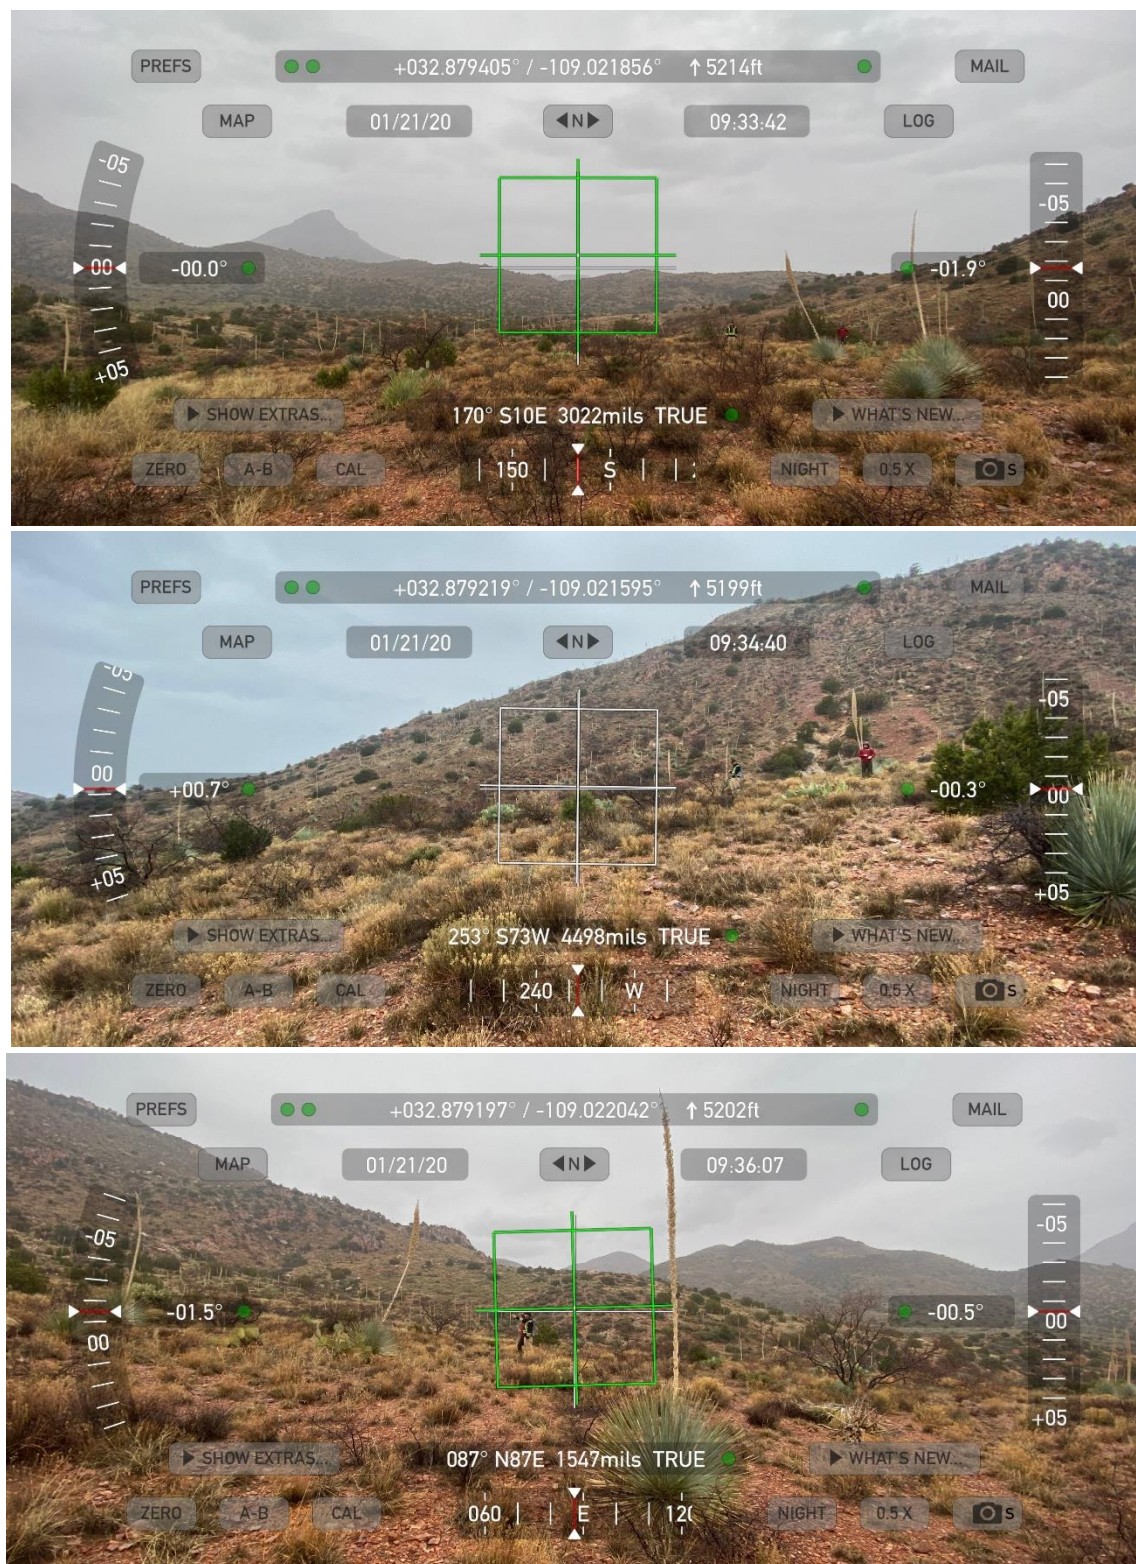
Figure 4: 19PDS-Fr before construction of drill site.

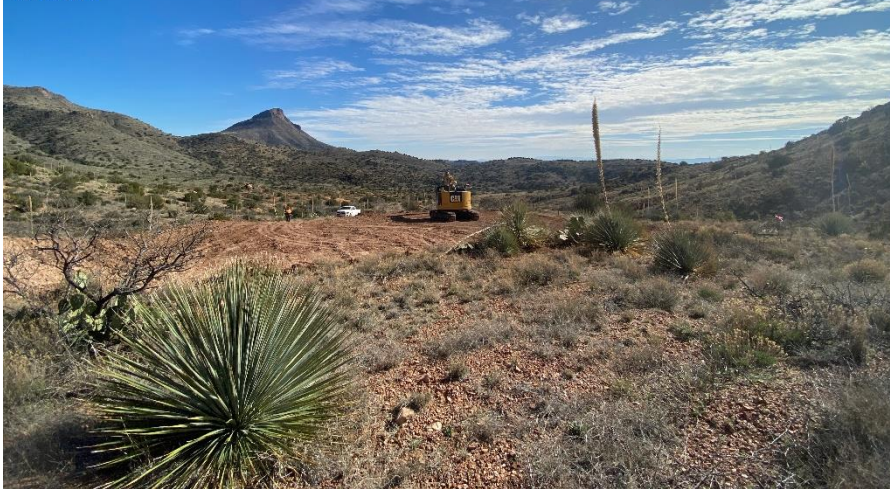
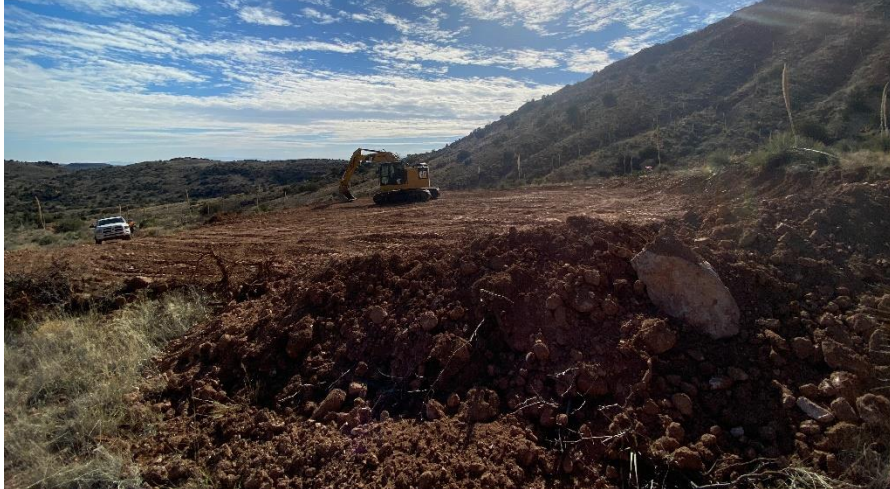
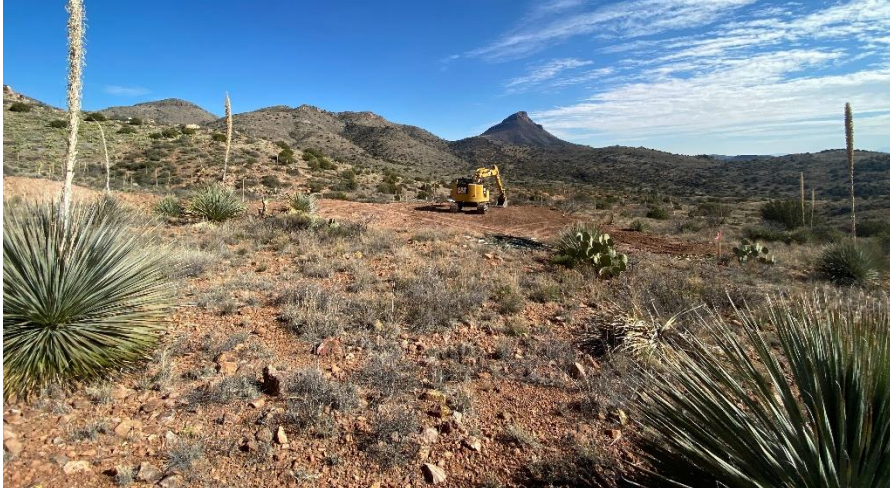
Figure 5: Drill site 19PDS-Fr after construction, before reclamation.

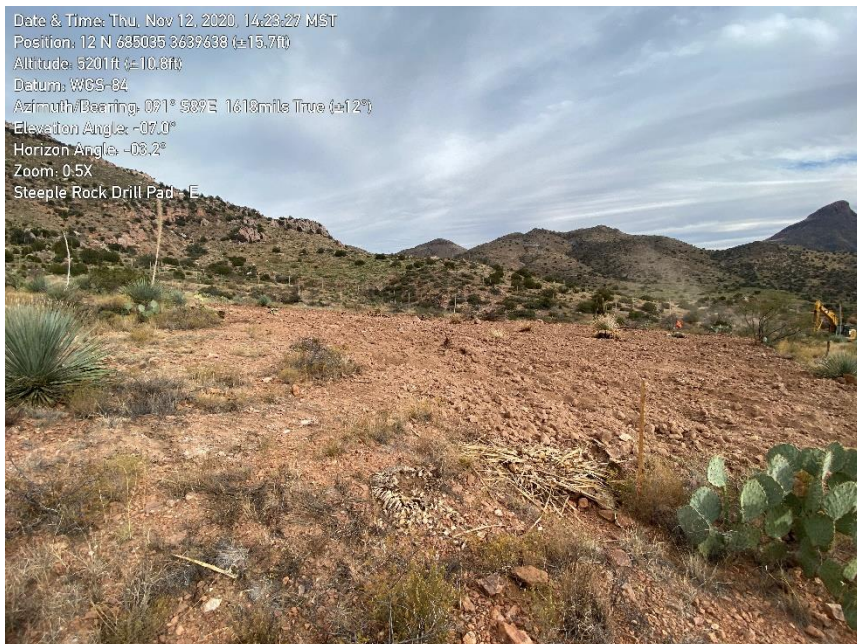
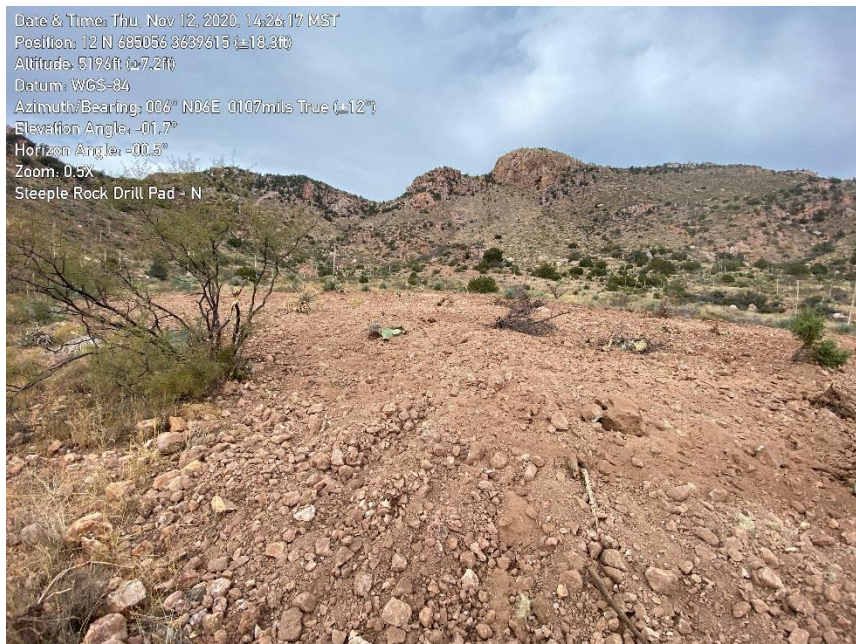
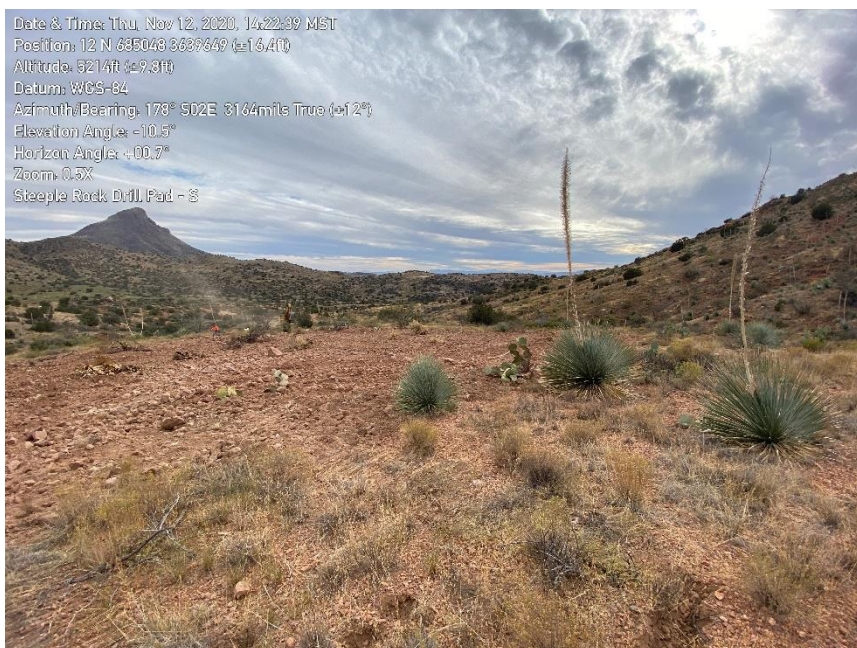
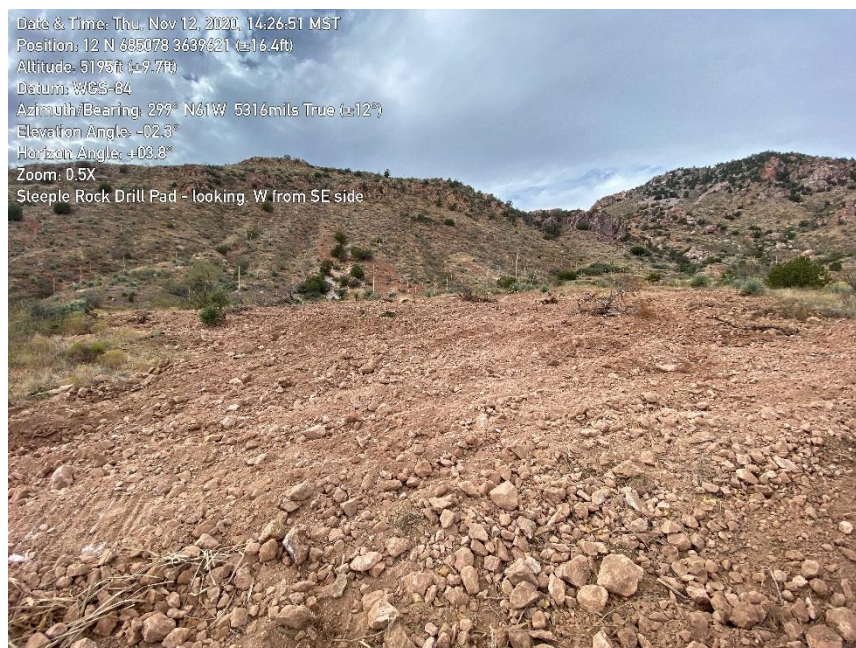
Figure 6: Site 19PDS-Fr after reclamation.

No boreholes were constructed on either site, thus no hole abandonment was necessary. While active, all sumps that were created were kept fenced, and no disturbance or entrapment to wildlife was noted during this period. Reclamation of the two drill sites and associated access trails was completed November 10th – 13th, 2020. All reclaimed areas were immediately re-seeded using the native seed mix recommended by the MMD, with the exception of Arizona fescue (*Festuca arizonica*) in place of Bush muhly (*Muhlenbergia porter*); this substitution having been approved by the MMD prior to placement (a copy of the seed mix is provided in Figure 3 below). The area where the drilling sites were constructed is on an active cattle ranch, where livestock have access to the area, as such, straw mulch was not placed. The sites were left unfenced at the request of the landowner. The minimum maintenance that was done to the existing “Goat Camp Road” was largely left as is. Any berms or ridges that were created from driving the heavy equipment through were flattened, especially in the (dry) washes, to allow any runoff to flow unimpeded, and such that no fill was added to the wash.

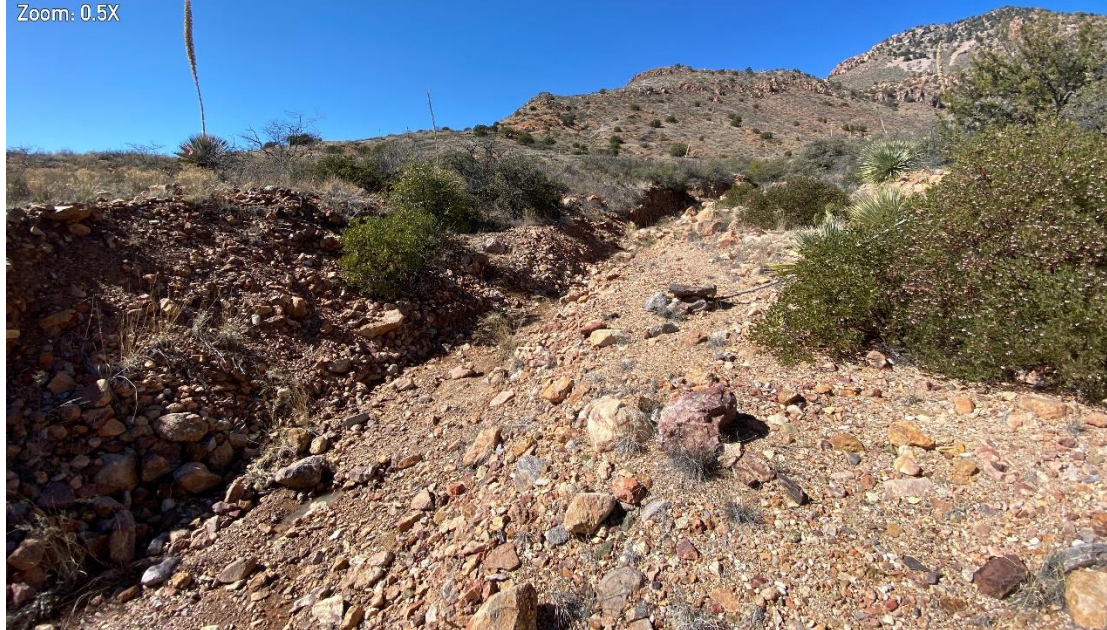
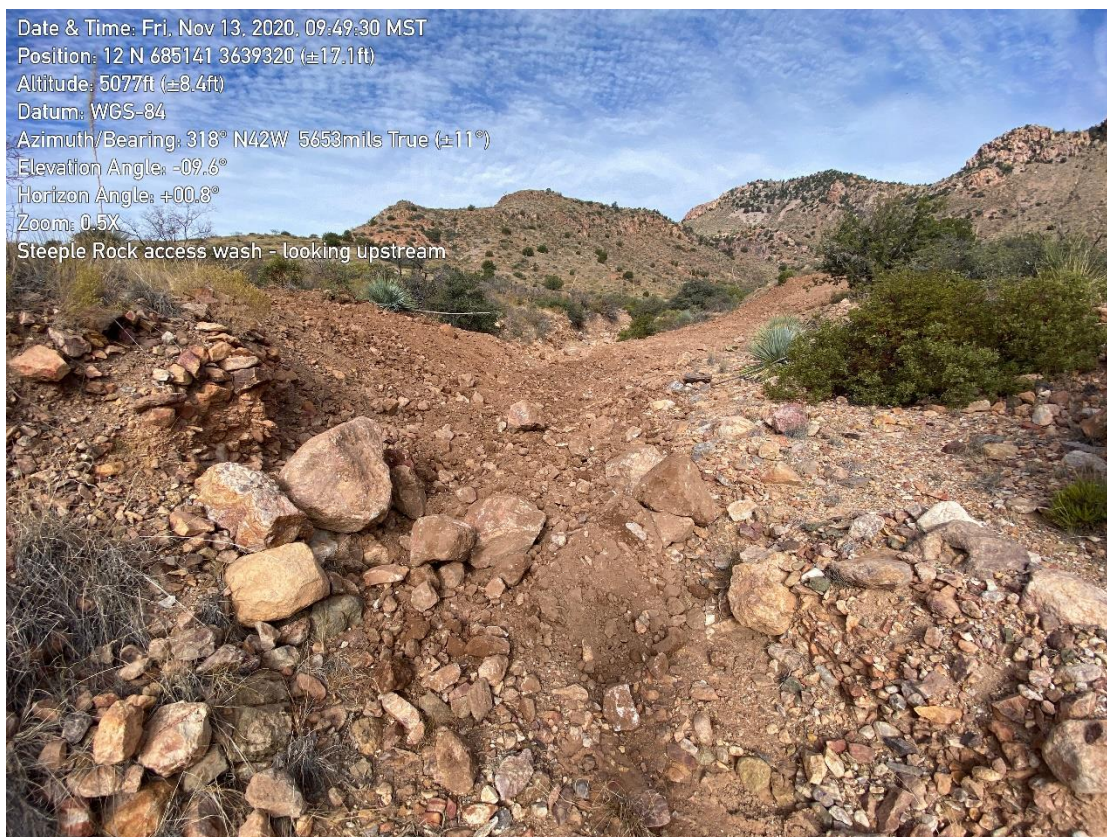
Date & Time: Fri, Nov 13, 2020, 09:49:30 MST
 Position: 12 N 685141 3639320 ($\pm 17.1\text{ft}$)
 Altitude: 5077ft ($\pm 8.4\text{ft}$)
 Datum: WGS-84
 Azimuth/Bearing: 318° N42W 5653mils True ($\pm 11^\circ$)
 Elevation Angle: -09.6°
 Horizon Angle: $+00.8^\circ$
 Zoom: 0.5X
 Steeple Rock access wash - looking upstream

Figure 7: Wash crossing going to 19PDS-Fr.

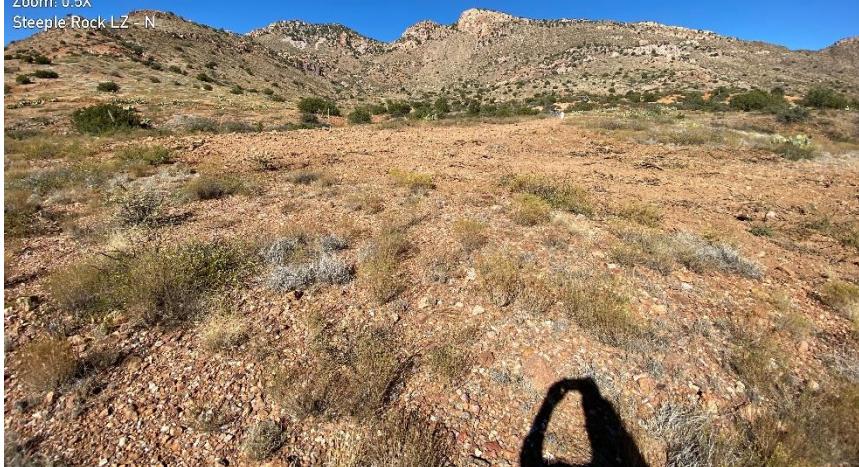
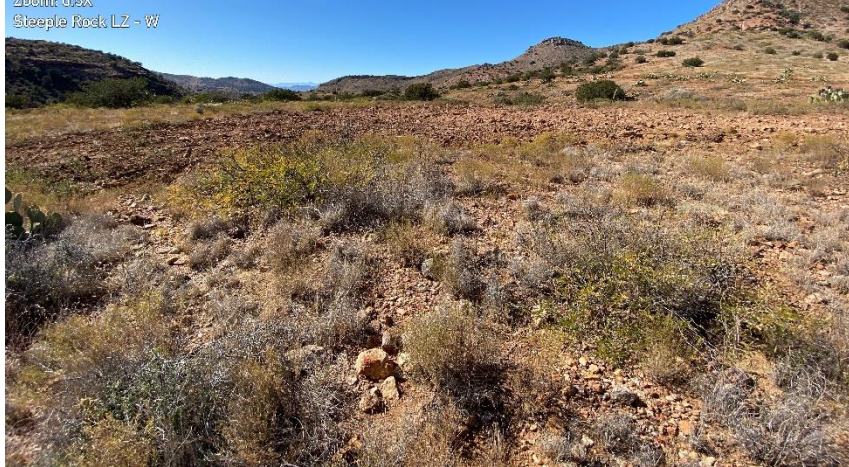
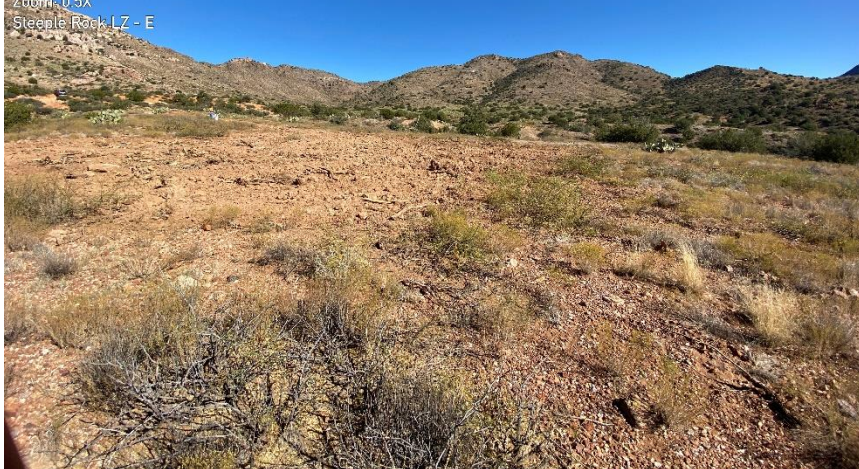
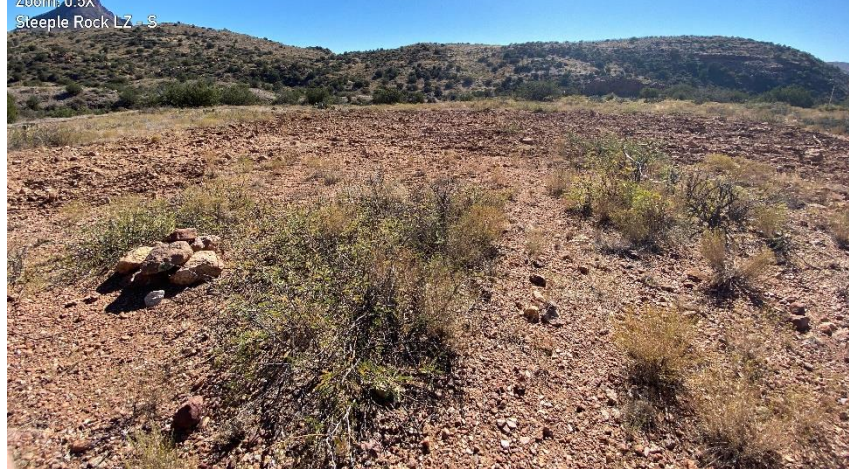
Figure 8: 19PDS-Ir after reclamation.
