Subject: Request for Submittal of a Permit Revision Application Including a Revised Closeout/Closure Plan for Mining Act Permit No. CI002RE and Additional Information for Discharge Permit 61 (DP-61) Renewal and Modification, Rio Grande Resource Corporation, Mt. Taylor Mine

FIGURE 4-1
**MINE CLOSEOUT / CLOSURE
DISPOSAL CELL**

FIGURE 6-1 MT TAYLOR MINE CLOSEOUT/CLOSURE PLAN

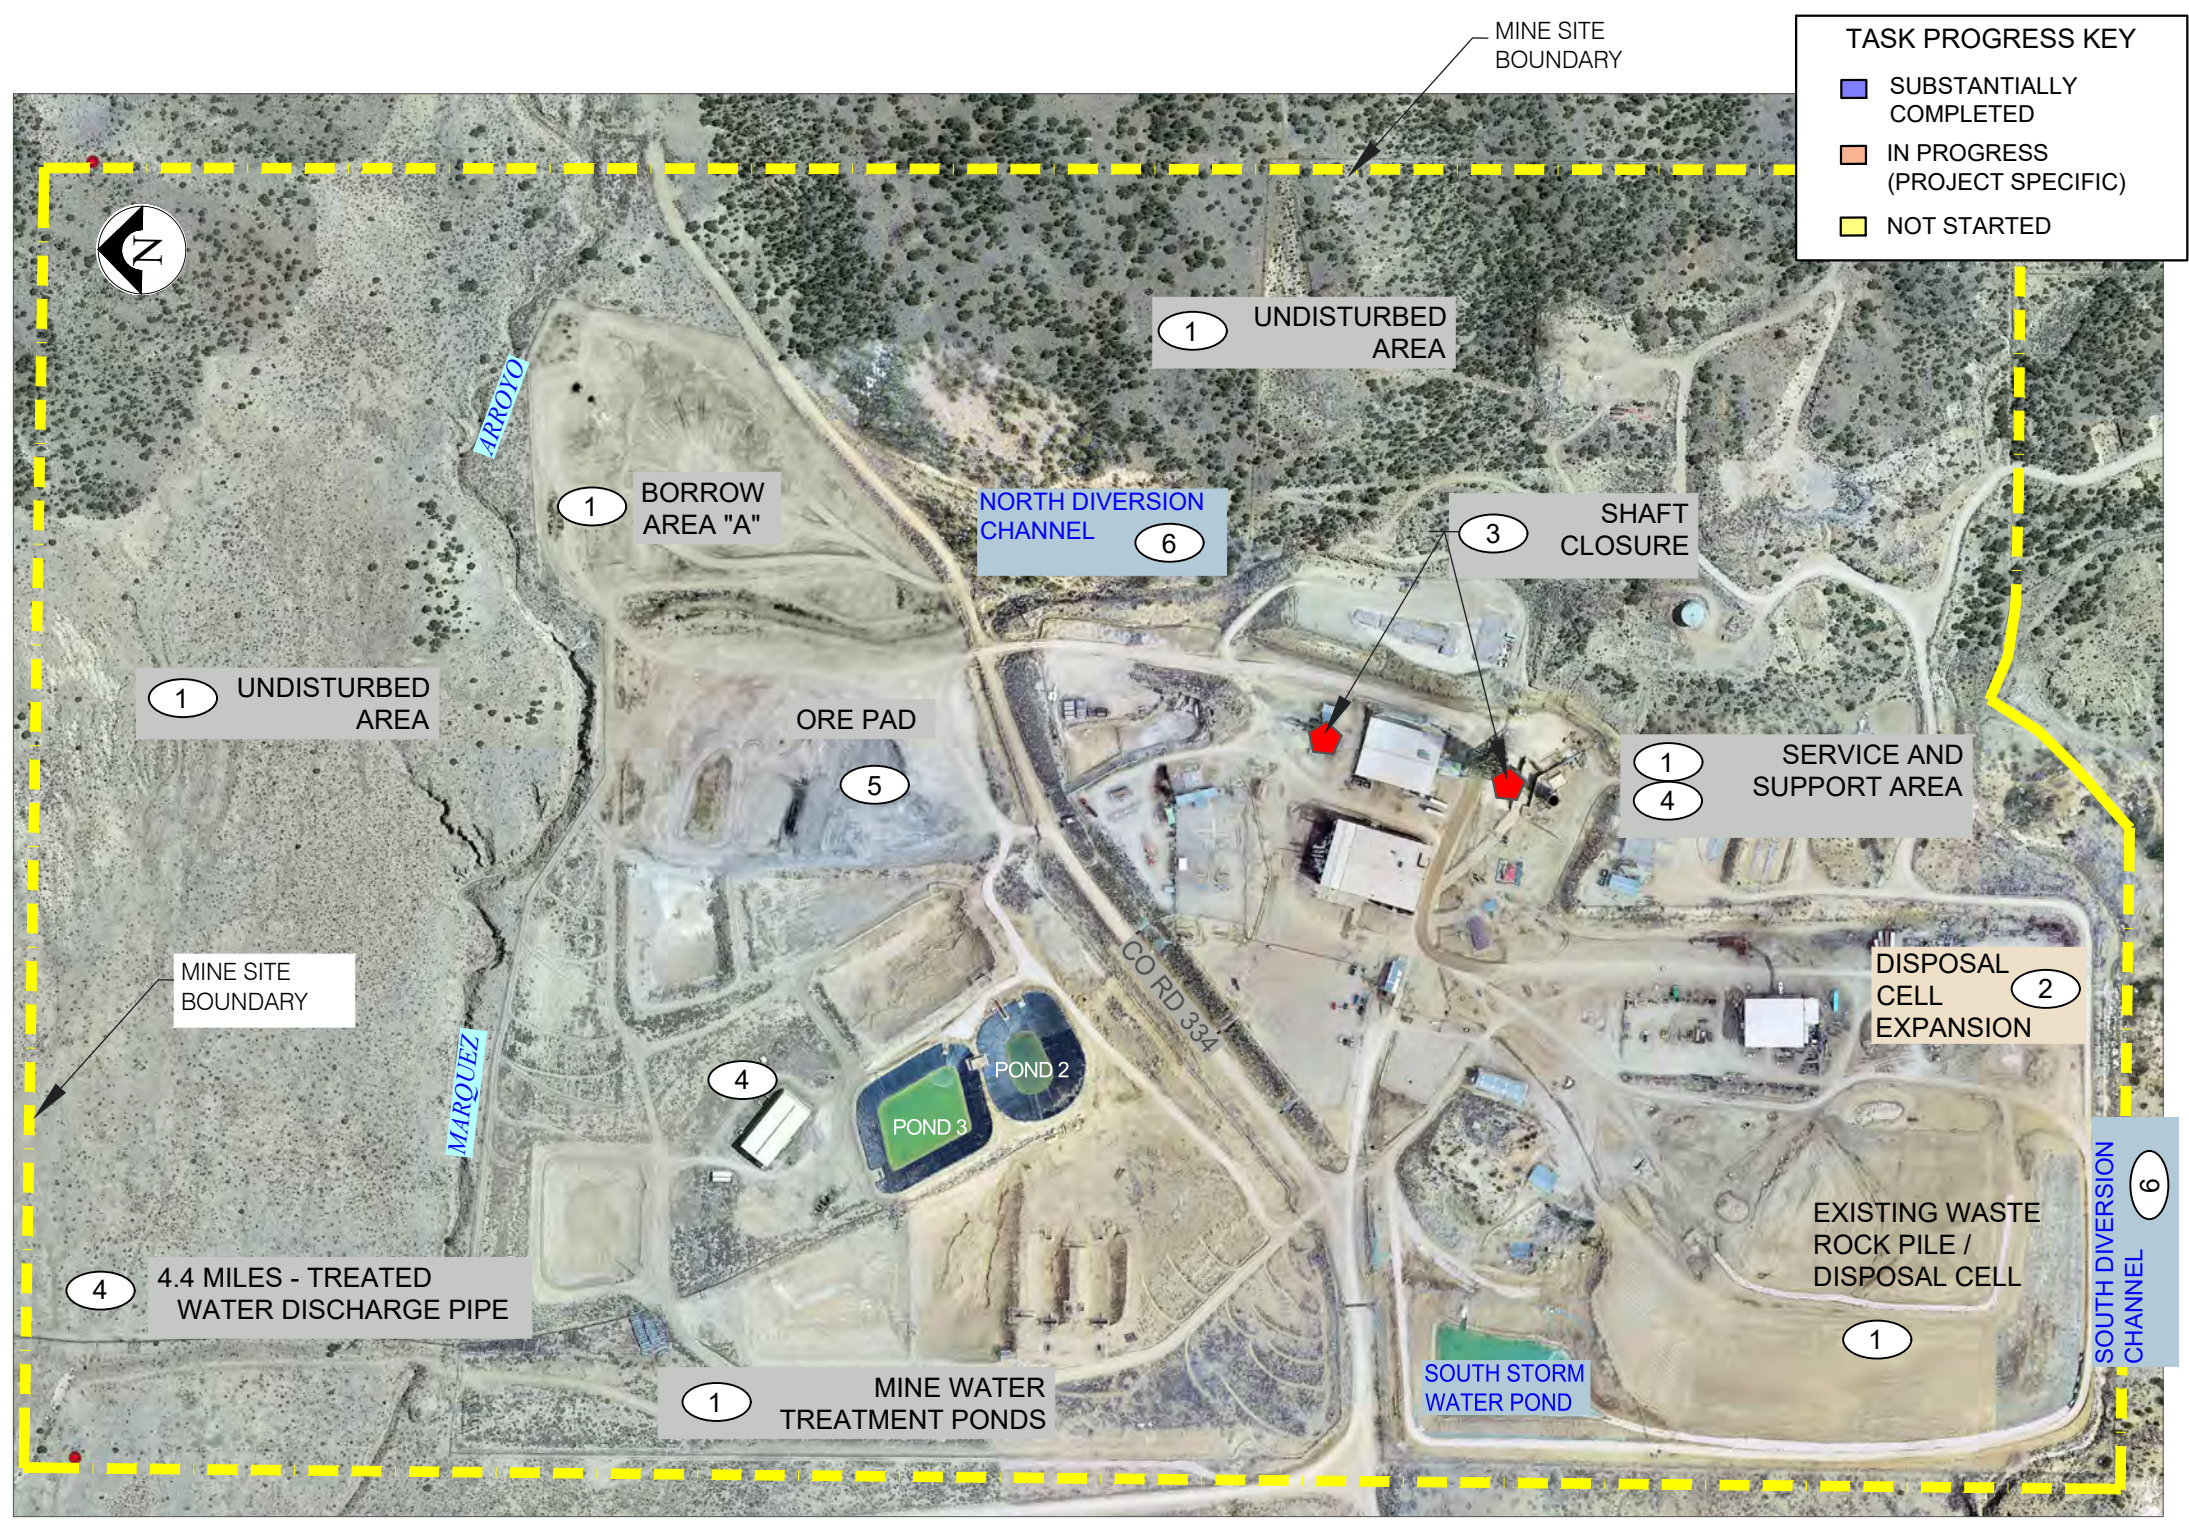
- ### CLOSEOUT TASKS

(COMPLETED AS OF APRIL 22, 2022 AND YET TO BE ACCOMPLISHED.)

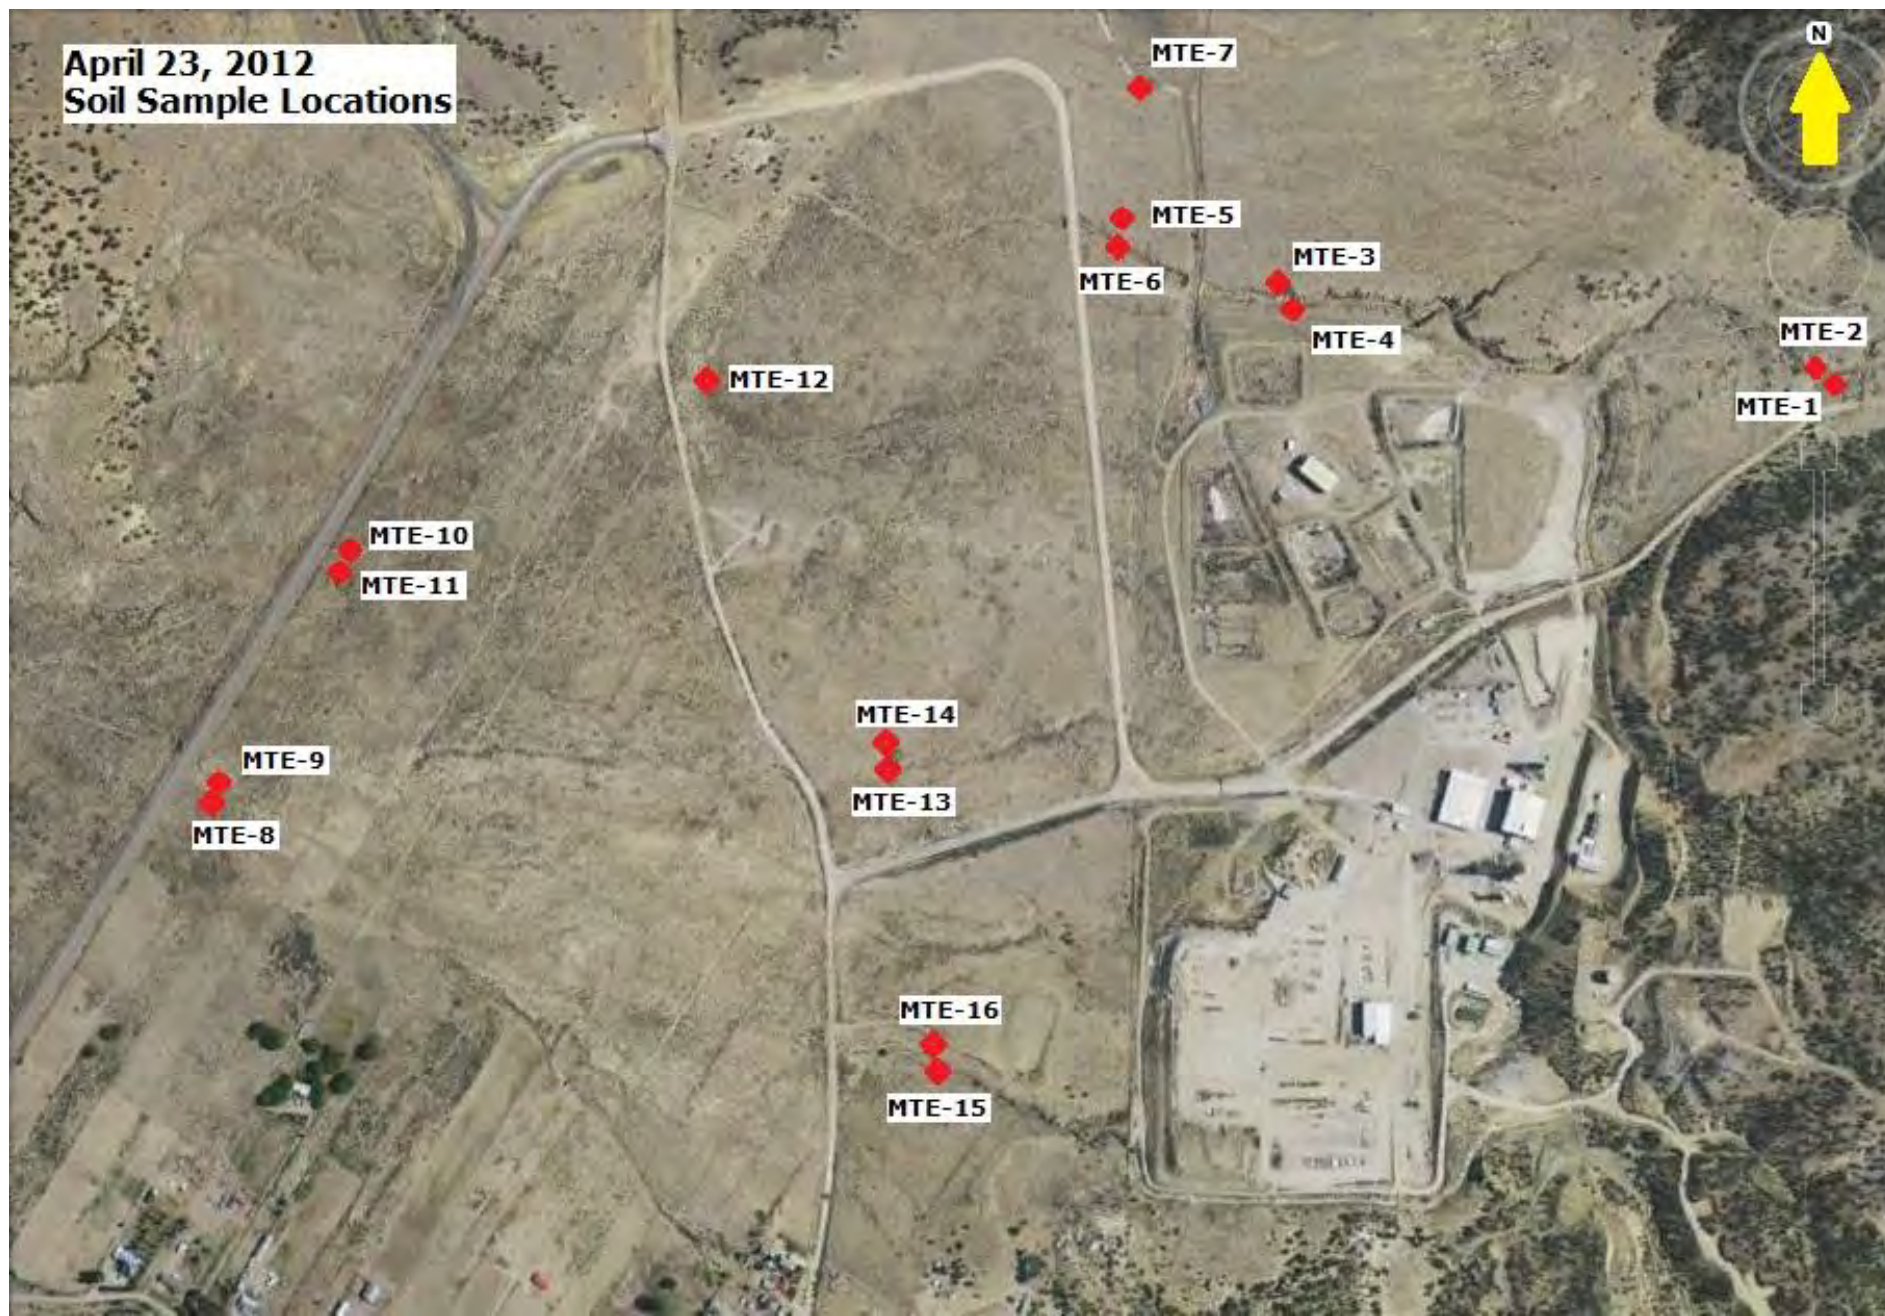
Table 2
RADIATION SURVEY AND SAMPLE RESULTS
April 23, 2012

Regression analysis of the data in Table 2 indicates very poor statistical correlation between the dose rates and the concentrations of Radium-226 in the soil.

The conclusions are that: 1) **radiation "shine" from nearby** and elevated rock and soils could be affecting the instrument readings; and 2) soil sample analyses must be performed along with dose rate surveys when evaluating remediation requirements.
