Swastika Mine and Dutchman Canyon Maintenance and Stream Restoration Project

Raton, New Mexico

SUMMARY OF THE SWASTIKA MINE AND DUTCHMAN CANYON MAINTENANCE AND STREAM RESTORATION PROJECT AND PROBLEM DESCRIPTION:

B. Project Description

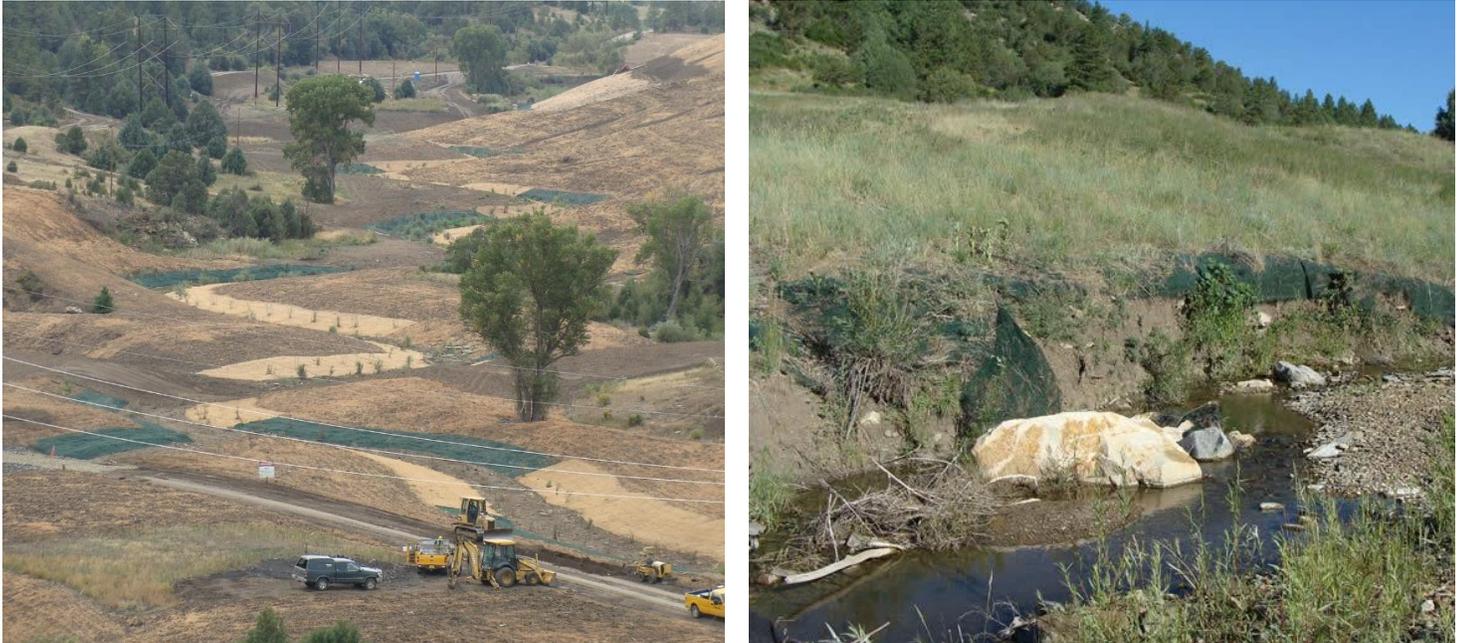
Figure 3. Finished Original Project and Aftermath of the Storm

The Swastika Mine and Dutchman Canyon Maintenance and Stream Reclamation Project follows an original 2012 reclamation project that added sinuosity to a straightened stream channel and buried nearly 200,000 cubic yards of gob piles utilizing geomorphic reclamation methods. Shortly after the first project was completed, torrential flooding in the canyon caused project-wide erosion to previously restored elements including gullying of swales and channels constructed as part of the upland landform restoration and down-cutting, scour, and lateral migration of the constructed stream channel. This project was designed to address the erosion issues resulting from the damage caused in the 2012 storm. The design methods used for this stream restoration project were dictated by applied morphology, hydrology and ecology to

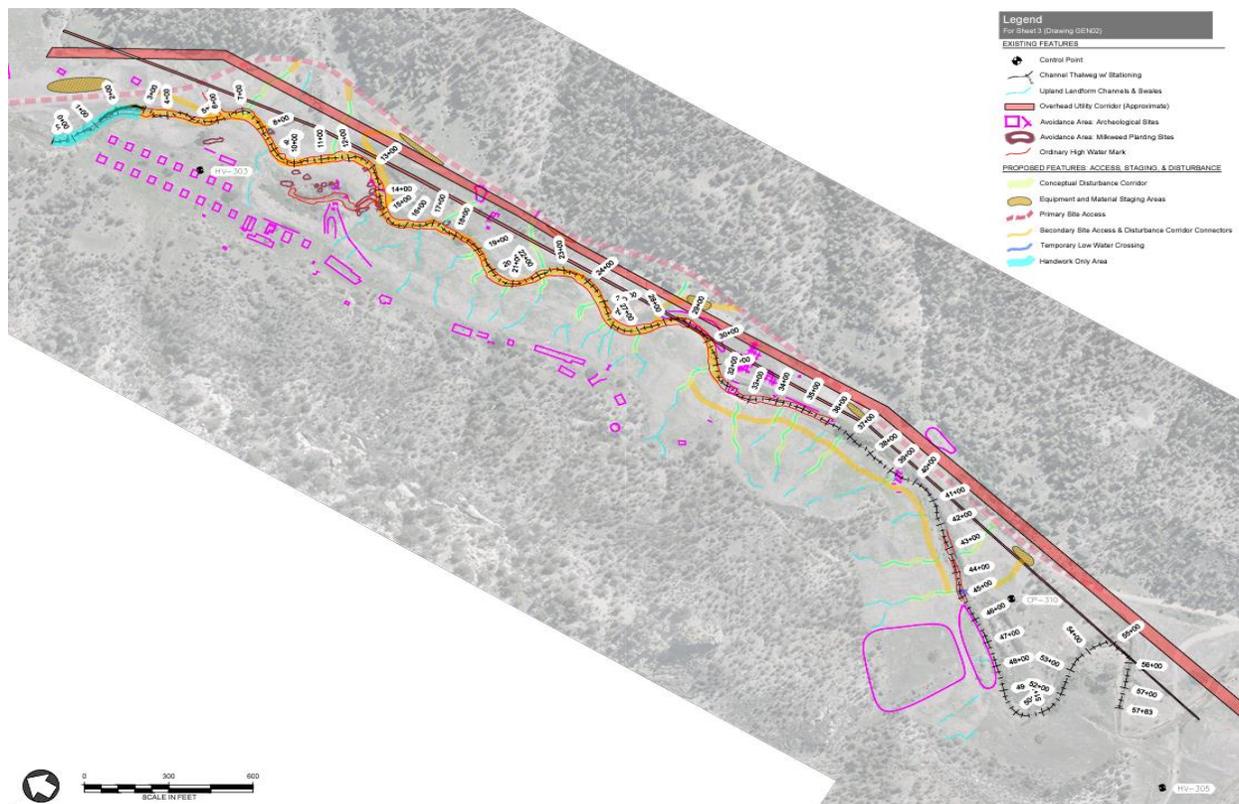
Figure 4. Overview of stream work

1. Pool construction and bank stabilization at meanders: to help dissipate energy, construct floodplain benches on the outside bank of meander, integrating large boulder clusters to protect bank bench,

2. Channel conversions and enhancements: stabilize by construction inner berms and benches,
3. Grade control: install cross vanes at the head of pools and riffles and sills at the tailout to provide grade control,
4. Upland erosion in gullies: install media lunas and one-rock check dams in actively eroding gullies in the uplands adjacent to the stream channel,
5. Native plantings: willow poles, native wetland plugs and seed,
6. Removal of erosion control fabric left over from previous project.

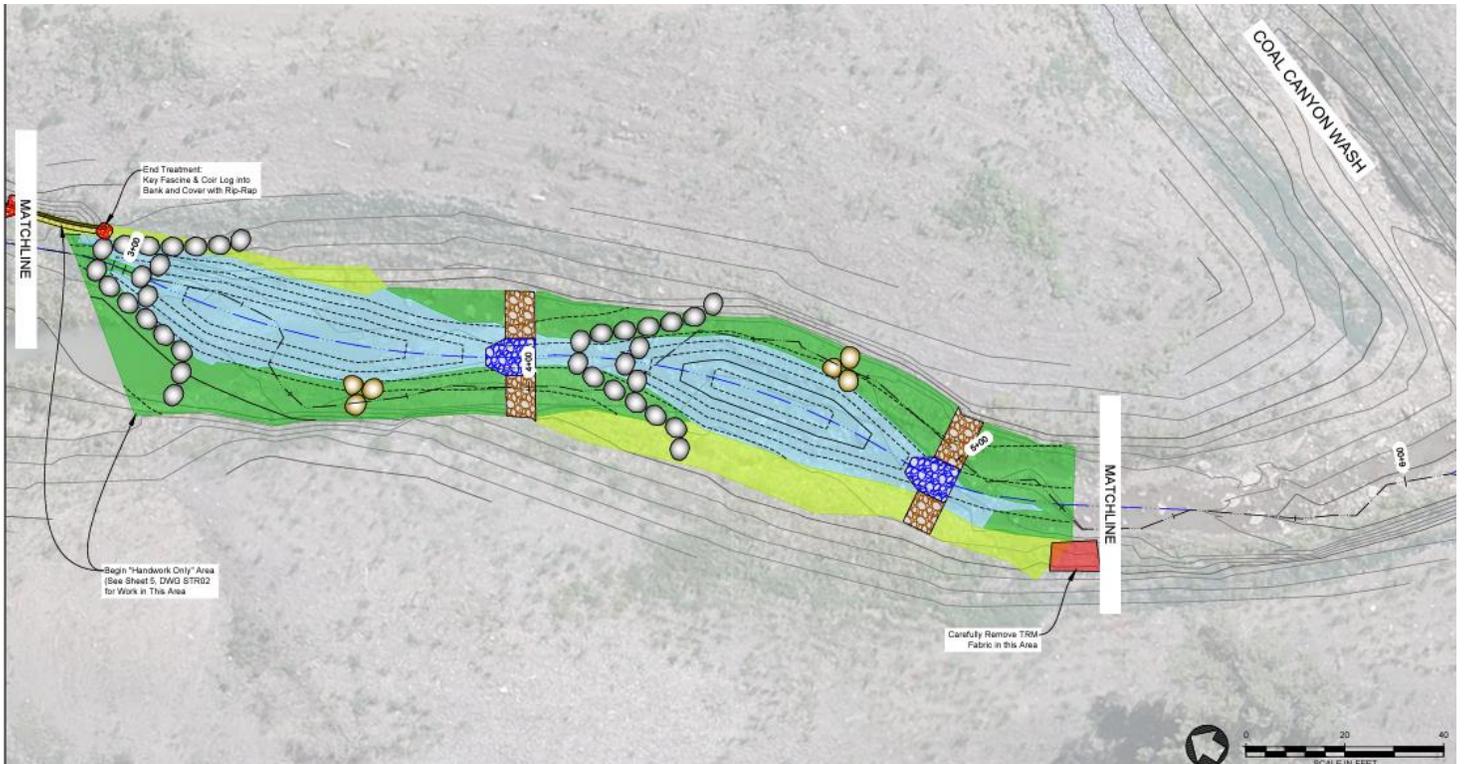
Figure 5. Typical Meander Overview

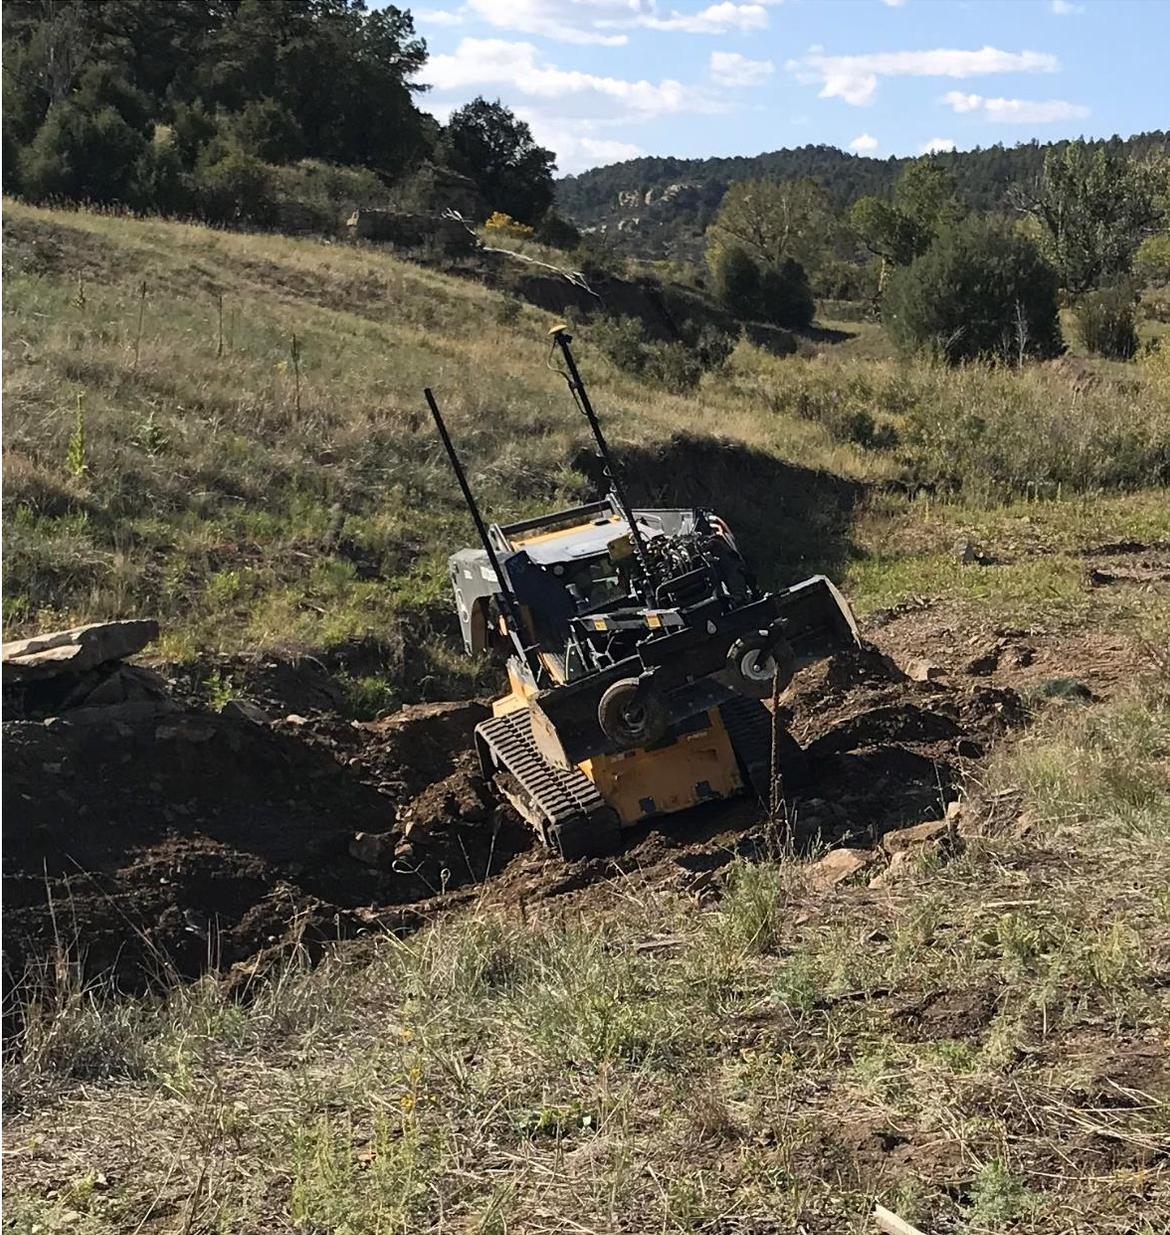
Figure 6. A John Deere track loader equipped with Level Best attachment and Topcon 3D-MC grade control software

Additionally, heavy equipment used to excavate and install stream restoration structures was programmed with highly precise GPS equipment by TopCon 3D-MC to excavate the pools and install the boulders to specification. Such precision was achieved with a Level Best attachment

by setting the grade on the model, and once the grade was set, the equipment would excavate up to specification, never exceeding the depth it was programmed to excavate. Accuracy of this was verified by minimal on-the-ground traditional surveying methods.

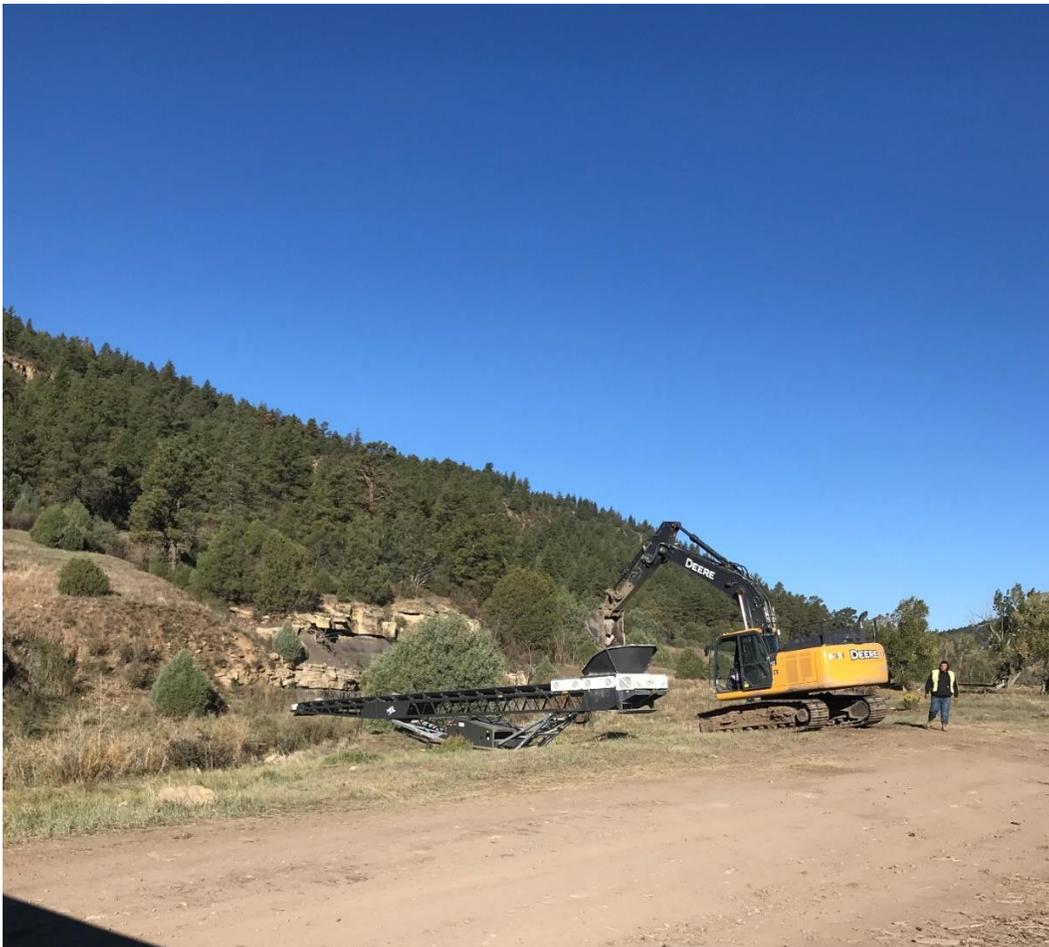
Figure 7. Conveyor belt being used to drop boulders into place in the stream channel across an archaeological avoidance area.

Challenges for geomorphic design at the Swastika channel included the presence of many valuable cultural and natural resources lying within an area that limited access for construction in the northernmost part of roughly 300 linear feet. It was required that the construction contractor limit their disturbance footprint by utilizing the actual stream channel as access route to preserve archaeological features surrounding the project including the buildings and facilities that served the mine, and the relics of the coal camp where as many as five hundred miners lived at the height of coal production in the late 1920's. The construction contractor solved this issue by utilizing a swinging conveyor belt to transport boulders into place while a crew in the channel installed them by hand and thus completely bypassing this avoidance area.

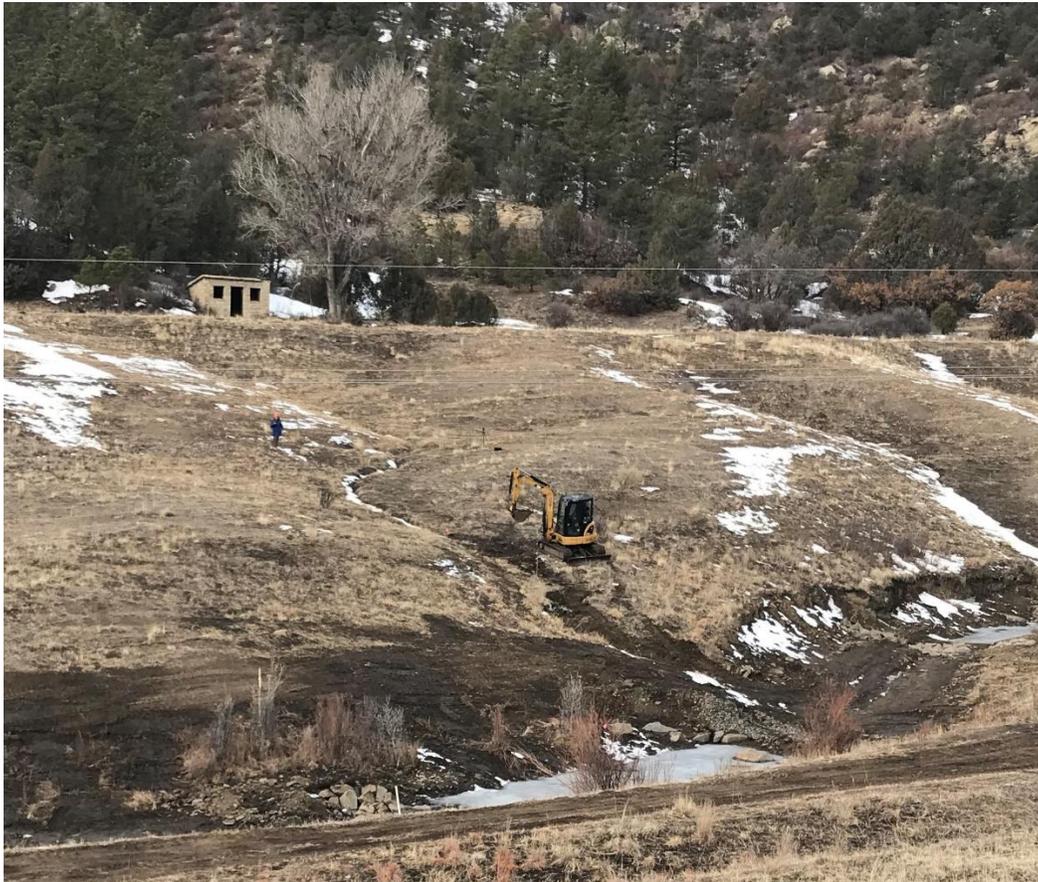
Figure 8. Working on upland erosion control structure in steep, frozen conditions.

While the logistics of navigating a project in the middle of a pandemic were challenging, the harsh winter weather of northern New Mexico is another factor to consider when talking about special considerations. The project area is located within a valley that has an elevation of approximately 6,600 feet and during a typical year gets an average of 28-30 inches of snow with temperatures ranging from 18°F to 44°F during the day. These low temperatures caused

the heavy equipment to warm up very slowly in the mornings, work in slippery steep conditions, and limited the work hours due to limited daylight.

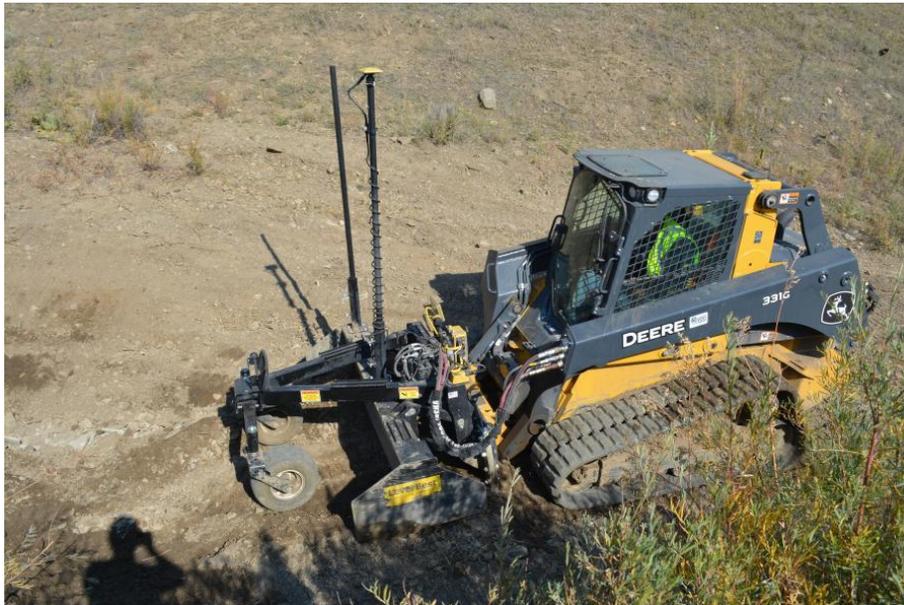
Figure 9. GPS-guided John Deere track loader above and Terramac Crawler below

This project utilized a combination small uncrewed aircraft system (sUAS) construction activities and GPS guided heavy equipment for accuracy of installation of structures to make sure they were built to specifications. It even included a low-impact Terramac Crawler Carrier with rotating bed. The channel designs used low-impact erosion control measures with no man-made materials.

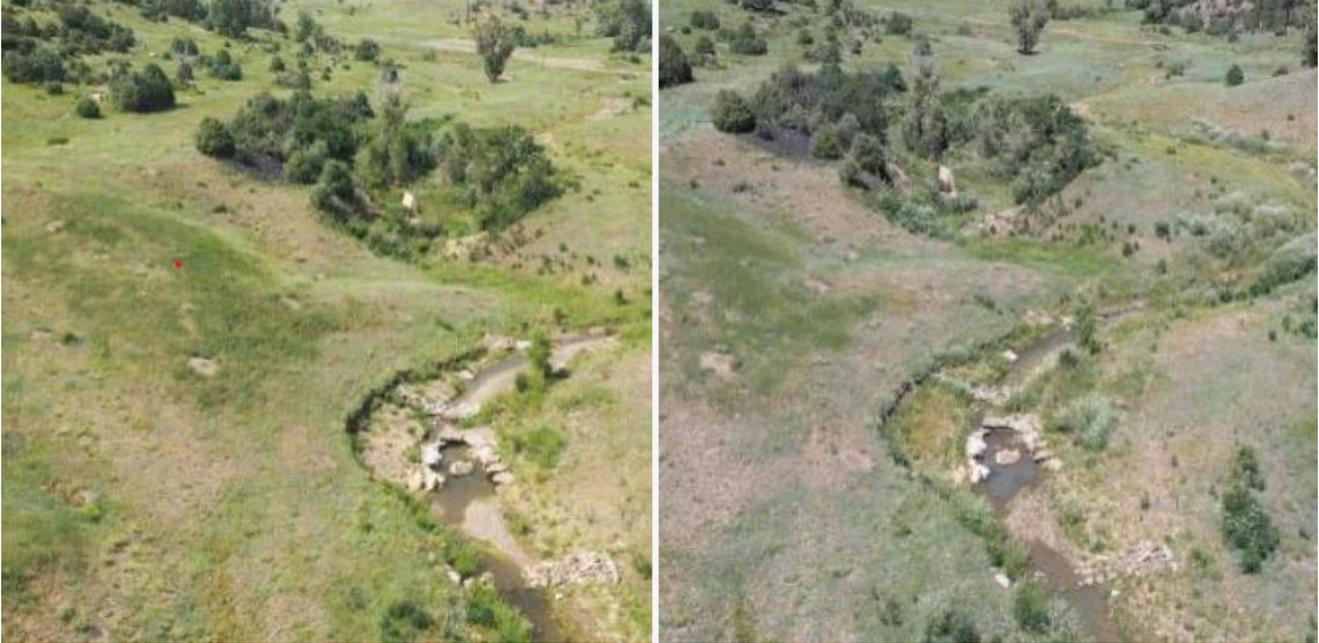
Figure 10. One year after reclamation monitoring using small uncrewed aircraft systems

The New Mexico AML Program used small uncrewed aircraft systems (sUAS) as an innovative method to monitor construction activities and post-construction changes in the terrain and resulting revegetation. Small UAS video flights documented construction activities and changes in the constructed pools within the creek during the span of construction and post-construction. These videos were paired with on-ground video and time-lapse video/photos of construction to inform viewers of the reclamation process.

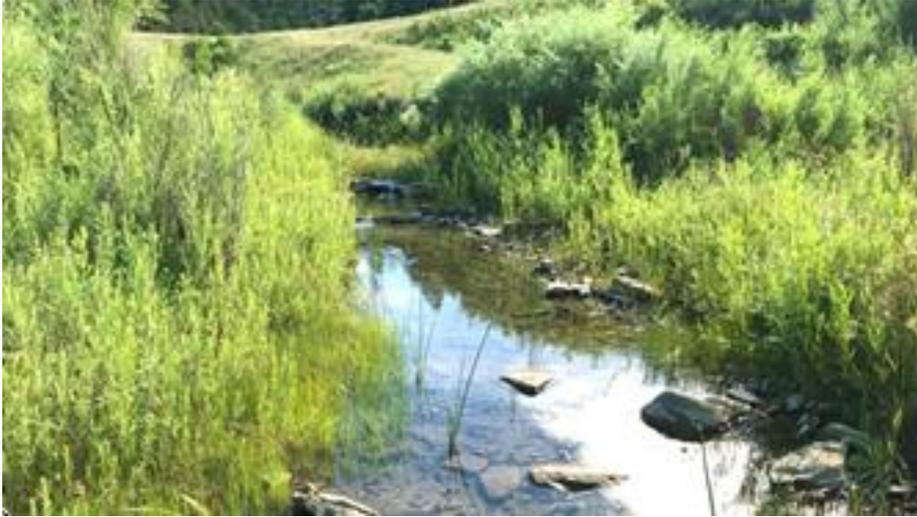
Figure 11. Recovered Riffle Section

Water was moving too fast through the system and causing erosion of the banks of the channel. Rock structures were created using local sourced materials that were intended to be covered over with sediment as the water was slowed. The deposited sediment provides a stable formation for plants to thrive and further protect the channel from erosion. The design used geomorphic criteria developed from measurements of nearby, undisturbed features of the stream channel to mimic thriving sections that have developed naturally. This approach was used in every meander throughout the project.

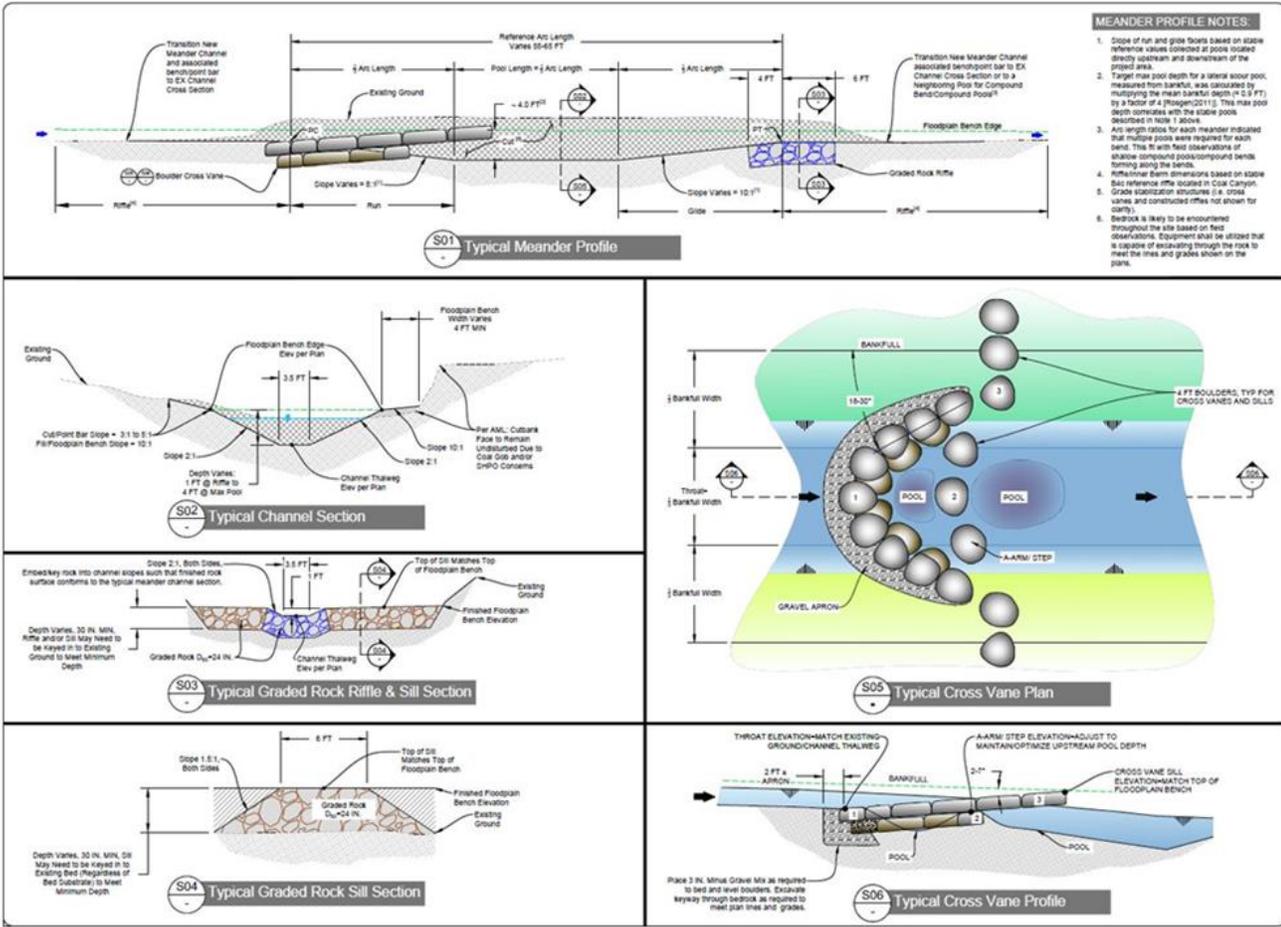
DRAWING: Stream Stabilization
 Meander & Structure
 Sections & Details

Channel Structure details in Engineering Design

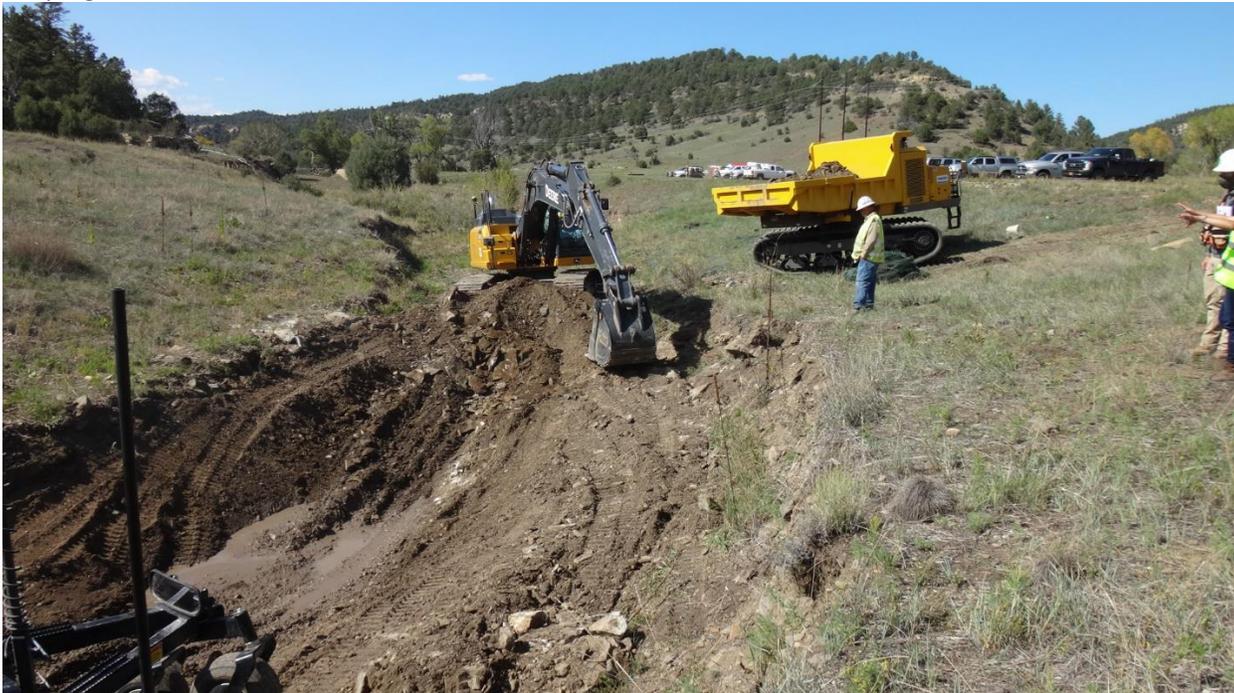
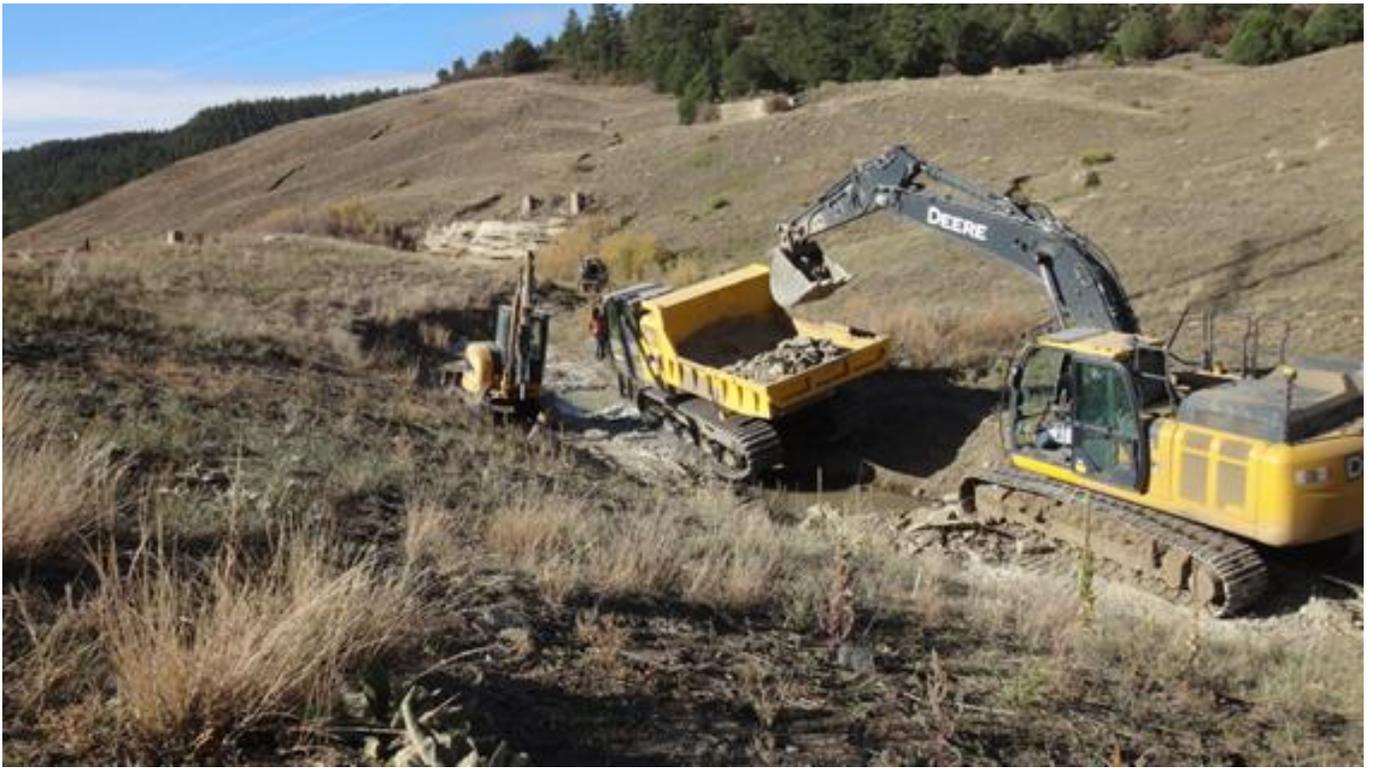
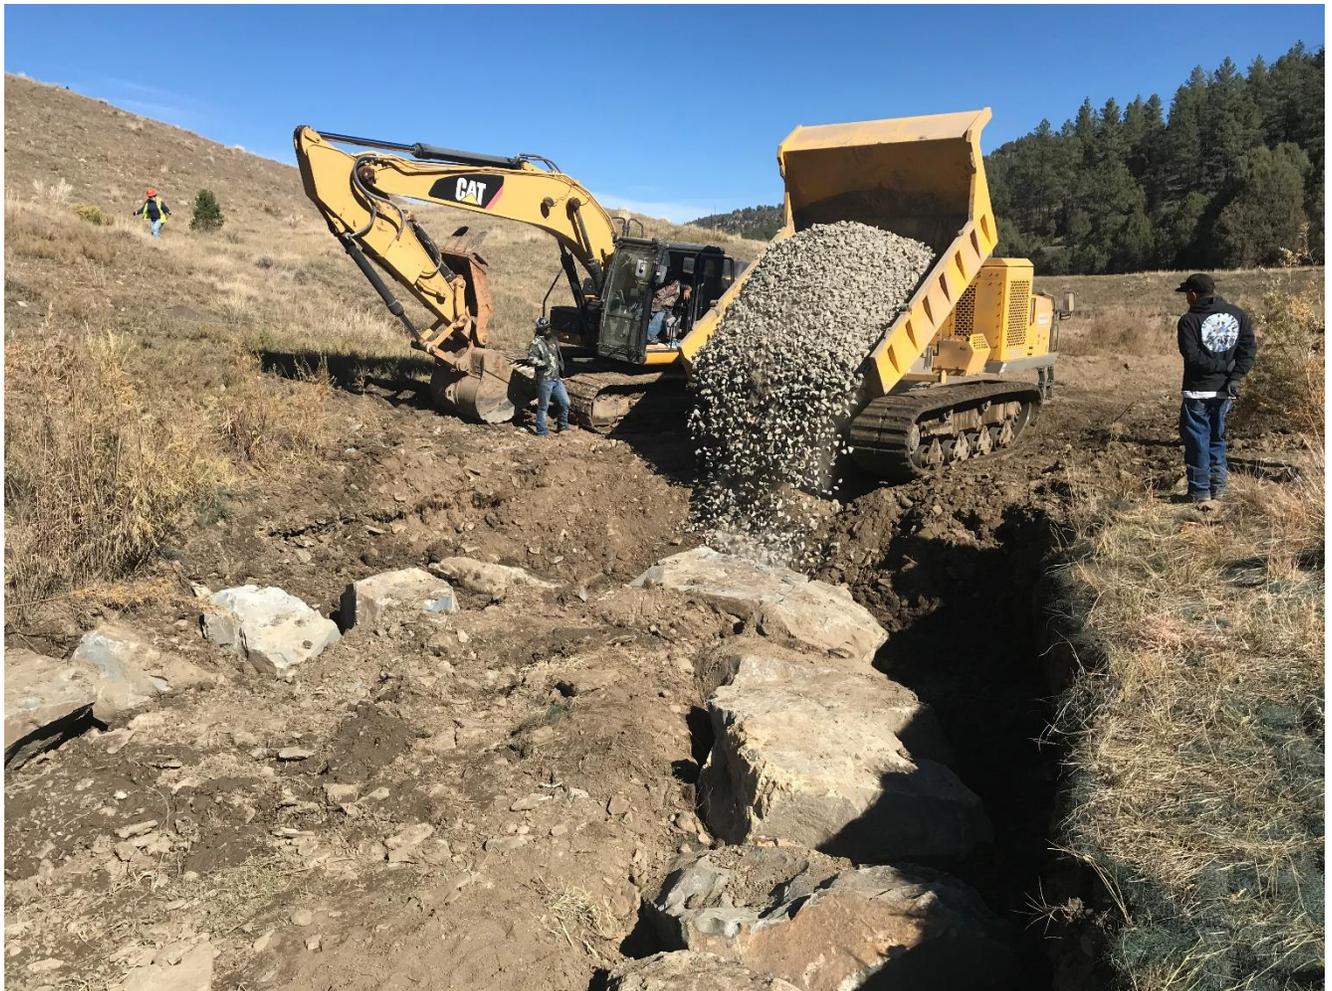
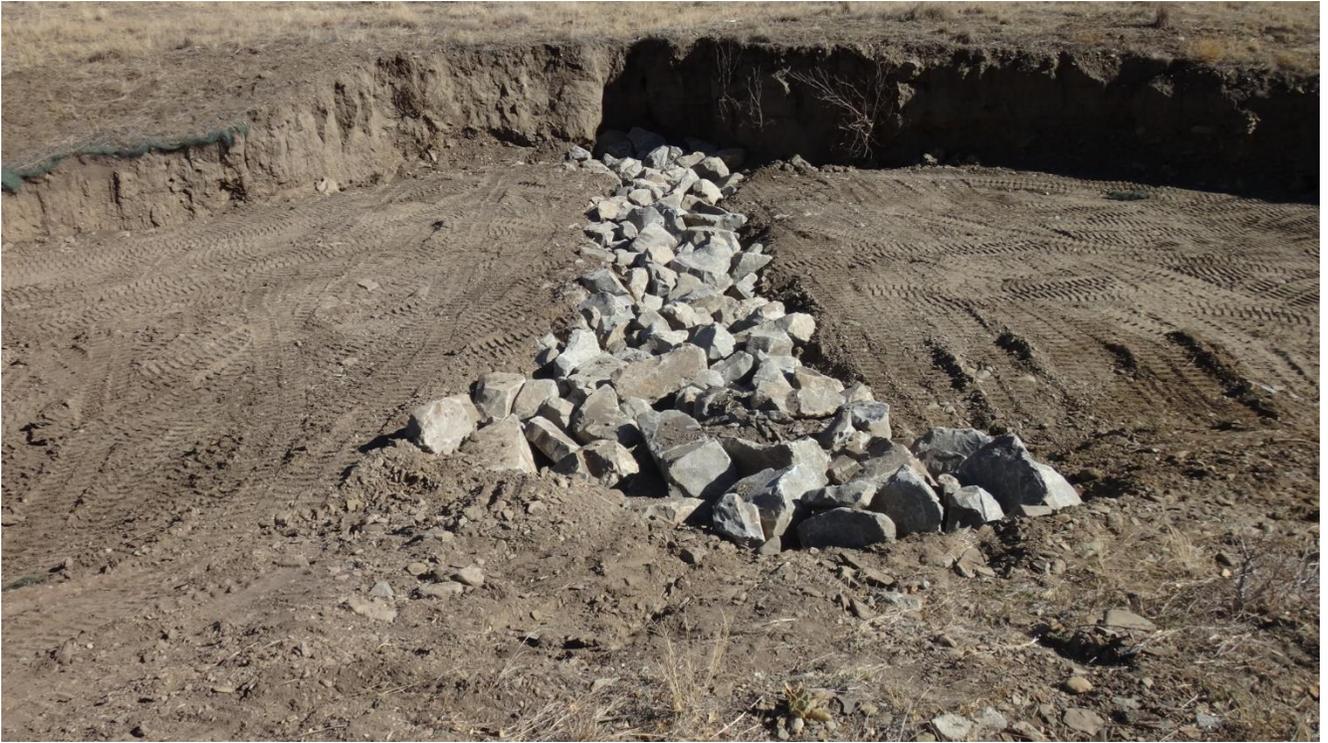
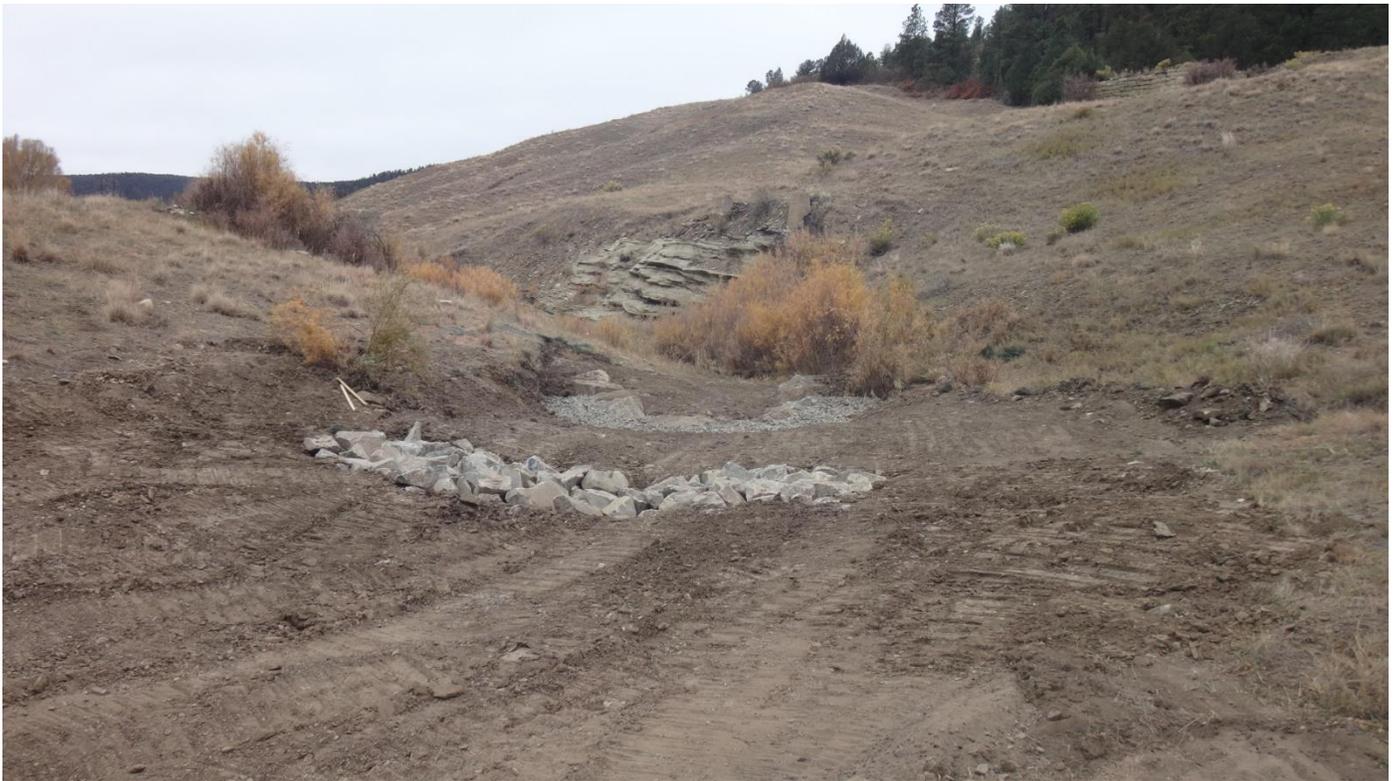
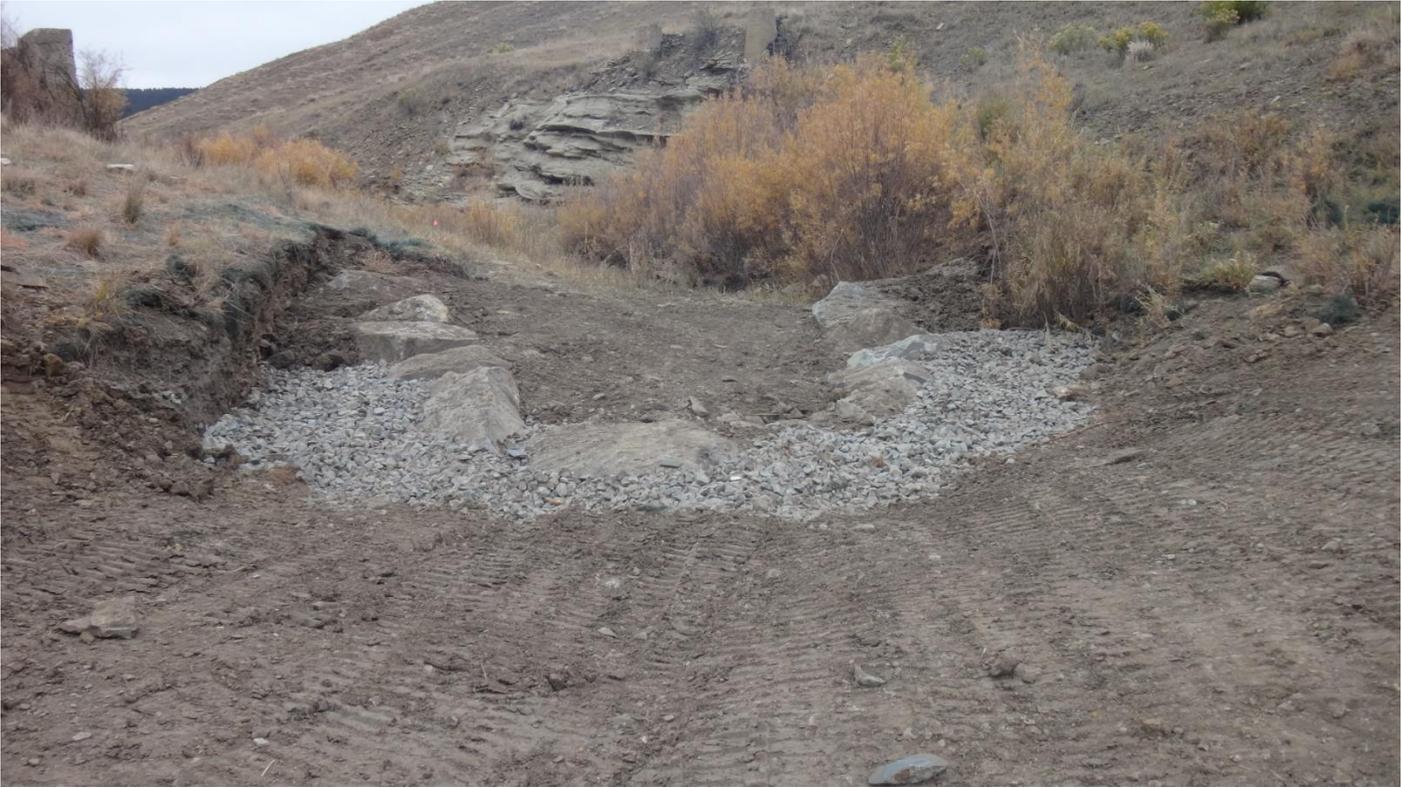
Shaping channel for rock structures

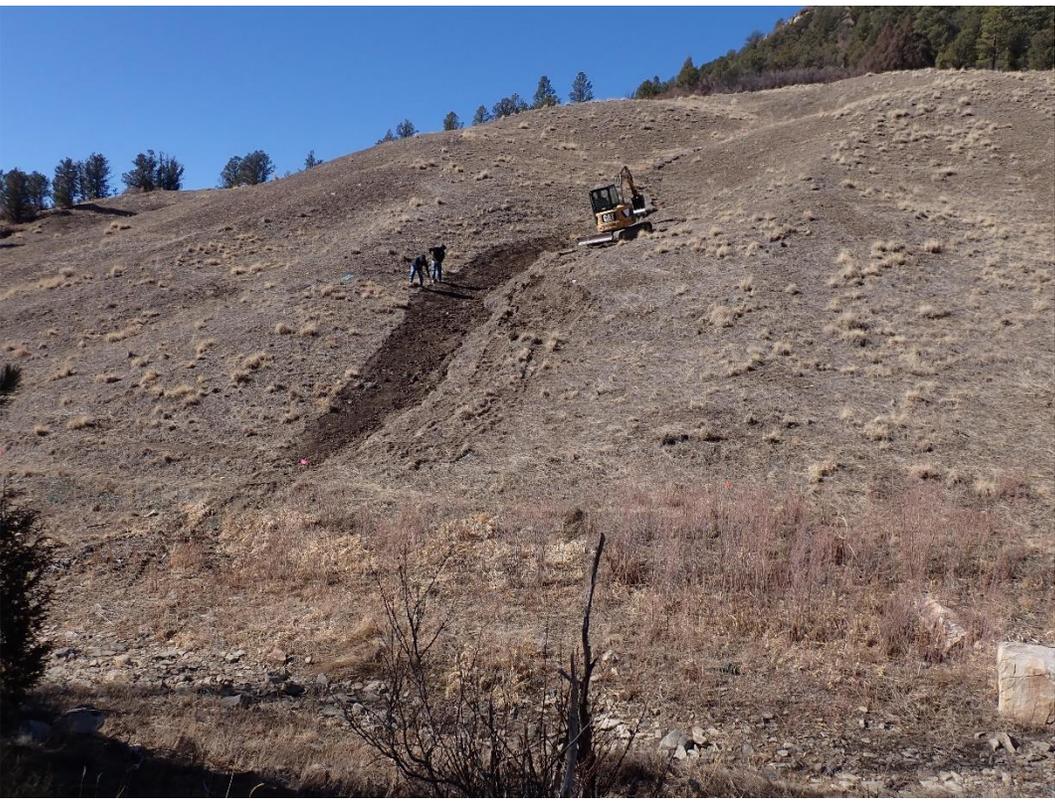
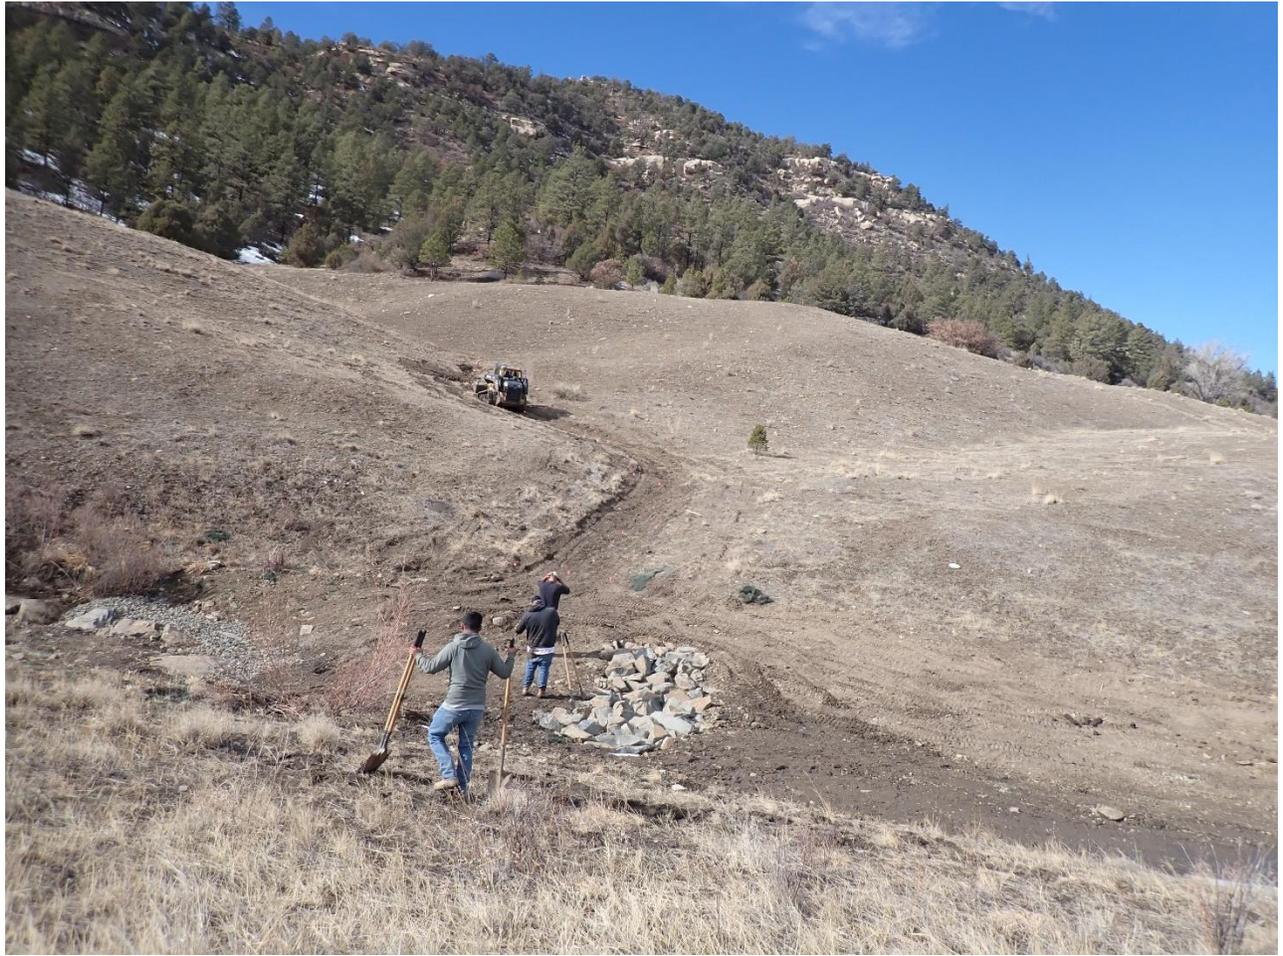
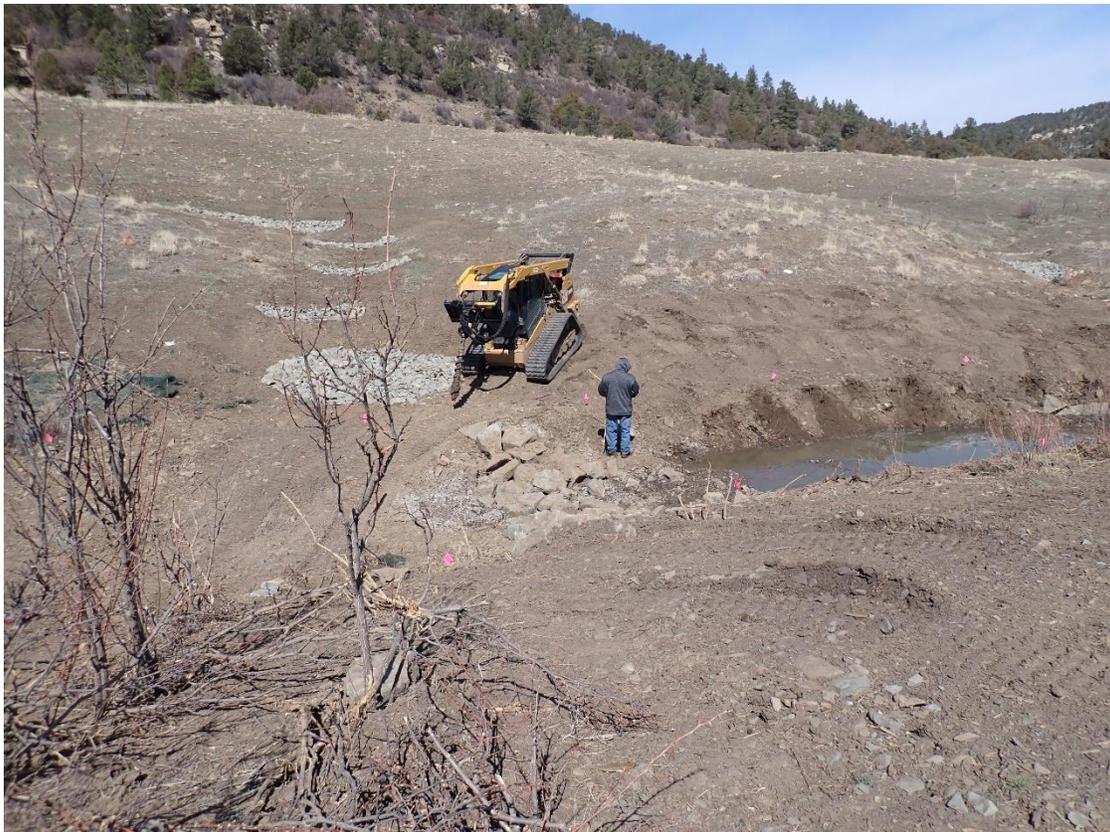
DRAWING: Upland Stabilization: Sections & Details

Upland rock structures to cure gullying and rilling

A low profile control structure built with a single layer of rock on the bed of the stream. It is designed to slow the flow of water, allowing sediment to settle and vegetation to grow. This structure is used to stabilize stream banks and prevent erosion.

A flow control structure where the floor of the channel has been laid back to a desired level of erosion resistance at 2:1 slope, and then covered with a single layer of rock mulch. The mulch serves to slow runoff, promote soil moisture, retard vegetation, and ultimately prevent the headcut from regressing further up slope. Rock Mulch Rundowns are used to stabilize stream banks and prevent erosion.

A headcut control structure composed of rock rip-rap slabs and slung posts that provide headcut. These structures are designed to stabilize stream banks and prevent erosion.

There are two types of Media Luna structures - both used to manage sheet flow and prevent erosion. Sheet flow collector (Type 2019) prevent erosion by collecting the head of rills and gullies by creating a stable transition from sheet flow to discrete flow in the collection point. Sheet flow spreader (Type 101) prevent erosion by spreading sheet flow over a larger area, reducing the head of rills and gullies.

Adjust Channel Depth to Balance Cut and Fill and Provide Sufficient Cover Where Gob is Exposed. Equipment shall Operate Only Within the Delineated Disturbance Corridor without Deviation to Minimize Disturbance to Existing Vegetation. Extent of Disturbance shall be Staked to Provide Clarity to the Contractor (Typical Both Sides). All Low Impact Structures Constructed of D50-10 IN. Rock Rip-Rap, 10 IN. Thick (TYP).

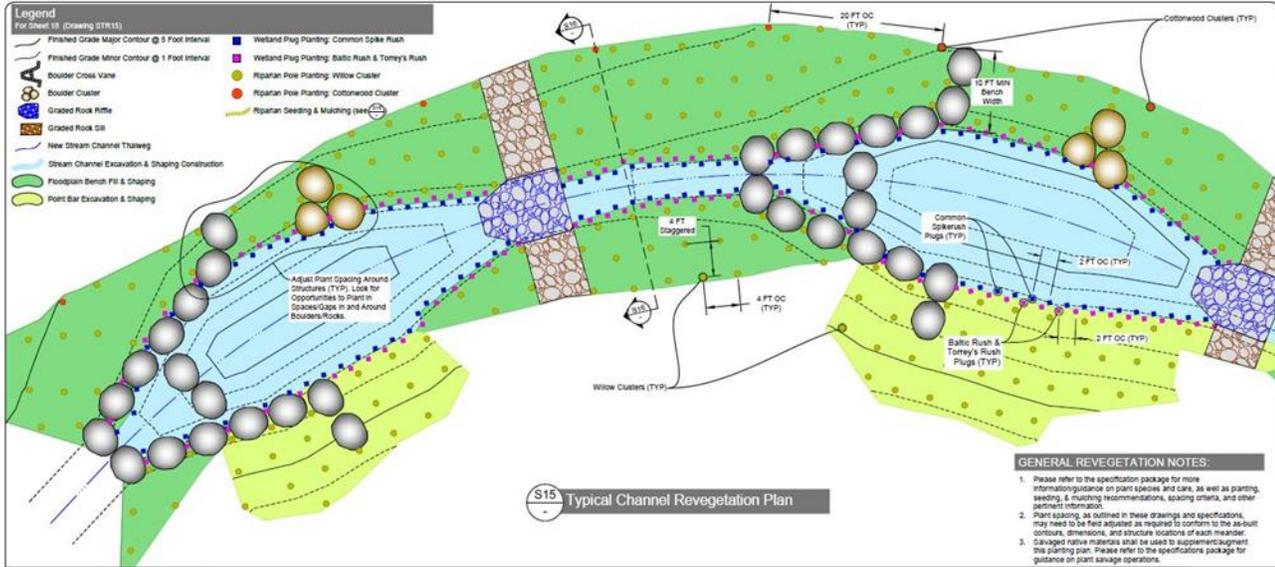
S15 Typical Channel Revegetation Plan

Revegetation Plan
