Swastika Mine and Dutchman Canyon Maintenance and Stream Restoration Project

Raton, New Mexico

SUMMARY OF THE SWASTIKA MINE AND DUTCHMAN CANYON MAINTENANCE AND STREAM RESTORATION PROJECT AND PROBLEM DESCRIPTION:

B. Project Description

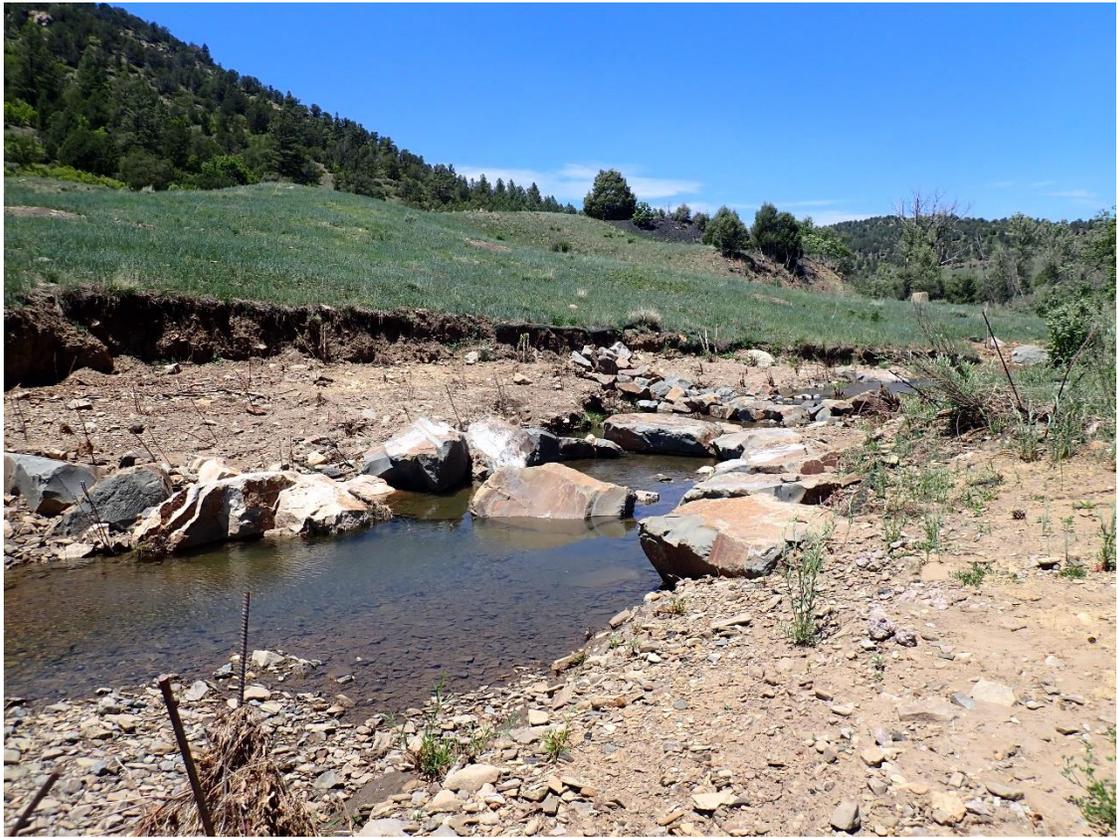
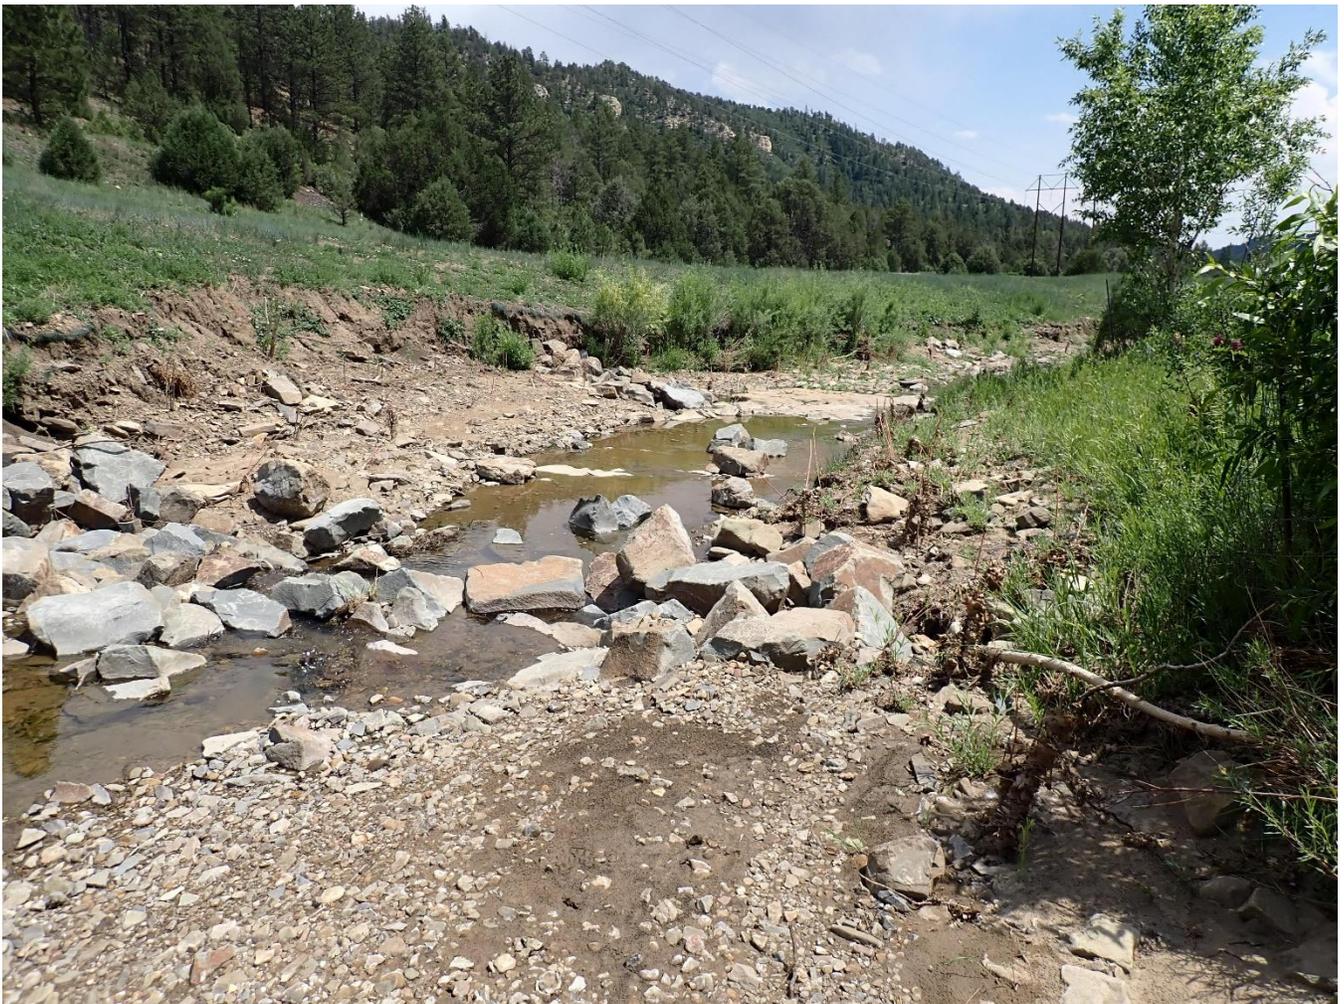
Channel after a season of good precipitation
