REQUEST FOR REVISION 26-01

CR Minerals Company New Mexico LLC

Permit No. RA004RE

May 2026

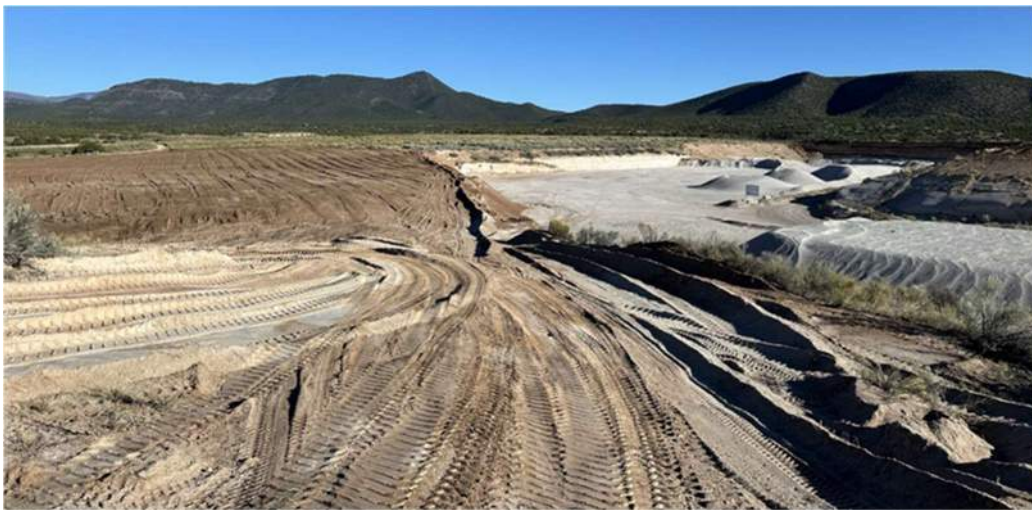
Final graded surfaces generally have slopes of less than 5H:1V. There are no perennial, intermittent, or ephemeral drainages downgradient of the reclaimed areas, and the reclaimed surfaces do not drain directly into any defined channel or erosion feature. Drainage occurs as sheet flow across stable surfaces.

Earthwork and seeding activities were completed using standard mine equipment and in accordance with the approved reclamation and Close-Out Plan (Figures 2 and 3).

Figure 3. Photo of grading area, seeded after final stabilization

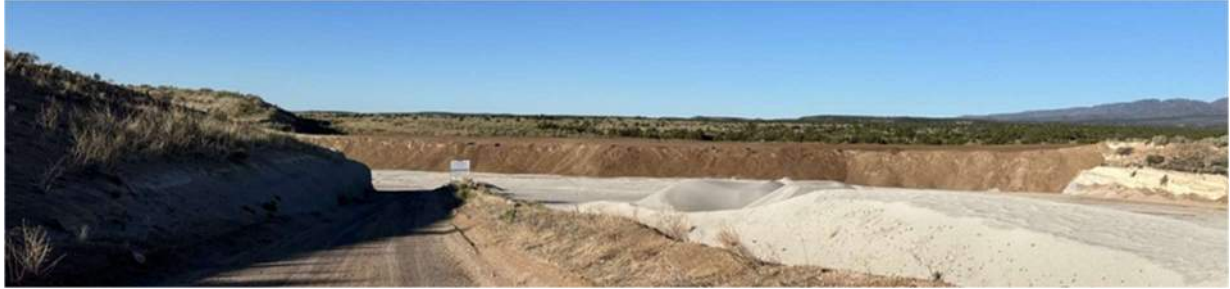
Figure 4. Photo of grading area, seeded after final stabilization

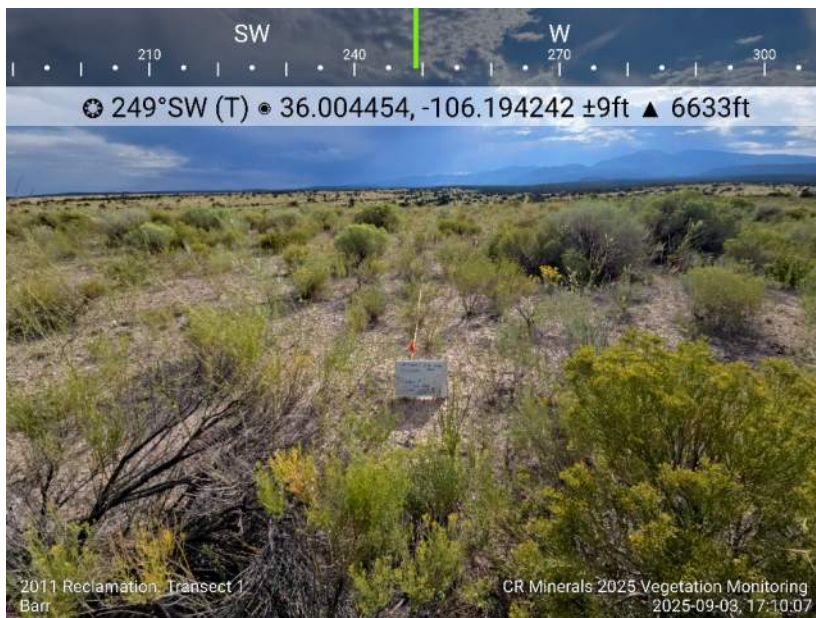
The 2011 Reclamation Unit showed continued progress in 2025, with perennial vegetation cover averaging 36%. This represents a modest improvement over the 28.4% cover observed in 2022, indicating a positive trend in plant establishment. Shrub density was strong at 7,457 shrubs per acre, surpassing the 75% reference threshold and demonstrating successful shrub recruitment and survival. However, total dry weight production remained low at 881 grams (49.8 kg/ha). While the unit meets shrub density standards and shows incremental gains in cover, the limited biomass production suggests that perennial grass and forb establishment is still lagging. Compared to 2022, the unit is on a stable or slightly improving trajectory, but further efforts may be needed to boost herbaceous productivity and overall ecological function.

Transect	2011 Reclamation
1	36%
2	56%
3	60%
4	32%
5	28%
6	24%
7	20%
8	36%
9	36%
10	28%
Mean	36%

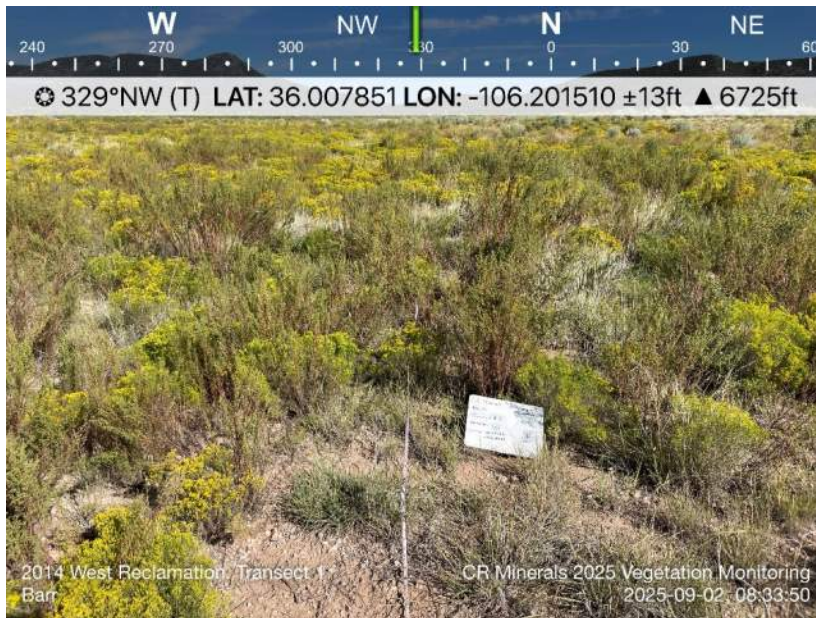
In 2025, the 2014 West Reclamation Unit demonstrated strong performance in both vegetation cover and shrub density. Perennial cover averaged 54% and shrub density soared to 17,389 shrubs per acre—a dramatic increase from the previous count of 819 shrubs per acre. Despite these gains, total dry weight production remained relatively low at 781 grams (85.4 kg/ha), similar to the 2022 result. The unit clearly meets or exceeds the 75% reference threshold for both cover and shrub density, but the persistent gap in biomass production suggests that perennial herbaceous growth is still limited. Overall, the 2014 West unit is highly successful in terms of structural vegetation metrics, but continued monitoring of species composition and productivity is warranted.

Transect	2014 W Reclamation
1	88%
2	56%
3	68%
4	32%
5	24%
Mean	54%

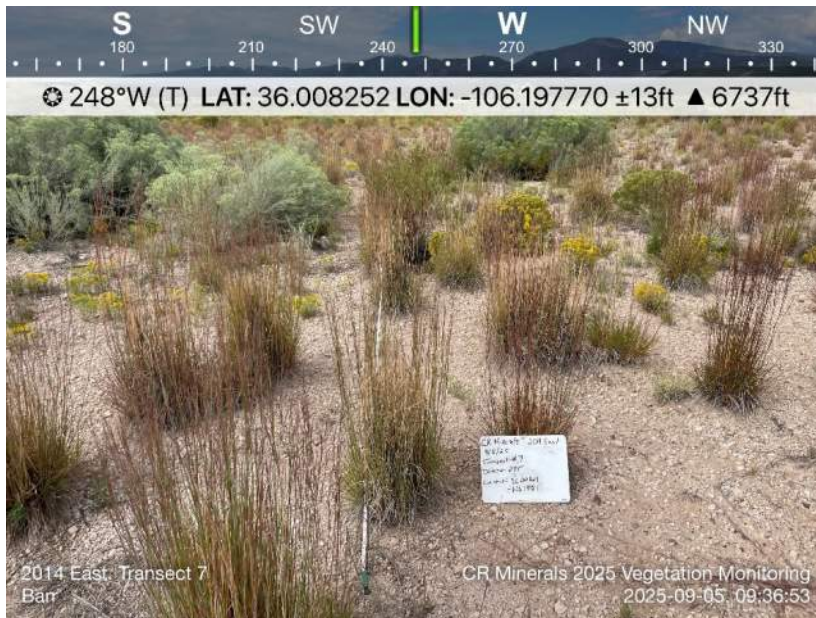
The 2014 East Reclamation Unit continued its gradual performance in 2025. Vegetation cover averaged 41%, an improvement over the 27.6% observed in 2022. Shrub density reached 6,429 shrubs per acre, meeting the 75% reference threshold and more than doubling the 2022 value of 2,596 shrubs per acre. Total dry weight production also increased to 1,140 grams (60.3 kg/ha), though it remains below the reference standard. These results indicate that while perennial cover and biomass are still developing, shrub establishment has become robust. The positive trends since 2022 suggest that the unit is on a path toward greater ecological stability, but additional efforts to enhance perennial grass and forb cover may be beneficial for long-term success.

Transect	2014 E Reclamation Unit
1	28%
2	36%
3	36%
4	60%
5	52%
6	40%
7	52%
8	56%
9	20%
10	28%
Mean	41%

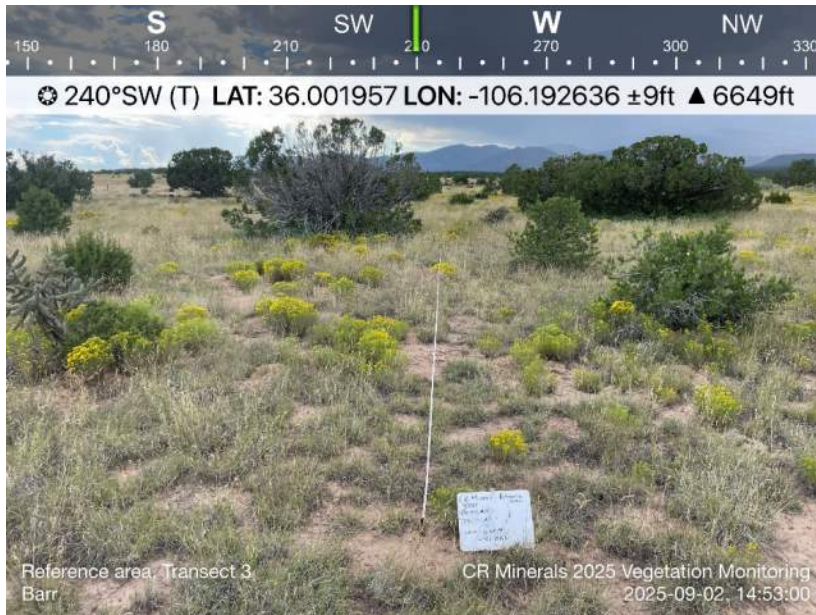
In 2025, the reference area at CR Minerals Rocky Mountain Mine continued to provide a benchmark for reclamation success. Vegetation cover averaged 64%, with shrub density at 8,520 shrubs per acre and total dry weight production reaching 2,869 grams (223 kg/ha). These values are consistent with the high standards set in previous years, although the 2022 study reported an even higher vegetation cover of 89%. It is important to note that the reference area may be situated in a slight depression, which likely allows it to capture and retain more surface water than the surrounding reclamation units. This hydrologic advantage could contribute to consistently higher vegetation cover, shrub density, and productivity observed in the reference area compared to the reclamation sites. As a result, the reclamation units may be facing an inherent challenge in reaching the same ecological benchmarks, despite ongoing improvements in vegetation establishment. Given these site differences, it may be worth reconsidering whether the current reference area provides a fully appropriate or attainable target for evaluating reclamation success at the Rocky Mountain Mine. A more nuanced or site-adjusted standard could offer a fairer assessment of reclamation progress under the actual landscape conditions.

Transect	Reference Area
1	60%
2	80%
3	64%
4	64%
5	56%
6	76%
7	64%
8	44%
9	64%
10	60%
Mean	64%

The reference area's location in a depression likely allows it to retain more moisture, supporting higher vegetation cover and productivity. This context suggests that while the reference area remains a valuable benchmark, a flexible approach that considers local site conditions may provide a fairer assessment of reclamation success.
