Sugarite Gob Reclamation Project

Raton, NM 1999 - 2002

- New Mexico Abandoned Mine Land Bureau
 - John A. Kretzmann, P.E., Project Engineer
 - Randall Armijo, Project Manager
- Construction Contractors
 - St. Cloud Mining Company, T or C, NM
 - C&R Forestry Inc., Albuquerque, NM

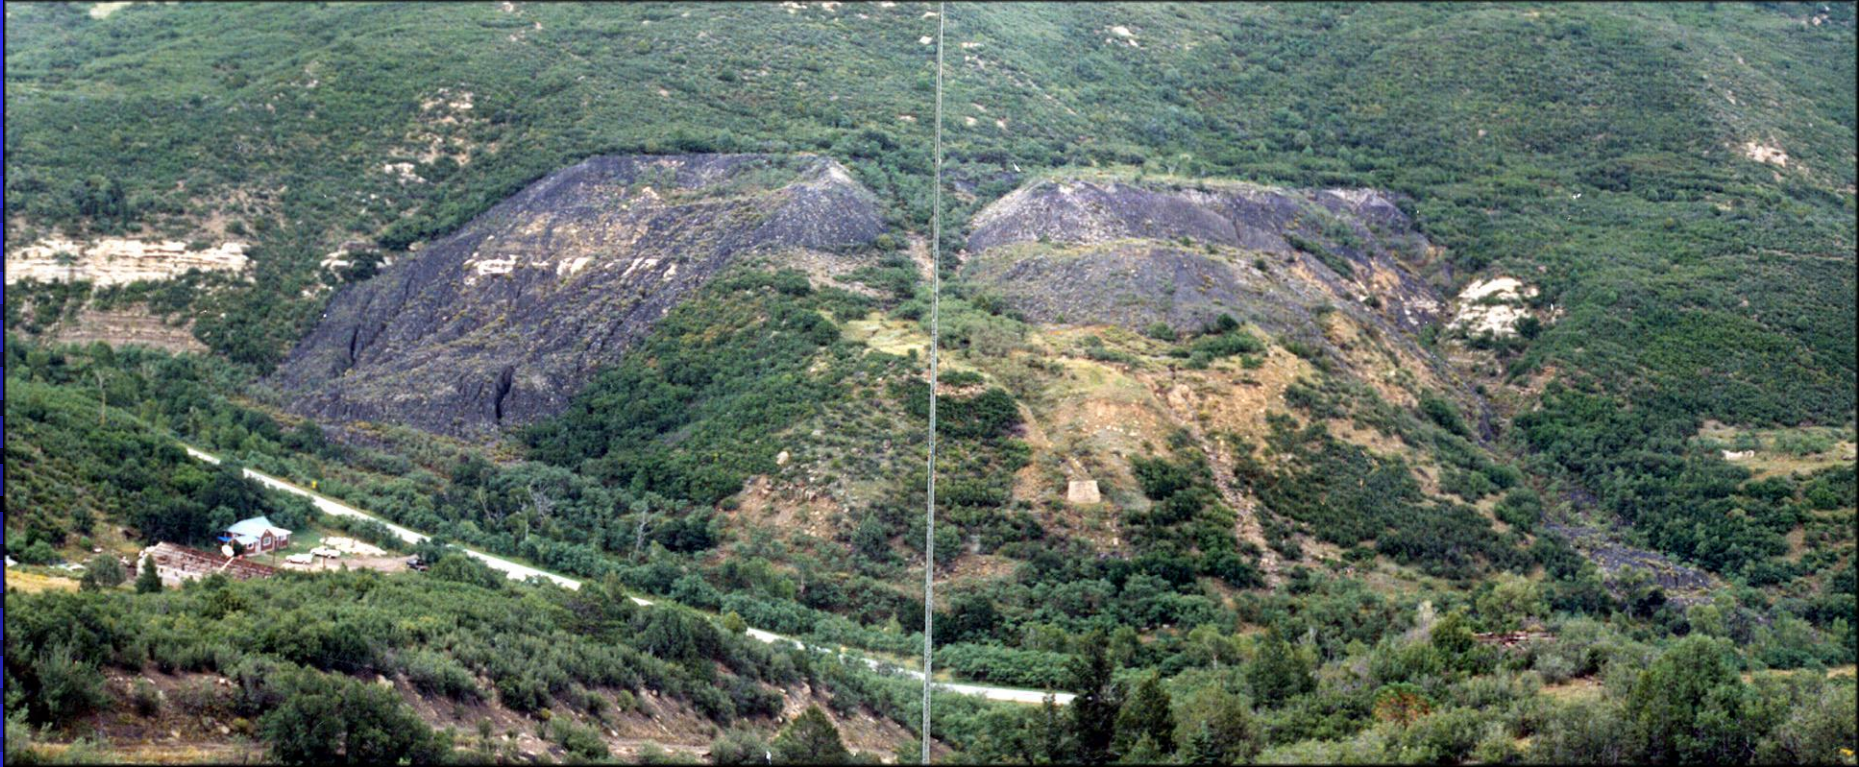
Gob Piles A2N & A2S
(prior to reclamation)

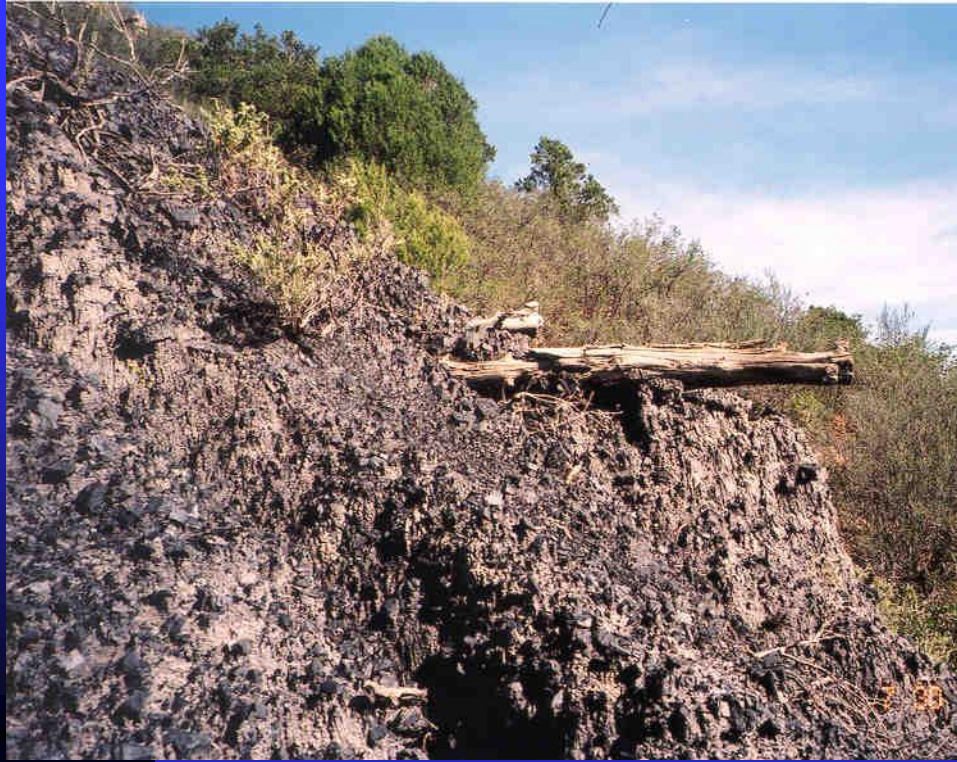
Typical gob
slope and gully

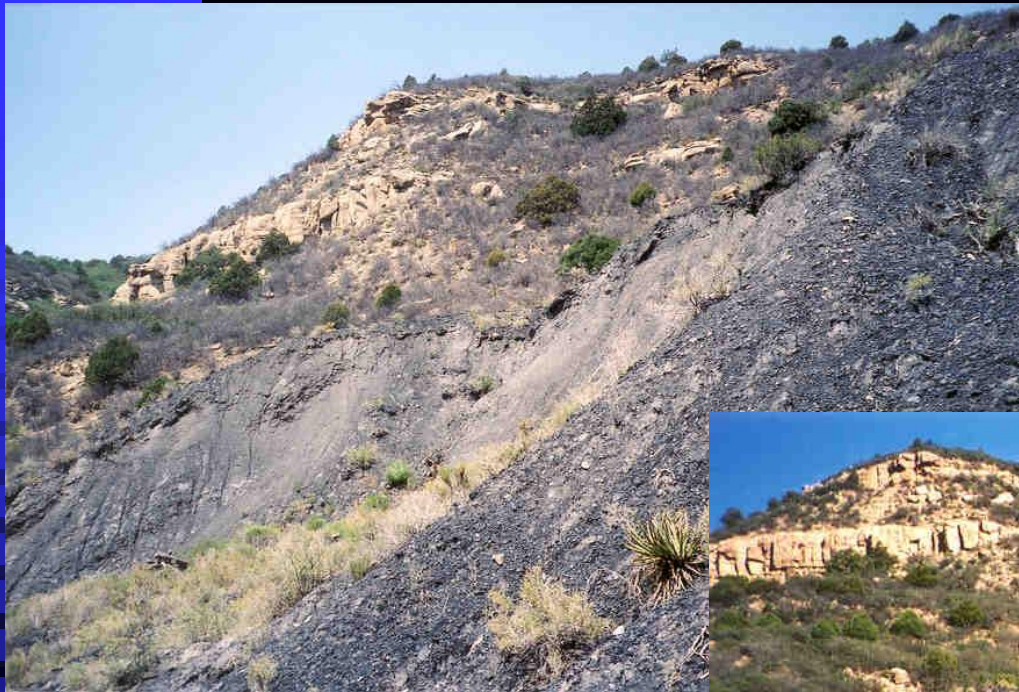
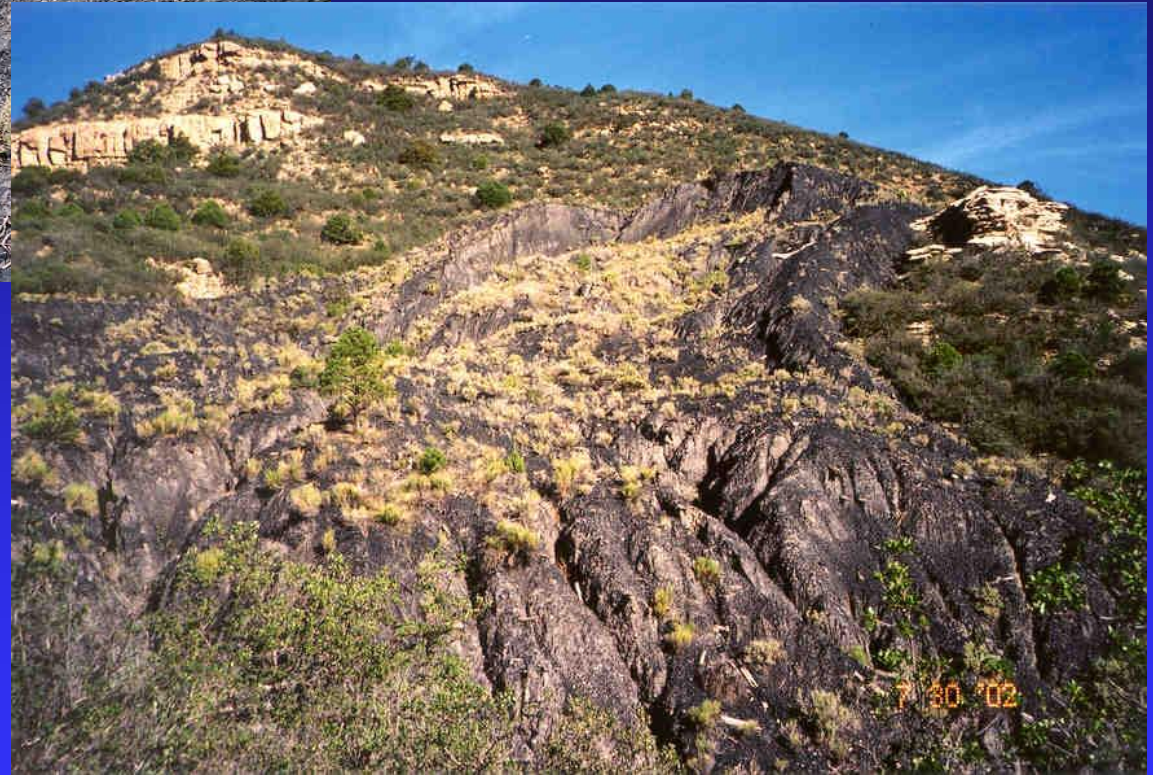
Landslide at Gob Pile A3

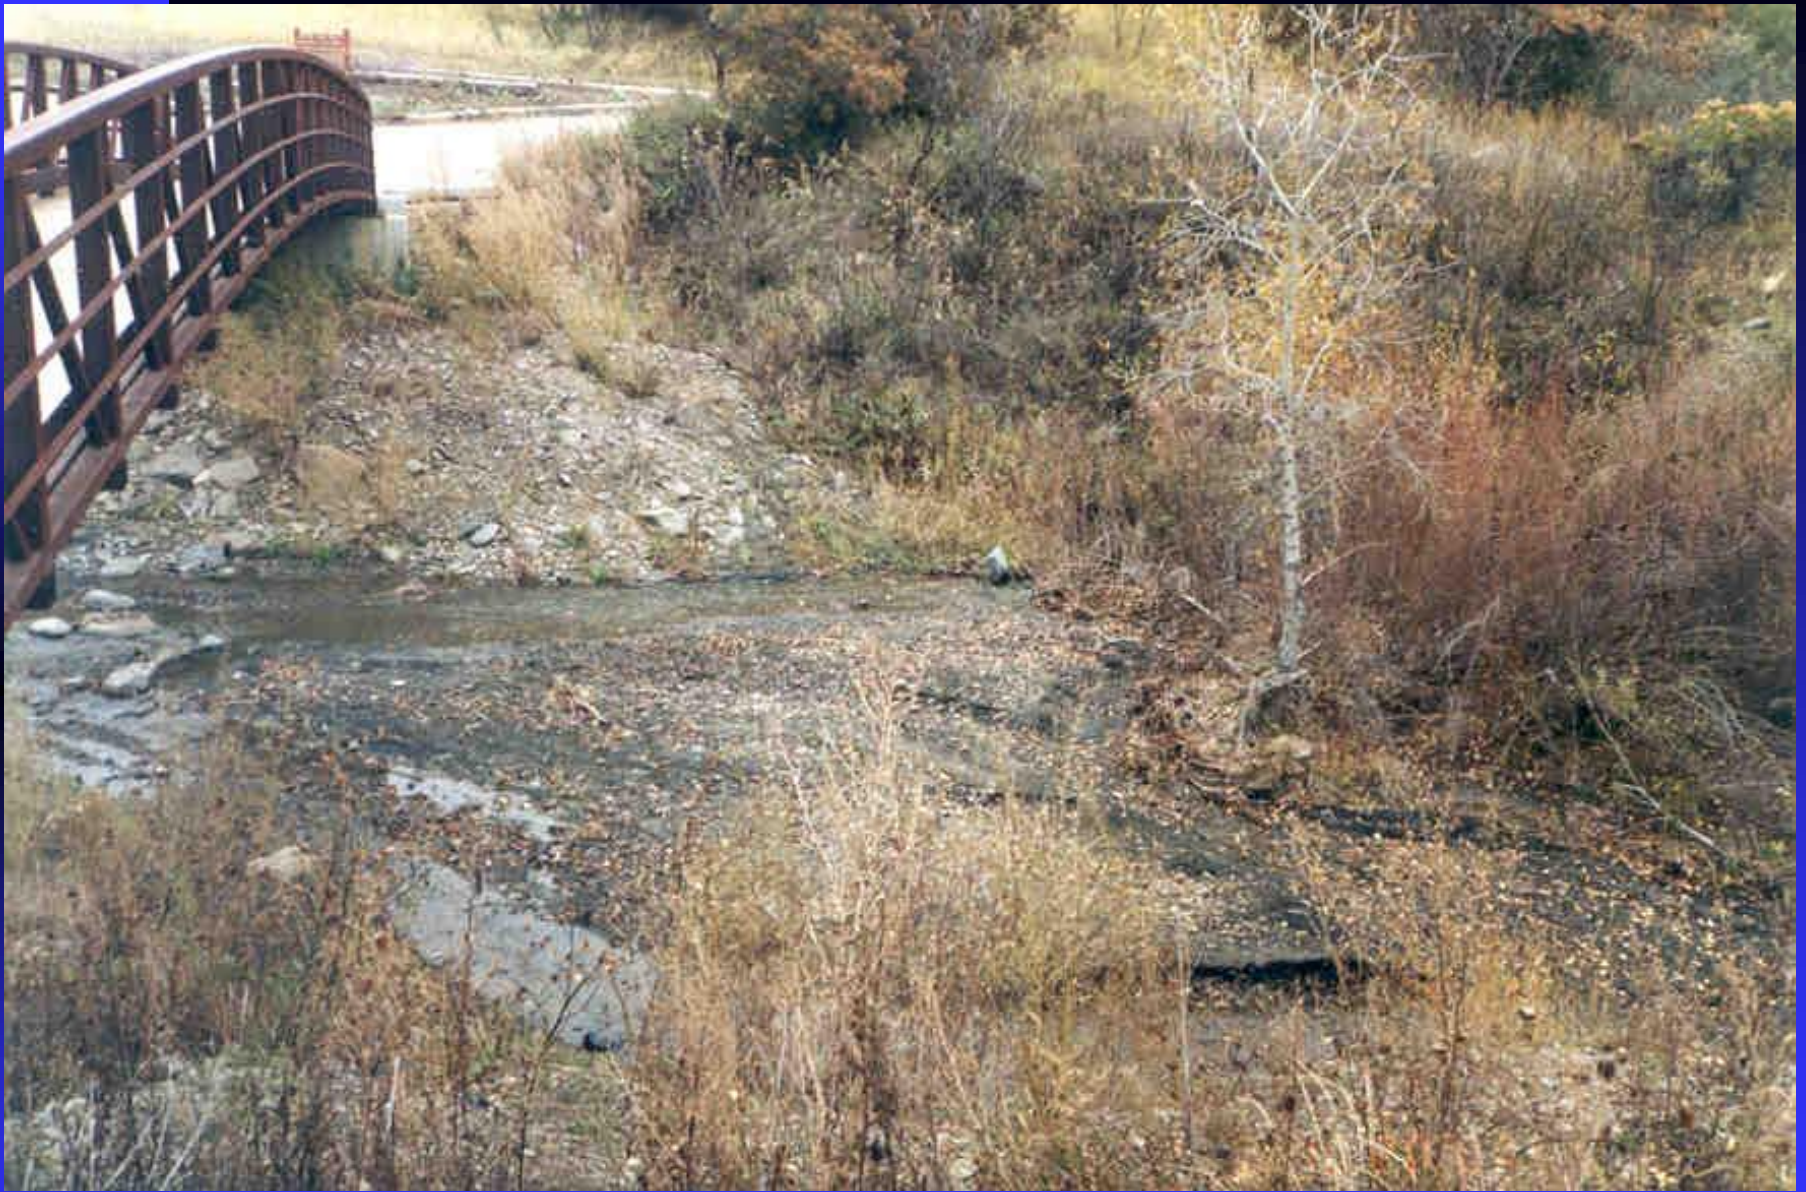
Gob material in creek

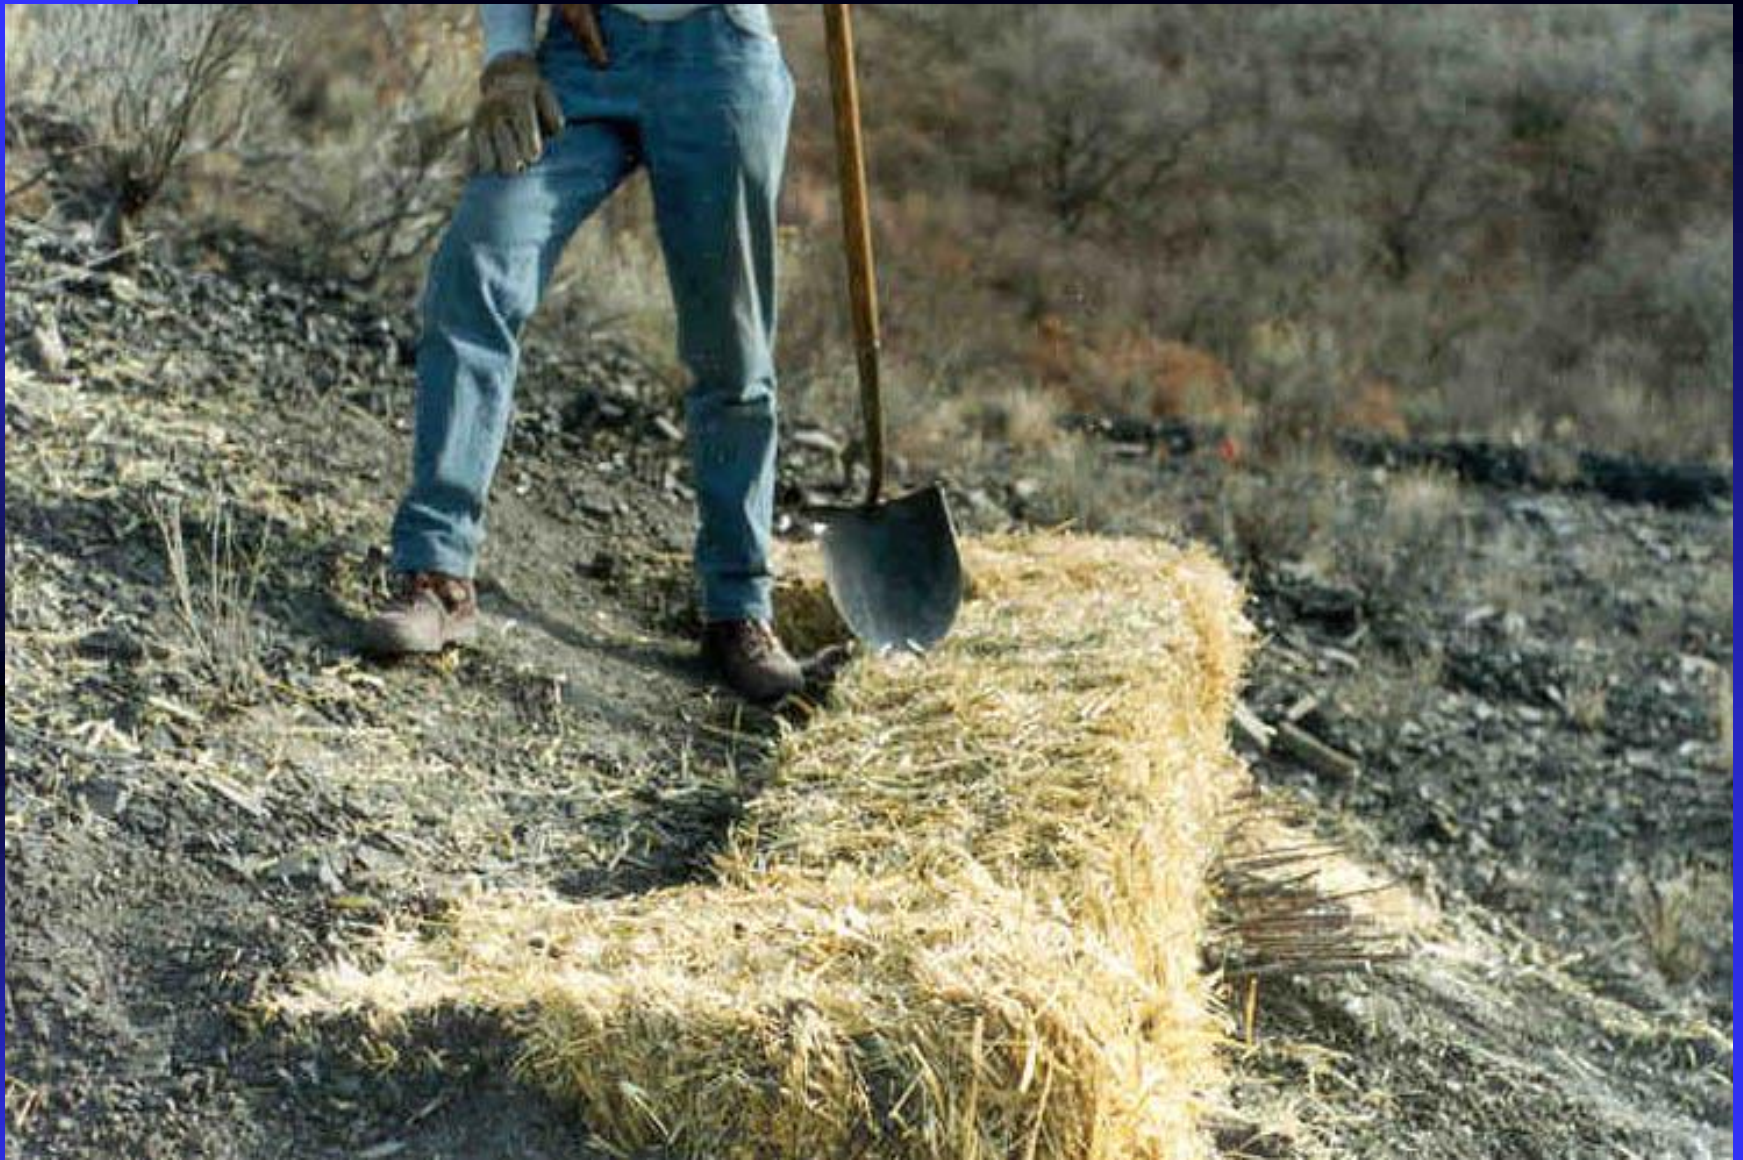
Straw bale terrace test installation

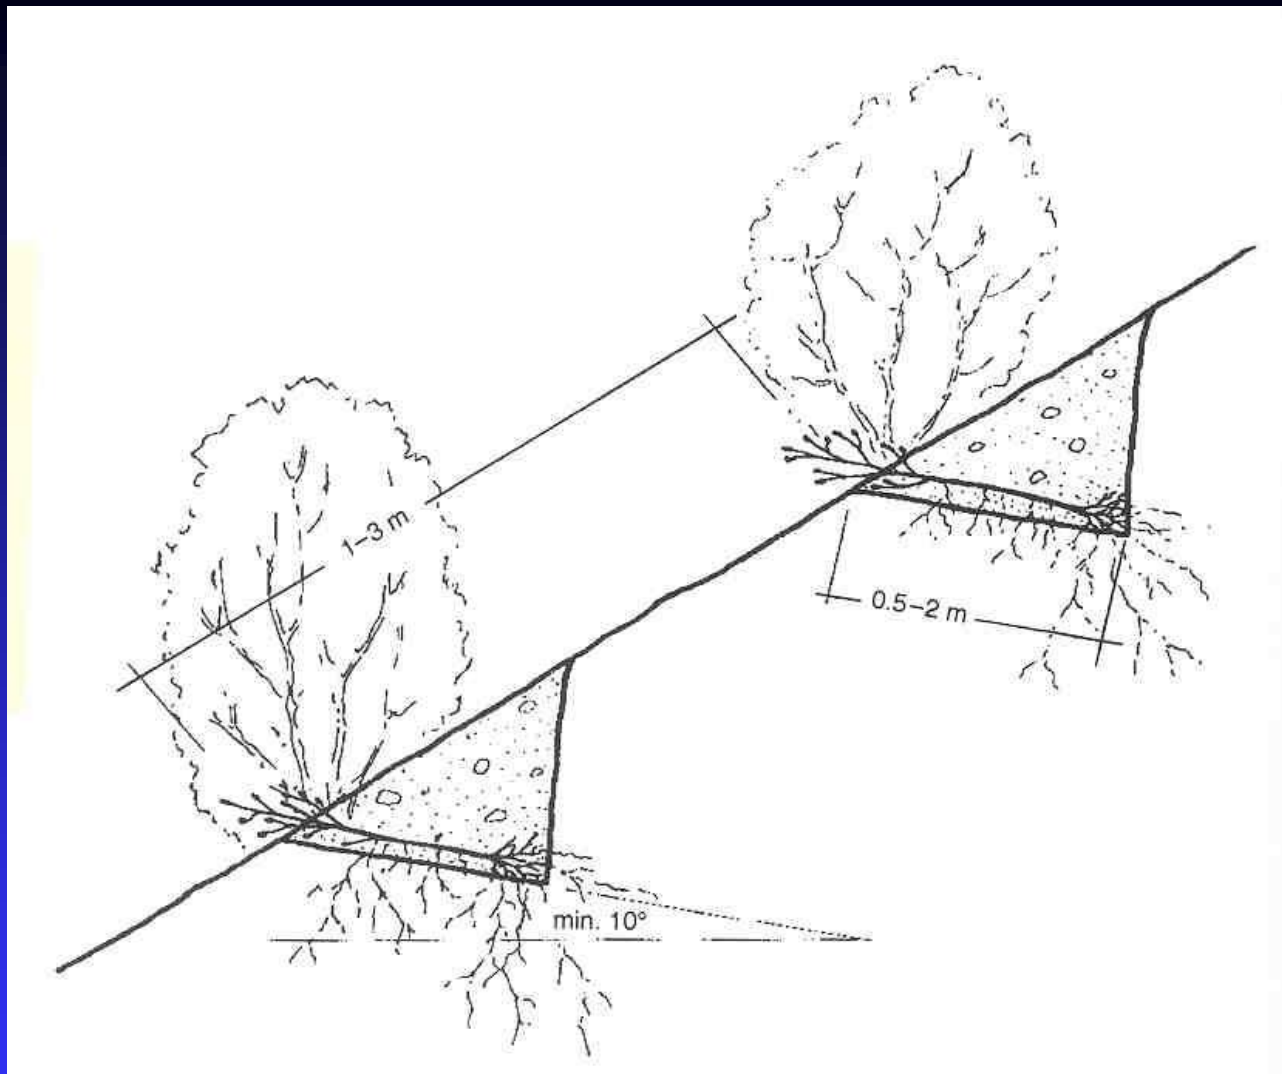
Hedge layer construction
(by Hugo Schiechl)

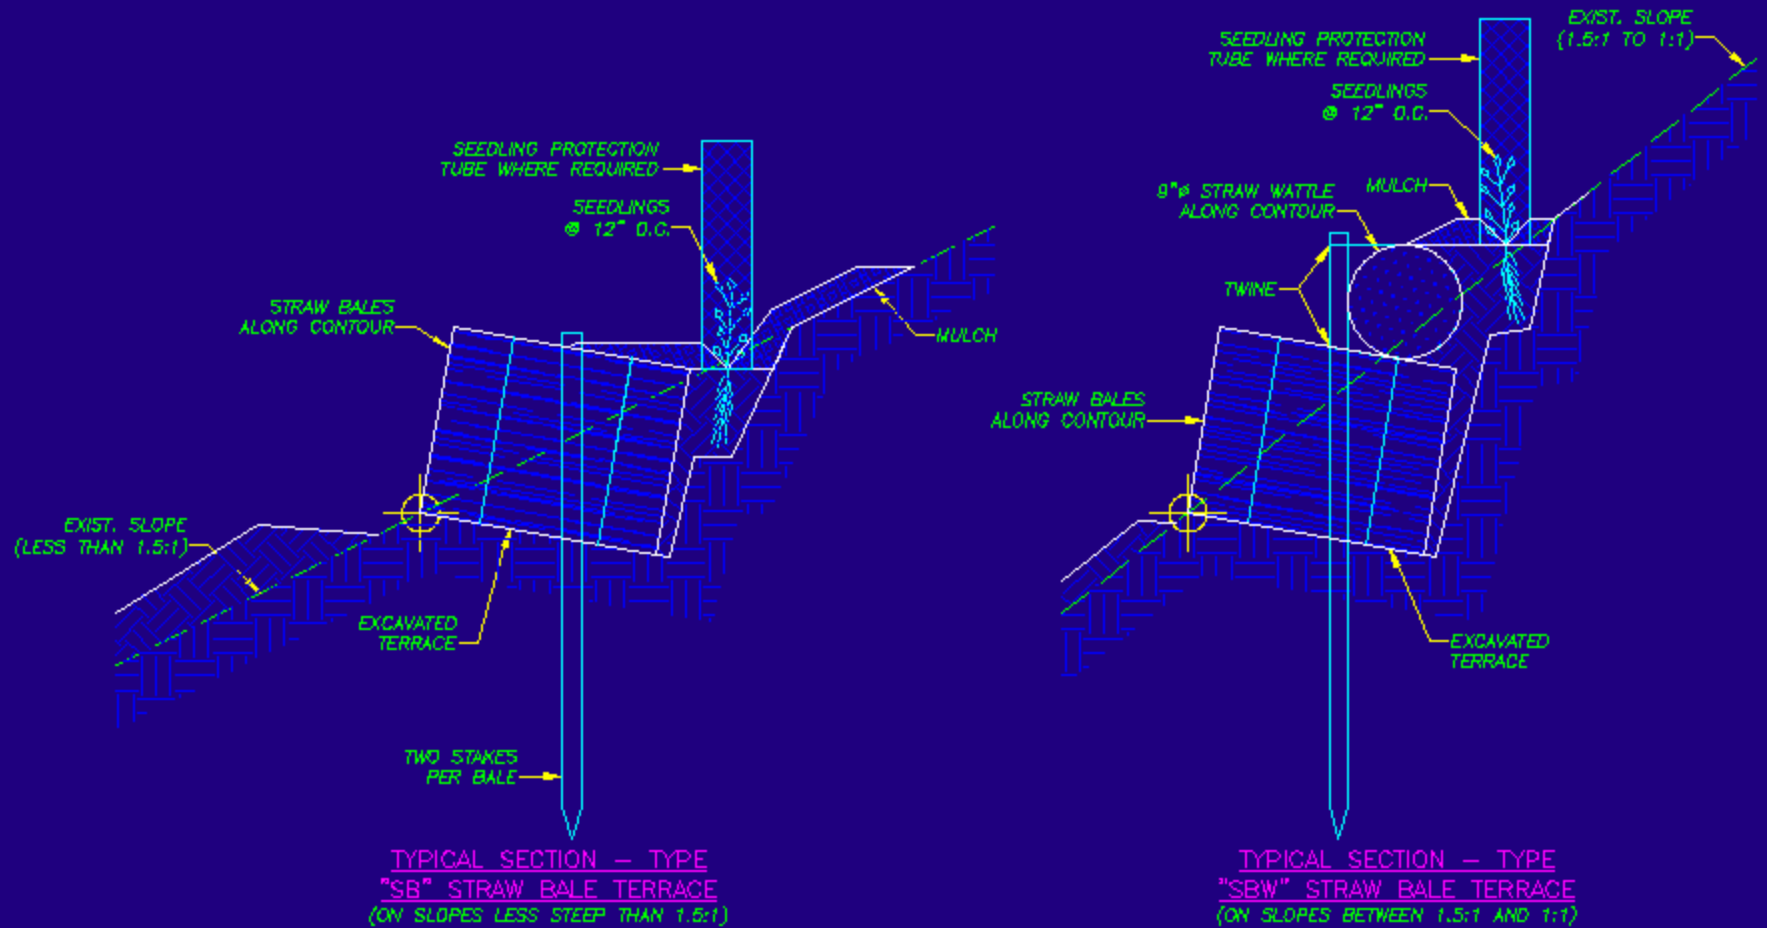
Straw bale terrace construction

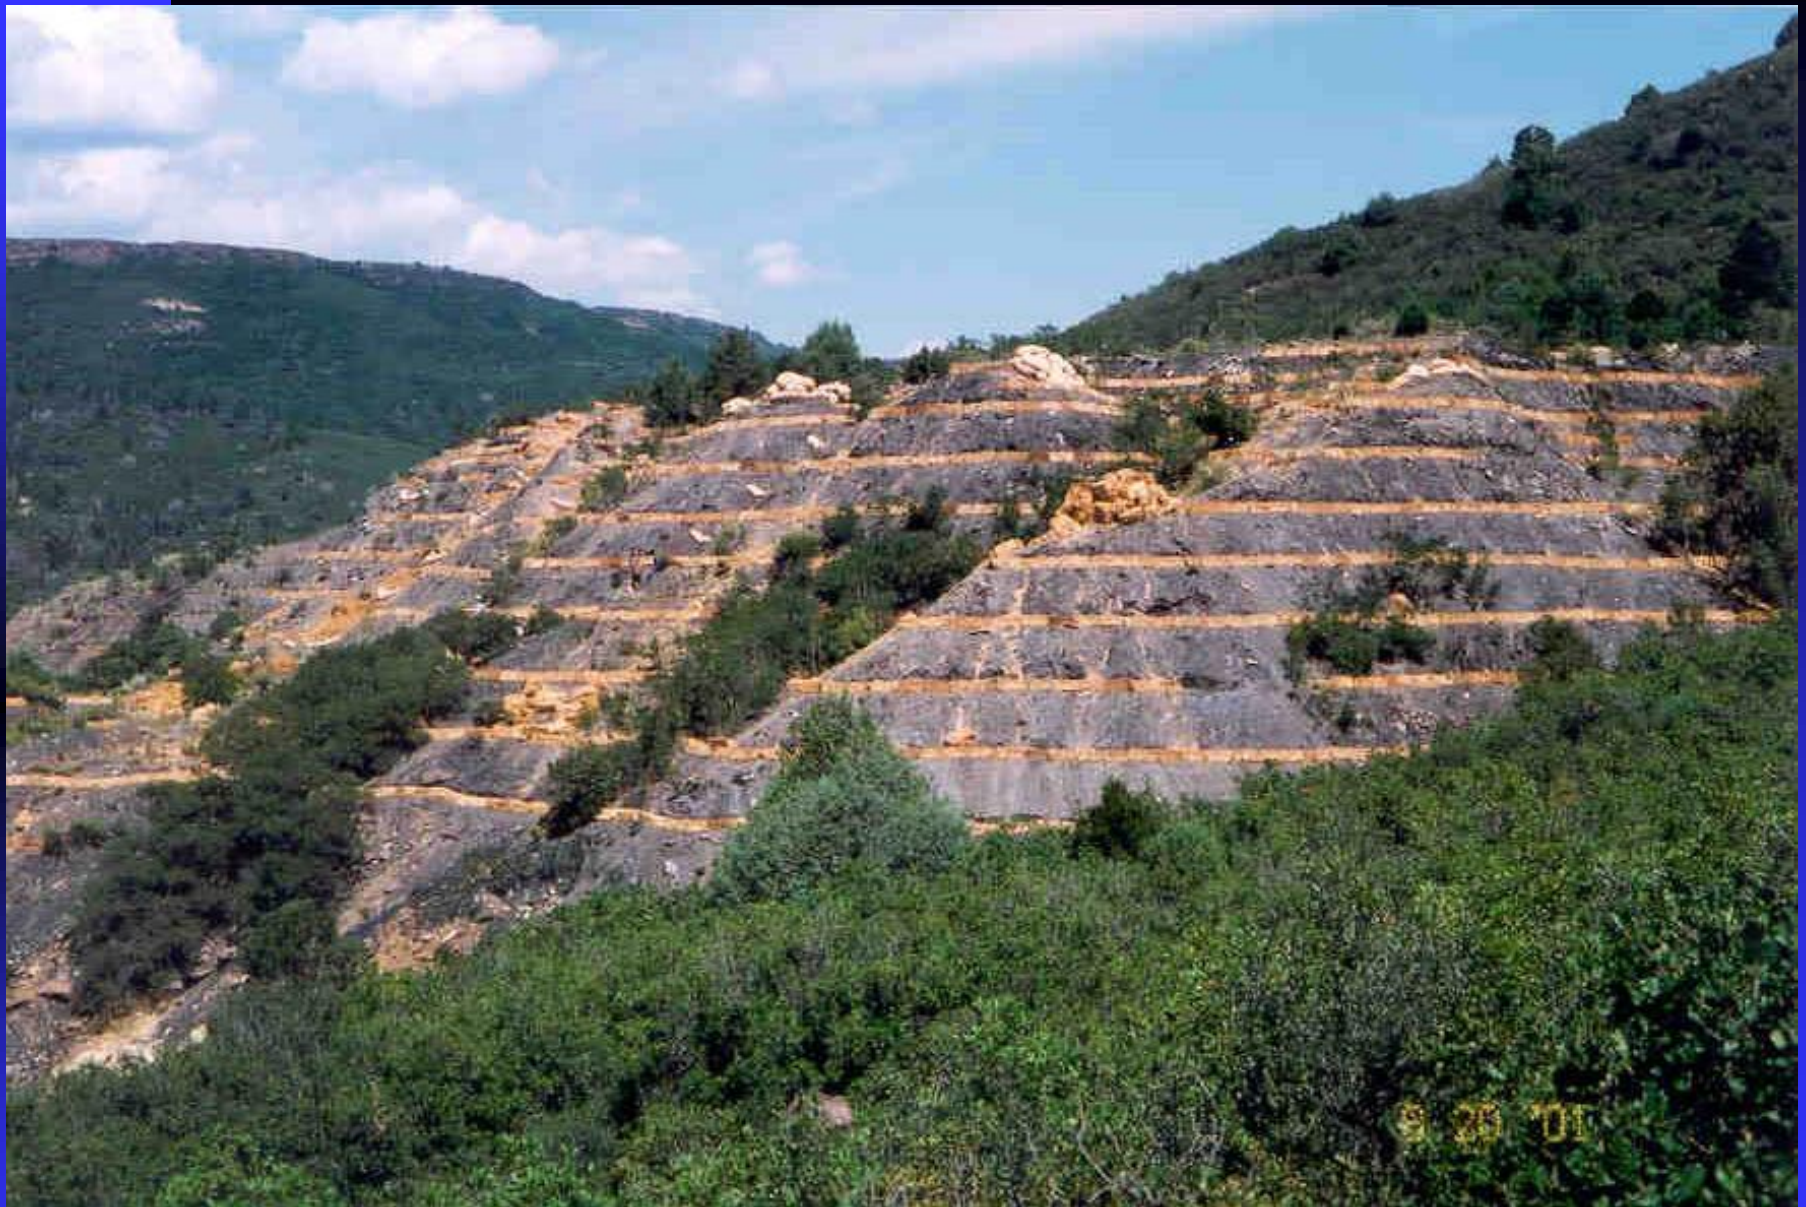
Straw bale terraces on Gob Pile A2S

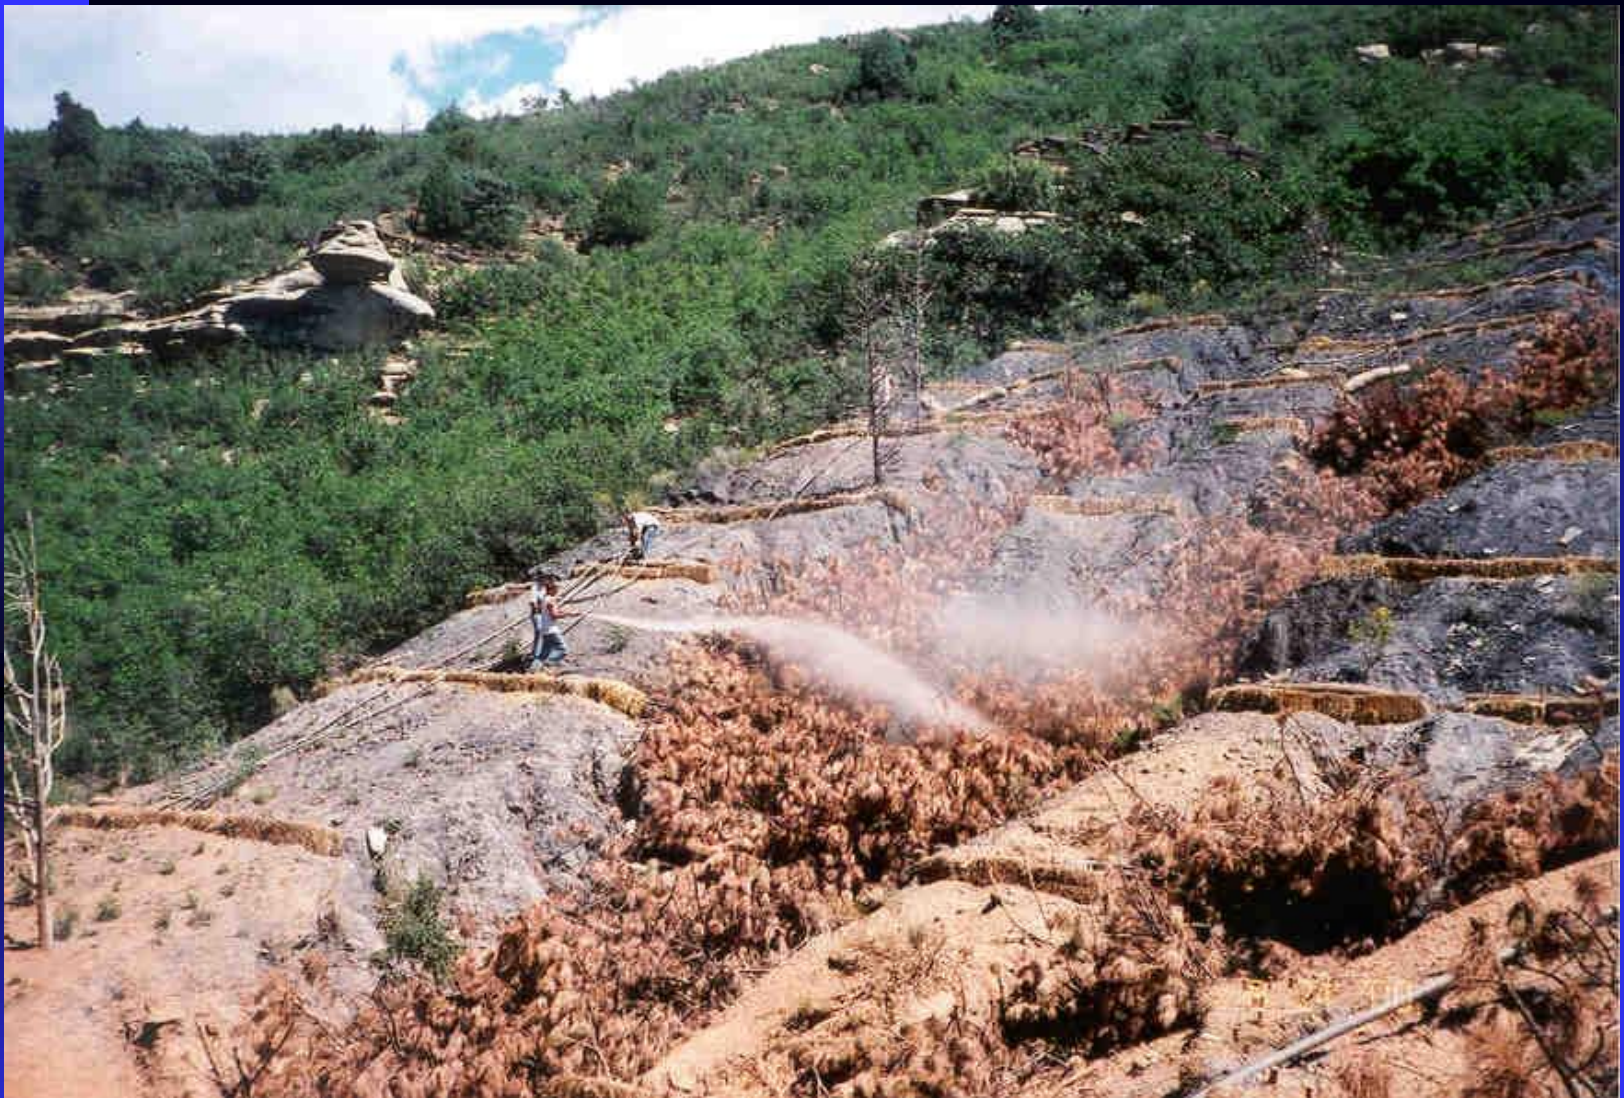
Hydroseeding with bonded
fiber matrix and gypsum

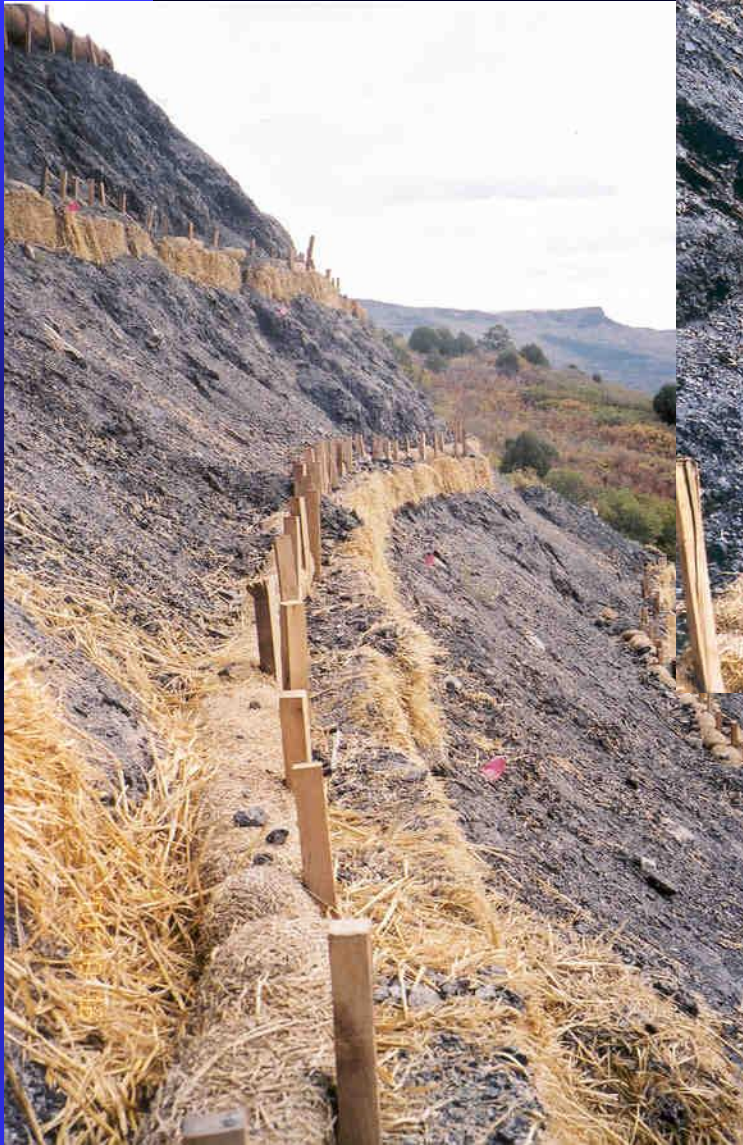
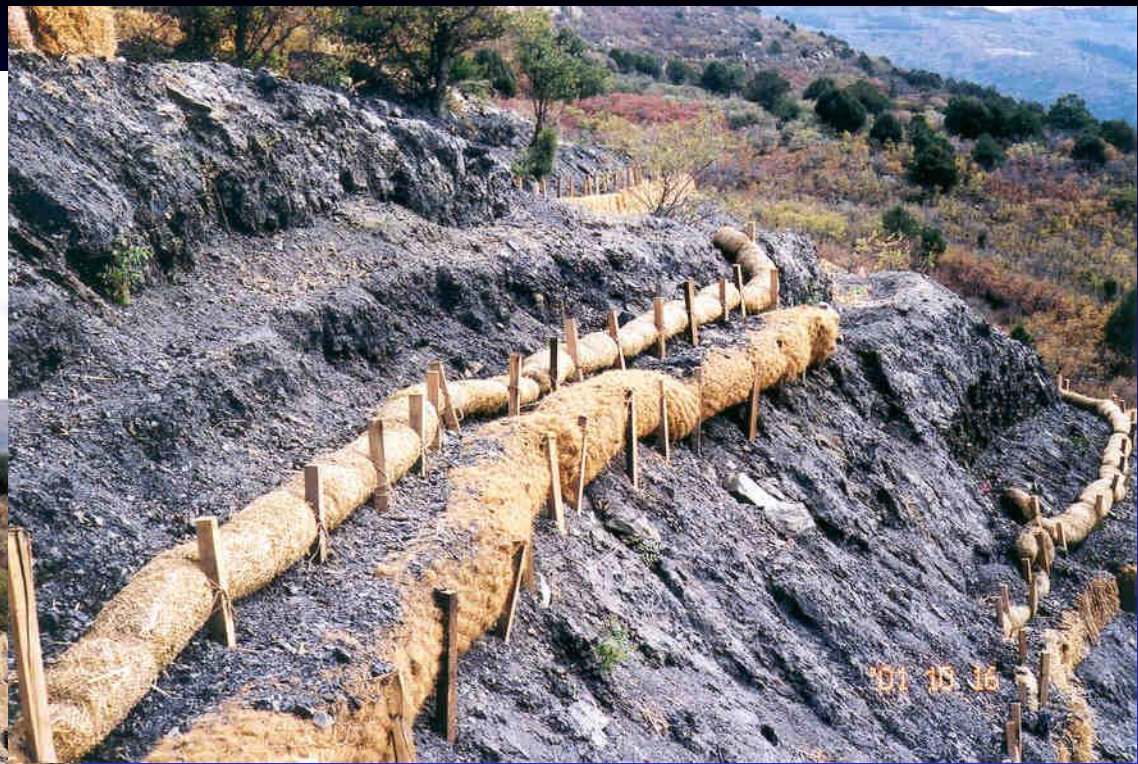
- Coir rolls on slopes between 1:1 and 0.75:1
- Straw bales with straw wattles on slopes between 1.5:1 and 1:1

Terraces on steeper slopes

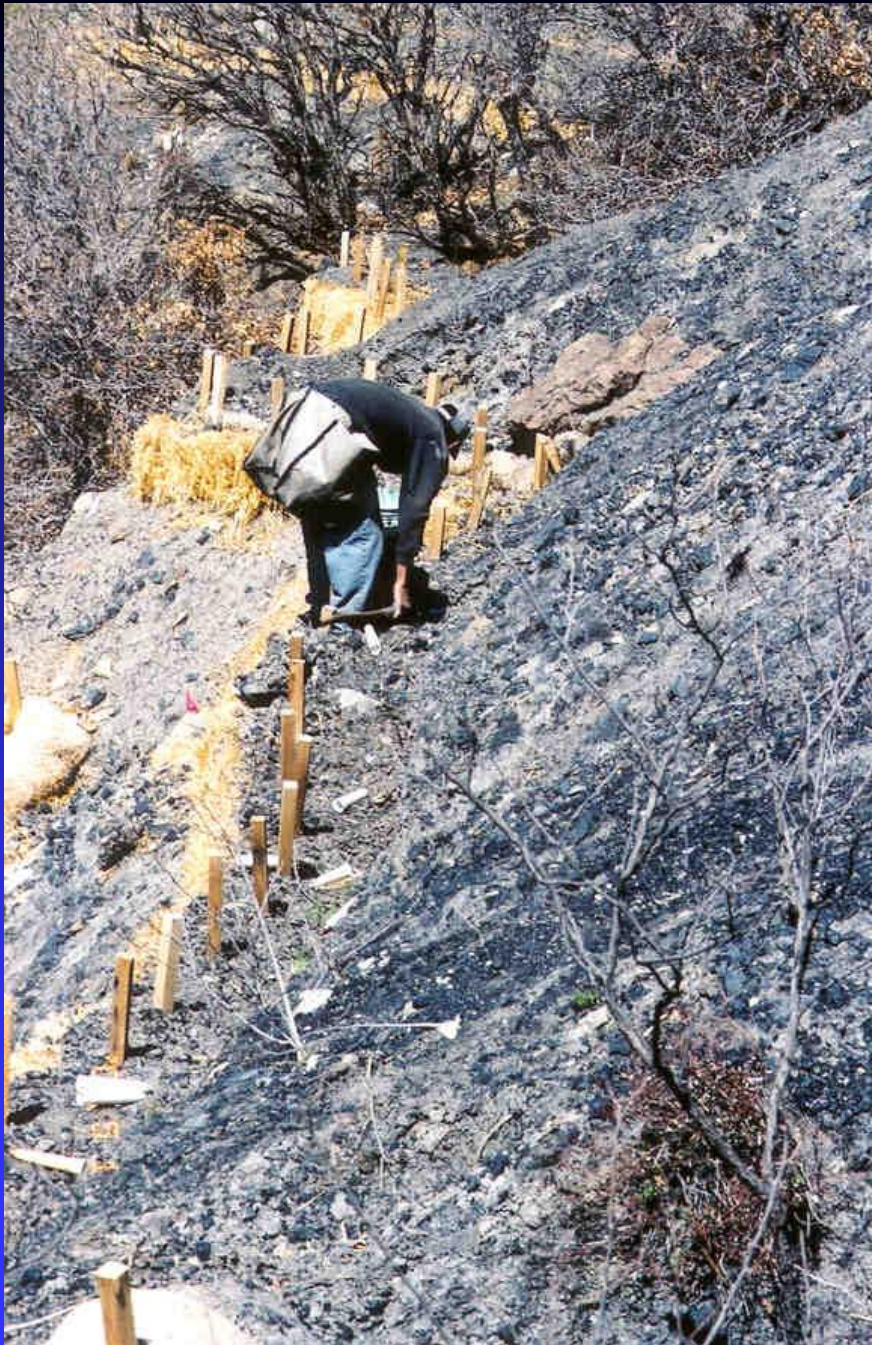
Planting tublings

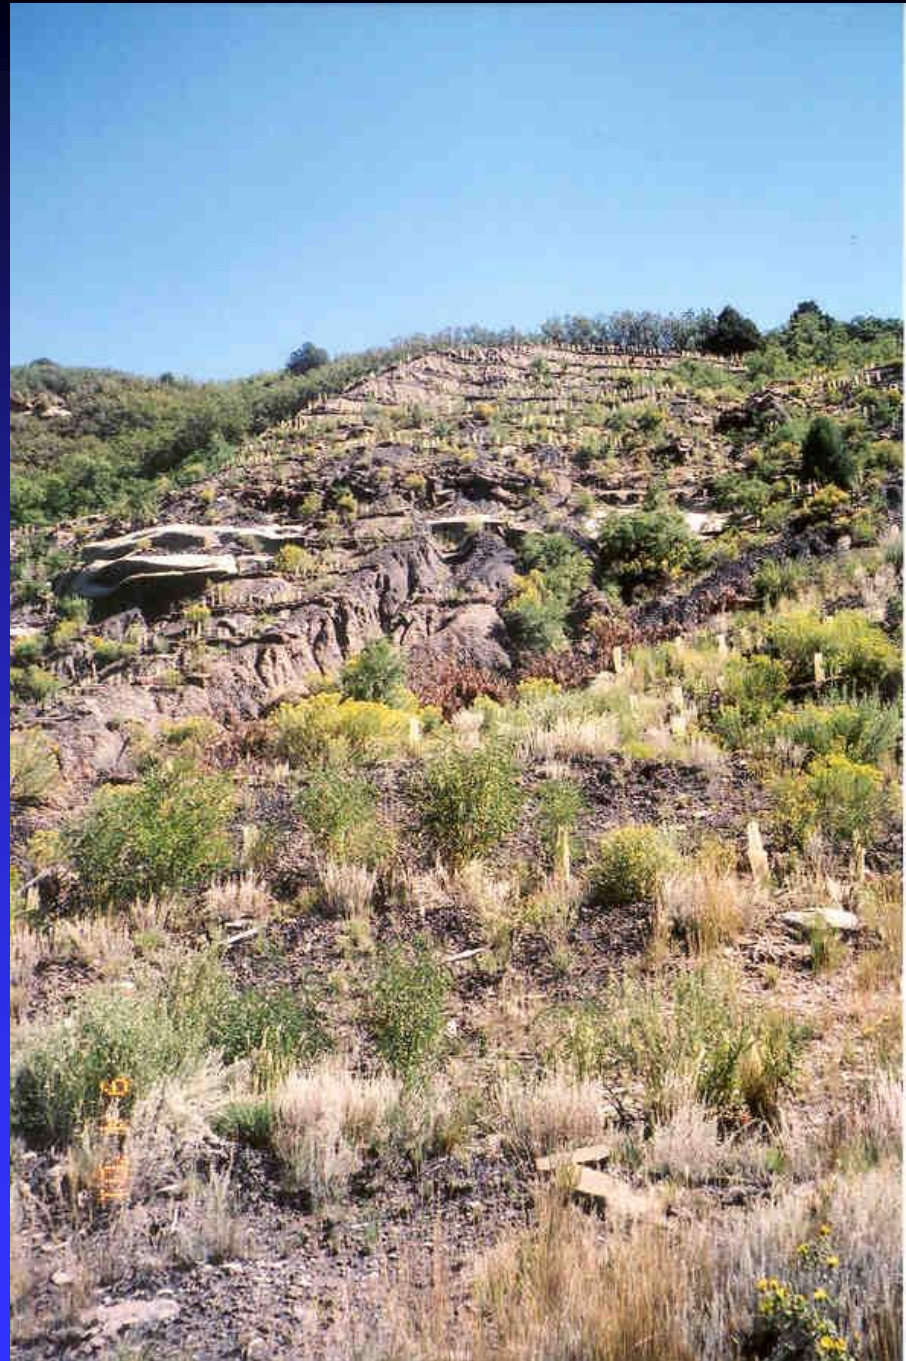
■ Gob Pile A2N

Seedlings after one and three seasons of growth

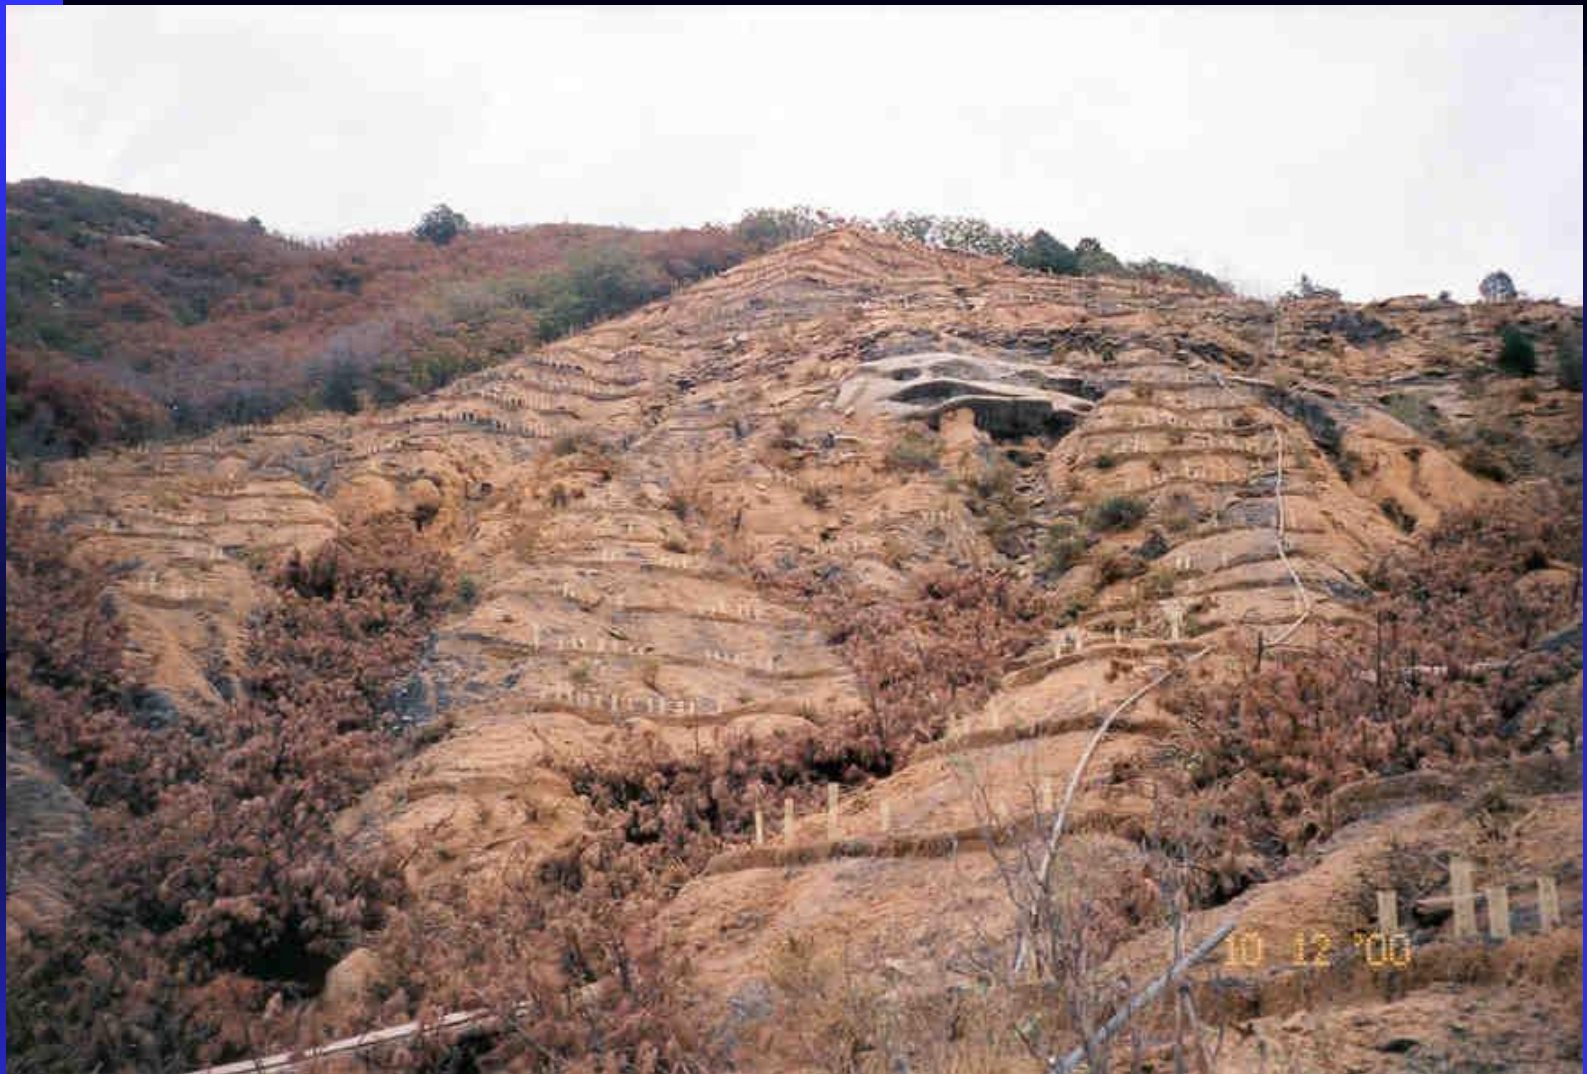
Hydroseeded slopes
at Gob Pile A2N

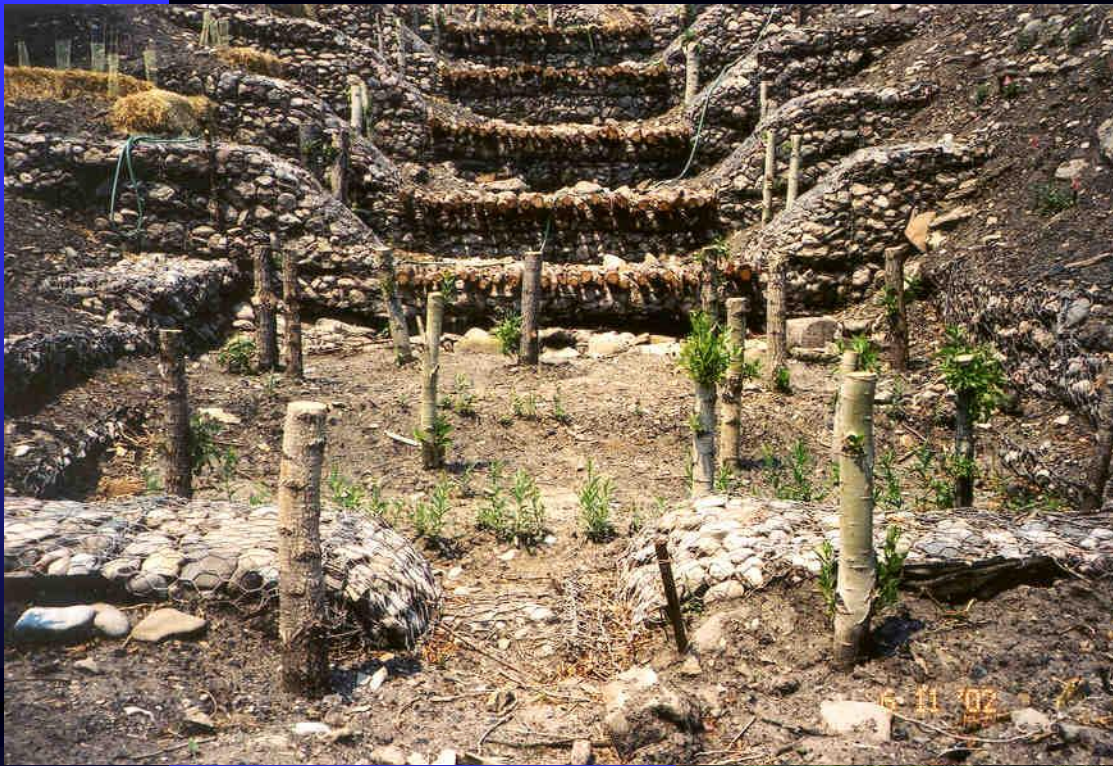
- At base of
Gob Pile A7

Gabion drop structures
