Sugarite Gob Reclamation Project

Raton, NM 1999 - 2002

- New Mexico Abandoned Mine Land Bureau
 - John A. Kretzmann, P.E., Project Engineer
 - Randall Armijo, Project Manager
- Construction Contractors
 - St. Cloud Mining Company, T or C, NM
 - C&R Forestry Inc., Albuquerque, NM

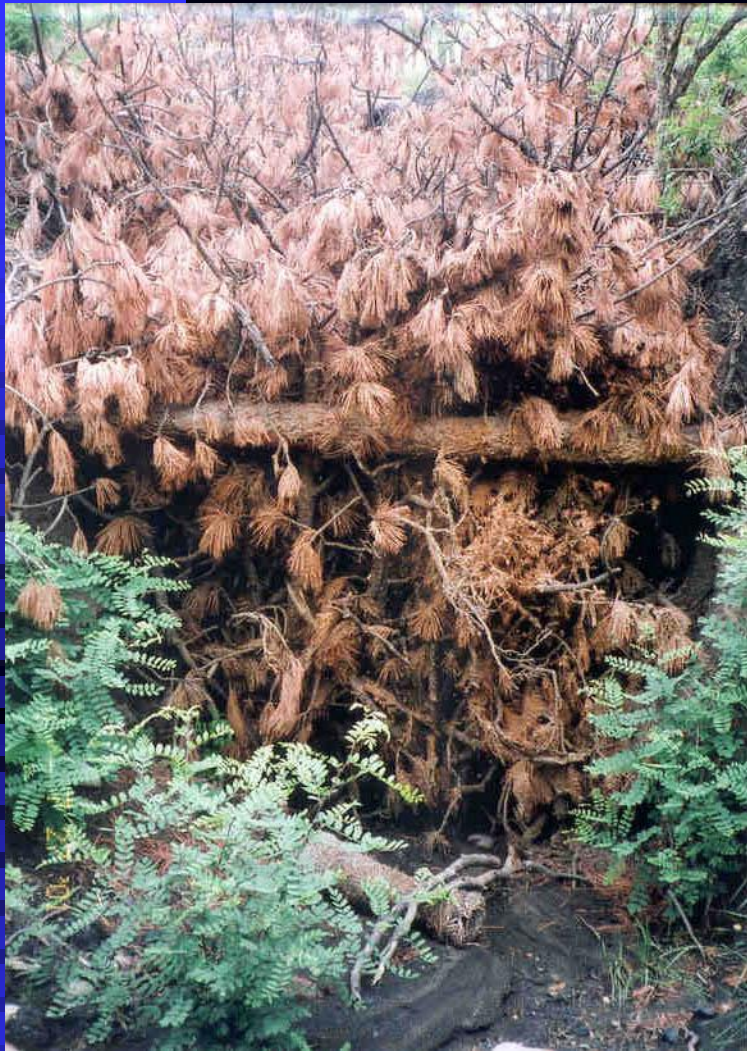
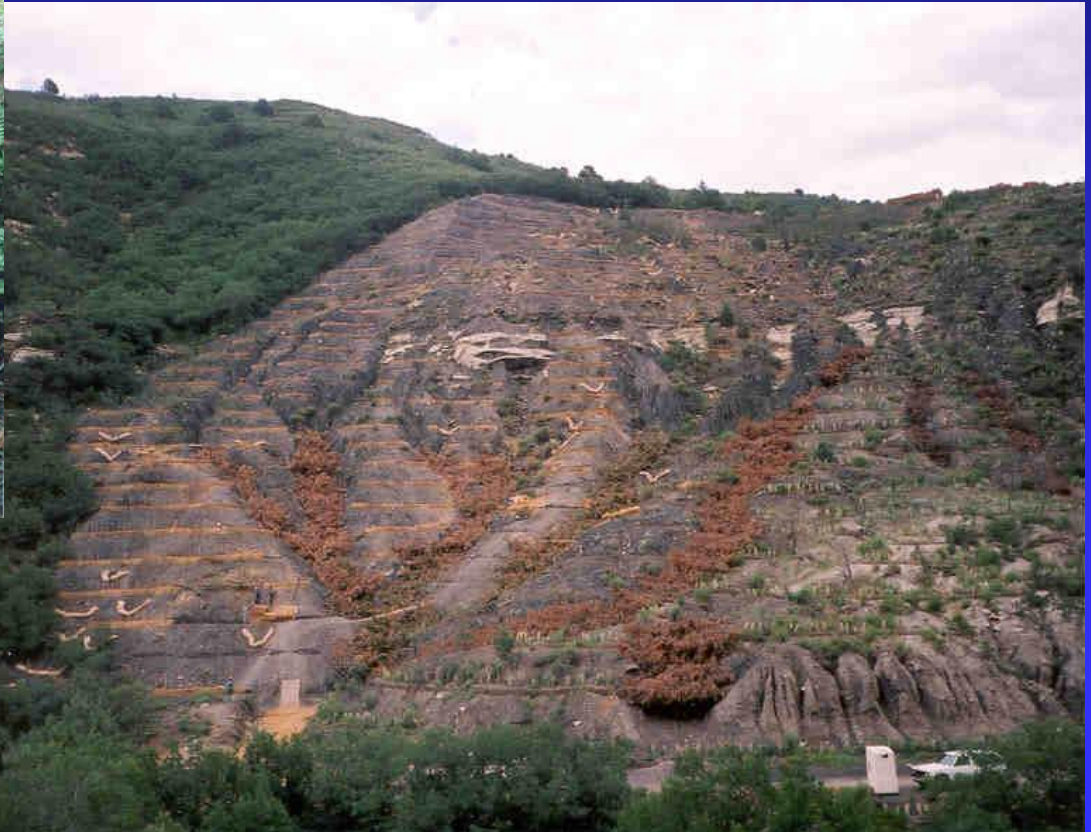
■ Gob Pile A2N

Branch packing of gullies

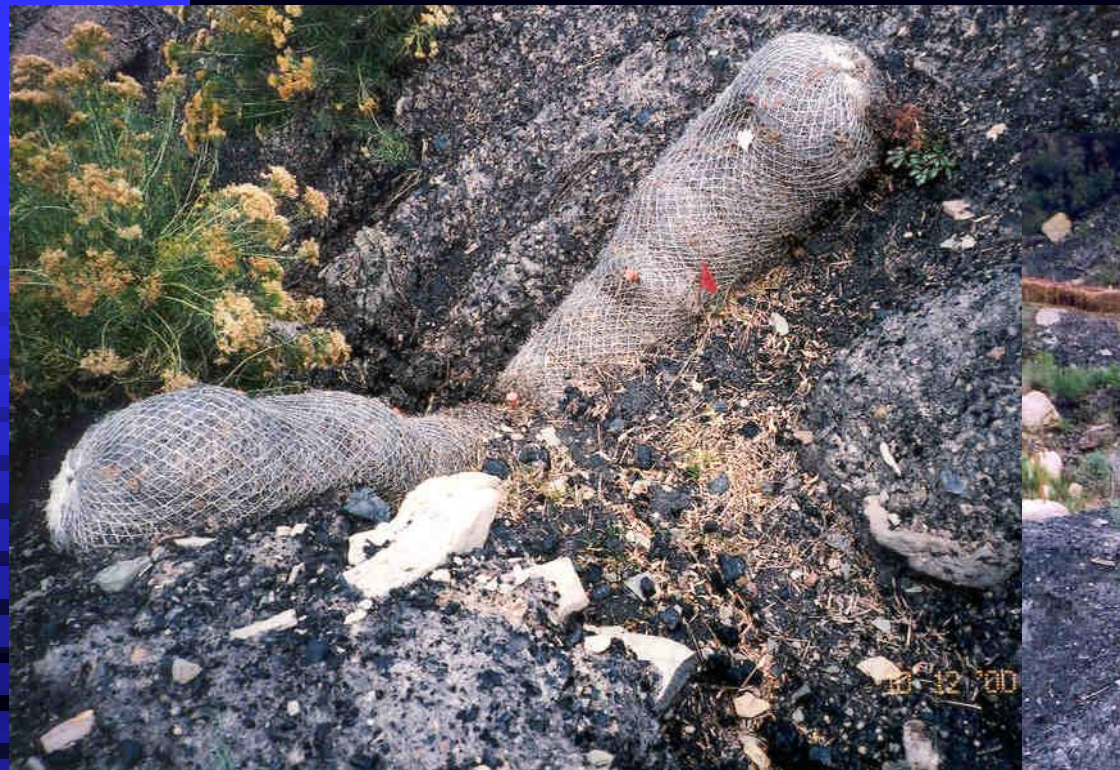
Sediment logs

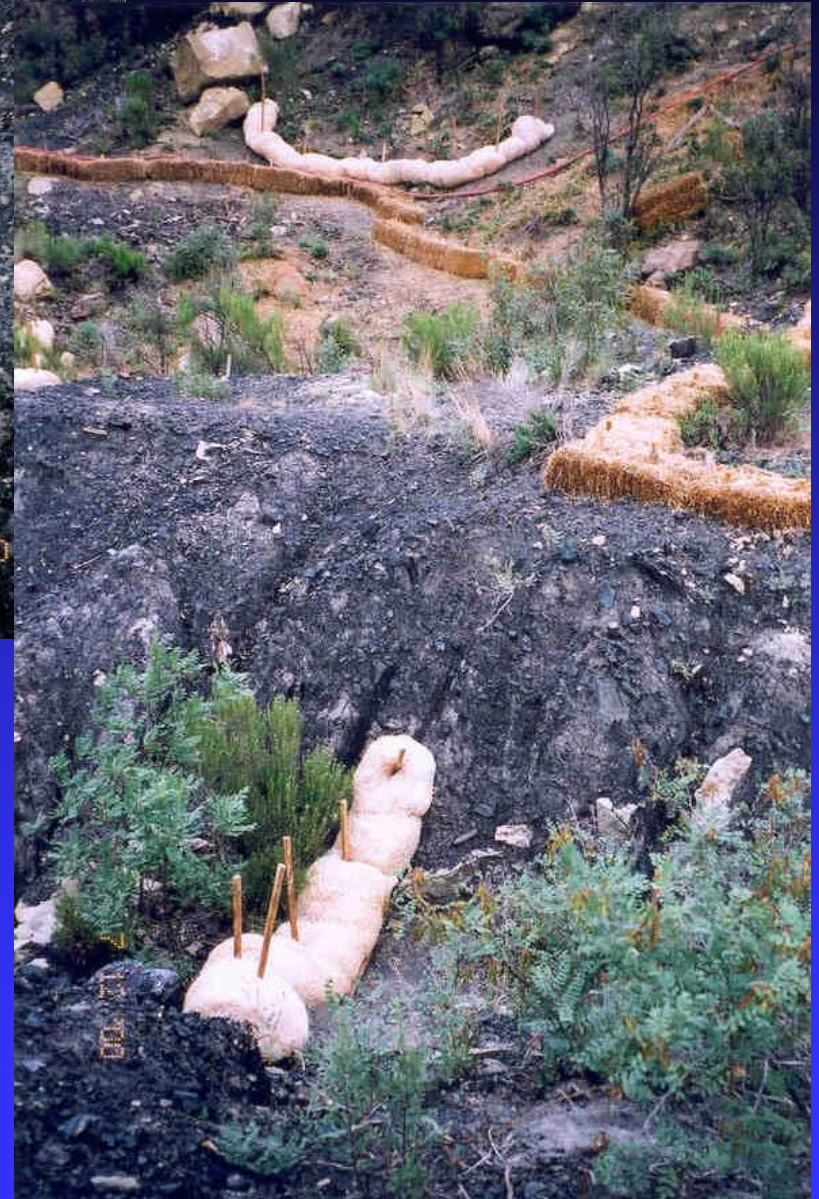
■ June 1999

Reclamation
results at Gob
Pile A2N

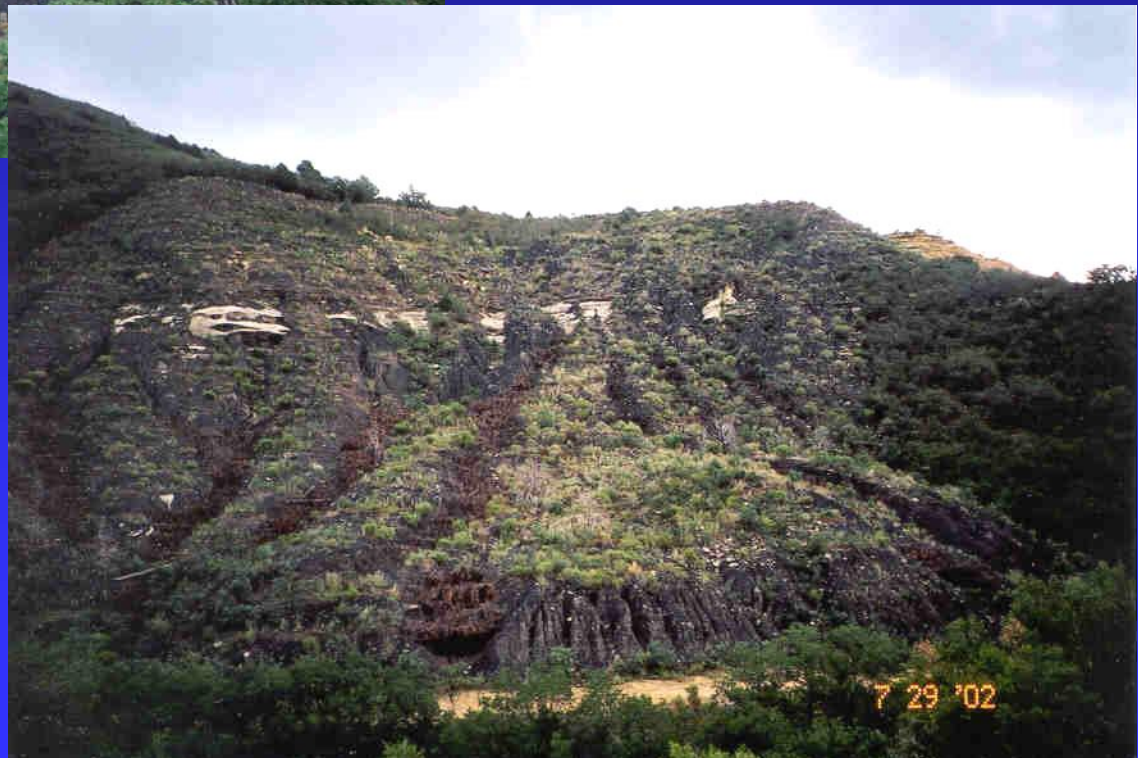
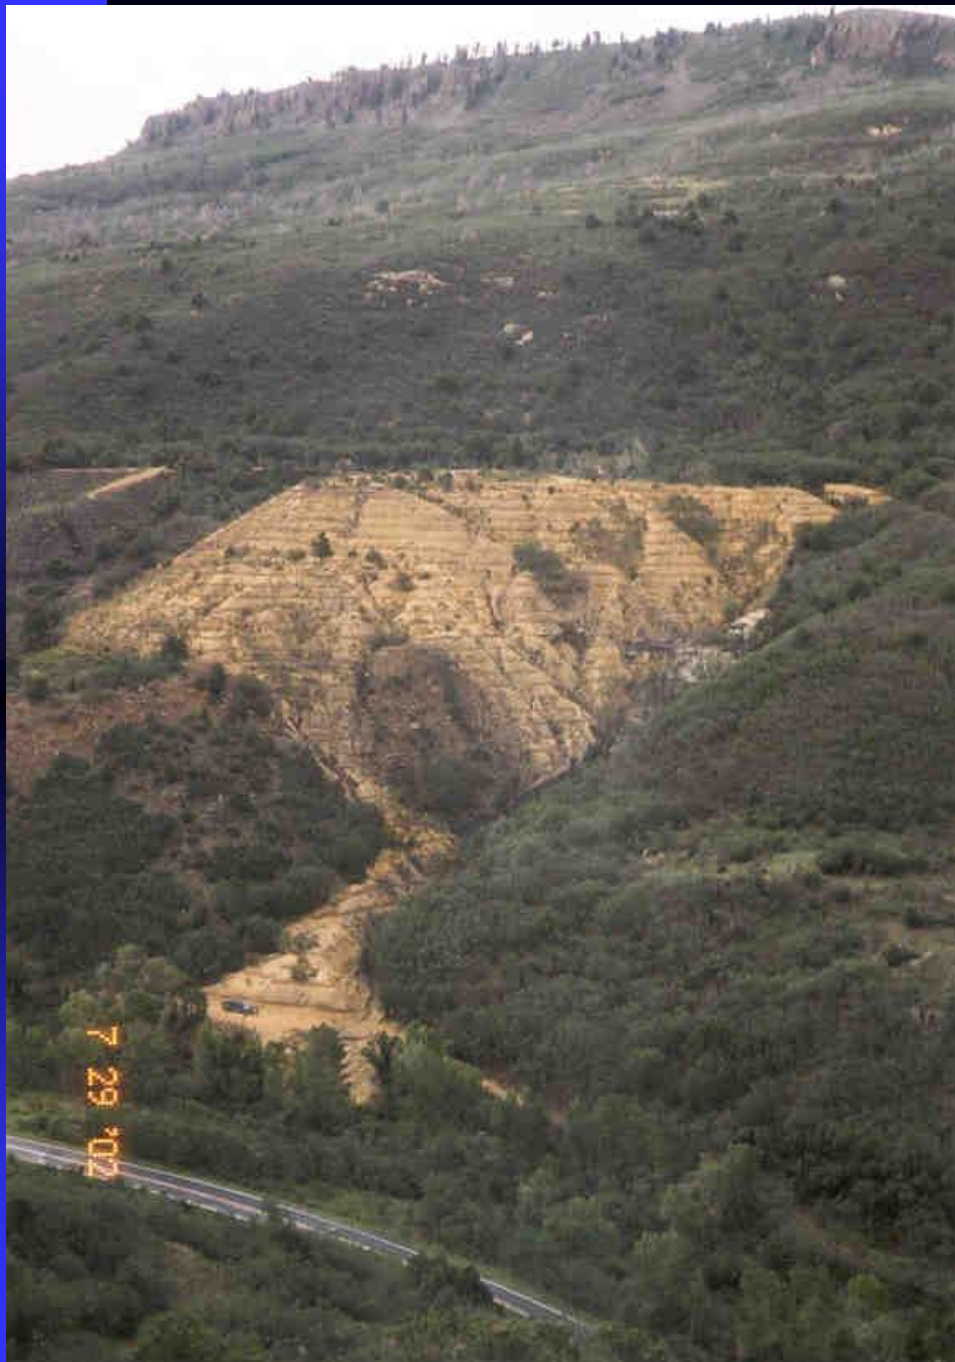
■ July 2002

Hydroseeded slopes at Gob Piles A2S & A7
