## **Steep Slope, In-Place Reclamation of Abandoned Coal Gob Piles in Sugarite Canyon, Raton, New Mexico**

John A. Kretzmann, P.E.

New Mexico Abandoned Mine Land Program

April 2014

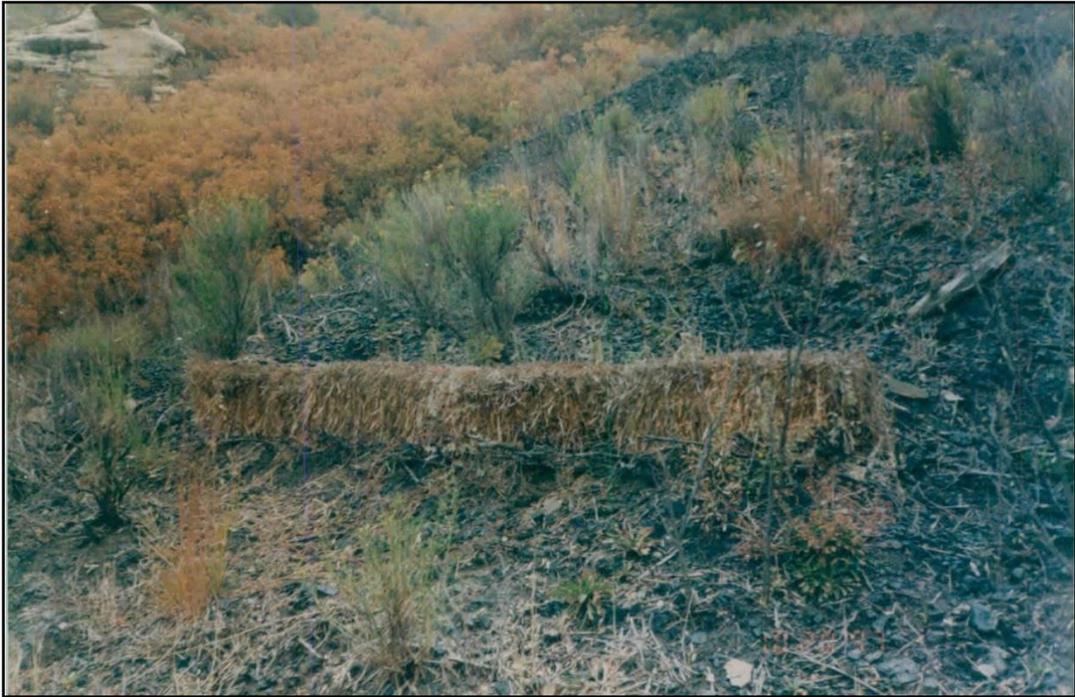
Trial installation on Gob Site A2N of straw bales with live cuttings at the base of the bales a few months after installation, 1997

In the late fall of 1995 and early springs of 1996 and 1997, New Mexico Abandoned Mine Land Program (AML) staff conducted small scale trials using straw bales placed along contour on 20-inch wide, hand-dug terraces. Live, adventitious rooting cuttings, primarily a mix of locally sourced willow (*Salix*) species, with some narrowleaf cottonwood (*Populus angustifolia*), box elder (*Acer negundo*), and snowberry (*Symphoricarpos albus*), were placed along the terraces underneath and behind the bales. Although the bales clearly helped to infiltrate precipitation and runoff, the cuttings had difficulty coping with the sodic, slightly saline soils and droughty soil conditions and most died in the first year except in the most mesic areas of the gob piles. In 1996, small trials were conducted by packing gullies with dead branches, to slow water and enhance sedimentation in narrow gullies, while providing a carbon and nutrient source. These proved successful, as were initial trials of aspen excelsior sediment control logs in shallower gullies.

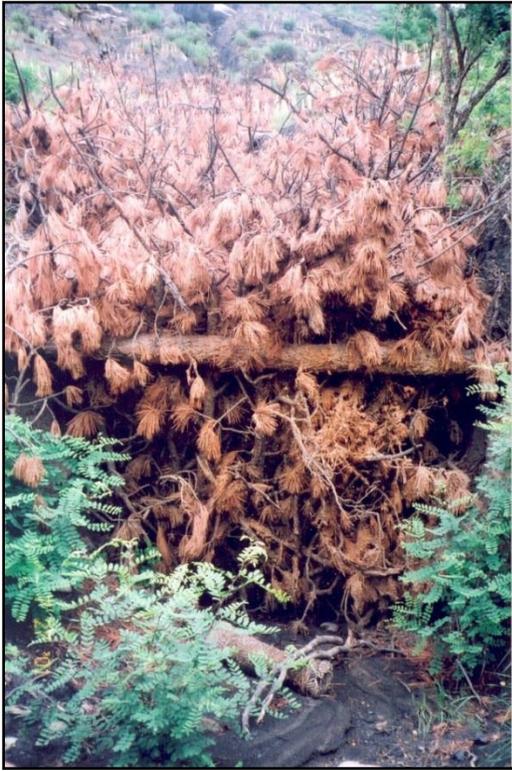
Branch packing in large gully,  
looking upstream, 1999

Another important observation was that concentrating vegetation in gullies was essential to overall success in erosion and sediment control. Heavy growth of vegetation could be achieved in the naturally wetted gully bottoms and serves to slow runoff and filter sediment out of storm flows. This sediment buildup is slowly raising the base of the gullies while the steeper, generally higher and more erodible parts of the landform are dropping in elevation, leading to a slow smoothing and rounding off of the landforms.

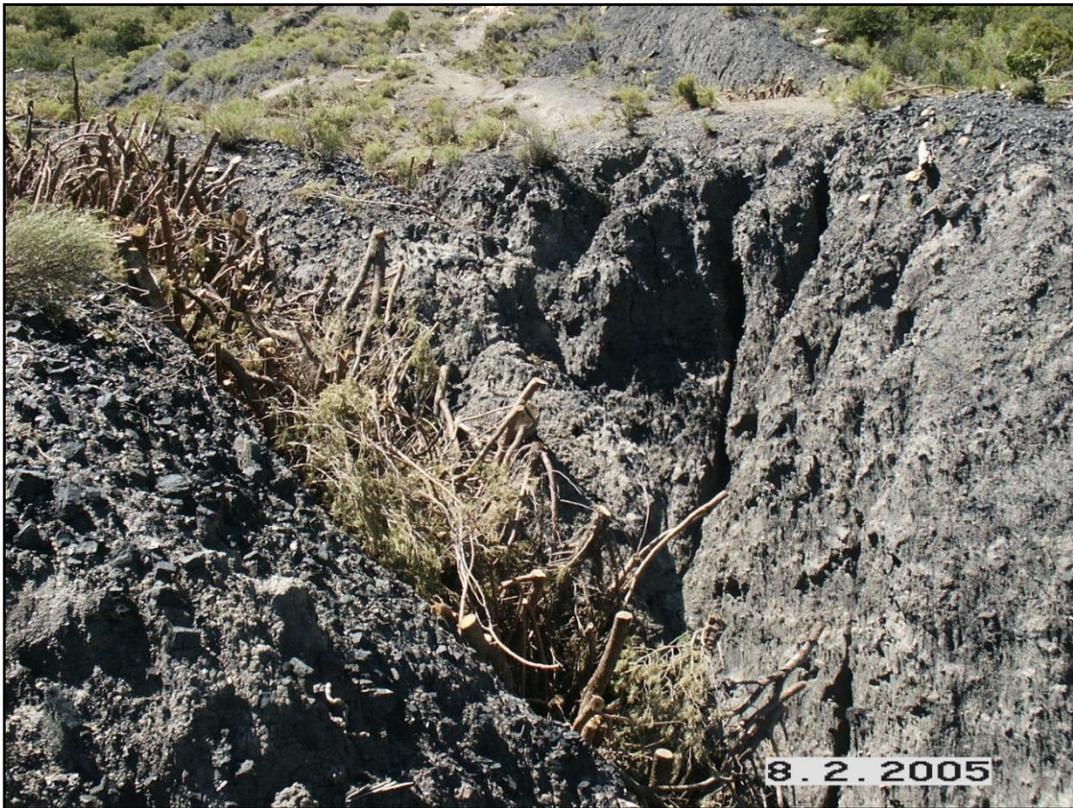
Newly installed branch packing in small, deeply incised gully, looking upstream, 2005

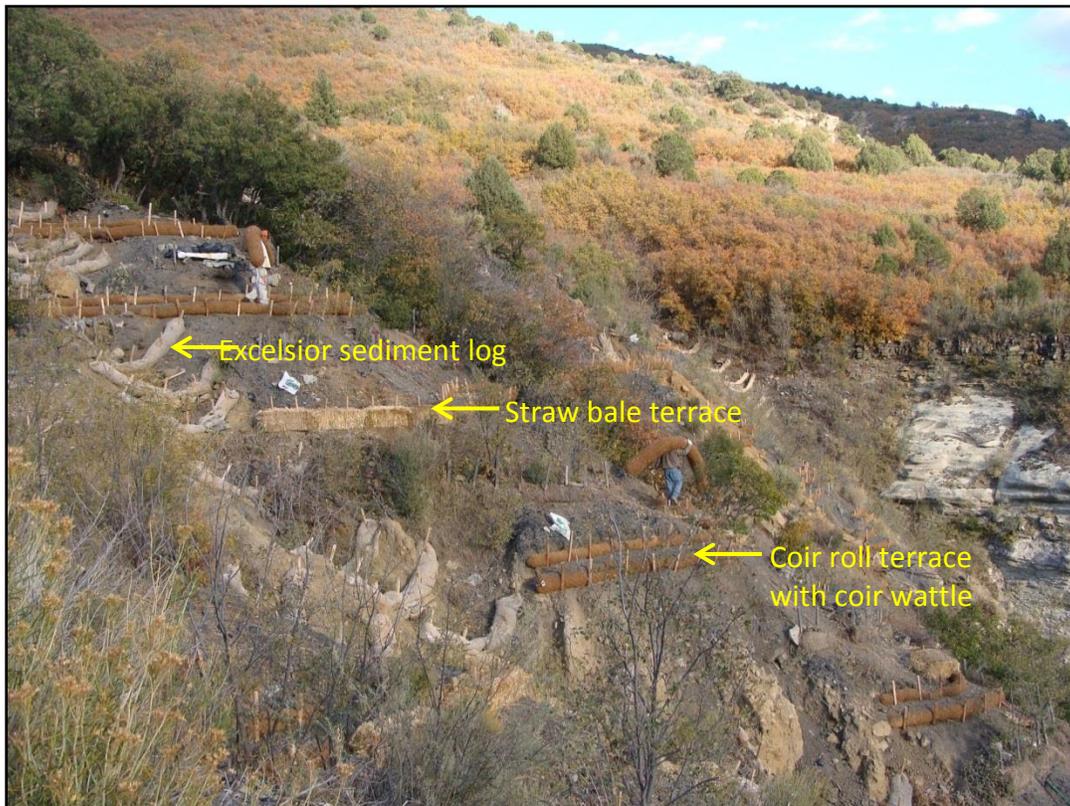
Aspen excelsior sediment logs in gully and straw bale and coir roll terraces on gob slope prior to seedling planting, 2010

Trials of 12-inch diameter coir (coconut husk fiber) rolls, as a replacement for straw bales on slopes steeper than 1.5:1, indicated that they were a good substitute. Coir rolls are better able to cope with the higher velocity runoff on those slopes, last significantly longer, and lead to better establishment and vigor of the seedlings planted along their upper edges. Six-inch diameter coir wattles (wattles are packed less densely with coir than rolls) were placed just above the rows of seedling plantings at coir rolls to protect them from upslope sediment.

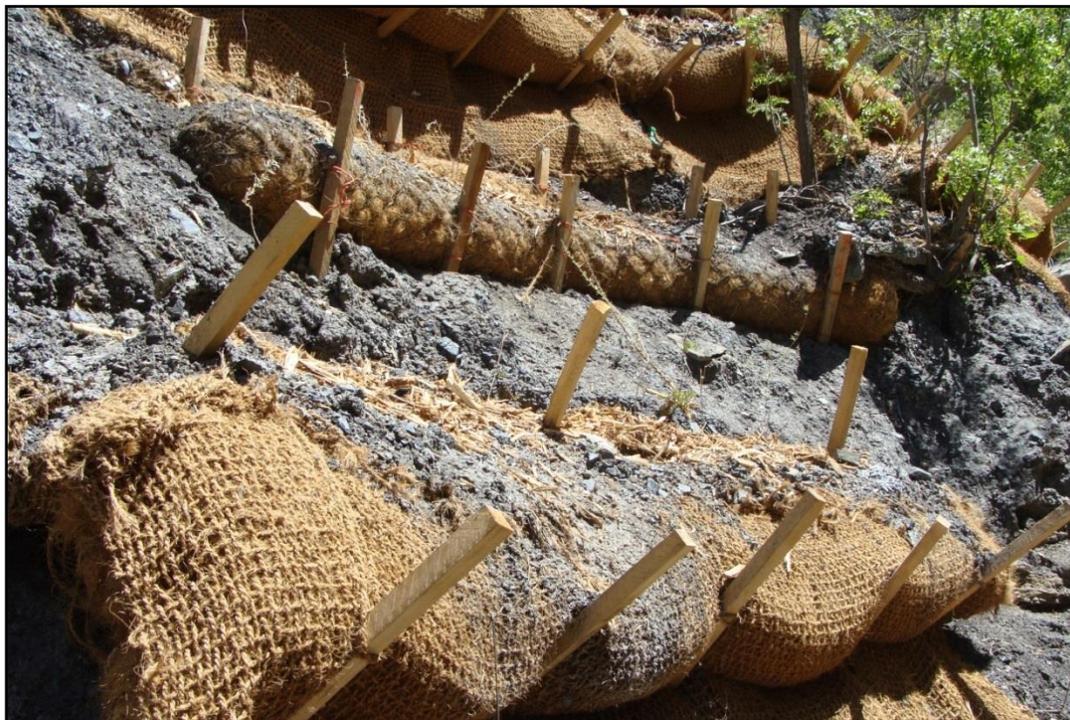
Coir block and coir roll installations on extremely steep slope prior to seedling planting, 2011

But even coir rolls were found to have their limits. On slopes steeper than about 0.75:1, excavation of the narrow terraces needed for their installation quickly led to shallow land slipping that wiped out the coir roll terraces and their seedling plantings. In 2011 at one area with significant areas of slopes steeper than 0.75:1, the AML Program experimented with the use of rectangular coir blocks, nine inches by sixteen inches in cross-section, staked directly onto the slope without terracing, on contour at three-foot vertical spacing, and with plantings of seedlings immediately above them. Initial results have been encouraging and a second installation of coir blocks at the 1980s gob landslide scarp was completed in 2013.

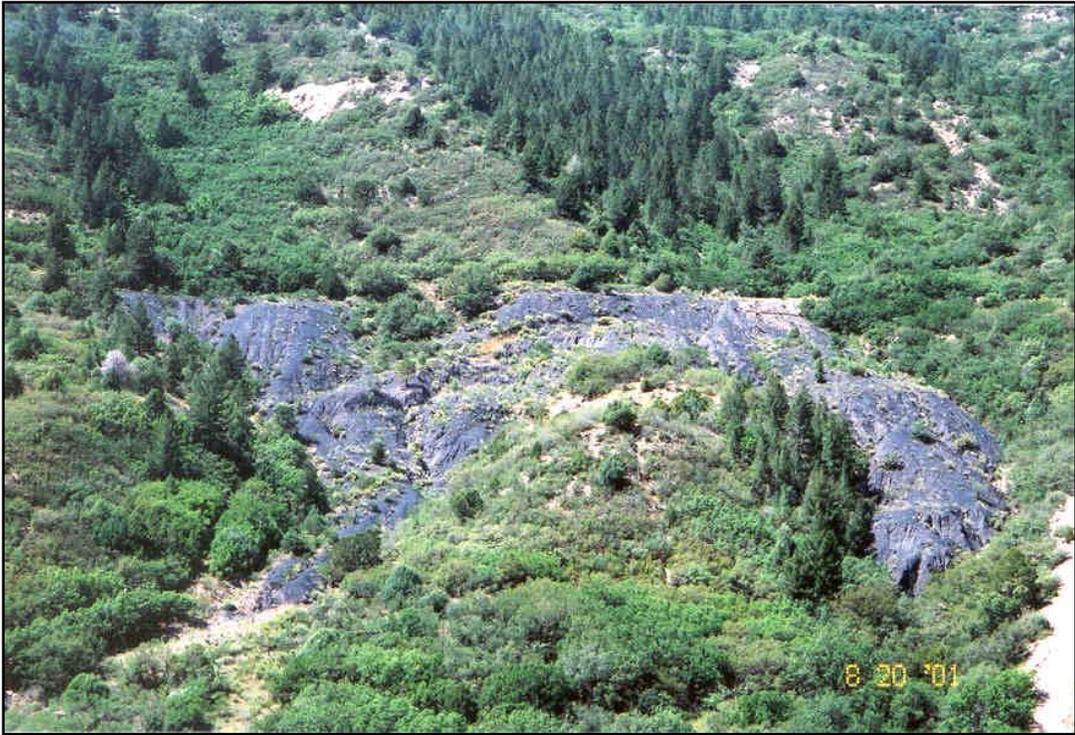
East-facing Gob Site A1, August 2001

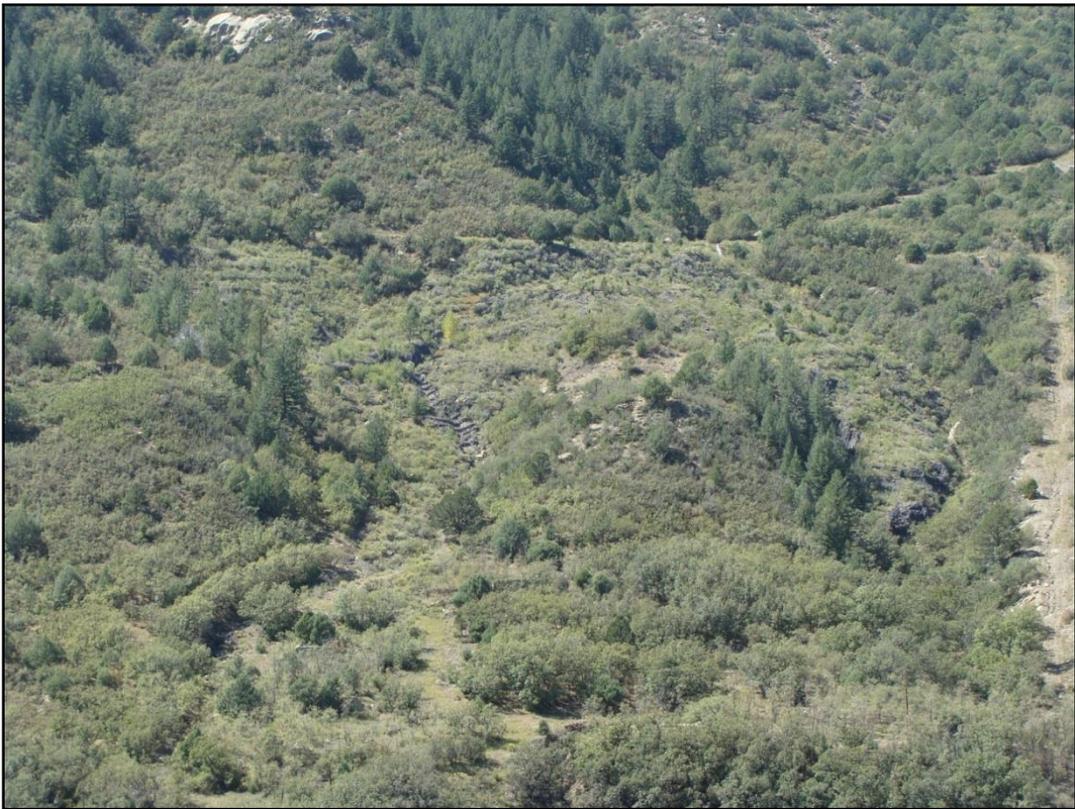
Gob Site A1, September 2010

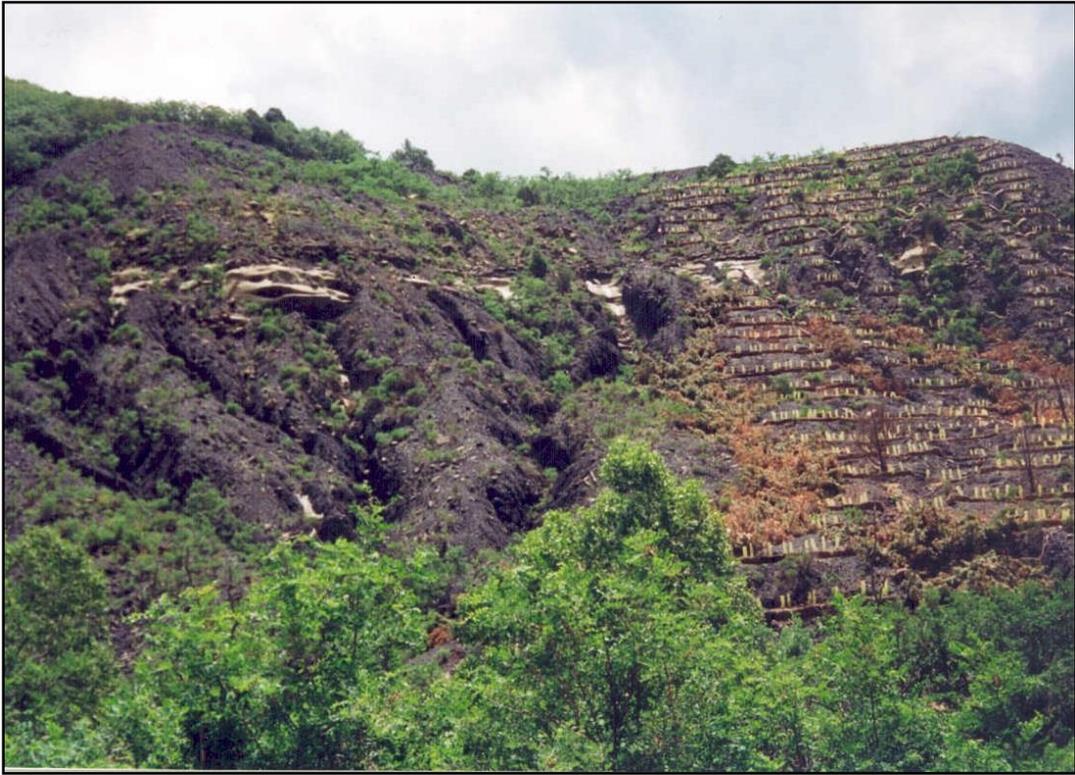
West-facing Gob Site A2N during pilot project, 1999

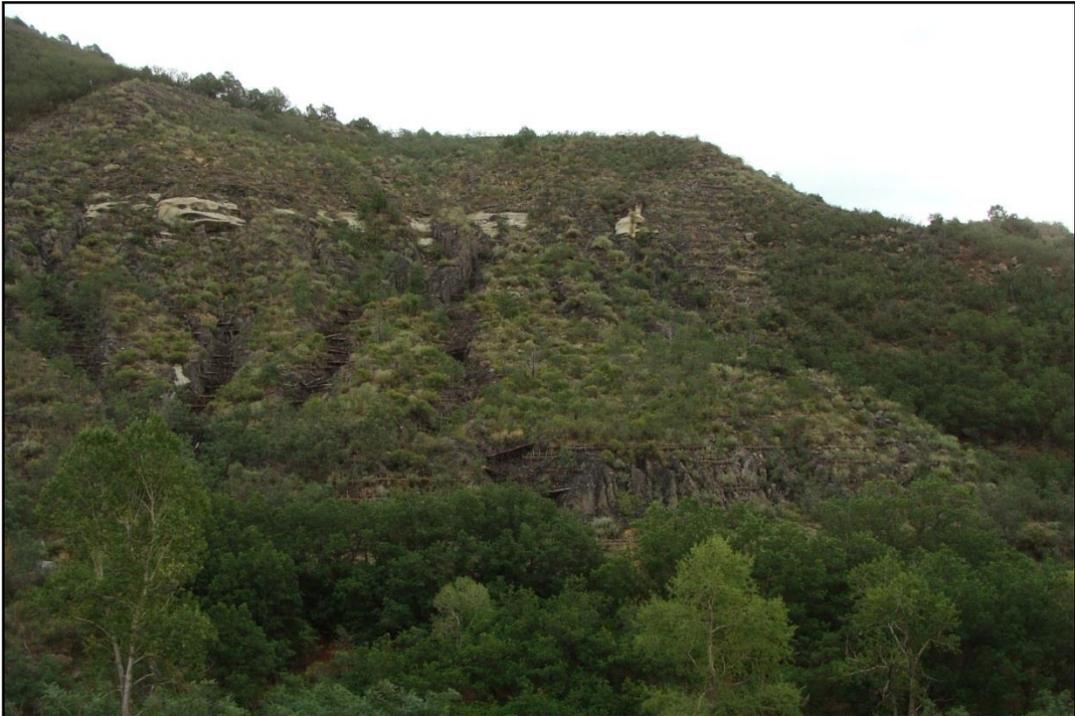
Gob Site A2N, 2011

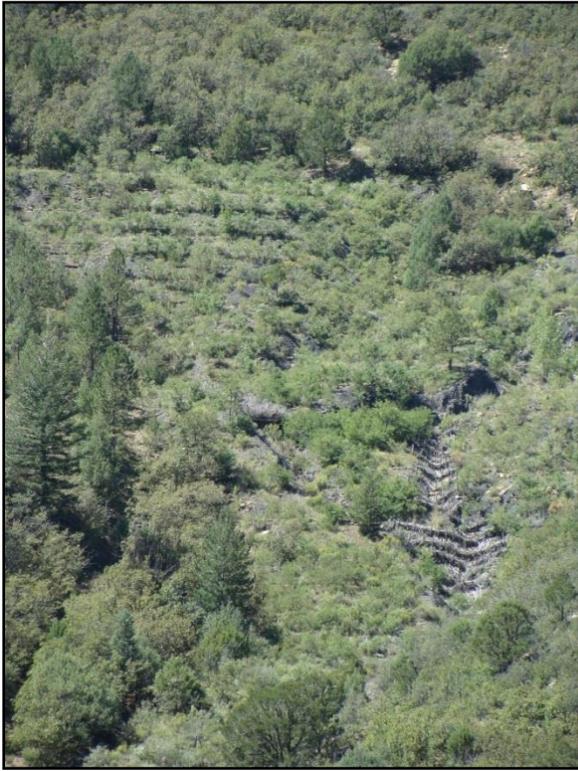
Close-up of Gob Site A1, 2010

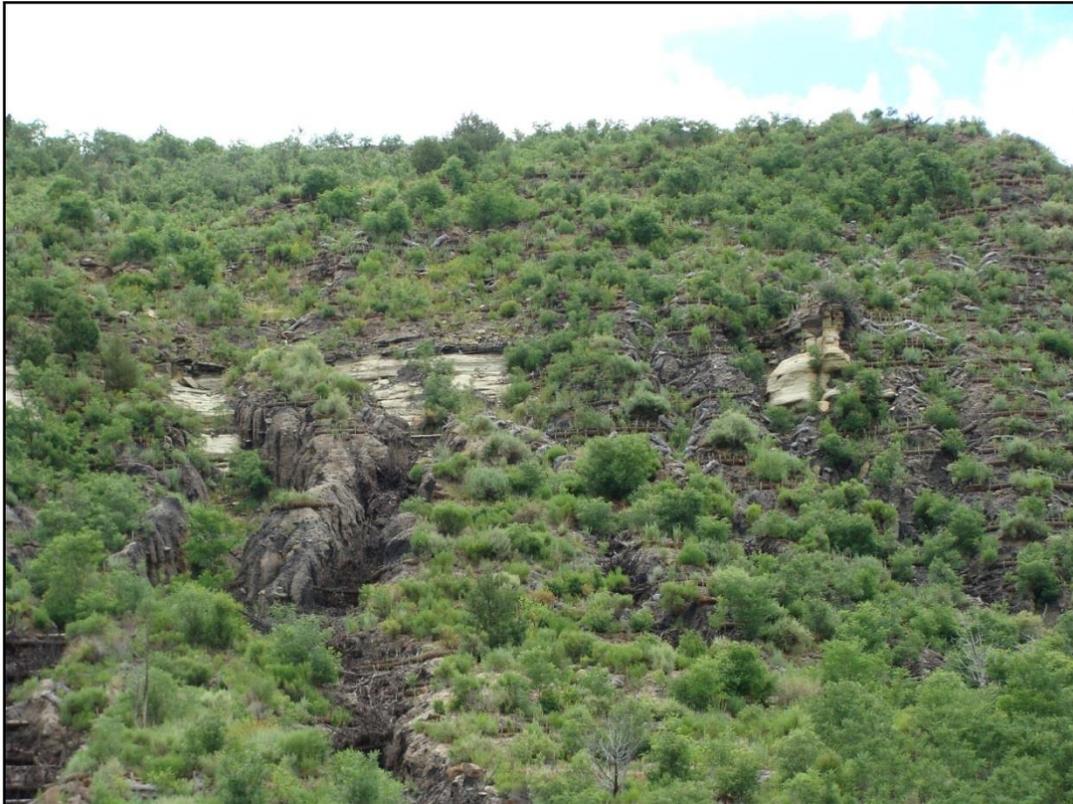
Close-up of Gob Site A2N, 2010

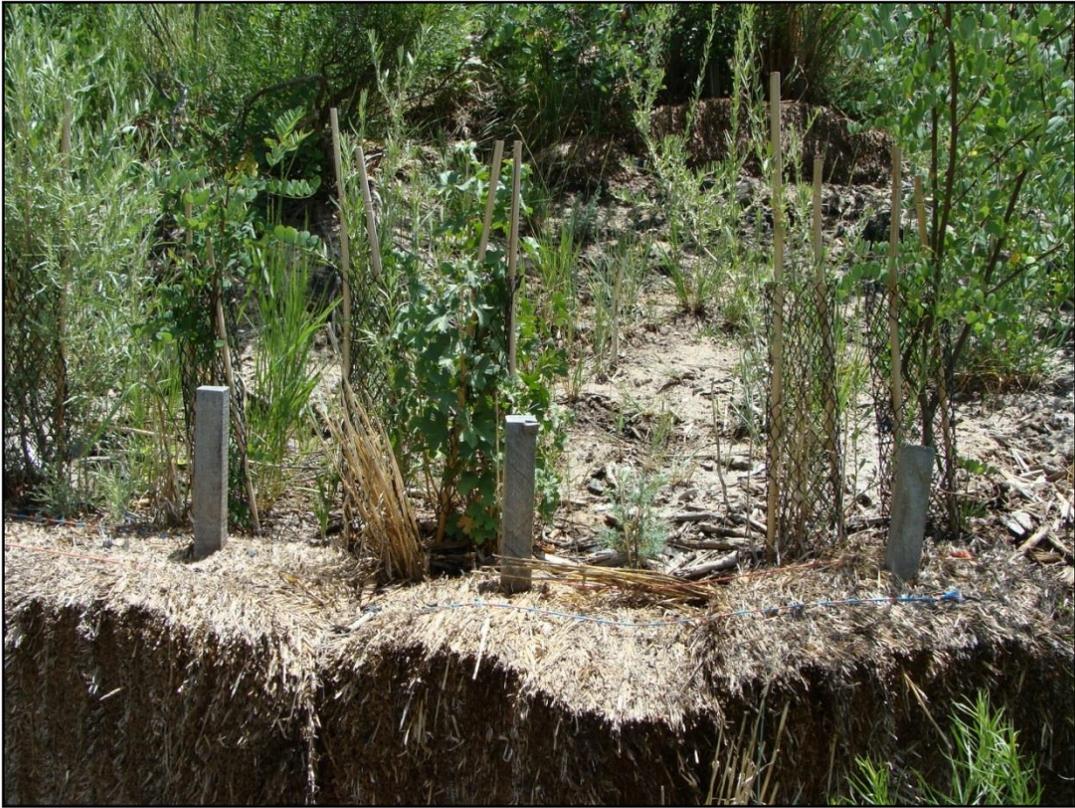
Closely spaced seedling plantings along straw bale terrace, 2010

slope, in-place gob reclamation. One was that the eight-foot vertical spacing for on-contour barriers, such as straw bales, with seedling plantings was too great and needed to be reduced to four-foot contour intervals, with exception of the flattest slopes. Too much runoff was generated between the barrier rows, leading to seedling washout or burial in sediment and to bare eroding slopes between the rows of straw bales. The excelsior sediment barrier dams spacing also needed to be tightened from four- and eight-foot to two-foot contour intervals and planted with seedlings for improved vegetative success in gullies. These final vertical spacing parameters for vegetative erosion barriers are similar to spacing guidelines developed in the field of soil bioengineering (Gray & Sotir, 1996).

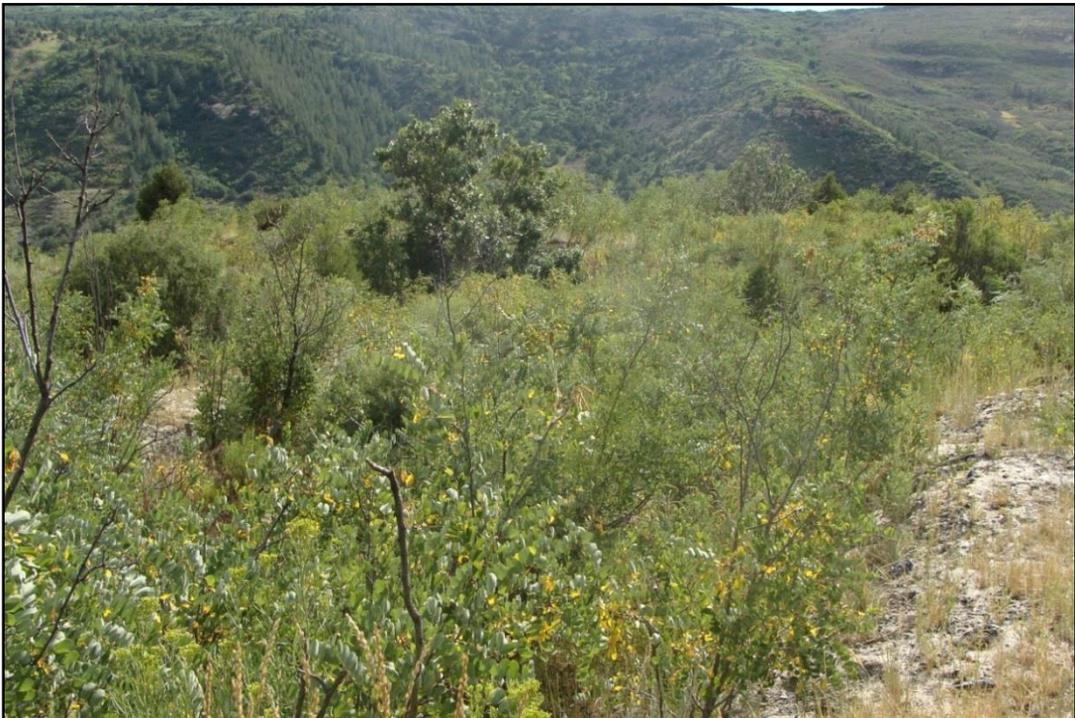
Yellowing of leaves and dieback of New Mexico locust, July 2012

effects. Despite the recent drought, good reclamation results have been achieved, at least visually, including establishment and growth of vegetation and diminishment of erosion and sedimentation. Note that no scientific measurements of reclamation results, other than six-month survival analysis of planted seedlings, have been taken. The most visible impact of drought was some dieback of New Mexico locust on the gob piles noted in 2012.

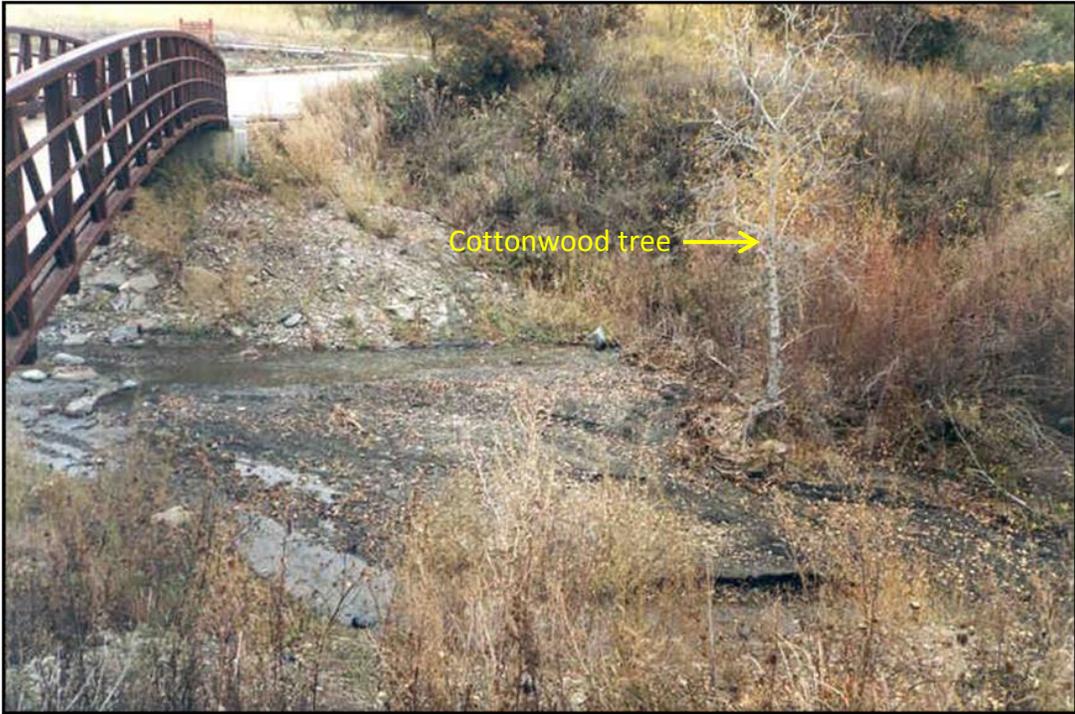
Coal gob in Chicorica Creek, 1997

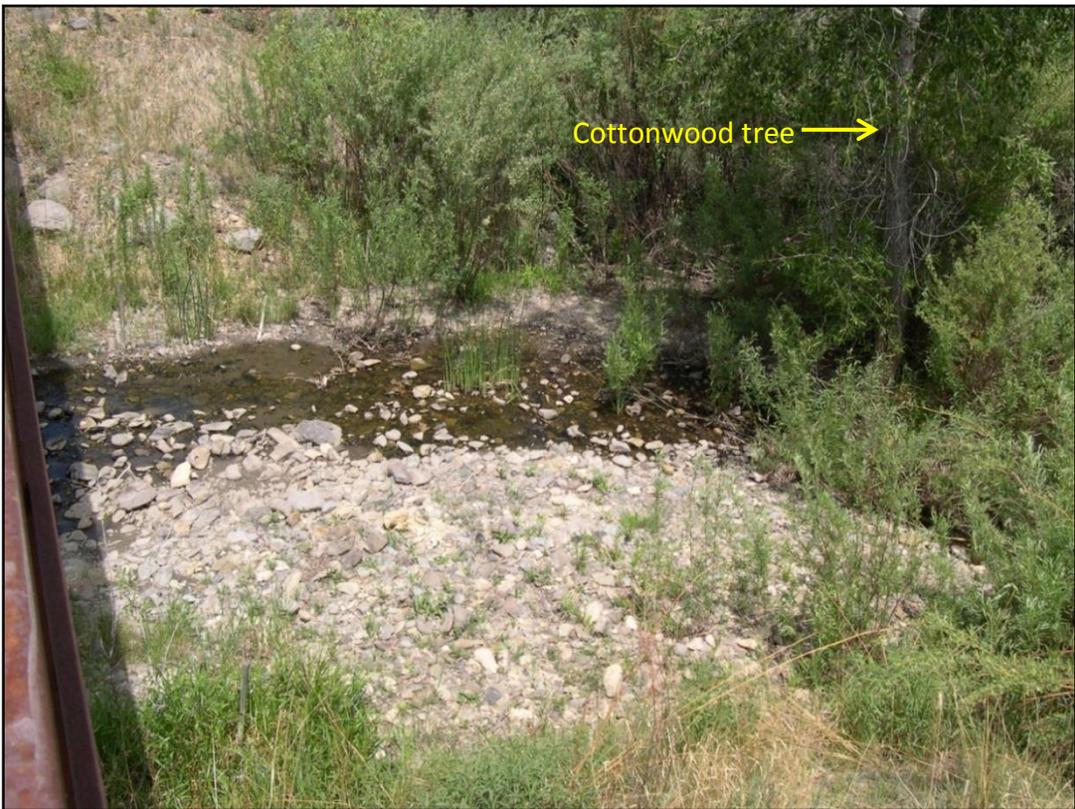
Same location in Chicorica Creek, 2006.  
Vegetation has since nearly completely covered the gravel bar.

Now 15 years after the first trials on the gob and several construction and maintenance projects between 1999 and 2013, vegetation has become well established on the gob, erosion has been significantly reduced, and natural cycles continue to reshape the gob to more stable forms. Coal fragments and fans of black clay deposits are now difficult to find in Chicorica Creek at the base of the gob piles.

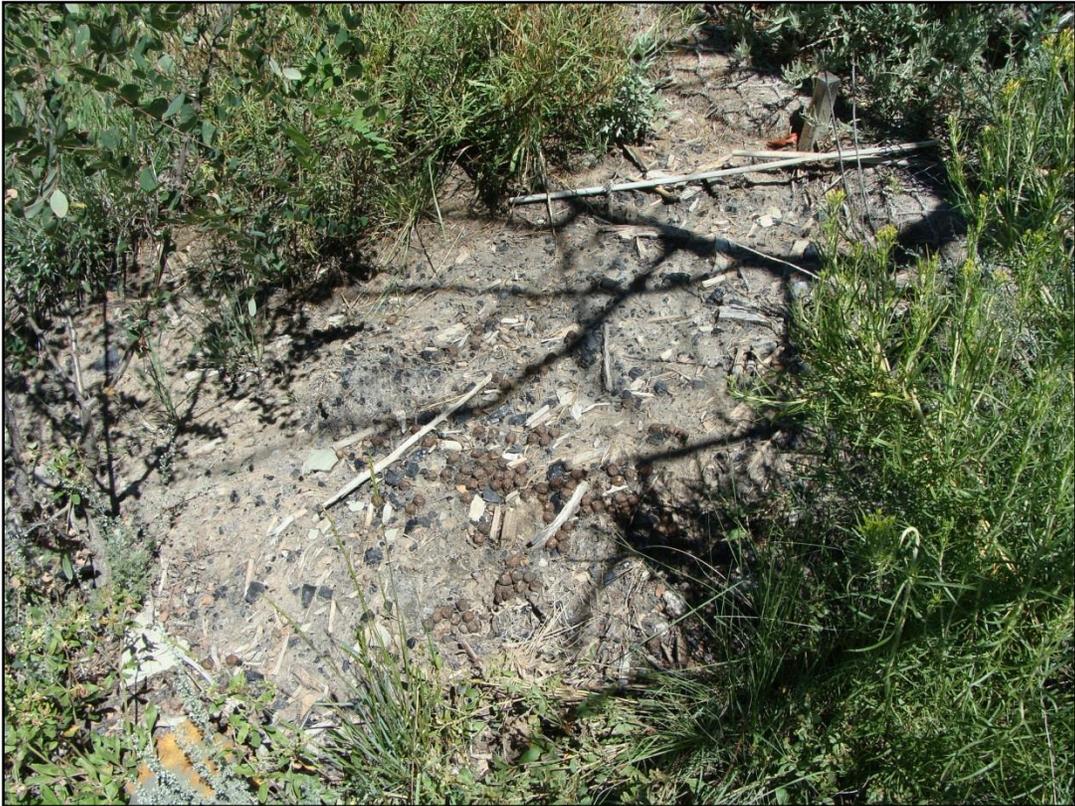
Animal impact on mineral cycle, Gob A2N, 2010

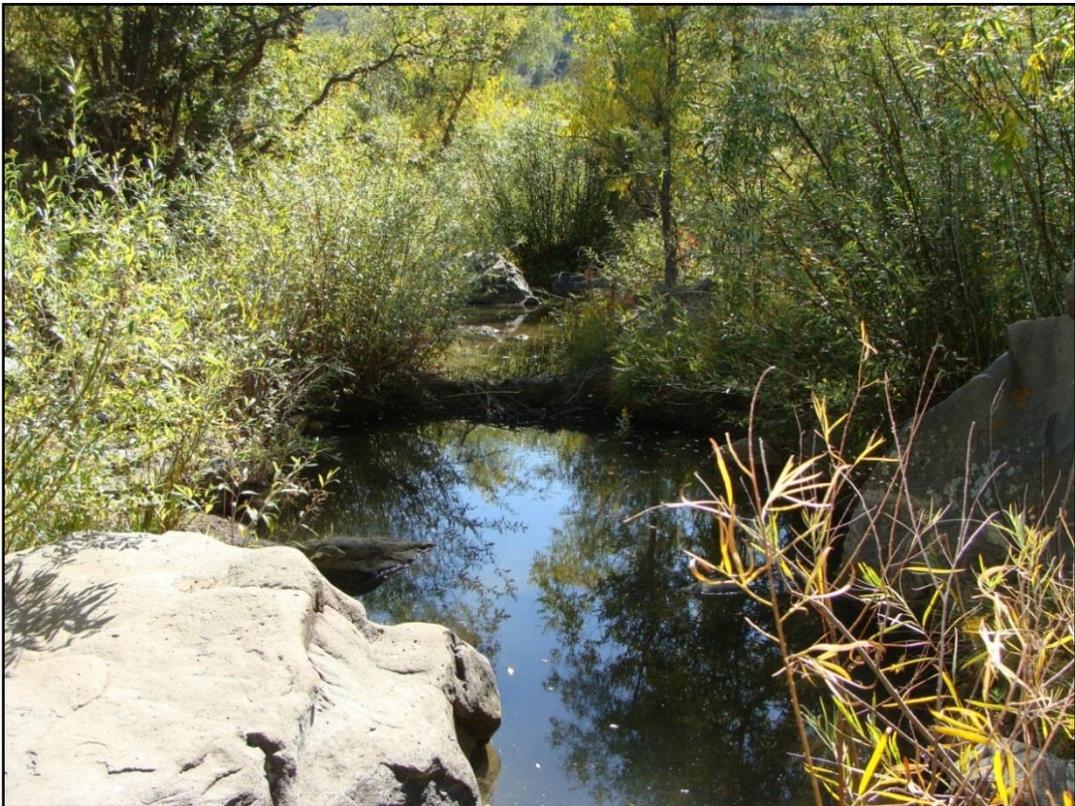
Beaver pond in Chicorica Creek below Gob Site A2N, 2010

A few years after work began, beavers moved in to build and maintain at least three ponds along Chicorica Creek below the gob pile furthest upstream. The Creek and small lakes upstream are stocked with trout and Park Rangers have commented that fishing in the creek below the gob piles has noticeably improved since reclamation began. The steep banks of the deepest gullies in the piles remain bare but some flattening of the gully side slopes is beginning to be seen. All but the deepest and narrowest of the gullies planted with seedlings exhibit a dense cover of vegetation and are often flanked by bare, steep gob banks full of rills episodically feeding sediment into the bottom of the gullies. It will be interesting to compare how the branch-packed gullies without vegetation evolve over time compared to gullies with vegetation plantings.
