Swastika Mine and Dutchman Canyon Maintenance and Stream Restoration Project Photos

PROJECT NAME:
Swastika Mine and Dutchman Canyon Maintenance and Stream Restoration Project

DRAWING:
Stream Stabilization:
Meander & Structure
Sections & Details

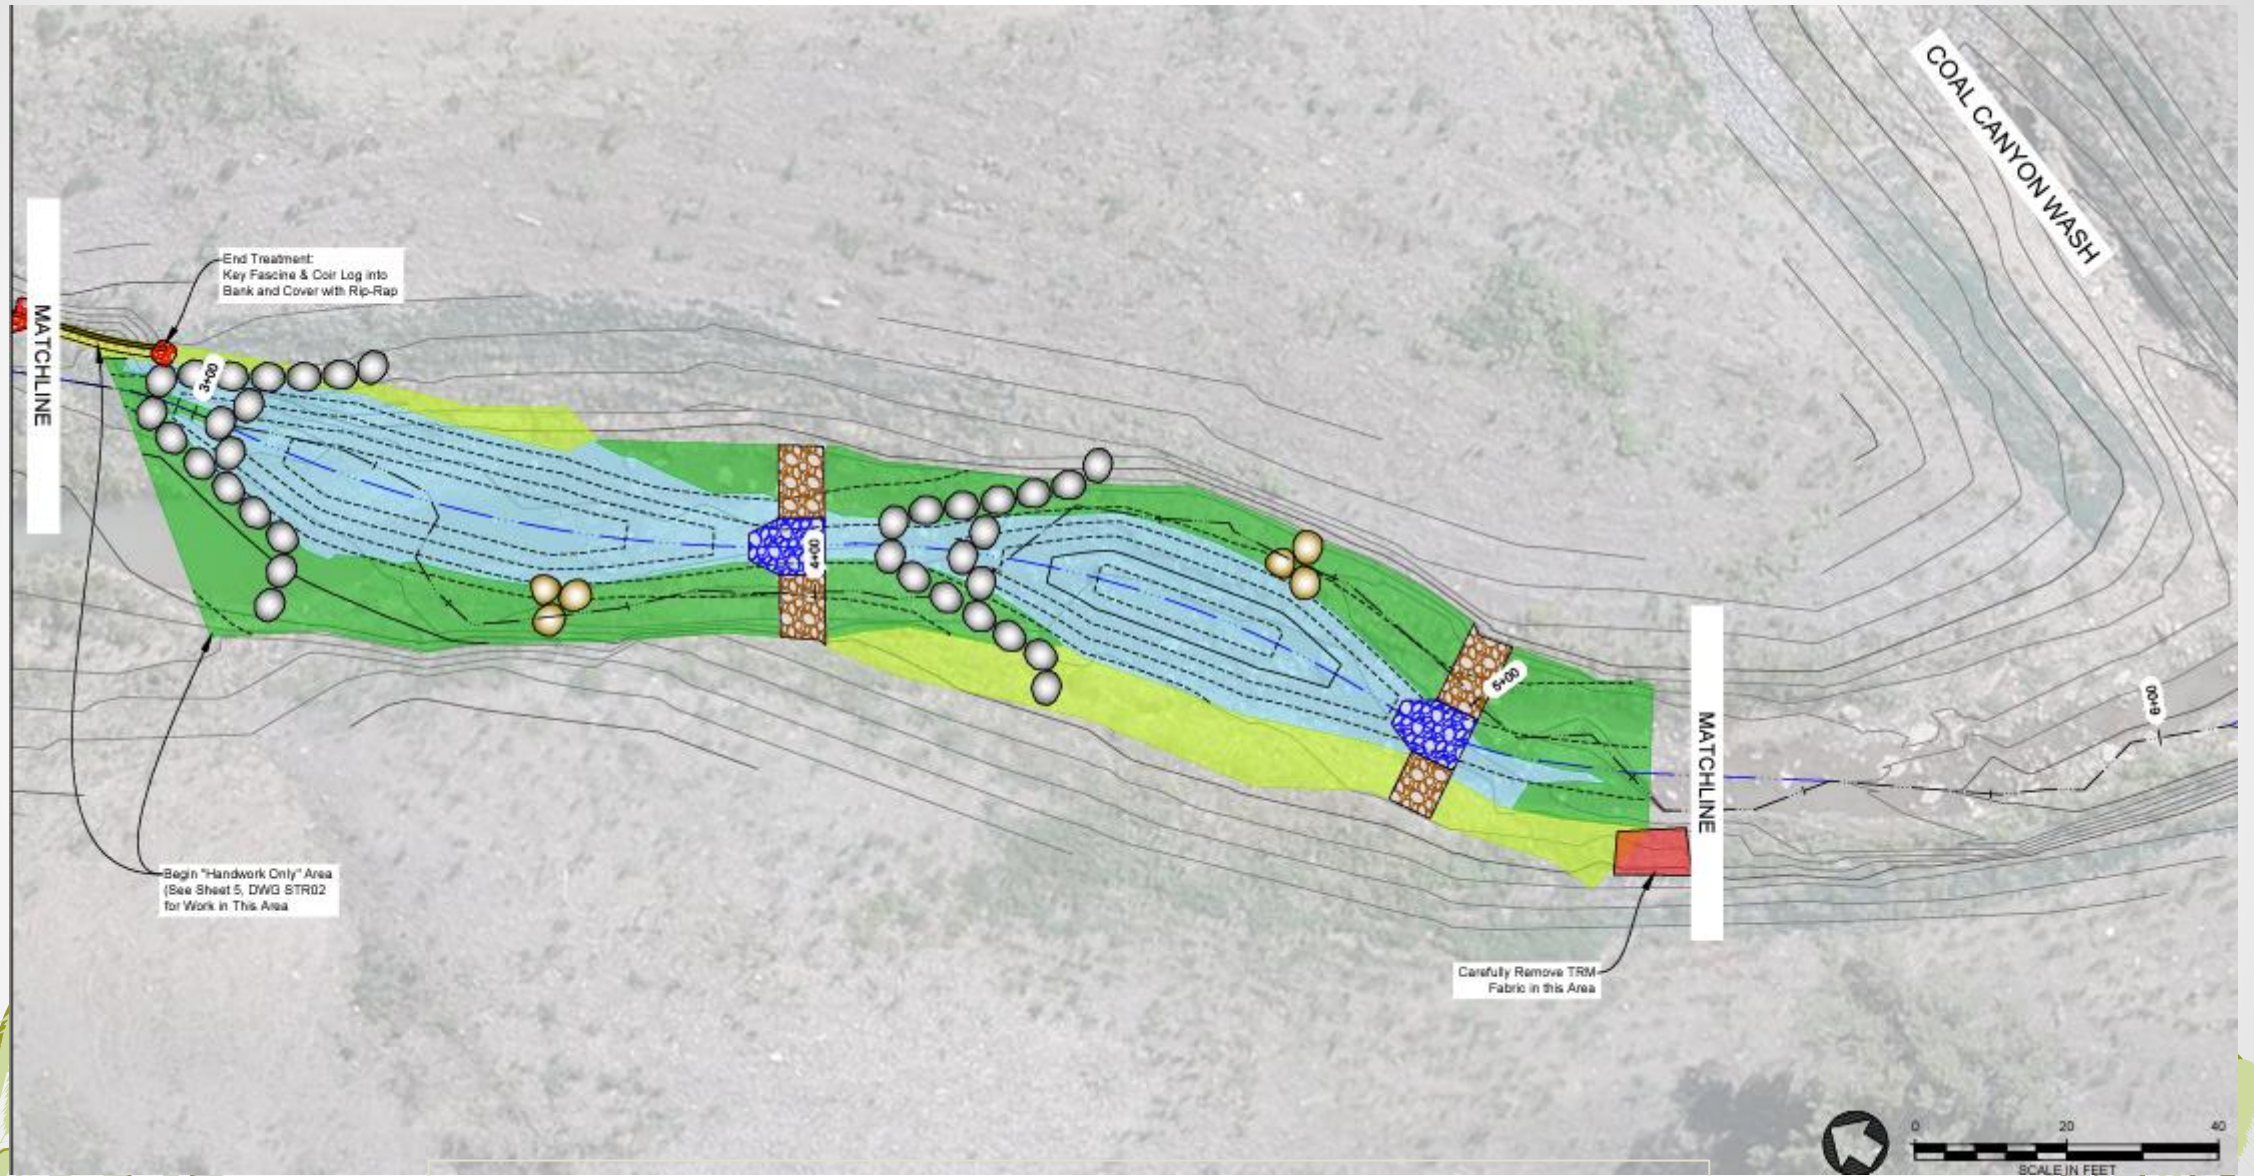
Figure 2. Overview of the Stream Work Design Elements

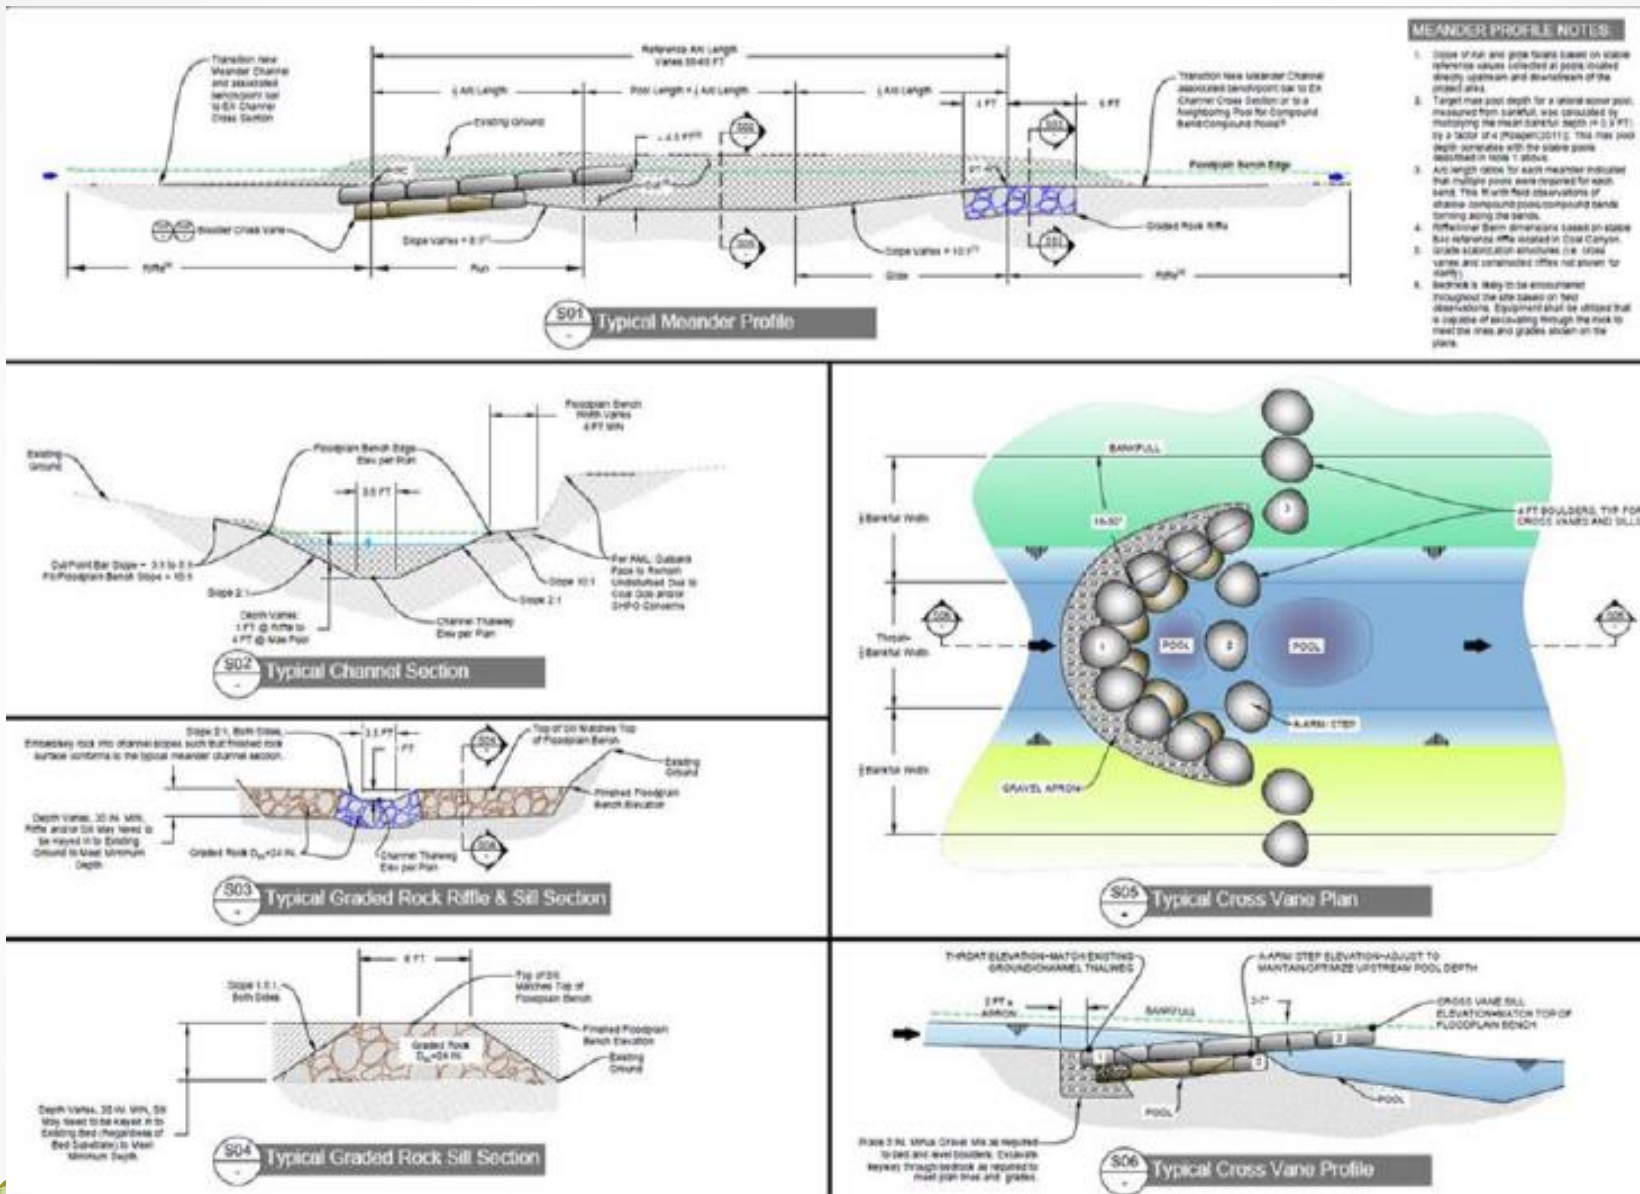
Figure 3. Typical Meander Overview

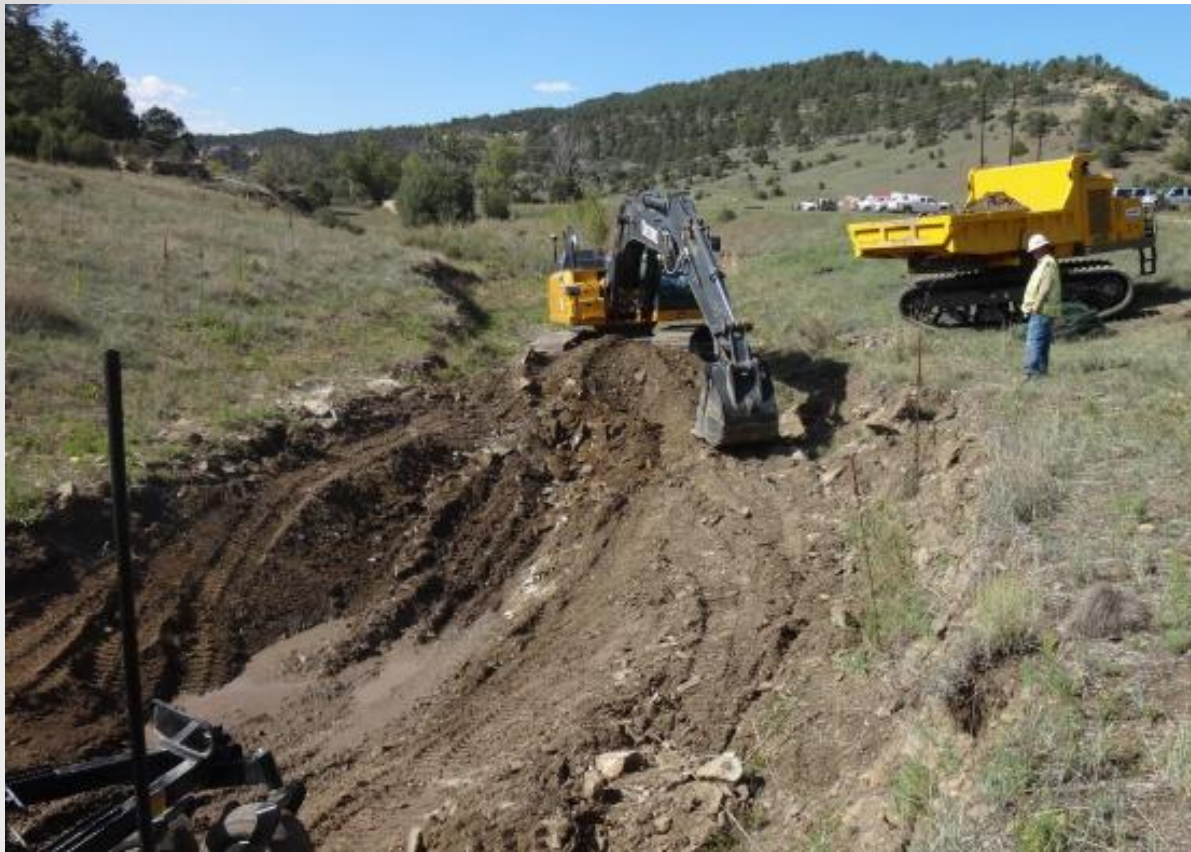
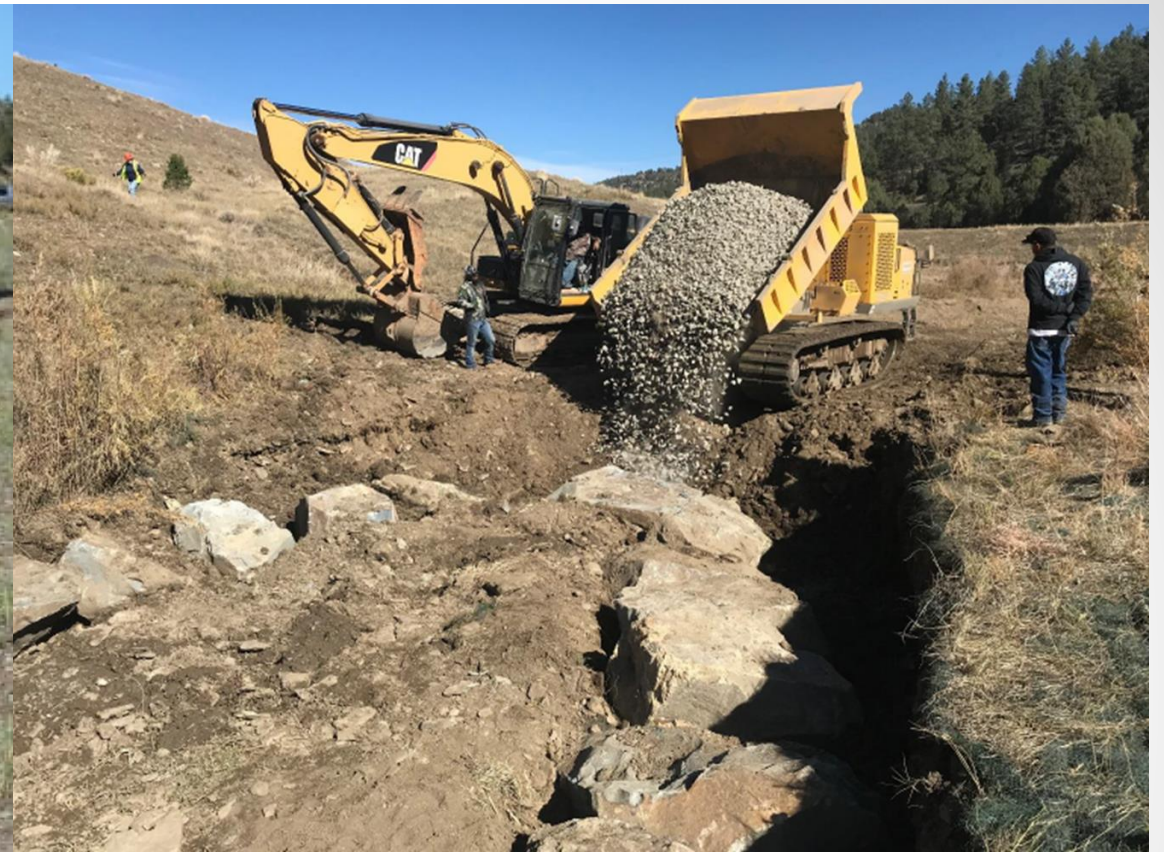
Figure 5. Conveyor belt being used to drop boulders into place in the stream channel across an archaeological avoidance area (left) and equipment work in the channel (above).

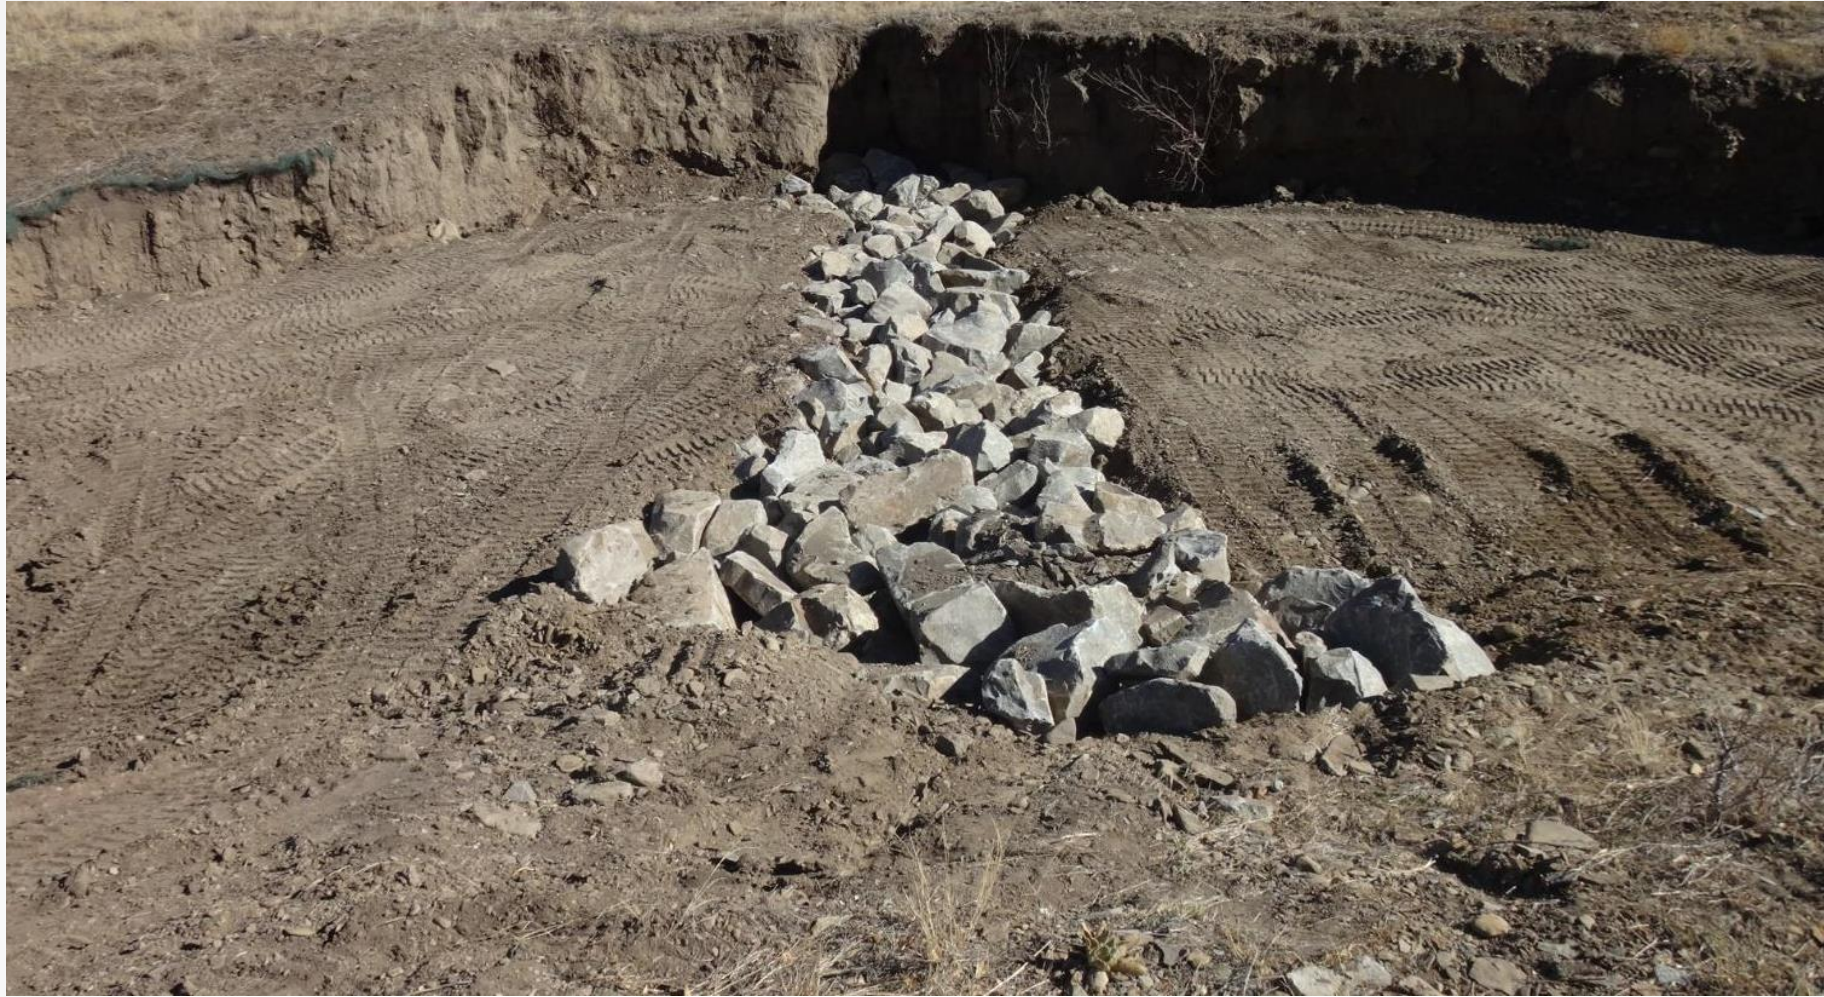
Figure 6. Shaping Pools within Channel for Installation of Rock Structures (Cross Vanes)

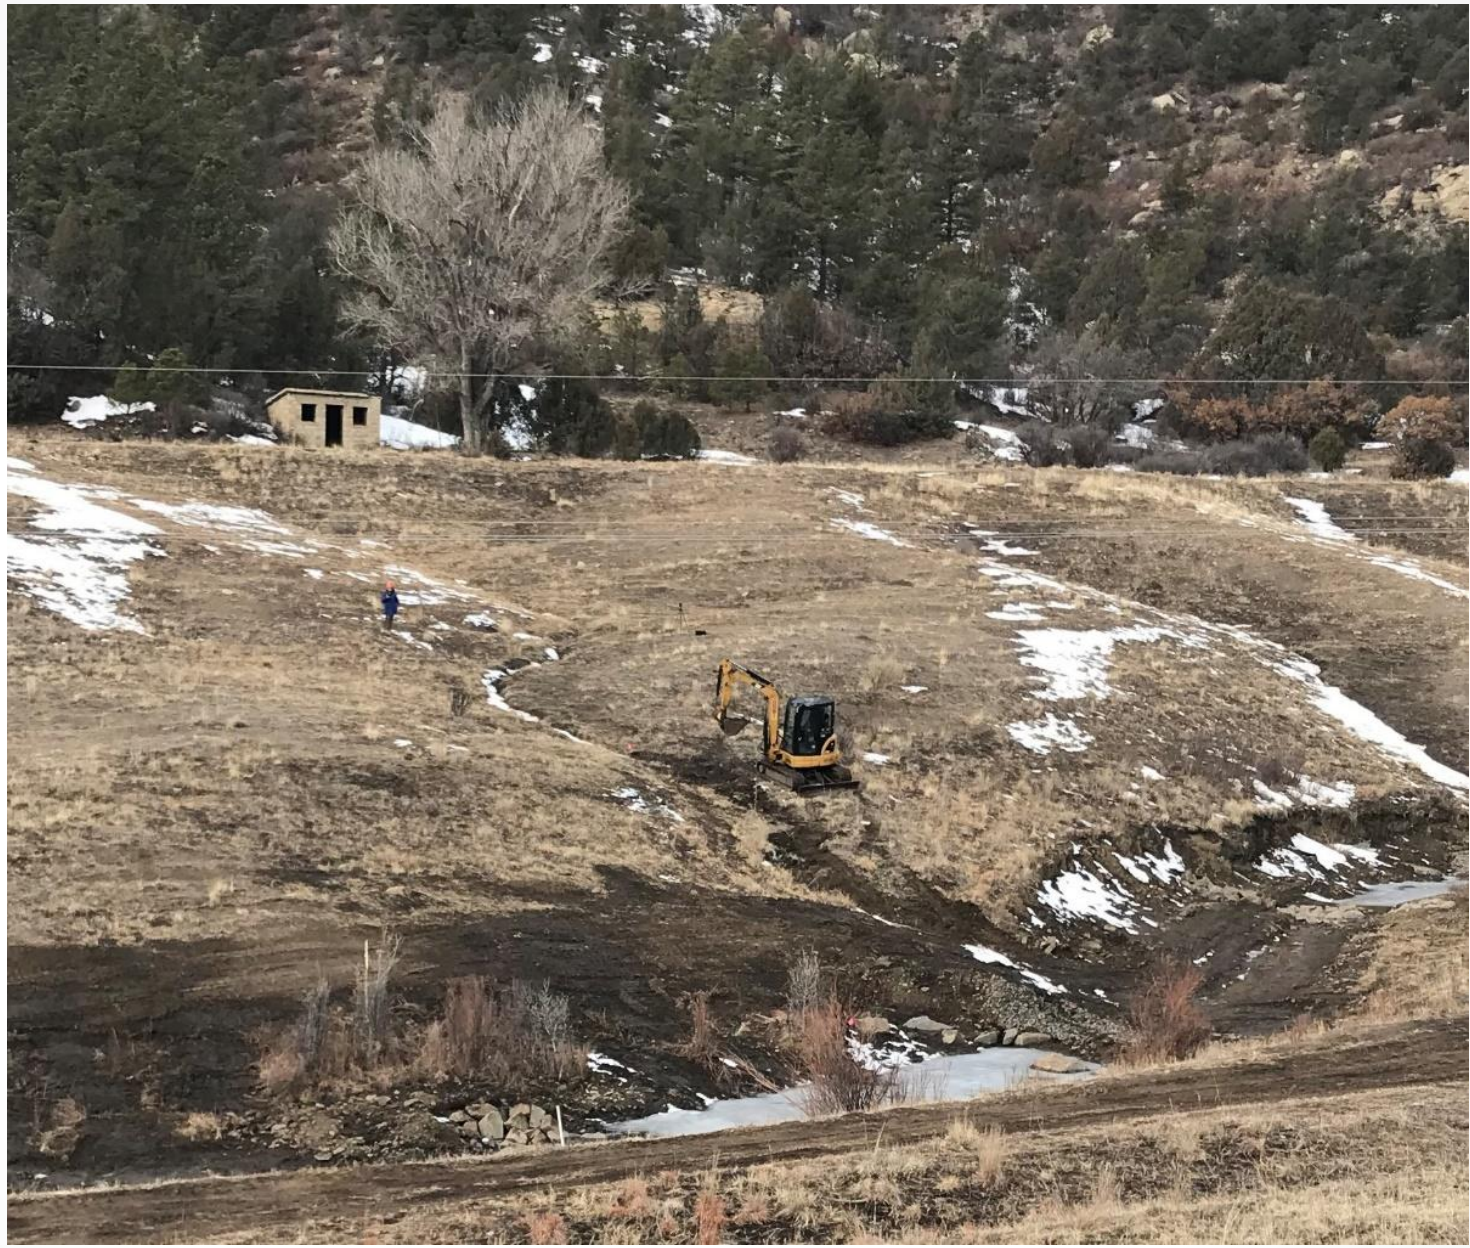
Figure 8. Working on upland erosion control structure in steep, frozen conditions.

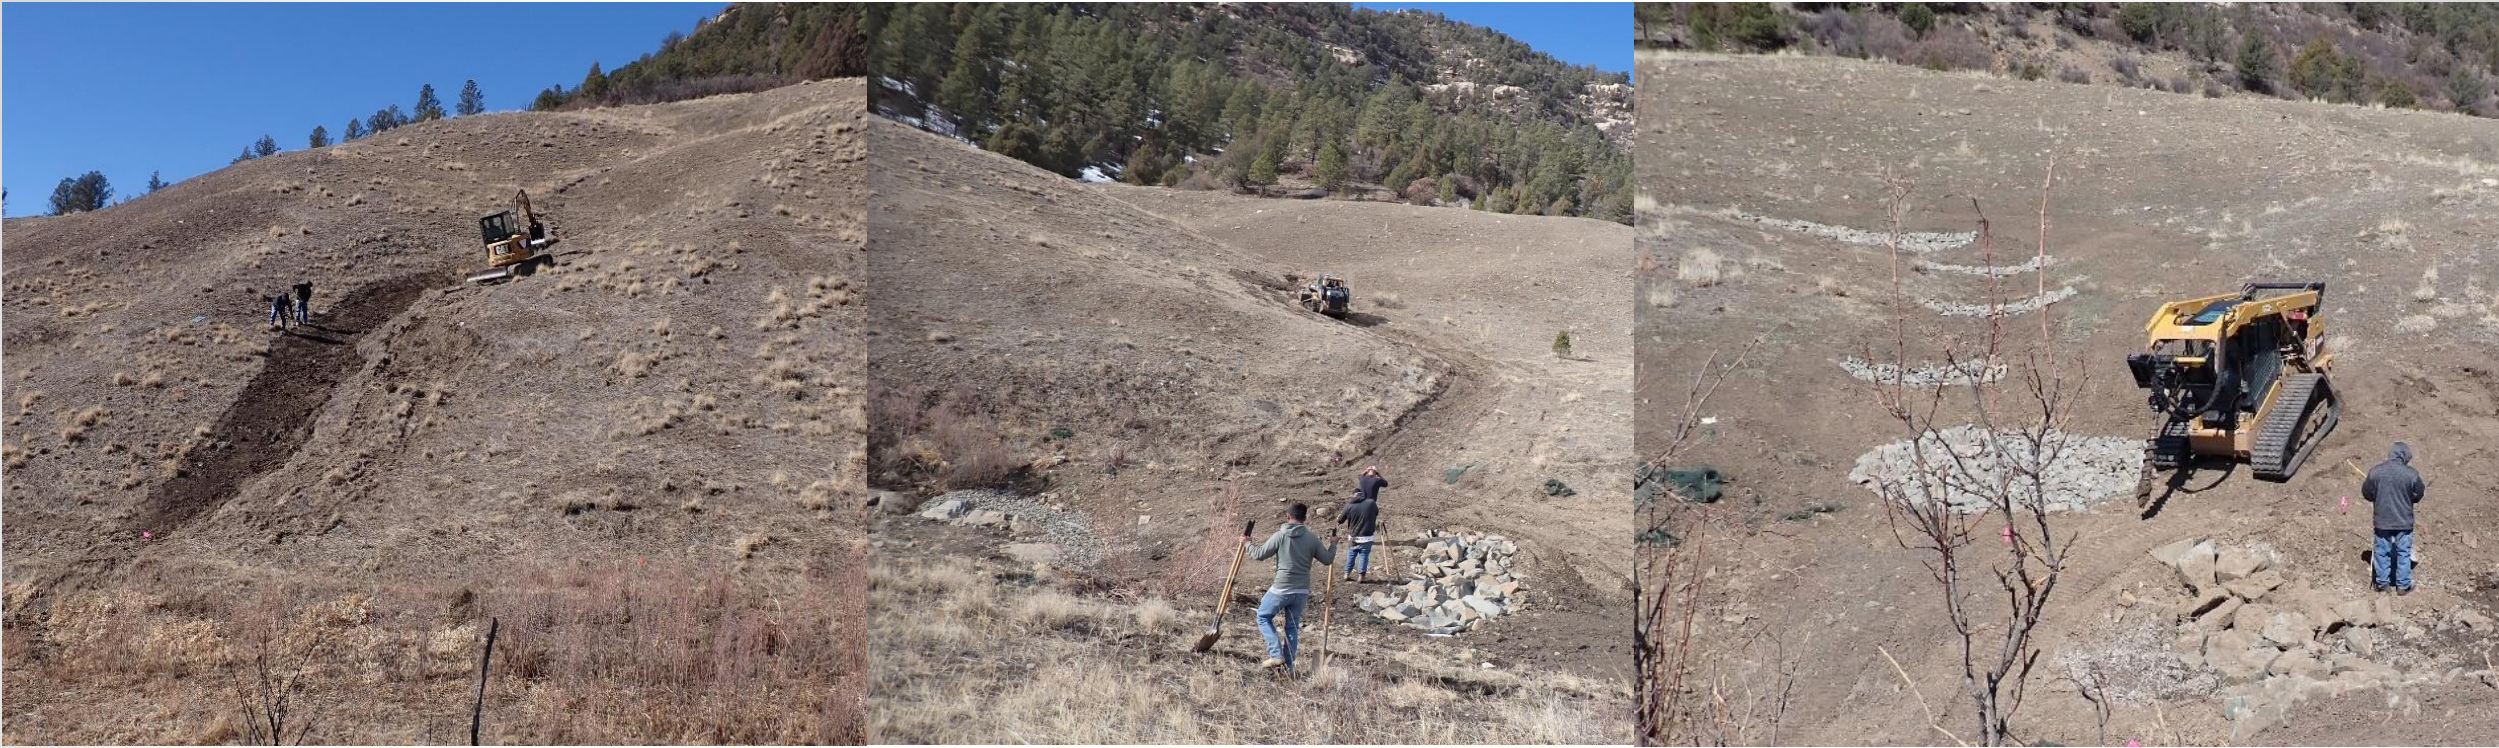
Figure 9. Shaping and installation of upland rock structures (one-rock check dams and media lunas)

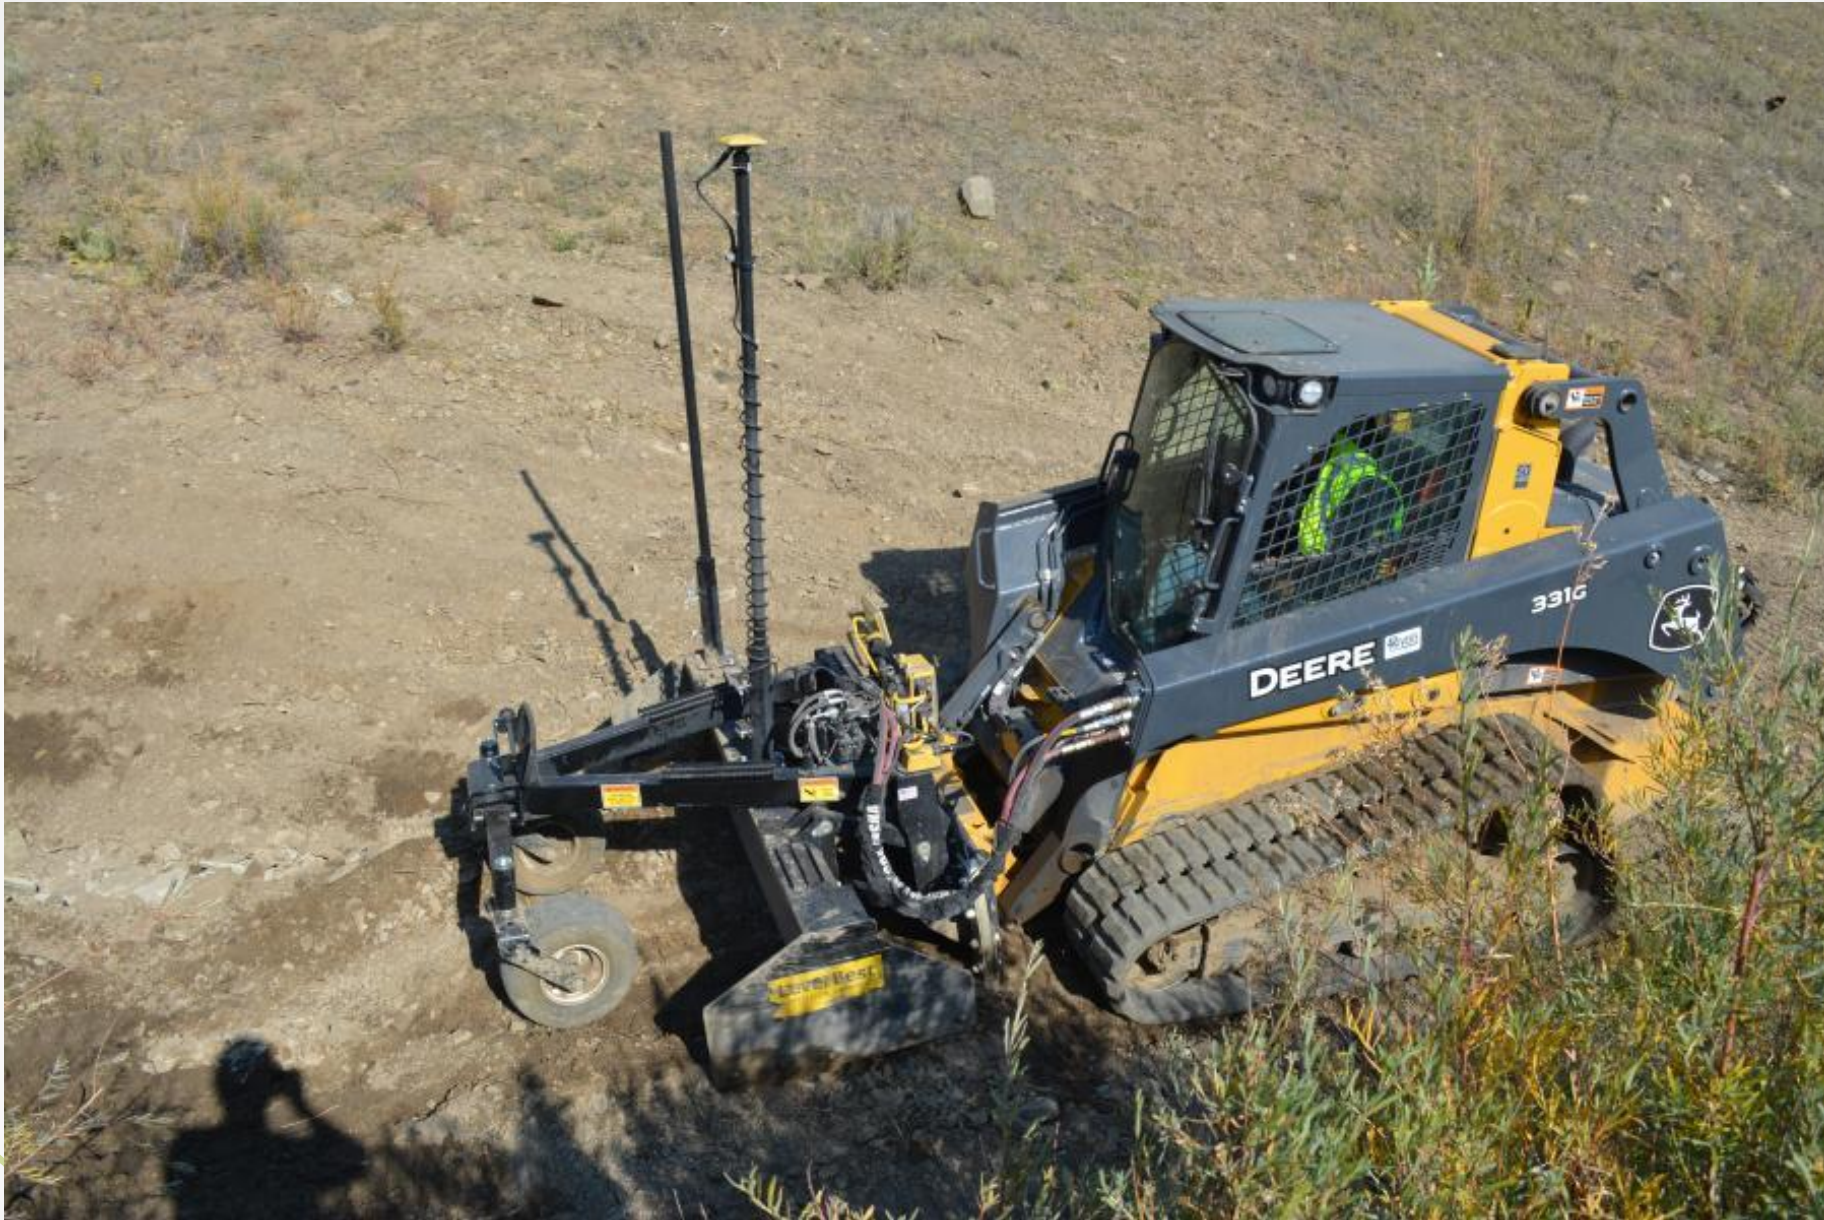
Figure 10. GPS-guided John Deere track loader above and Terramac Crawler below

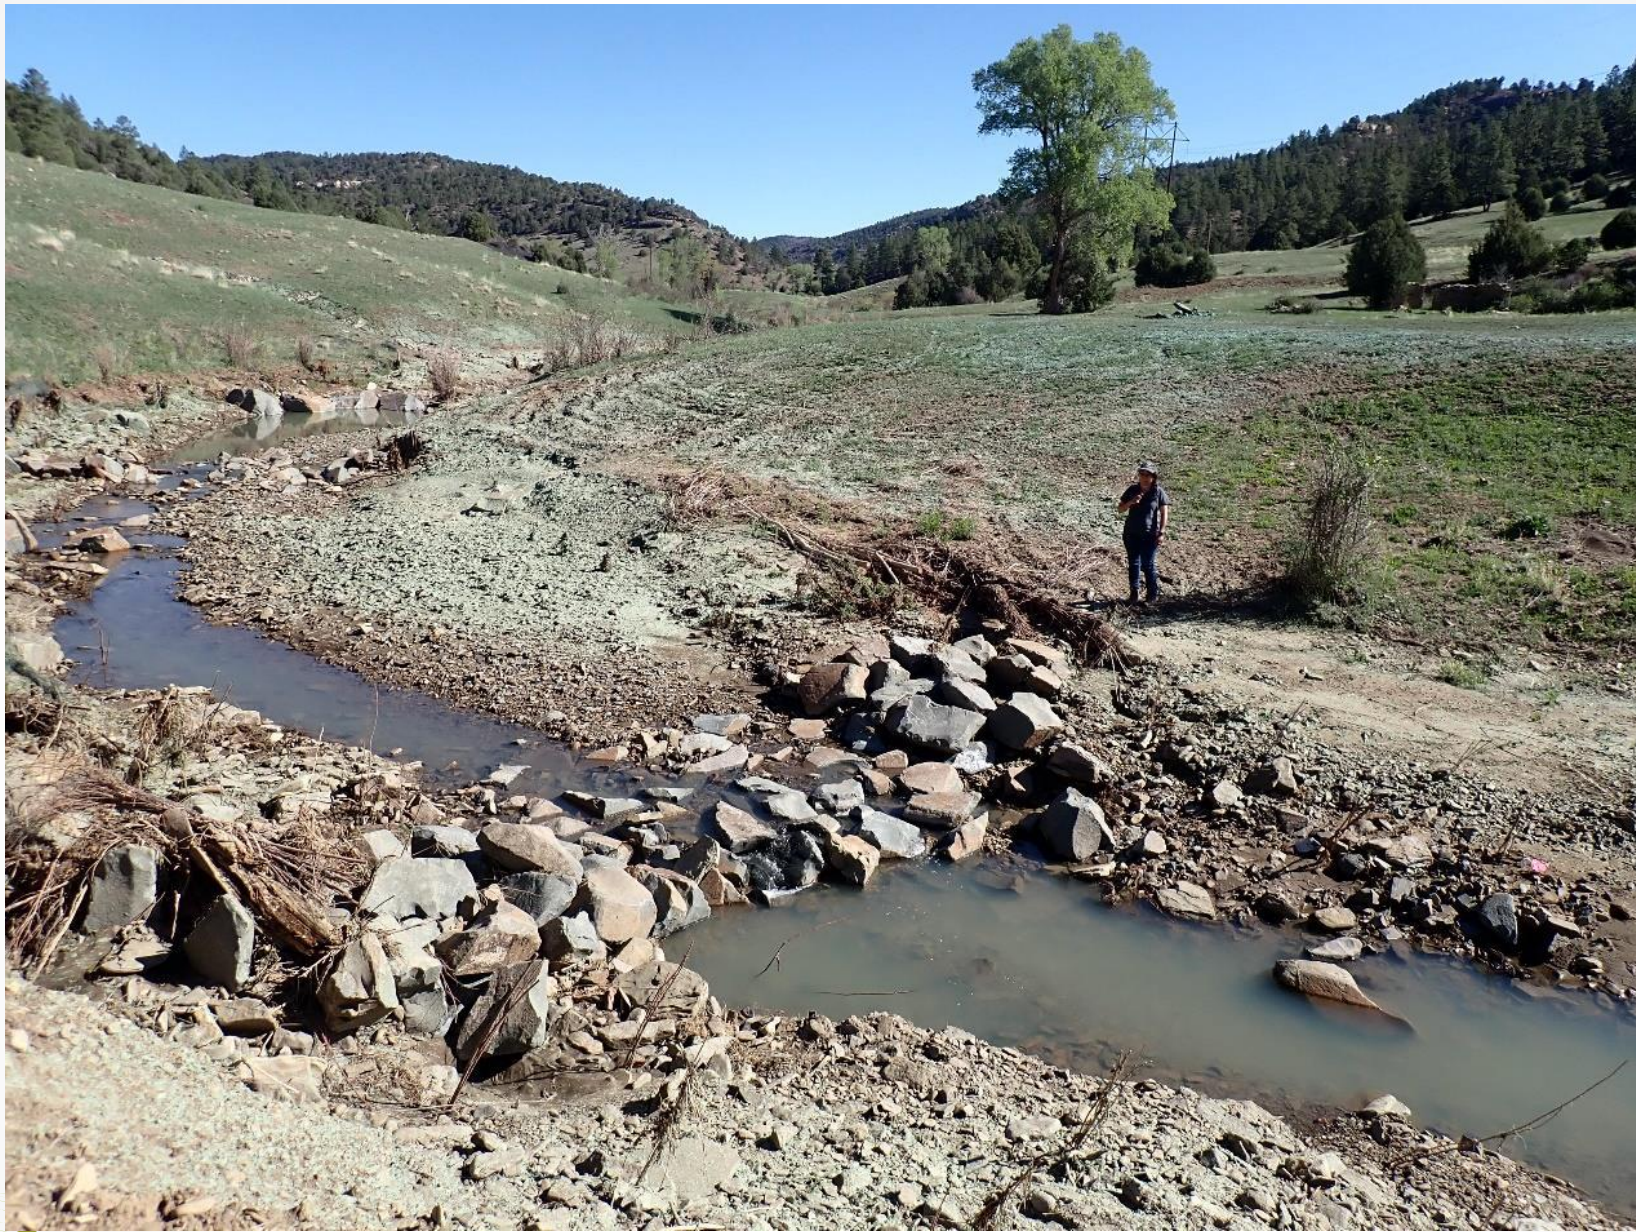
Figure 11. Structures doing their job after rain events, moving the flow away from eroding banks

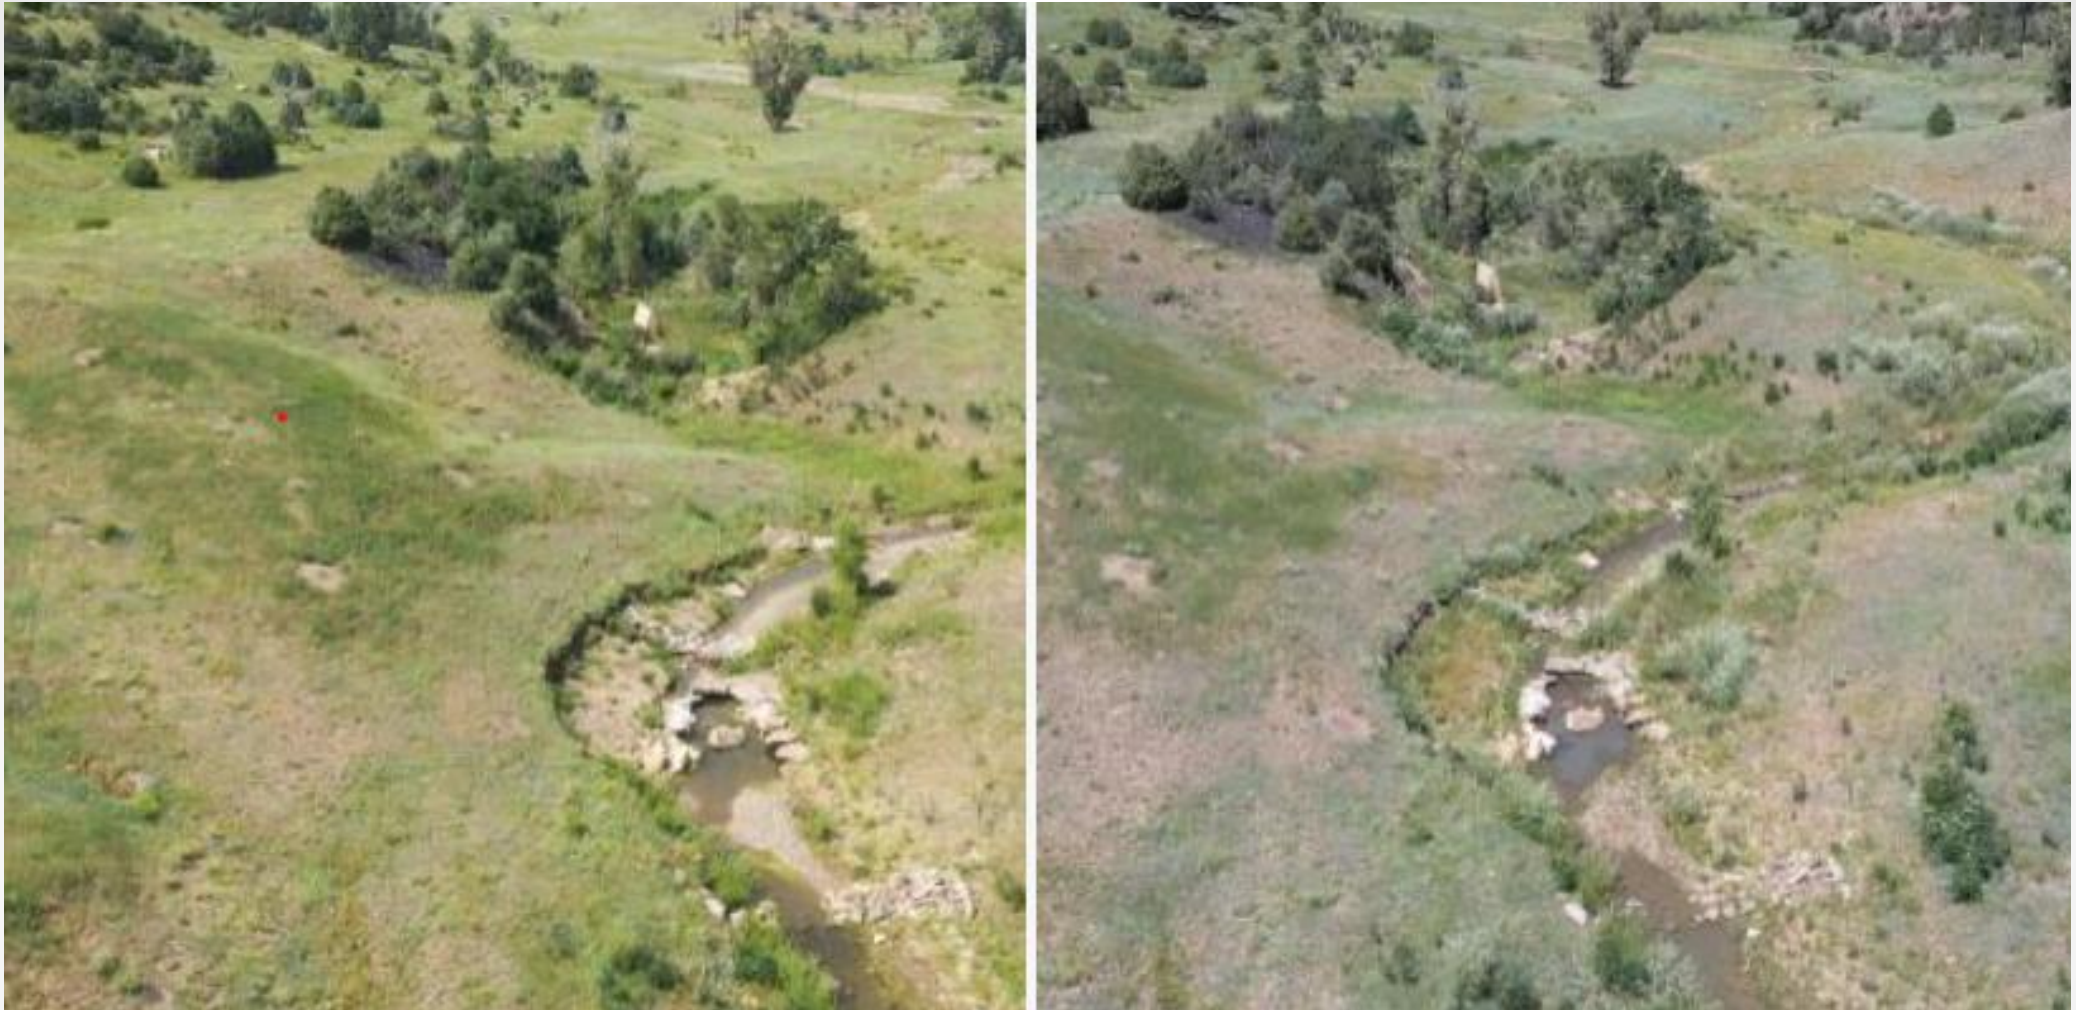
Figure 12. One year after reclamation monitoring using small uncrewed aircraft systems. Notice the pant growth on benches.
