# Request for Revision 26-1 GCC Rio Grande Tijeras Mine and Mill

*PERMIT NO. BE001RE*

Prepared for  
GCC Rio Grande, Inc

Prepared by  
Barr Engineering Co.

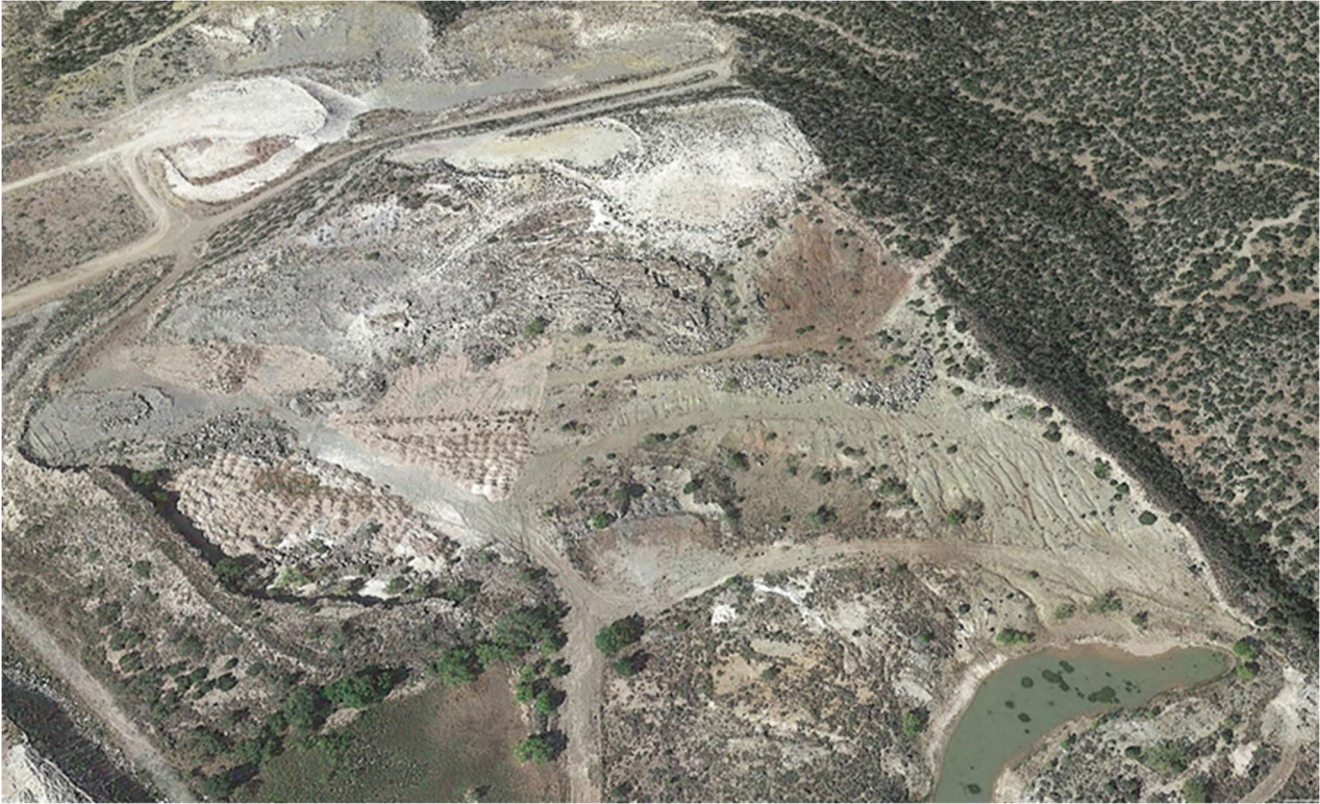
Figure 3 Quarry 1 Pre-Grading

GCC requests a partial release of reclamation liability for portions of Quarry 1 where reclamation activities have been completed. This request is based on a review of existing reclamation documentation and field verification of current site conditions. Pre and post-grading photos are shown in Figures 3 and 4

- Completion of earthwork and grading;
- Demonstrated surface stability; and
- No evidence of significant erosion or drainage issues.
- Supporting figures and documentation are included in Figures 2, 3, and 4

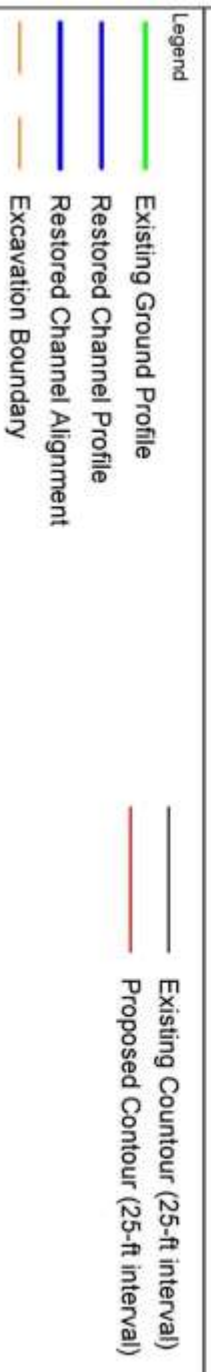
**Map 10**  
 Conceptual Plan & Profile for  
 Apachitos Canyon  
 Restoration  
 April 2, 2019

### APACHITOS CANYON PROFILE

### APACHITOS CANYON RESTORED CHANNEL TYPICAL CROSS SECTION

Apachitos Canyon will be restored to its approximate original alignment and gradient. Corral Canyon will be restored to a different alignment than pre-mining to minimize excavation, but with a longitudinal gradient similar to pre-mining conditions. Given that Apachitos Canyon and Corral Canyon will be restored with channel dimensions and longitudinal gradients similar to pre-mining conditions, riprap should not be necessary to stabilize the channels. Anywhere the restored channels deviate from the pre-mining alignments, those deviations do not result in a significantly steeper channel or include an abrupt change in channel gradient that would produce a severe nick point.
