Professional and Technical Services for the I&W Brine Cavern Project

Task 1: Site Monitoring

Monthly Site Monitoring Report – December 2017

***Project:* Seismic Data Processing Results & Health Analysis Report
for AMEC Monitoring System**

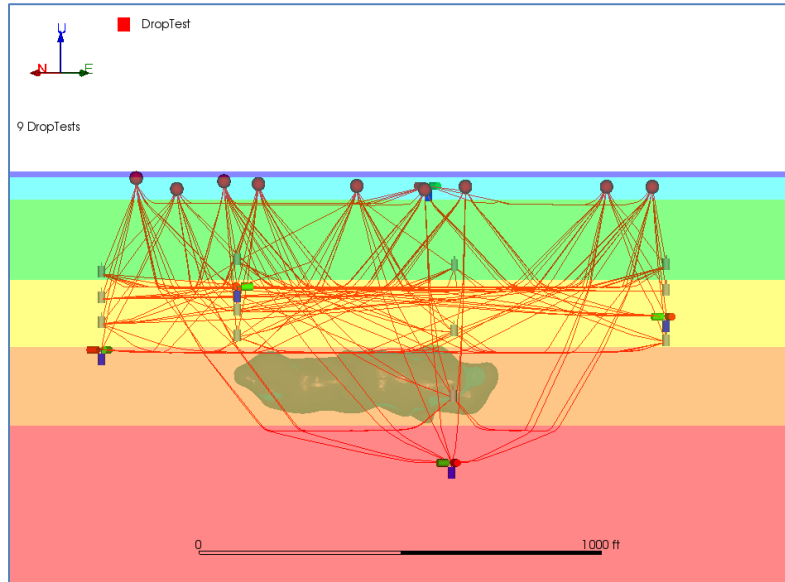
Results of P-wave Velocity Model Inversion

- P-wave ray paths from the 9 calibration seismic sources (drop-tests, with clear signal) to sensors are illustrated below.

- The 3D seismic velocity model has been optimized.
- In particular, the seismic velocities of the six sedimentary layers, where multiple ray-paths of the calibration events (drop-tests) have traveled, were optimized by minimizing the absolute location errors of the calibration events with known coordinates.

Layer#	Elevation ¹ (ft)	V _P velocity estimates (ft/sec)		
		Original ²	New ³	Difference
1	3130	5591.2	5792	200.8
2	3090	9013.4	8801	-212.4
3	3032	8612.2	8448	-164.2
4	2887	12731.1	12049	-682.1
5	2720	12790.1	12993	202.9
6	2523	14973.3	14799	-174.3

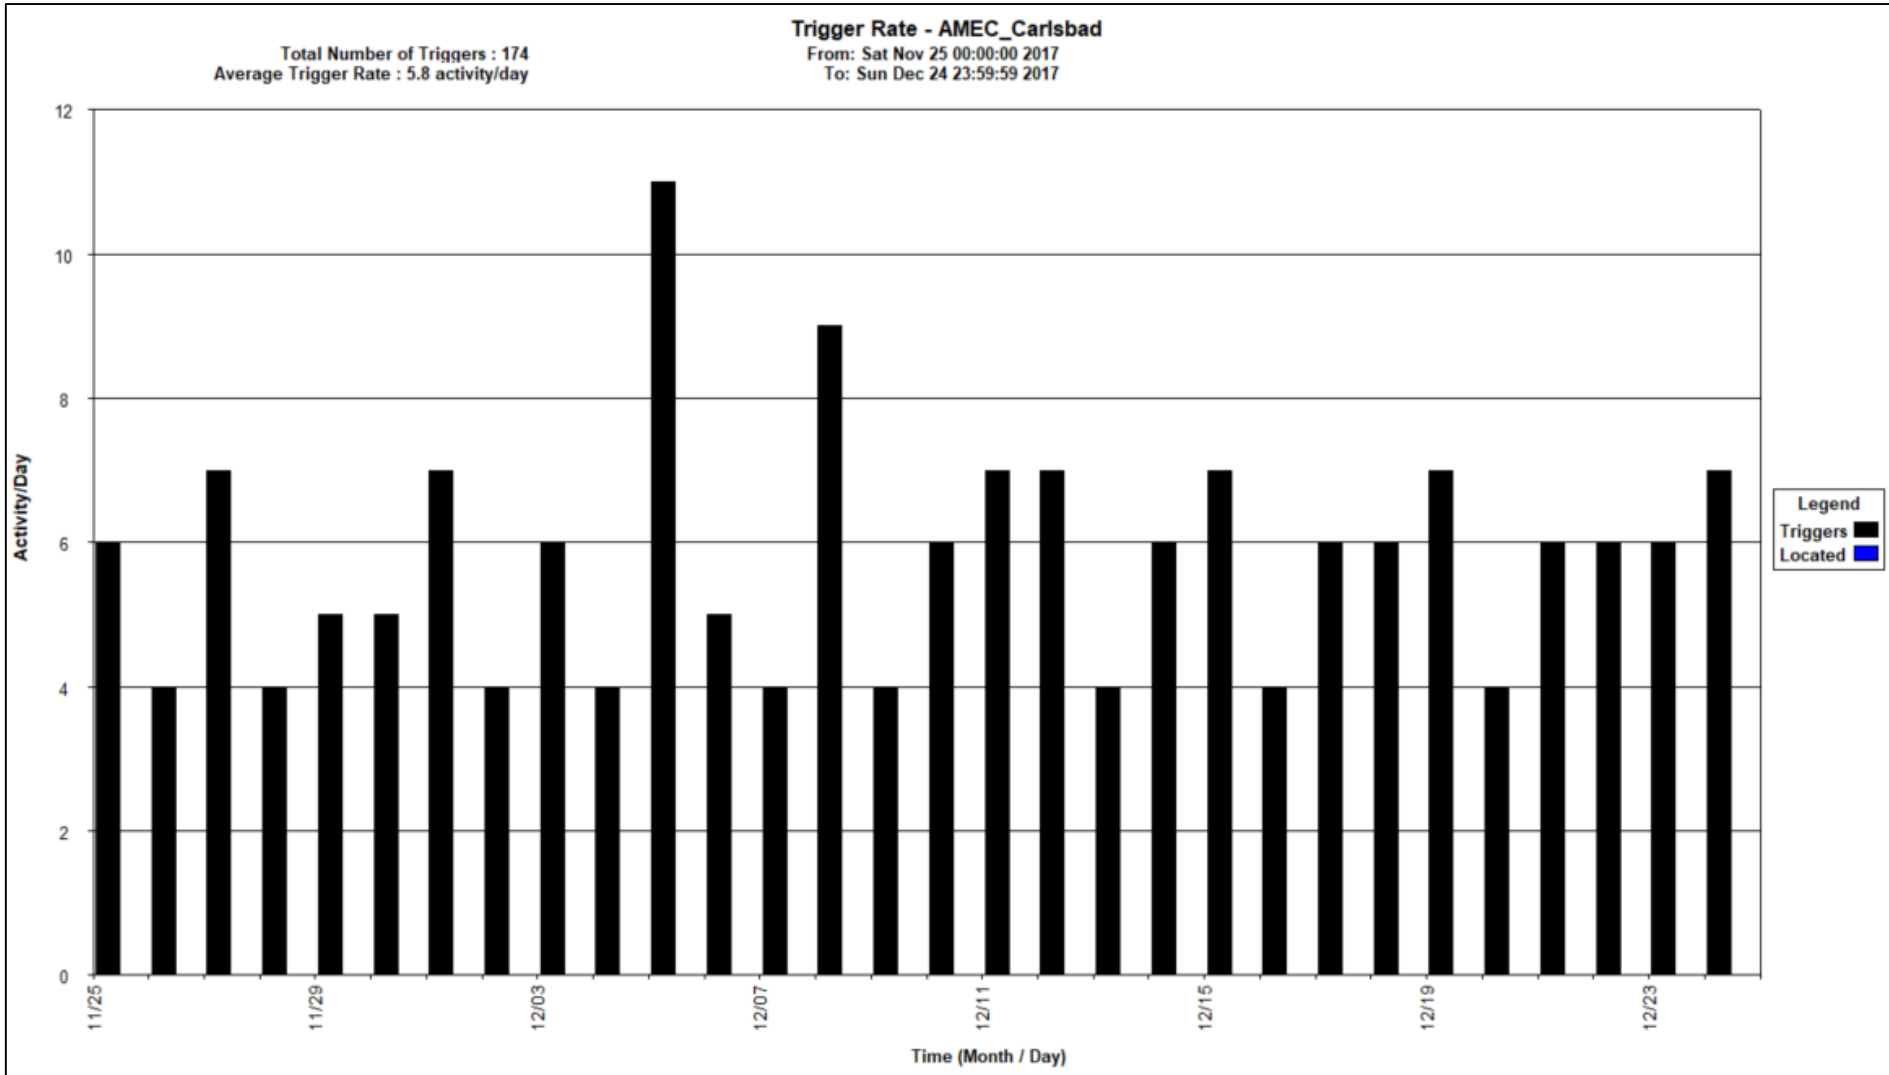
Trigger Rate Graph

- Trigger rate graph

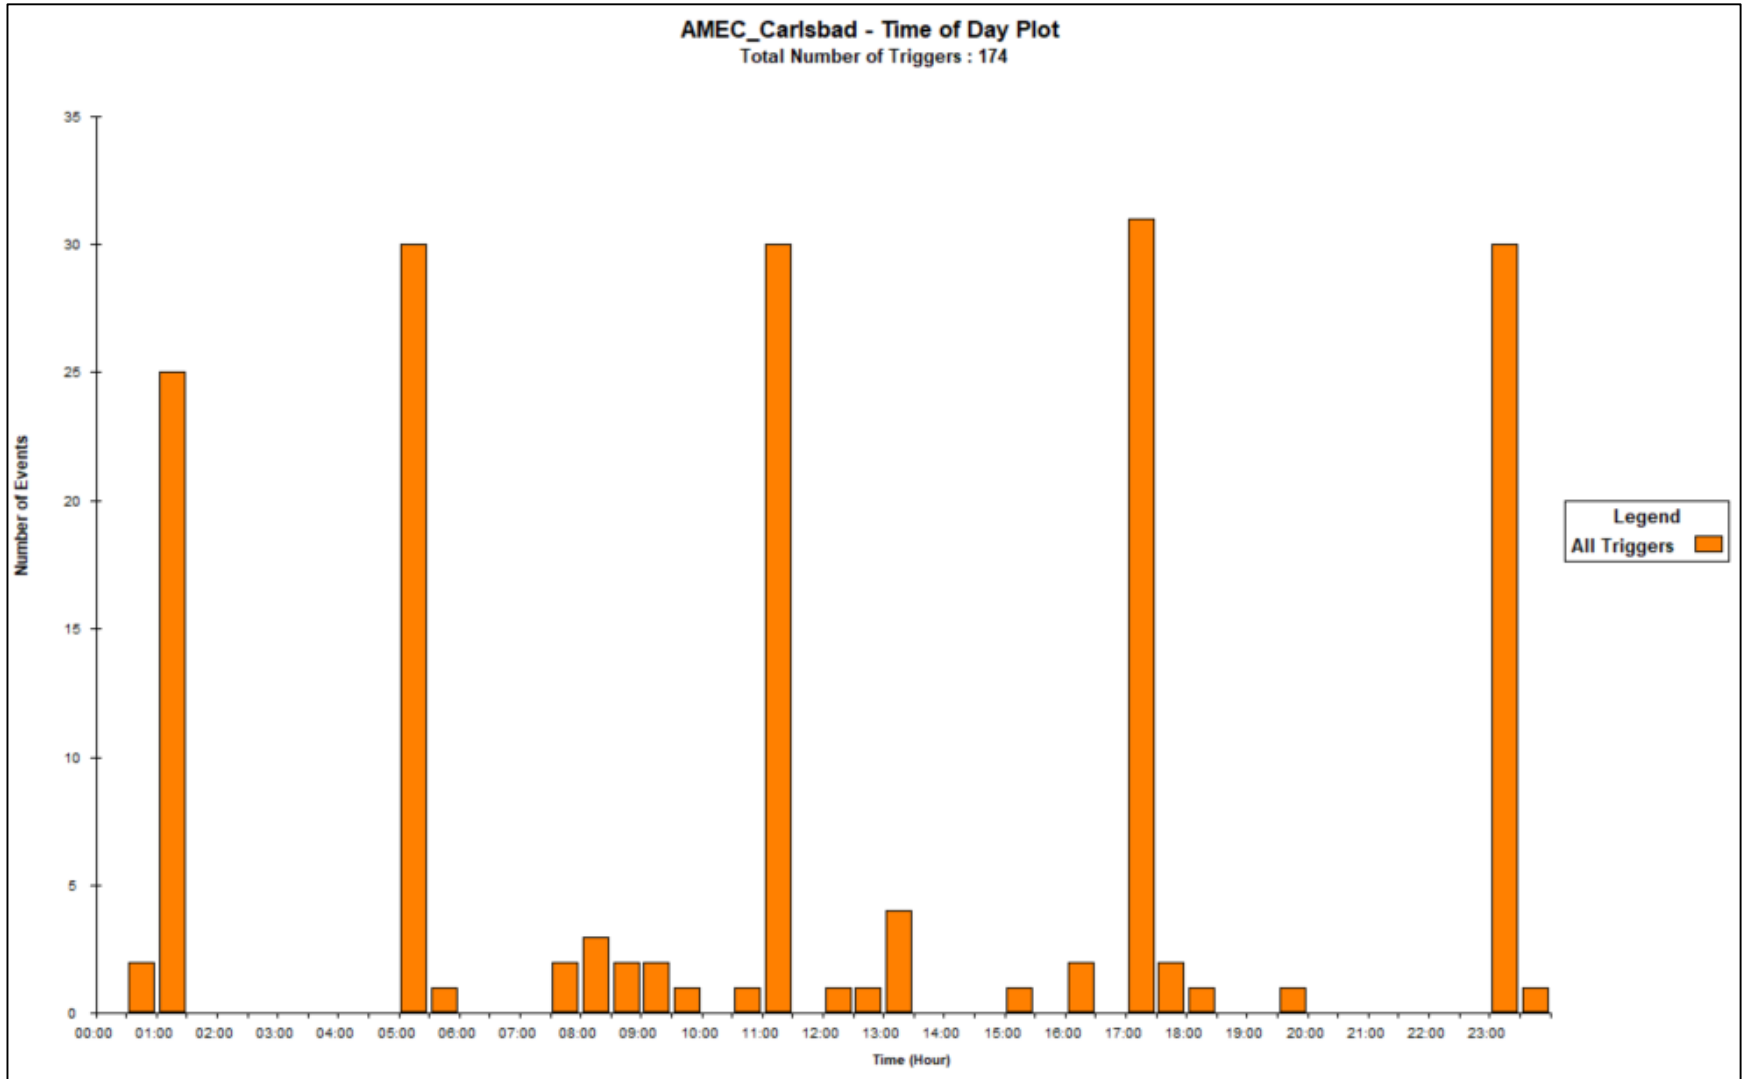
Time of Day Plot

- Please note that the system generates a background auto trigger every six hours each day at 06:00:00 am/pm and 12:00:00 am/pm. The graph shows these auto triggers.
- The graph also includes daily sensor pulse tests which occur at 01:00.

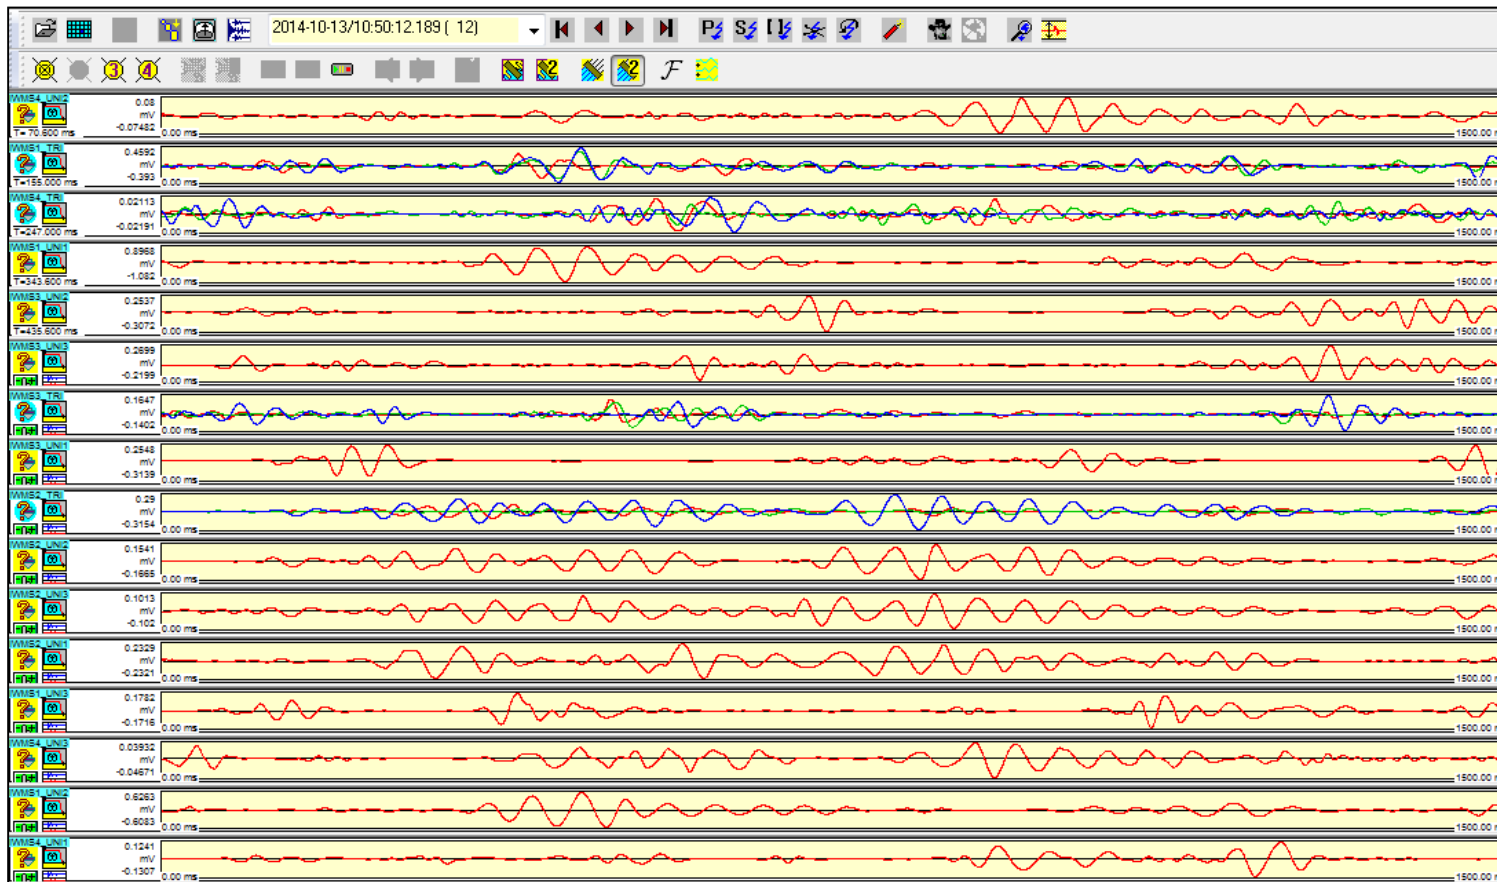
- Example of Noise Trigger

- Uncharacteristic seismic signal or elevated background noise resulting in a trigger.
- Examples include electrical spikes and mono frequency pulses.
- Cannot be source located.
