USACE PRECONSTRUCTION NOTICE AND AQUATIC RESOURCE REPORT

Nationwide Permit Pre-Construction Notification (PCN)

Questa Tailings Pipeline Removal

Taos County, New Mexico

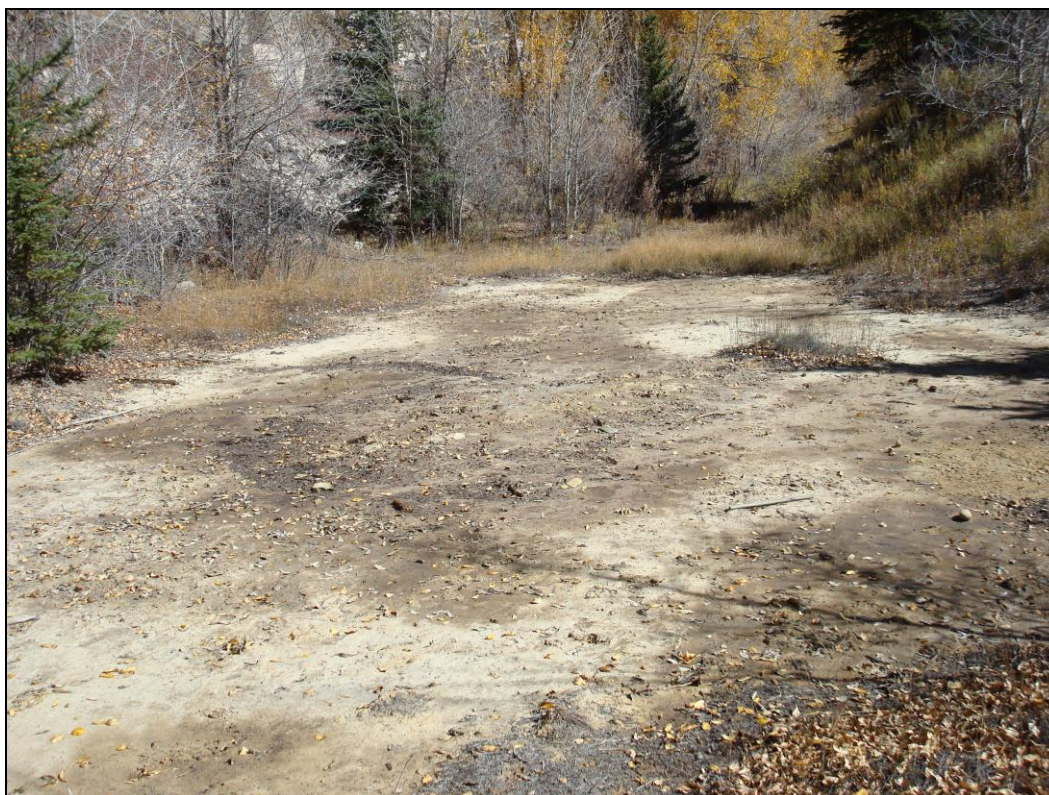
Photograph 2. To East. View of wetland HTS-2.

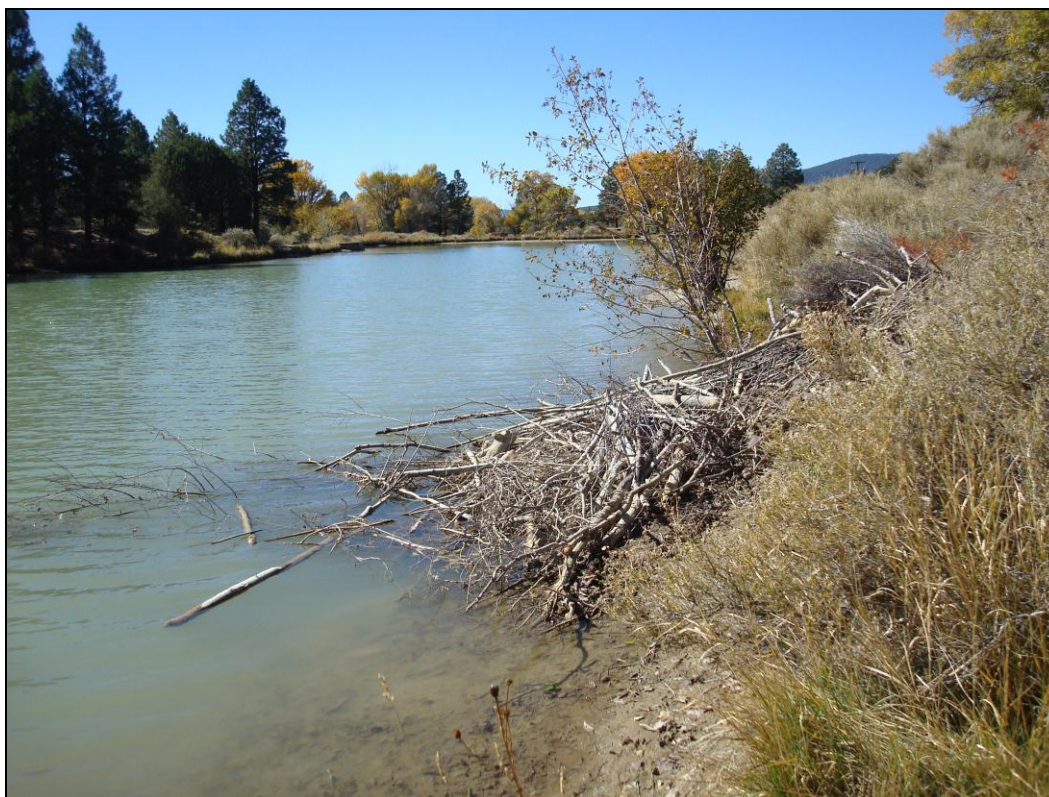
Photograph 5. To West. Beaver lodge on the north shore of Eagle Rock Lake (OW-ERL1).

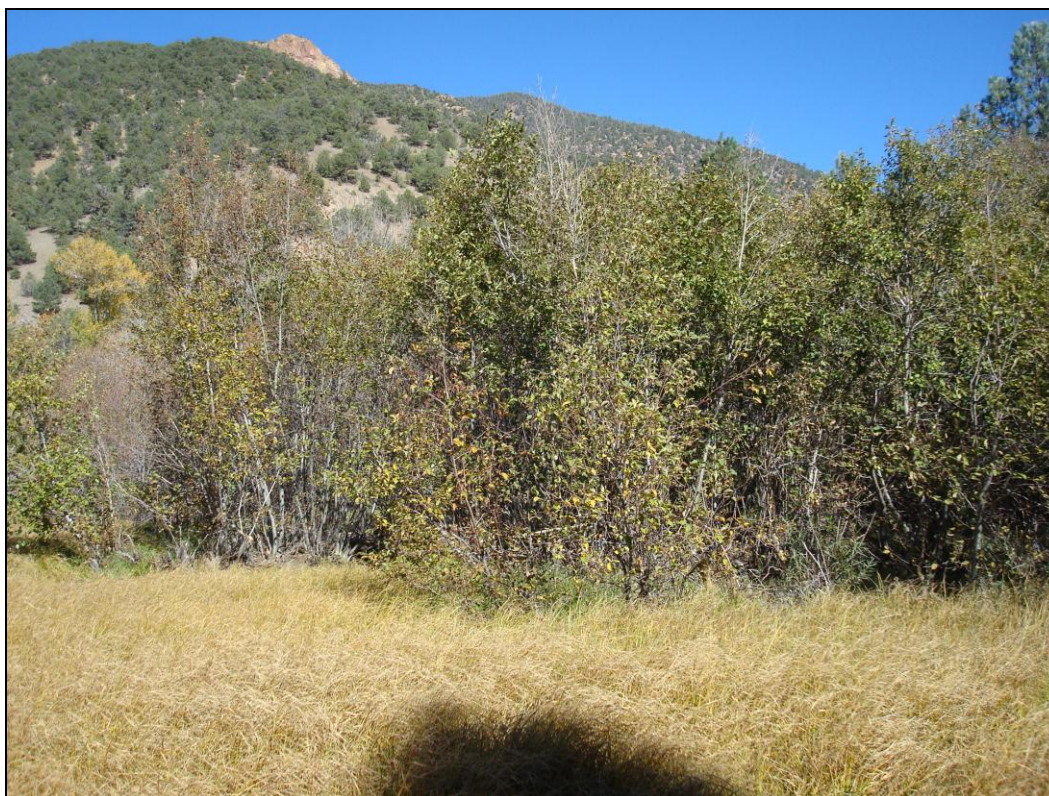
Photograph 6. To Northeast. View of wetland ERL-PFO. Wetland ERL-PEM occurs in photograph foreground.

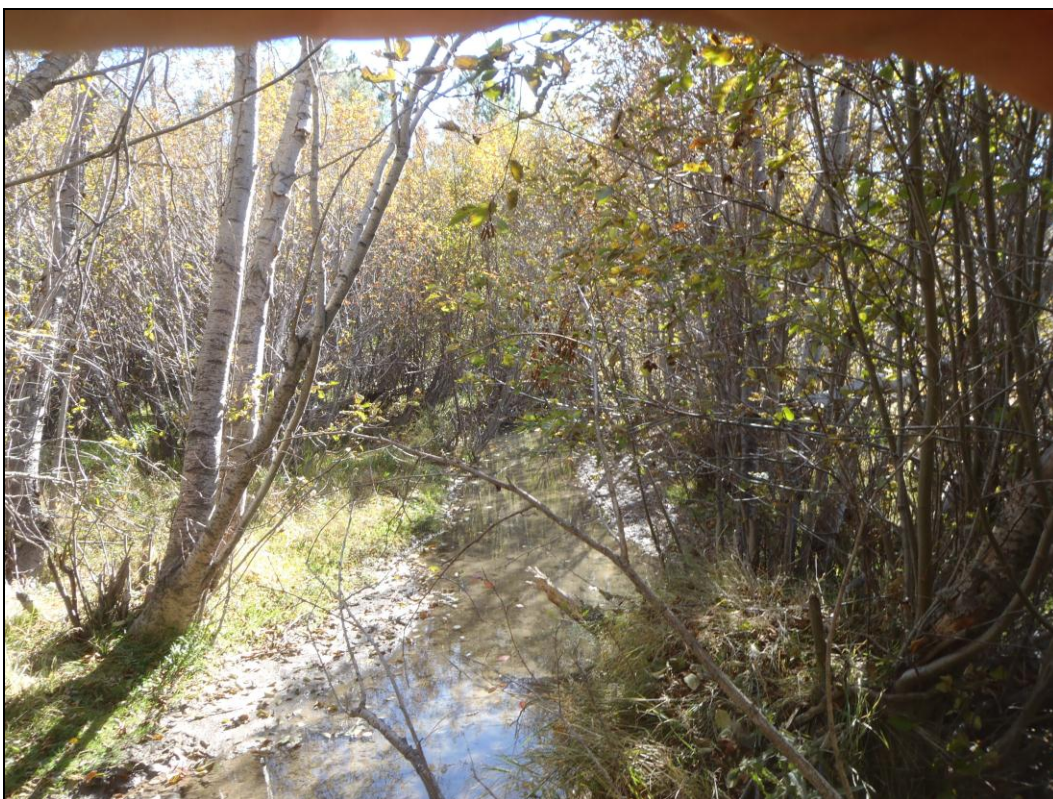
Photograph 7. To West. View of wetland ERL-PFO and Eagle Rock Lake diversion channel (OW-ERL3) near Eagle Rock Lake.

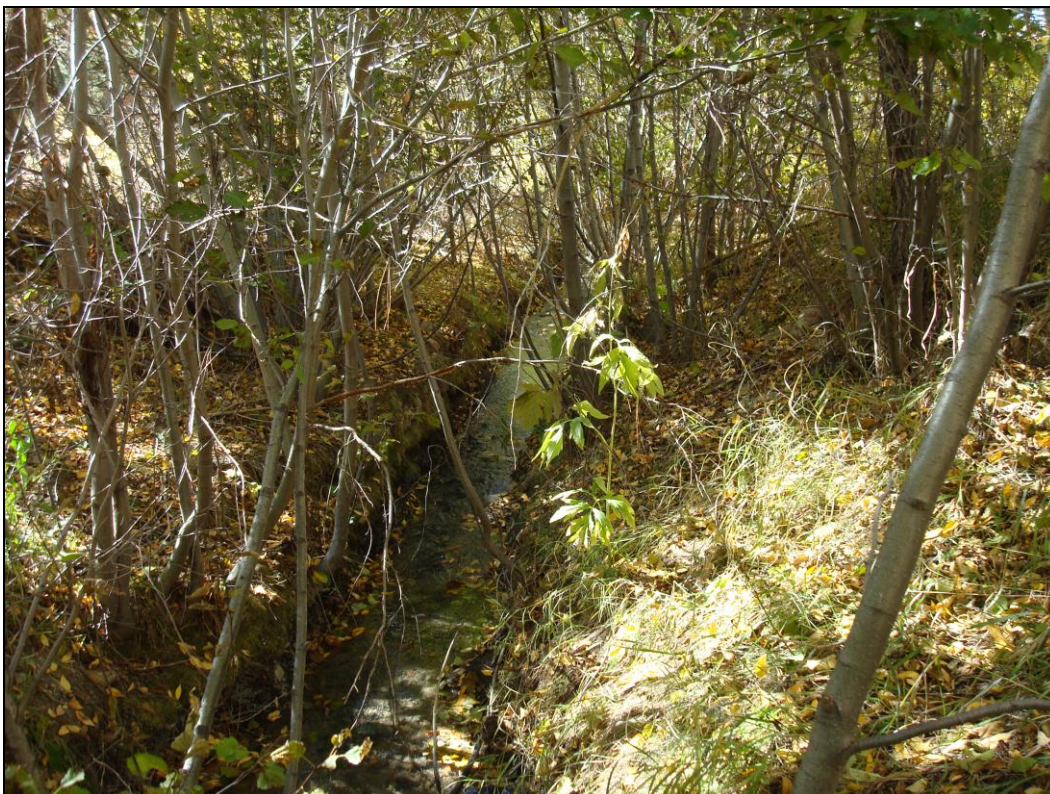
Photograph 8. To West. View of diversion channel OW-ERL3 upstream of wetland ERL-PFO.

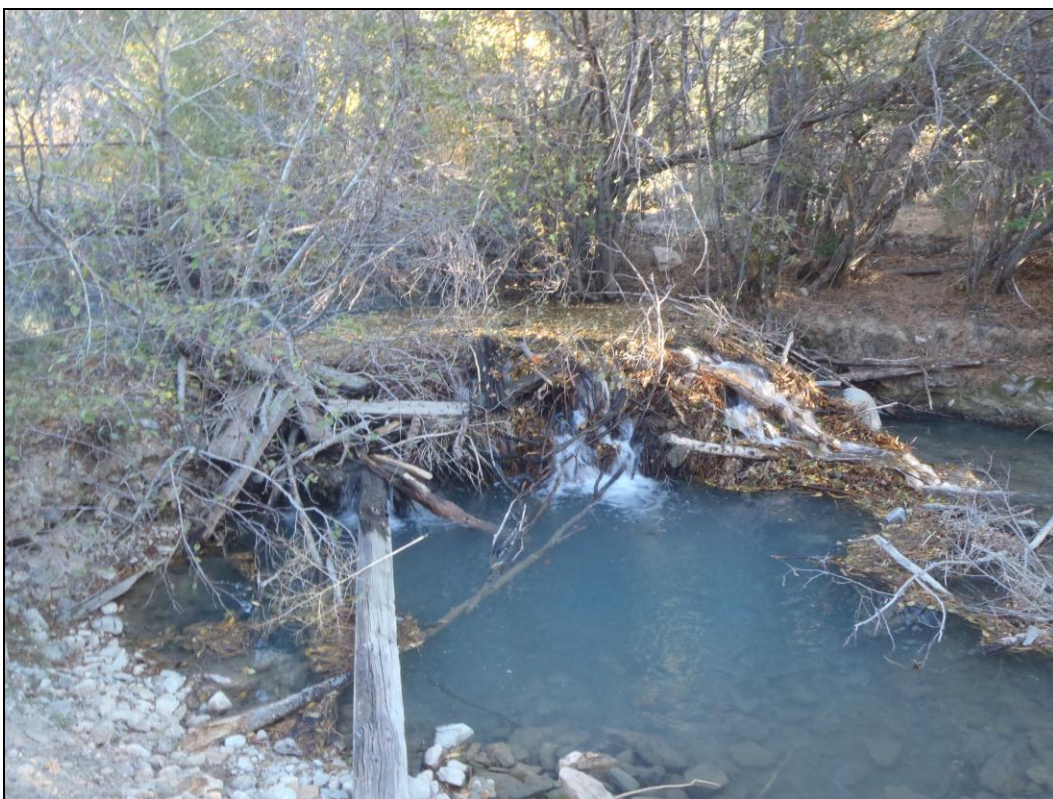
Photograph 11. To South. View of beaver dam within Red River (OW-ERL2) at the western end of the Eagle Rock Lake remediation area.

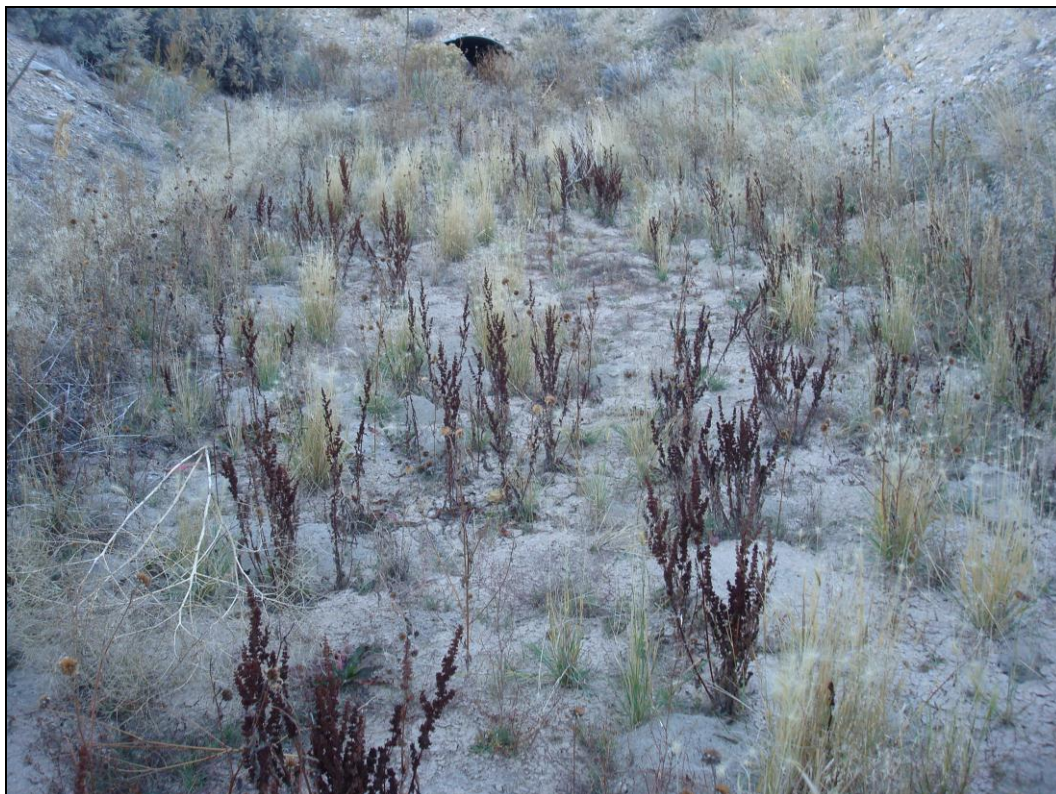
Photograph 17. To North. View of feature EDC-6 within the Eastern Diversion Channel. This area did not meet the three substantive criteria for wetlands.

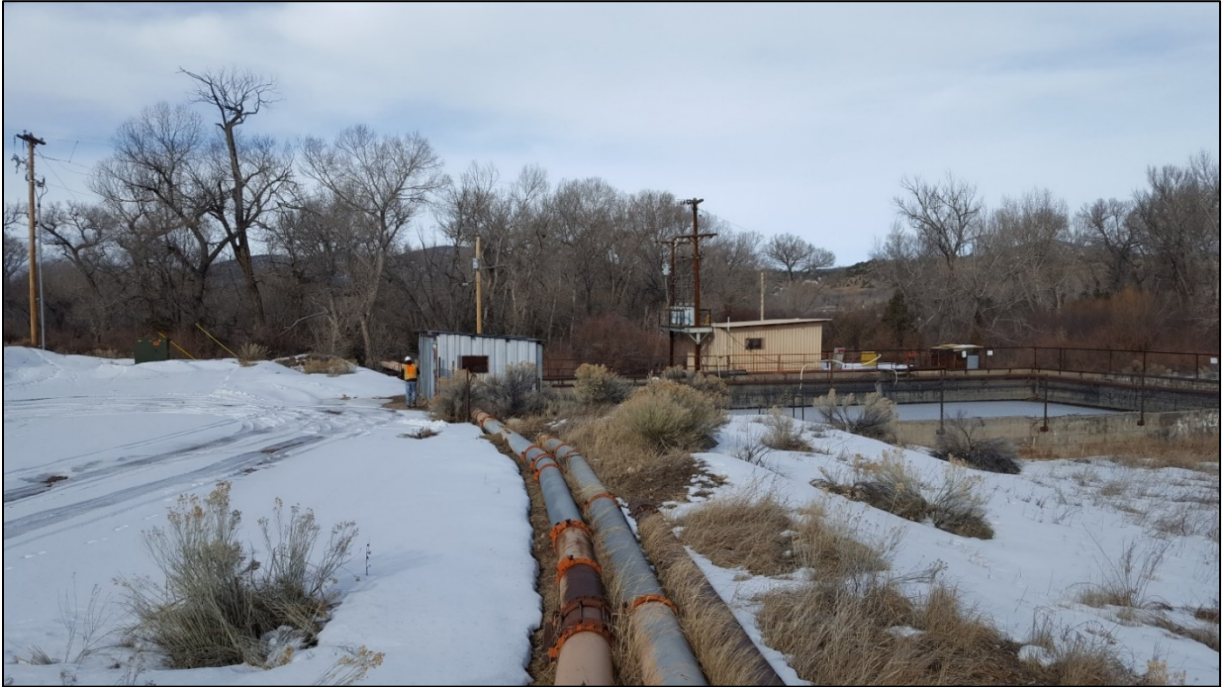
Photo 1. Lower Dump Sump, Viewed from East, Within Stage 8 Boundary

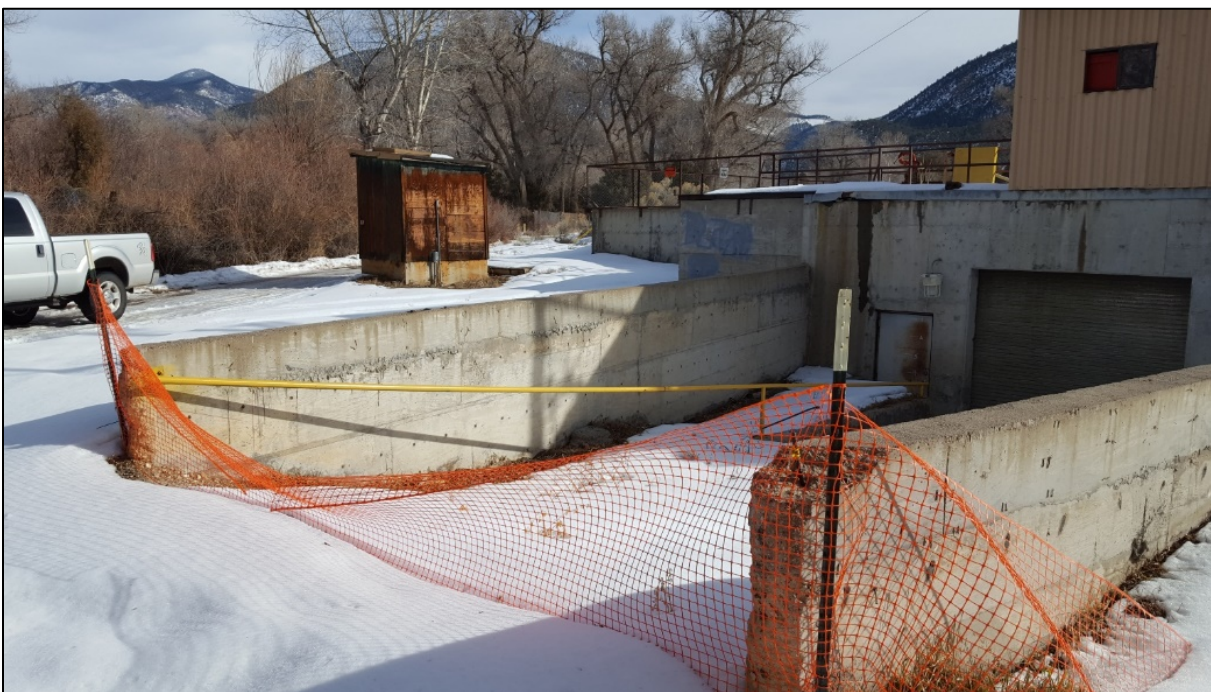
Photo 4. Ramped Access, Viewed from West, Within Site Boundary

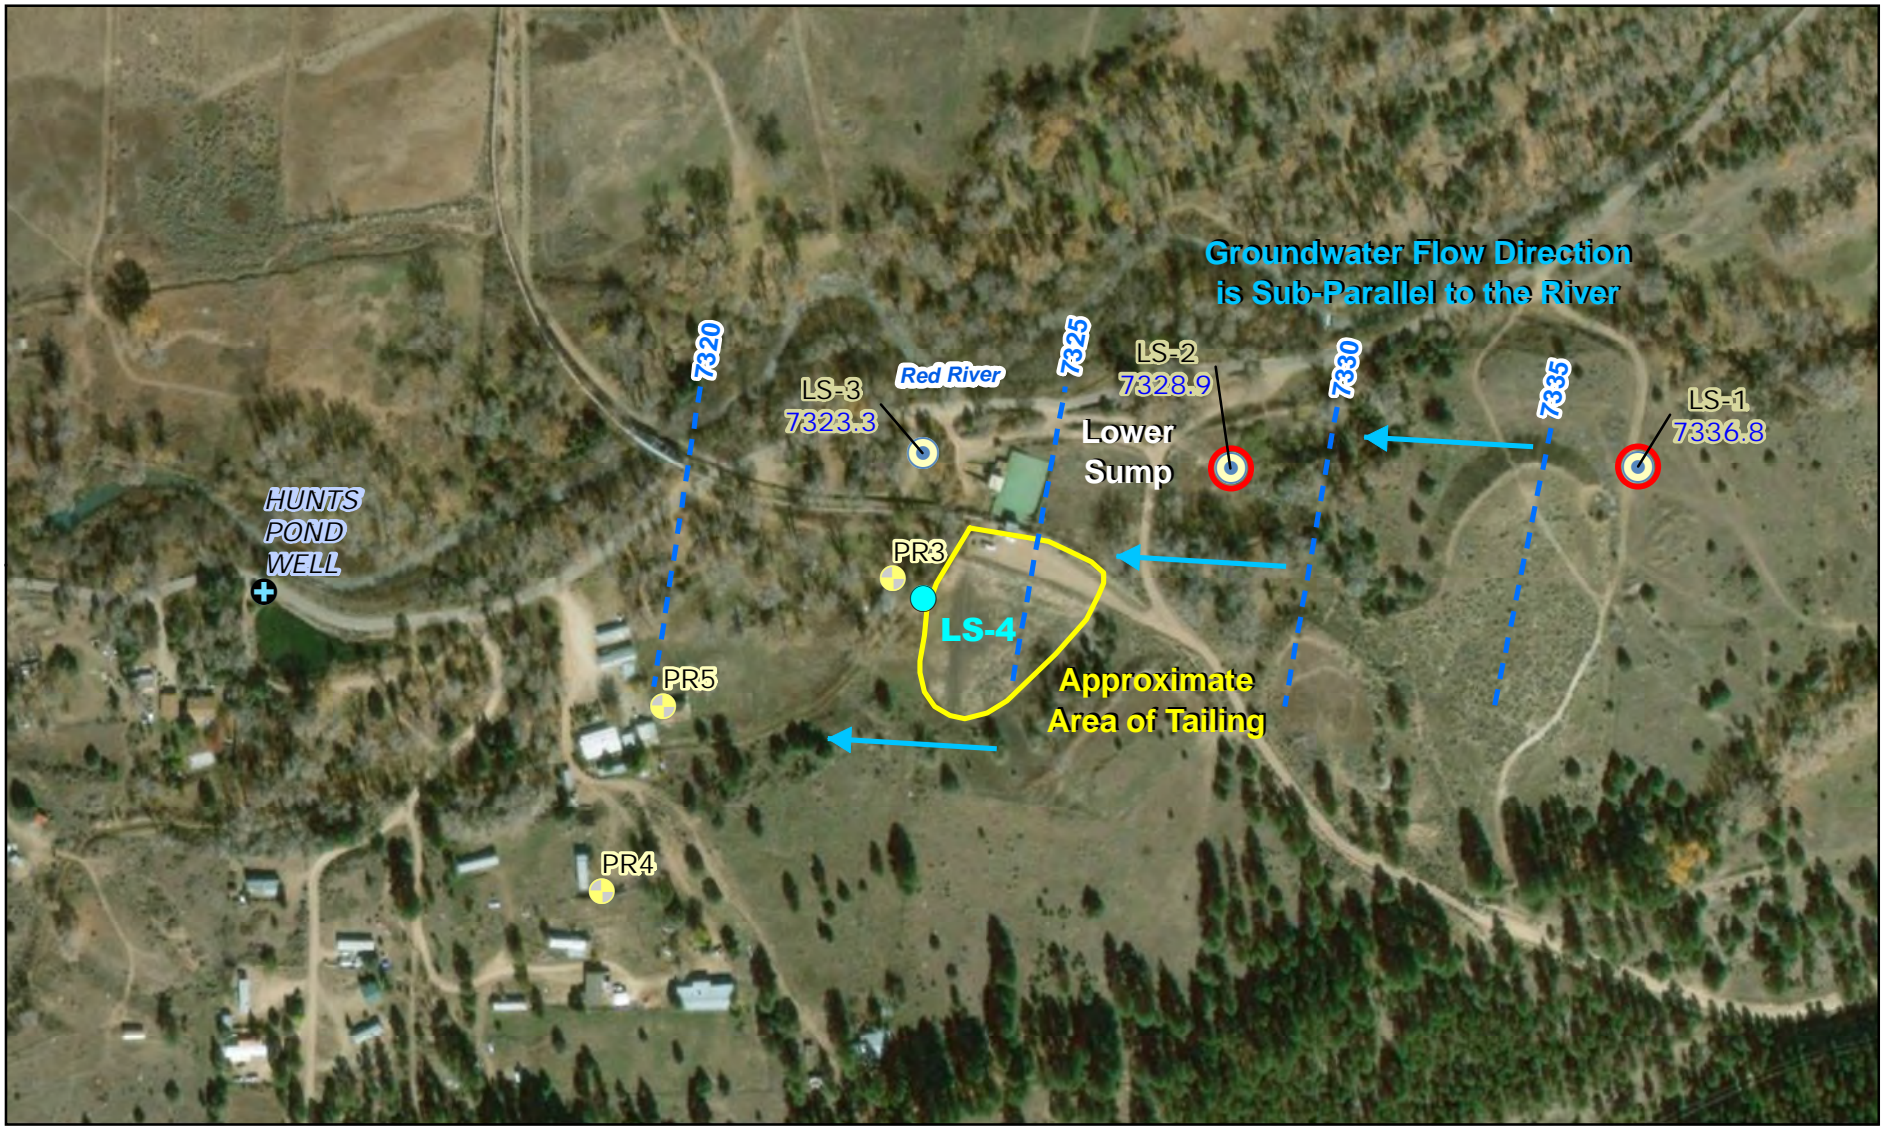
Figure 1 Existing Wells and Proposed Monitoring Well Near the Lower Dump Sump

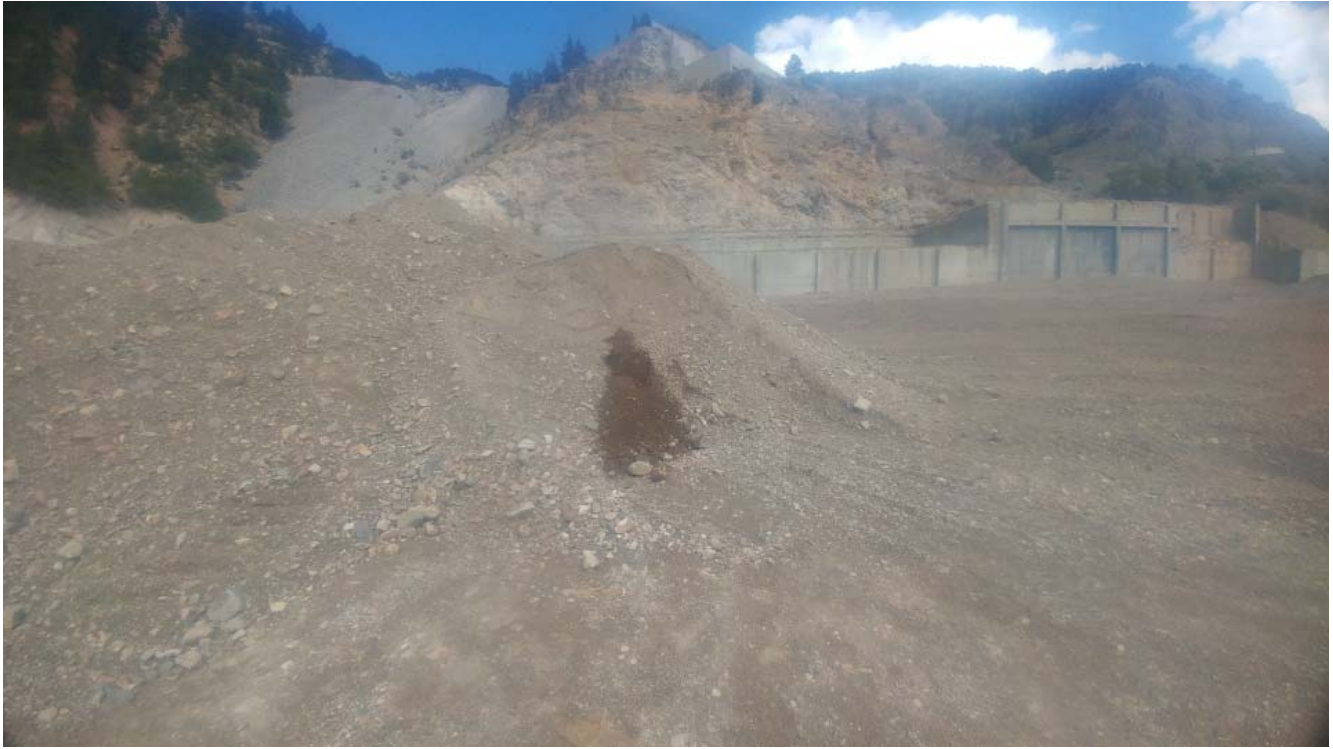
Figure 1 – MBS - 01 Location on the southeastern side of stockpile

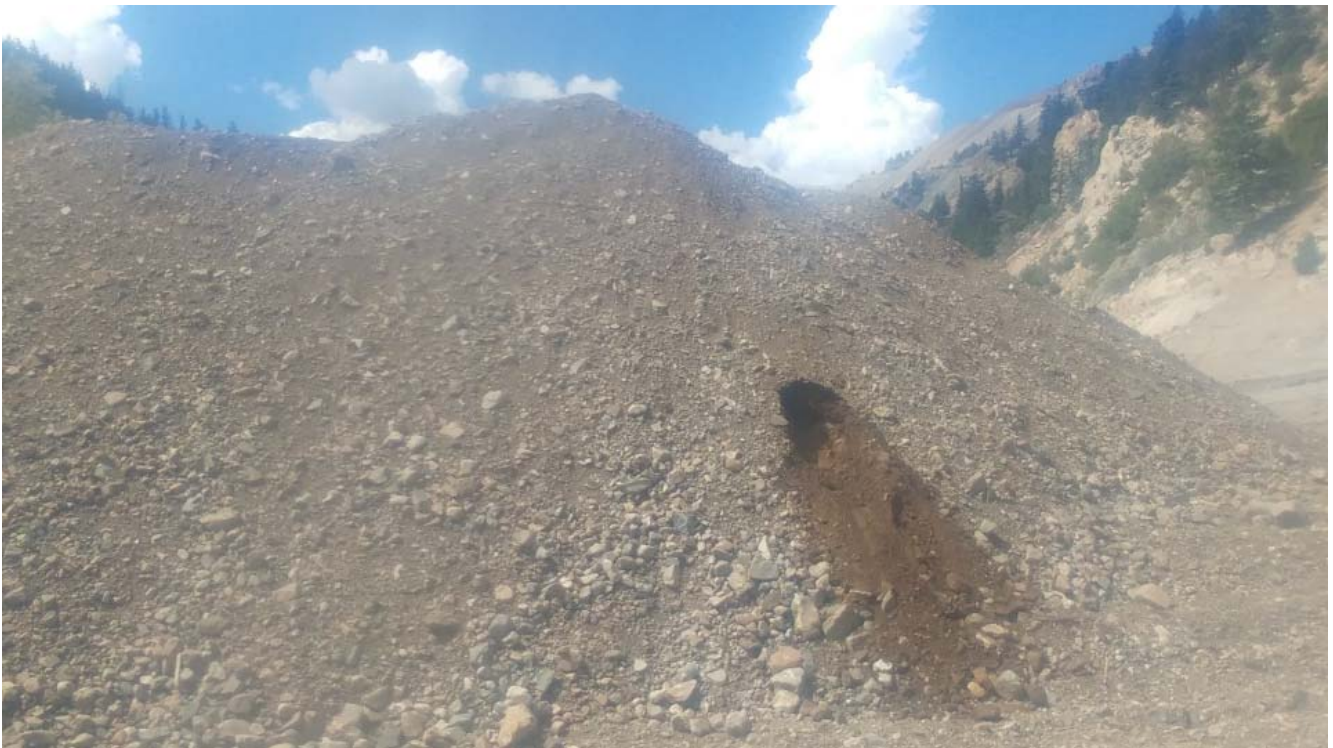
Figure 2– MBS-02 Location on the northern side of stockpile

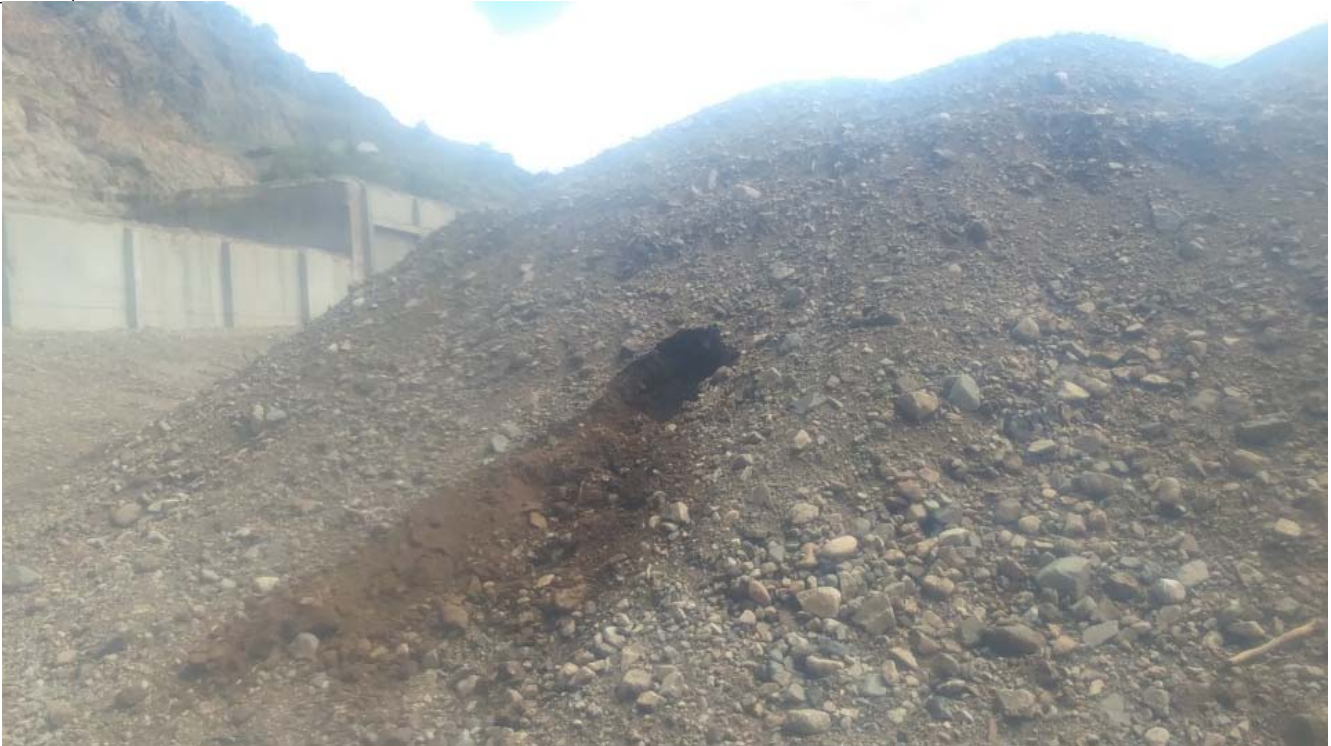
Figure 3 – MBS-03 Location on the western side of stockpile

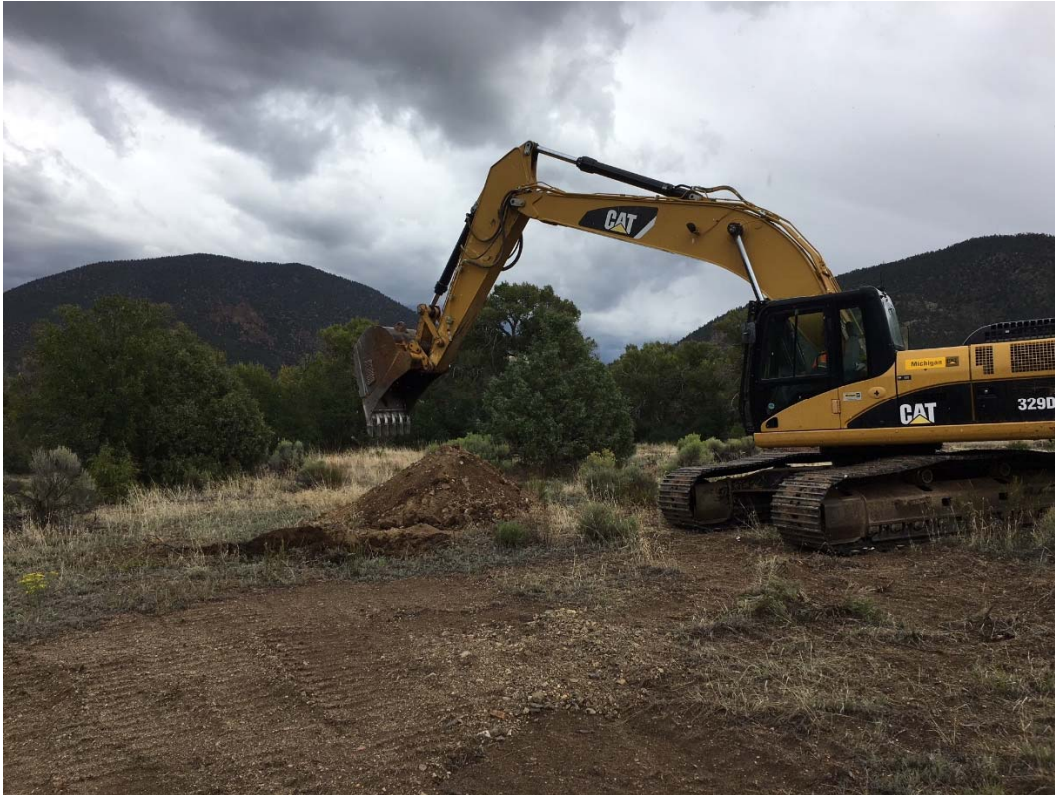
Figure 4 – LDS-TP-01 Location in the Auxiliary Borrow Area
