DRAFT Waste Characterization Study – Phase 2

Section 12 Mine (Mine Permit Application (NM MK046RE)

May 1, 2018

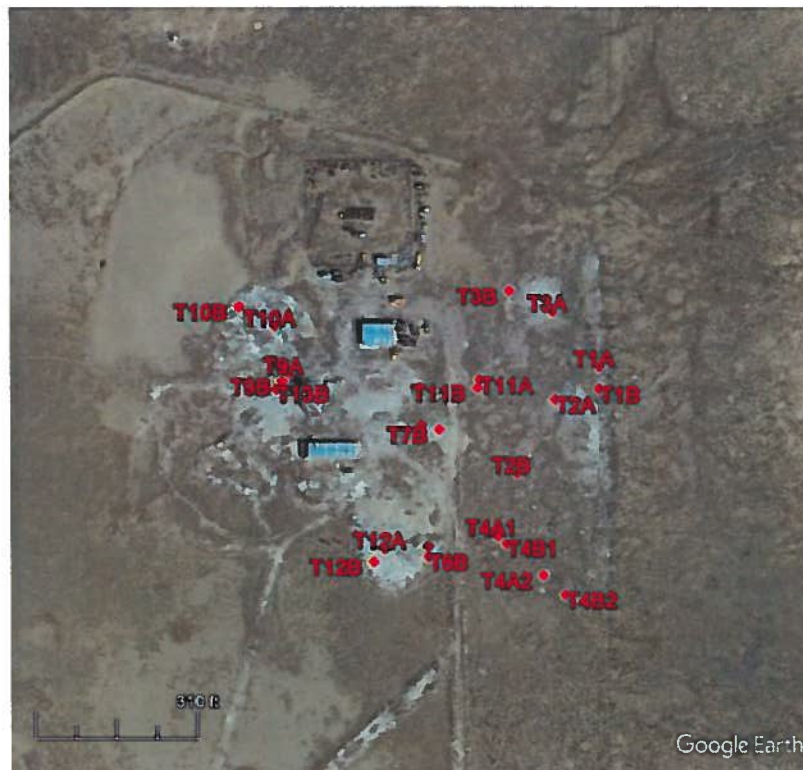
Figure 4. Beginning (A) and ending (B) locations of waste characterization trenches

A total of 13 soil trenches were excavated and visually evaluated by Permits West personnel for changes in color, texture, and soil structure, and by Mr. Coleman, who used the hand-held gamma detector to determine where materials with elevated readings were located in the trenches (Figure 4). The detector was held at approximately 18 inches above the ground surface (ags) as Mr. Coleman walked in or along each trench (Figure 5). Readings and observations were recorded by Robyn Tierney, Permits West Natural Resources Specialist, as they were called out by Mr. Coleman. Additional visual observations about the soil and waste rock's physical characteristics were also made and recorded by Ms. Tierney and photographs were tagged with positional information (i.e. GPS coordinates) for later review. Once the excavation and evaluation of each trench had been completed, the trenches were backfilled and lightly compacted.

Based on these results we have identified three areas that likely contain thicker layers of waste rock materials with elevated readings. The first is the graded area containing the T-12 trench (Figure 4). Located approximately 100 feet south of the mechanical building or hoist house, this area appears to contain waste rock materials from the first days of the mine's development that were later re-worked and manipulated through grading. Moreover, the five-foot depth of the T-12 trench and the dispersed

The T-6 and T-7 trenches located east and southeast of the mine (Figure 4), also show elevated readings ranging from 1,300 cps in Trench T-6 and 3,200 cps in Trench T-7. Both areas contain a mixture of variously sourced materials to a 4 - 5-foot depth above the lakebed clay. These materials were generated in the early 1980s during the construction of the Section 12 mine shaft and have been spread, graded, and compacted in layers on top of lakebed clays which appear to have slowed and limited the downward movement of water and leachates.

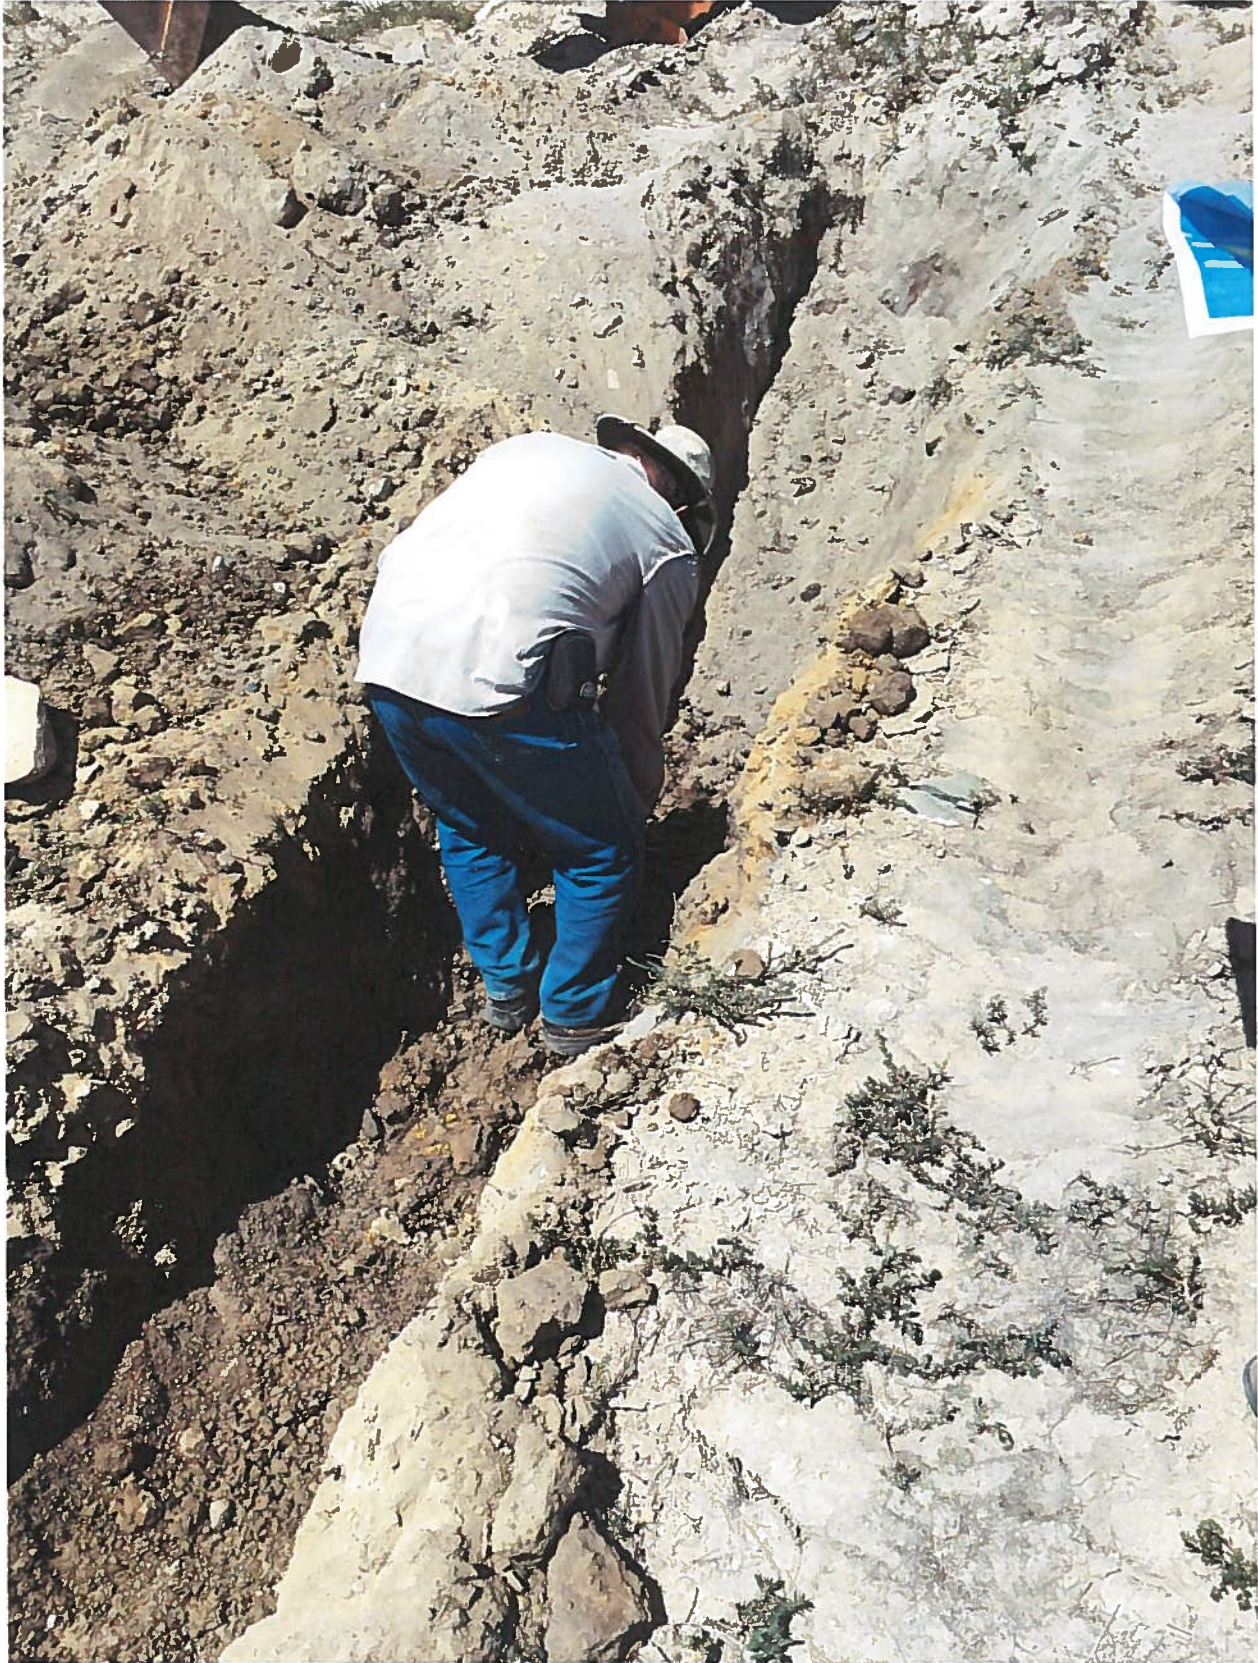
Figure 5. Photo: UQXW5676. Michael Coleman samples the sidewalls of waste characterization trench T-1.

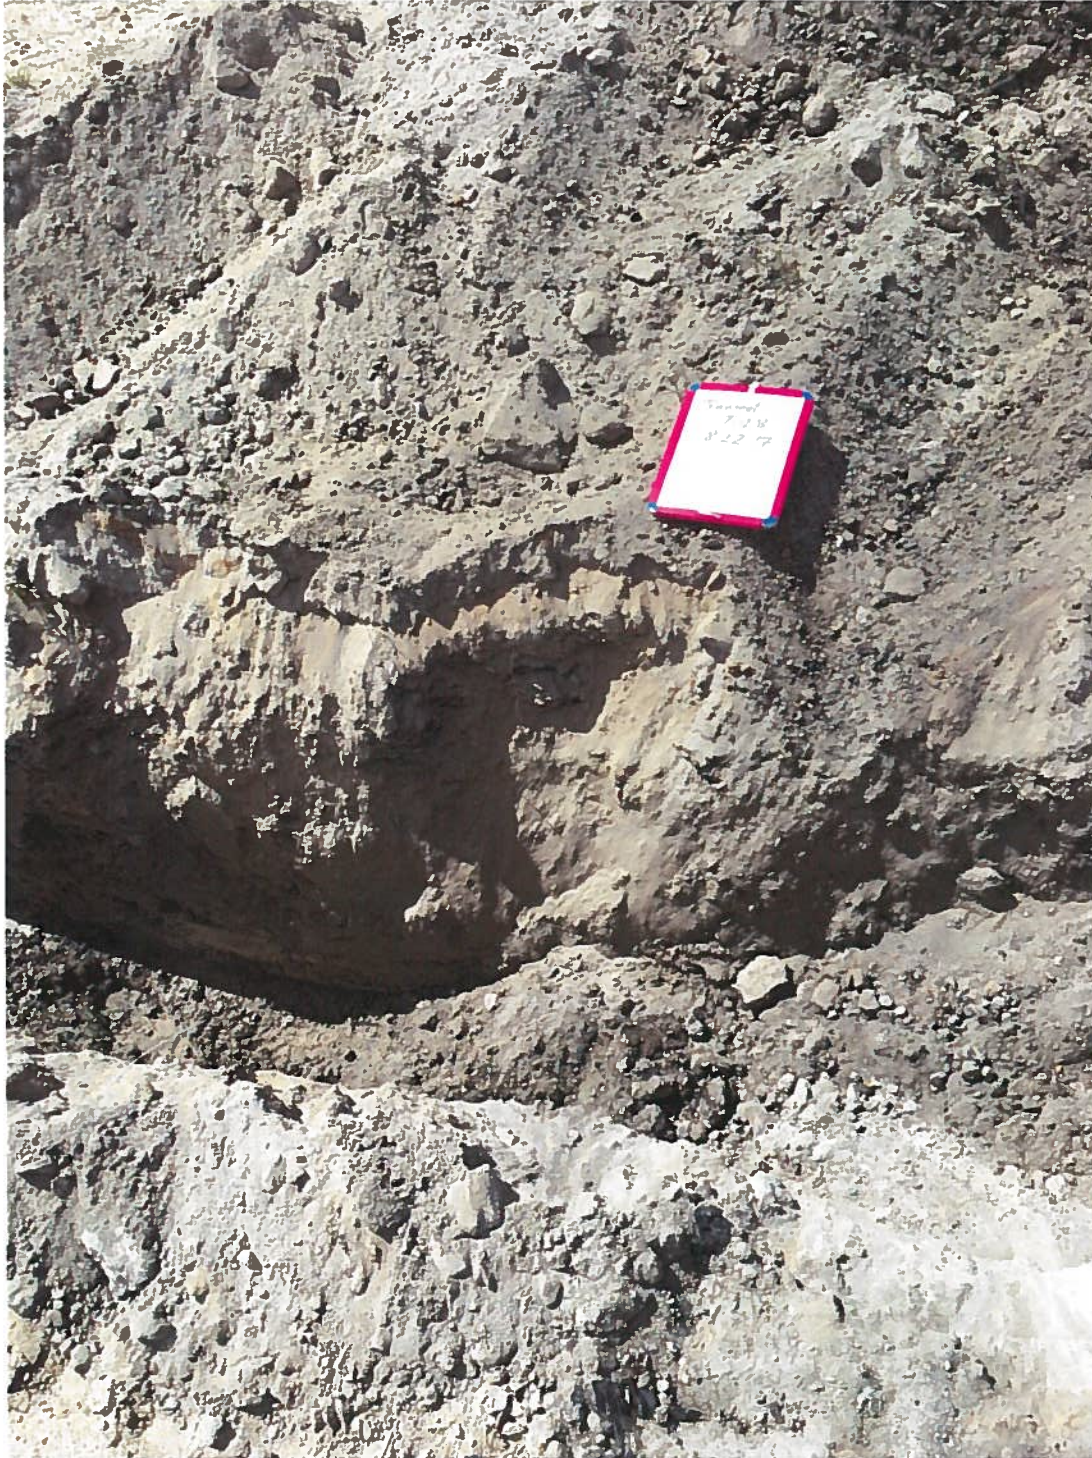
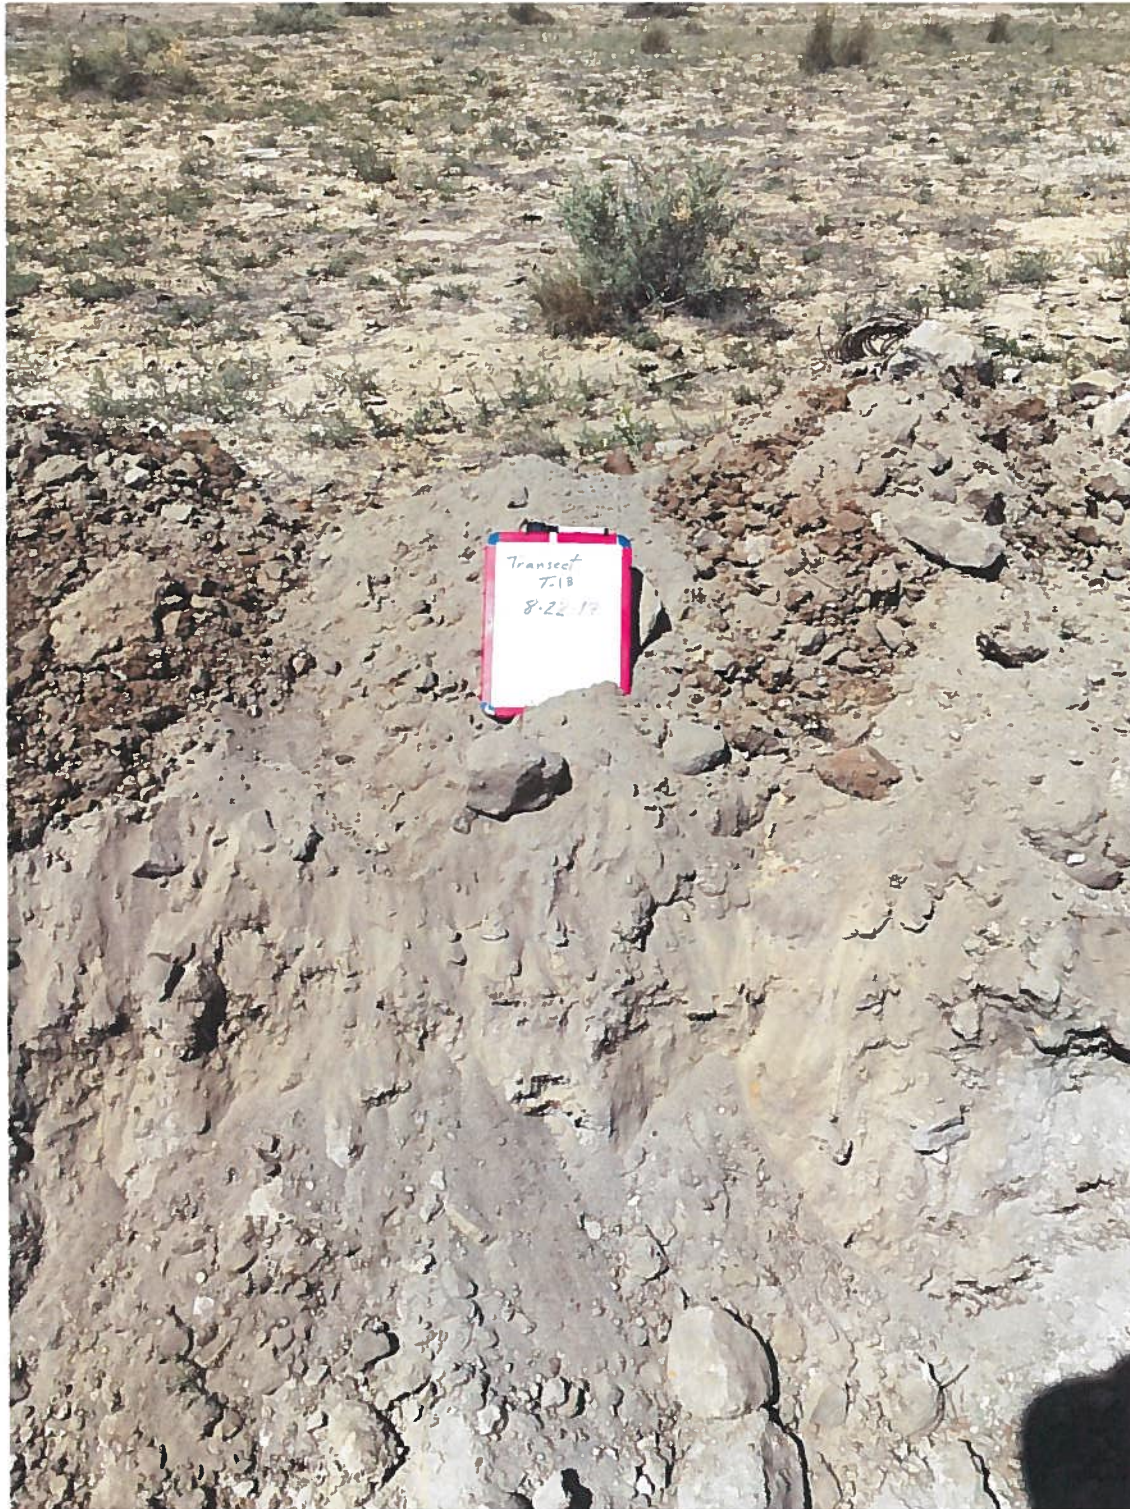
Figure 6. Photo: AMN18284. Trench 1-B (south end of trench)

Figure 8. Photo: UEES6706. Trench 1-B (south end of trench)

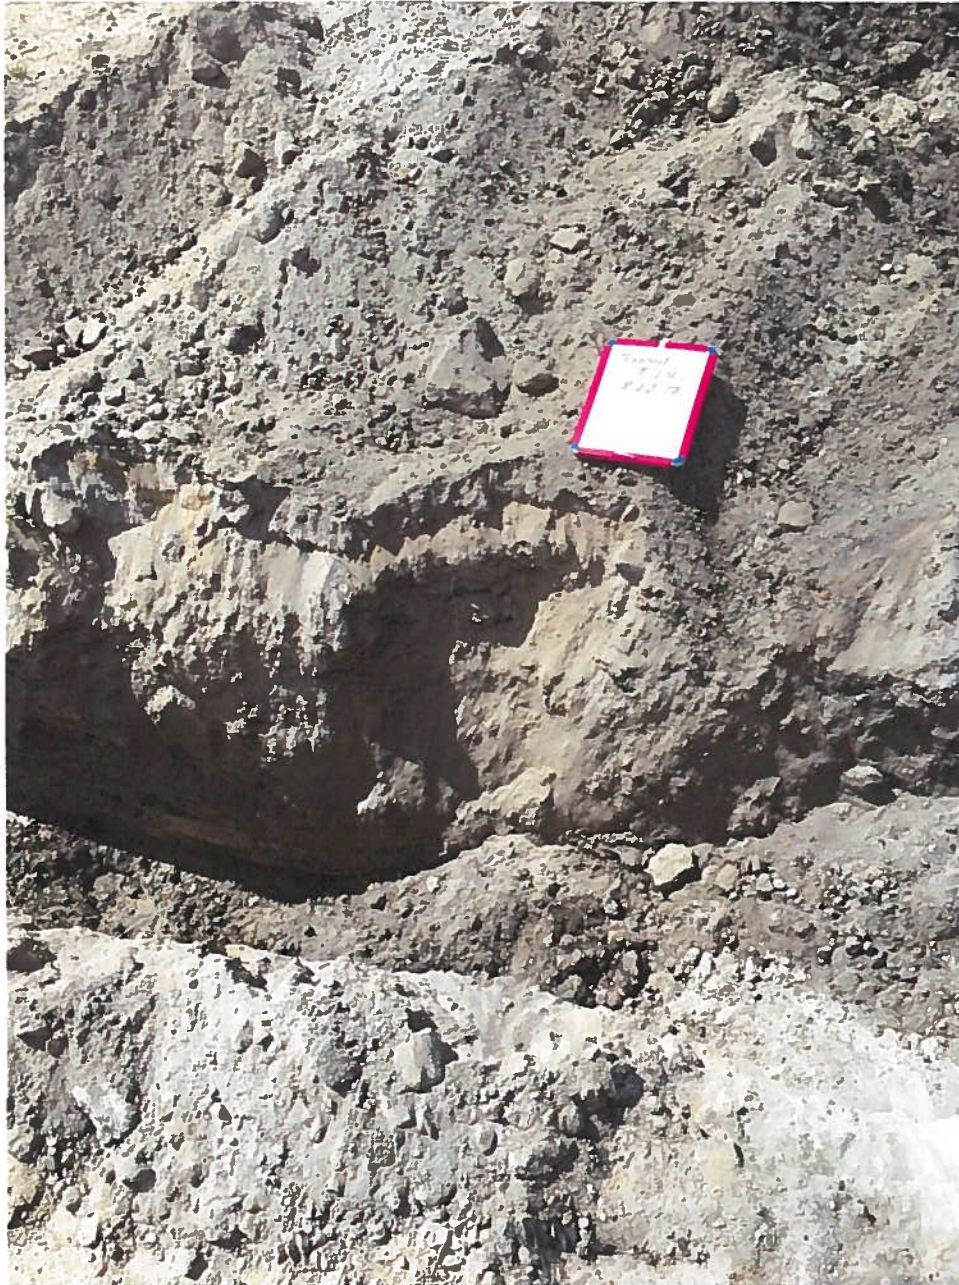
Readings at the northeast end of the T-2 trench were elevated (3,400 cps or counts per second) to a depth of 18 inches. The introduced materials were a distinct light grey with darker organic inclusions to a depth of 18 inches and were distinguished from the underlying layer of consolidated brownish lakebed clays below. Readings from these lakebed clays were not elevated and approached the baseline of 300 cps (400 – 600 cps). This suggests these lakebed clays may act as a barrier to downward leaching of materials. Readings of grey materials in the upper 18 inches at the southwest end of trench were also elevated (3,000 – 4,500 cps range).

Figure 9. Photo: AMN18284. Trench 2-B (southwest end of trench). Note darker grey inclusions or materials in left mid-frame of photograph.

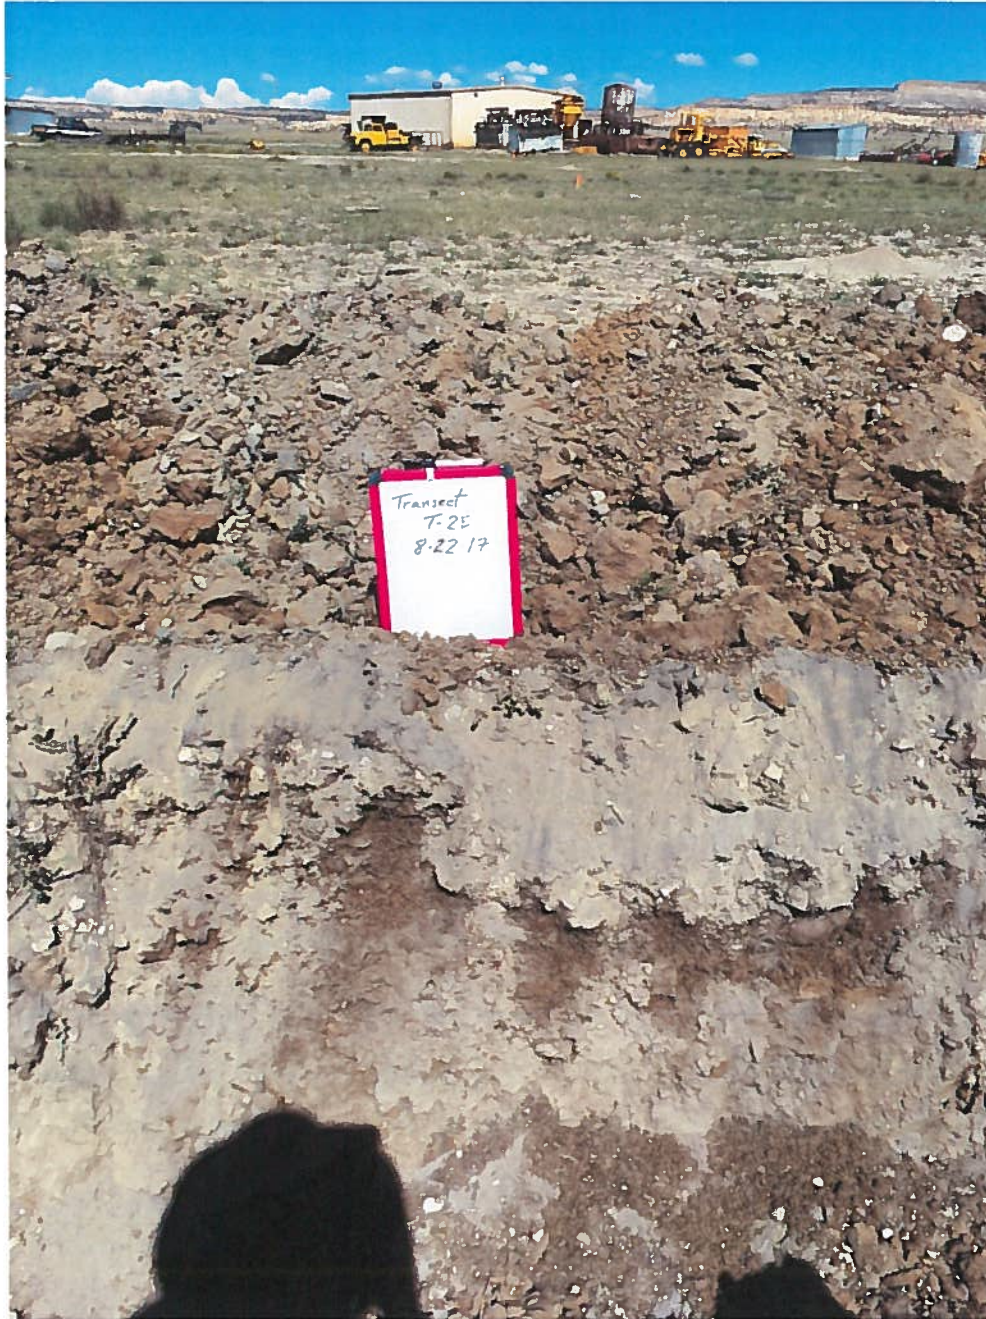
Figure 10. Photo: FWMJ. Note platy and blocky layer of brown-colored lakebed clays.

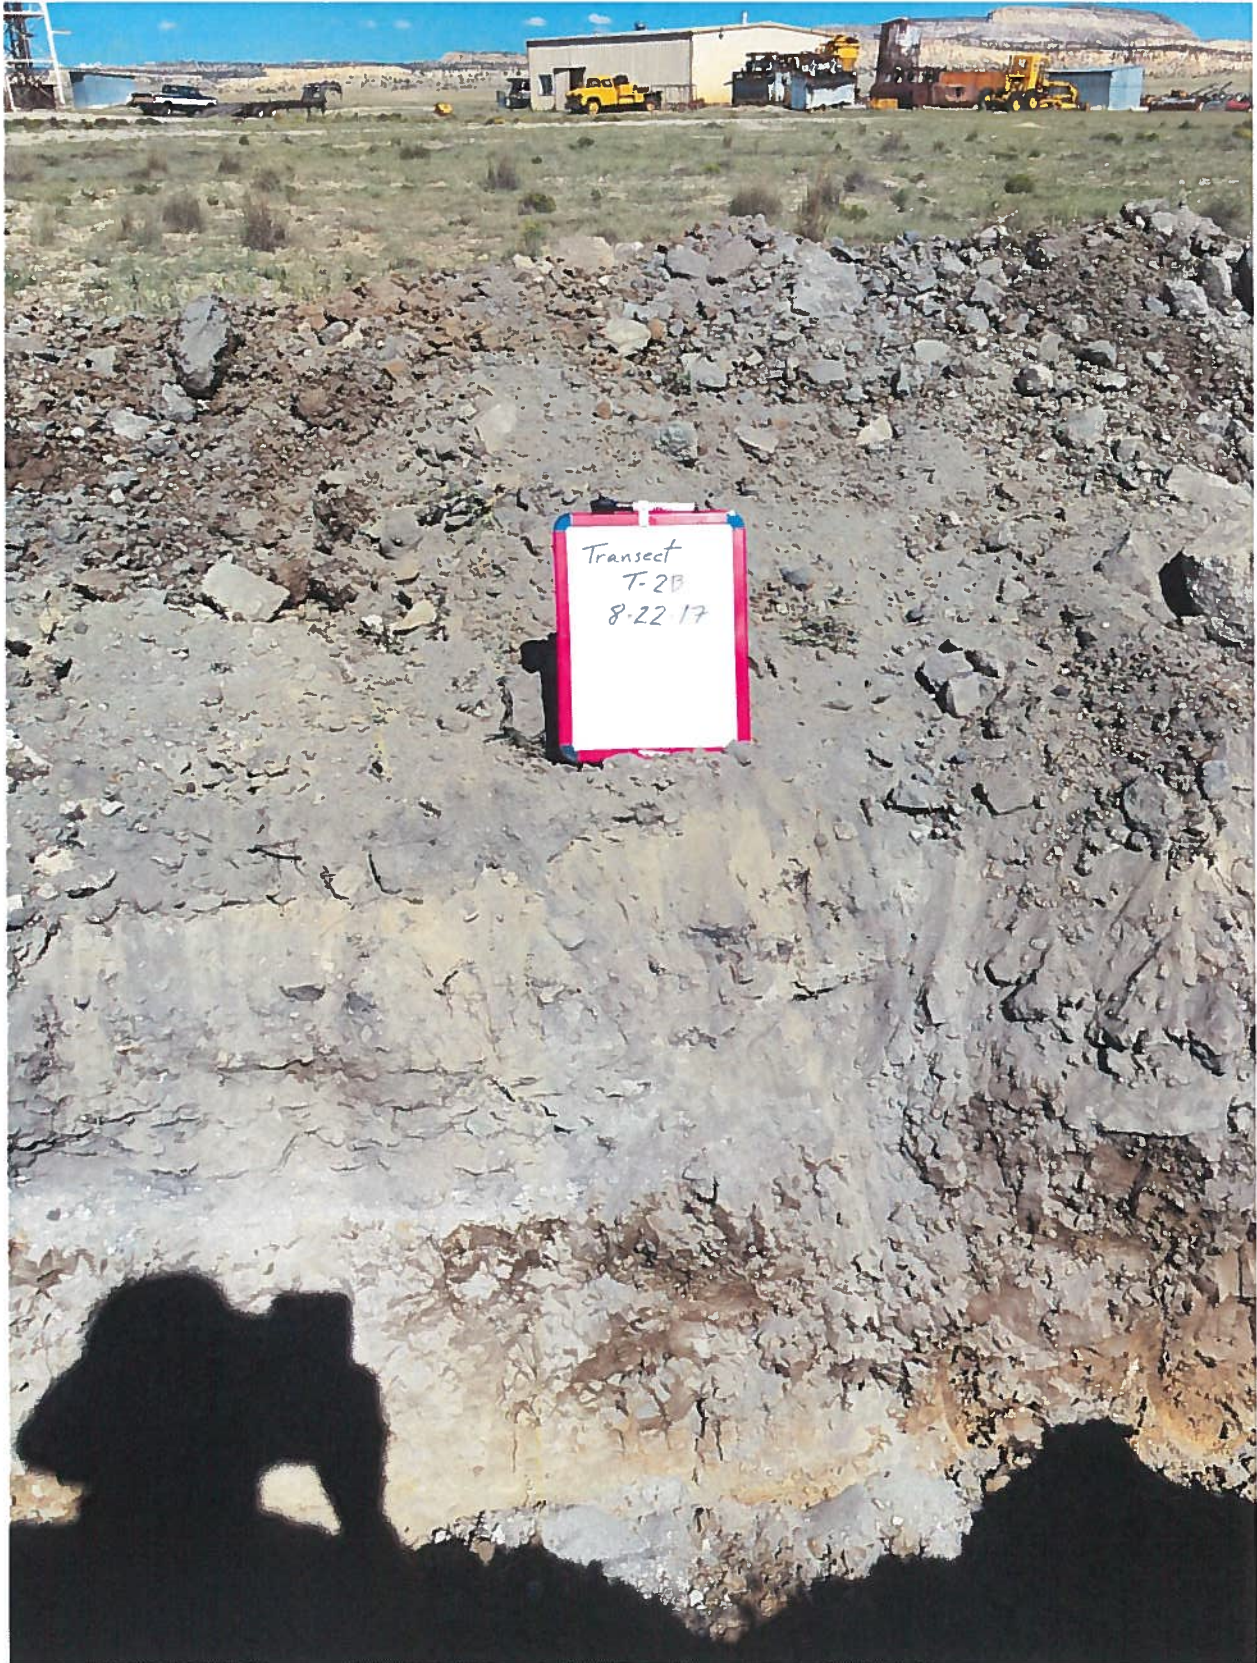
The southwestern or second part of the Trench T-2 is located adjacent to BLM land. Readings in this trench were also elevated (3,400 cpm) to an 18-inch depth, but not elevated below in the underlying lakebed clay layer. The first 18 inches of the material consists of a sandy, disintegrated waste material, with no clasts. There is a chalky or talc-like quality to the bottom of this 18-inch layer. Wires for blasting caps were identified in this trench.

Figure 11. Photo: OBCG5018. Trench 2-B (southwest end of trench). Note brownish clay layer below 18 inches.

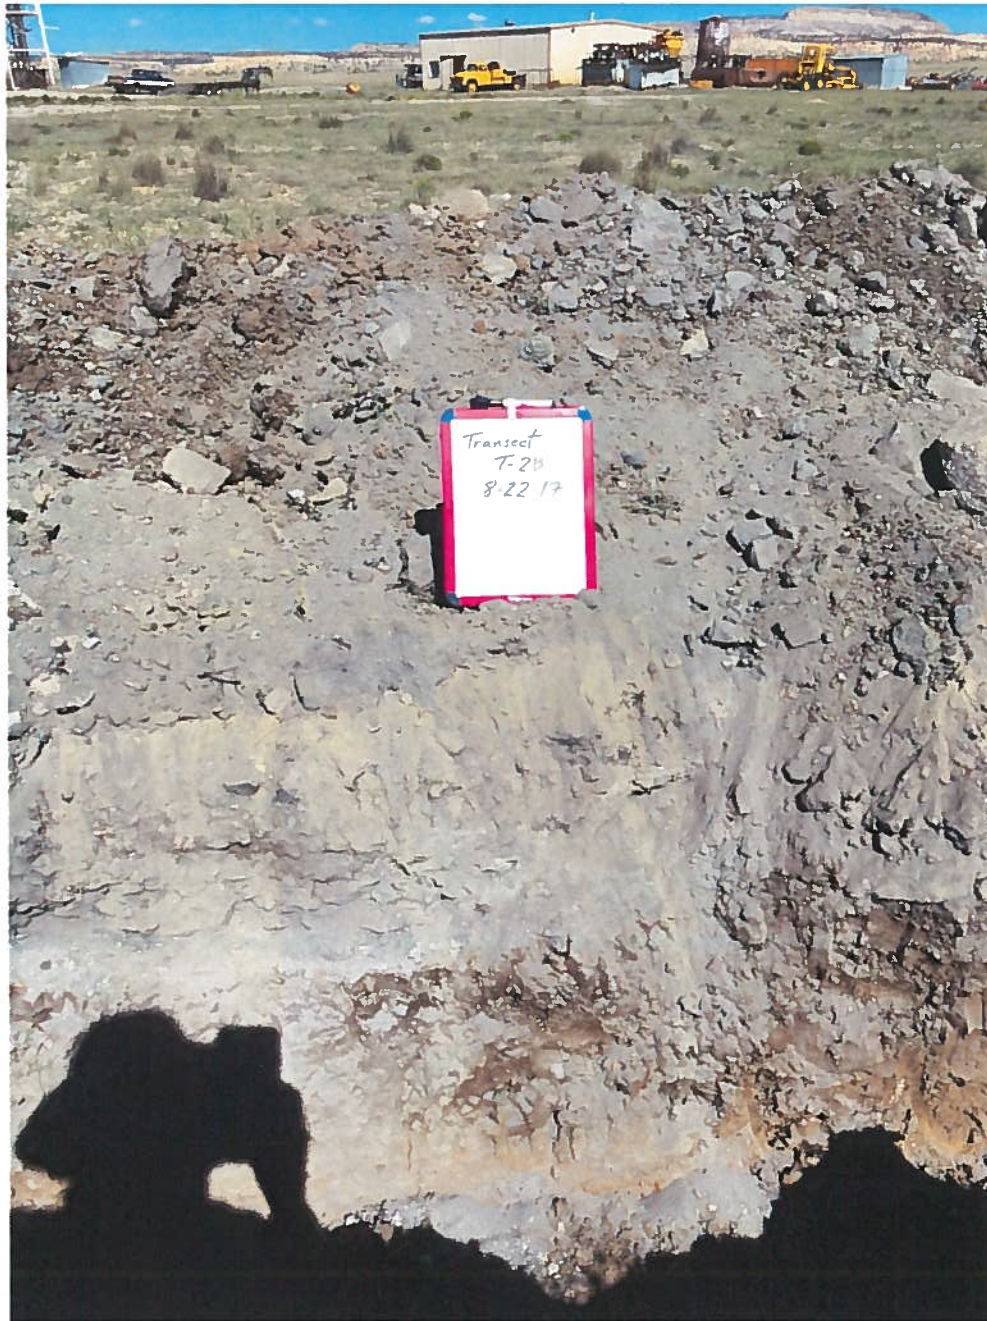
Figure 12. Photo: JZVX5553. Trench 2-B (southwest end of trench)

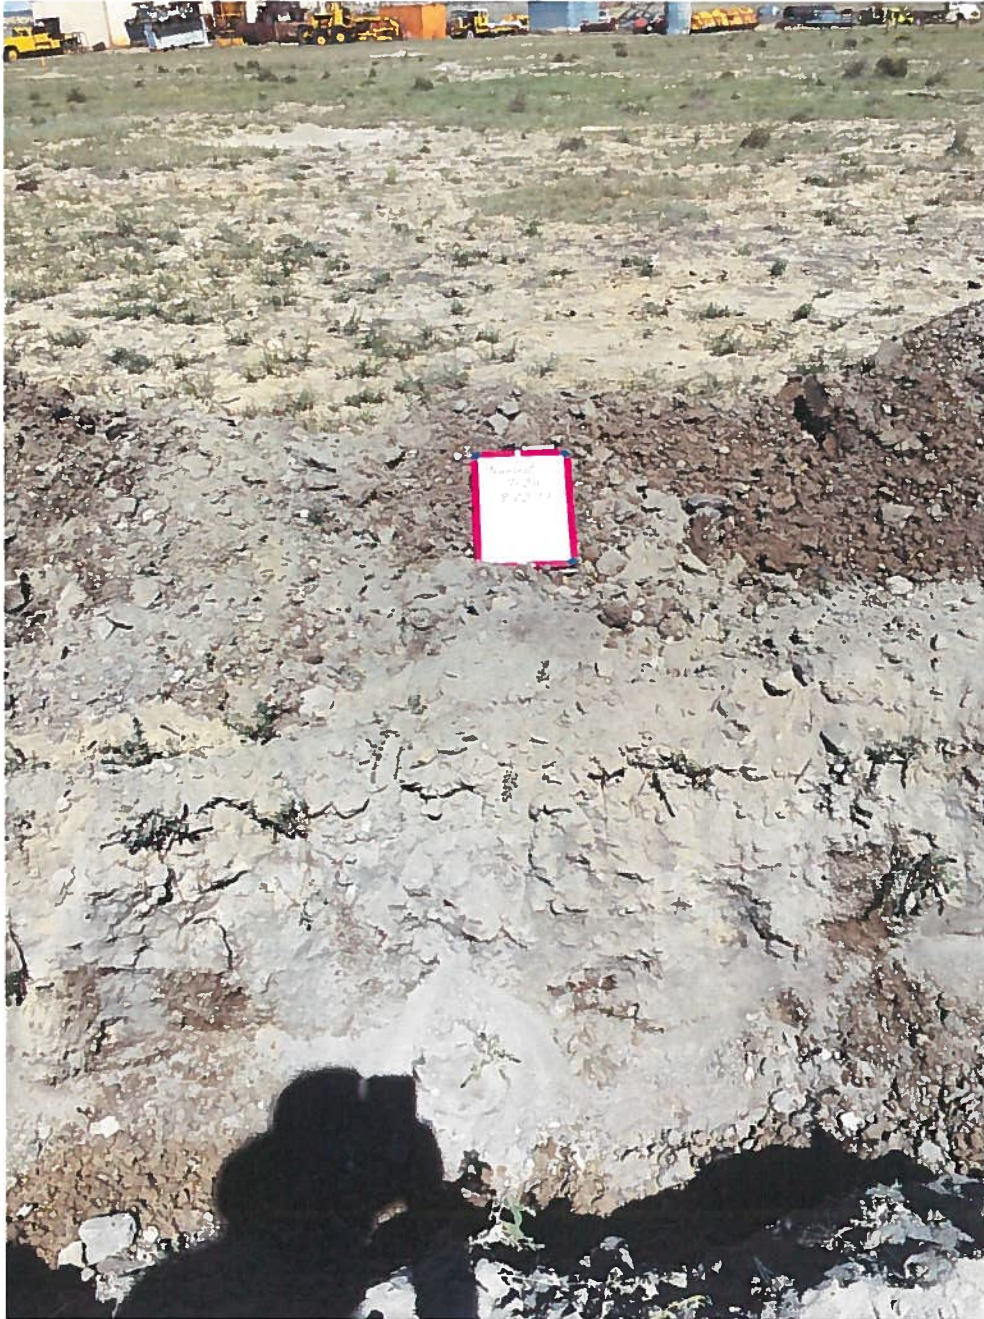
Figure 14. Photo: SBEE5011. T-2H (also at southwest end of trench). Note ashy layers overlying blocky clay layers.

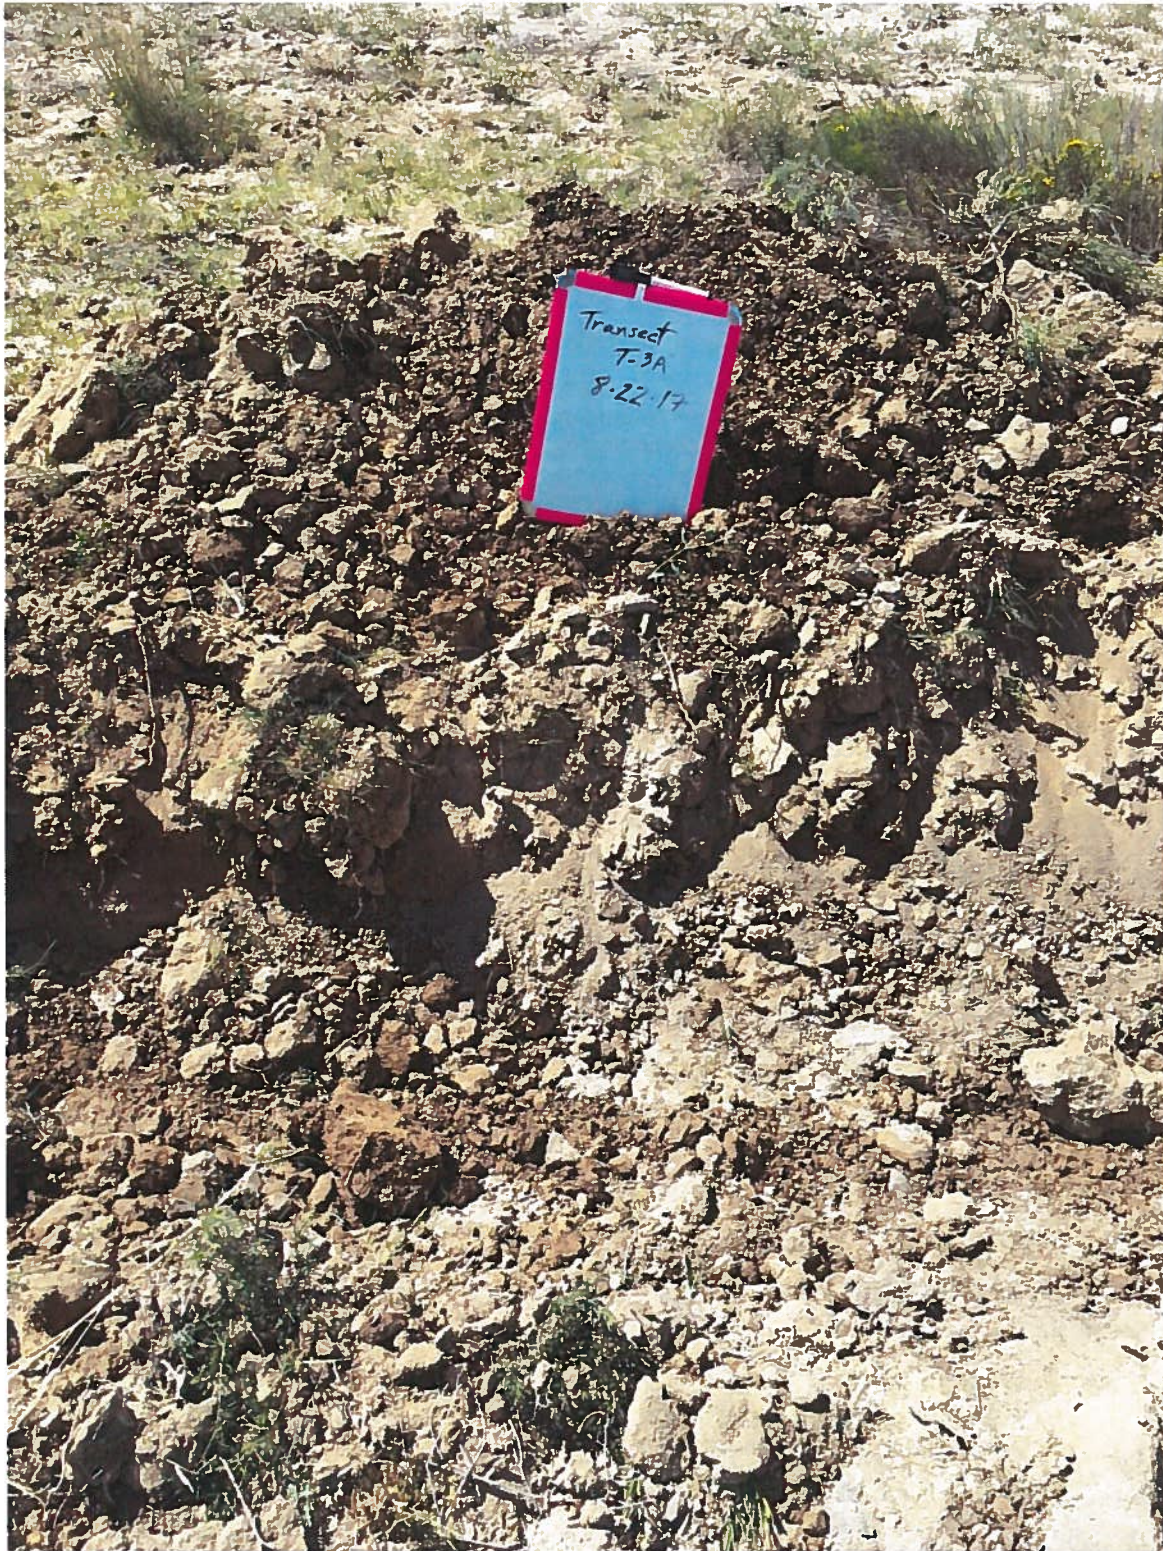
A trench was excavated from the east-facing side of a large waste rock pile, west to the apex or crest of the pile. The trench began in an eight-inch layer of atypical material overlying brown lakebed clays at the edge of the pile. The excavation on the east-facing side of the pile revealed an ashy grey layer of material with uniformly elevated readings (> 3,000 cps) interspersed with darker humate materials in the pile. The waste rock pile is estimated to be between six and eight feet deep and based on the readings from this trench, the entire pile should be removed.

Figure 15. Photo: ANTE4371. Beginning of trench T-3 on east of waste pile. Note brownish lakebed clays in mid-frame of photograph.

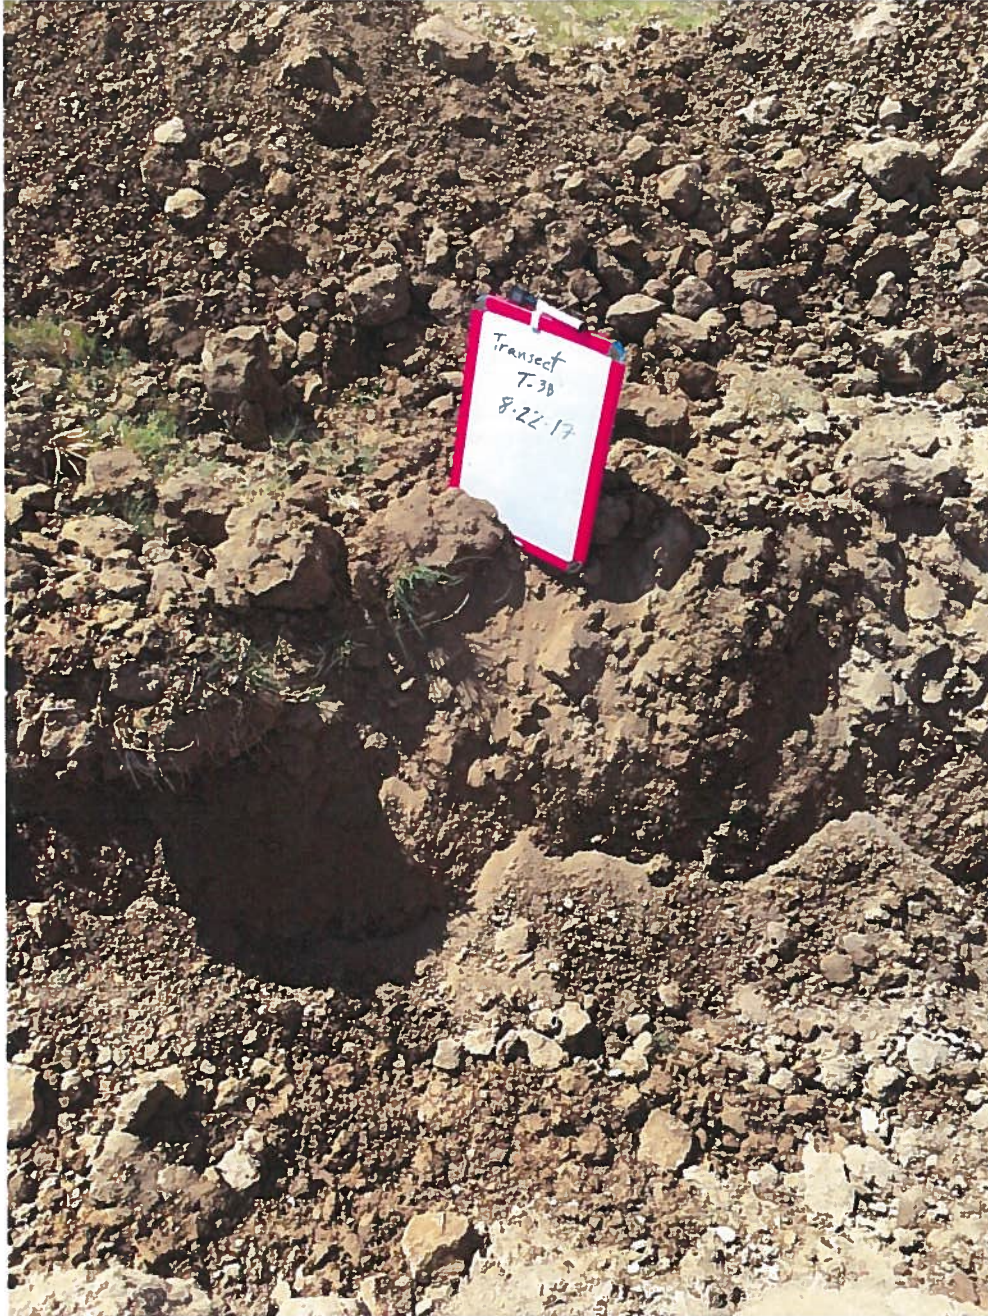
Figure 16. Photo: TXUY7756. Trench T-3 on east of waste pile

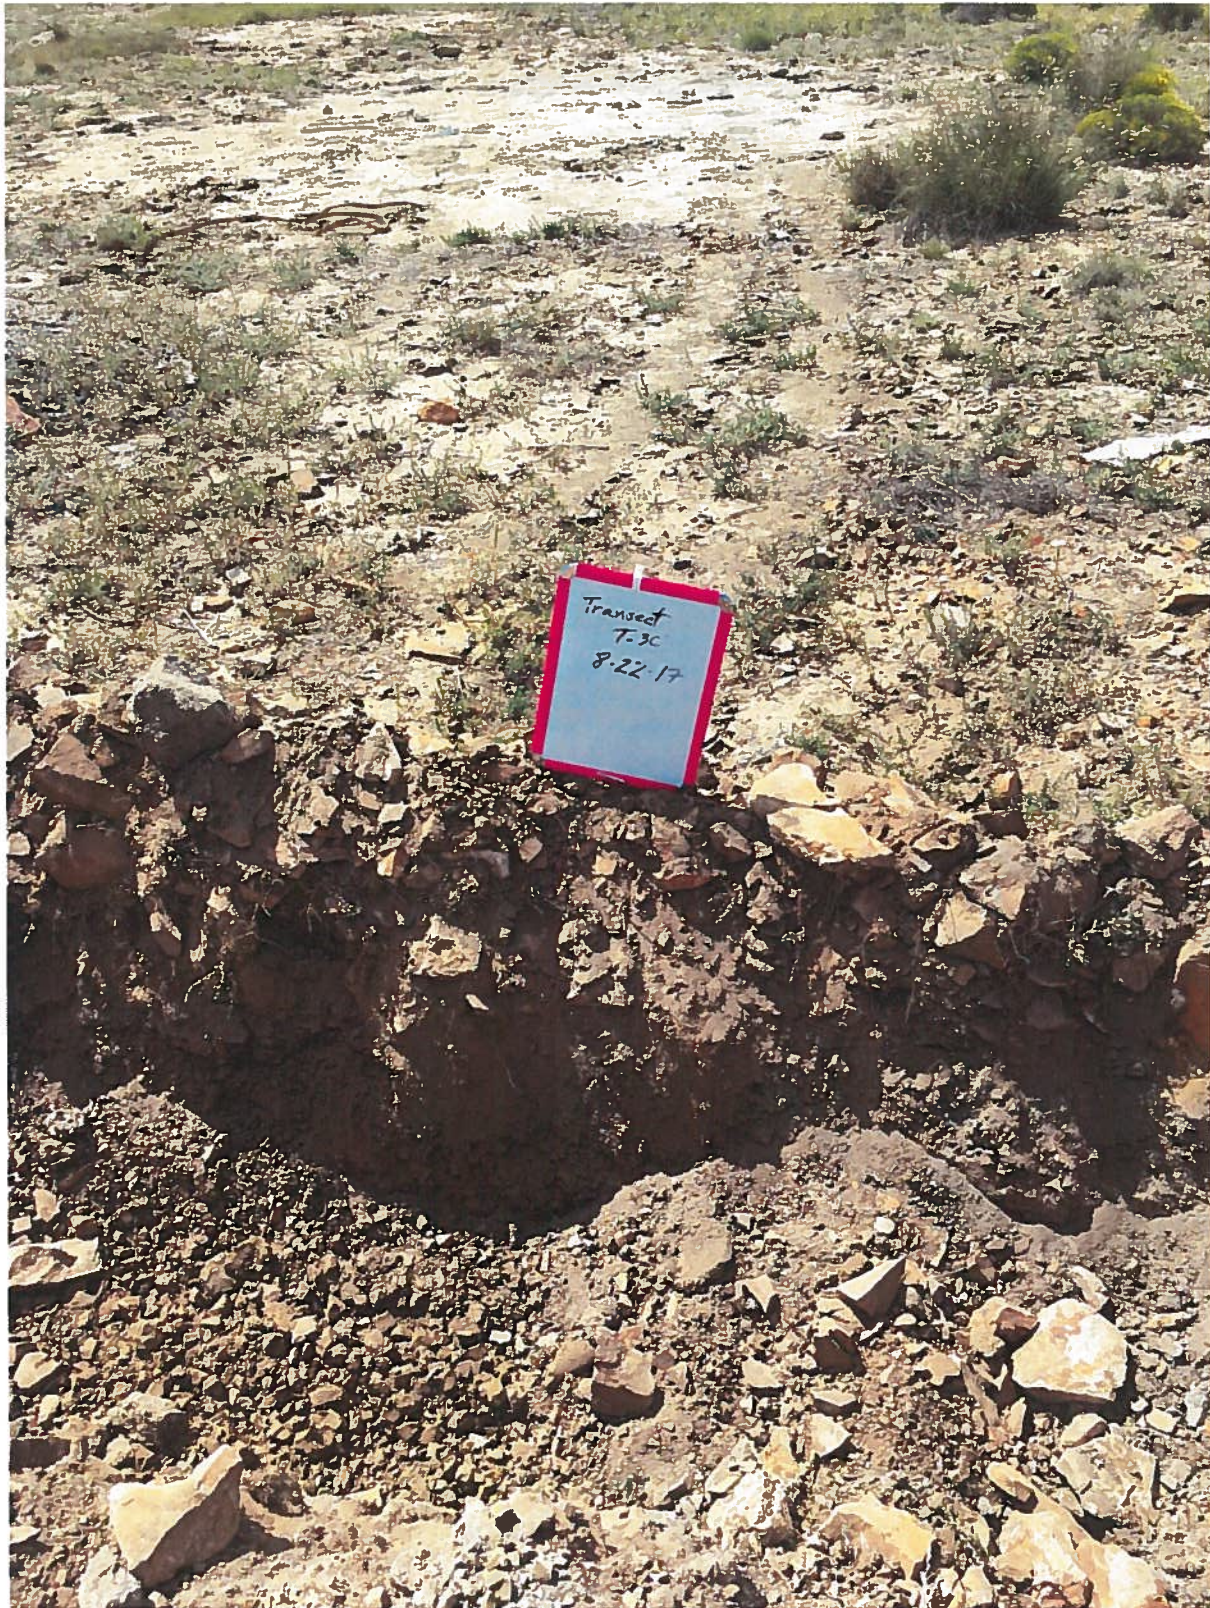
A separate trench on the west-facing side of the waste rock pile began in a smaller pile of atypical blocky rock fragments located at the base of the larger pile, then proceeded eastward through the pile to the pile's apex or crest. The materials in this trench rapidly changed from the blocky rock fragments at the base of the pile to a fine ash-like layer with elevated readings (>4,000 cps), then into three-and a half to four foot deep layer of altered sandstone and limonite materials (yellow streaky) near the crest of the pile. Again, the waste rock pile is estimated to be between six and eight feet deep and should be removed in its entirety.

Figure 17. Photo: QLUH0714. Trench T-3C on east side of waste pile. Note blocky and angular lakebed clays as well as fragments of sandstone rock with yellowish chroma (limonite).

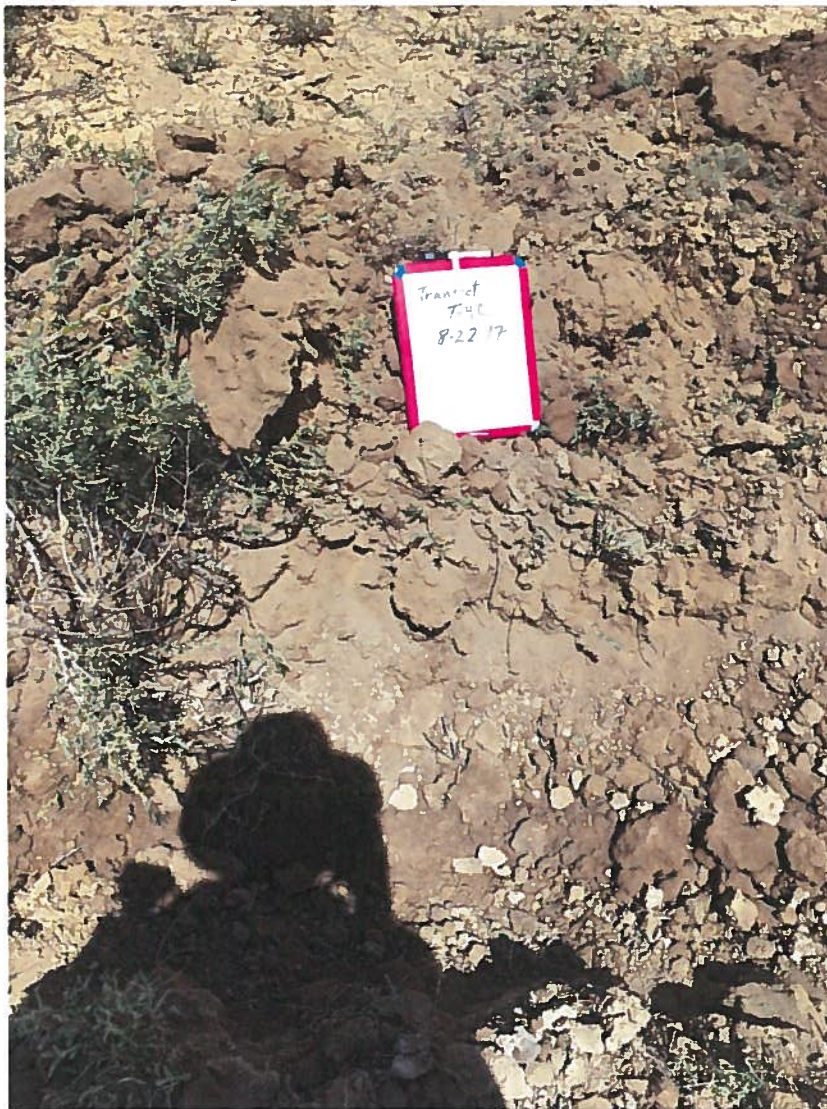
There are two places along this trench with intermittent grayish ash-like materials and elevated readings. The northwest end of the trench contains materials with a 1,400 cps reading to the six-inch depth, but not at deeper depths. The materials in the middle segment of the trench are yellowish with no elevated readings.

Figure 18. Photo: VIGF0896. Trench T-4C

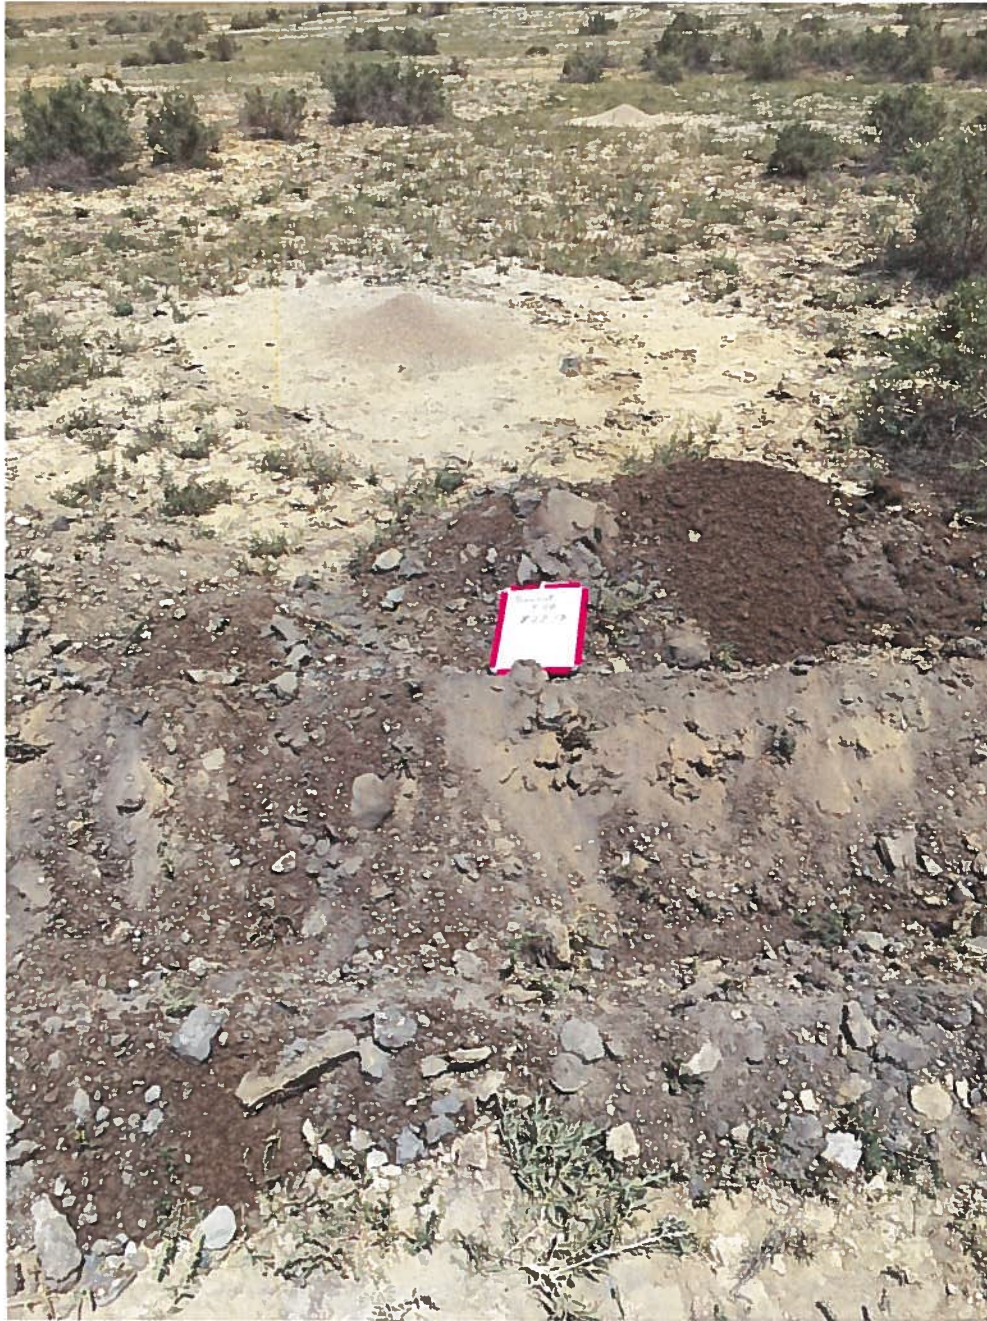
Figure 19. Photo: RXEW3330. Trench T-4A.
