DRAFT Waste Characterization Study – Phase 2

Section 12 Mine (Mine Permit Application (NM MK046RE)

May 1, 2018

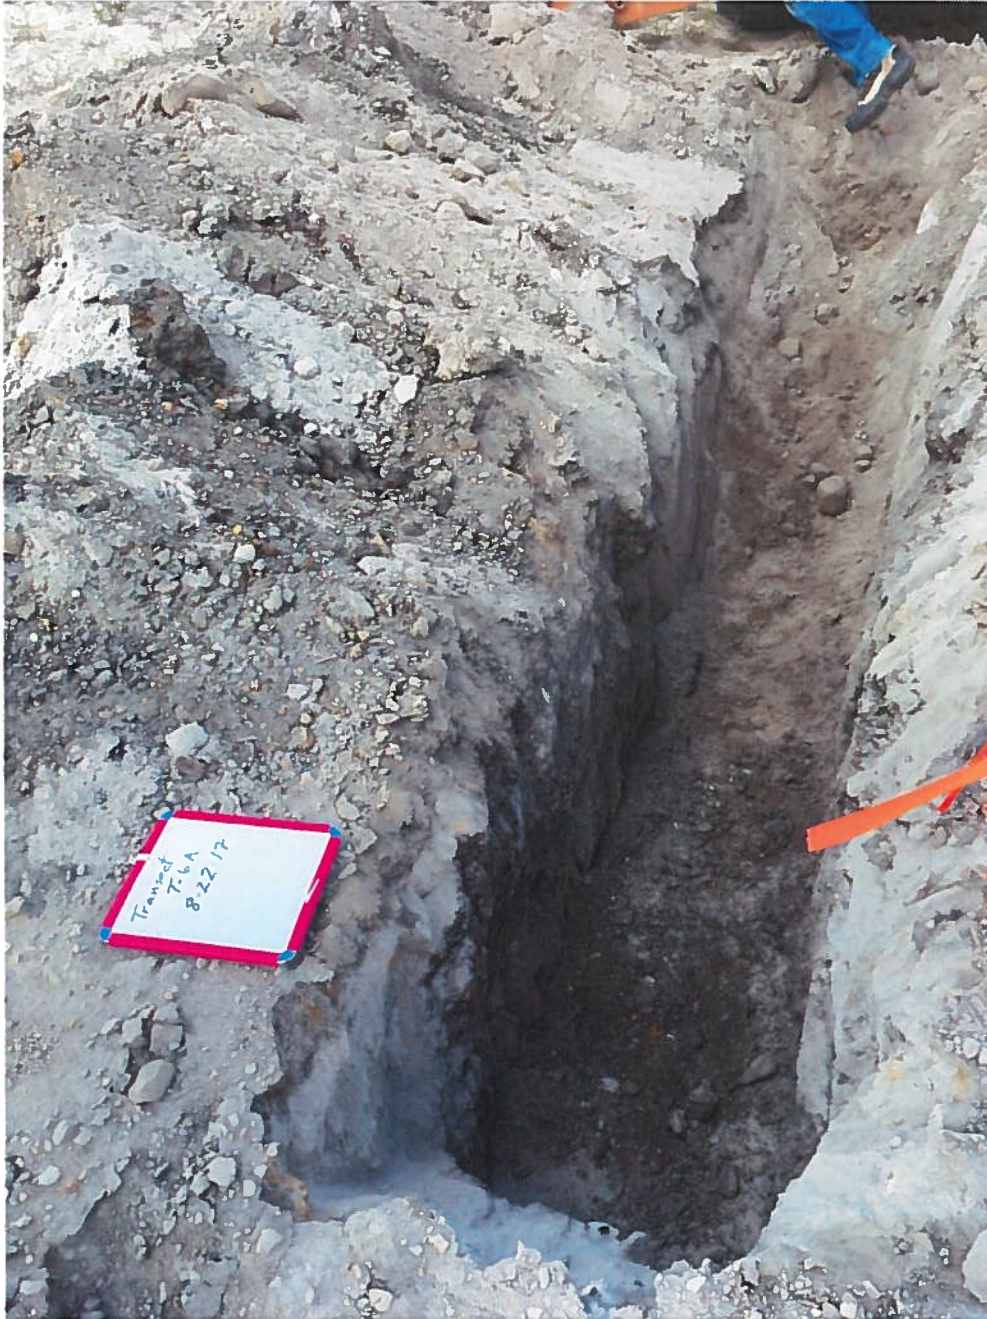
Excavation of the T-6 trench began at the south end of trench. Material in trench consists of a sandy white material (700 cps) on top of a darker ashy material with elevated readings (1,400 cps) to an eight-foot depth.

Figure 20. Photo: PXUQ0610. Trench T-6A

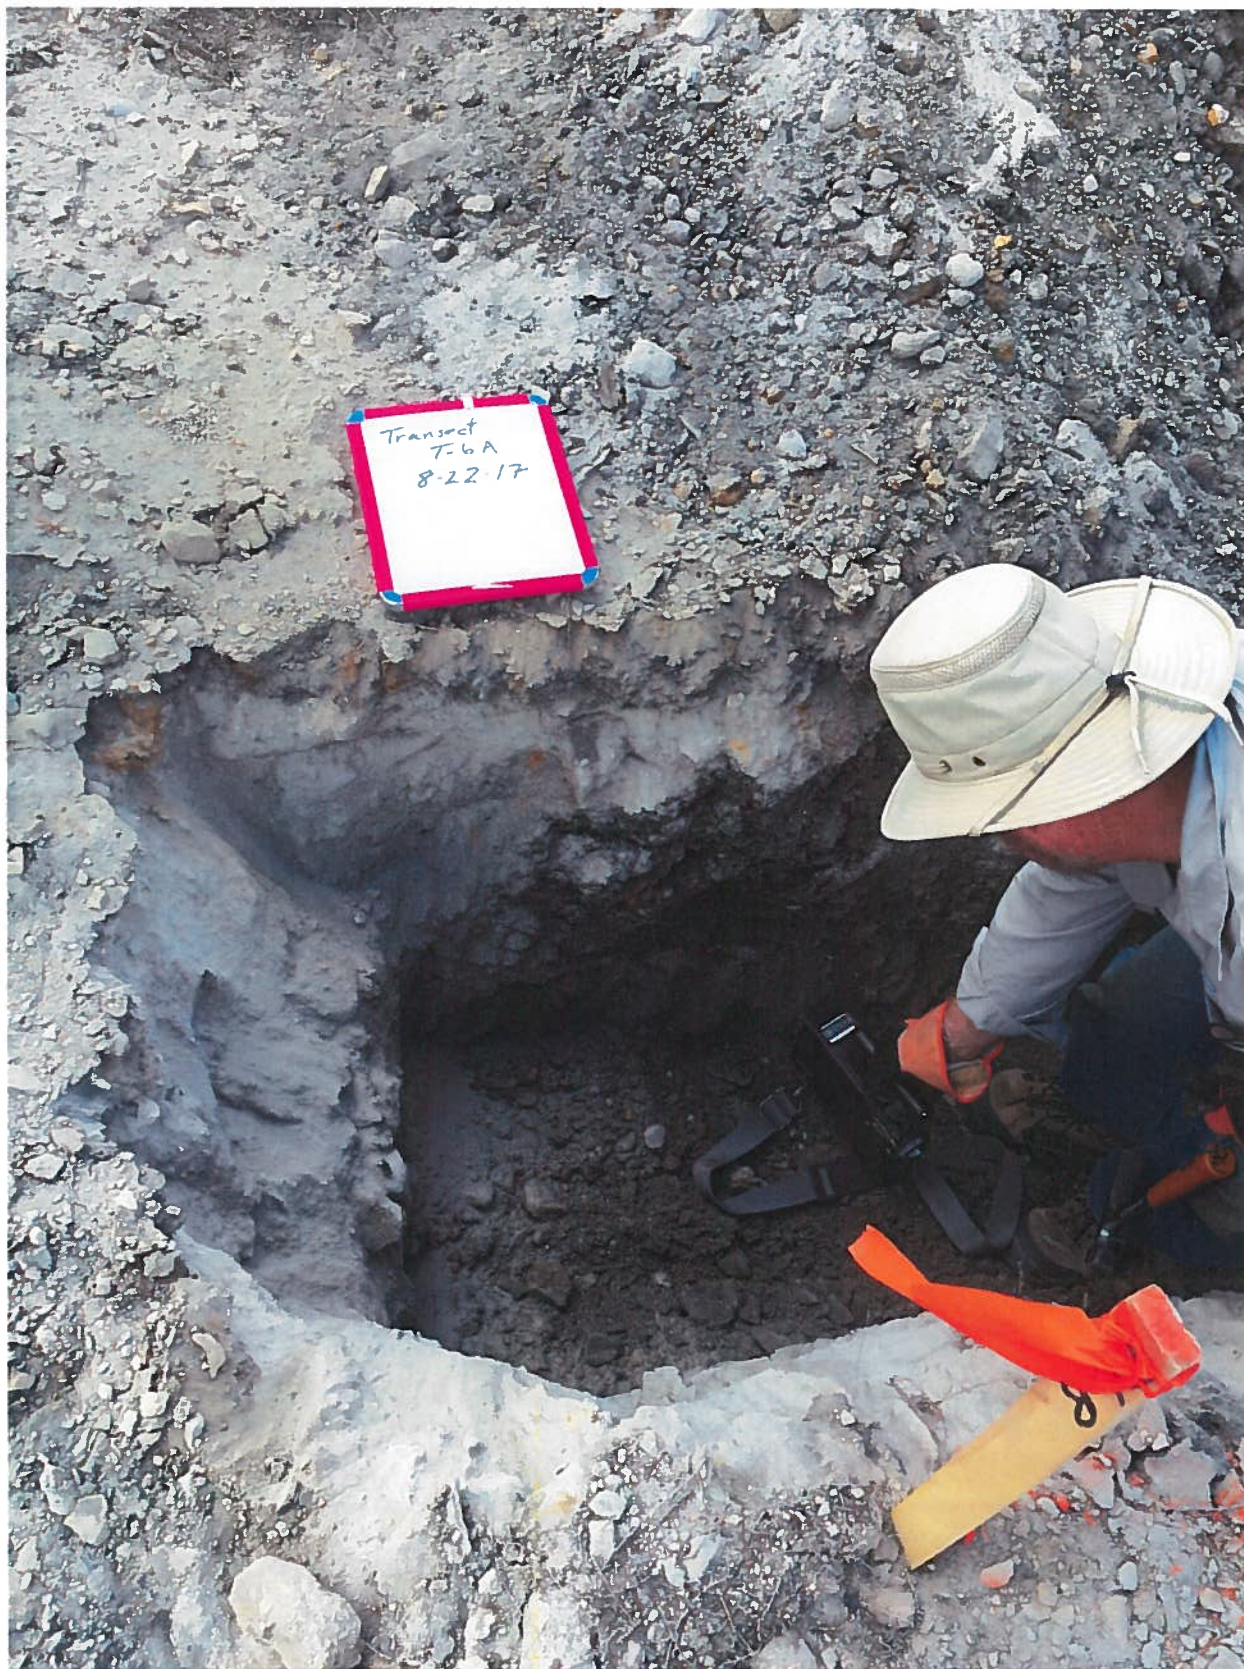
Figure 21. Photo: UNRK9162. Trench T-6A (detail).

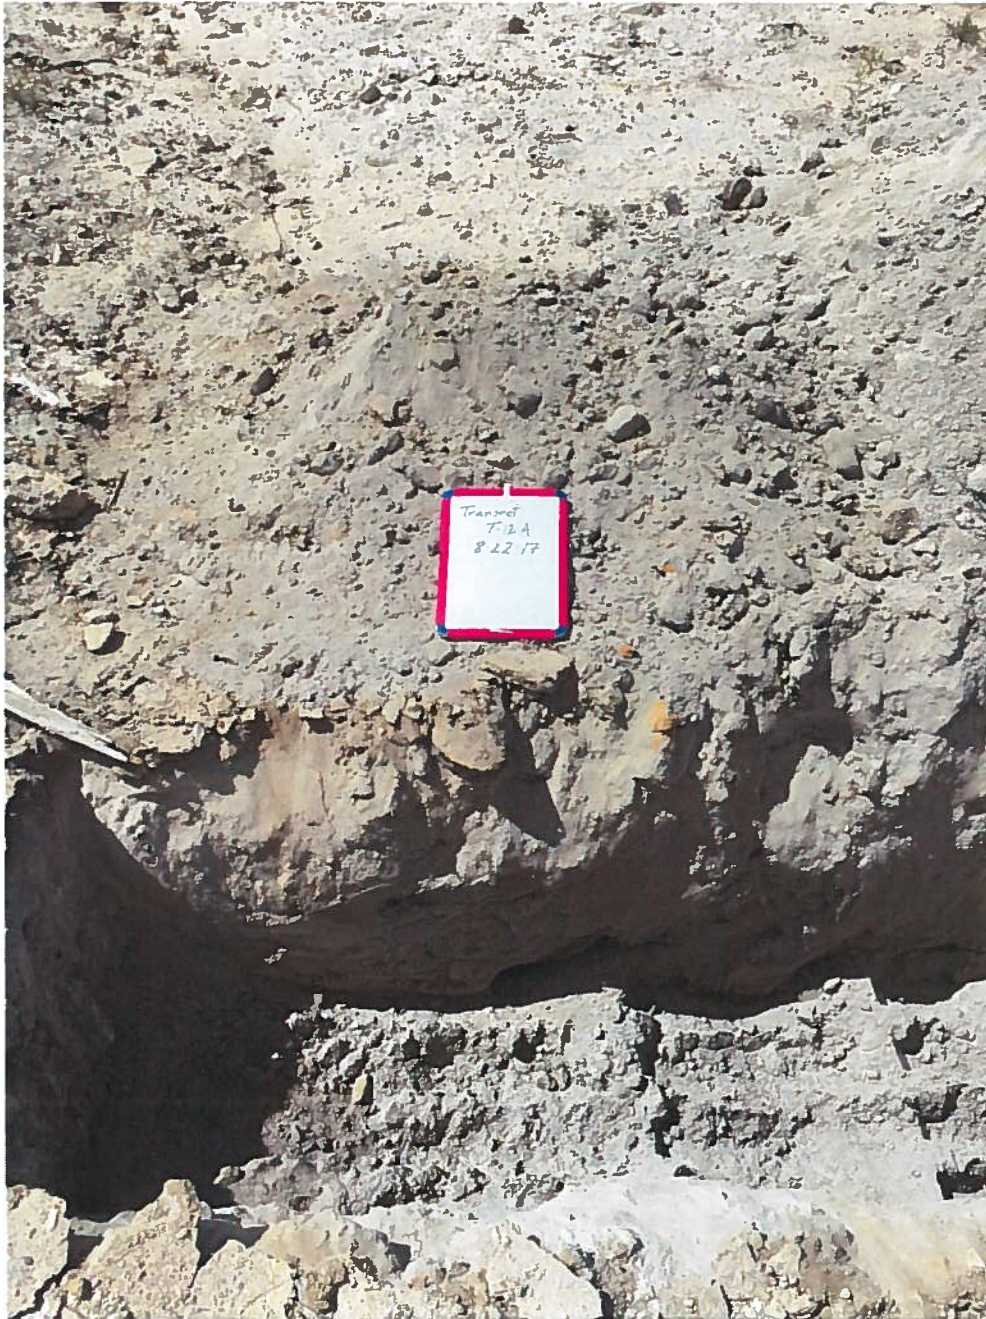
Material in this trench also consists of a layer fine whitish-gray sand (700 cps) which extends to an 18 inch depth (1,300 cps). The material is well weathered and may have come from the initial development of the shaft.

Figure 22. Photo: UGSH8425. Trench T-12A.

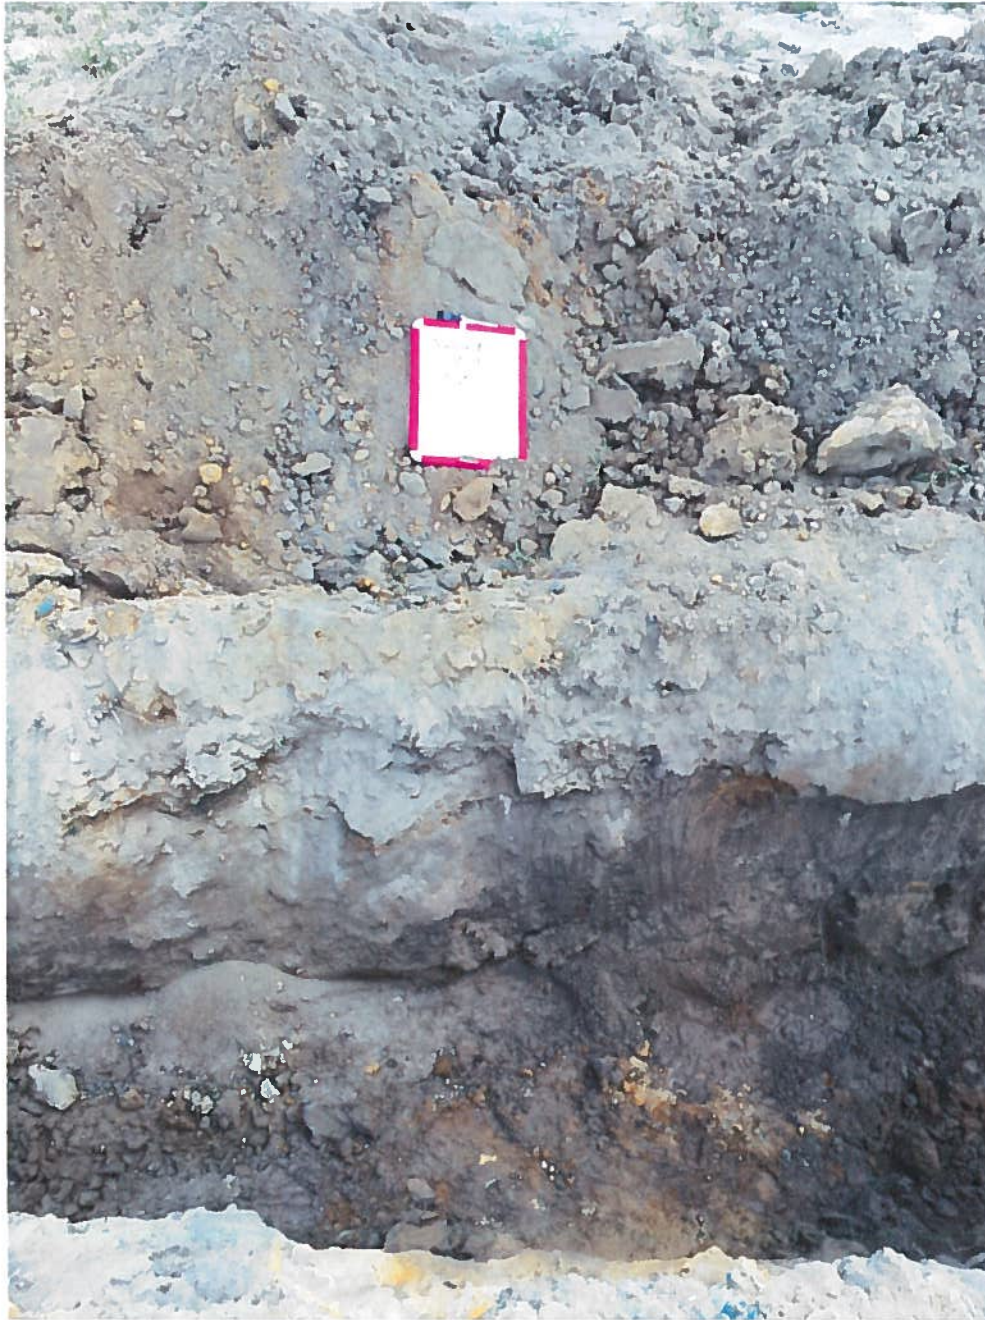
This trench was excavated in a flat area just west of the access road. Material in the trench at the six-inch to one-foot depth is blackish in coloration with elevated readings (3,200 cps) and is layered with or interbedded with a green montmorillonite clay. There are also some yellowish inclusions in the material. The bottom of the trench had a lakebed clay bottom (900 cps) that appears to contain the overlying material and limit its leaching.

Figure 23. Photo: SCN14332. Trench T-7A

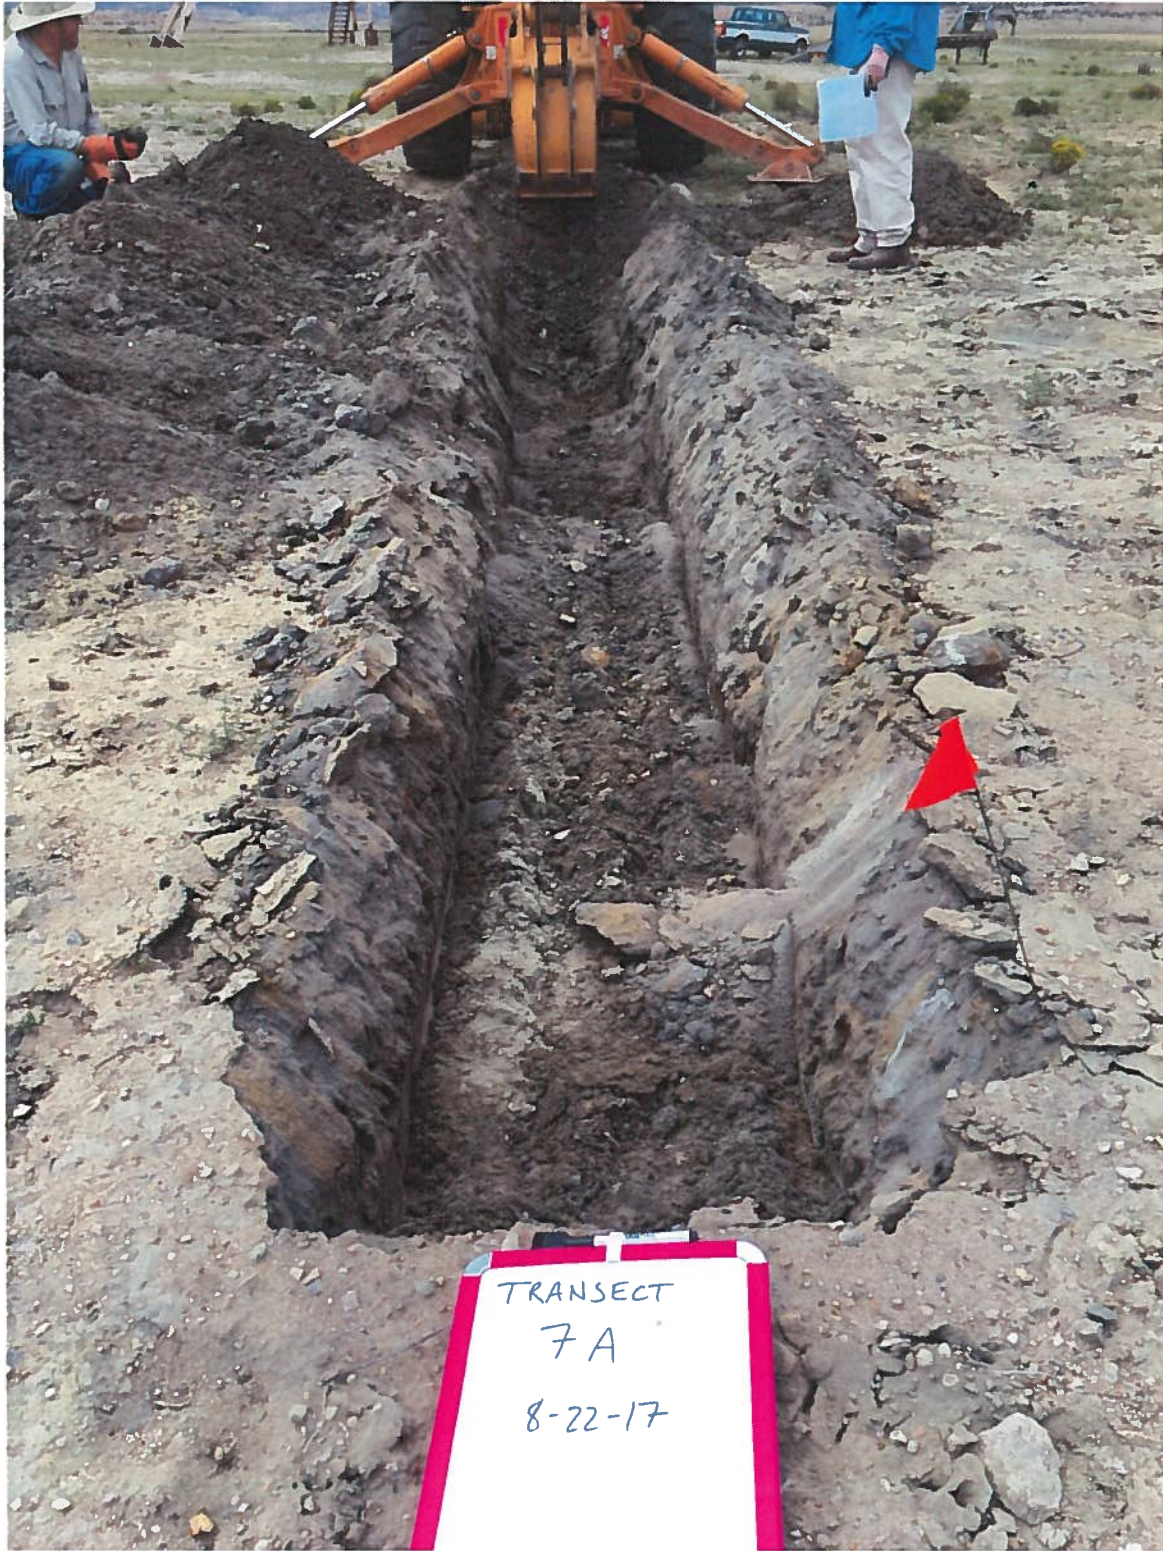
Figure 24. Photo: RNC16822. Trench T-7A (detail).

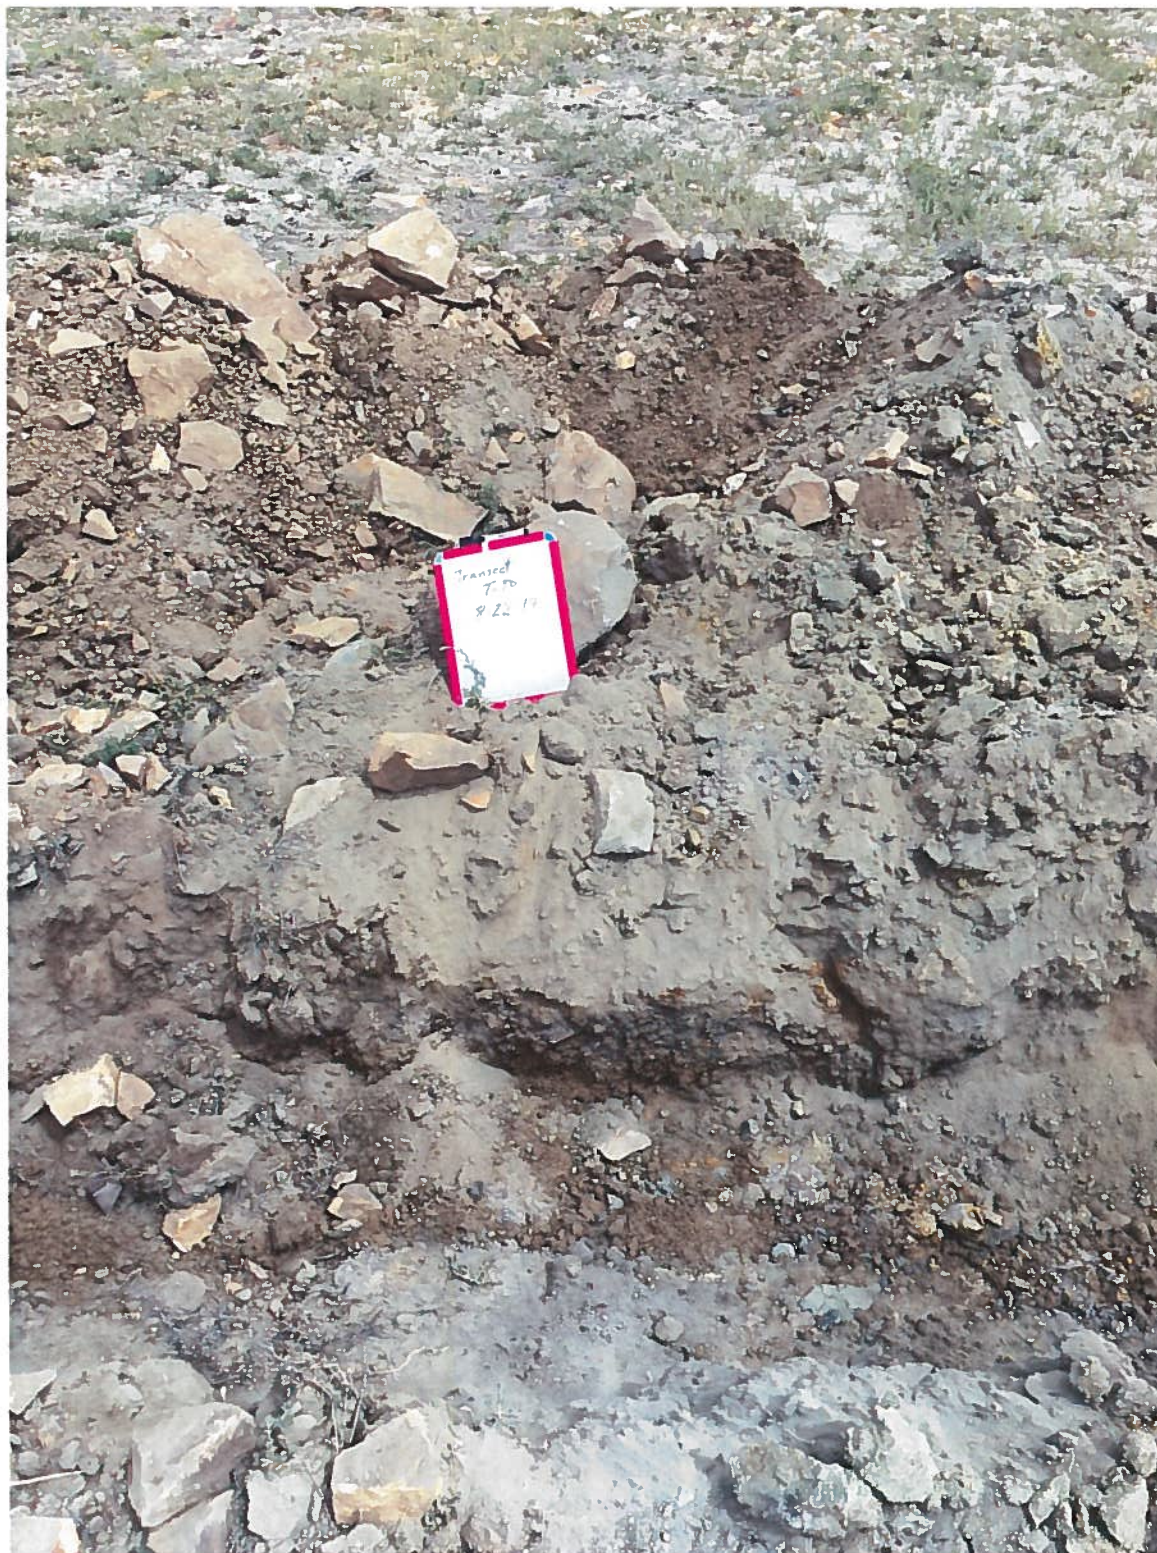
Figure 25. Photo: INBC1023. Trench T7B (detail)

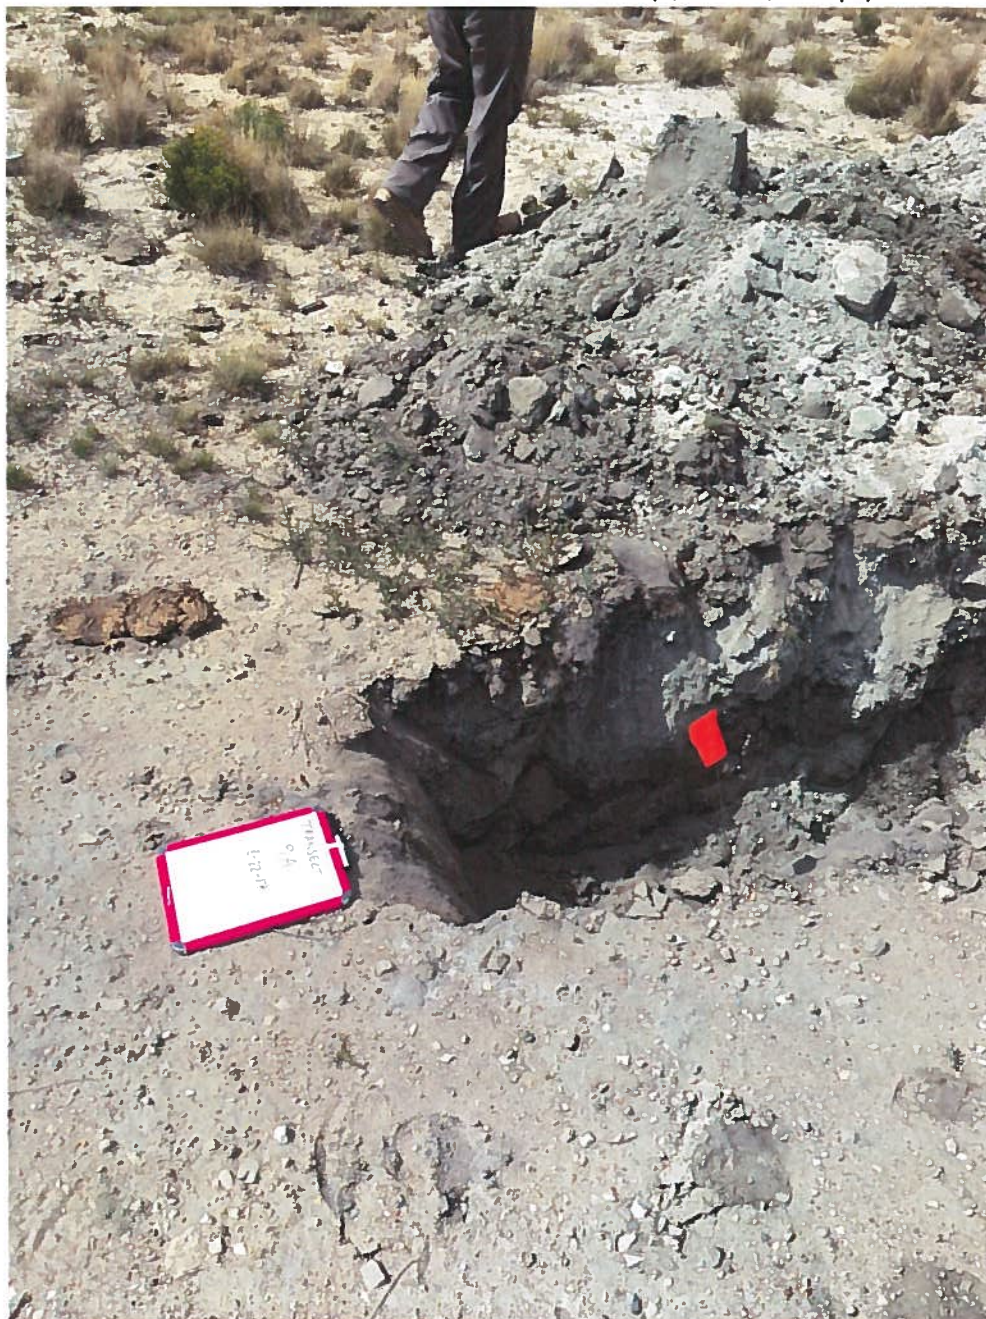
This excavation was conducted west of the headframe. Material from the trench consisted of a dominant light gray layer above thinner darker gray layers and blackish inclusions. No elevated readings were observed at the north end of the trench, though readings from the one-foot to 18-inch depth at the south end of the trench were somewhat elevated (1,800 – 2,300 cps).

Figure 26. Photo: UGKT4037. Trench T-9A (beginning of trench)

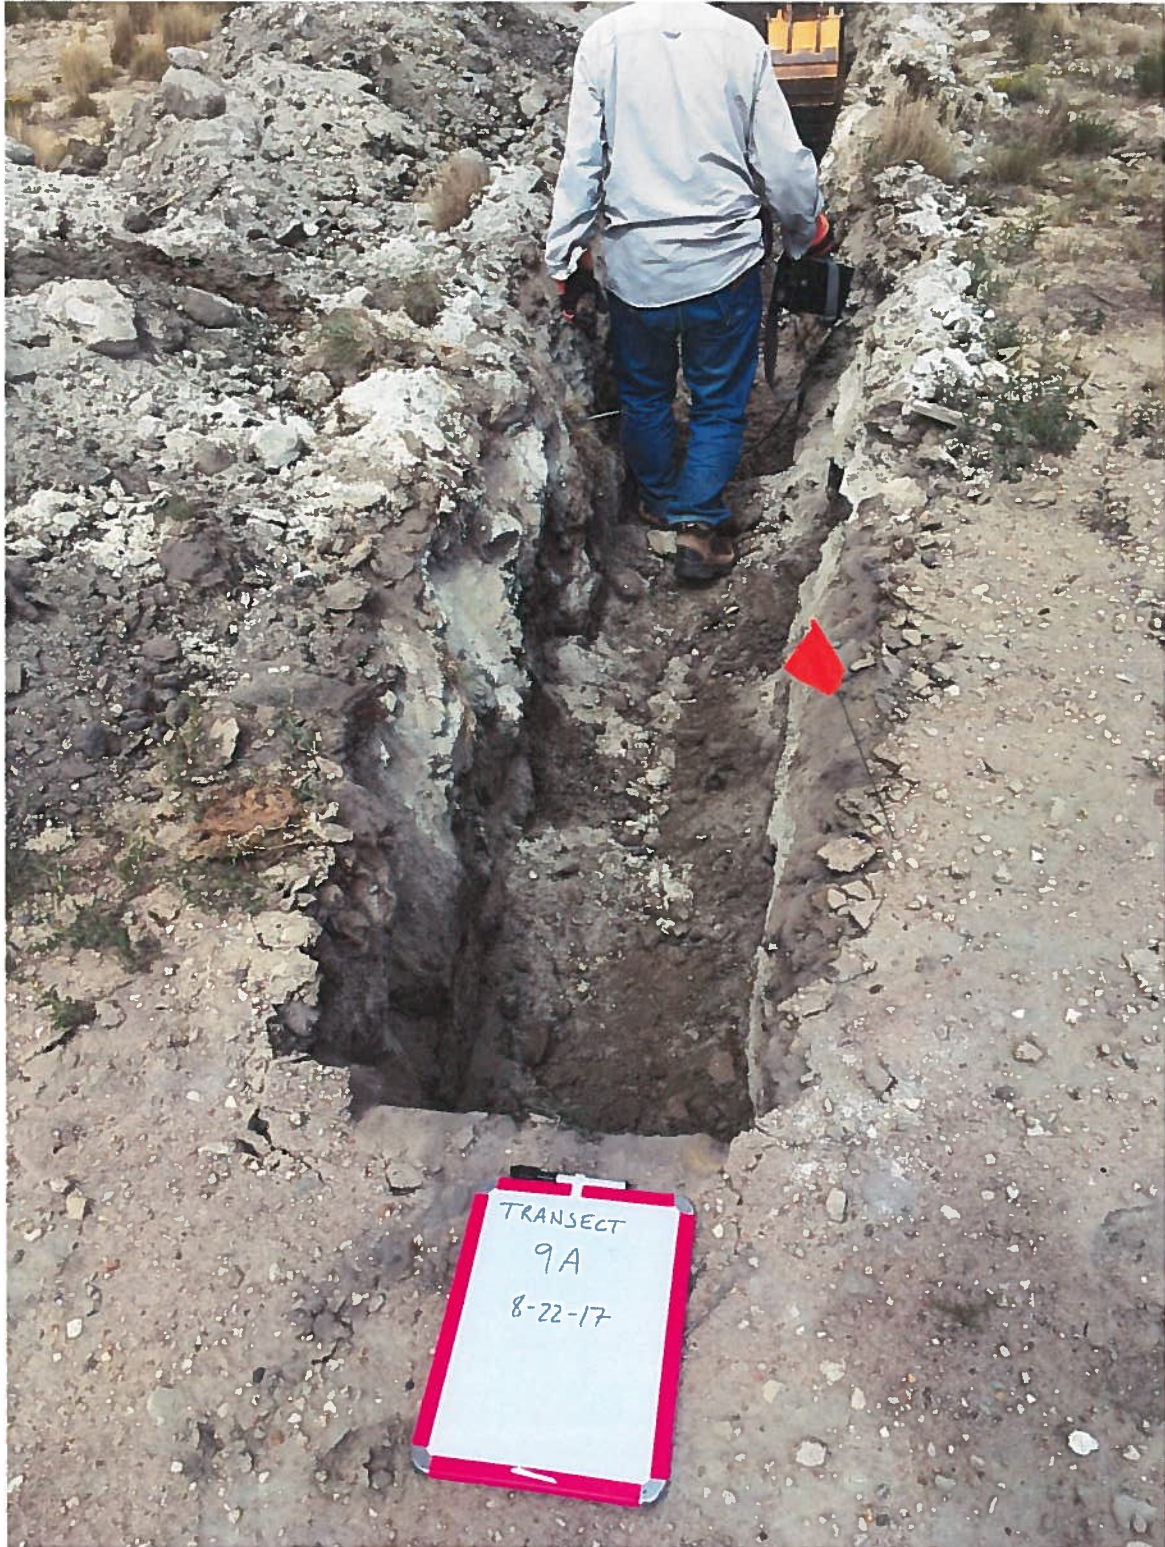
Figure 27. Photo: YCNB5702. Trench T-9A.

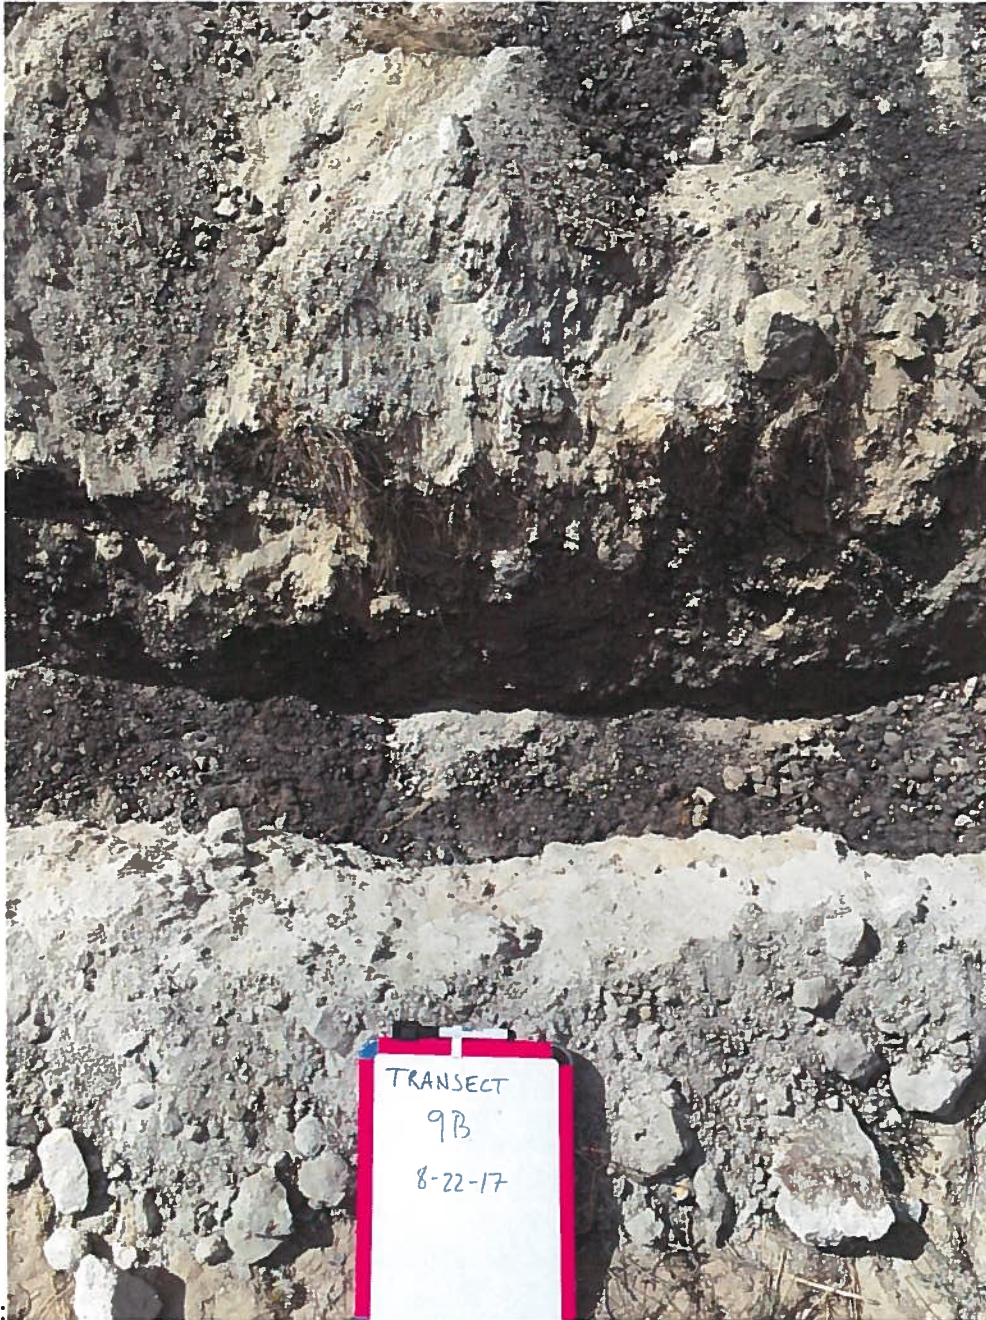
Excavation of the 9B trench was conducted in a graded area located just west of the headframe, west to the edge of the lake bed. The trench material consisted of a dark gray, chalky, homogeneous layer generally eight inches to one-foot deep with 2,500 cps. This layer overlies a greenish clay (montmorillonite) layer that contains some black charcoal-like organic or humate materials. Below this clay layer there were no elevated readings. Again, the clay layer probably represents the original lakebed profile and may act as a barrier to downward leaching of materials.

Figure 28. Photo: OSBV1639. Trench T-9B (at edge of lake bed)
