**QUESTA TAILINGS PIPELINE REMOVAL
STAGE 5 WORK PLAN
CHEVRON ENVIRONMENTAL MANAGEMENT COMPANY
QUESTA MINE**

Project #: 476-027-002

SUBMITTED BY: Trihydro Corporation

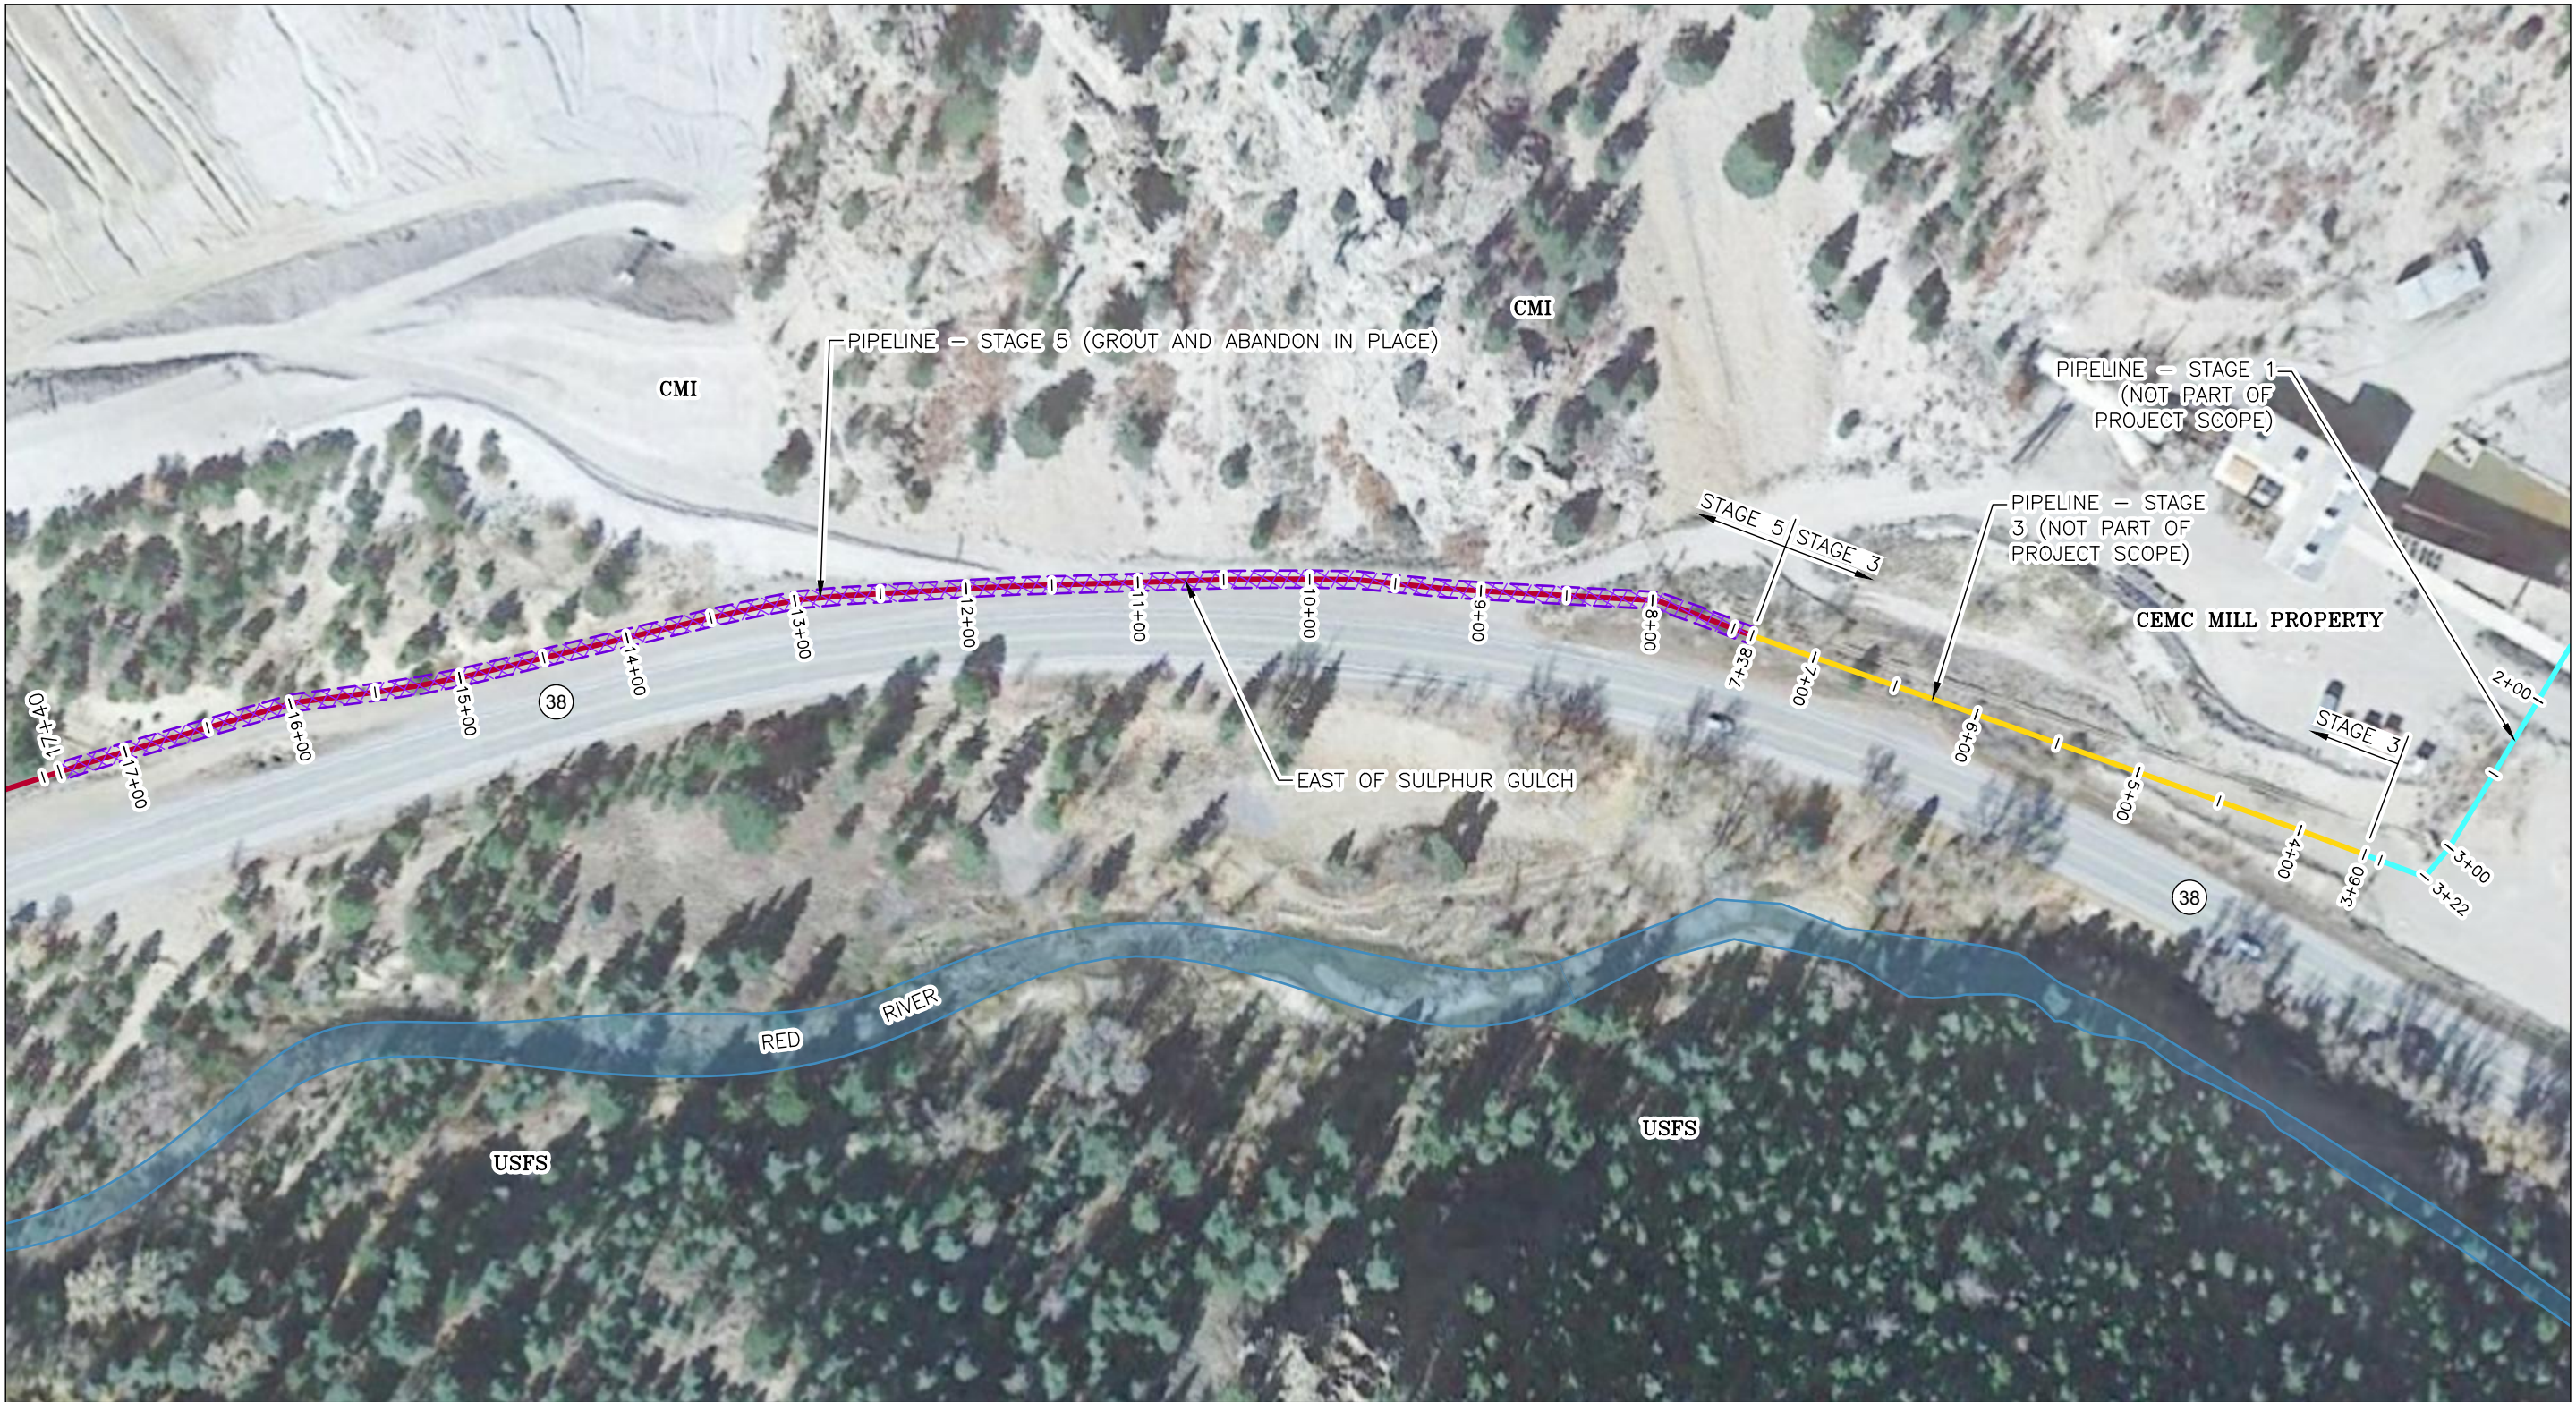
STAGE	BEGIN STATION	END STATION	NO. OF PIPES	PIPE LENGTH (LF)	DESCRIPTION	STRUCTURES	
						COUPLINGS (EA)	OTHER STRUCTURES (EA)
5	7+38	17+40	2	1002	BELOW GROUND, 2 - 14" Ø PAINTED AND/OR UNPAINTED STEEL - ABANDON IN PLACE - GROUT	60	1

5.01: East of Sulphur Gulch	1,000	Outside of winter conditions	U	Y	3-2
5.02: West of Sulphur Gulch	1,100	Outside of winter conditions	A	Y	3-3
5.03: Sugar Shack South	4,000	Outside of winter conditions	A	Y	3-4, 3-5, 3-6, 3-7

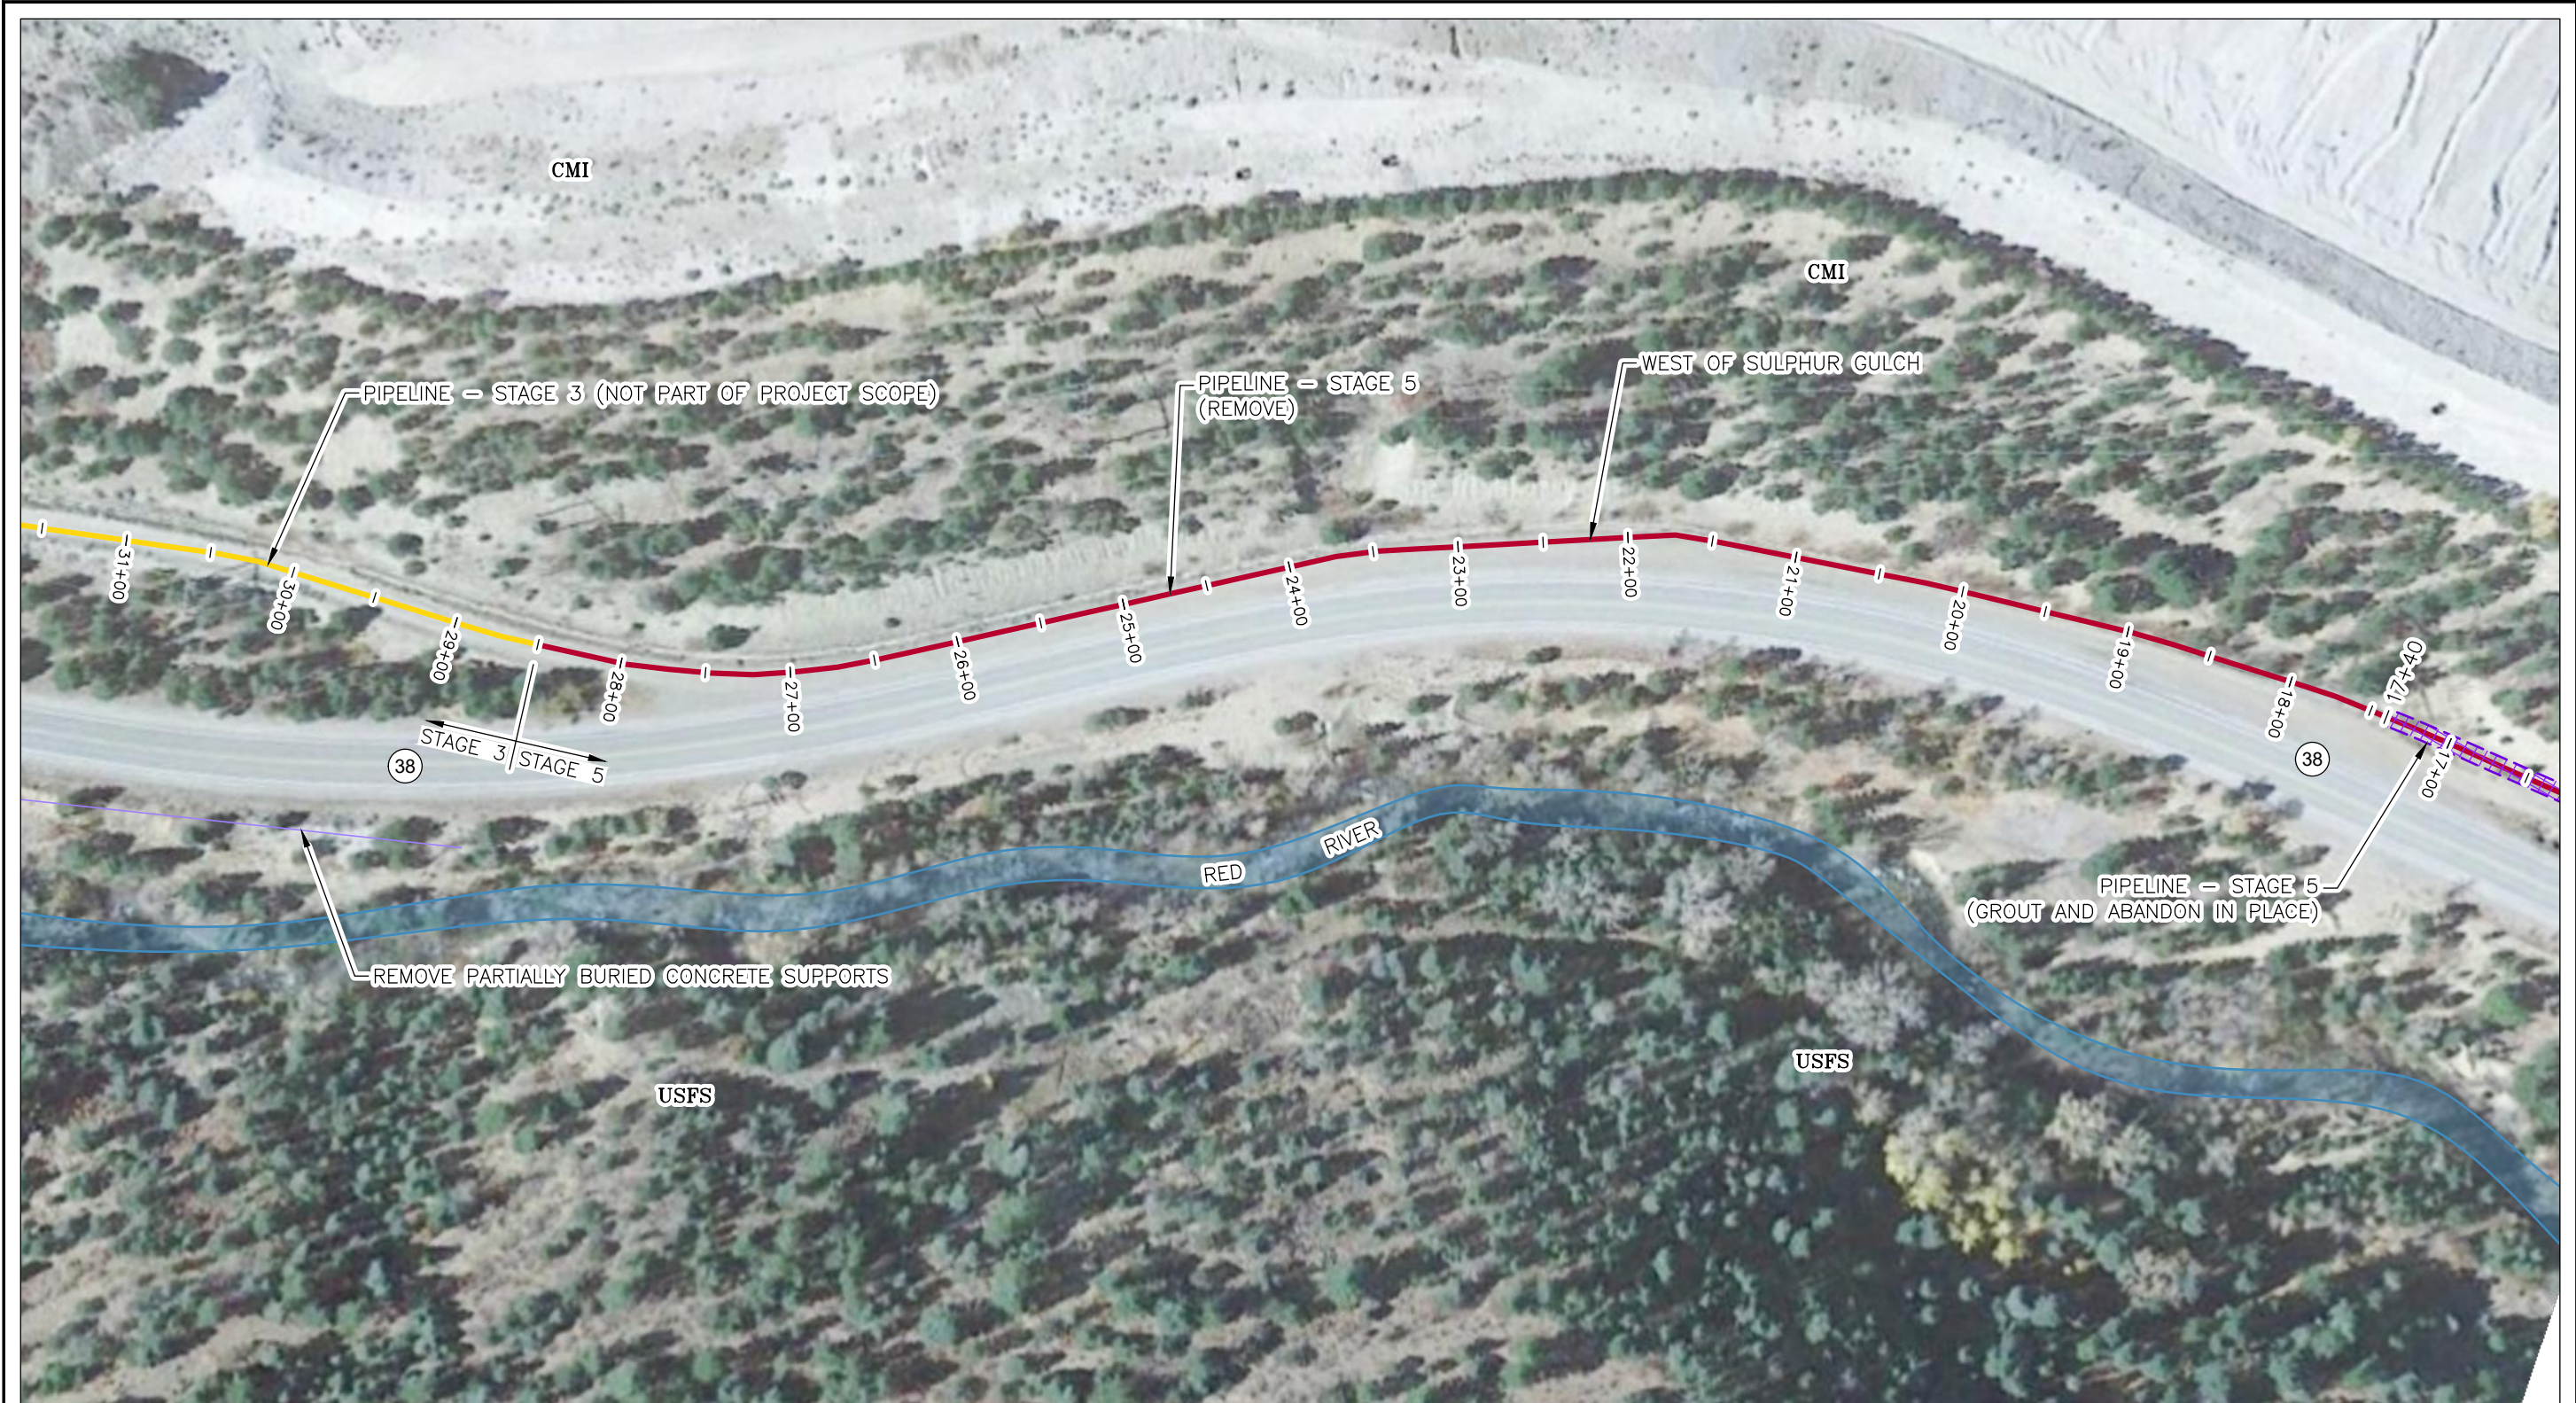
STAGE	BEGIN STATION	END STATION	NO. OF PIPES	PIPE LENGTH (LF)	DESCRIPTION	STRUCTURES
						COUPLINGS (EA)
5	17+40	28+50	2	1110	ABOVE GROUND, 2 - 14" Ø PAINTED AND/OR UNPAINTED STEEL - REMOVE	60

The West of Sulphur Gulch pipeline segment (Segment 5.02) is located on Chevron property between station numbers 17+40 and 28+50 and is between mile marker 6.5 and 6.7 of NM-38. The pipe in this segment starts where Segment 5.01 ends and where Segment 3.2 (already removed) began on the short dirt road that branches off of Highway 38. Details of this segment can be found on Figure 3-3. The West of Sulphur Gulch segment is approximately 1,100 linear feet and consists of two pipe runs. The pipe and associated structures in this segment will be removed and disposed of in accordance with Section 4.1 of the Removal Work Plan (Trihydro 2017). Quantities of demolition materials can be found on Table 4-2.

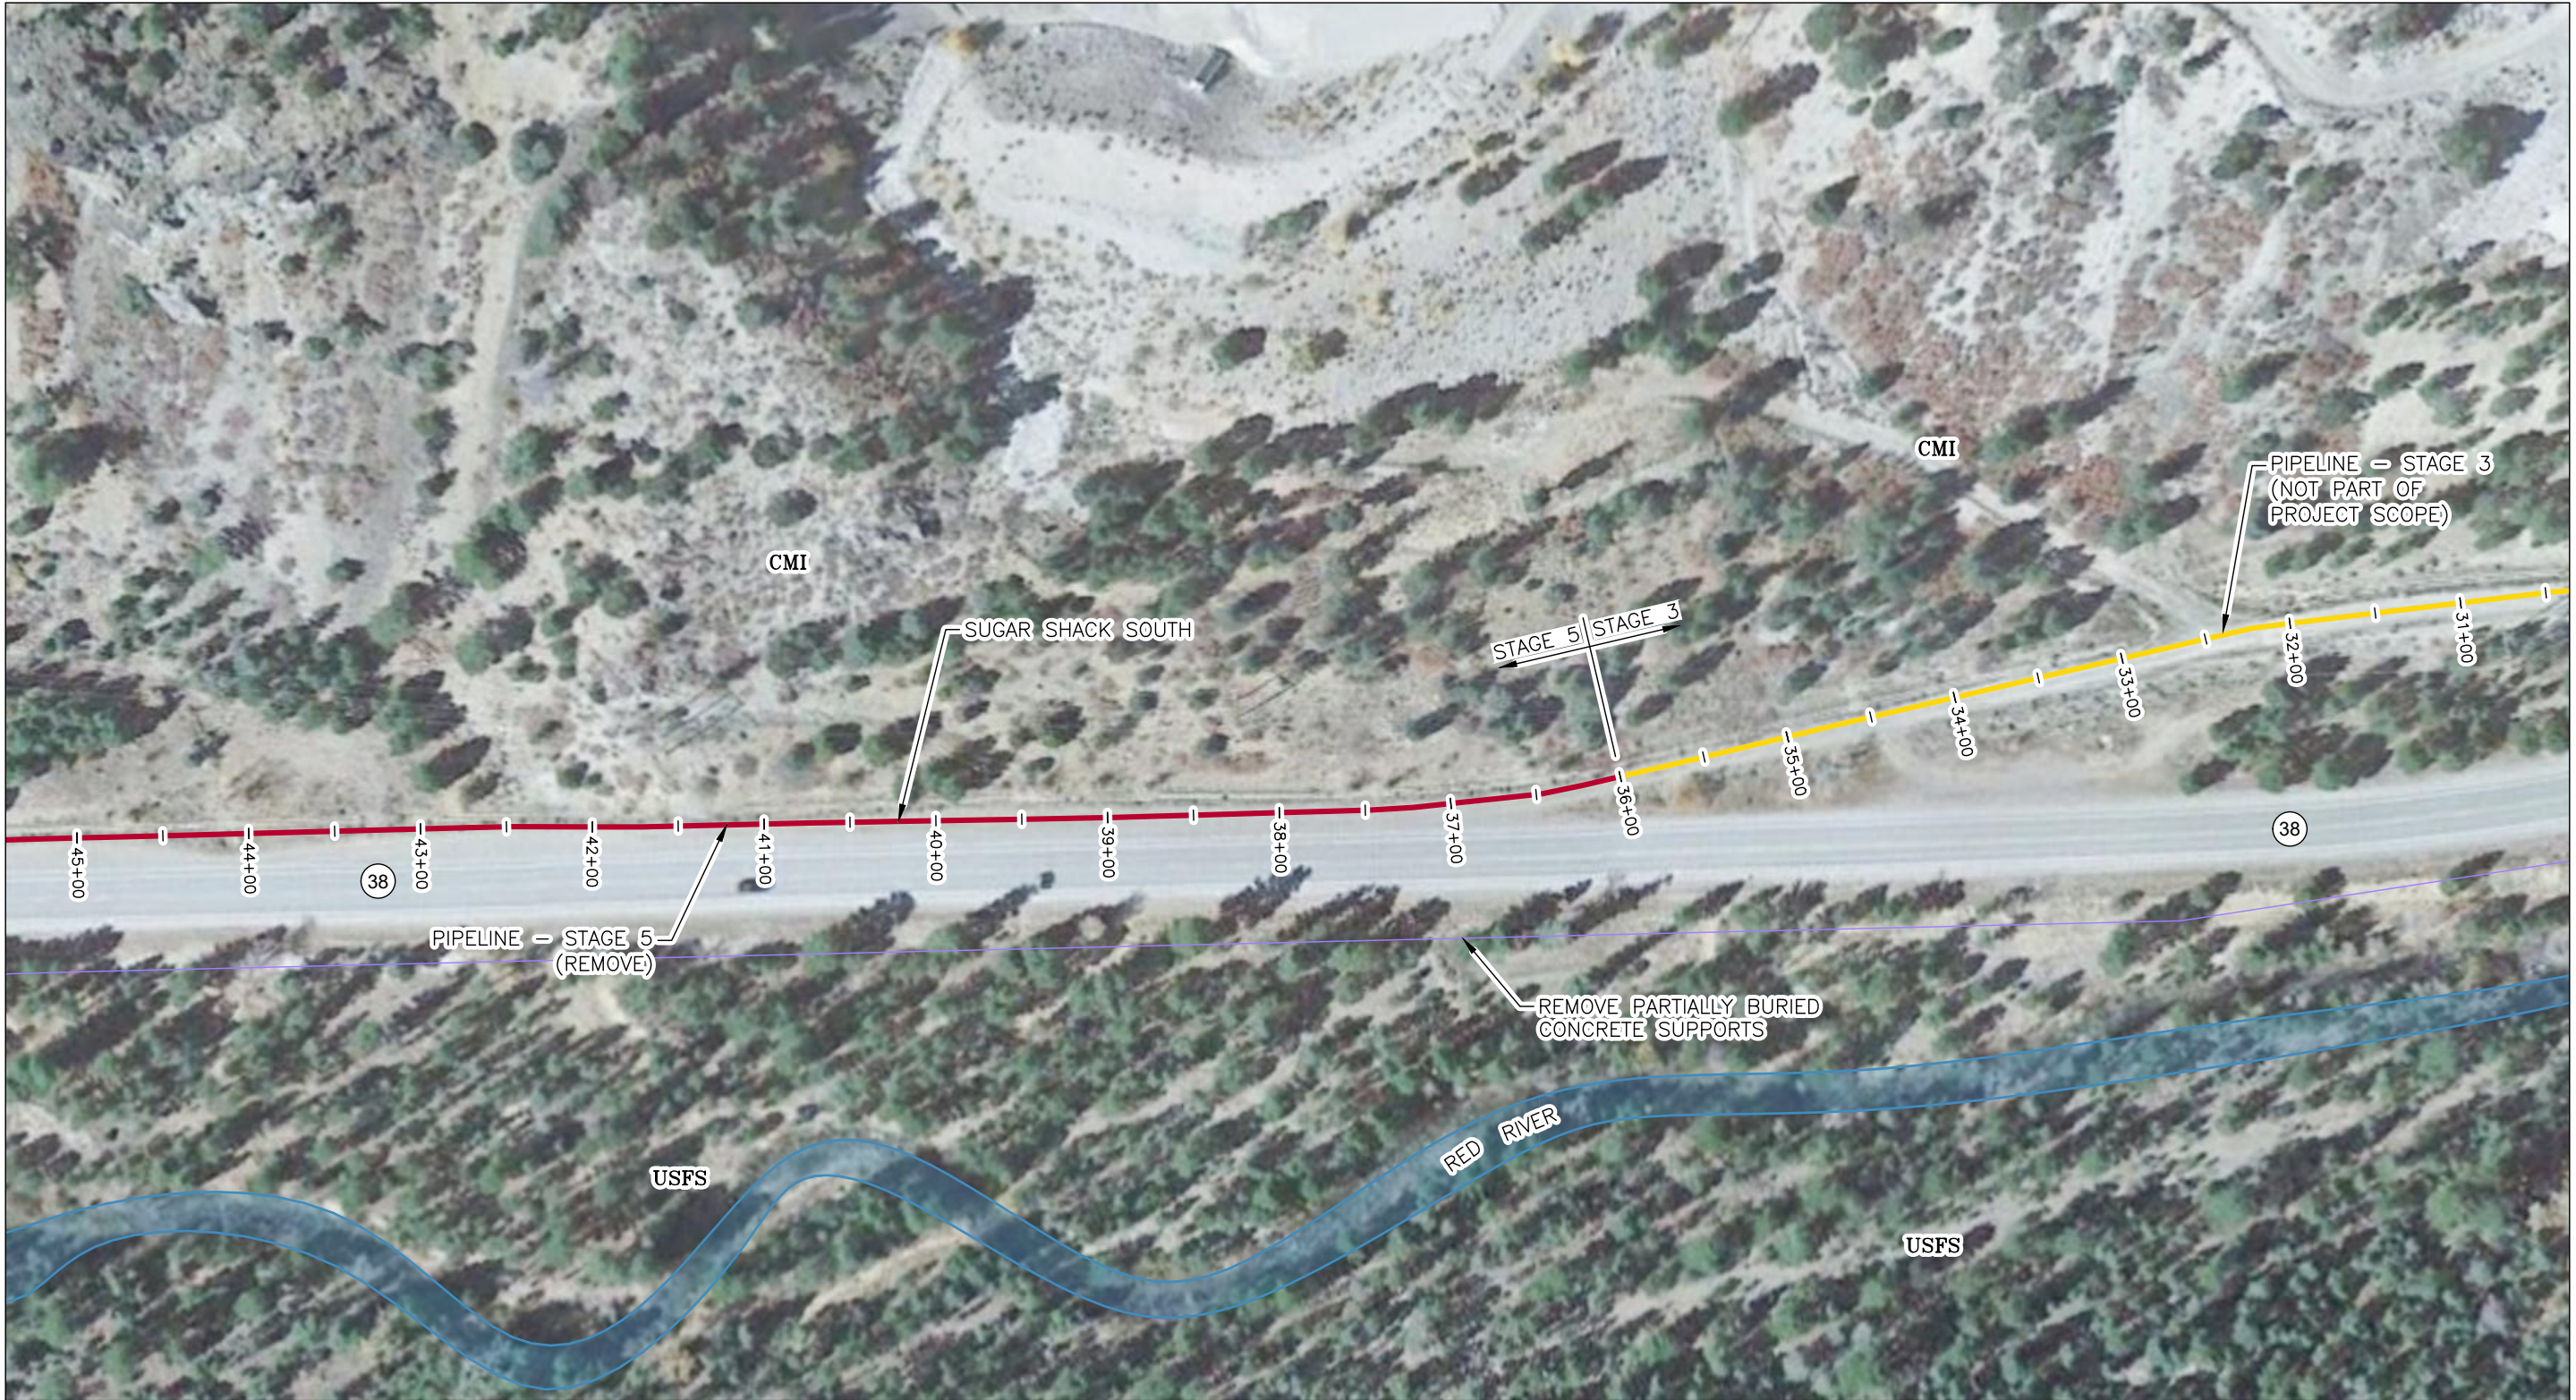
FIGURE 3-4	
STAGE 5 PIPELINE REMOVAL LOCATION SUGAR SHACK SOUTH STA. 36+00 THROUGH 45+00	
CEMC QUESTA MINE QUESTA, NEW MEXICO	
Drawn By: PAC	Checked By: RN
Scale: 1" = 100'	Date: 1/11/2019
File: 476-QM-S5-PIPEREMOVAL201812

STAGE	BEGIN STATION	END STATION	NO. OF PIPES	PIPE LENGTH (LF)	DESCRIPTION	STRUCTURES
						COUPLINGS (EA)
5	36+00	45+00	2	900	ABOVE GROUND, 2 - 14" Ø PAINTED AND/OR UNPAINTED STEEL - REMOVE	60

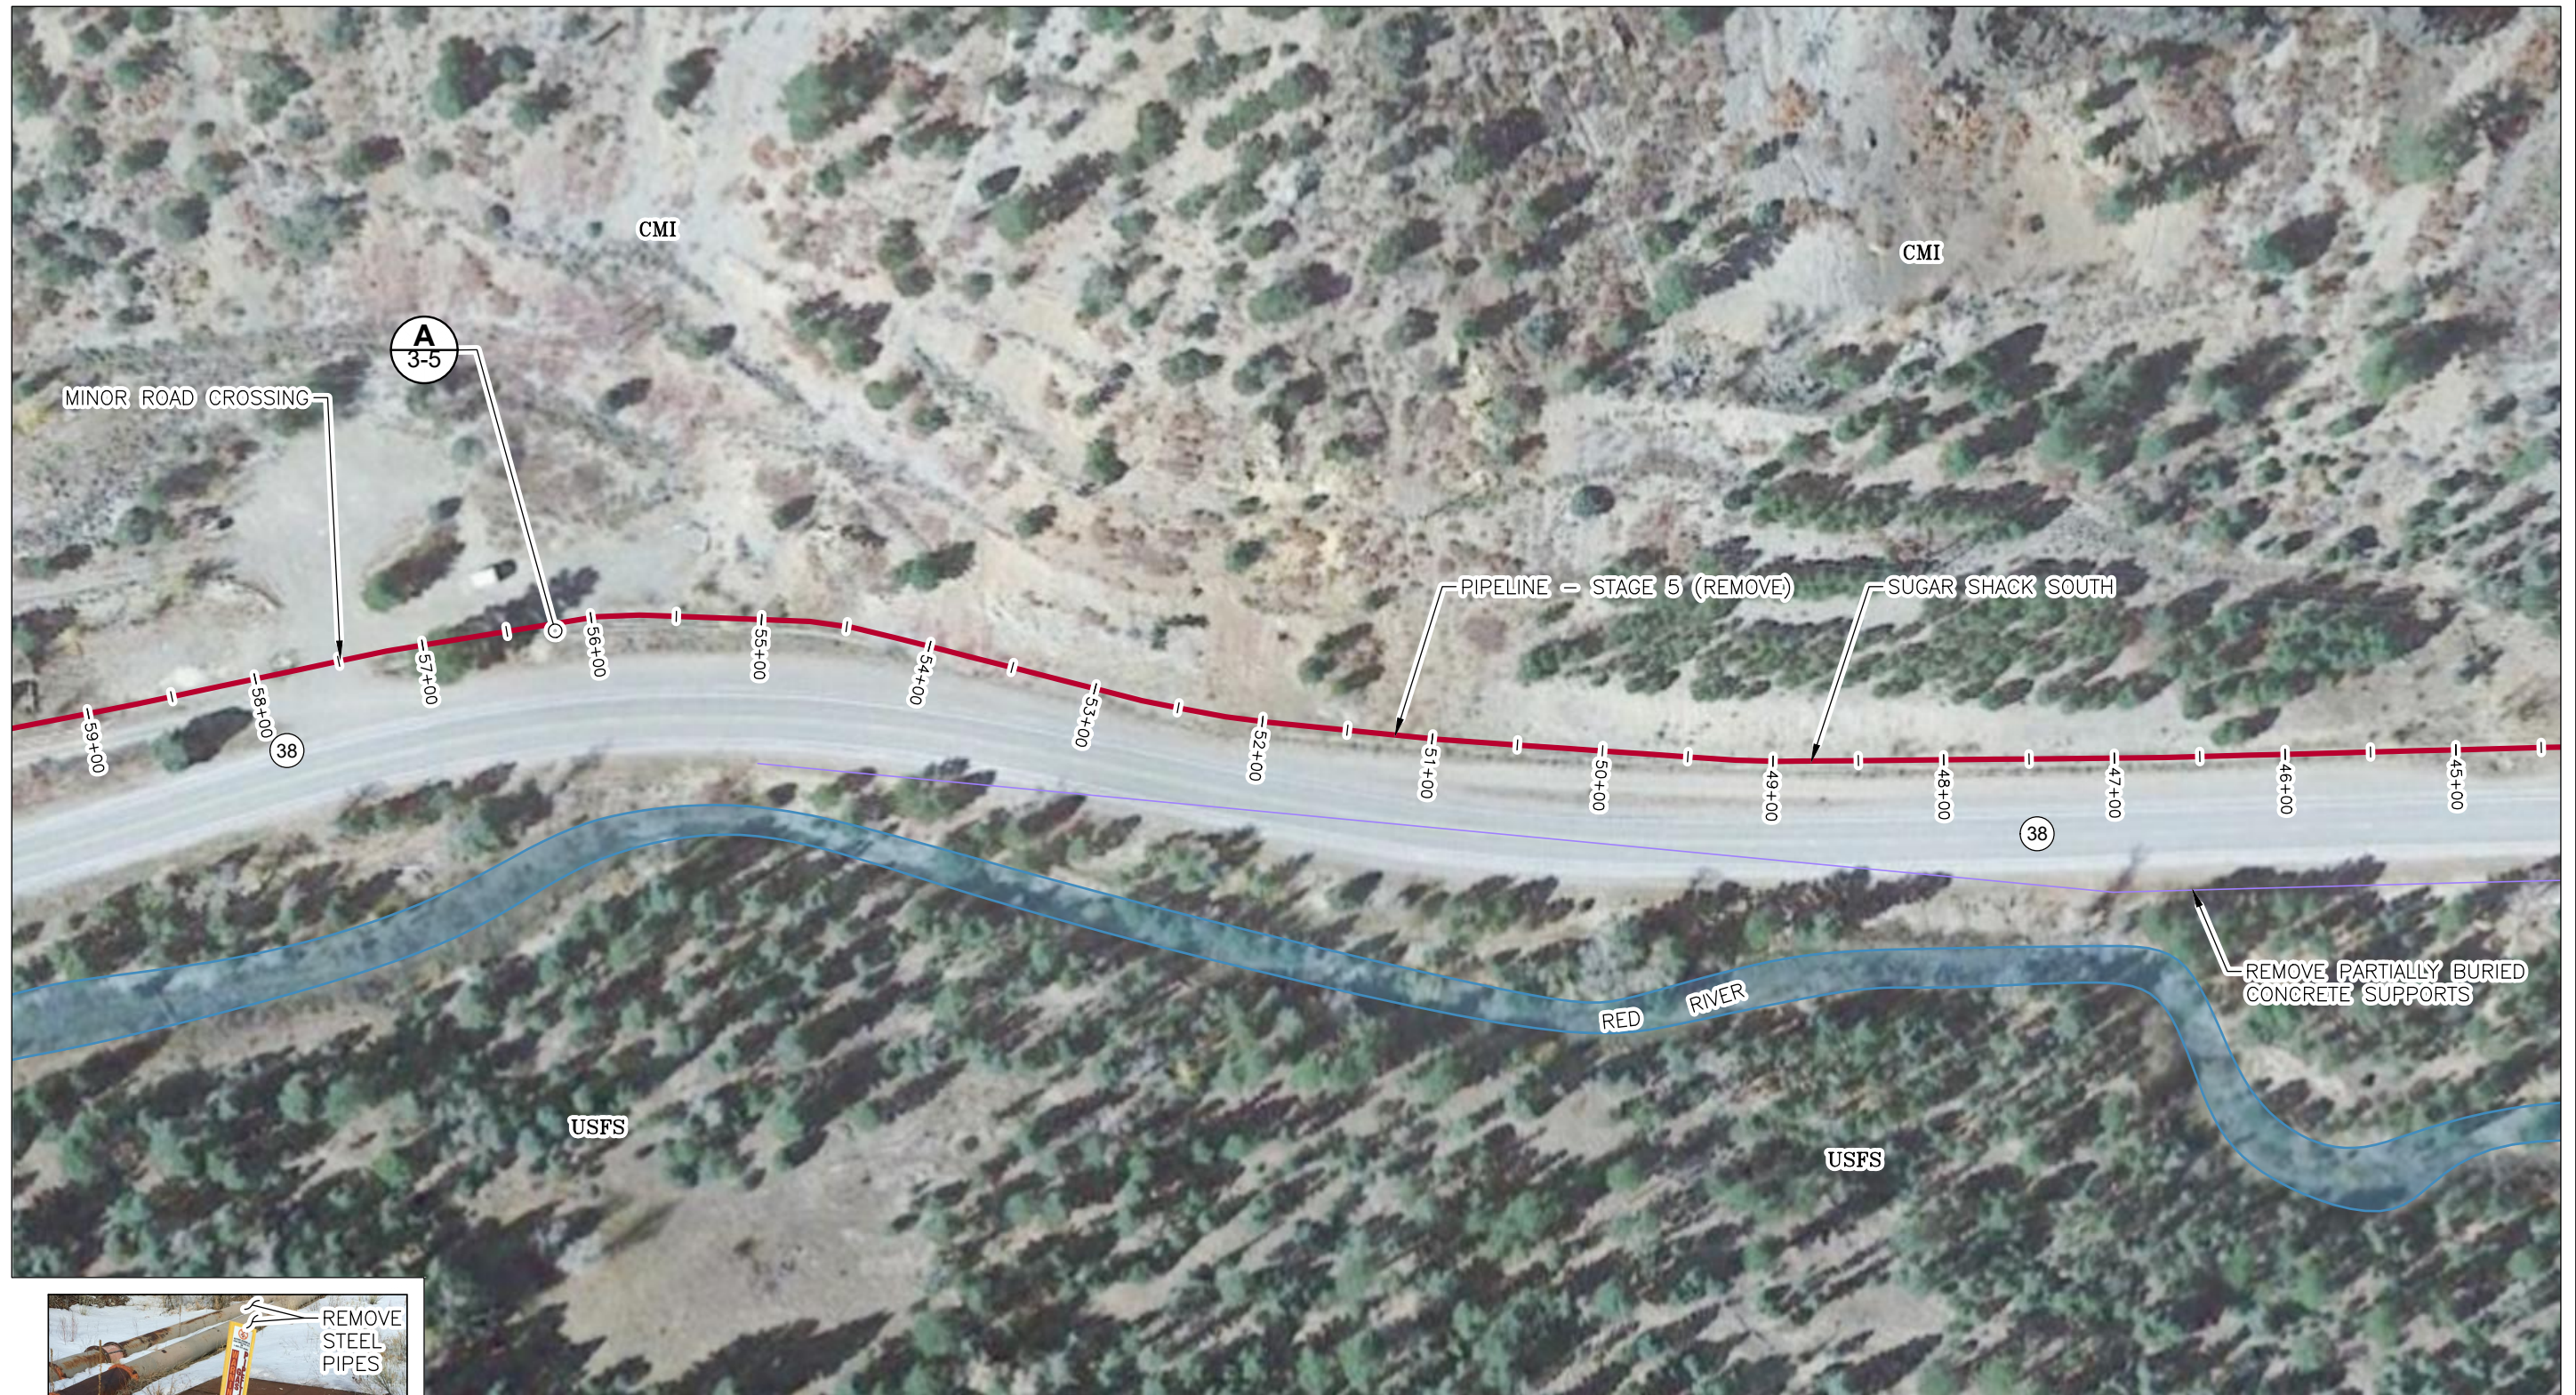
STAGE	BEGIN STATION	END STATION	NO. OF PIPES	PIPE LENGTH (LF)	DESCRIPTION	STRUCTURES	
						COUPLINGS (EA)	MINOR ROAD CROSSINGS (EA)
5	45+000	59+000	2	1400	ABOVE GROUND, 2 - 14" Ø PAINTED AND/OR UNPAINTED STEEL - REMOVE	60	1

Sugar Shack South (Segment 5.03) is a pipeline segment located on Chevron property between station numbers 36+00 and 76+00 and is between mile marker 5.5 and 6.2 of NM-38. The pipe in this segment begins where Segment 3.2 terminated, continues past the Moly Adit onto the dirt road north of Highway 38 and ends where the dirt road meets Highway 38 again. This segment is approximately 4,000 linear feet and contains two pipe runs. The pipe in this segment will be removed and disposed of in accordance with Section 4.1 of the Removal Work Plan (Trihydro 2017). Demolition material quantities can be found on Table 4-2. Details of this segment can be found on Figures 3-4, 3-5, and 3-6.

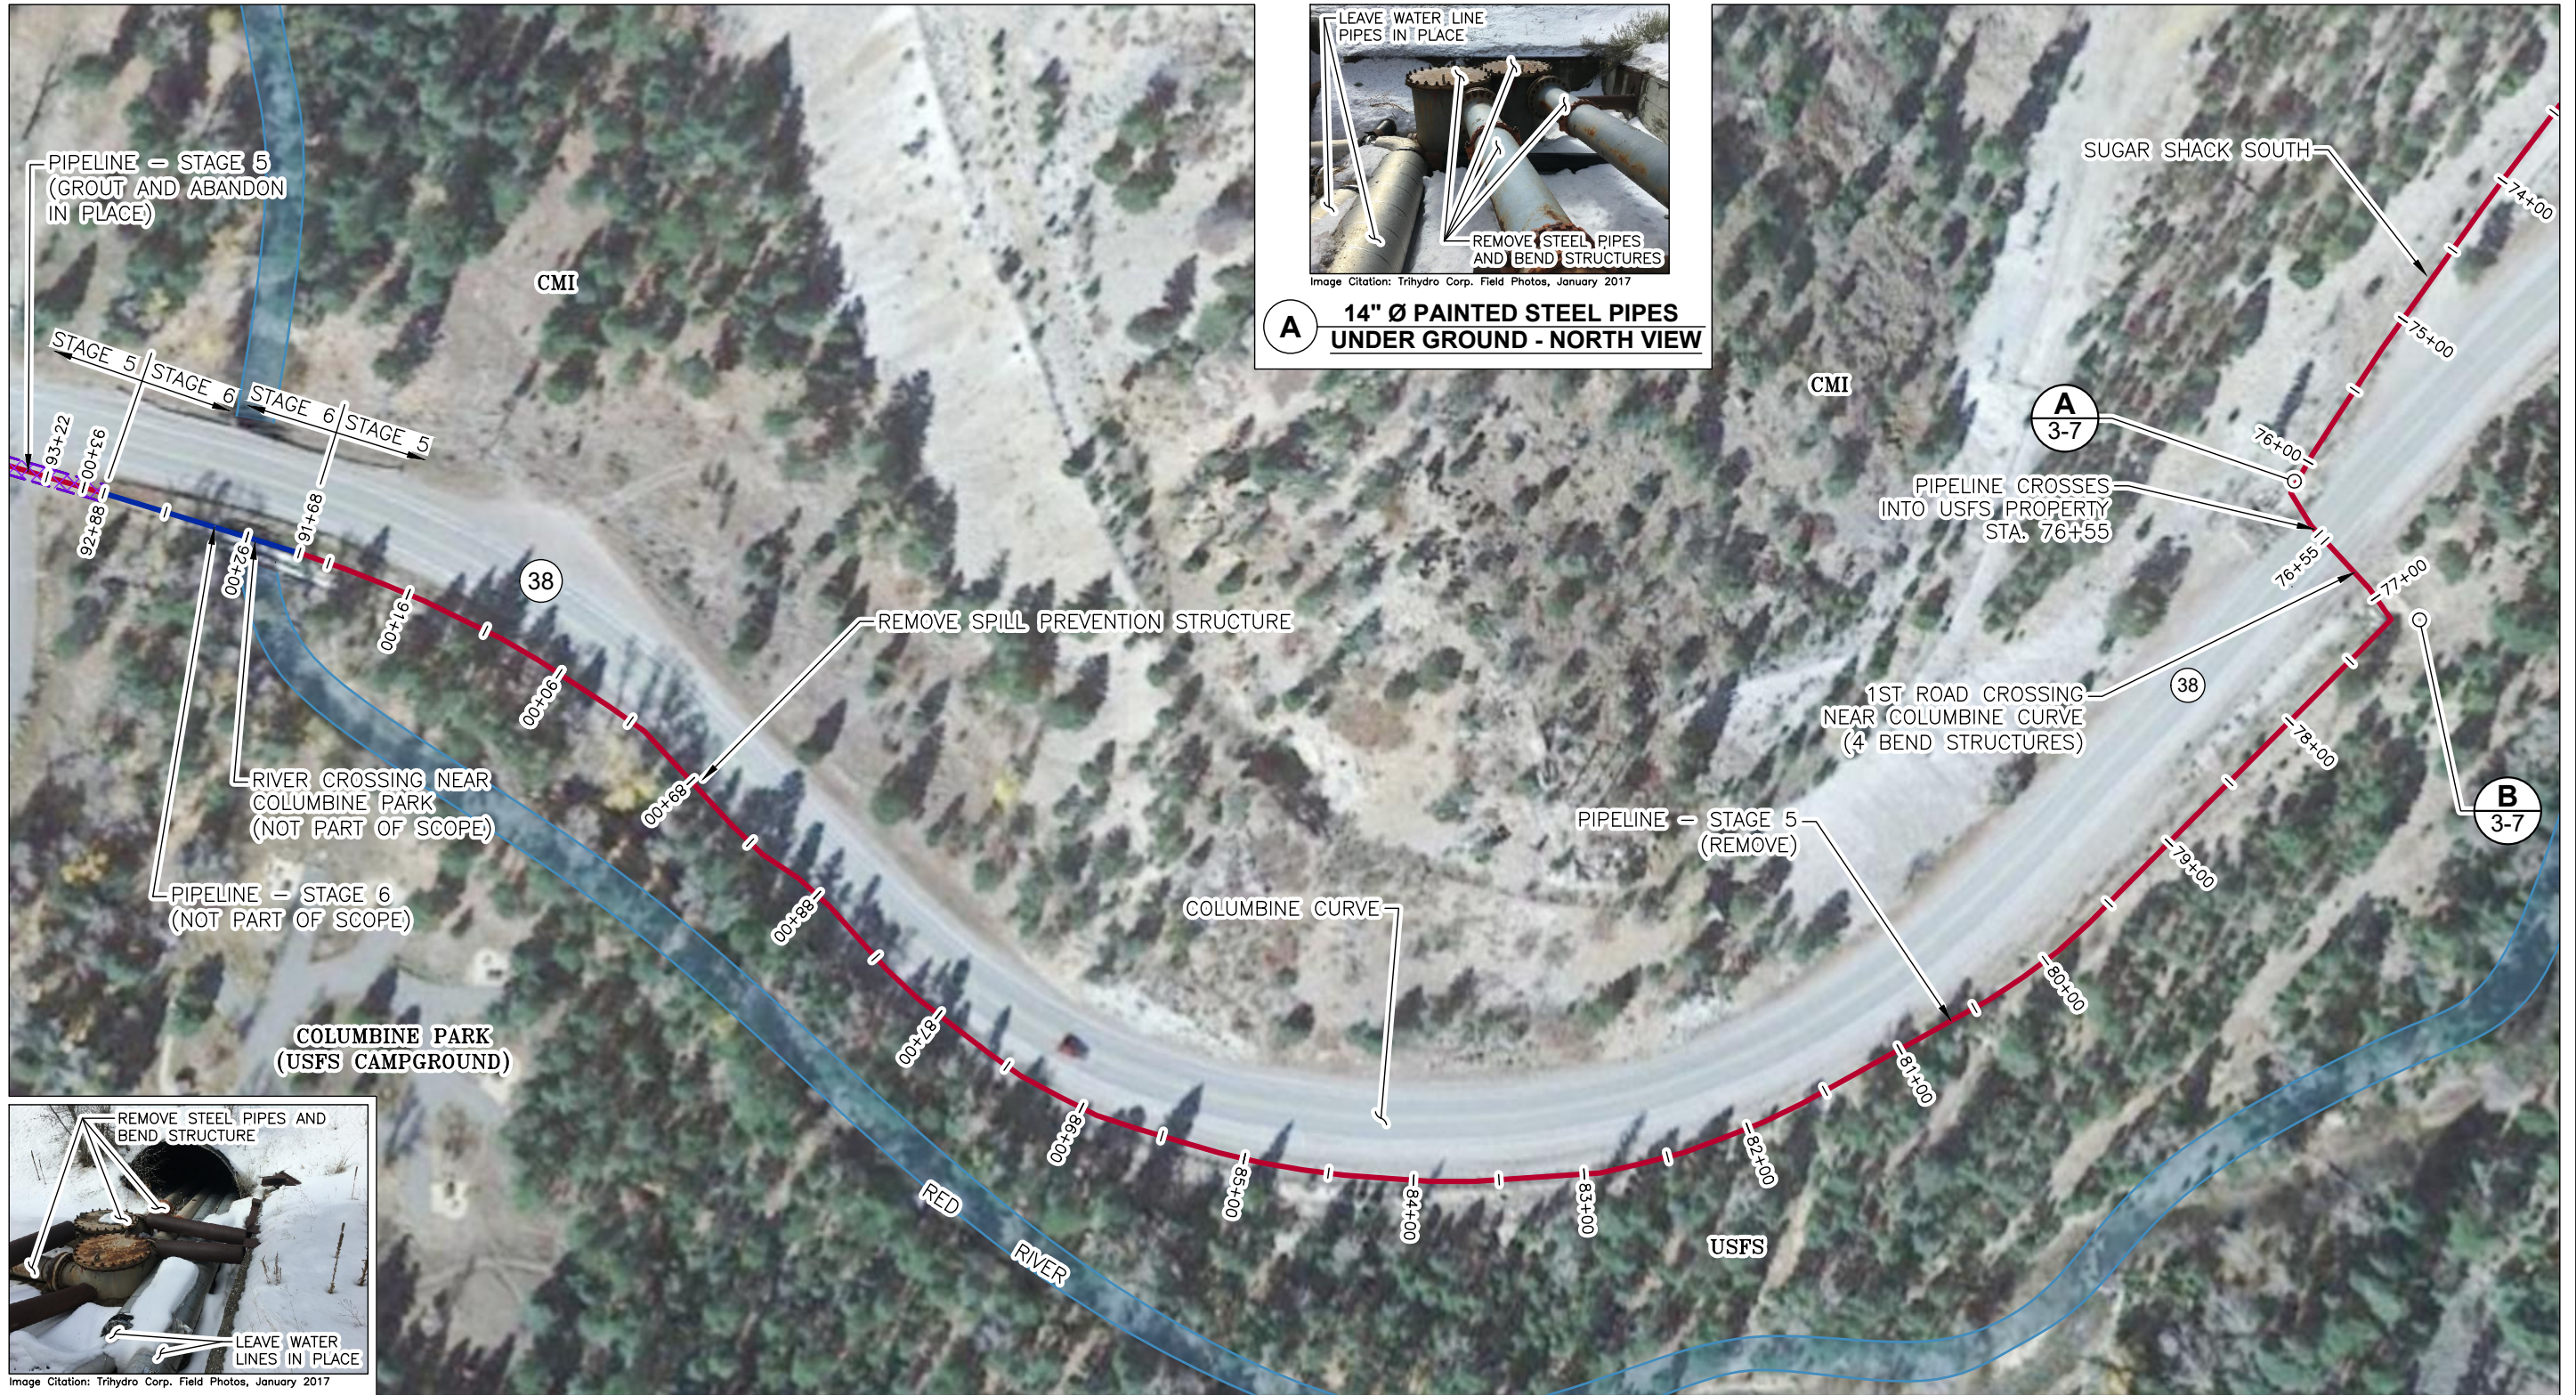
FIGURE 3-6 STAGE 5 PIPELINE REMOVAL LOCATION SUGAR SHACK SOUTH STA. 59+00 THROUGH 74+00		
CEMC QUESTA MINE QUESTA, NEW MEXICO		
Drawn By: PAC	Checked By: RN	Scale: 1" = 100'
Date: 1/11/2019	File: 476-QM-S5-PIPEREMOVAL201812

B 14" Ø PAINTED STEEL PIPE BEND STRUCTURE

STAGE	BEGIN STATION	END STATION	NO. OF PIPES	PIPE LENGTH (LF)	DESCRIPTION	STRUCTURES			
						COUPLINGS (EA)	STEEL PIPE BEND STRUCTURES (EA)	OTHER STRUCTURES (EA)	ROAD CROSSINGS (EA)
5	74+00	91+68	2	1768	ABOVE GROUND, 2 - 14" Ø PAINTED AND/OR UNPAINTED STEEL - REMOVE	100	4	1	1

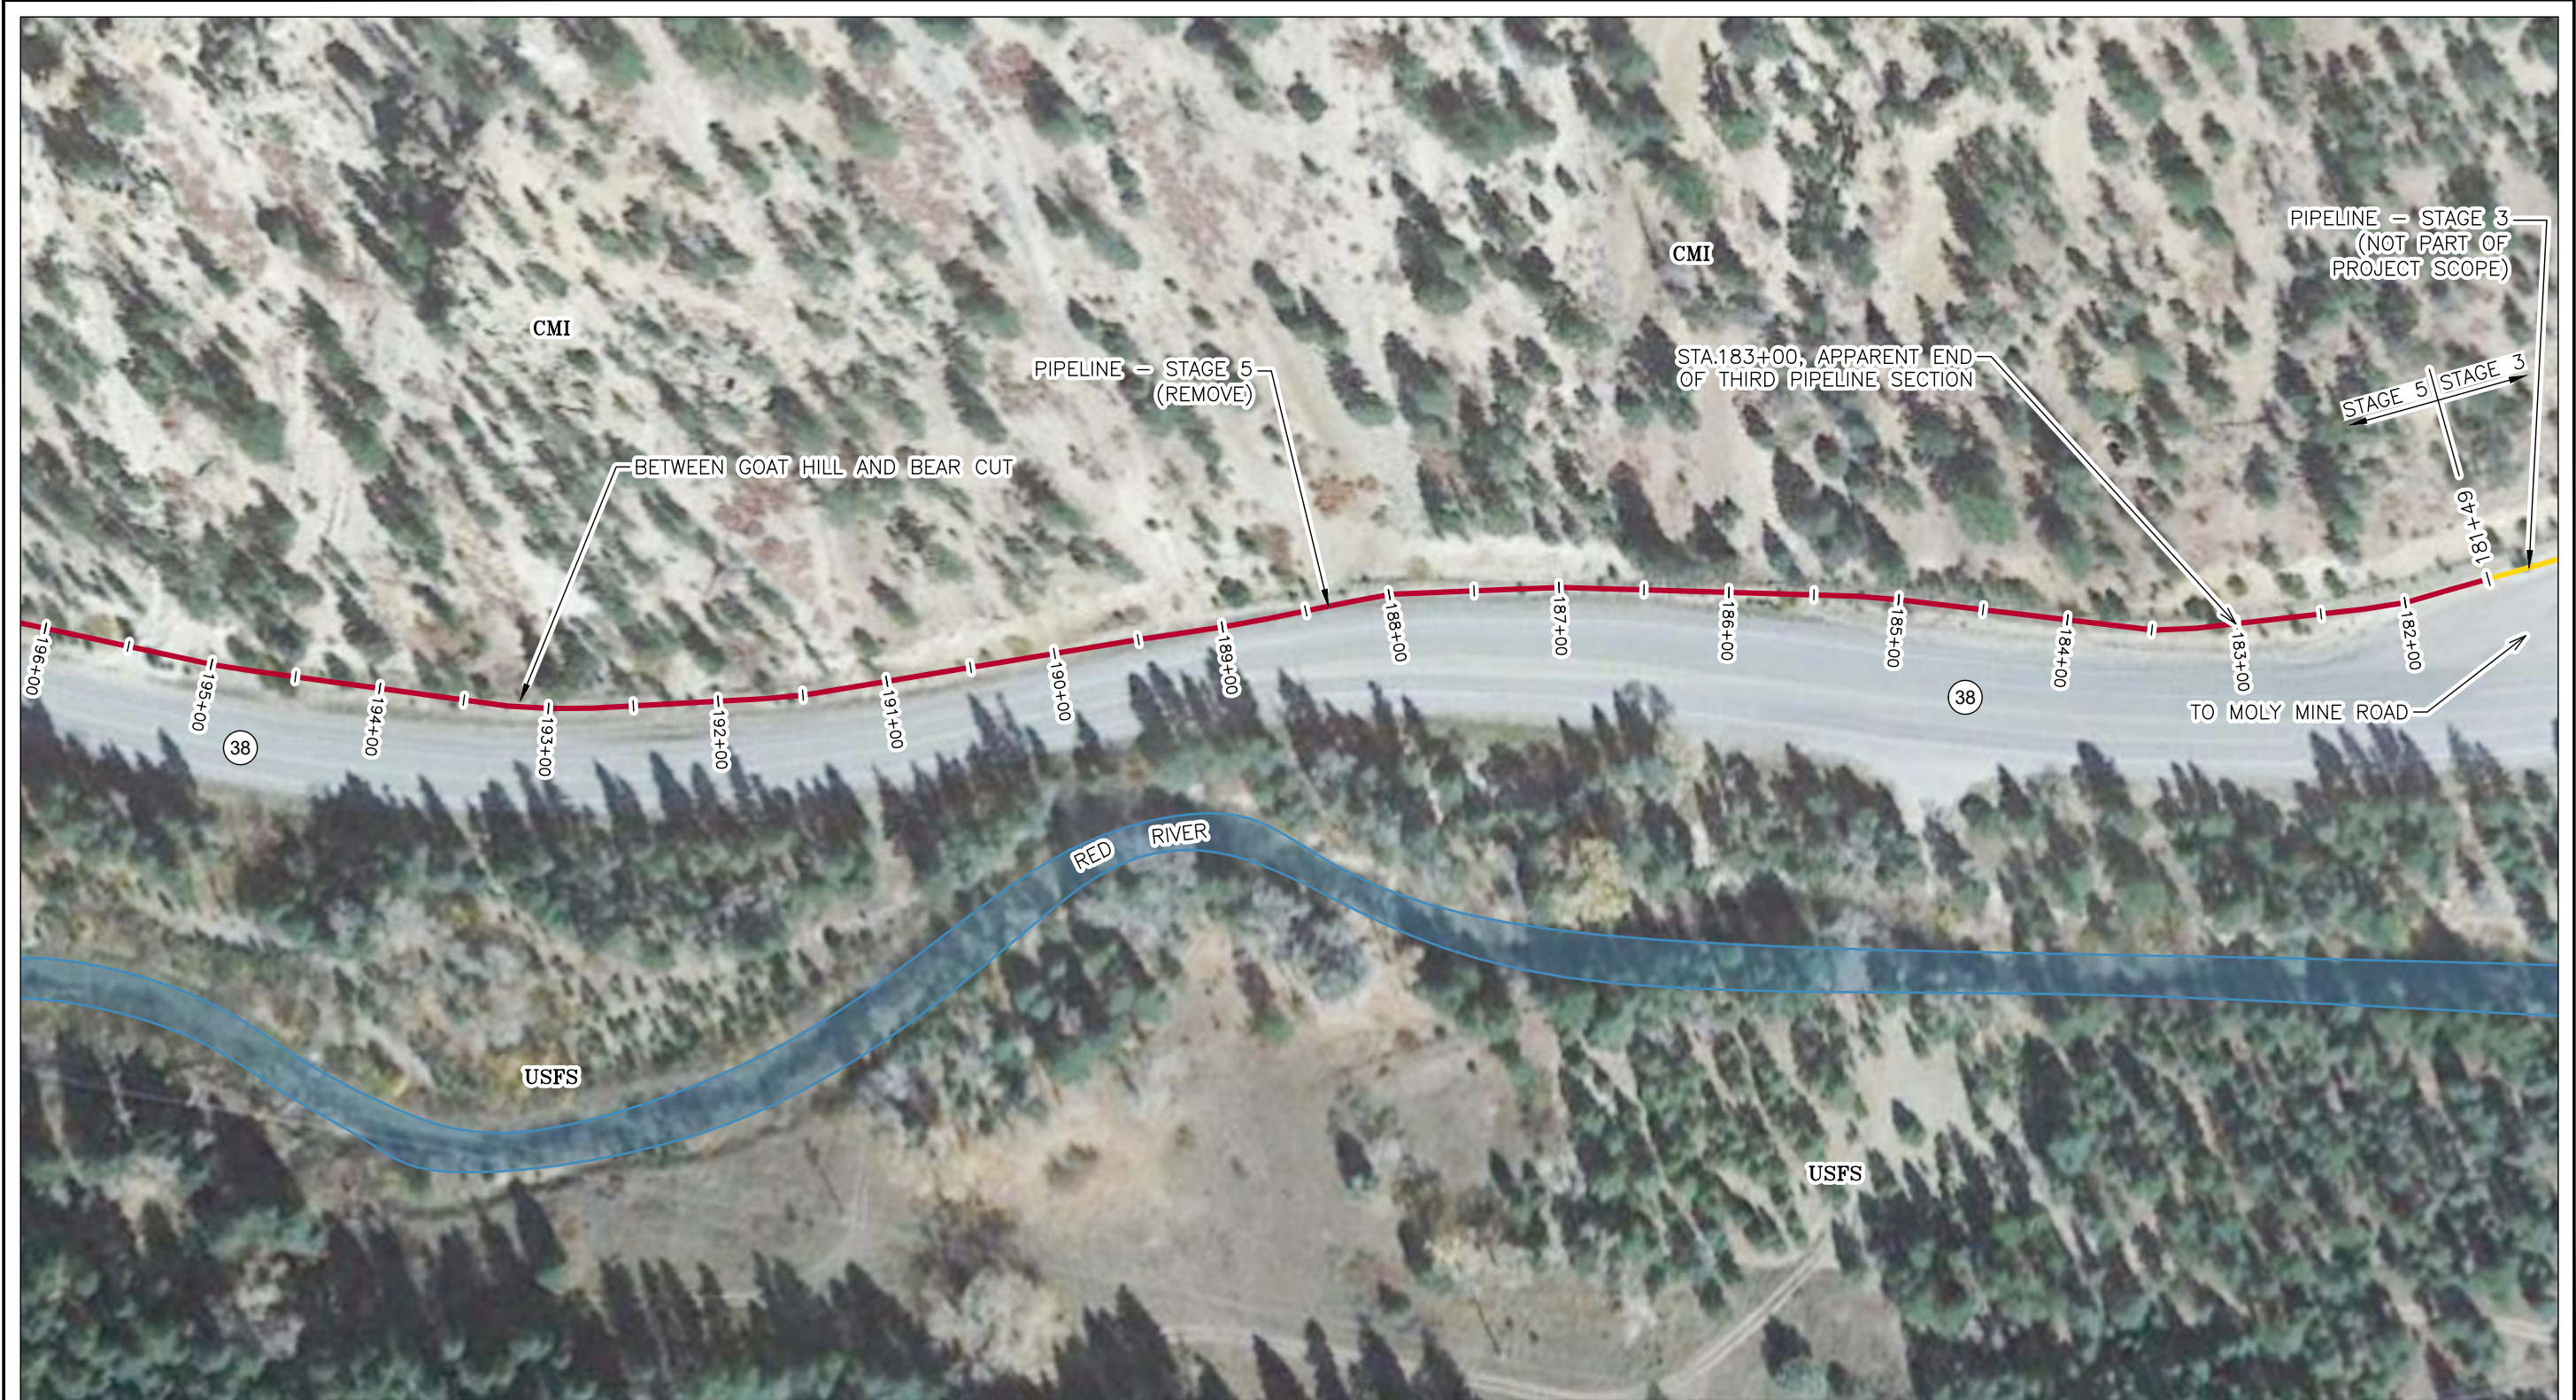
B STEEL TROUGH STRUCTURE
- NORTH VIEW

STAGE	BEGIN STATION	END STATION	NO. OF PIPES	PIPE LENGTH (LF)	DESCRIPTION	STRUCTURES
						COUPLINGS (EA)
5	181+49	183+00	3	151	ABOVE GROUND, 3 - 14" Ø PAINTED AND/OR UNPAINTED STEEL - REMOVE	15
5	183+00	196+00	2	1300	ABOVE GROUND, 2 - 14" Ø PAINTED AND/OR UNPAINTED STEEL - REMOVE	70
