**QUESTA TAILINGS PIPELINE REMOVAL
STAGE 5 WORK PLAN
CHEVRON ENVIRONMENTAL MANAGEMENT COMPANY
QUESTA MINE**

Project #: 476-027-002

SUBMITTED BY: Trihydro Corporation

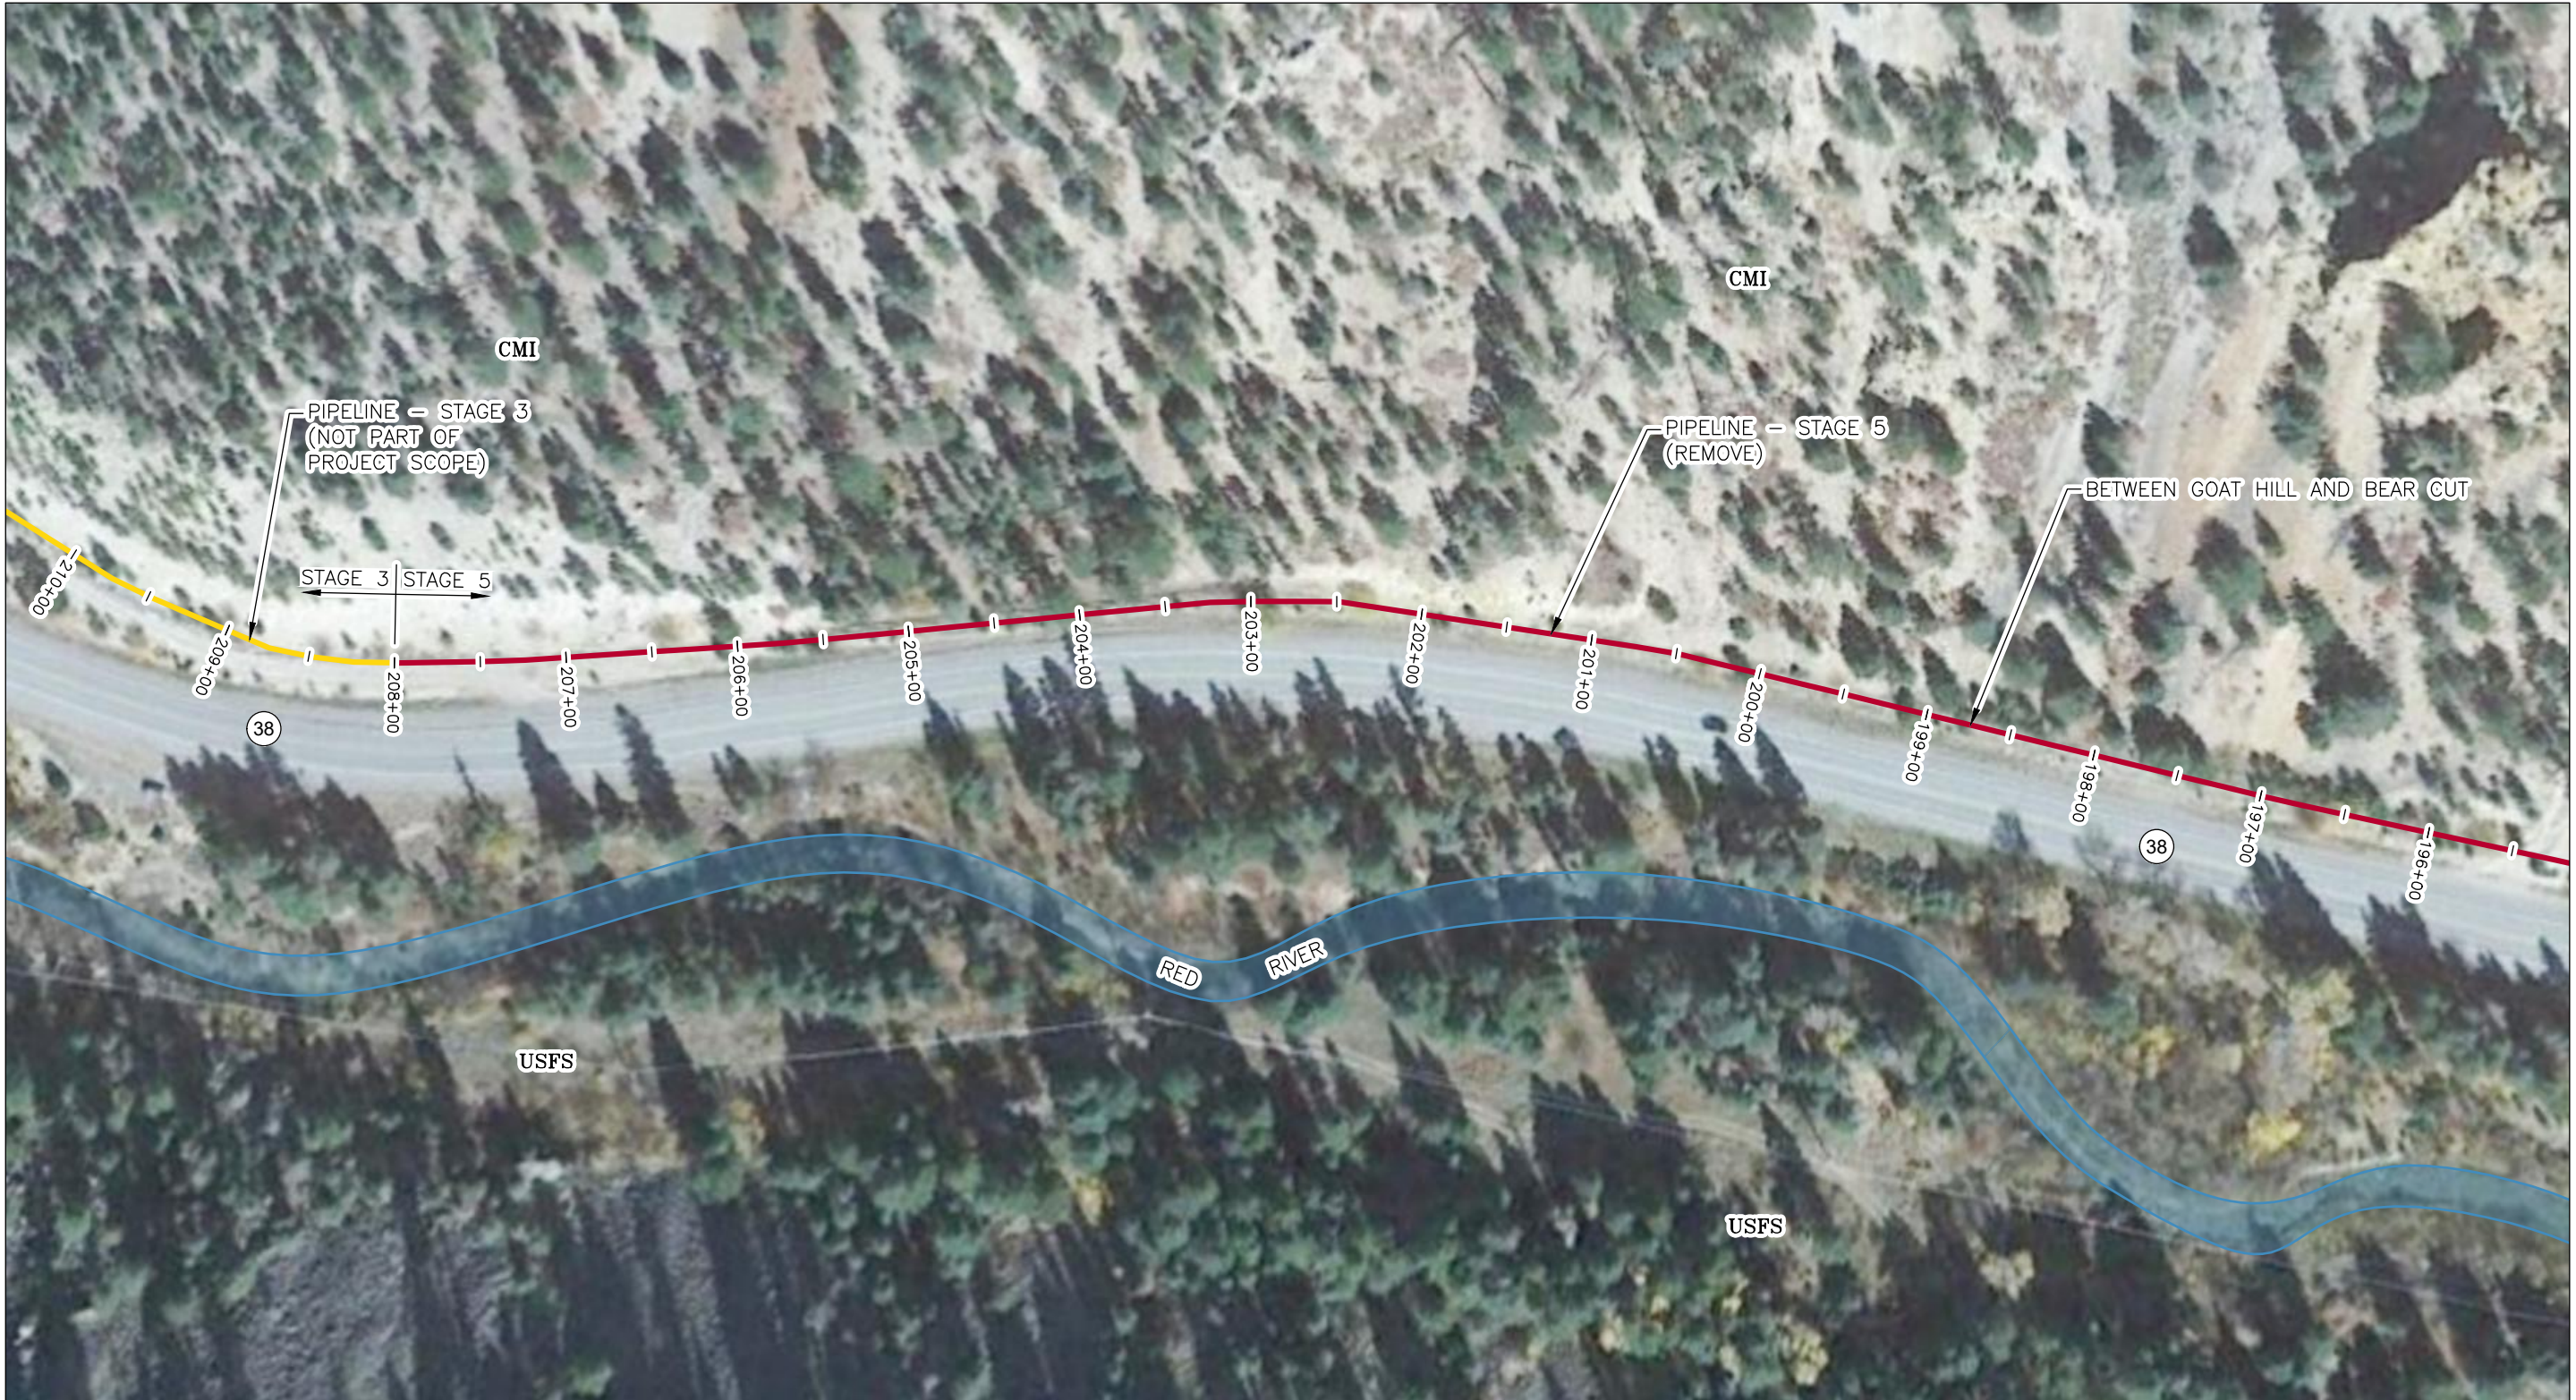
FIGURE 3-12			
STAGE 5 PIPELINE REMOVAL LOCATION BETWEEN GOAT HILL AND BEAR CUT STA. 196+00 THROUGH 208+00			
CEMC QUESTA MINE QUESTA, NEW MEXICO			
Drawn By: PAC	Checked By: RN	Scale: 1" = 100'	Date: 1/11/2019
File: 476-QM-S5-PIPEREMOVAL201812

STAGE	BEGIN STATION	END STATION	NO. OF PIPES	PIPE LENGTH (LF)	DESCRIPTION	STRUCTURES
						COUPLINGS (EA)
5	196+00	208+00	2	1200	ABOVE GROUND, 2 - 14" Ø PAINTED AND/OR UNPAINTED STEEL - REMOVE	50

The segment identified as Between Goat Hill and Bear Cut (Segment 5.08) is located on Chevron property between station numbers 181+49 and 208+00 and is between mile marker 3.0 and 3.5 of NM-38. As the name implies, the pipe in this segment is between the entrance to Goat Hill and the dirt road east entrance to the Bear Cut area (Stage 3). Details for this segment can be found on Figures 3-11 and 3-12. This section is approximately 2,700 linear feet. The first 150 feet (station 181+49 to 183+00) has three runs of pipe. The remaining portion of this segment appears to have two pipe runs. All pipe and associated structures will be removed and disposed of in accordance with Section 4.1 of the Removal Work Plan (Trihydro 2017).

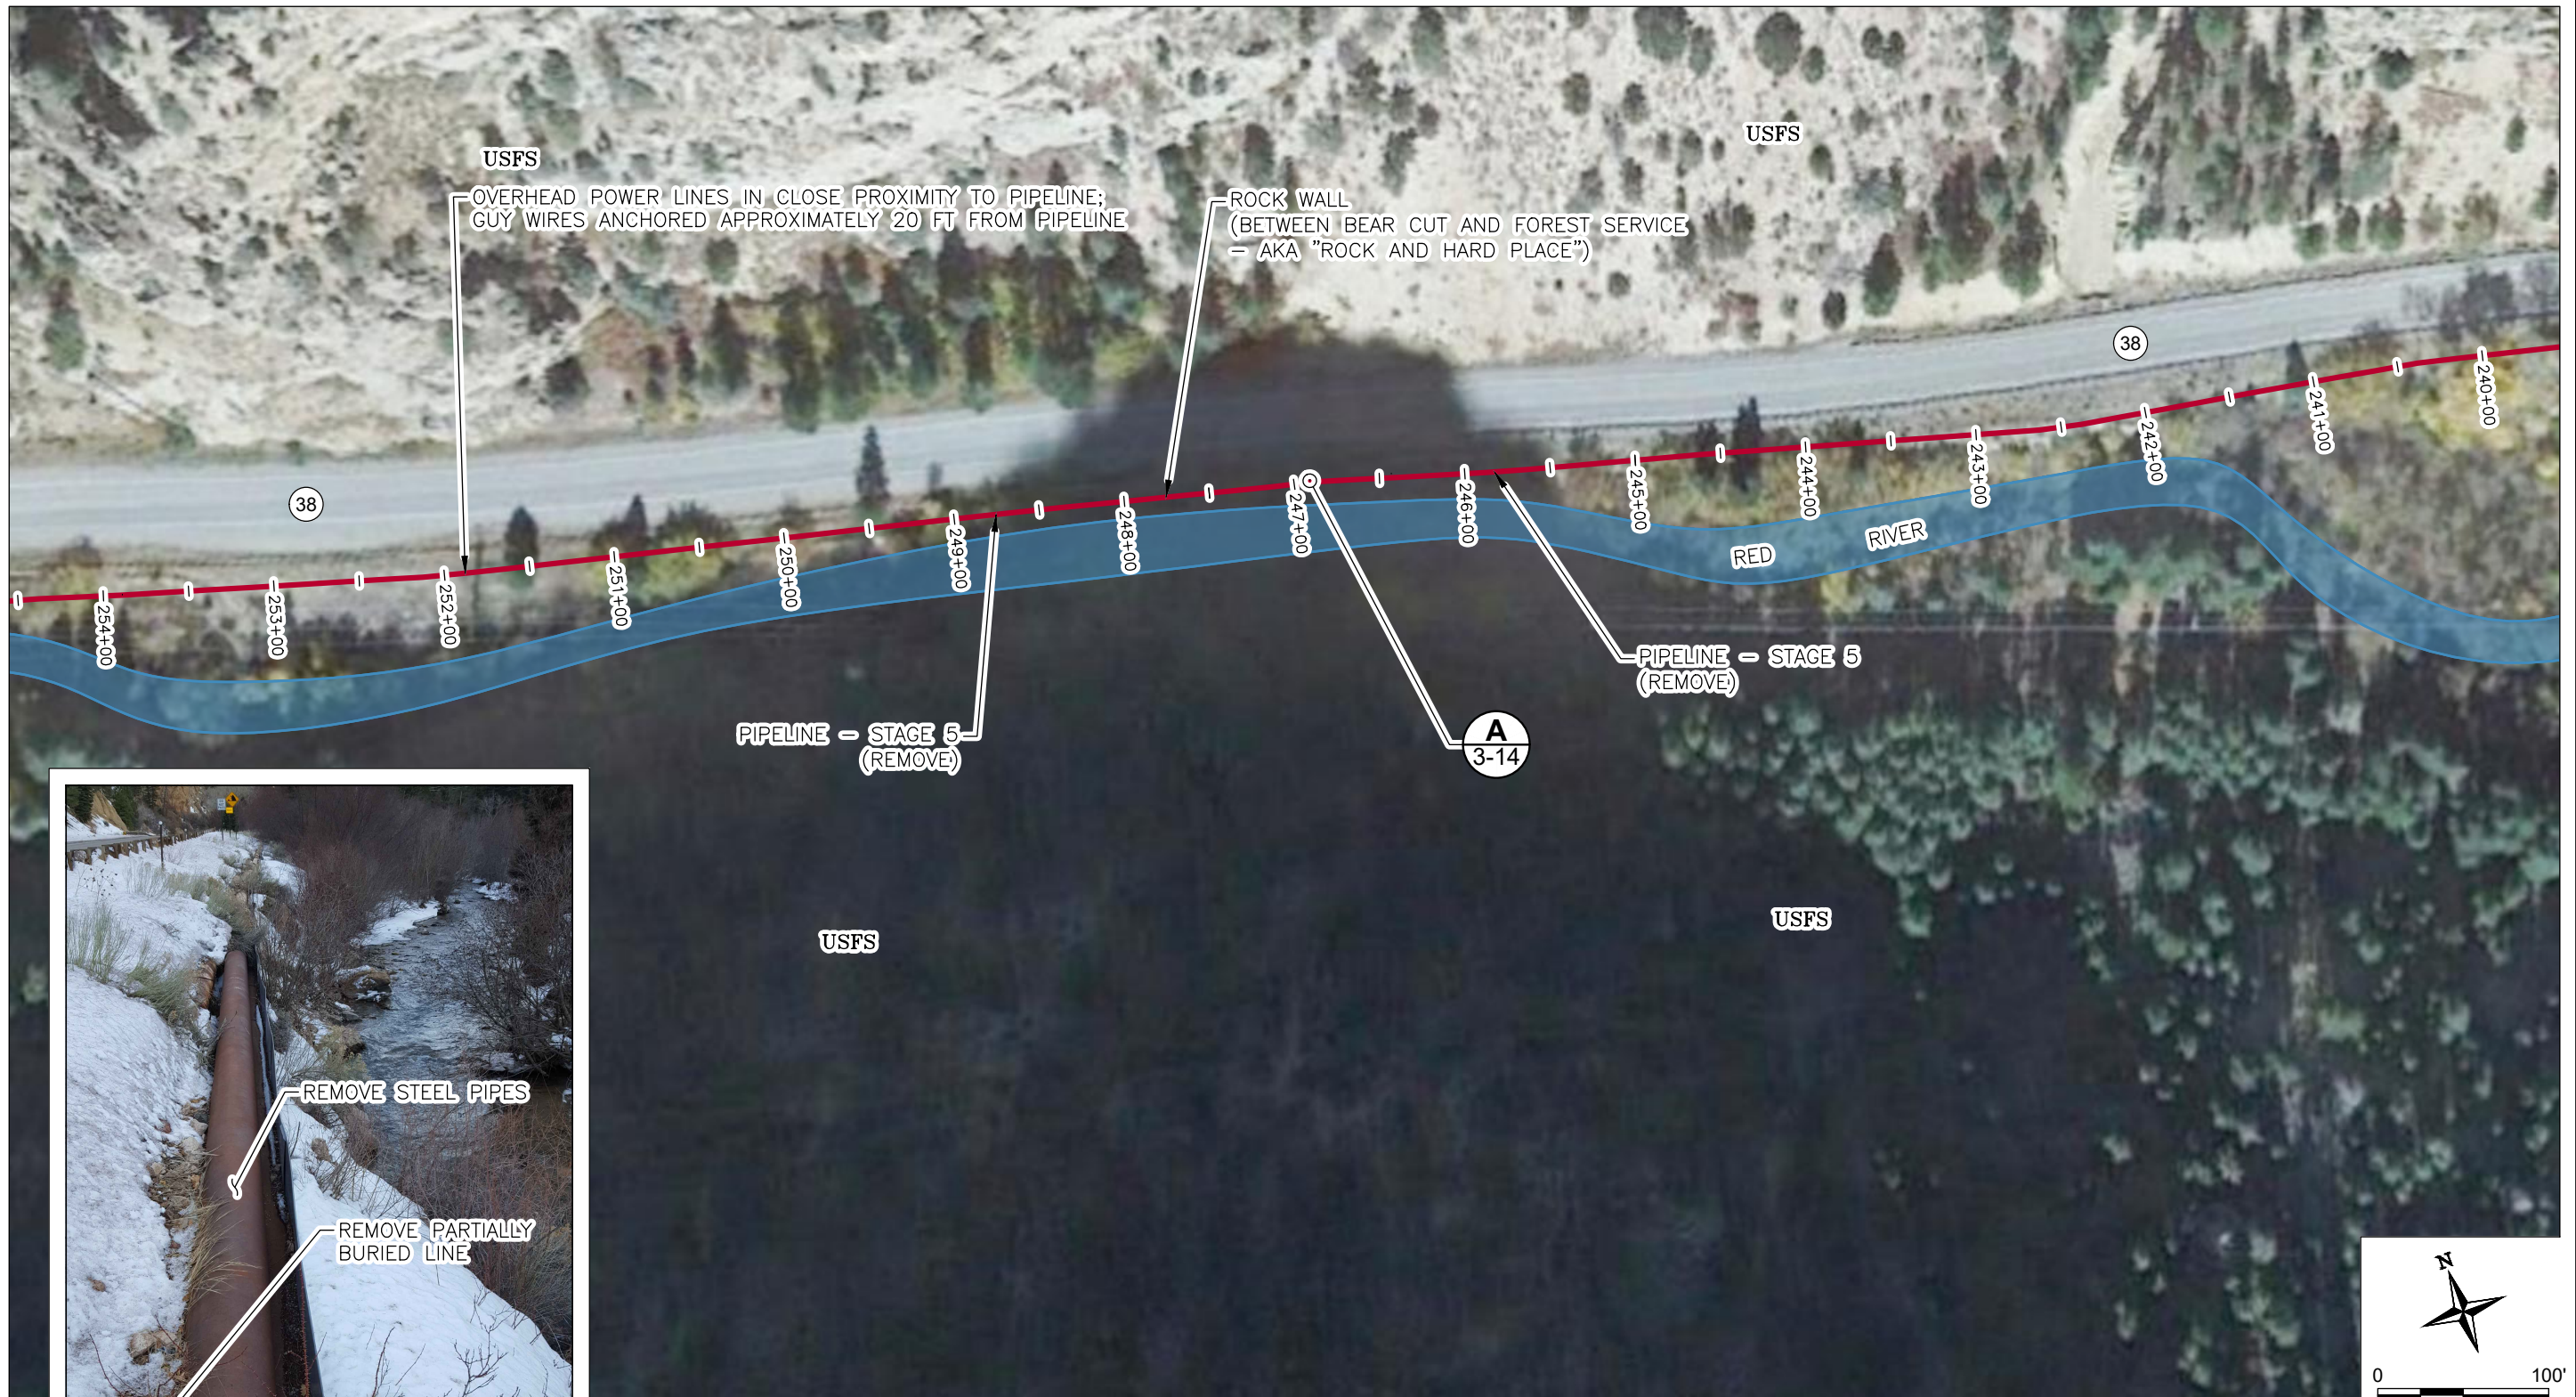
A 14" Ø UNPAINTED STEEL PIPE WITH GALVANIZED SPILL PREVENTION - EAST VIEW

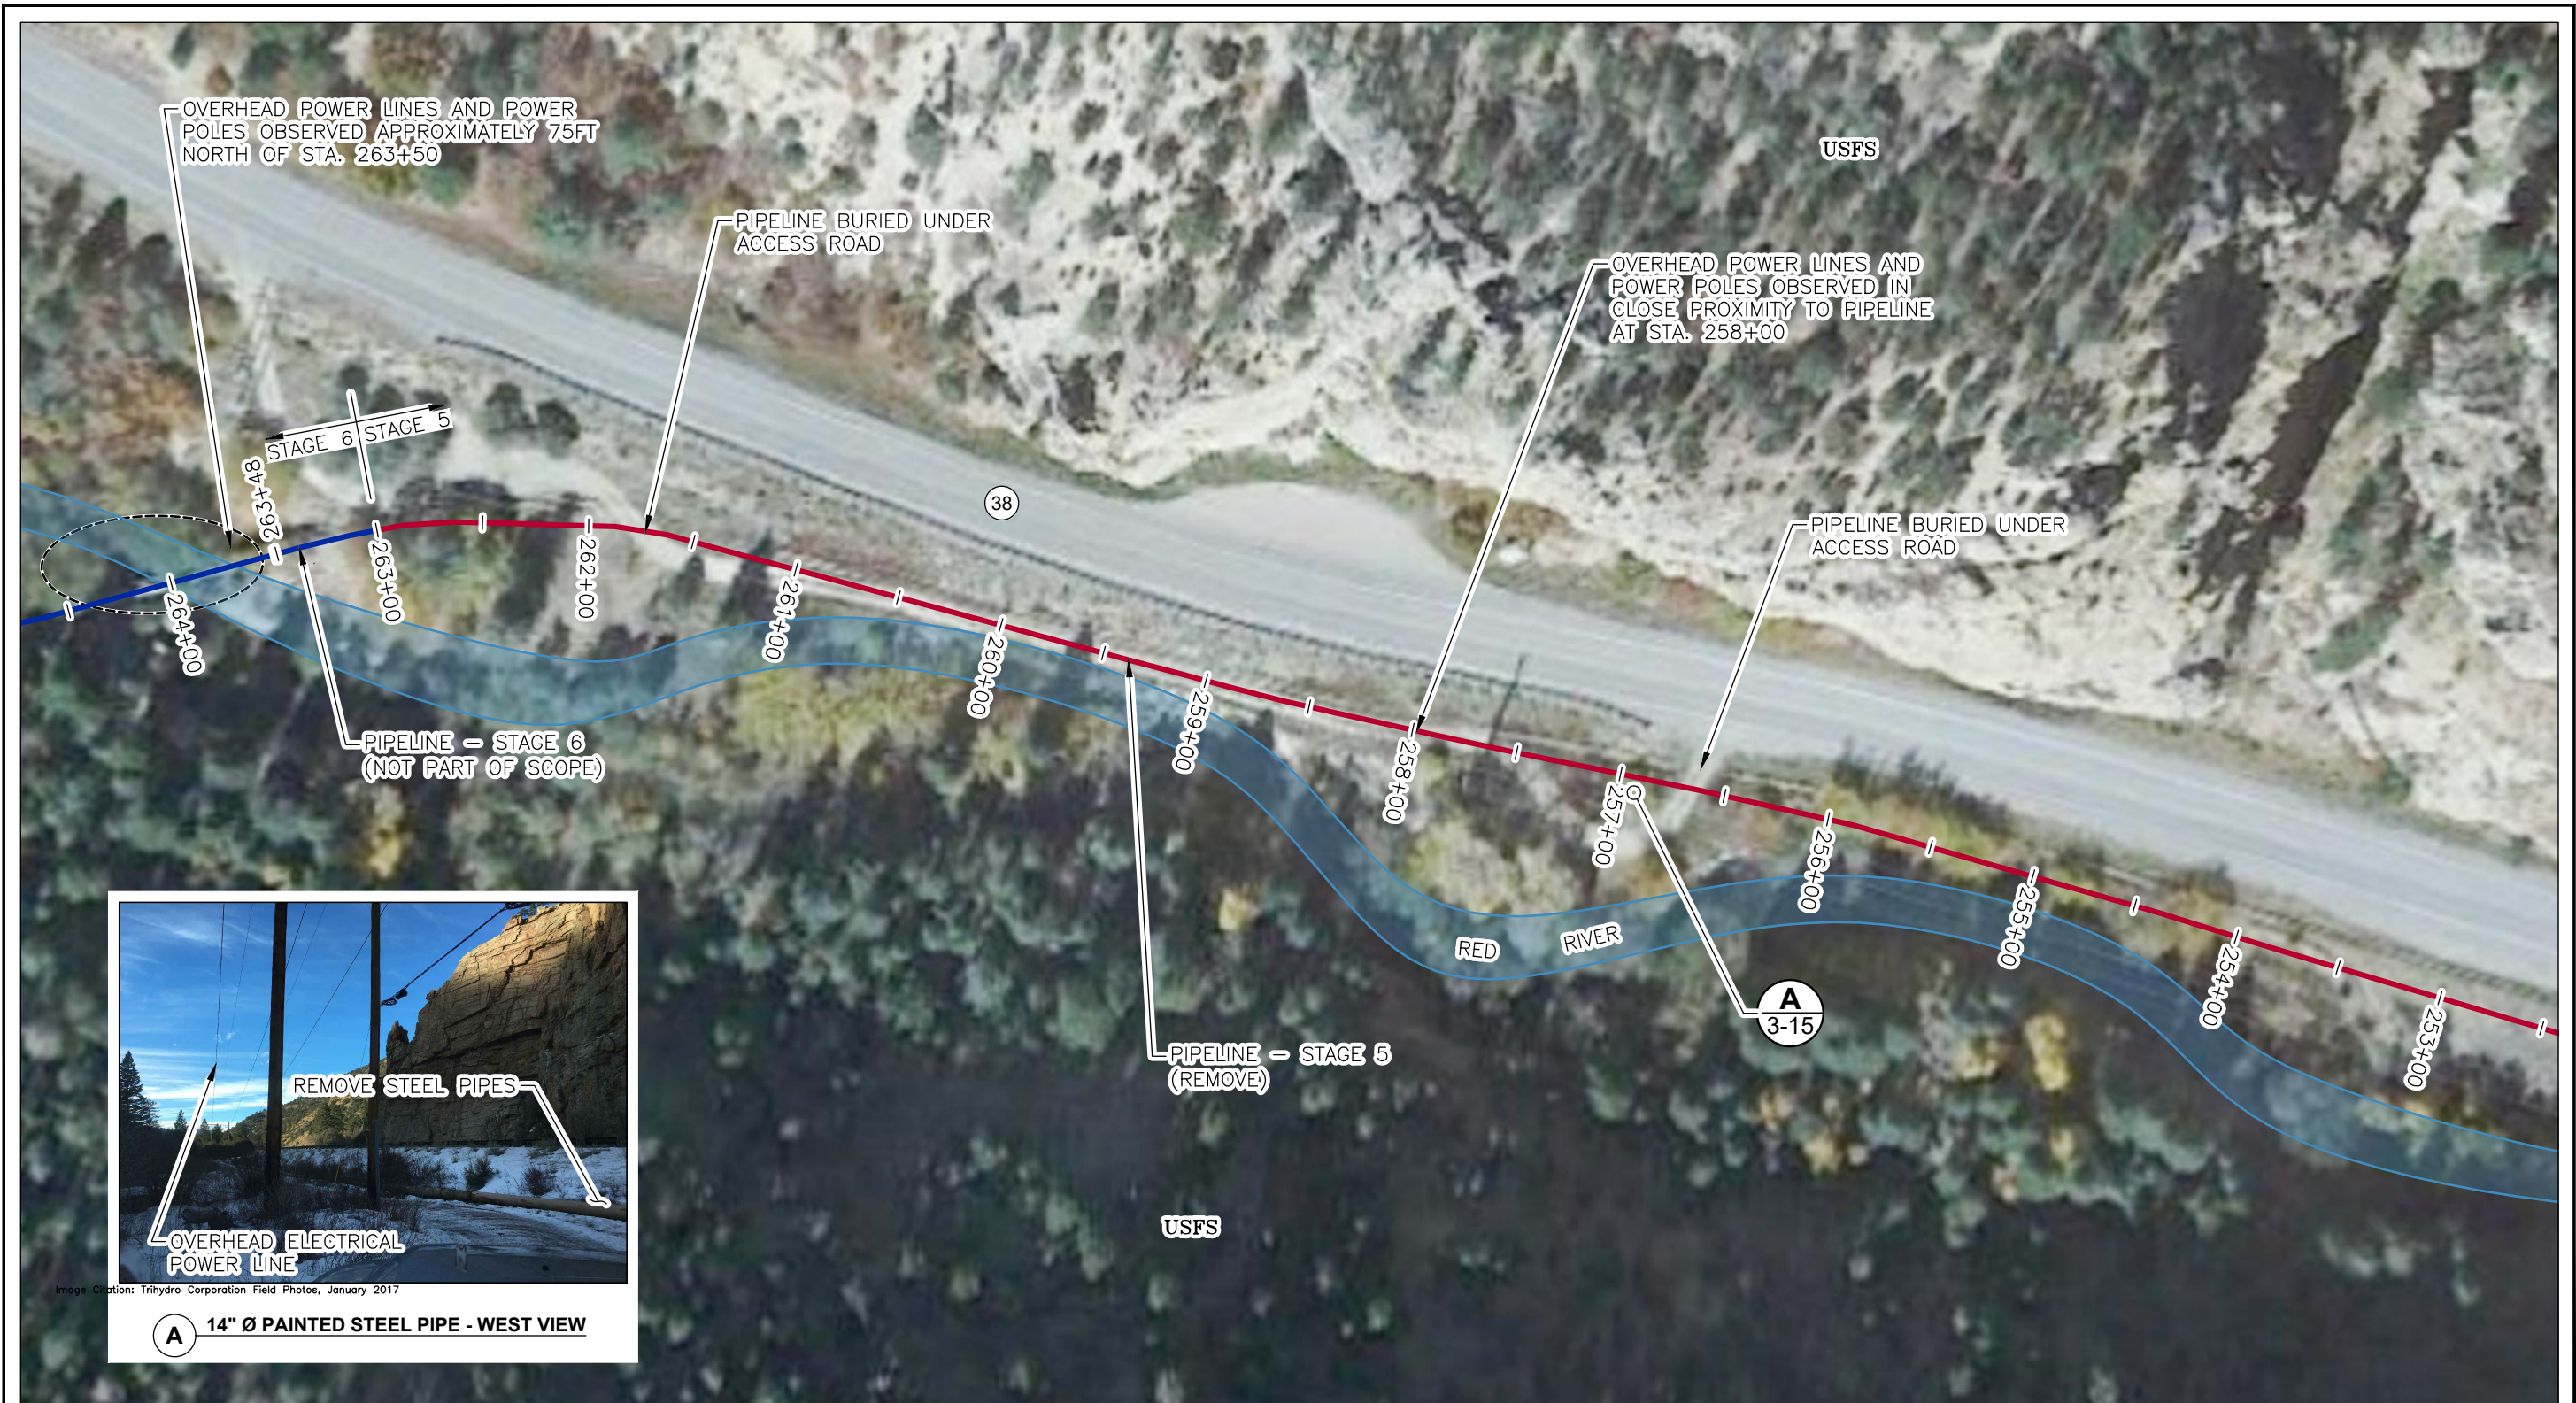
FIGURE 3-15
STAGE 5 PIPELINE REMOVAL LOCATION
ROCKWALL
STA 254+00 THROUGH 263+00

STAGE	BEGIN STATION	END STATION	NO. OF PIPES	PIPE LENGTH (LF)	DESCRIPTION	STRUCTURES		
						COUPLINGS (EA)	CONCRETE THRUST BLOCK (EA)	MINOR ROAD CROSSINGS
5	254+00	263+00	2	900	ABOVE GROUND, 2 - 14"Ø PAINTED AND/OR UNPAINTED STEEL - REMOVE	50	UNKNOWN	2

The Rock Wall (Segment 5.10, also known The Rock and a Hard Place) is found on USFS lands between station numbers 237+00 and 263+00 and is between mile marker 2.0 and 2.5 of NM-38. Pipe in this segment begins where 5.09 ends (after crossing Highway 38) and ends at the “USFS bridge” segment from Stage 6 (Segment 6.4). Details of this segment are provided on Figures 3-14 and 3-15. This is a 2,600 linear foot section with two pipe runs located between Highway 38 and the Red River. All pipe and associated structures will be removed and disposed of in accordance with Section 4.1 of the Removal Work Plan (Trihydro 2017). Demolition material quantities can be found on Table 4-2.
