Sugarite Gob Reclamation Project - Phase III

The Sugarite Gob Reclamation Project – Phase III is located about six miles northeast of Raton in Colfax County, New Mexico. The project area is on unplatted public and private land within the Maxwell Land Grant.

This project consisted of reclaiming and controlling erosion on Gob A2S and Gob A7. Included was the construction of a gabion structure (PVC-coated) at the base of Gob A7, construction of straw bale and coir roll terraces and sediment barrier dams, construction of diverter and spreader coir rolls, incorporation of lime, gypsum, compost, wood waste and fertilizer into equipment accessible flat areas of Gob A2N, Gob A2S and A7, placement of deep straw mulch in indicated areas of Gob A2S, bank toe stabilization of the gully along the south edge of Gob A7 using juniper bales and coir rolls, installation of culverts near the top of Gob A2S to improve access, planting of 12,808 seedlings, and hydroseeding using a bonded fiber matrix.

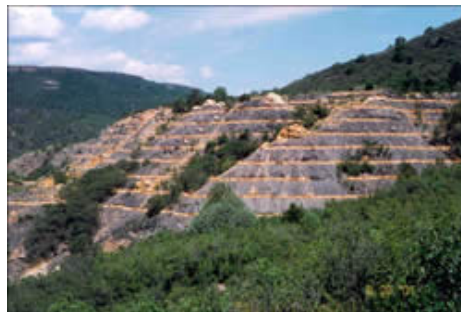
Combining these approaches on slopes inaccessible to almost any type of construction equipment lead me to the idea of embedding straw bales partially into the slope and end-to-end along contour. Native seedlings would then be planted on one foot centers just above the resulting straw bale terraces. In addition to ameliorating the sodicity, the straw bales also serve as temporary erosion barriers and harvest storm runoff to water the establishing seedlings. The terraces are spaced at eight-foot contour intervals and gypsum and bio-organic fertilizer spread along the 20-inch wide benches onto which the bales are placed and staked. On gob slopes, up to 1000 pounds per acre of gypsum, along with seed and bonded fiber matrix material, is applied using hydroseeding equipment and long hoses.

Observation of the pilot construction project on 1.9 acres in 1999, led to the addition of straw wattles on top of the straw bales on slopes steeper than 1.5:1 in subsequent projects. This allows the seedlings to be planted closer to the original slope line.
