UNITED NUCLEAR CORPORATION
P.O. Box 3077
Gallup, New Mexico 87305

**ST. ANTHONY MINE
SITE CLOSEOUT PLAN**

January 2006

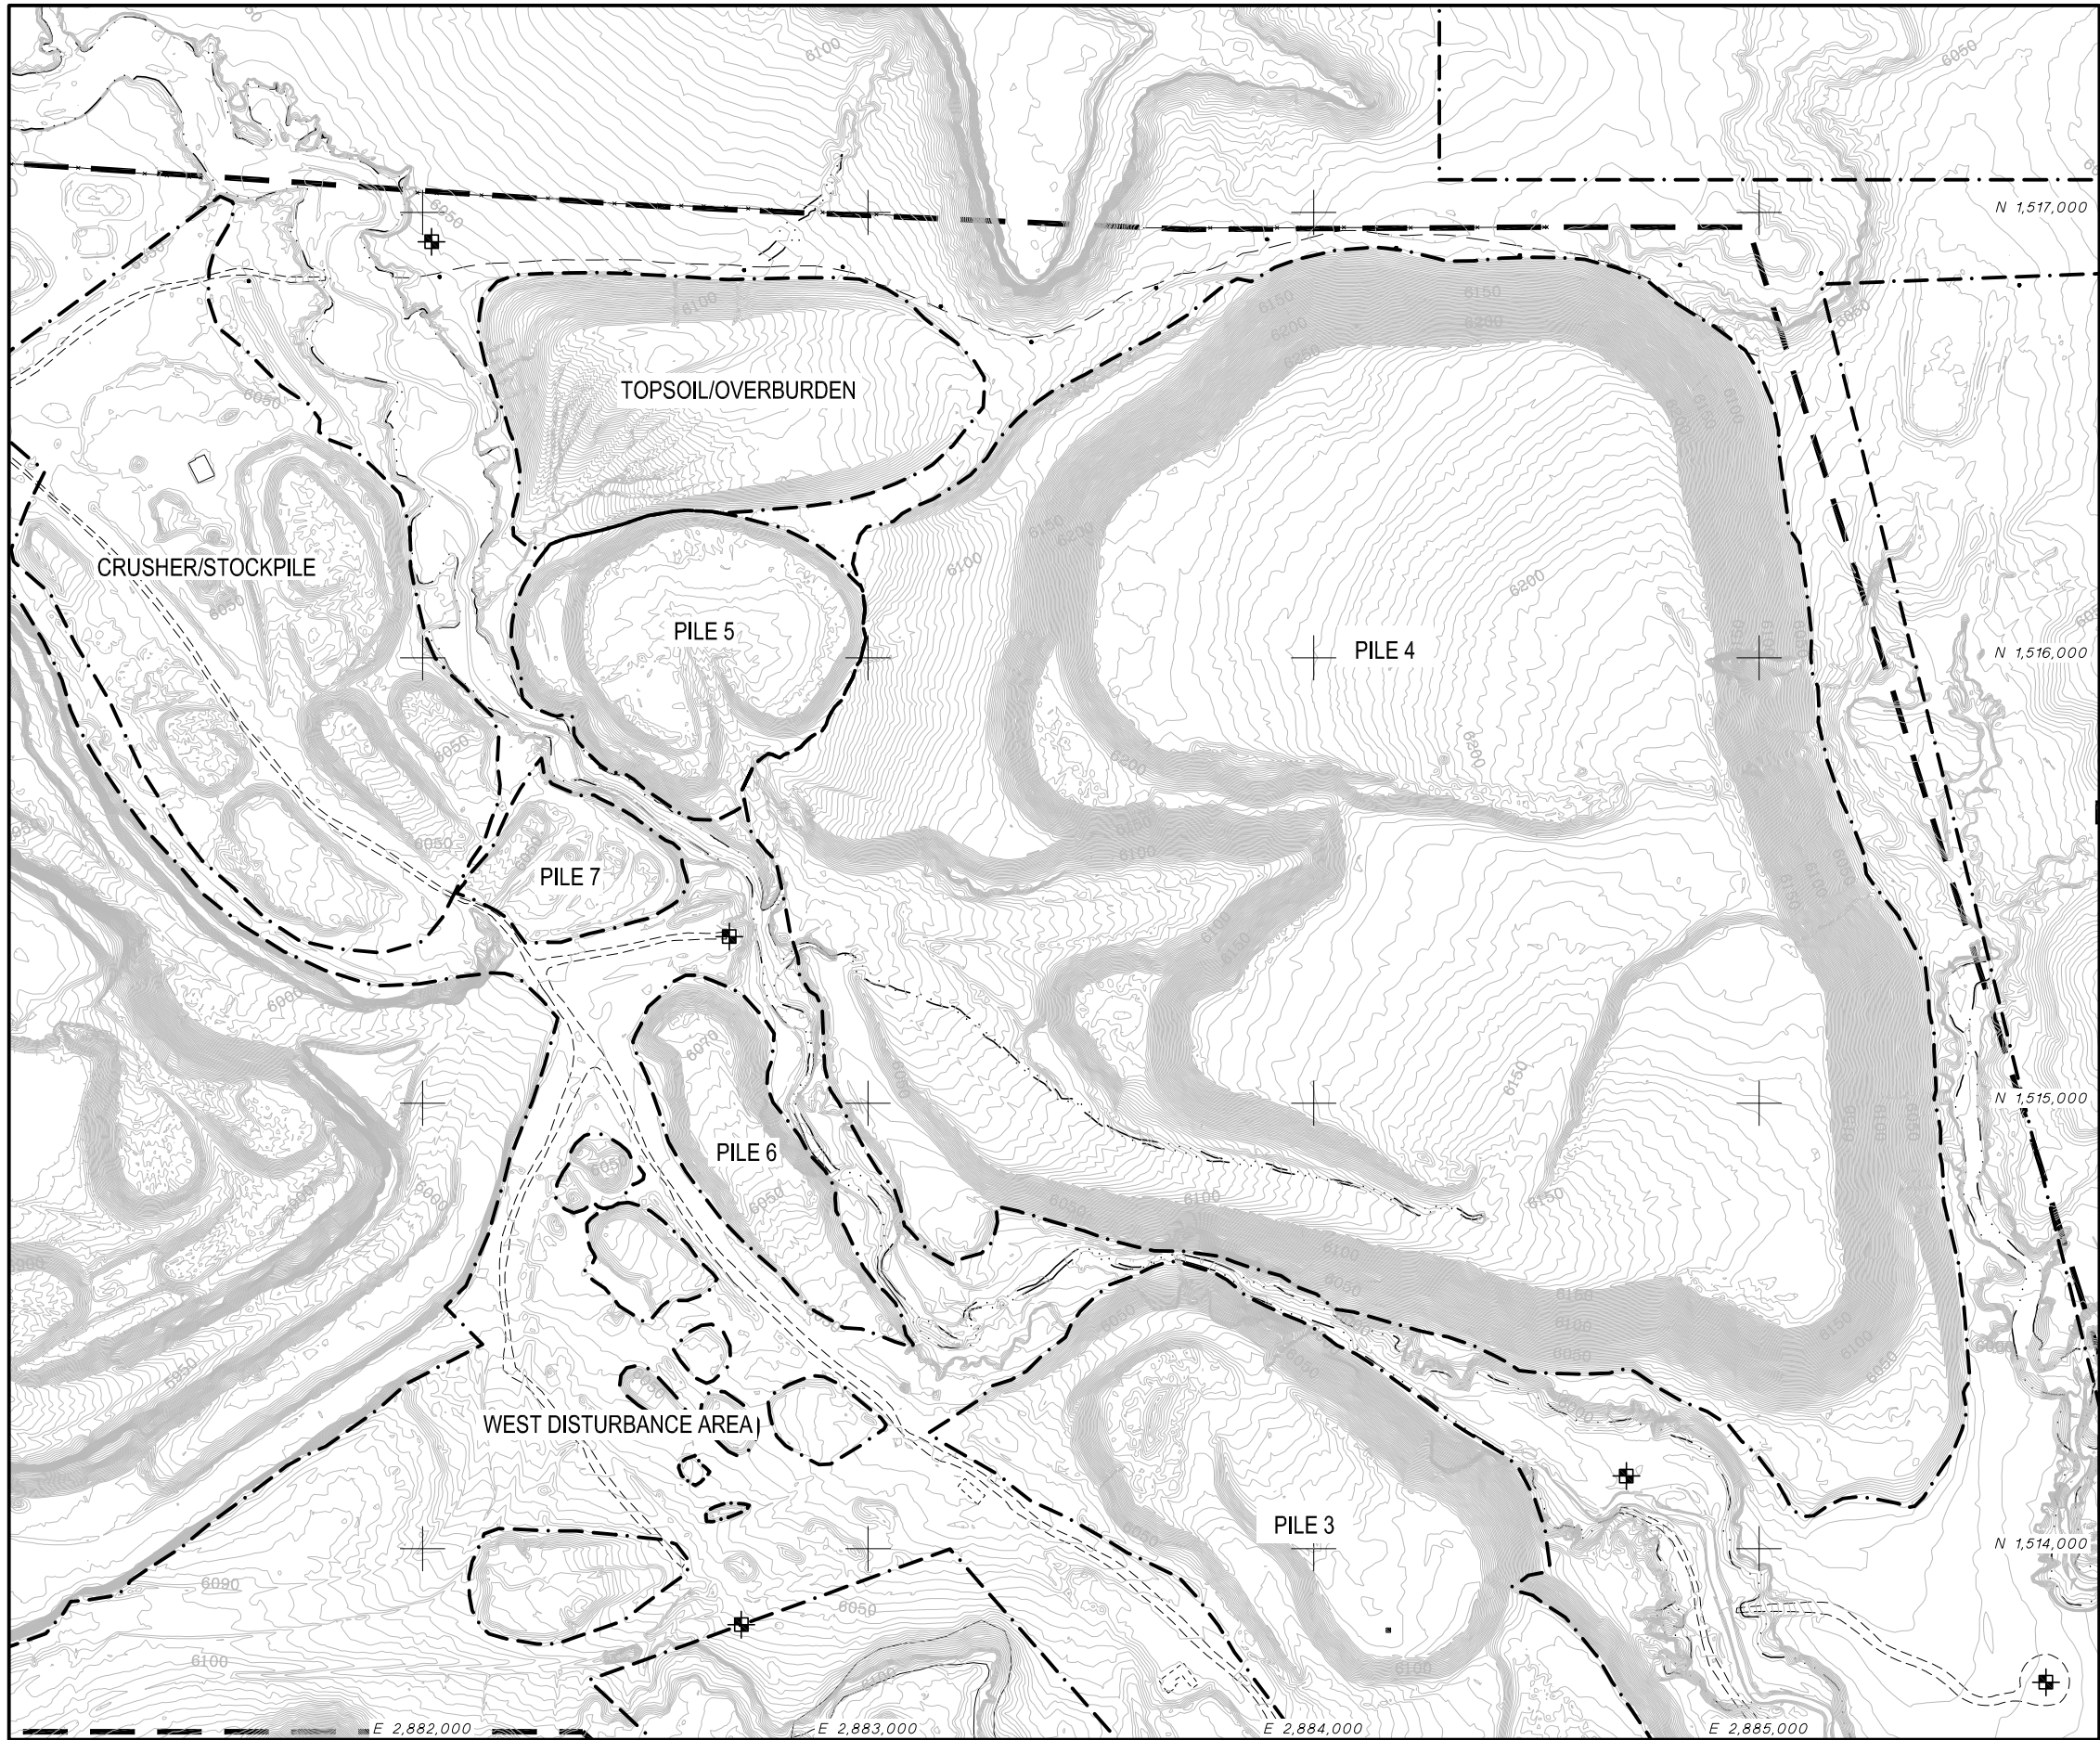
The site includes underground workings consisting of one shaft, and a number of vent shafts that are sealed at the surface, two open pits (one containing a pond), seven large piles of non-economical mine materials with some revegetation, numerous smaller piles of non-economical mine materials, and three topsoil piles. No perennial streams occur within the St. Anthony site, but an arroyo (Meyer Gulch) passes through the site. The site layout of the St. Anthony Mine is included as Figure 2, *Site Layout*. The two open pits at the mine site are located in Sections 19 and 30, Township 11 North, Range 4 West, and the entrance to the underground mine is located in Section 24, Township 11 North, Range 5 West. The area disturbed during mining encompasses approximately 430 acres and includes roads and other disturbed areas along with the open pits and non-economical mine materials piles. Existing conditions at the St. Anthony Mine Site are shown on Figure 3, *Existing Conditions*.

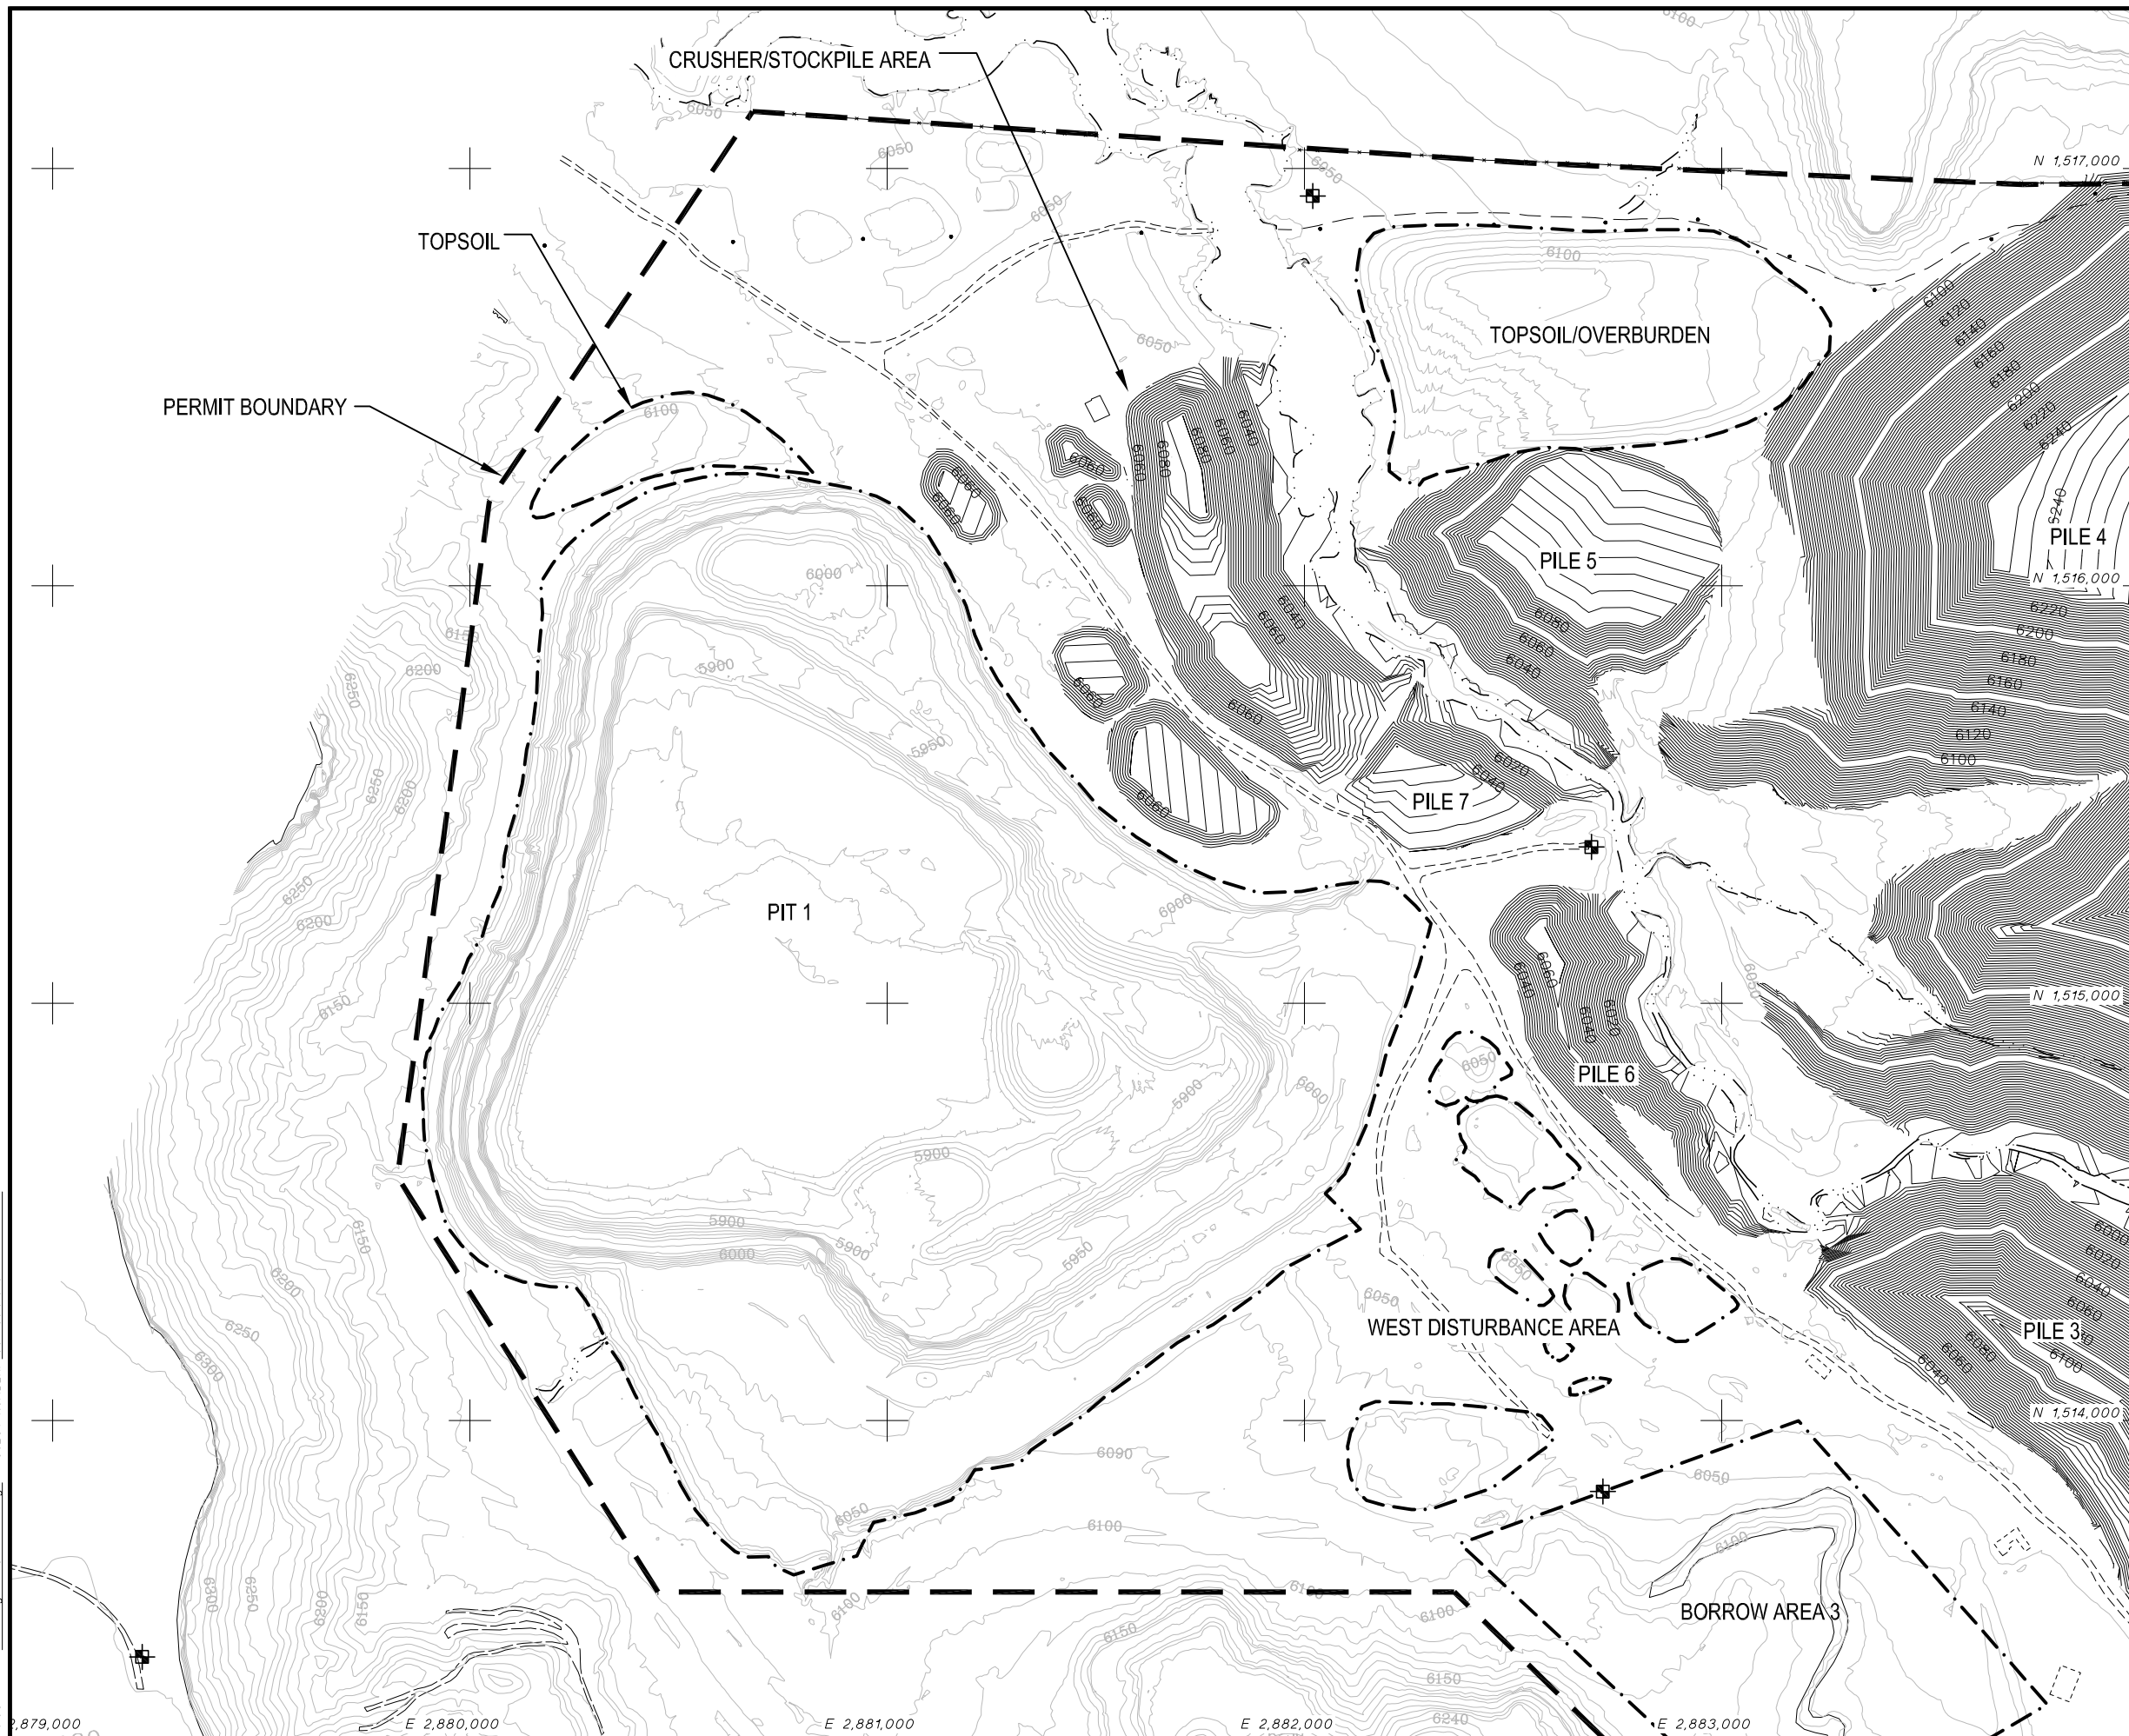
The regrading requirements listed above are incorporated into the regrading plan shown in Figure 4, *Regrade Plan*. The regrade volume for each pile is summarized in Table 2.1, *Regrade Volumes*.

- A 3H:1V slope angle is to be used for all final side slope regrading.
- All slopes of greater than 50 feet of elevation will be interrupted with a flat, ten-foot wide bench.
- Material piles will be set back 50 feet from the edge of the natural channels.
- All materials extracted from Piles 1, 2, and 3, as a result of area specific regrading, are to be consolidated into Pit 2. The total volume of material to be deposited into Pit 2 is 1,505,000 cubic yards (cy).
- All materials excavated from Piles 4, 5, 6, and 7, as a result of area specific regrading, will be consolidated into Pit 1. The total volume of material to be deposited into Pit 1 is 3,541,000 cy.
- All regraded areas will be covered with a minimum of two feet of cover material.

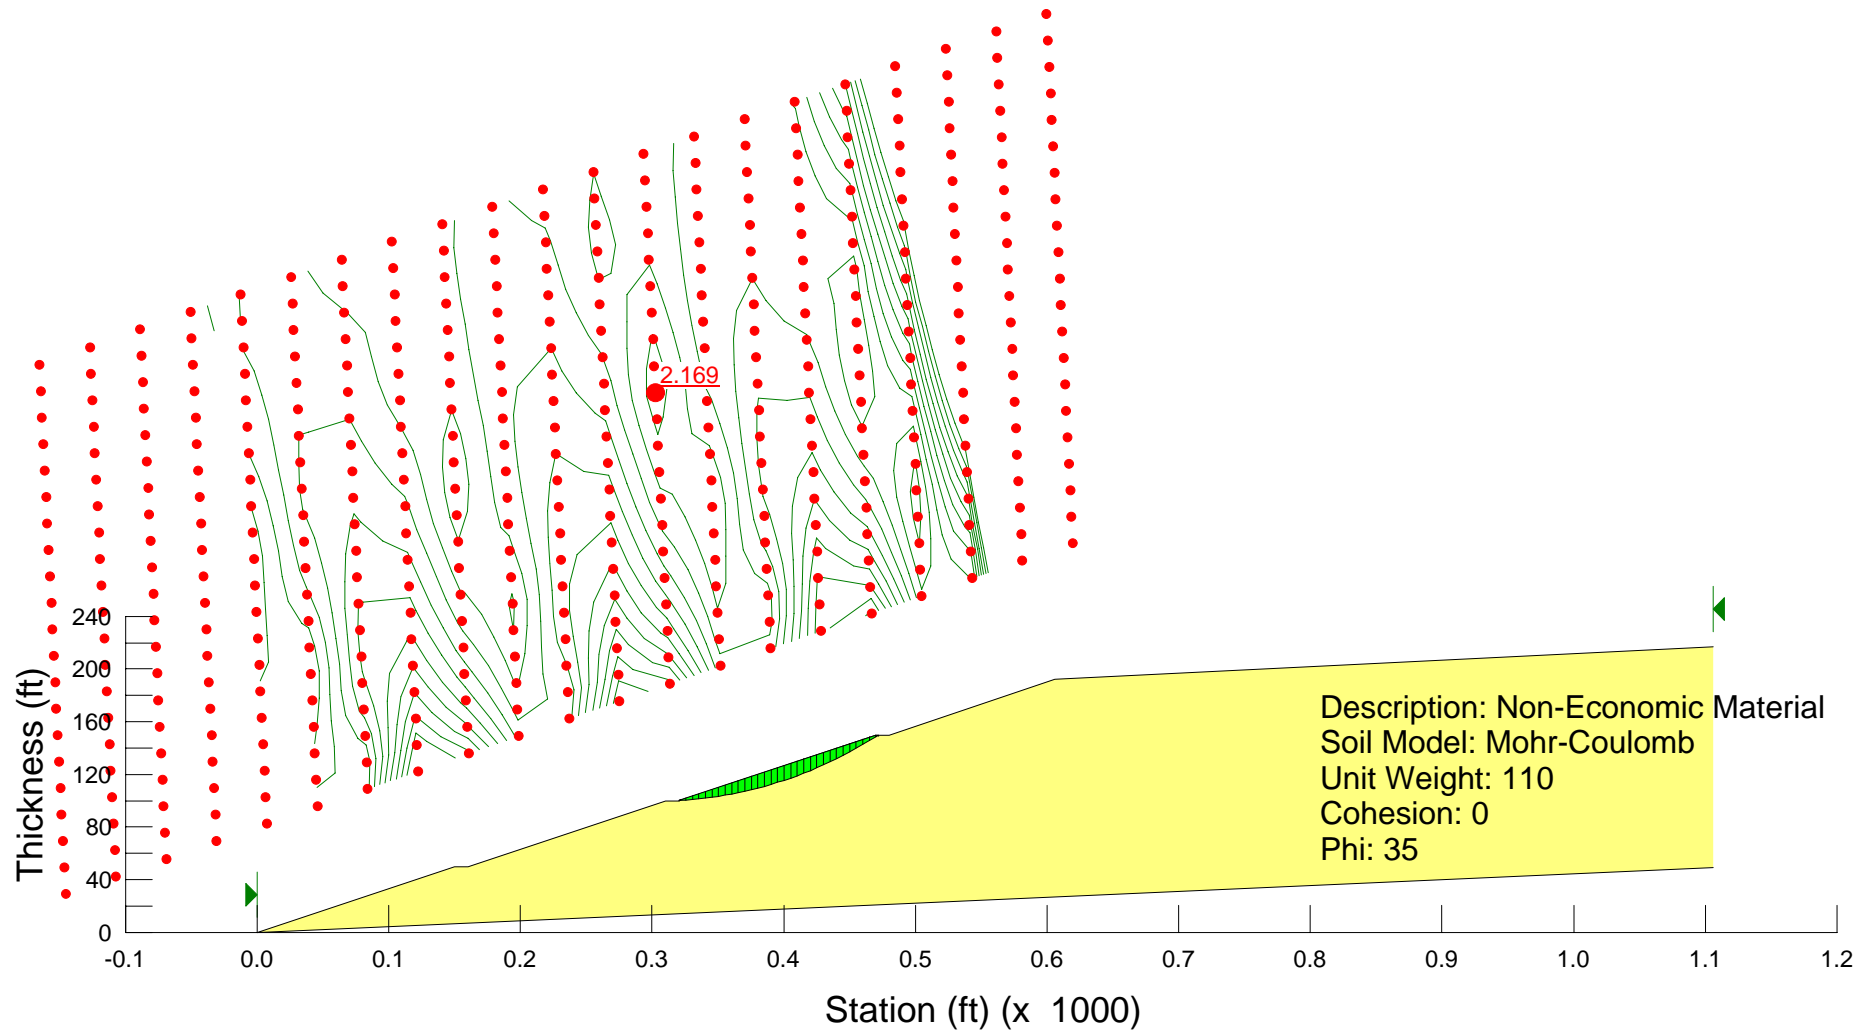
Description: St Anthony Pile 4 Stability Analysis
File Name: St Anthony Stability Analysis.slz
Analysis Method: Morgenstern-Price
Slip Surface Option: Grid and Radius
Seismic Coefficient: (none)

A stability analysis was performed on the regraded pile using available geotechnical data. The internal friction angle was estimated using the existing slope angles assuming that the material is at angle of repose (Factor of Safety of one). Remaining parameters were estimated based on professional experience. Given these assumptions, the factor of safety for the regraded slope of Pile 4 is 2.1. This is greater than the acceptable factor of safety of 1.5 typical for this situation. The stability analysis will be refined based on the material properties acquired during implementation of the Material Characterization Plan.
