RE: Summit Mine; Permit No. GRO11ME; Waste Facility Slide; Revised Corrective Action Plan

Pyramid Peak Mining LLC (PPM), hereby, submit a revised Corrective Action Plan (CAP) to address the failure of a development material stockpile (DMS) and operations area at the Summit Peak Mine (Mine). The CAP was requested by the New Mexico Energy, Minerals and Natural Resources Department, Mining and Minerals Division (MMD) on August 31, 2017.

To:	Andrew Conover	Date:	July 17, 2018
Company:	Pyramid Peak Mining, LLC	From:	Karena Carpenter Edward Wellman, PE NM #18364
Subject:	Analysis of Summit Mine DMS Dump Instability and Proposed Remediation Plan	Reviewed by:	John Tinucci
		Project #:	511800.030

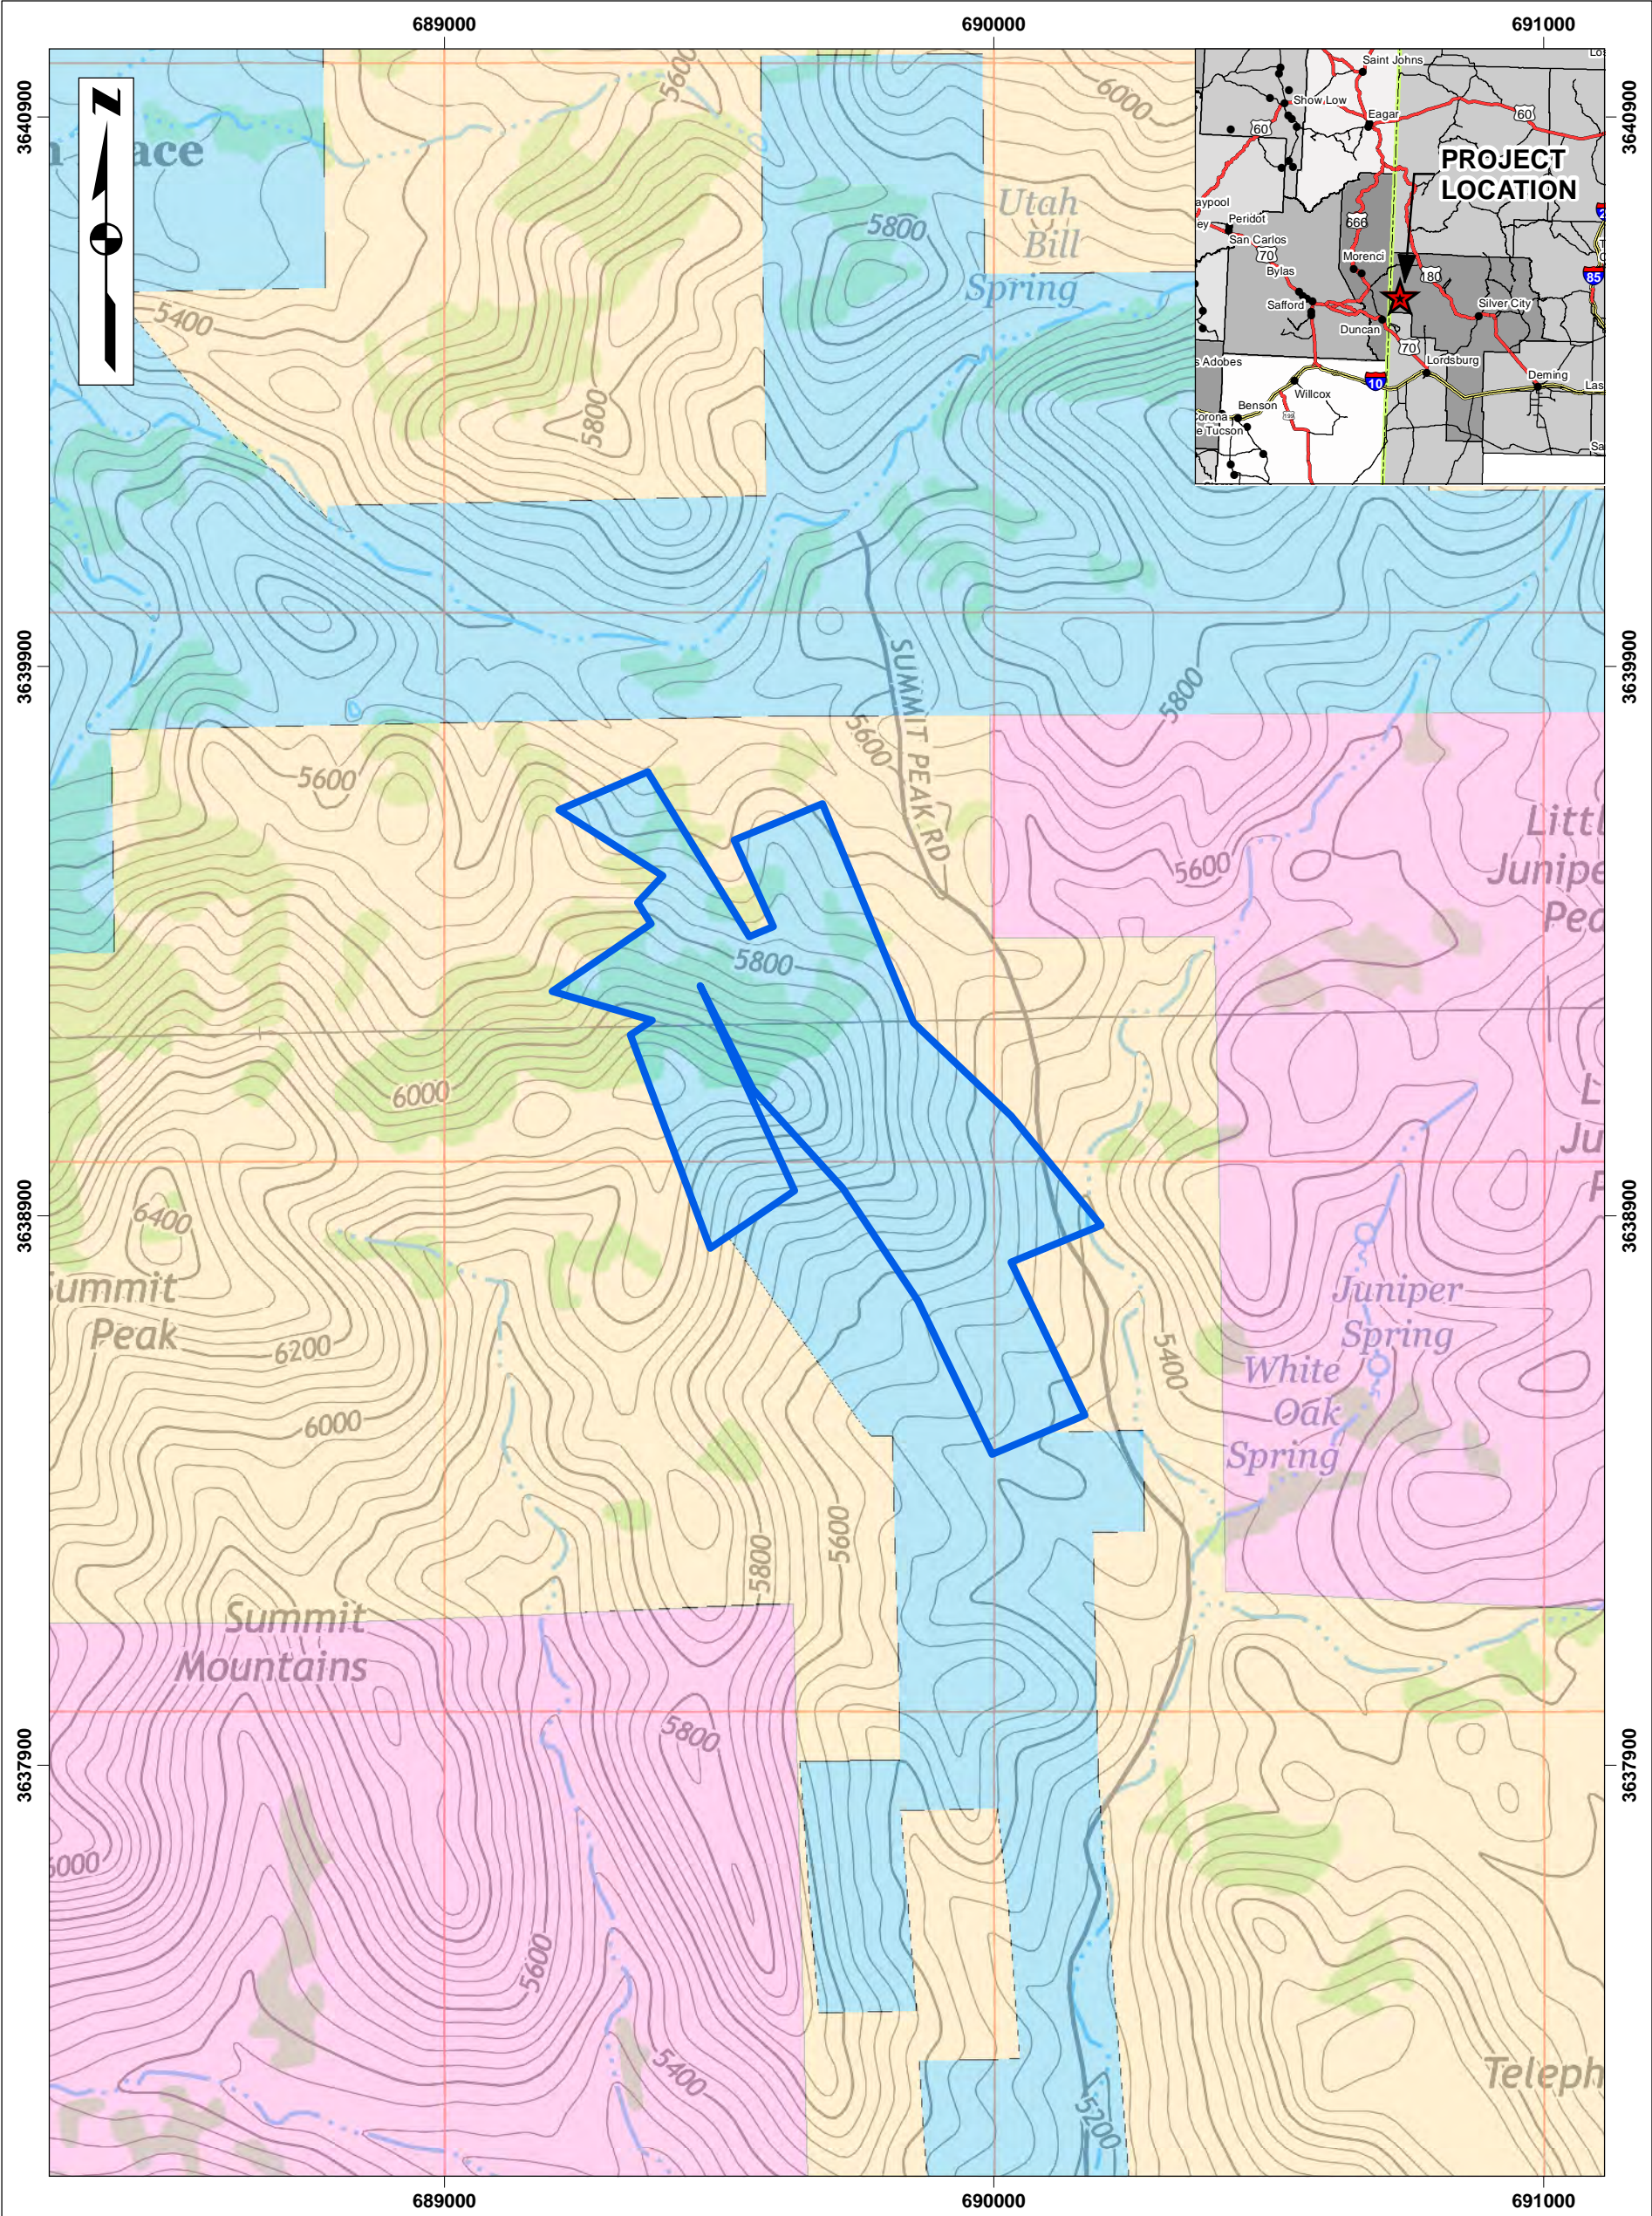
As constructed, the DMS was located entirely on patented claims owned by PPM. After the first slide, PPM performed a visual assessment of the modified footprint and compared it to the BLM Public Land Survey System Survey data (PLSS). The assessment indicated that material had not encroached into the BLM administered public lands downgradient and east of the Mine (**Figure 1**).

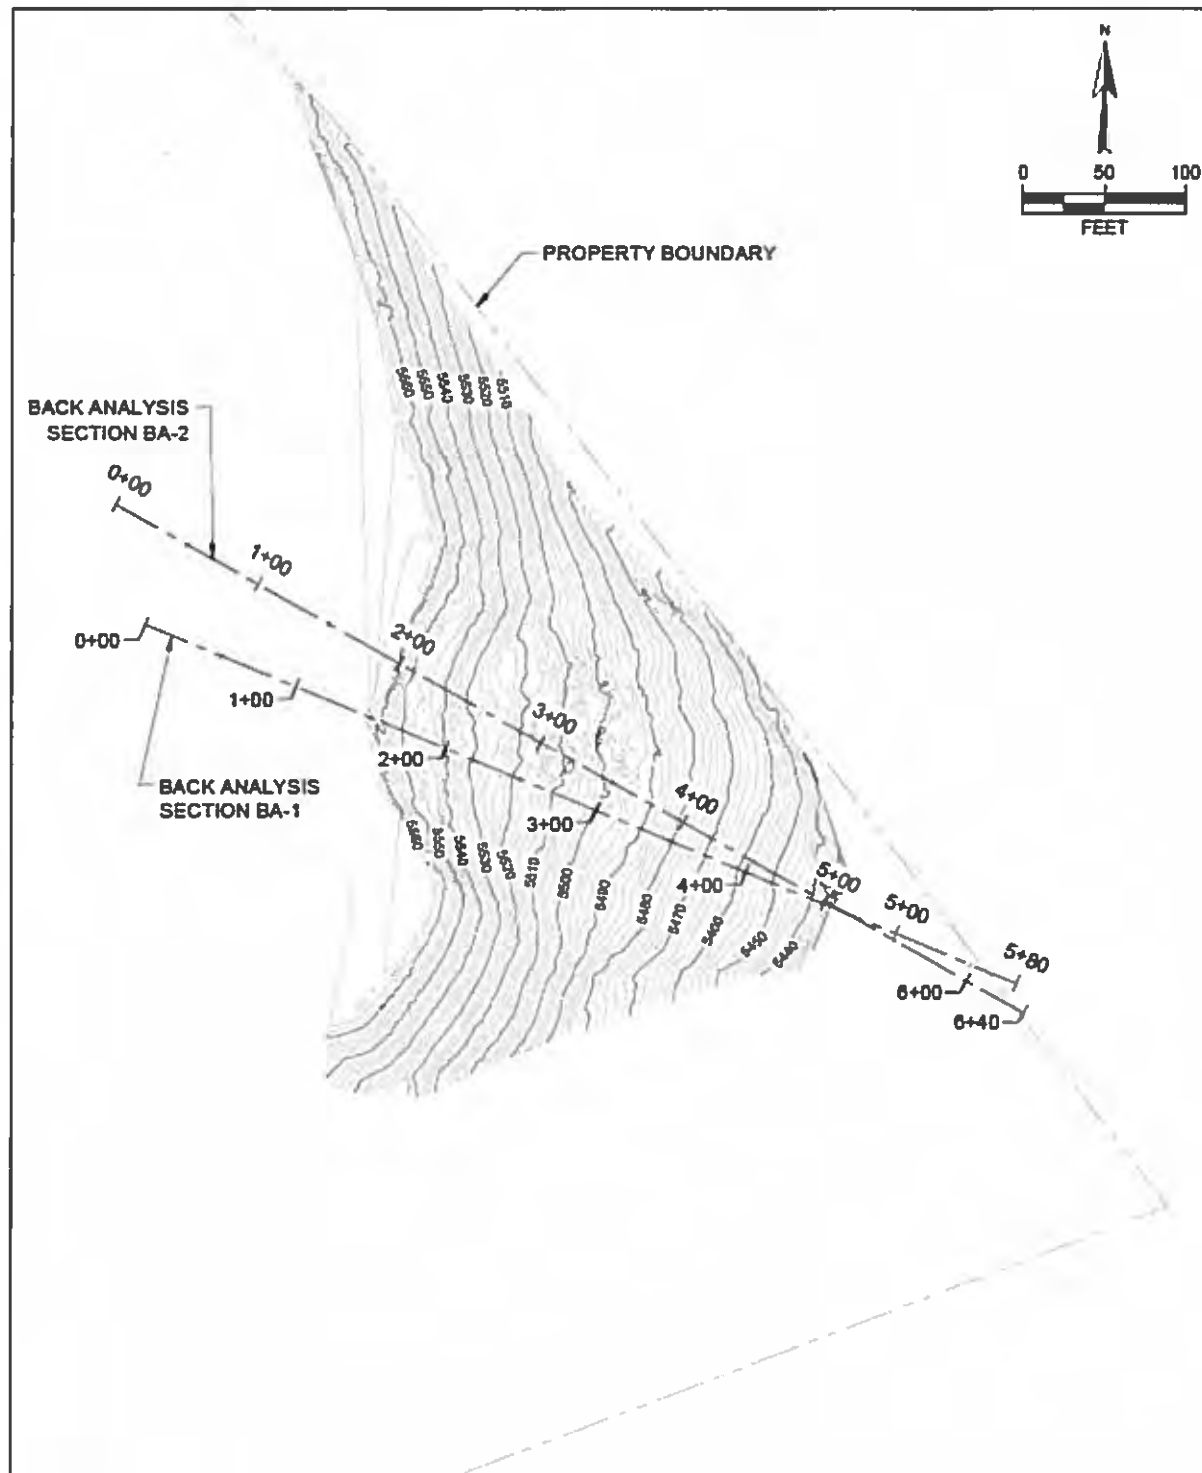
Figure 2: Back-Analysis Section Locations

Topography for the back-analysis was estimated based on an angle-of-repose DMS dump from the pre-failure crest elevation. Due to the lack of information, a phreatic surface was not explicitly modeled in the back-analysis. As a result, the forward analysis is an effective stress model using the back-calculated strengths. This means that the same groundwater conditions at the time of the original failure are assumed present for the forward analysis. The back-analysis reproduced the observed tension cracks and location of displacement at the toe of the slope. The back-analysis section locations are illustrated on Figure 2.
