MINING INSPECTION REPORT

Name of Operator:	Gulf Coast Mining Group, LLC
Name of Mine:	Iron Duke Mine
Address:	Sections 3 and 4, Township 22 S, Range 8 E
Permit Number:	OT006MN
Commodity: hematite & magnetite	<input checked="" type="checkbox"/> SURFACE <input type="checkbox"/> UNDERGROUND
Date of Inspection:	October 8, 2019
Time of On-Site Inspection:	12:40 PM – 2:00 PM
Weather Conditions:	slight clouds, 73°F
Purpose of Inspection:	Annual
Lead Inspector:	Jenn Johnson
Present During Inspection:	DJ Ennis, Carmen Rose (MMD), David Davidson (Gulf Coast Mining Group)
ENFORCEMENT ACTION TAKEN: None	
NOTICE OF VIOLATION: # _____ YES: ____ NO: <input checked="" type="checkbox"/>	
CESSATION ORDER: YES: ____ NO: <input checked="" type="checkbox"/>	
Time: On-Site: <u>1.5 hrs</u> Permit Review: <u>2</u> Travel: <u>2</u> Report Writing: <u>2</u>	
TOTAL INSPECTION TIME: <u>7.5</u> HOURS	
NOTE: Turn left onto a dirt road 3 miles north from Orogrande on US-54. Follow the dirt road west for almost 3 miles until you reach a gate. Go through the gate to get to the mine site.

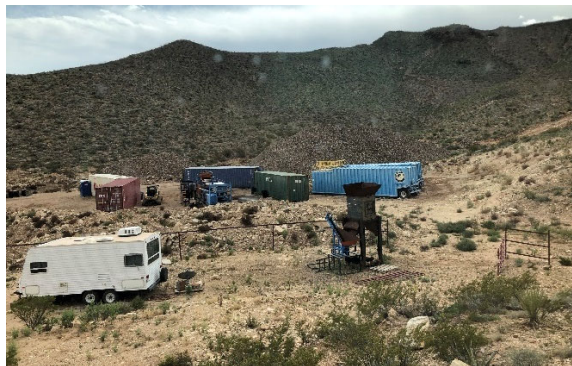
Figure 6: Mill Site (S)

We met David Davidson at the mine and he drove us around the site. There were workers sampling 55 gal drums for the customer in Europe. The new ball mill was on site and there were no signs of water discharge from the mill. There were two shipping containers which hold the
