**NEW MEXICO ABANDONED MINE LAND PROGRAM
COUNTY ROAD A-25 SUBSIDENCE
COLFAX COUNTY, NEW MEXICO
SITE CHARACTERIZATION AND MITIGATION RECOMMENDATIONS REPORT**

January 10, 2023

Project #: 01A-003-002

SUBMITTED BY: Trihydro Corporation

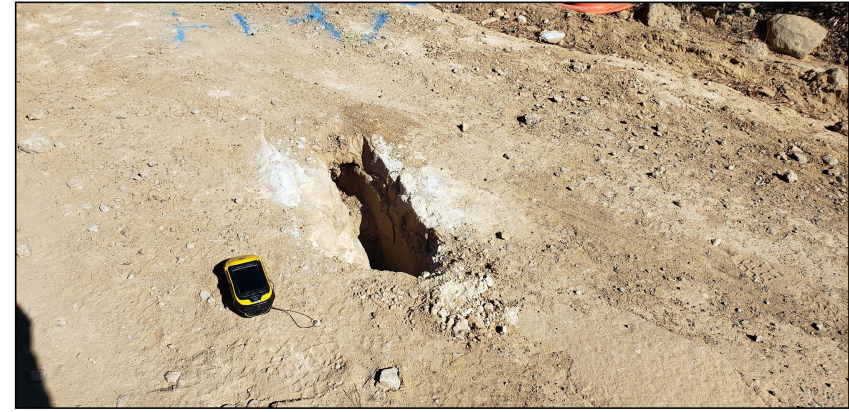
A COUNTY ROAD A-25 SUBSIDENCE FEATURE
SCALE: NONE

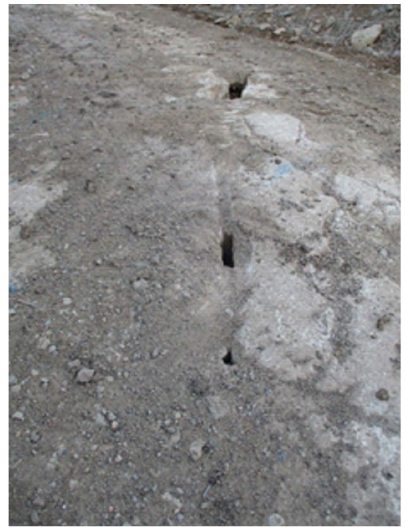
B COUNTY ROAD A-25 SUBSIDENCE FEATURES
SCALE: NONE

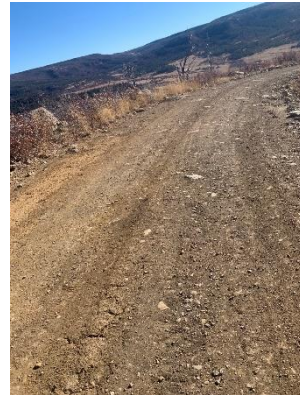
Site photo of the scan area above the rocky area with the crack.

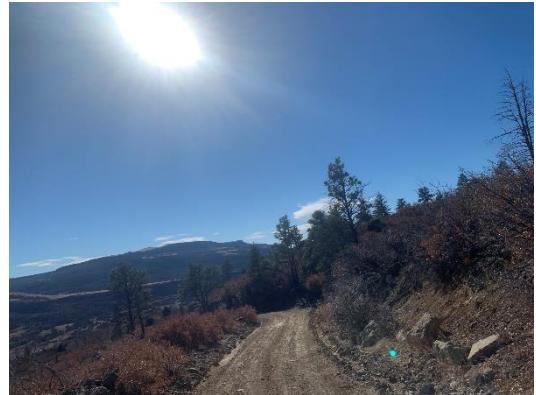
Photo of the road just above the crack, in the scan area.

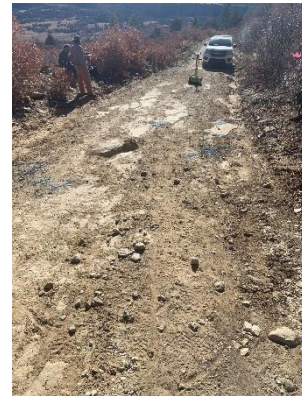
Site photo above the crack looking down the road to the other end of the scan area.

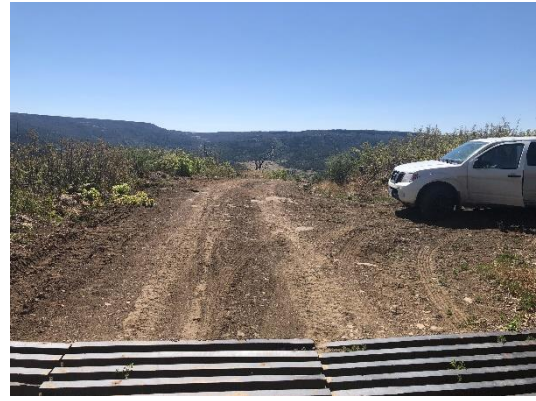
Photo of scan area. Start of scan area at cattle guard.

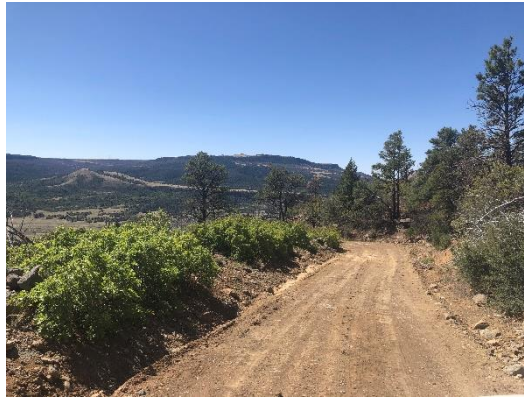
Photo of scan area. Section of road after first bend following cattle guard.

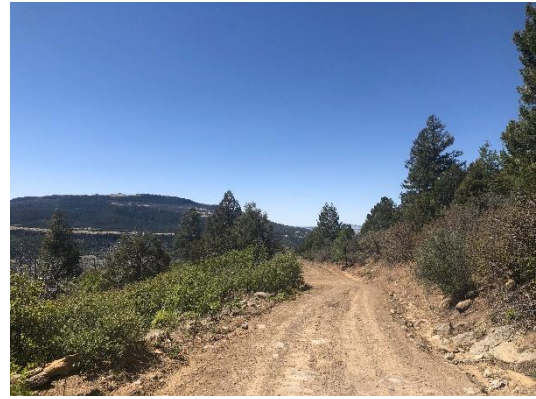
Photo of scan area. Last section leading to end of scan area at switchback.

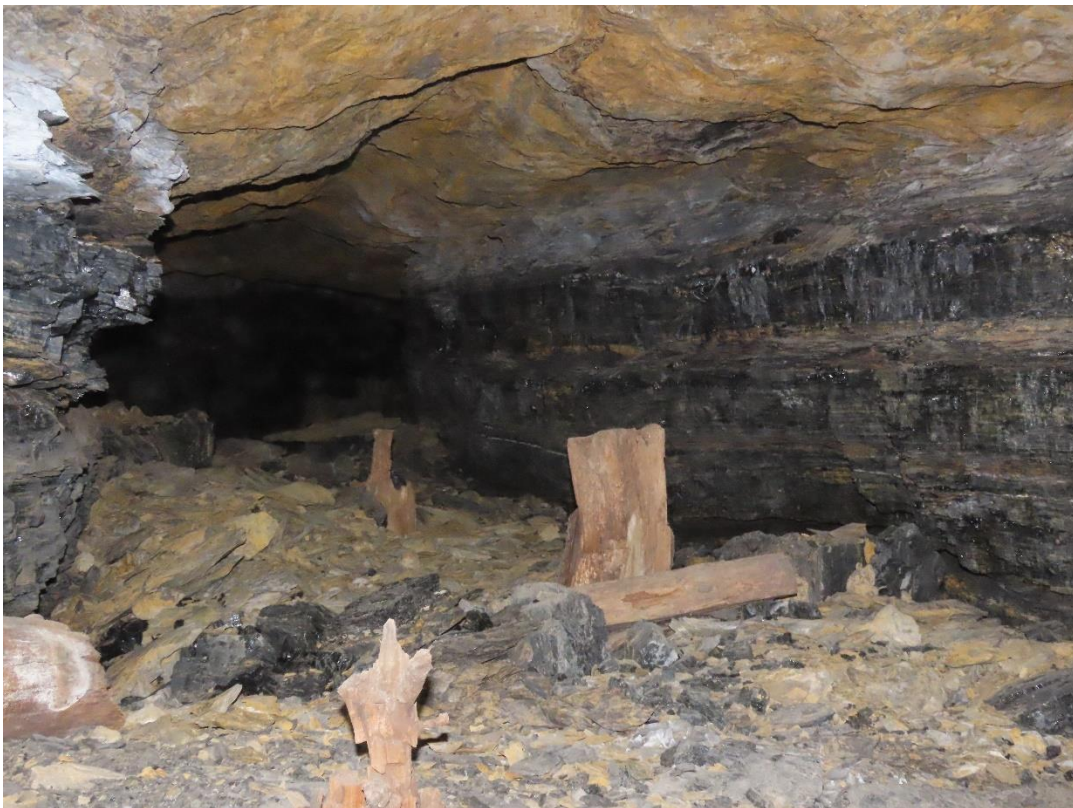
Yankee Adit 01: The coal seam is visible along the ribs.
BCI Photo by Bill Burger

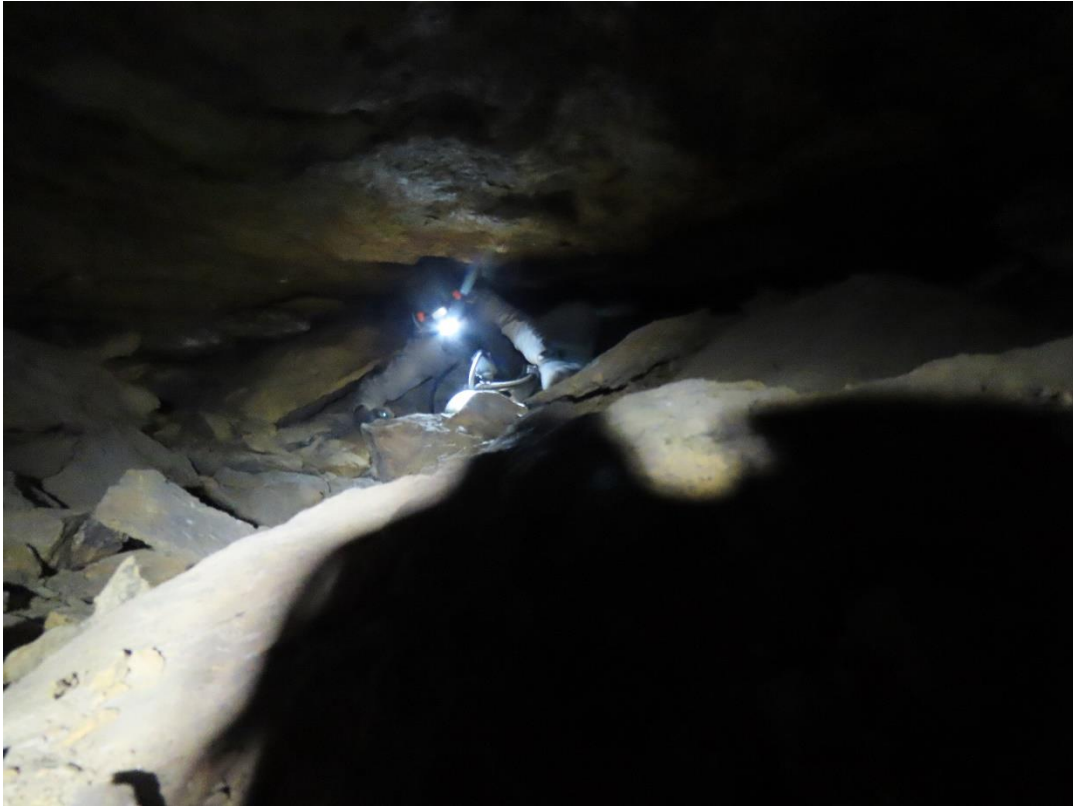
Yankee Adit 02: Another view of the dangerous blockage.

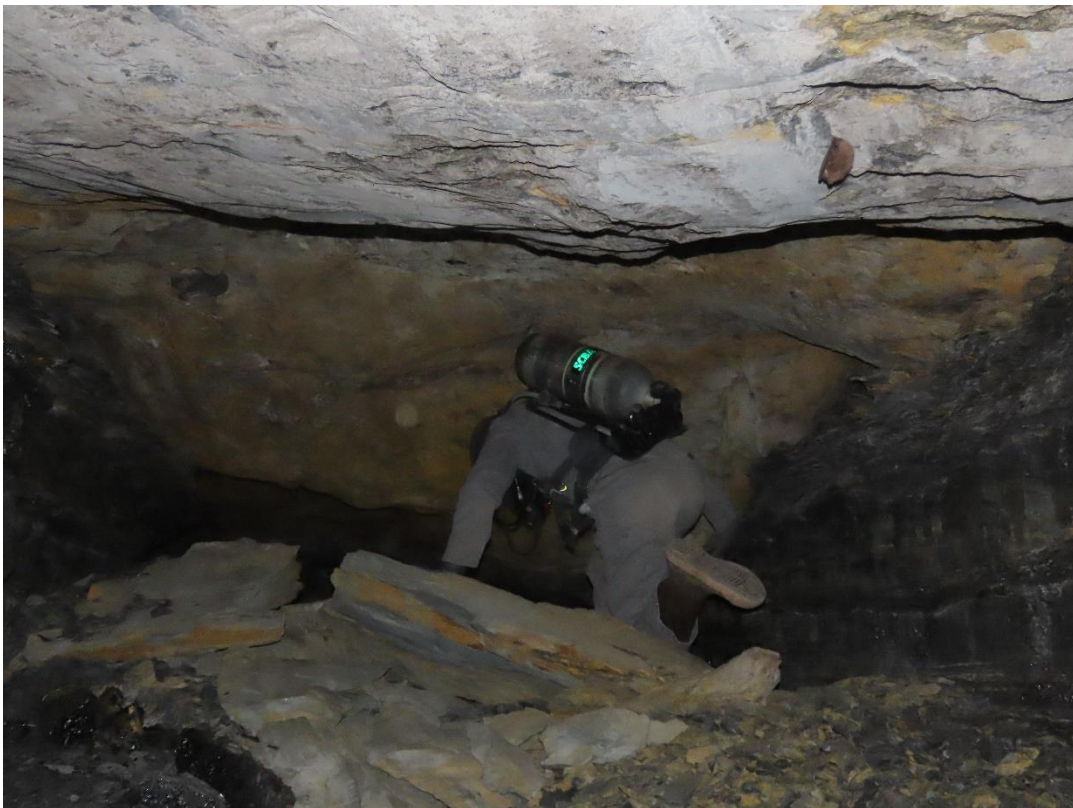
Yankee Adit 01: Much of the feature required crawling squeezes to negotiate.
BCI Photo by Bill Burger

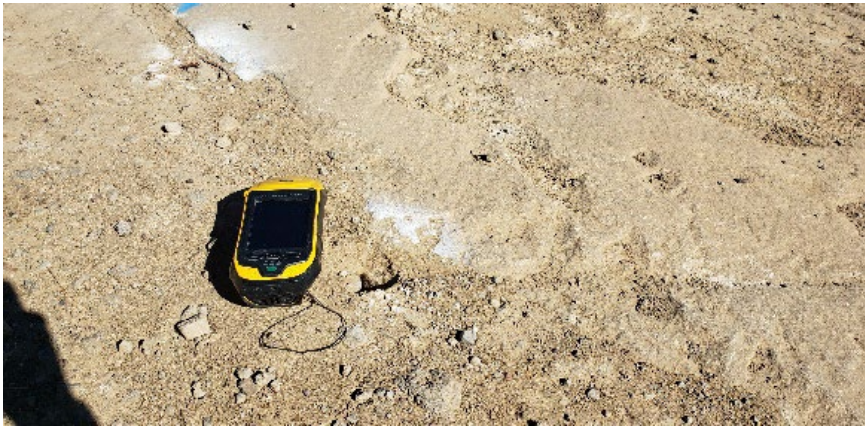
Photo 11. Logging subsidence features in County Road A-25 with GPS unit.

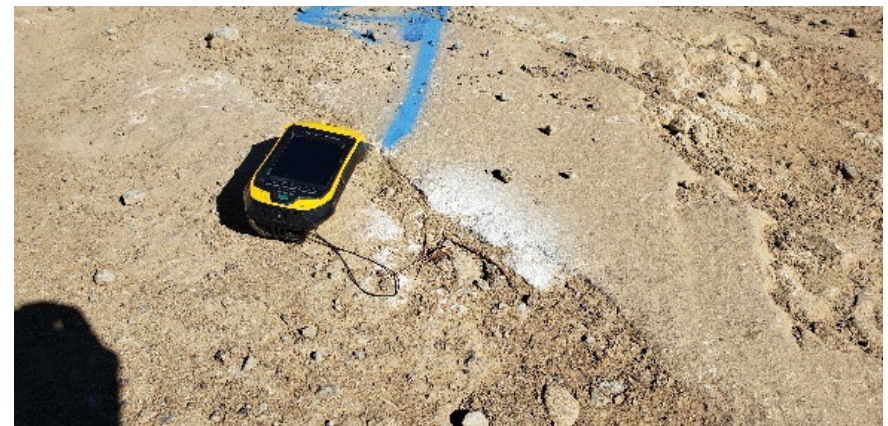
Photo 12. Logging subsidence features in County Road A-25 with GPS unit.

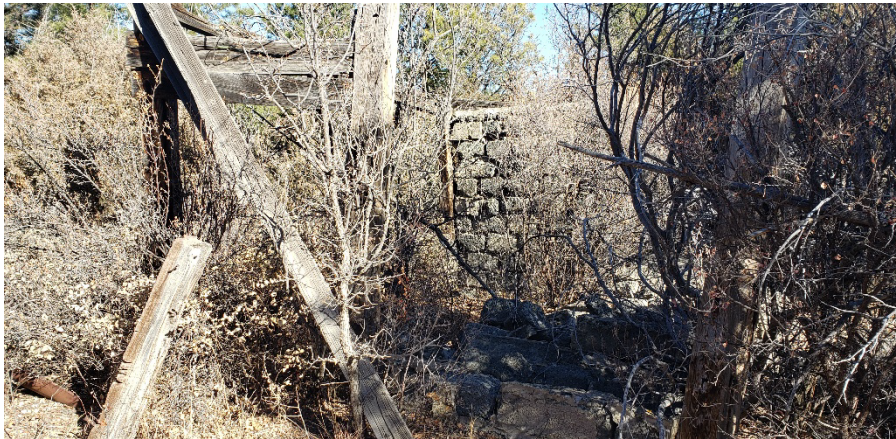
Photo 19. Mine structures near Adit A-3.

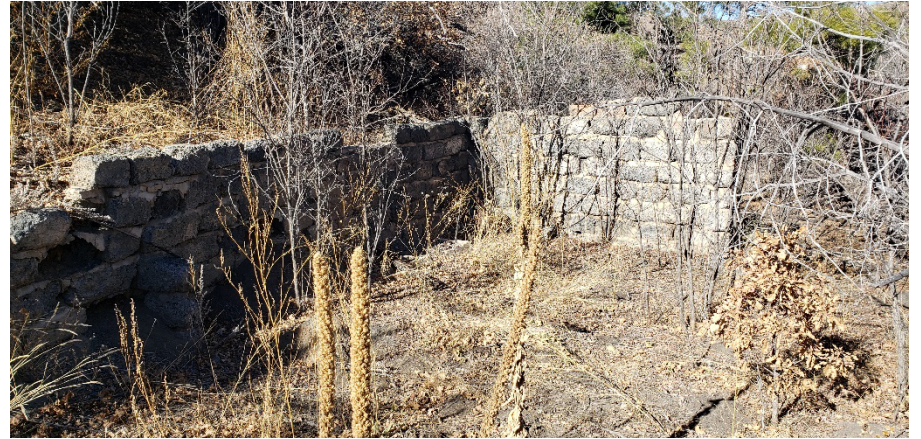
Photo 20. Mine structures by Adit A-3.

Trihydro recommends a bat-compatible culvert with a bat gate closure at the Turner-Urtado mine adits A-1 and A-2, and the Denton Mine adit A-3. This closure will provide an entrance for bats to continue to use the Turner-Urtado and Denton Mines as well as provide a landmark noting the existence of nearby underground mine workings. The proposed culvert with the bat closure consists of a 24 in. corrugated metal pipe (CMP) culvert and bate gate with a removable crossbar for further investigation and monitoring of the bat habitat. The vertical opening (VO-1) will be included in the over-excavation of the adit A-1 (Figure 3) opening. A separate closure is not proposed for VO-1.

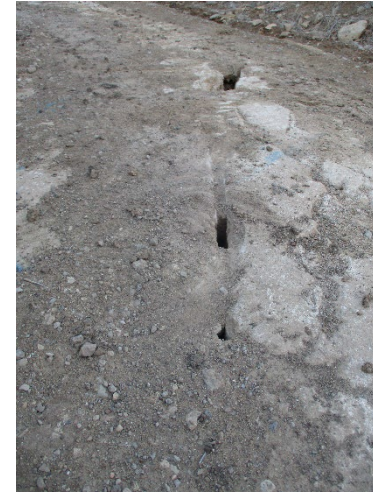
Photo 22. Subsidence features in County Road A-25; February 16, 2022.

Trihydro recommends the drilling and grouting option. This option involves drilling the area immediately adjacent to the A-25 subsidence features and areas where related mine workings may impact the road, and injecting grout into the voids beneath and adjacent to the A-25 alignment. The grouting work may take place concurrently with the drilling investigation. The goal of drilling and grouting the A-25 subsidence features is to map the voids under and near the road alignment and to fill those voids with grout to stop additional subsidence in the area and stabilize the road. The drill holes will be spaced every 30 ft along the A-25 alignment with an increased drilling density of every 20 ft around the existing subsidence features (Figure 6). Based on room and pillar findings in the field, some adjustments to the hole locations may be made to encounter more voids. The proposed drilling program includes 31 holes. Based on projections of the mined coal seam, the proposed drilling program includes drilling up to expected mine floor depths of 100 ft. This drilling plan includes approximately 1,938 ft of drilling. The mined coal seam outcrops very close to the southern edge of the surface investigation area and holes drilled on this end will encounter the mined coal seam at very shallow depths.

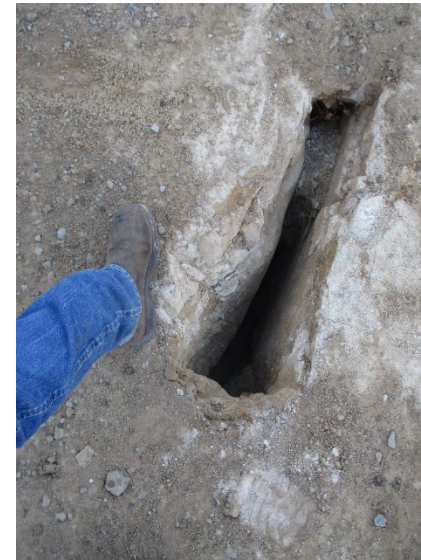
Photo 24. Largest subsidence feature in County Road A-25; February 16, 2022.
