**RE: Notice of Violation N24-4 Failure to contain fluids within Permit Area, Cebolleta Uranium Exploration, Permit No. CI018EM Operated by Cibola Resources, LLC.**

NOTICE OF VIOLATION NO.: N24-4

March 22, 2024 Cebolleta Uranium Exploration Inspection Report

**MINING INSPECTION REPORT**  
**Cebolleta Uranium Mine Exploration**  
**Permit #: CI018EM**  
**Date of Inspection: March 22, 2024**

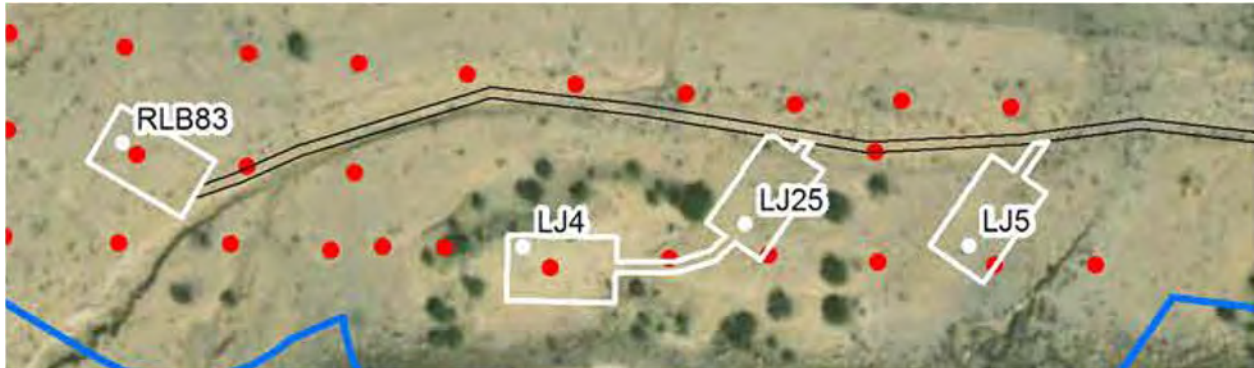
South Sections:

*Notes below are from right to left.*

LJ5/LJ25: Observed possible area where core was laid out. Appeared to have the same gradient of soil to shale layering visible
