FINAL DRAINAGE REPORT ALLISON, NEW MEXICO

FINAL DRAINAGE REPORT

PROJECT NO.: LT2043298.01

DATE: AUGUST 2020

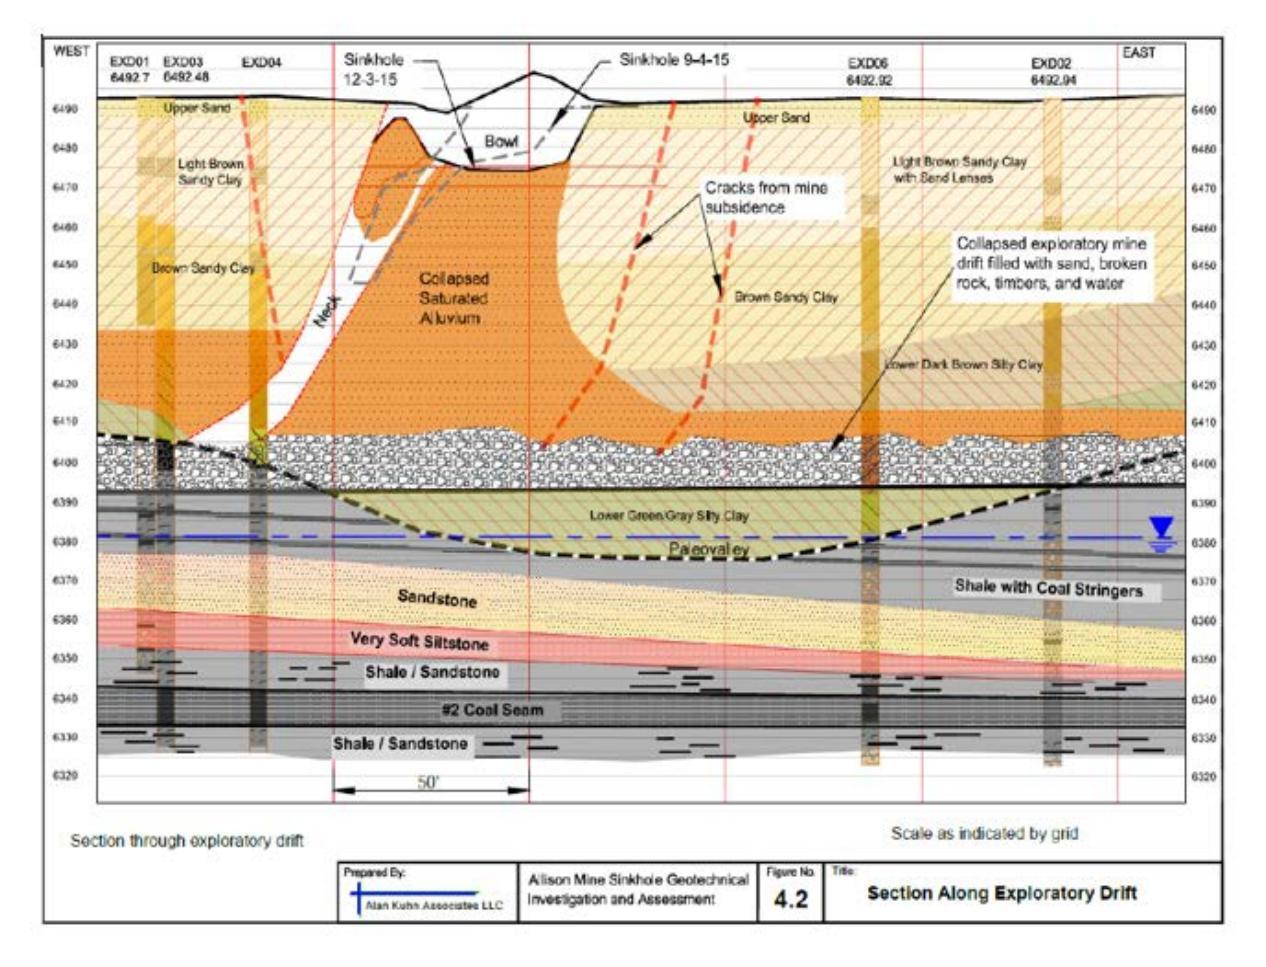
Figure 5 - Subsurface Profile by Alan Kuhn Associates (NM AML Program, Alan Kuhn)

In 2015, the AML Program was notified that a sinkhole approximately 40'x20'x30' (Length x Width x Depth) developed within a drainage channel on private property (Figure 4). The sinkhole quickly advanced and had grown to 90'x45'x30' (Length x Width x Depth) in a matter of weeks. AML contracted Alan Kuhn Associates to investigate subsurface conditions of the subsidence and its margins, and profile the conditions underground (Figure 5).

The AML Program ultimately determined the subsidence was likely caused by failing underground mine workings, surface tension crack development, and infiltration of water through the tension cracks to the subsurface voids. AML also believed that the development of the sinkholes was exacerbated by an earthen dam ('fill pad") built by a landowner upstream.

To impede the development of future sinkholes, AML filled the subsidence and tension cracks and rerouted surface water away from the sinkhole.

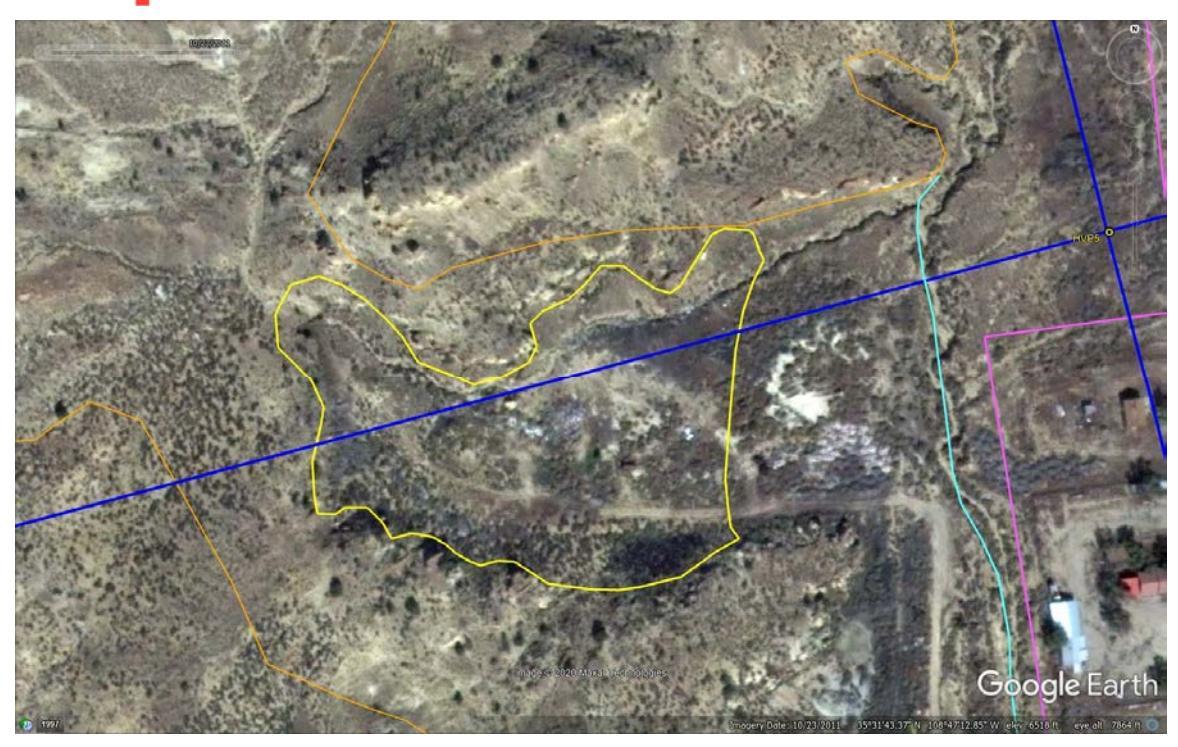
Figure 18 – Historical Channel Alignment (Source: Google Earth 10/23/2011)

Figure 18 depicts the historical drainage channel alignment prior to the construction of the Fill Pad Area. **Figure 19** shows the Fill Pad Area after construction. The perimeter of the Fill Pad Area is shown as a yellow boundary in both figures for comparison purposes.

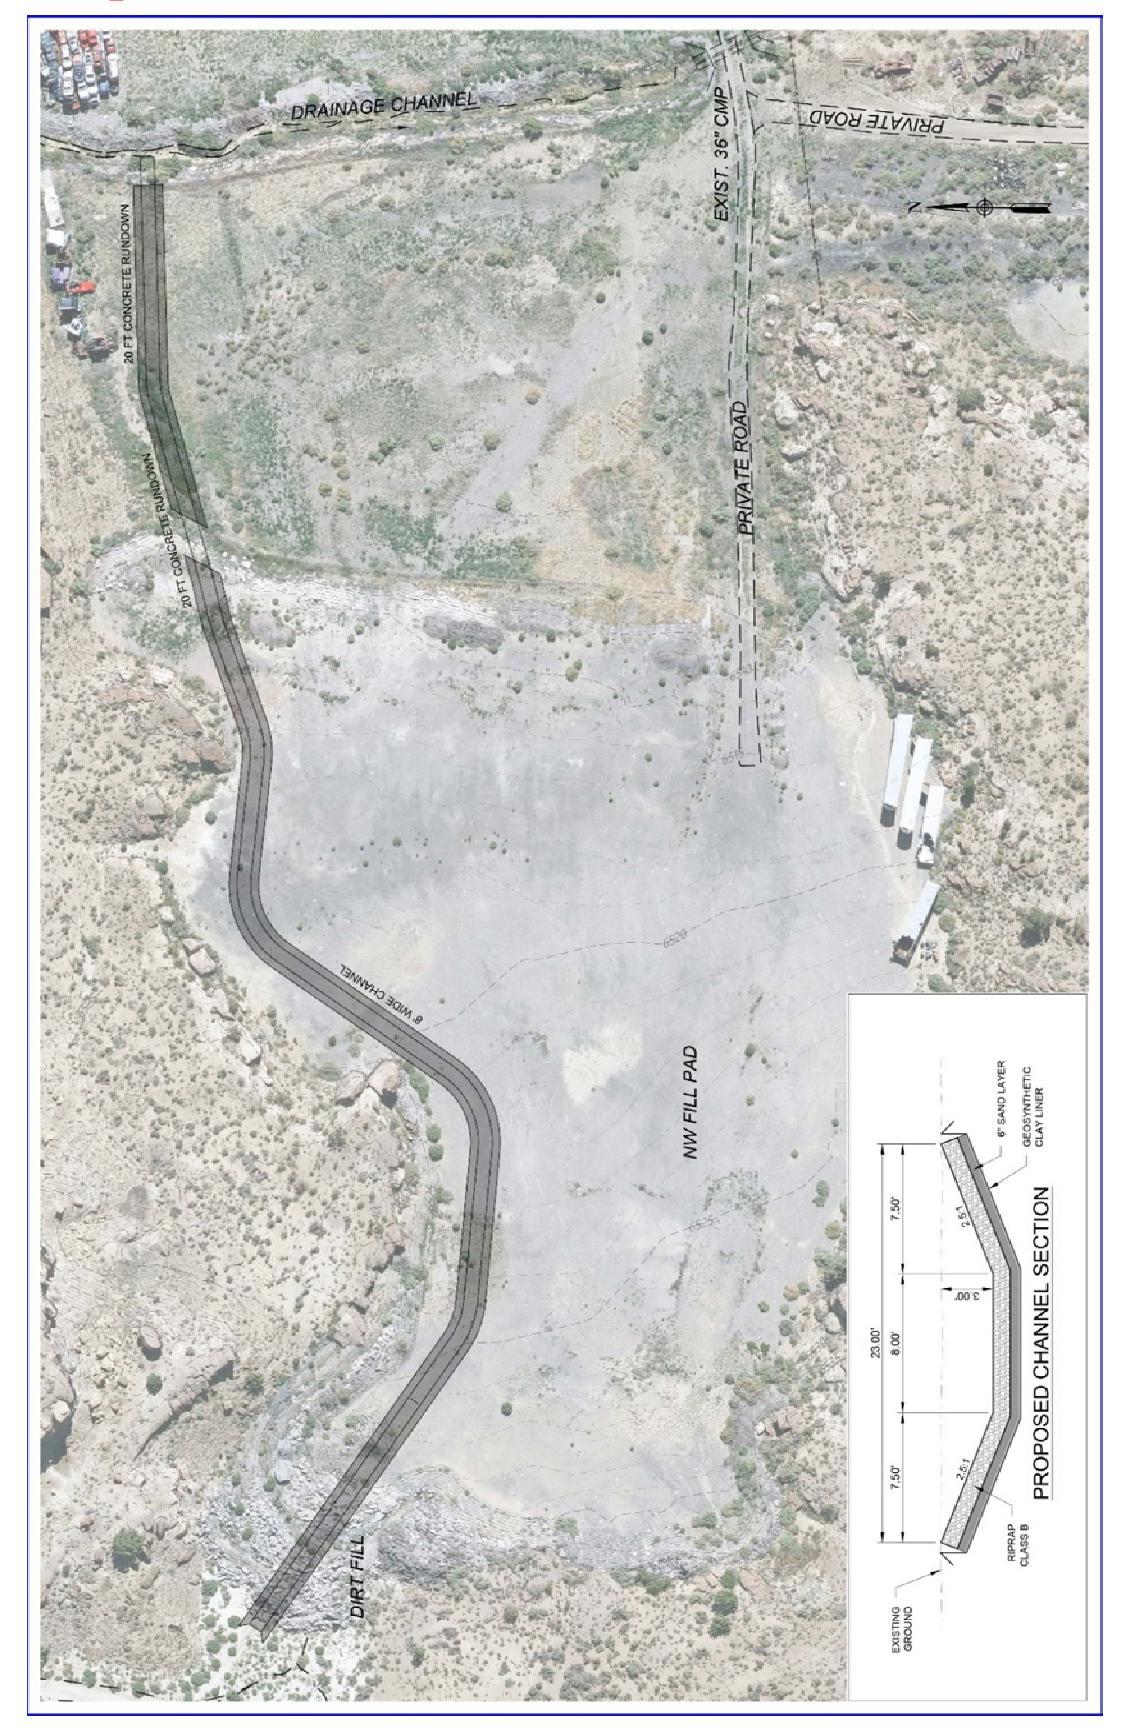
Figure 20 - North Fill Pad Area Alternative No. 1

A schematic of proposed alternative is shown in **Figure 20**Error! Reference source not found.. Hydraulic analysis for the channel is also shown in **Appendix B**. **Table 6**Error! Reference source not found. and **Table 7** identify characteristics of the Alternative including pros and cons, design life and rough order of magnitude costs. A conceptual cost estimate for the alternatives are provided in **Appendix E**.

Design Life	Cost (Rough Order-of-Magnitude)
• 50-75 years for channel with periodic cleaning	\$293,850 (Details are included in Appendix E)

Due to the maintenance issues in long term, WSP's preferers alternative -1 Northwest field Pad area improvement.

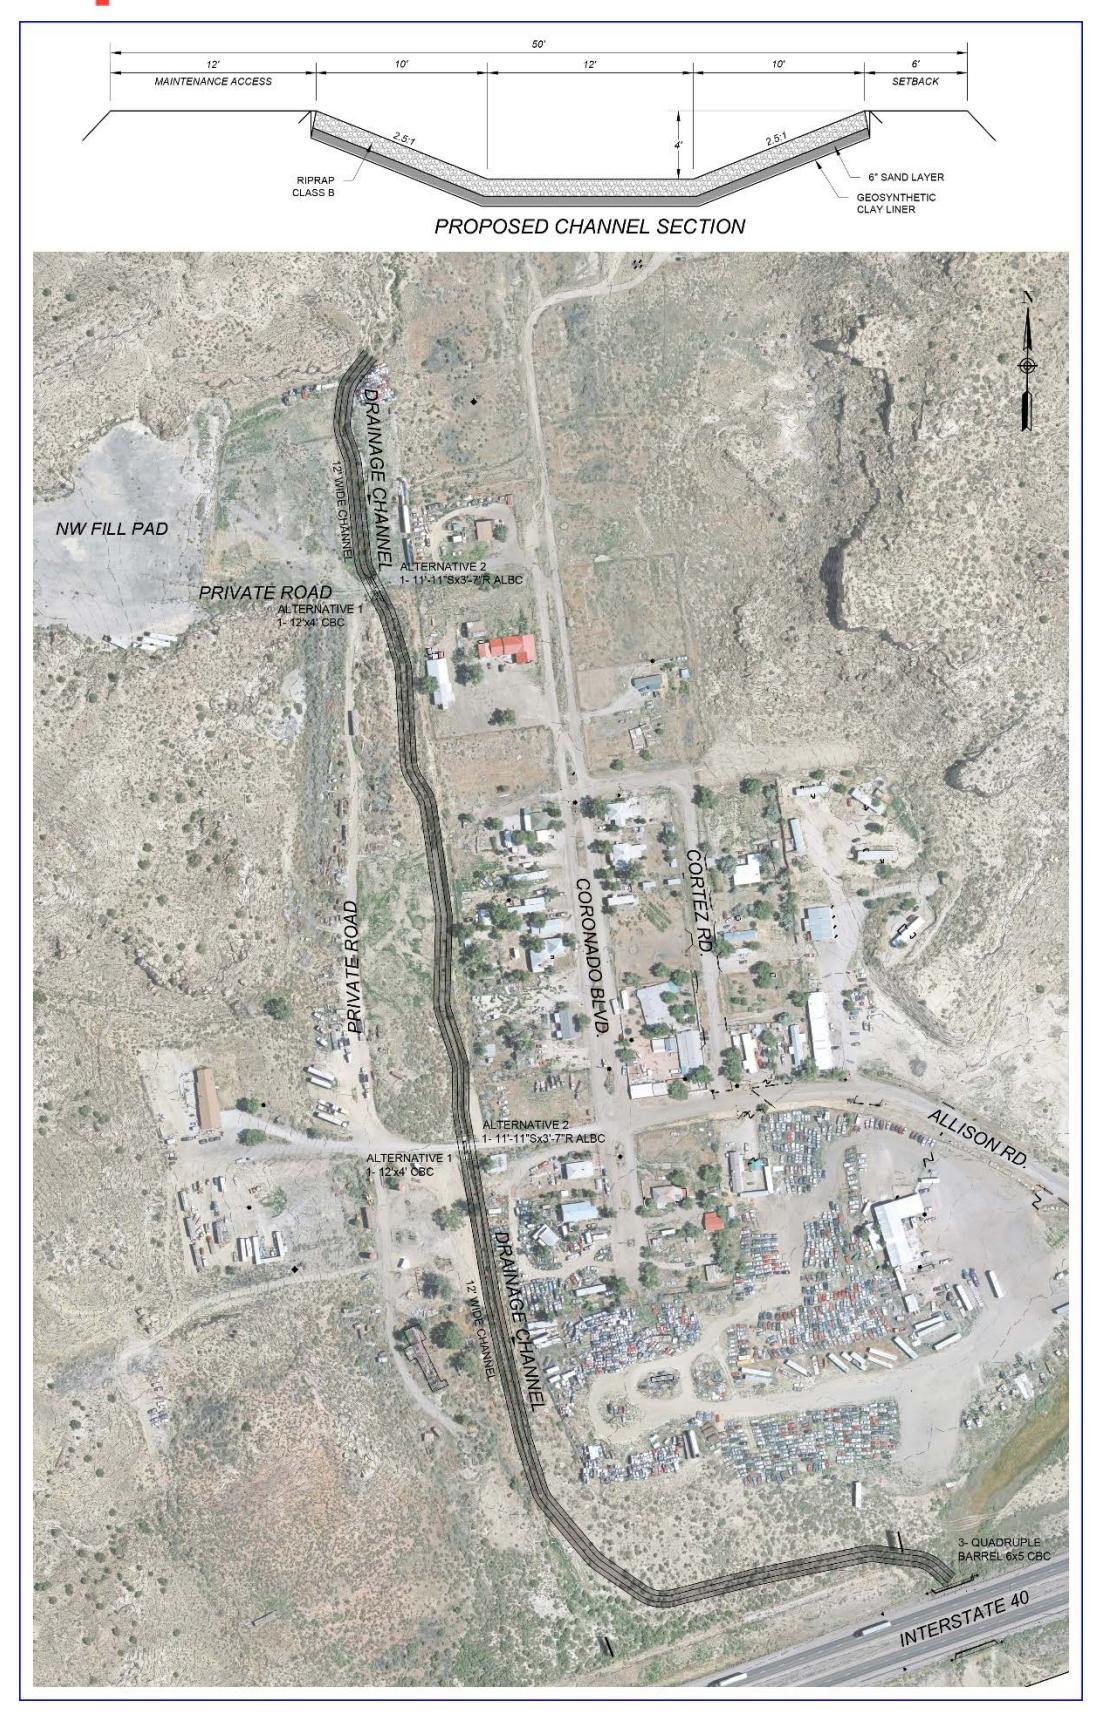
Figure 22 - Drainage Channel Schematic Drainage Plan

For the lower reach of the drainage channel, the proposed alignment maximizes the use of property for private or commercial purposes. The same size channel is continued up to the inlet of the existing I-40 CBC as shown in **Figure 22**. The same upstream channel slope is maintained in the lower reach to carry the design flow.

Because of the durability and low cover availability in the field, WSP's preferers alternative -1 for drainage channel improvement.
