F-33 MINE RECLAMATION REPORT

**ATLANTIC RICHFIELD COMPANY
HOMESTAKE MINING COMPANY**

AUGUST 1994

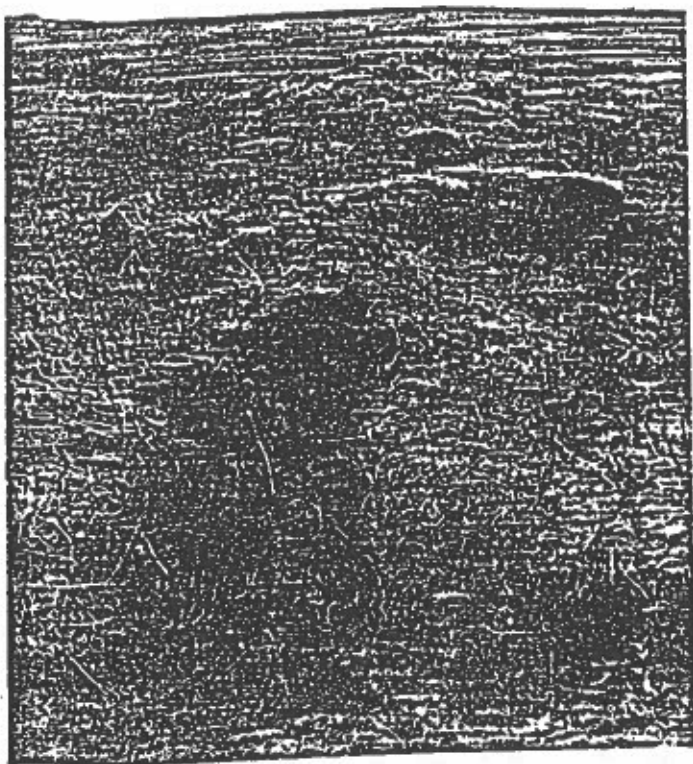
FIGURE 7.2.1

EXAMPLE OF A COLLAPSED ROOM
WHERE THE SWELL OF THE OVER-
BURDEN WAS SUFFICIENT TO FULLY
FILL THE WORKINGS AND THE
VOLUME ABOVE THE VOID

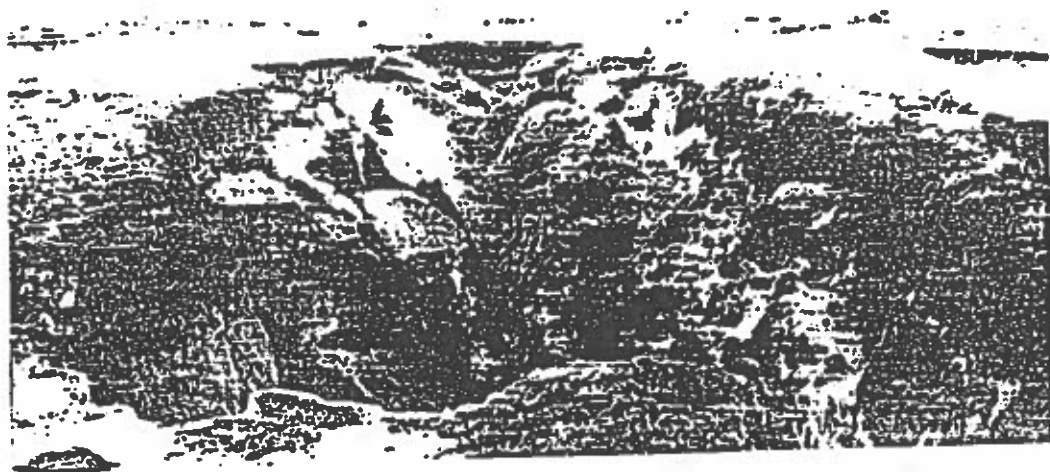
FIGURE 7.2.2

THE SWELL OF THE
OVERBURDEN WAS NOT
SUFFICIENT TO FILL
THE ROOM AND THE
VOLUME ABOVE, HOW-
EVER THE WORKINGS
ARE SEALED

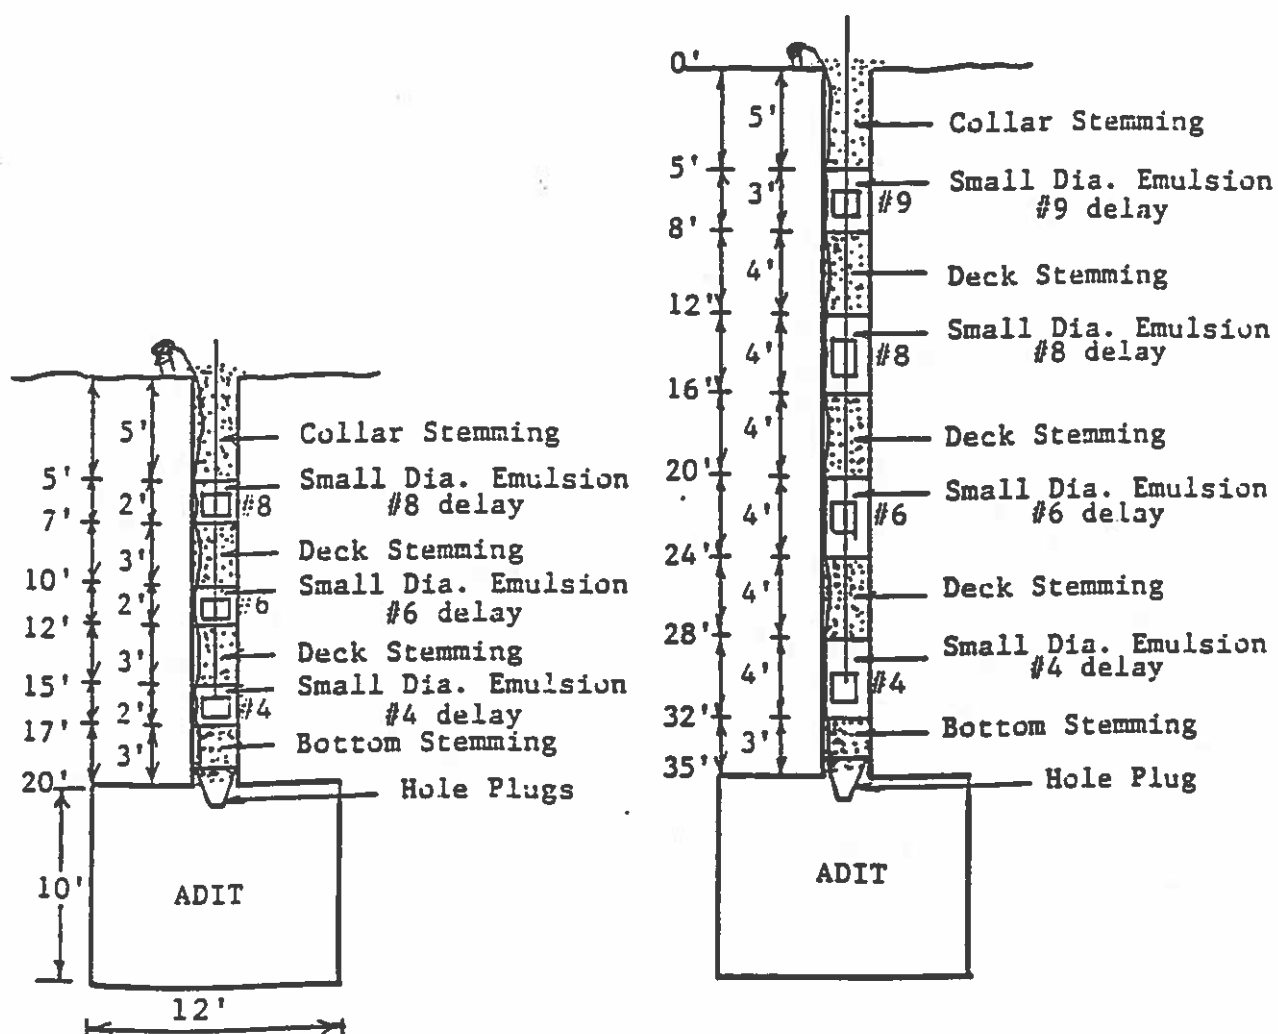
Figure 7.2.6 shows the recommended hole load, for holes drilled over the void, for holes 20 feet and 35 feet deep.

FIGURE 7.2.6: EXAMPLES OF HOLE LOADING FOR HOLES OVER THE ADIT DESIGNED TO CRATER DOWN INTO THE ADIT

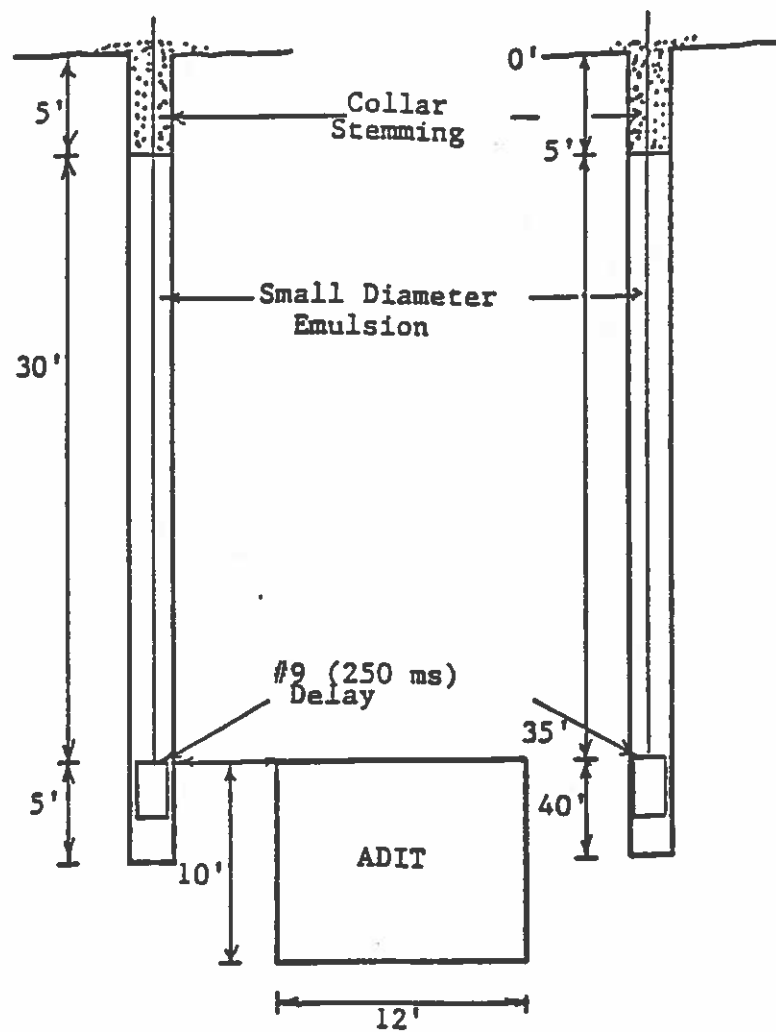
The holes along the side may be loaded as a continuous column. For the delay sequence recommended above, for holes over the void, the side holes should have a number 9 (250 ms) down-hole delay.

The scaled depth of burial at the top of the charge should be $3.0 \text{ ft/lb}^{1/3}$. This will break to the surface, while avoiding excessive flyrock. For 3-inch holes 5 feet of stemming are required to achieve this design. This stemming height should be used for both the holes along the side and those over the void. For holes over the void the length of the upper deck may need to be varied, as the hole depth varies, to obtain the recommended 5 feet of stemming.

FIGURE 7.2.7: HOLE LOADING FOR HOLES ALONGSIDE THE ADIT

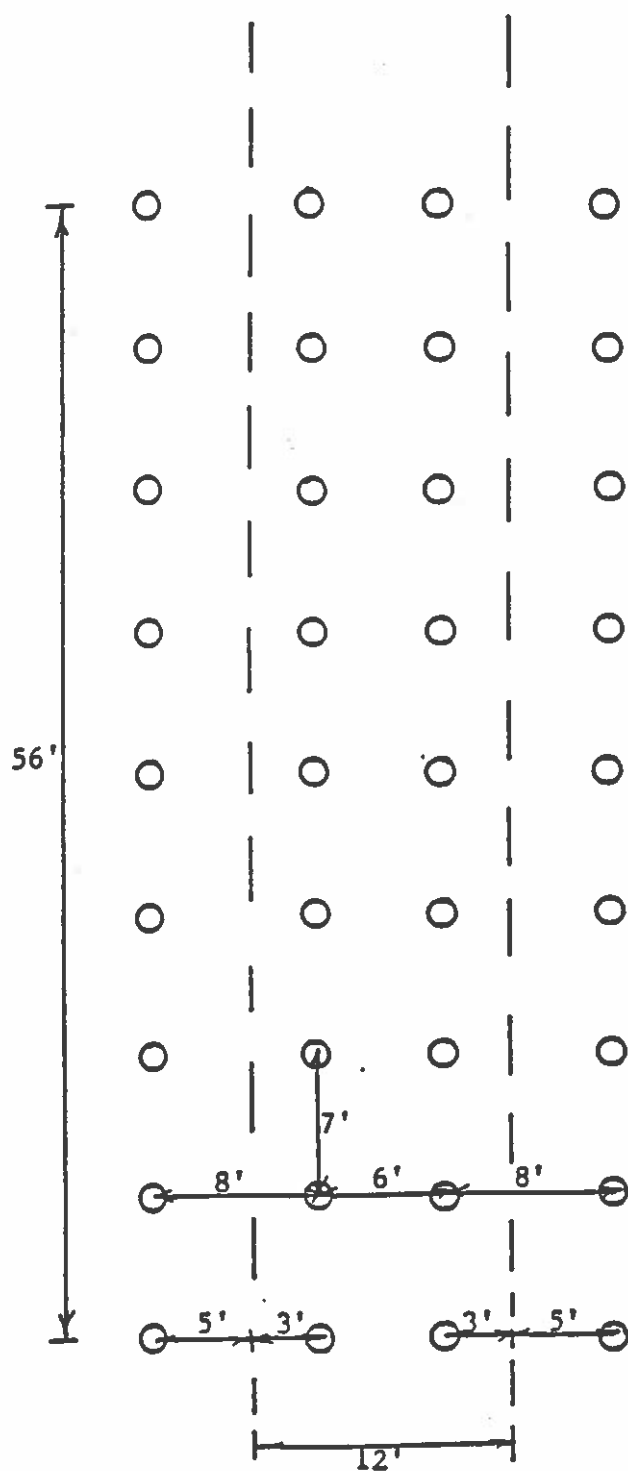
For the stated conditions it will be necessary to drill back 55 feet from the current location of the portal to obtain 35 feet depth and assurance of filling the void and area above it.

Four rows of holes would be drilled with two rows directly above the void and one on either side of the adit. Figure 7.2.8 is a diagram showing the blast design for the given assumptions with appropriate dimensions.

FIGURE 7.2.8: BLAST LAYOUT TO CAVE AND
FILL F-33 ADIT

A test blast, using the design above should be fired initially. This would be a small blast and allow us to determine how the planned approach performs in the specific strata found at F-33. Then, any adjustments could be made to optimize the plan.

The test blast could comprise the first three rows of holes shown in figure 7.2.8. The remaining six rows could then be shot as one, or two additional blasts of three rows could be initiated. Fewer blasts is probably better to minimize the chance of damage behind a shot that would make subsequent drill placement difficult.

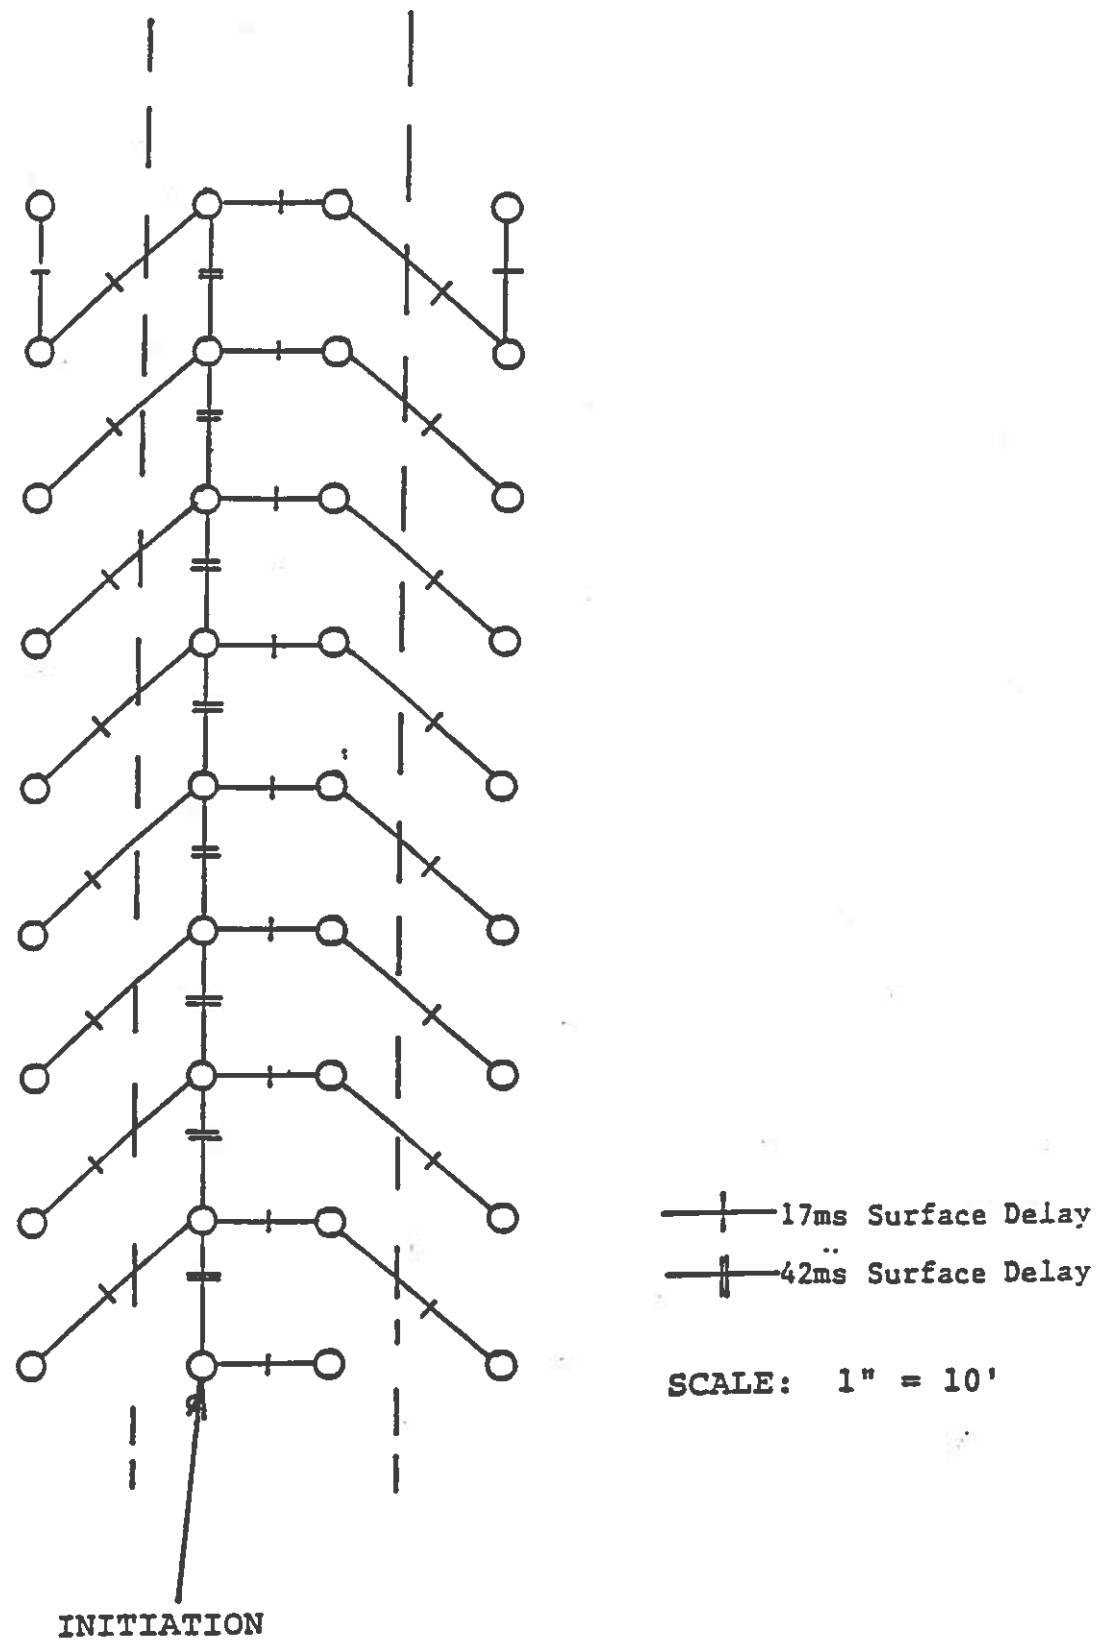
FIGURE 7.2.9: PROPOSED SURFACE TIE-IN FOR
BLAST TO CLOSE F-33 ADIT
