ISABELLA

**RE:
Prior Reclamation Inspections**

PRIOR RECLAMATION INSPECTION

**PRIOR RECLAMATION INSPECTION REPORT
AND
RECOMMENDATION FOR RELEASE OR PERMIT
REQUIREMENT**

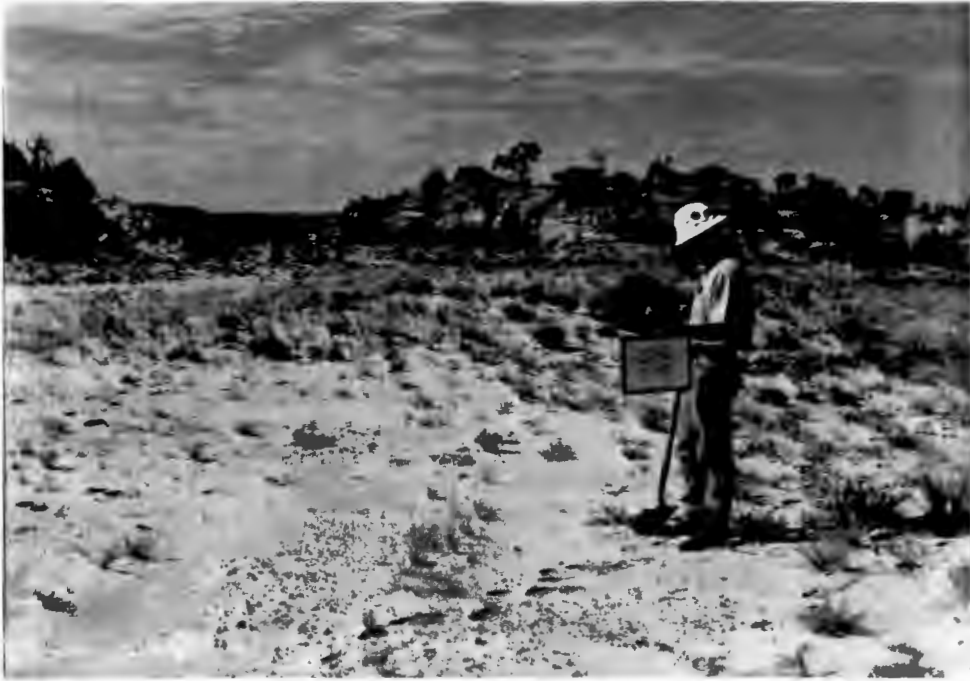
Section 1 T13N R9W, Shaft Site looking South, 9/13/95

Essentially, the site had been safeguarded but not topsoiled or reseeded. The site is characterized by white fine grained sandstone covered by a few inches of fine white sand. The sand is subsequently being eroded away by wind and water. A mine access road had significant erosion. An impoundment had been constructed to impound sediment from the mine site, however, erosion from the access road was bypassing the impoundment and was entering the mine site. Photographs documenting vegetation and the general condition of the site are presented in Appendix C.

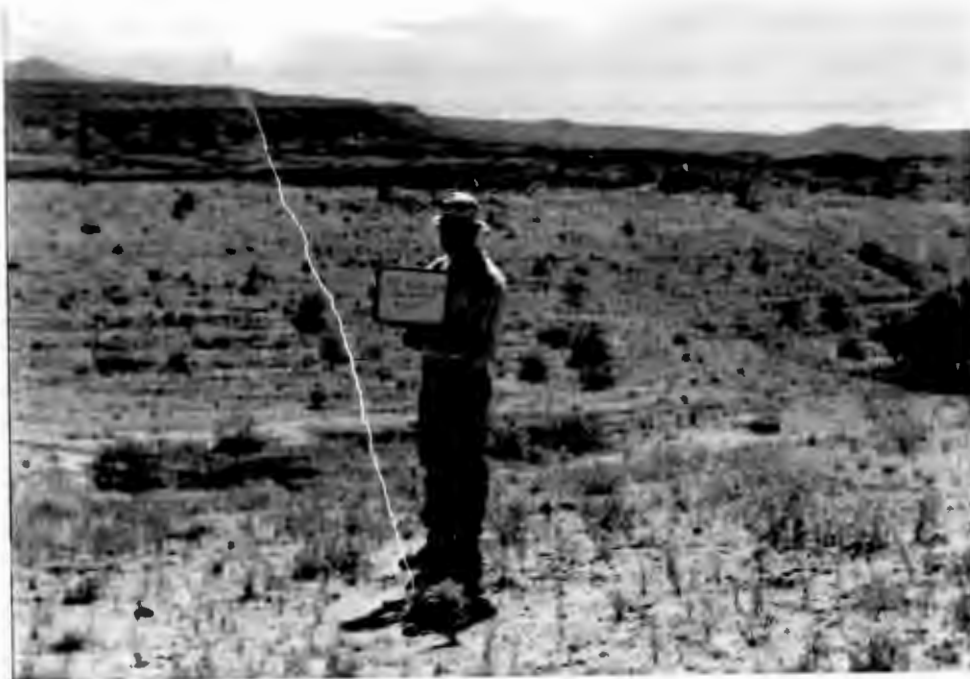
Section 25 Mine, West Side Looking West, 9/12/95

The Section 25 mine is located 14 miles northwest of Grants, New Mexico. This 8-acre site was a surface mine operated by Reserve Oil and Minerals. It was reclaimed and reseeded by Santa Fe Pacific Gold in 1993. Additional reclamation activities were performed in 1994. A barbed wire fence surrounded the site. All structures, trash or junk had been removed from the site. There were no piles or accumulations of toxic or waste material on the site. There were no apparent hazards that could effect public health and safety. There were several topsoil mounds left by Santa Fe because small mammals had extensively burrowed into them and were using them for habitat. Photographs documenting the vegetation and the general condition of the site are presented in Appendix F. The regrading included construction of three large depressions that impounded rainwater for livestock. There was one significant erosion feature and several areas of minor erosion on the sides of these depressions. Topsoil depths across the site were greater than 12 inches. An earthworm found while measuring soil depths at this site is a good sign that the soils are generally non-toxic.

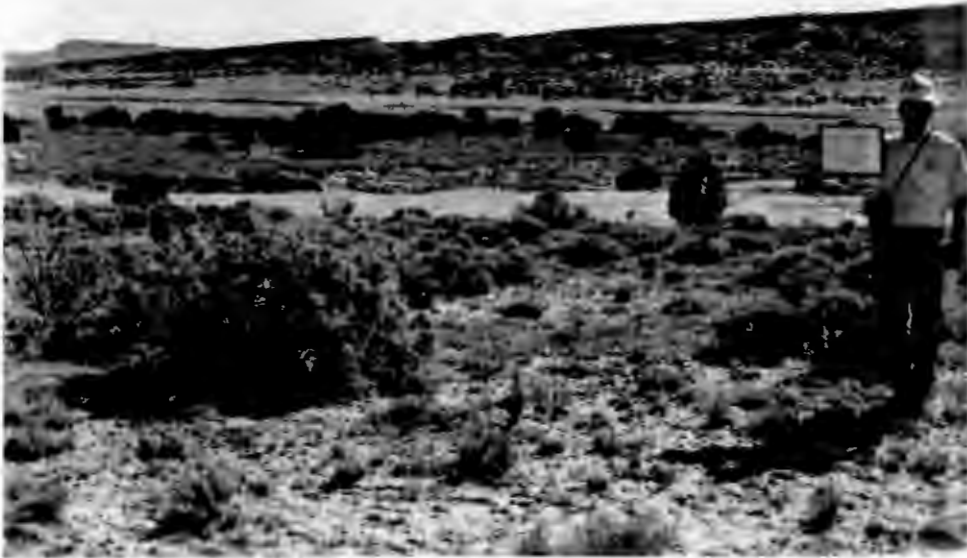
Faith Mine Shaft Site, Looking East, 9/12/95
Regraded Area in Background
