# Photo Tour of the Gallup Mine Fires Mitigation Project

GALLUP, NEW MEXICO

# Enterprise Brown Mine Fire

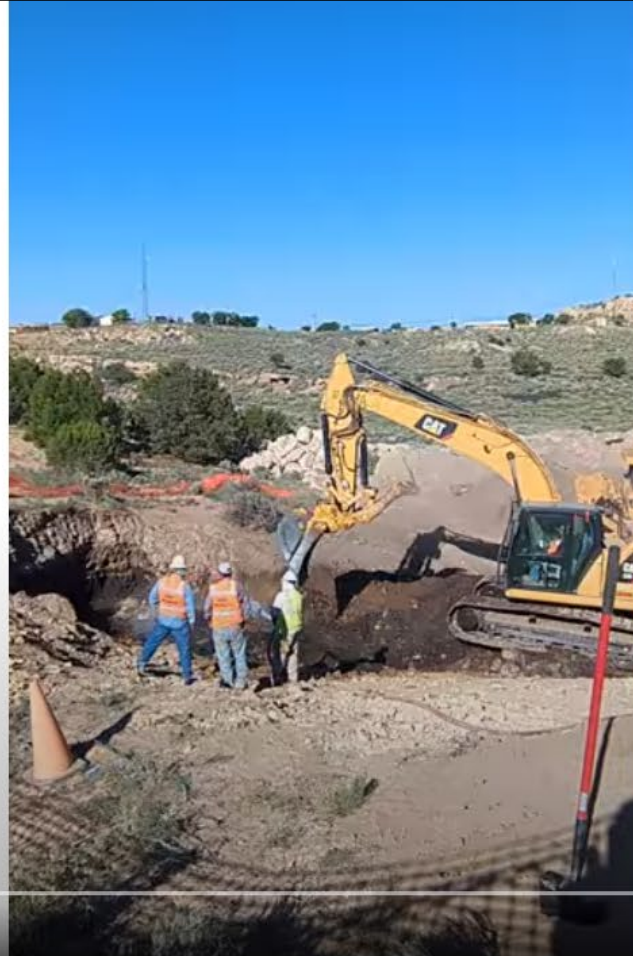
Visibility on site presented numerous challenges include heavy dust and burned coal ash pockets. Far more water than expected was utilized to ensure workers safety and to keep work on schedule.

Timelapse of construction on the Enterprise Brown Mine fire. Burning coal and ash pockets were removed from underground, placed into a pile and then a D6 dozer spread the hot material to cool before being mixed with overburden.
