Carlsbad Brine Well Remediation Project - Carlsbad, New Mexico
State of New Mexico - Energy, Minerals and Natural Resources Department (EMNRD)

Presentation to the Carlsbad Brine Well Remediation Authority

April 23, 2019

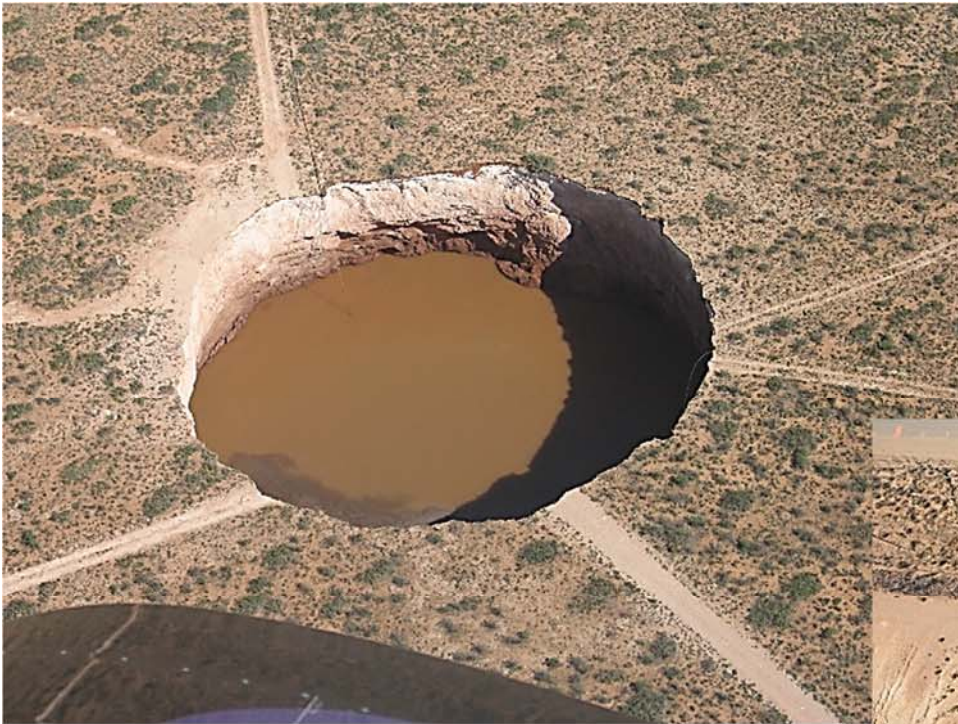
Jim's Water Service – July 2008

Loco Hills Water Disposal – November 2008

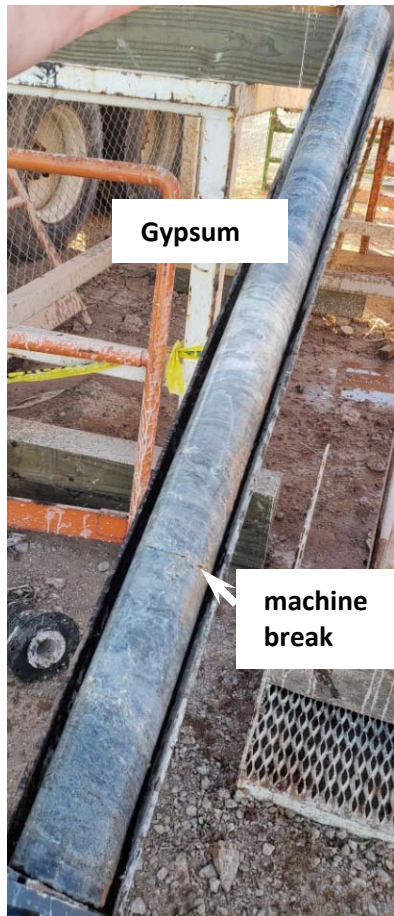
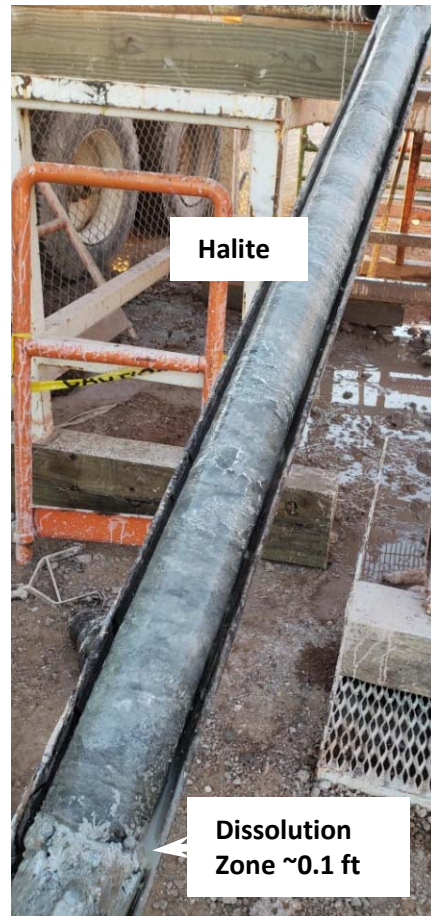
**Corehole IWMS-08
southwest of Eugenie #1**

443 ft

459 ft

438 ft

5-ft section of
Intact roof rock

454 ft

Top of halite with
Dissolution zone

First corehole; bottom was cemented to control brine pressure

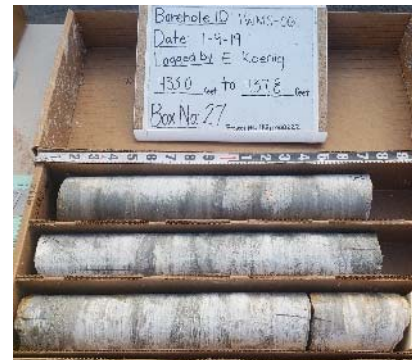
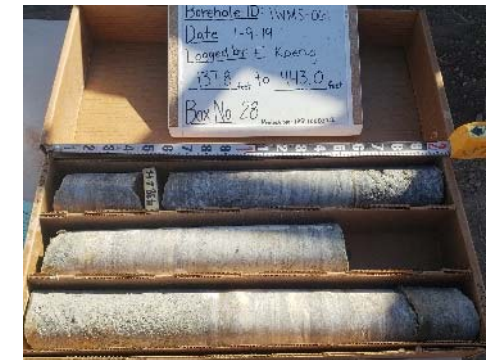
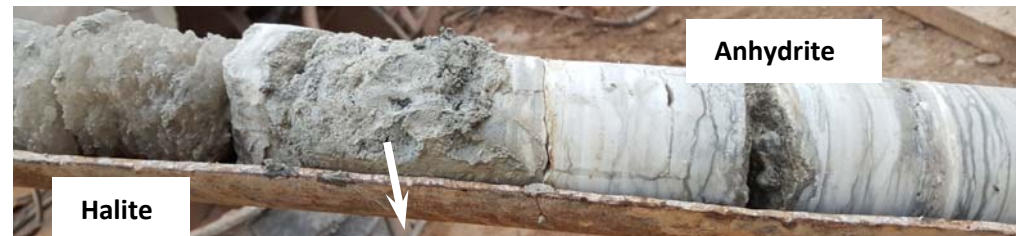
**Corehole IWMS-06
northeast of Eugenie #1**

433 ft to 437.8 ft roof rock core 437.8 ft to 443 ft

No core loss, so no void, fracture near bottom of the anhydrite, about 449.4 ft. About 3 inches of soft clay at 449.8; then an inch of anhydrite, and below that is the halite. Near contact, halite looks partially dissolved.

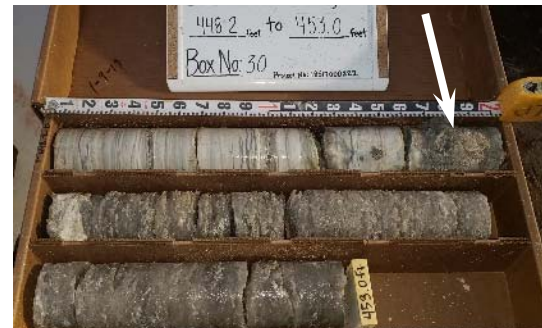
448.2 ft to 453 ft showing
Anhydrite above halite and
upper few feet of halite in
pressurized brine zone.
100% core recovery.
Second corehole, brine
pressure was controlled using
barite

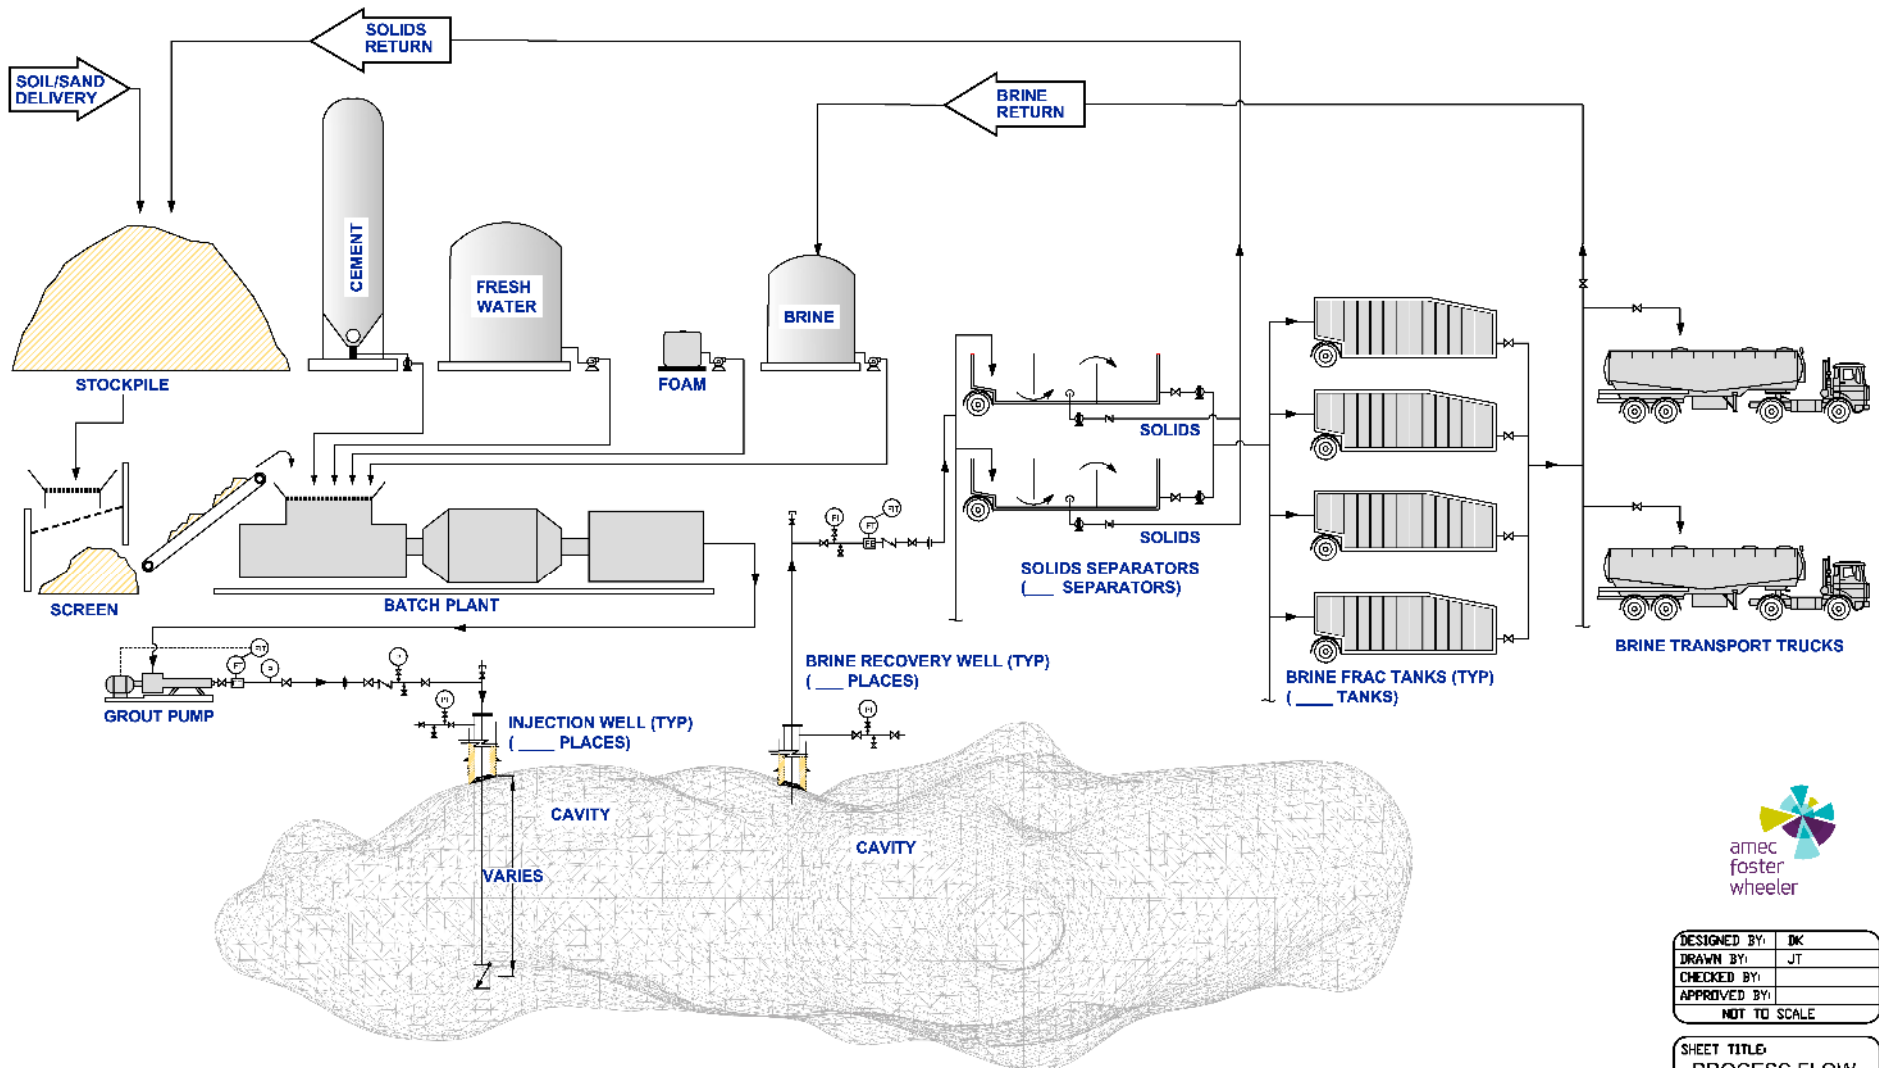
SHEET TITLE:
PROCESS FLOW
DIAGRAM
I&W Brine Cavity

Process Flow Diagram

- Install a series of wells to extract brine and inject grout
 - Maintain cavity pressure
 - Balance volume of brine removed with volume of grout injected
 - Install a grout cap using high mobility grout to support cavity roof
 - Install grout columns using low mobility grout to support grout cap
