BASELINE DATA REPORT

Section 8.0

Surface Water

MAY 2013

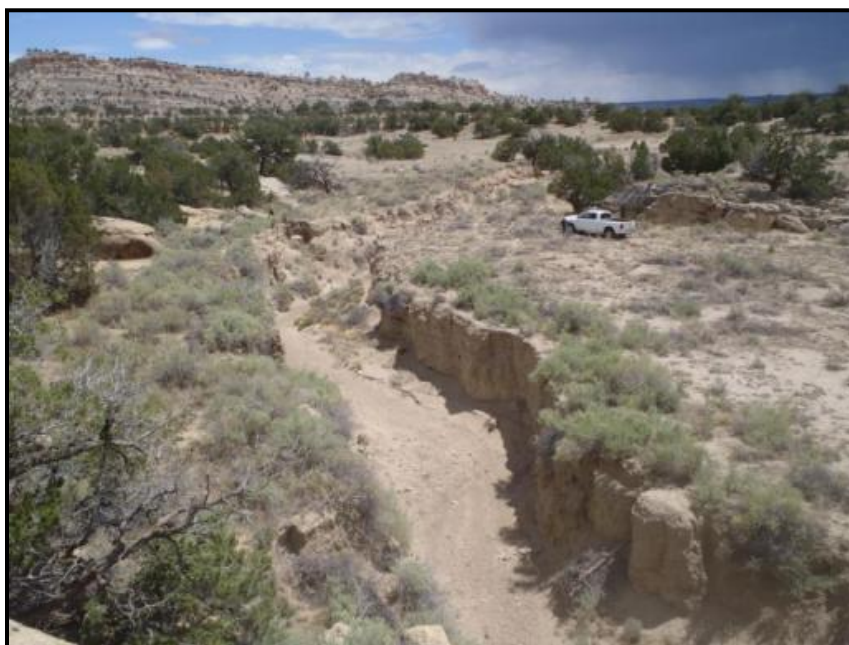
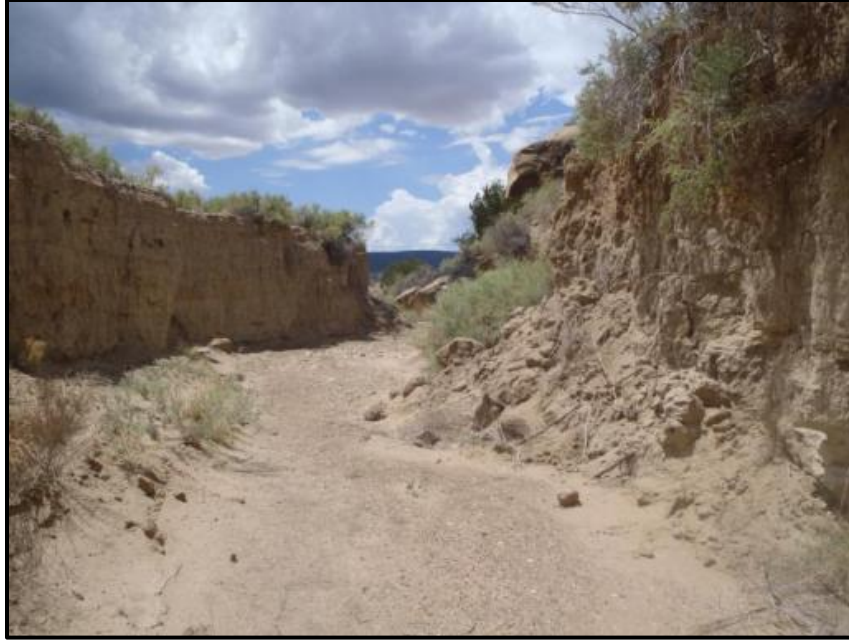
Arroyos 1 and 2 are ephemeral drainages in the north eastern portion of Section 16. The Arroyo 1 is a deeply incised channel, approximately 20 feet wide and 20 feet deep (Figure 3 and Figure 4). It originates as storm runoff from nearby hillsides in the southeast quarter of Section 9. The Arroyo 2 has smaller incised channels and is somewhat braided. It is approximately 20 feet wide and 6 feet deep (Figure 5 and Figure 6). It originates as sheet flow from nearby hillsides in Section 9, which come together to create the Arroyo 2. These two ephemeral drainages merge in front of a rock formation (Figure 7) and flow south to a man-made impoundment. Arroyo 3 is south of the impoundment. Neither arroyo has an OHWM and no other hydrological characteristics were observed in either arroyo. Dominant plant species include blue grama and fourwing saltbush.

Figure 3. Unnamed Arroyo 1 Looking Up-Arroyo (Northeast).

Figure 4. Unnamed Arroyo 1 Looking Down-Arroyo (South).

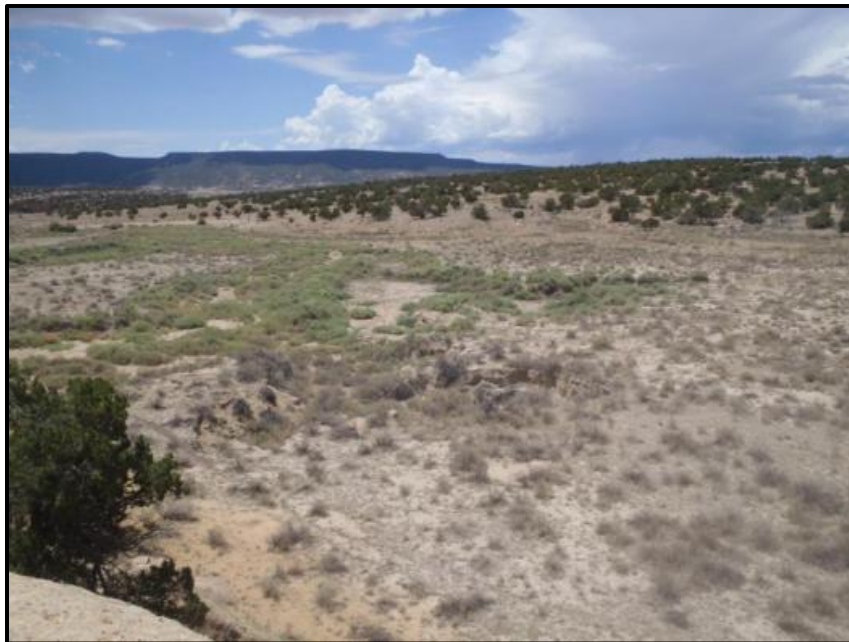
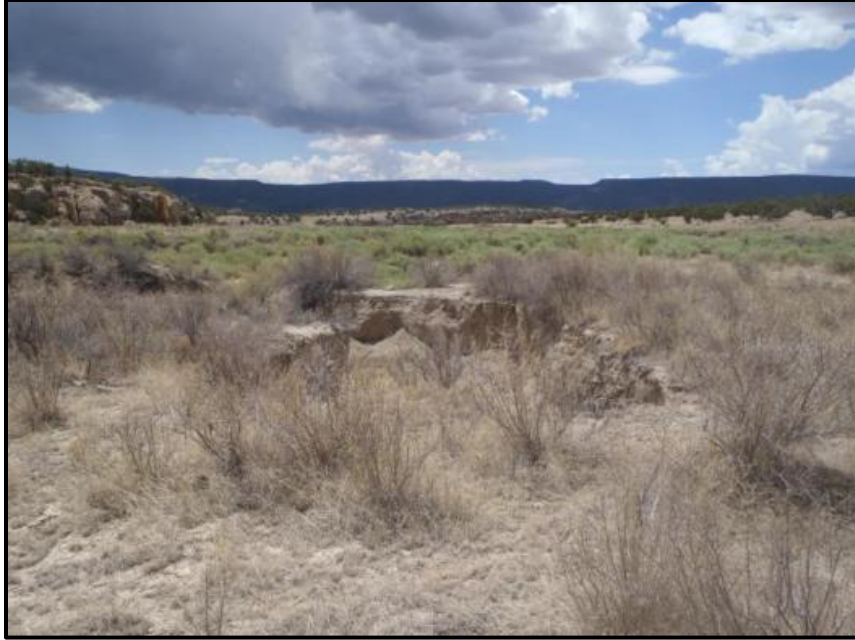
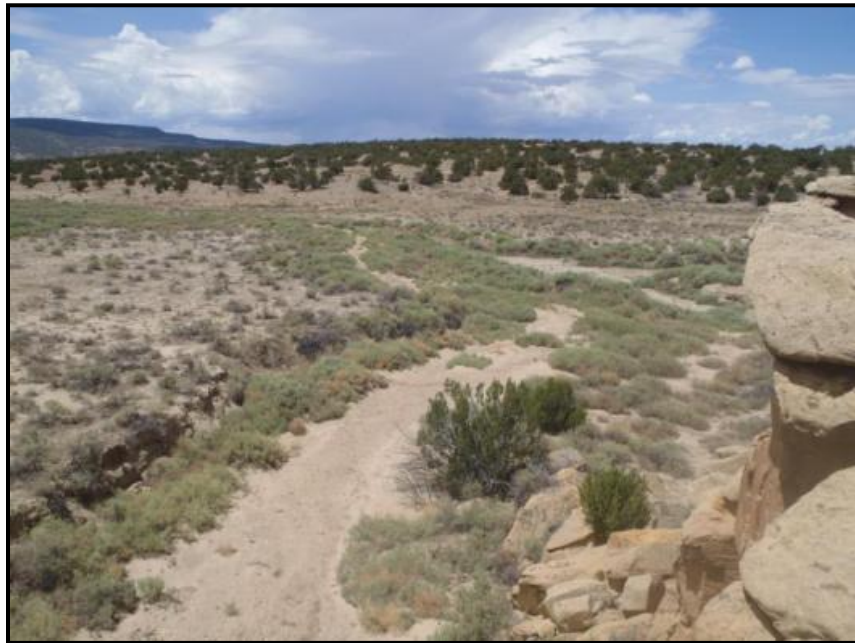
Figure 5. Unnamed Arroyo 2 Looking Down-Arroyo (Southwest).

Figure 6. Unnamed Arroyo 2 Looking Up-Arroyo at Ground Level (South).

Figure 7. Area Where Arroyos 1 and 2 Merge Looking Down-Arroyo (Southwest).

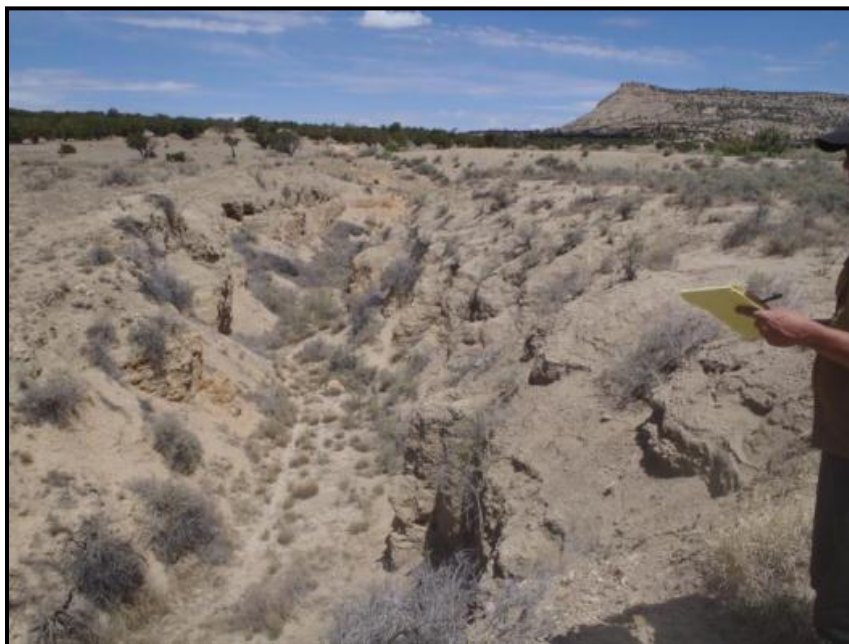
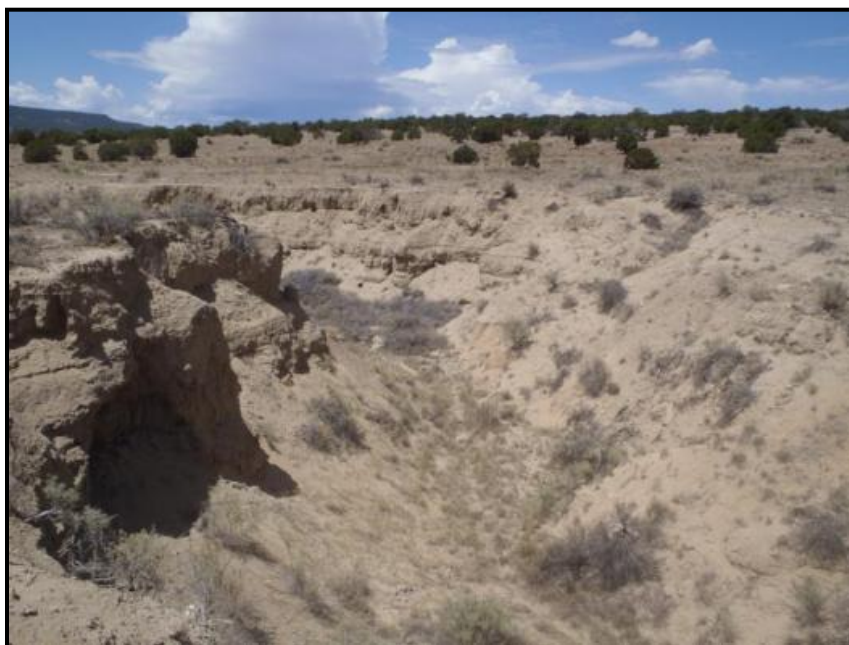
Arroyo 3 is an ephemeral drainage that is approximately 40–50 feet wide and 30 feet deep in Section 16. This arroyo combines the flows from Arroyos 1 and 2 and continues toward San Mateo Creek. The observation point was south of a man-made impoundment which retained water for cattle. Arroyo 3 flows in a southerly direction and meets San Mateo Creek, south of the project boundary (Figure 8 and Figure 9). There is no OHWM and no other hydrological characteristics were observed. Dominant plant species include fourwing saltbush and pale wolfberry (*Lycium pallidum*).

Figure 8. Unnamed Arroyo 3 Looking Up-Arroyo (North).

Figure 9. Unnamed Arroyo 3 Looking Down-Arroyo (South).

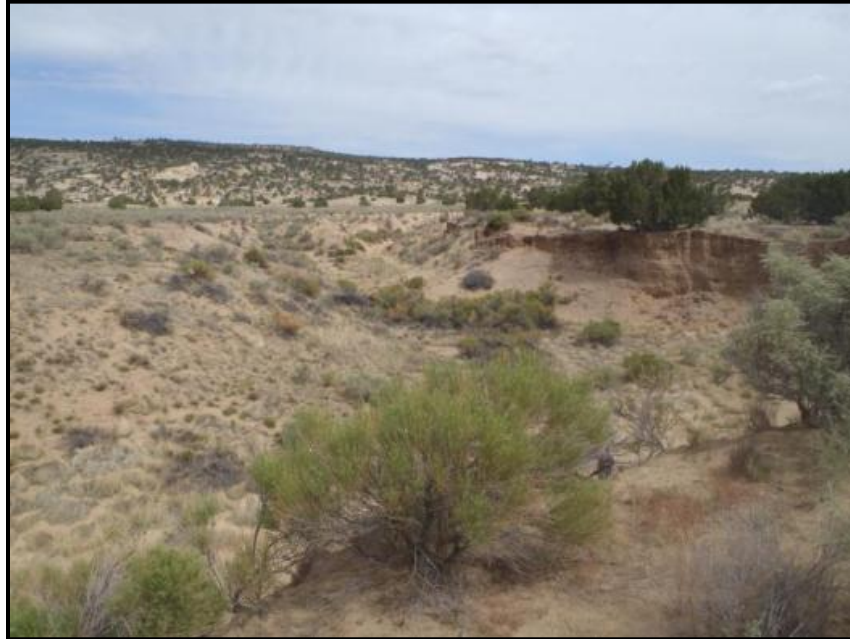
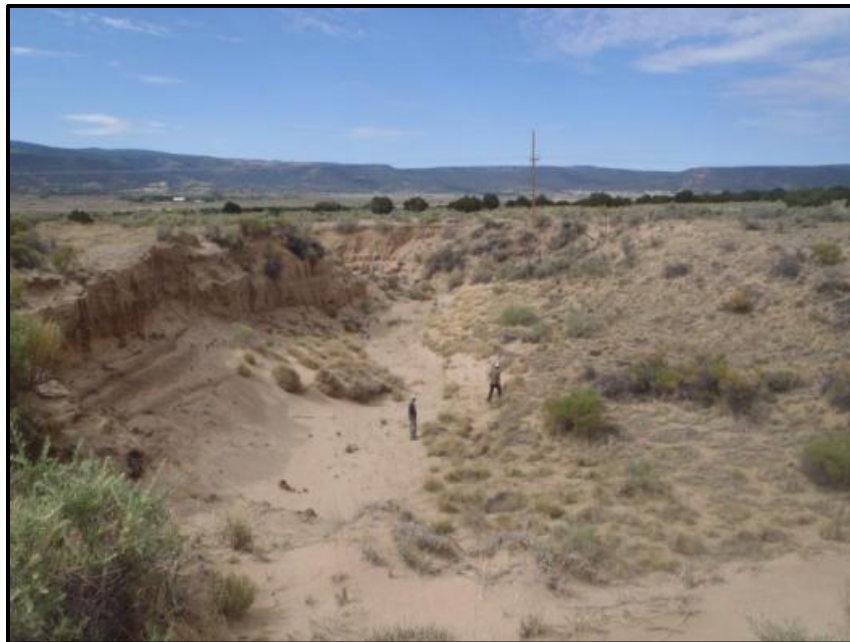
Arroyo 4 is a deep ephemeral drainage that is approximately 50–75 feet wide and 20–30 feet deep (Figure 10 and Figure 11). It originates in Section 10 and flows south. The arroyo meets San Mateo Creek south of the project boundary after flowing through two small tanks. It is heavily incised. There is no OHWM and no other hydrological characteristics were observed. Dominant plant species include alkali sacaton, Indian ricegrass (*Achnatherum hymenoides*), and fourwing saltbush.

Figure 10. Unnamed Arroyo 4 Looking Up-Arroyo (Northwest).

Figure 11. Unnamed Arroyo 4 Looking Down-Arroyo (South).

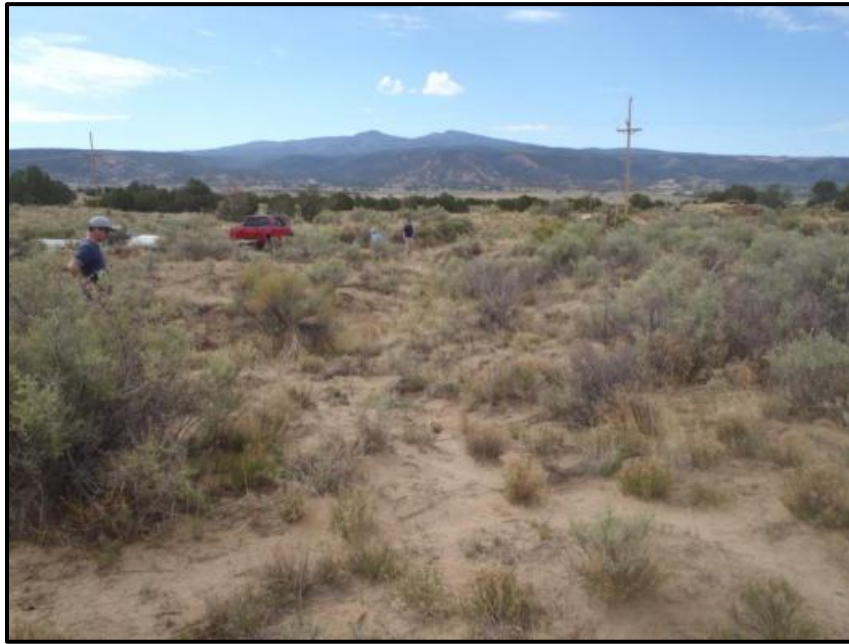
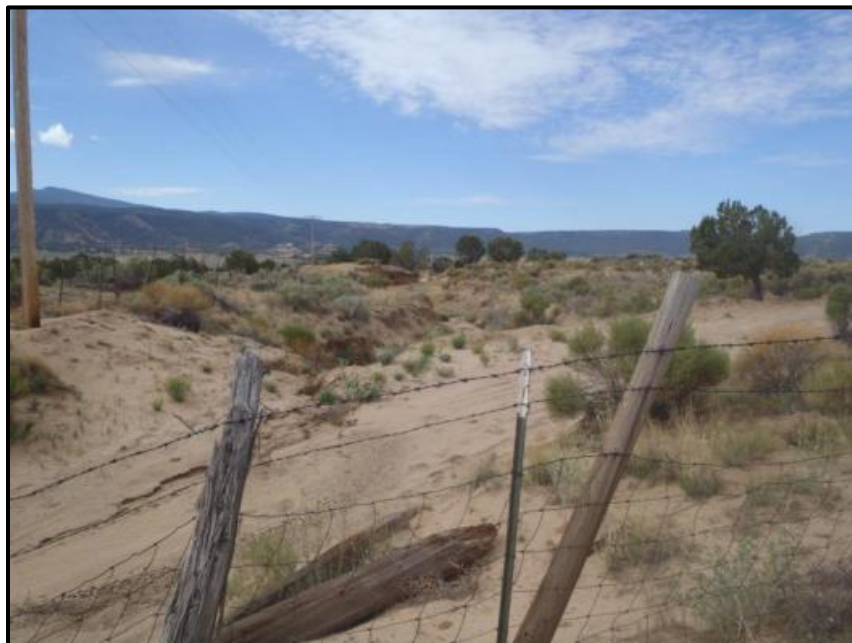
Arroyo 5 is an ephemeral drainage that originates in the northeastern portion of Section 10 and flows south toward the southeastern corner of Section 10. The drainage flow change to sheet flow approximately 200 yards until it reaches small incised cuts (approximately 10 feet wide), and then flows into an incised drainage/dirt road at the corner of Section 10 (Figure 12 and Figure 13). The arroyo flows into a tributary of San Mateo Creek outside the project area. There is no OHWM and no other hydrological characteristics were observed. Dominant plant species include alkali sacaton, blue grama, and fourwing saltbush.

Figure 12. Unnamed Arroyo 5 Looking Down-Arroyo (Southeast).

Figure 13. Unnamed Arroyo 5 Looking Down-Arroyo (South).

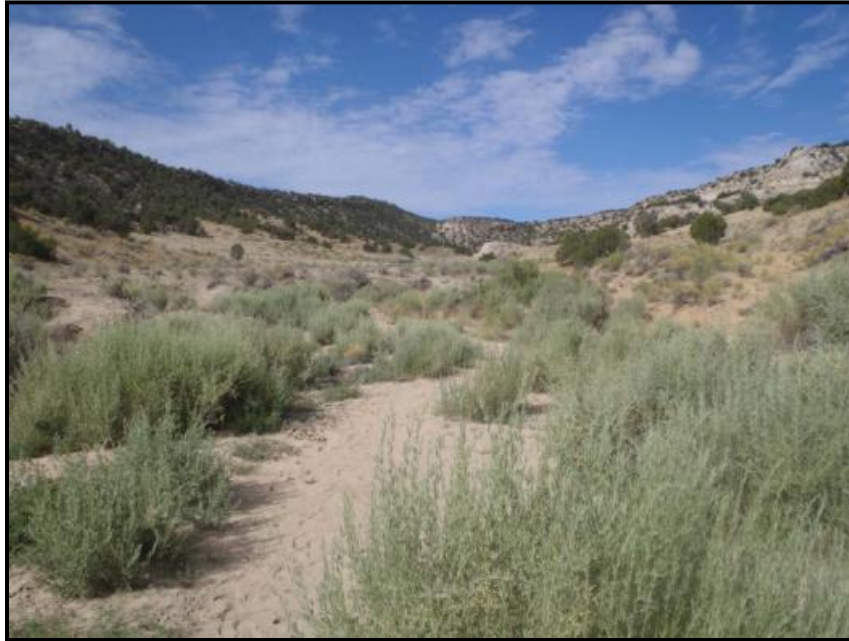
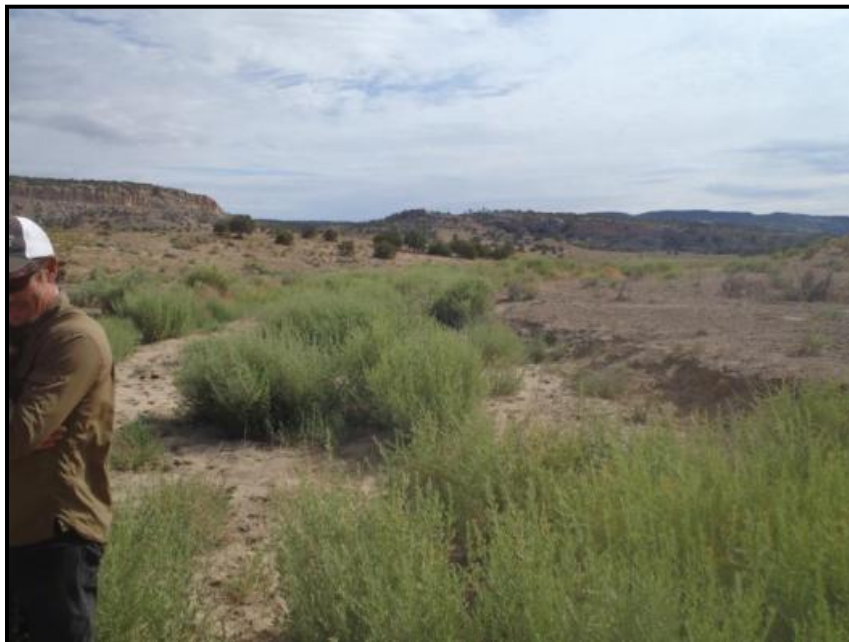
Arroyo 9 is an ephemeral drainage that originates in the northwest portion of Section 10 and flows northeasterly into Cañada la Vacas. Cañada la Vacas drains into San Lucas Dam, which connects to San Miguel Creek. This location was selected because a small portion of the permit area drains to this unnamed arroyo. The arroyo is approximately 15–20 feet wide with banks less than 2 feet high (Figure 14 and Figure 15). The channel is somewhat incised. There is no OHWM and no other hydrological characteristics were observed. The dominant plant species is fourwing saltbush (*Atriplex canescens*).

Figure 14. Unnamed Arroyo 9 Looking Up-Arroyo (South).

Figure 15. Unnamed Arroyo 9 Looking Down-Arroyo (North).

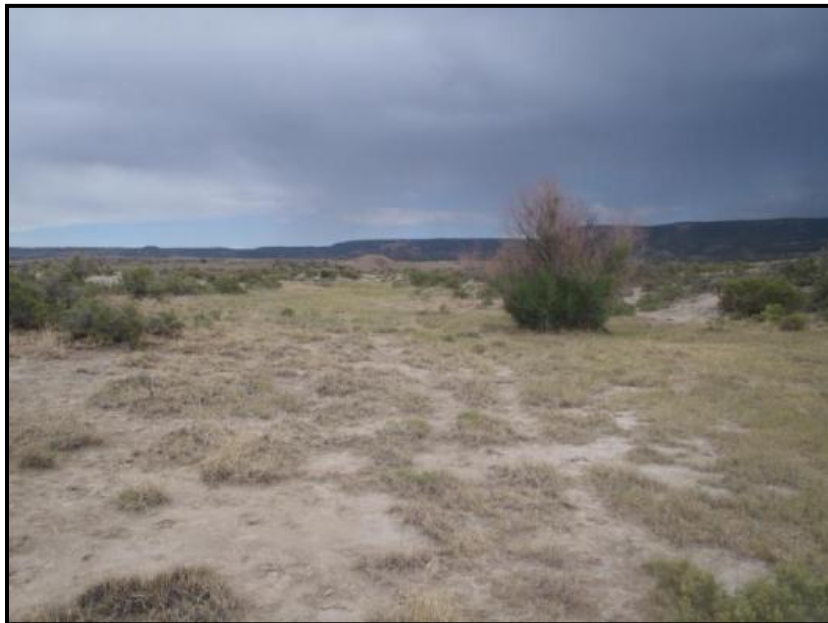
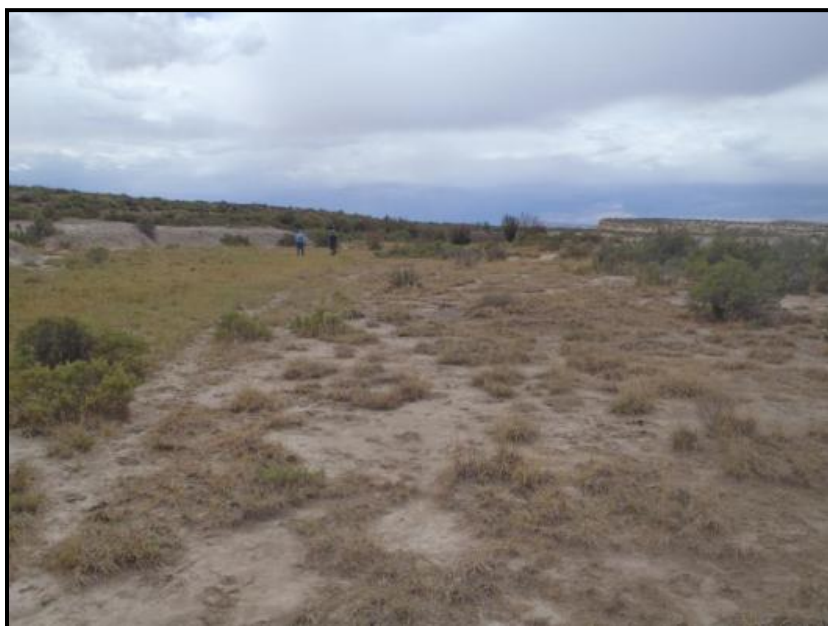
Arroyo 6 is an ephemeral drainage on the Lee property that flows in a northwesterly direction into San Mateo Creek, south of the project boundary. It is approximately 35 feet wide and 10–12 feet deep (Figure 16 and Figure 17). This location was selected because the USGS maps indicate South Spring is located here. Also, RHR staff have sampled surface water at the location. Cattle tracks were observed in this arroyo. There is no apparent ordinary high water mark (OHWM). Hydrological characteristics include a few surface soil cracks in areas where ponding has occurred from recent rainfall. Dominant plant species include alkali sacaton (*Sporobolus airoides*), blue grama (*Bouteloua gracilis*), saltcedar (*Tamarix ramosissima*), and greasewood (*Sarcobatus vermiculatus*).

Figure 16. Unnamed Arroyo 6 Looking Up-Arroyo (East).

Figure 17. Unnamed Arroyo 6 Looking Down-Arroyo (West).

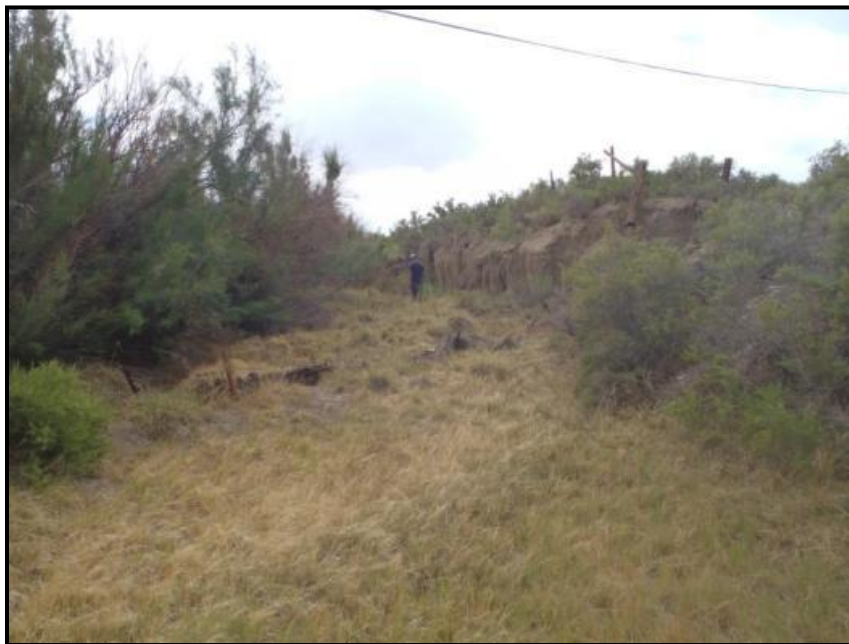
Figure 18. San Mateo Creek at Location 7 Looking Up-Arroyo (North).

Location 7 is a potential spring immediately north of Highway 605 within San Mateo Creek. The area has held water for months and other times it is dry. It is located downstream of Bridge Spring and south of the project boundary in Section 21. The location is approximately 30 feet wide and 10 feet deep (Figure 18 and Figure 19). The channel widens upstream, toward Bridge Spring. There is no OHWM and no other hydrological characteristics were observed. Dominant vegetation includes saltcedar and saltgrass (*Distichlis spicata*).

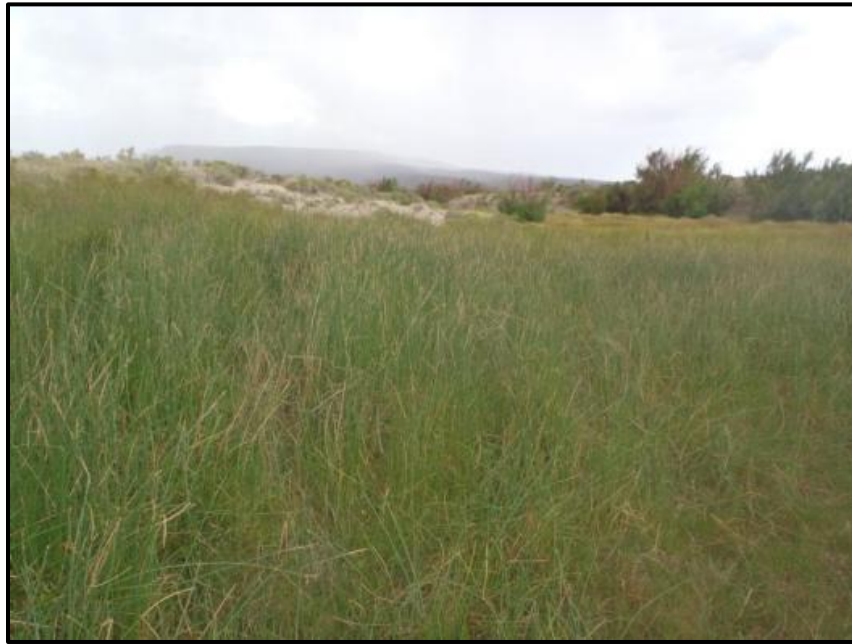
Figure 20. Bridge Spring Looking Down-Arroyo (Southwest).

Location 8, Bridge Spring is a spring-fed wetland area north of Highway 605 within the San Mateo Creek drainage (Figure 20 and Figure 21). It is located south of the project boundary in Section 21. The wetland area is approximately 0.56 acre. This part of San Mateo Creek is ephemeral, but likely flows during storm events. These flows probably also help sustain the wetland. Hydrological characteristics include surface water, wetland obligate plant species, and salt crusts. Dominant plant species include saltcedar, sedges (*Carex* sp), rushes (*Juncus* sp), and bulrush (*Schoenoplectus* sp).

Three of the nine locations were potential spring areas. Arroyo 6 was surveyed because South Spring may be evident during wet seasons but the area does not remain wet long enough to develop wetland characteristics. Location 7 in San Mateo Creek at a 605 bridge was also found dry and no wetland characteristics. Location 8 was selected for the survey because Bridge Spring has been identified on USGS maps. This location was found to be a spring-fed wetland within San Mateo Creek. This wetland area is south of the Roca Honda Permit Area.
