BASELINE DATA REPORT

Section 8.0

Surface Water

Roca Honda Resources, LLC
4001 Office Court, Suite 102, Santa Fe, NM 87507

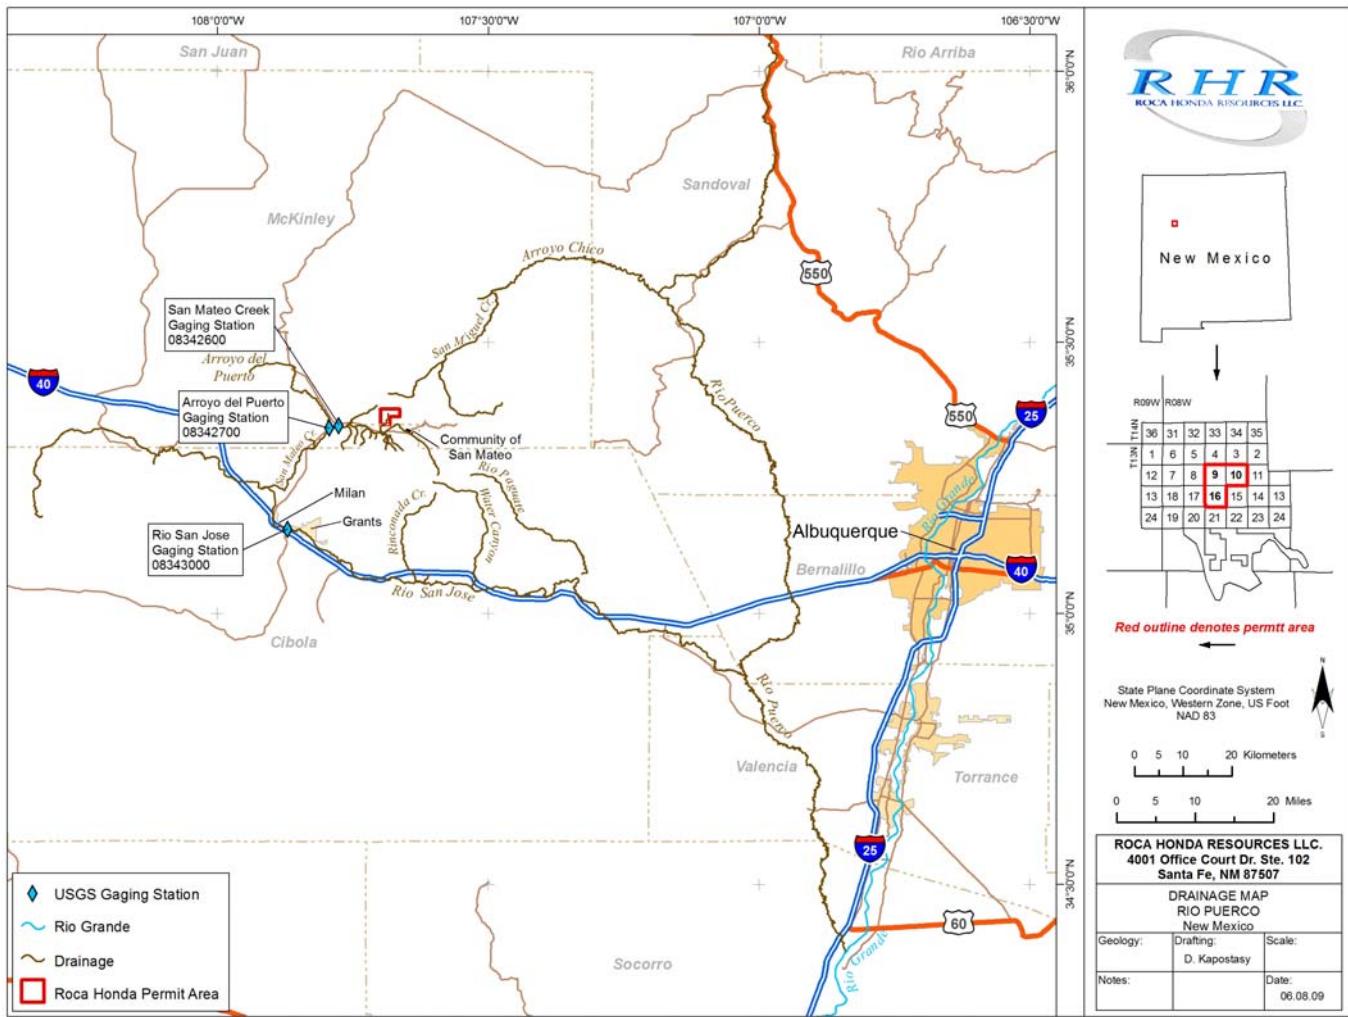
Figure 8-1. RHR Project Location within the Rio Puerco Drainage

The RHR permit area lies within the middle portion of the watershed of San Mateo Creek, a small stream system that is tributary to the Rio San Jose, the Rio Puerco, and ultimately the Rio Grande (Figure 8-1). Because the stream is perennial only in its headwaters, and that flow is completely diverted for irrigation purposes, no permanent gaging station exists on the creek. The limited historical water quality and water quantity data for San Mateo Creek were collected either for the purpose of establishing baseline hydrologic conditions prior to development of the Gulf Mt. Taylor mine, or in response to subsequent mining and dewatering activities. These data include measurements from a stream flow gaging station that measured mine water discharge to San Mateo Creek above its confluence with Arroyo del Puerto (USGS gaging station 08342600), a short period of measurements for Arroyo del Puerto (USGS gaging station 08342700), water quality and quantity data collected in the middle and upper San Mateo Creek watershed by the New Mexico Environmental Institute (NMEI) in 1974, and streamflow gaging records for the Rio San Jose (USGS gaging station 08343000) just below its confluence with San Mateo Creek.

The permit area lies within the middle portion of the San Mateo Creek Watershed. Figure 8-1 and Figure 8-2 identify the location of surface watercourses in and adjacent to the permit area and designate the location and size of the watersheds in and adjacent to the permit area.

del Puerto (which drains Ambrosia Lake Valley). The gaging stations, designated as San Mateo Creek near San Mateo, NM (Station 08342600) and Arroyo del Puerto near San Mateo, NM (Station 08342700), are approximately 1 mile apart. These locations are shown in Figure 8-1 on page 8-2. The San Mateo gaging station was located about 8 miles west of the community of San Mateo. It recorded daily flow of the creek from a watershed drainage area of 75.6 square miles from May 23, 1977 to October 7, 1982. Mean daily streamflow data for the 5-year operational period are shown on Figure 8-3. Mean monthly flow of San Mateo Creek is shown on Figure 8-4 for the same period. Elevated stream flows, which ranged from 2 to 12 cfs (900 to 5,400 gpm) prior to March 1978, reflect mine dewatering discharge during prior mining activities including the Johnny M mine and discharge during excavation of the Mt. Taylor mine shafts. Sporadic high flows of the creek after that period generally reflect high rainfall episodes during the summer/early fall and spring snowmelt runoff periods.

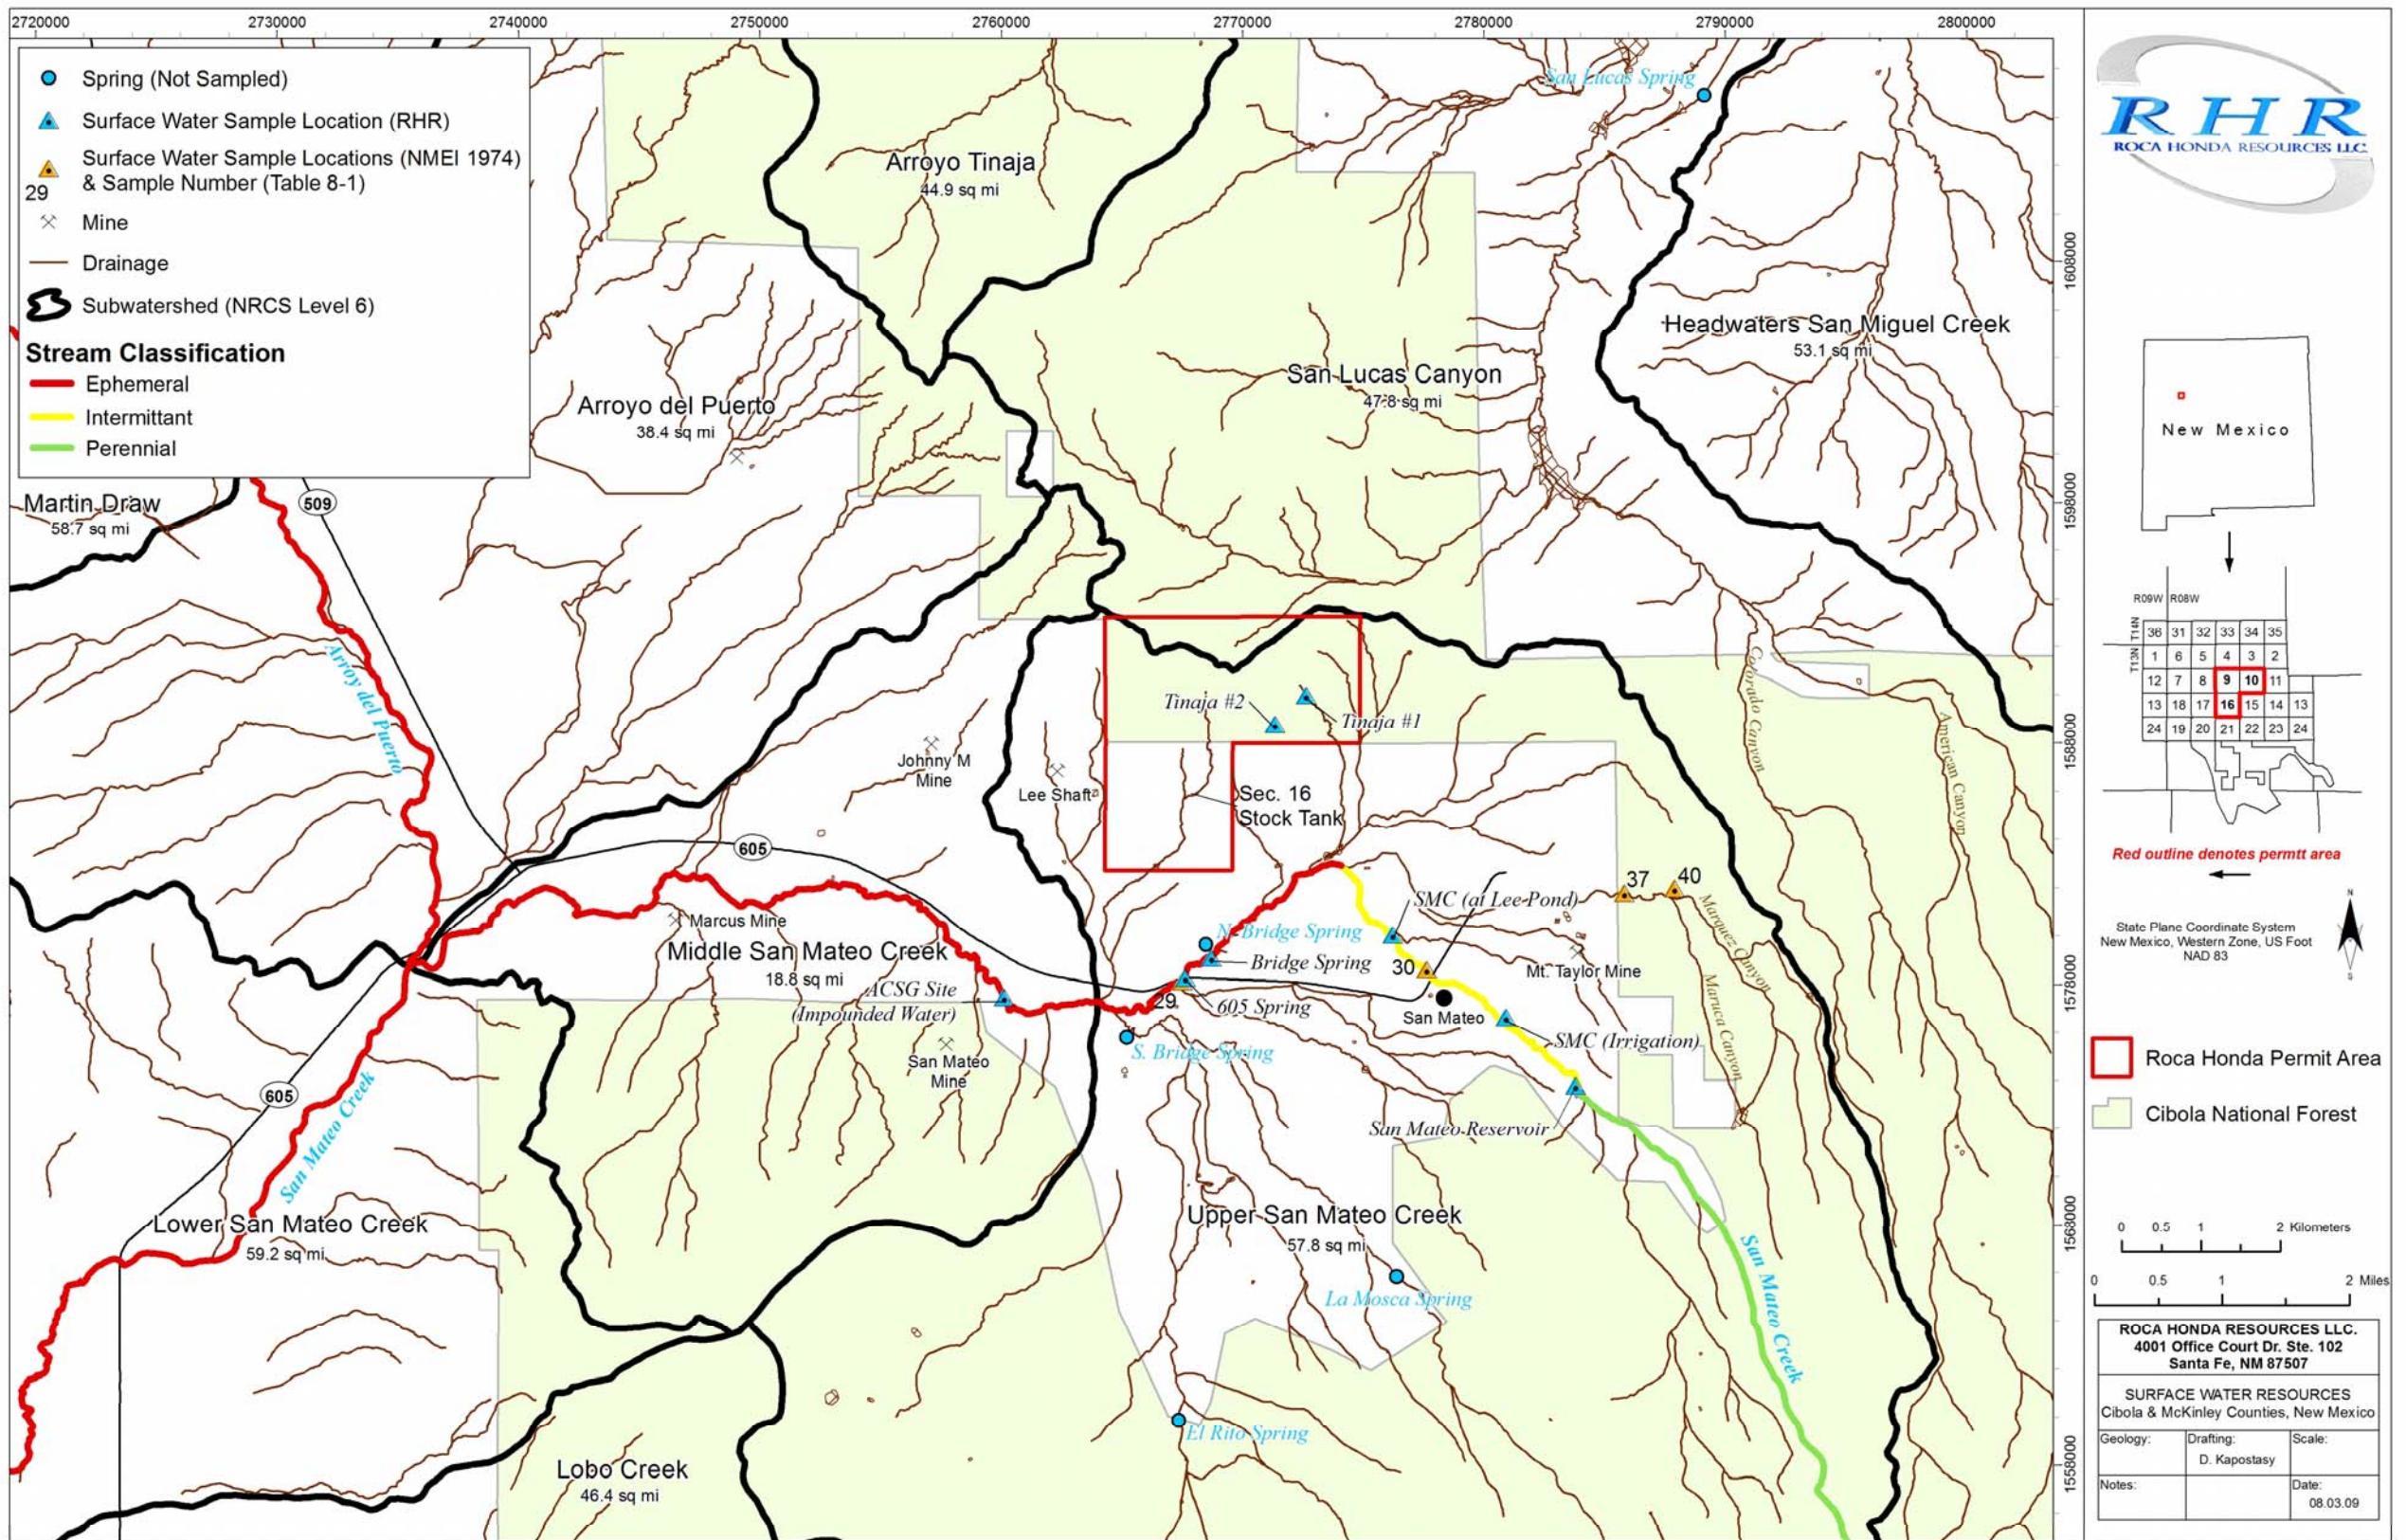
Figure 8-2. Permit Area Watershed and Water Resources

Watercourses in the vicinity of the RHR permit area are identified as ephemeral, intermittent or perennial in Figure 8-2.

NMEI collected surface water samples from upper San Mateo Creek and the Marquez Canyon drainages within the upper San Mateo Creek watershed. Table 8-1 tabulates chemistry data for two locations along San Mateo Creek south of and closest to the permit area (locations 29 and 30 on Figure 8-2 on page 8-4) and two locations (Nos. 37 and 40 on Figure 8-2) in Marquez Canyon. Marquez Canyon is drained by an ephemeral stream that flows as a result of snowmelt or heavy rainfalls during the summer/early fall period. Water flowed only periodically at these locations due to upstream diversion of stream flow for irrigation and loss of water to the streambed alluvium. It was estimated that the drainage in Marquez Canyon had an annual discharge of 7.5 ac-ft/yr (NMEI 1974).

located in tinajas (seasonal water pockets in bedrock) along the eastern side of Section 10, ponded in San Mateo Creek, seeping from two springs along the creek, in San Mateo reservoir, and flowing in San Mateo Creek above the community of San Mateo. When these locations were revisited during different seasons, surface water was found only in the reservoir, as irrigation releases from the reservoir, and at Bridge spring. Appendix 8-B presents the water chemistry results for surface water in the vicinity of the RHR permit area. The sample locations are on Figure 8-2.

Other springs are present within five miles of the RHR permit area, including El Rito and La Mosca Springs, but they get their water from volcanics of the north slope of Mt. Taylor across San Mateo Creek valley from the permit area (Figure 8-2). These springs are upgradient and outside of the drainage arroyo where the proposed mine water would discharge in Section 16, which is underlain mainly by the Mulatto Tongue of the Mancos Shale. Therefore, the discharge of mine water or dewatering operations will not have any surface impact on these springs.

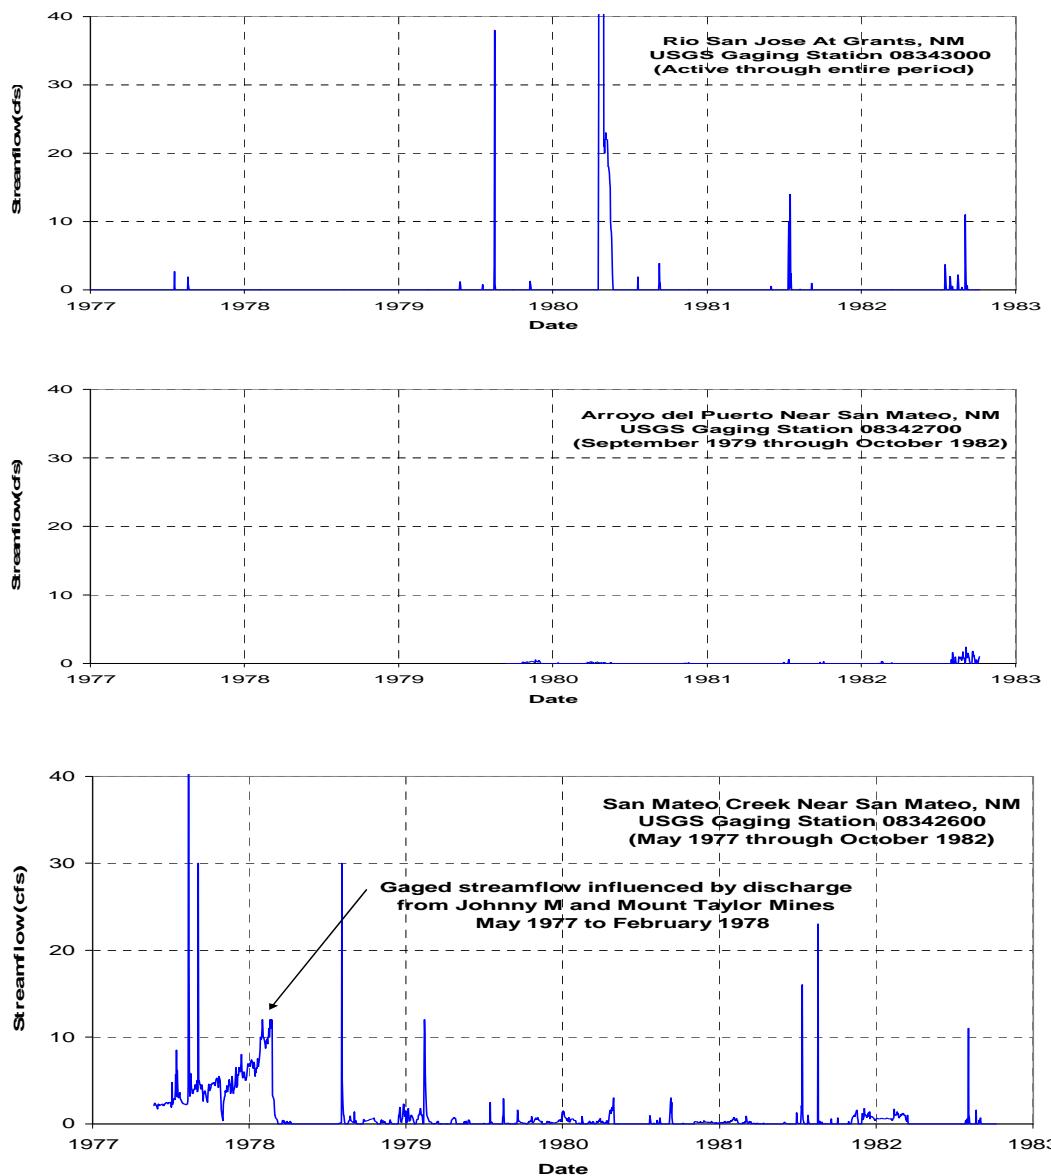
Figure 8-3. Mean Daily Stream Flow for San Mateo Creek, Arroyo del Puerto, and Rio San Jose 1977 through 1982

The Arroyo del Puerto gaging station was located about 0.1 mile north of the confluence of that drainage with San Mateo Creek. The station operated from mid September 1979 through early October 1982. Average daily streamflow data for this 3-year operational period are shown on Figure 8-3. Although the Arroyo del Puerto drains a large area, historical flows appear to mainly reflect discharge from prior mining activities in the Ambrosia Lake valley. The Arroyo del Puerto is presently ephemeral.

The Rio San Jose is gaged above and below Grants (Stations 08343000 and 08343500 respectively). The Rio San Jose was gaged below its confluence with San Mateo Creek at Grants over the period of October 1912 through September 2008. Mean daily stream flows are plotted for the 6-year period from 1977 through 1982 in Figure 8-3 and for the complete period of record in Figure 8-5. Elevated flow in this drainage generally reflects high rainfall episodes during the summer/early fall period. Mining discharge into San Mateo Creek from May 1977 to February 1978 had no apparent effect on flows in the Rio San Jose. It should also be noted that high peak flows of 30 to 40+ cfs at the San Mateo gaging station during the summers of 1977 and 1978 had little or no expression at the Rio San Jose Station.

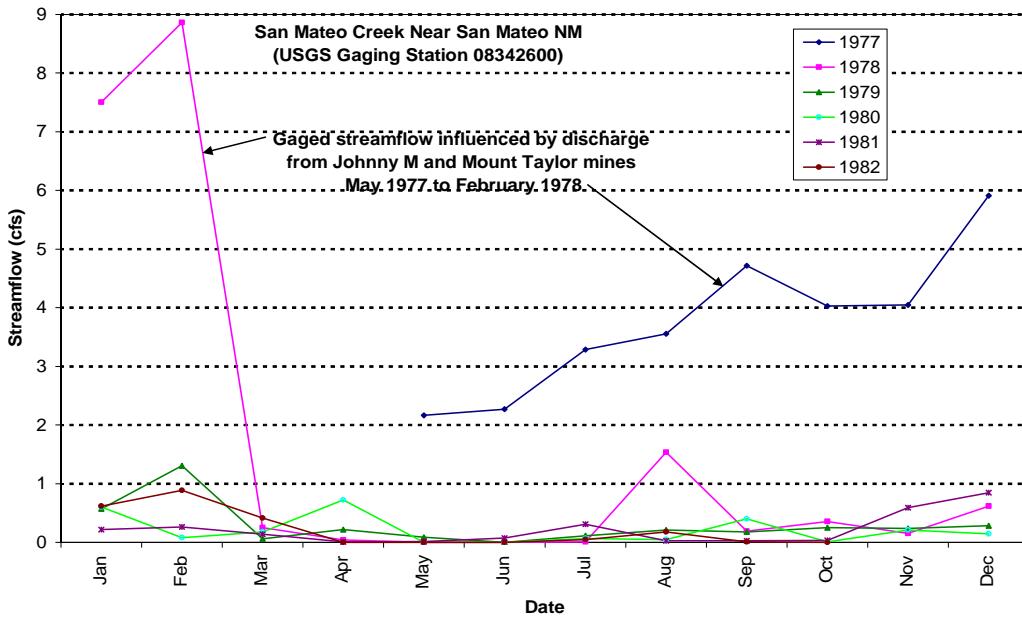
Figure 8-4. Mean Monthly Average Flow of San Mateo Creek

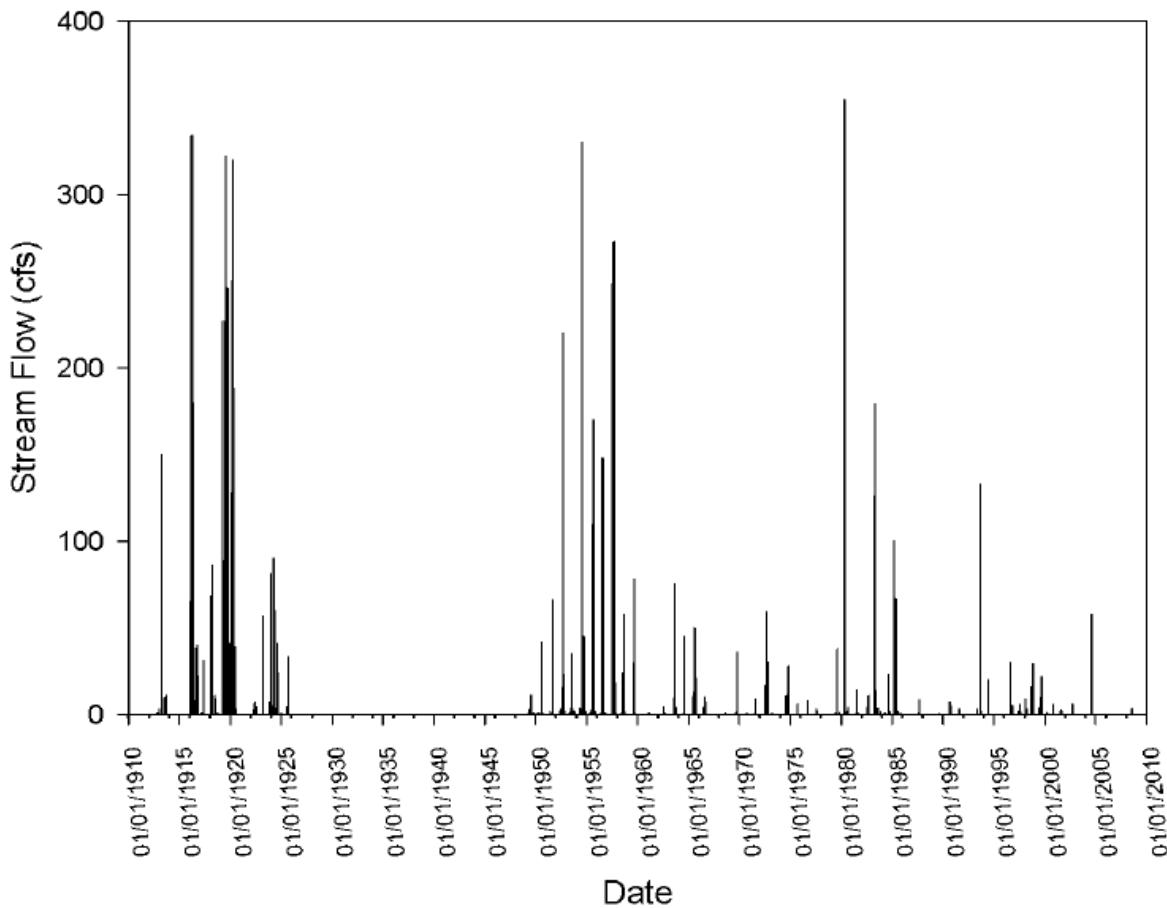
Figure 8-5. Daily Stream Flow from Rio San Jose at Grants (USGS Gaging Station 8343000)

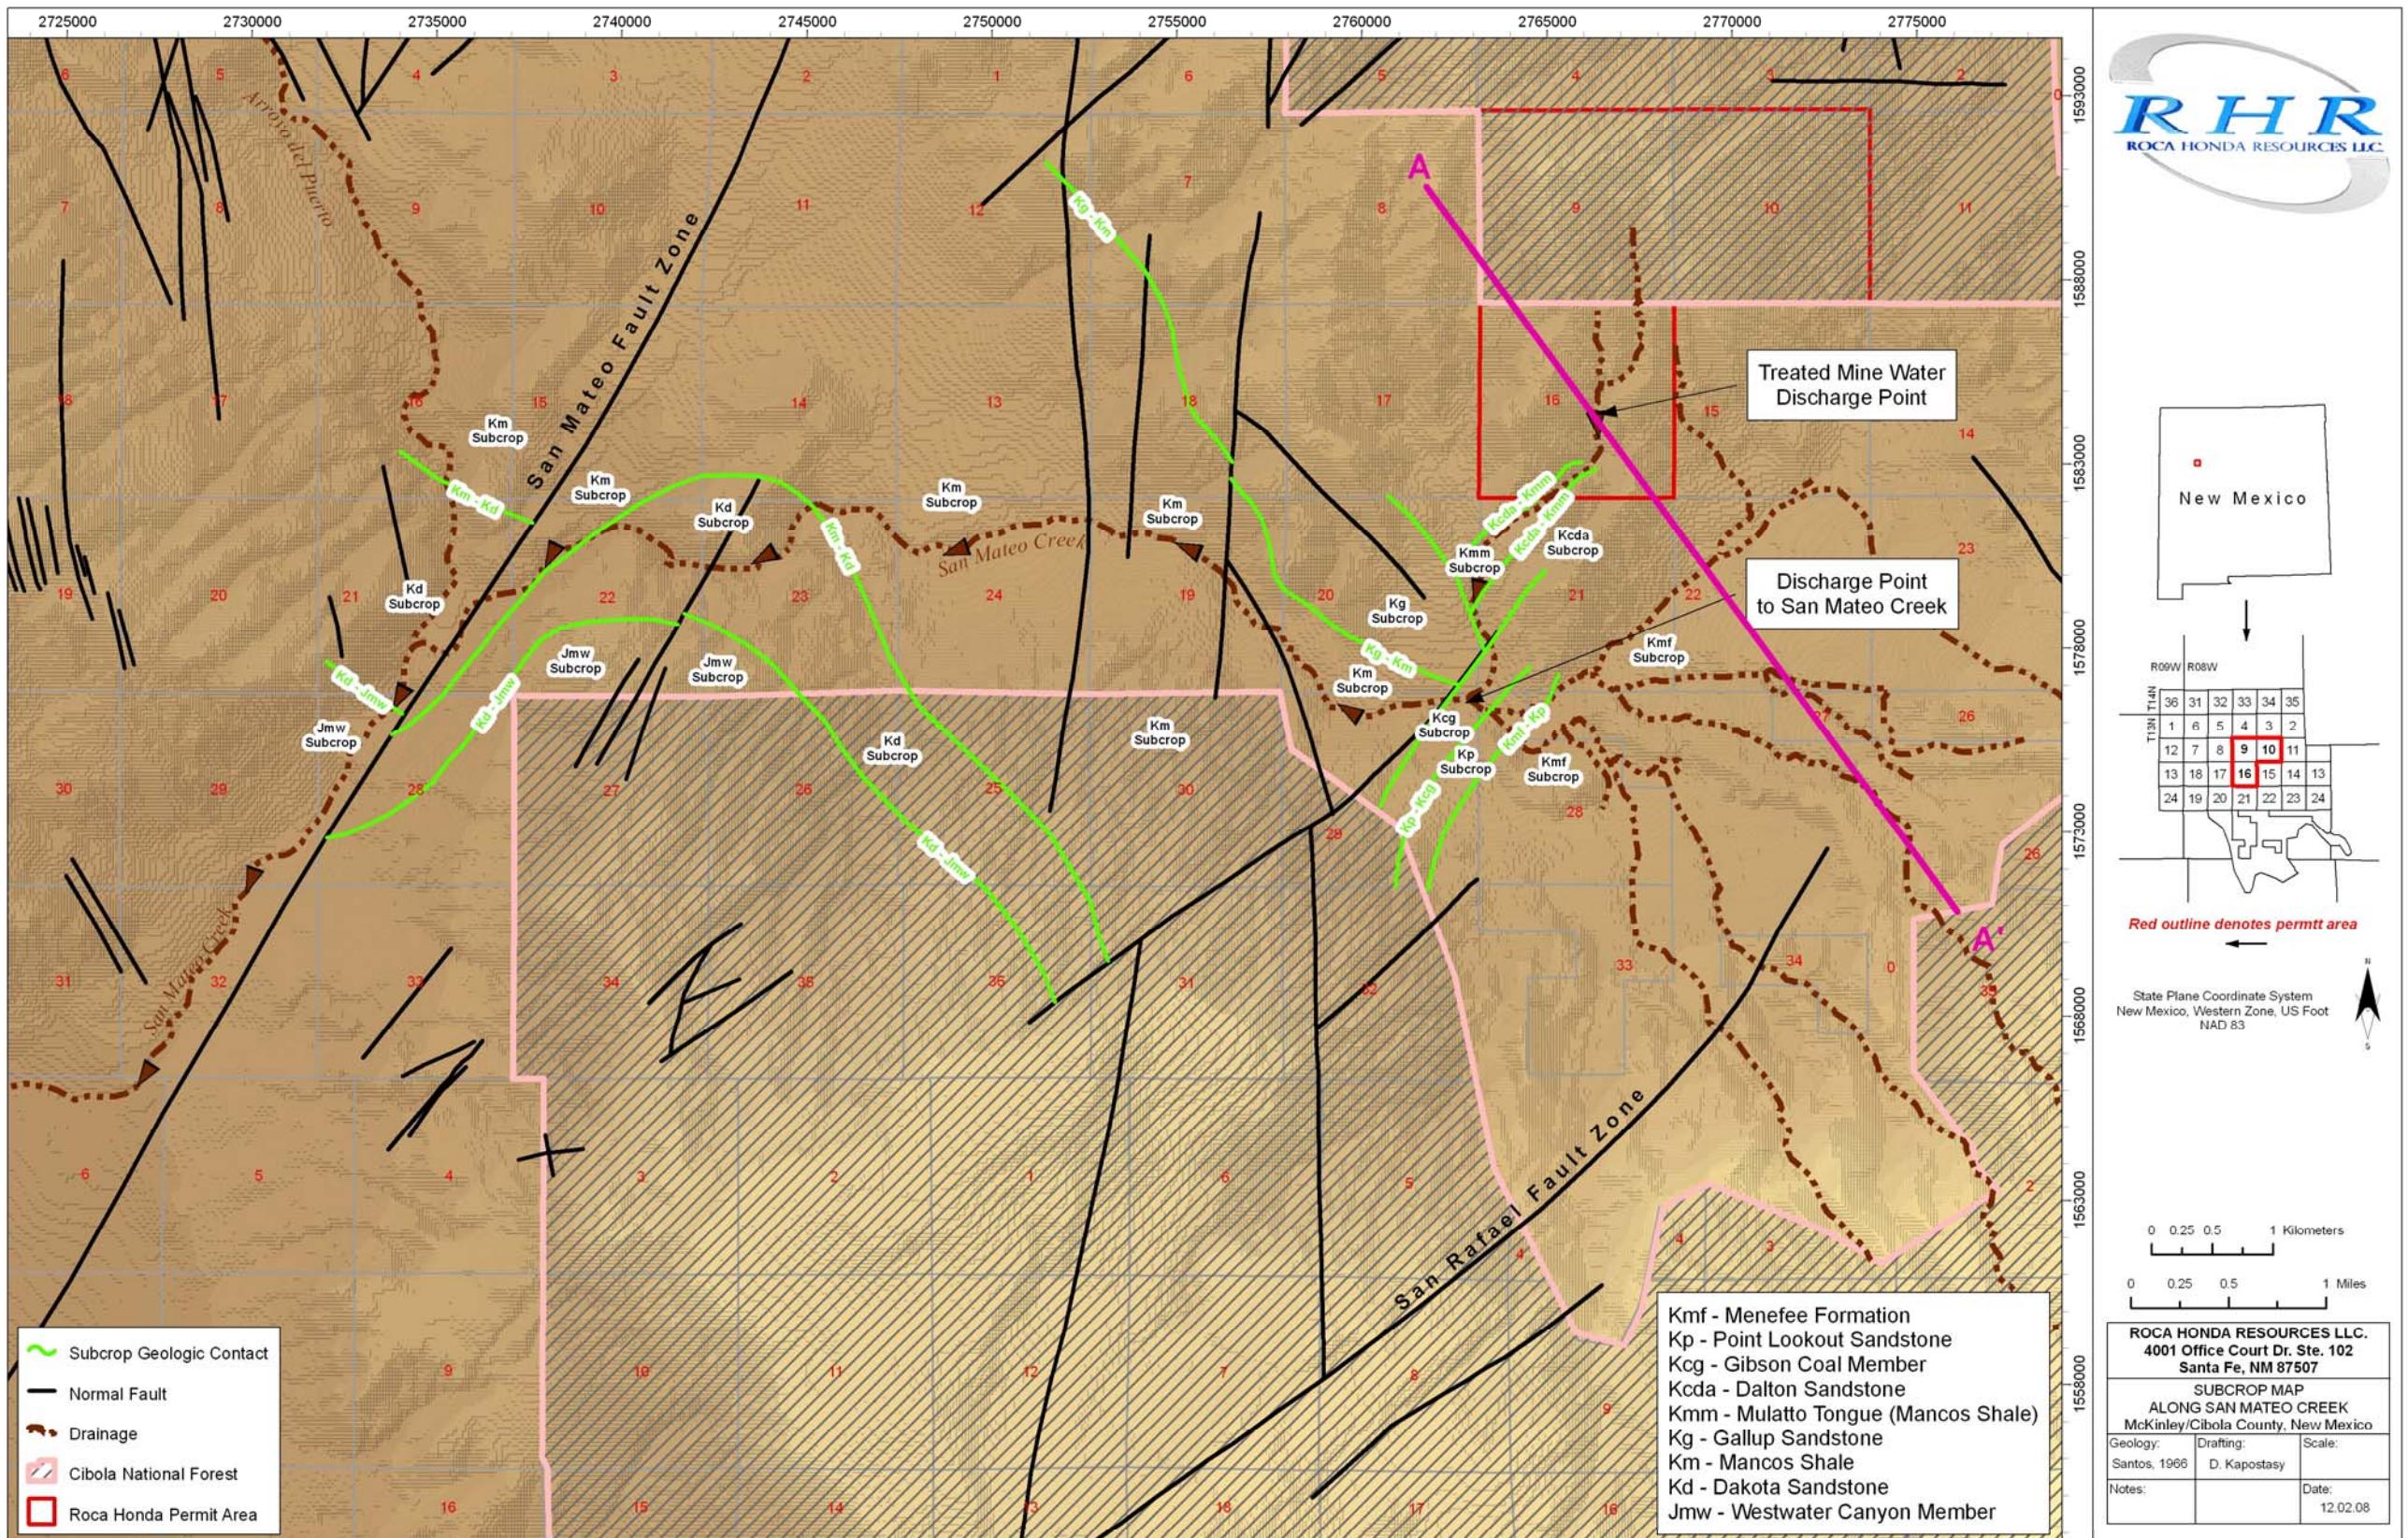
Figure 8-6. Subcrop Geology along the San Mateo Creek Drainage

The pathway of the discharged water from the proposed Roca Honda mine related to the sub-cropping (underlying) bedrock units is shown in Figure 8–6. Normal faults affect the geologic units along the drainage pathway to the south through Section 16 and the NW $\frac{1}{4}$ Section 21.

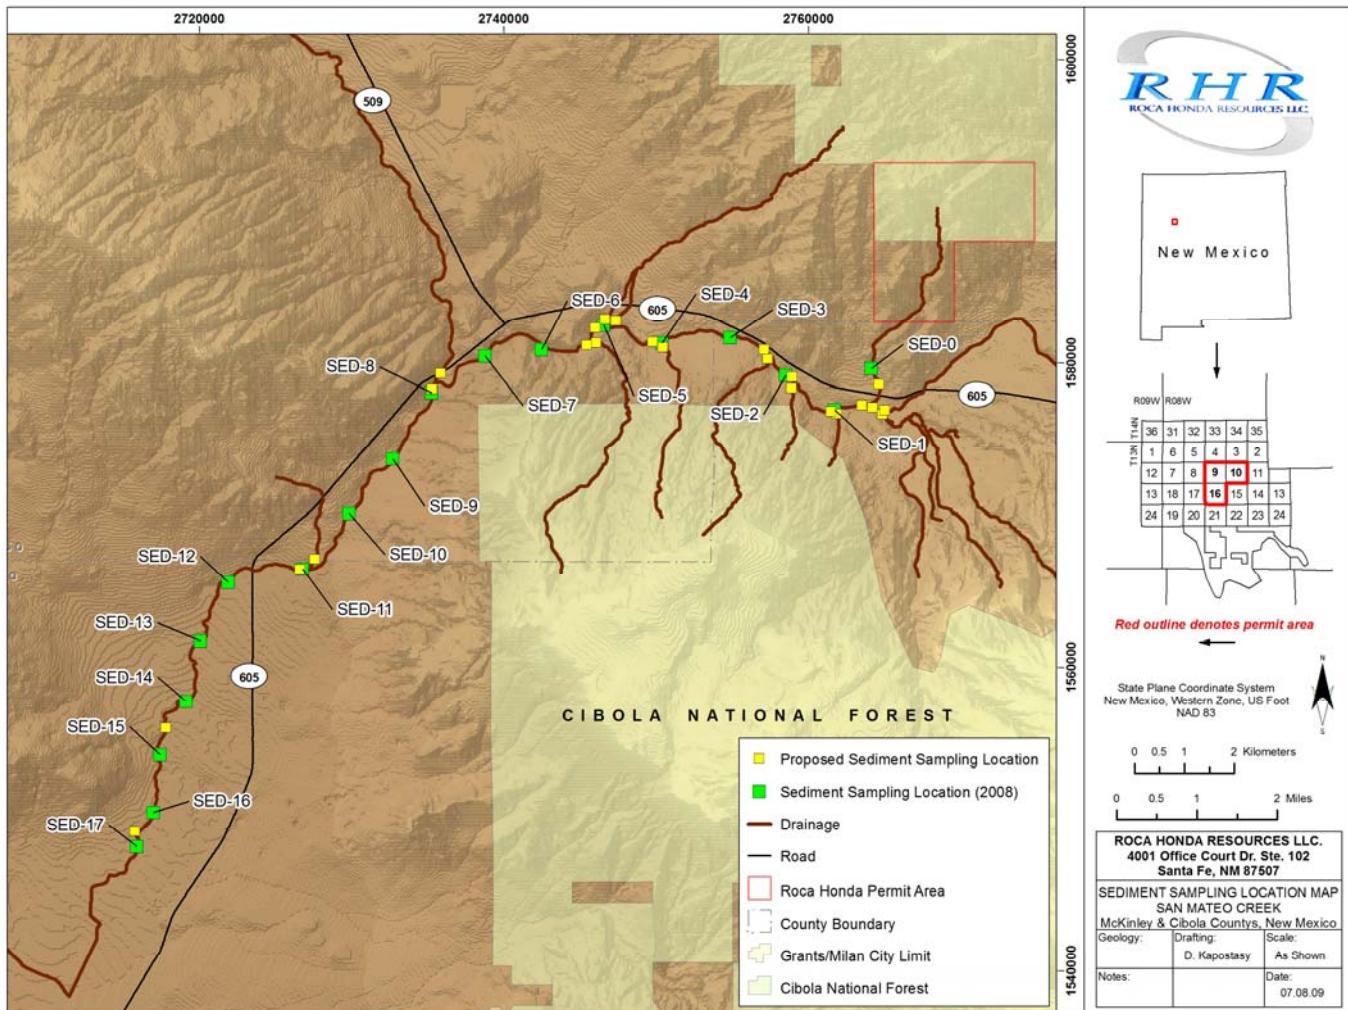
Figure 8-7. Sediment Sampling Locations Along Receiving Drainages

Water flowing over alluvial stream sediments can potentially mobilize chemical constituents found in the sediments or physically move those sediments. The existing chemistry of stream sediments has been investigated. RHR determined the chemistry of sediments along the drainage from Section 16 and San Mateo Creek basin by collecting and analyzing sediment samples for a wide range of constituents. Sediment samples were also analyzed for grain size to help determine erosion potential and for correlation to chemical data. Figure 8-7 shows the sediment sampling locations. Appendix 8-C presents the results of chemical analysis on the eighteen samples collected along the drainage from Section 16 and San Mateo Creek.

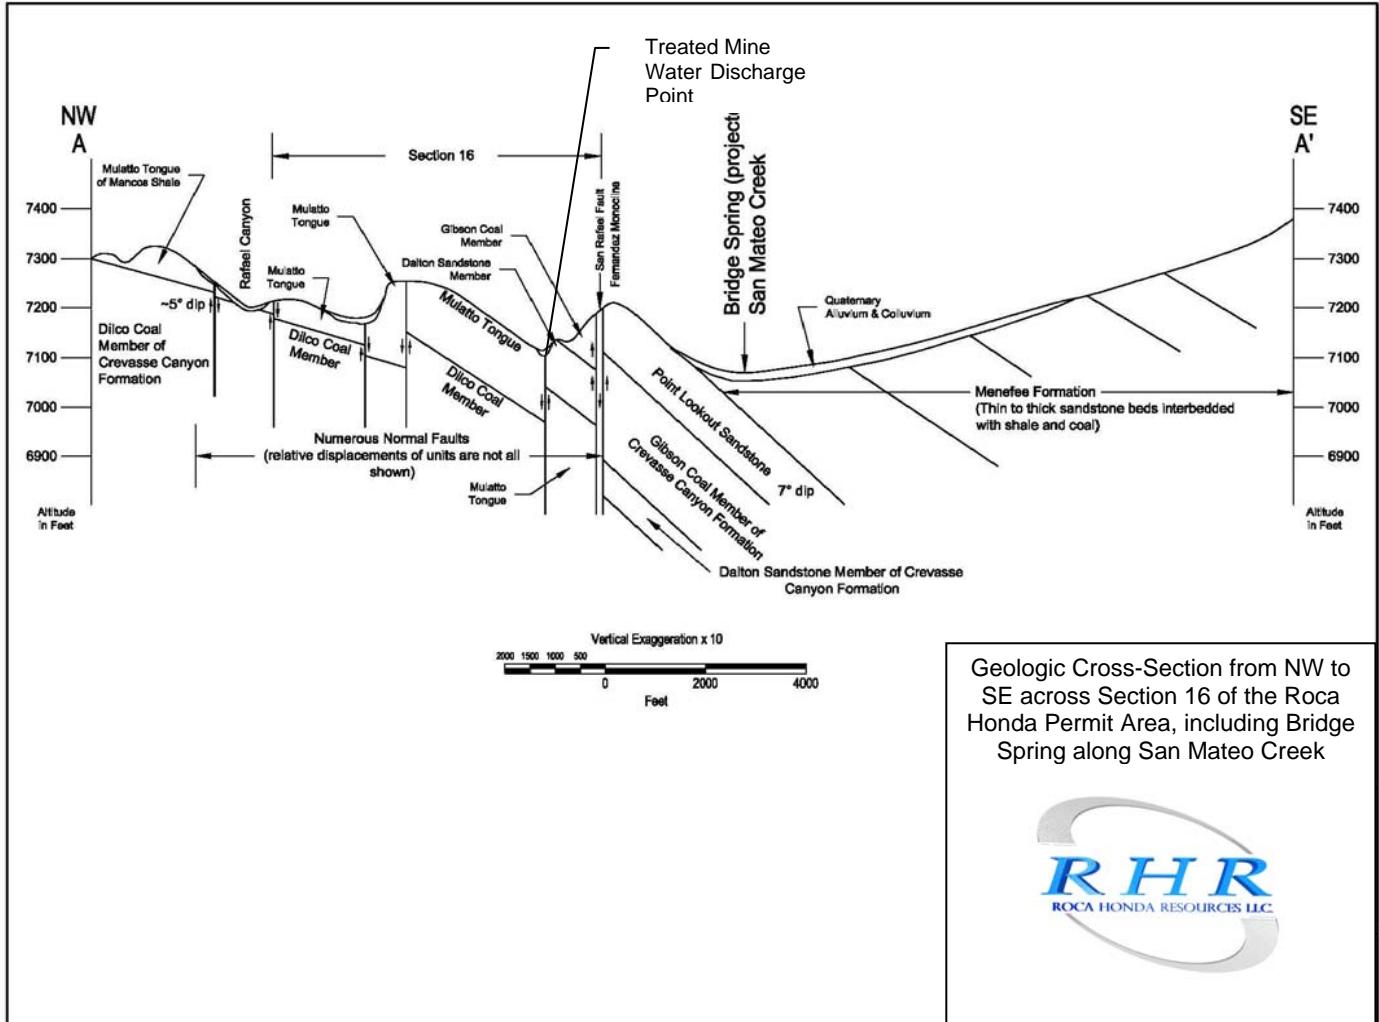
Figure 8-8. Geologic Cross-Section across Section 16 and San Mateo Creek.

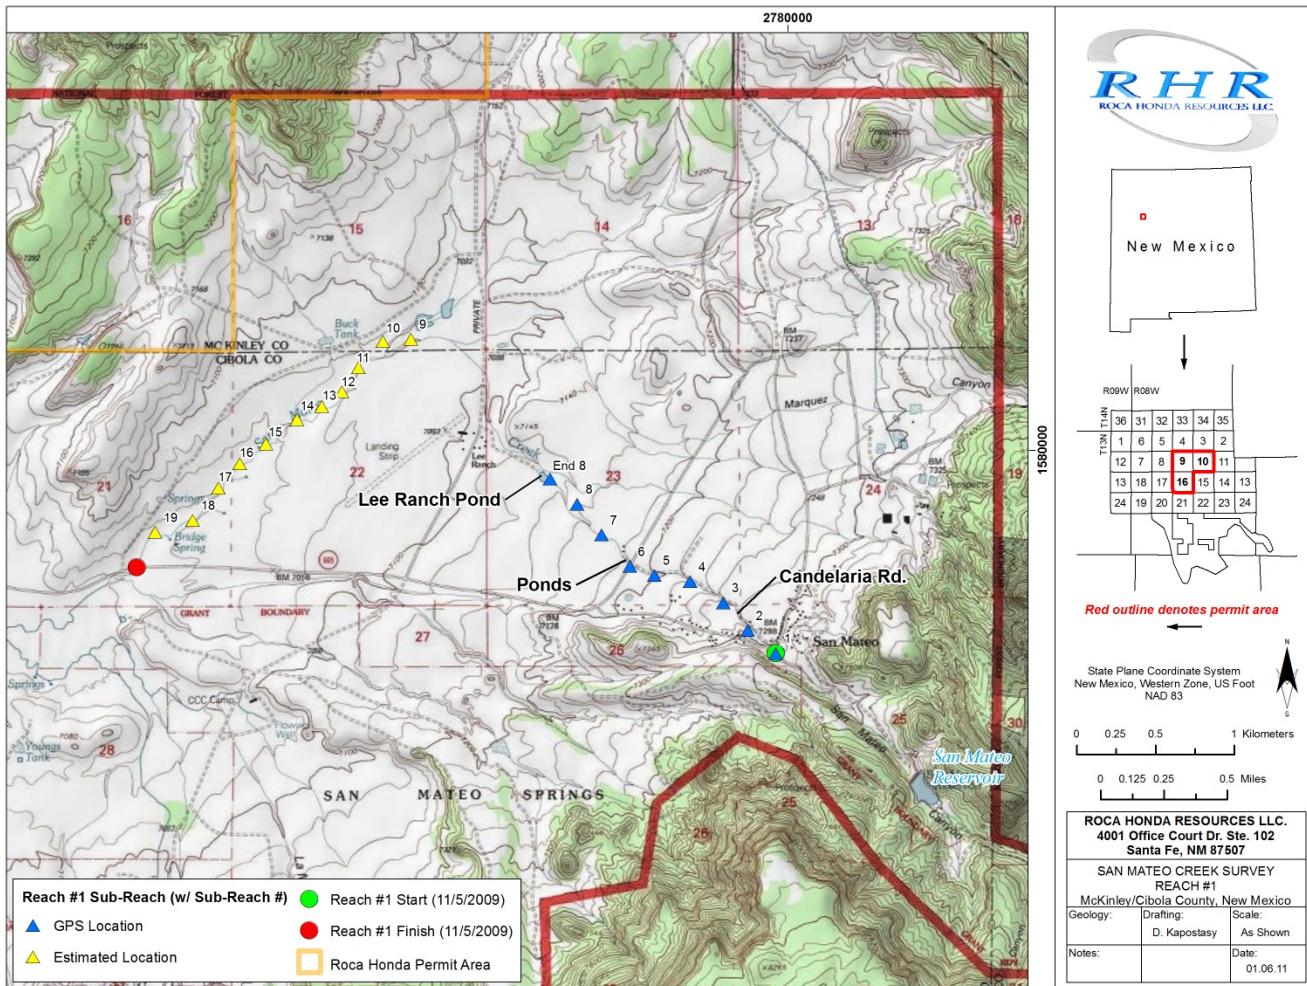
Figure 1. Location of Reach #1 Sub-reaches

The Level 1 Stream Determination of Reach #1 of SMC was performed on November 5, 2009. The reach extends from the community of San Mateo to approximately three-miles west where the stream channel passes under State Highway 605 and contained 19 sub-reaches each of approximately 750 feet in length. The reservoir had been visited previously on several occasions. Figure 1 shows the locations of Reach #1 and its sub-reaches (#1 through #19). Table 1 identifies each sub-reach location. Precipitation had last fallen in the area eight days earlier as snow (approximately two inches) which had mostly disappeared by the time of the survey, leaving the stream channel dry.

About 2/3 mile above the community of San Mateo the flow of the creek is completely blocked by a dam which creates San Mateo Reservoir, a small, cattail-filled lake with a surface area of less than 10 acres (Figure 1). The impounded water is used for irrigation. It is diverted from the reservoir through the bottom of the dam into a pipe, and then routed through pipes and open ditches for distribution to irrigated fields. Below the dam the only flow in the stream channel itself is minor seepage from beneath the dam. Irrigation water is discharged into the creek from a twelve inch diameter pipe open gate valve, which at the time of the stream survey was about $\frac{3}{4}$ mile below the dam where the pipe crosses under Candelaria Road. When the irrigation water is not discharged, the stream channel would be dry. Below the irrigation discharge point, the creek flows along a stream course which has in some areas been modified so that it resembles a ditch more than a natural creek. Fish and micro-invertebrates were absent in this area, although some algae were found on rocks in some areas.

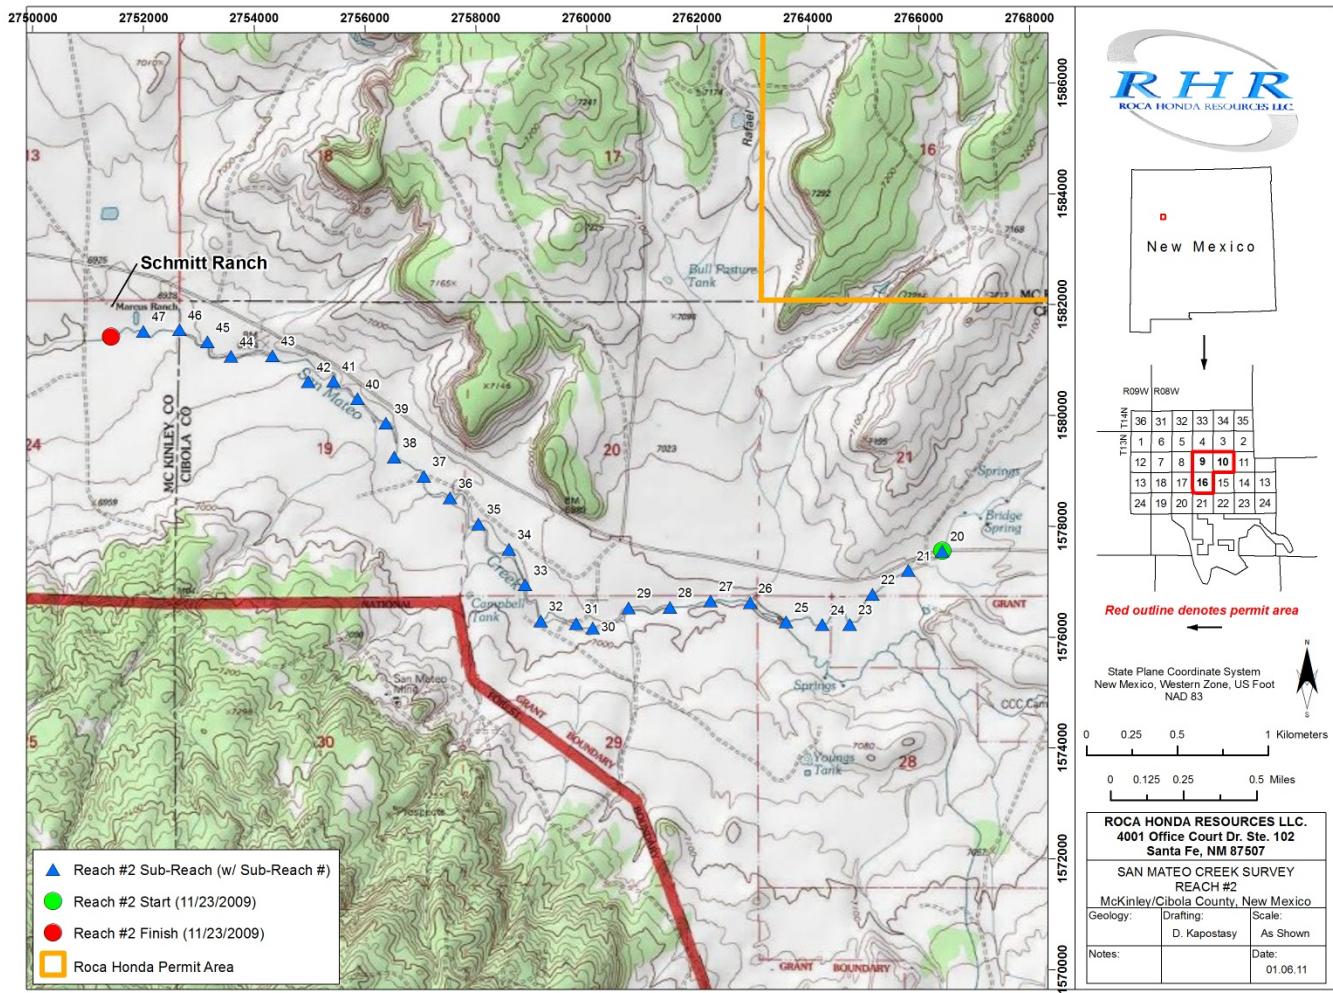
Figure 2. Location of Reach #2 Sub-reaches

The Level 1 Stream Determination of Reach #2 of SMC was performed on November 23, 2009. The survey reach extended from where the stream channel passes under Highway 605 in the SE $\frac{1}{4}$ of Section 21, T13N R8W, downstream four miles west to the Schmitt Ranch main house and contained 28 sub-reaches each of approximately 750 feet in length. Figure 2 shows the locations of Reach #2 sub-reaches (#20 through #47) and Table 2 identifies each sub-reach location. The work was accomplished during a clear, sunny day at the end of November. Precipitation had last fallen in the area several weeks earlier as snow (approximately two inches), but had almost entirely disappeared by the time of the survey, leaving the stream channel dry.

In general, the stream course was a wide arroyo with steep banks with a height to width ratio of approximately 1:3. Thick stands of tamarisk lined the sides of the arroyo and the bottom was grassy. The course of the occasional stream flow was confined to a narrow (1-2 feet) channel. Stream flow was absent. Ponded water was present in one sub-reach. Except for a 50-foot section of the channel in the NW $\frac{1}{4}$ of Section 29, T13N, R8W, the channel was dry. In this area, two small pools that proved to be temporary flood flow catchments were present. The pools were too murky for investigators to ascertain whether fish, micro-invertebrates, or algae were present. Later visits by RHR to the site of the pools found them dry. In general, the stream channel was a wide, high-banked, grassed arroyo cut in alluvial sands and silts. Thick stands of tamarisk, grass, and chamisa typically lined the sides. A narrow (1-2 feet in width), sandy or silty-bottomed, non-incised channel which was also a cow path snaked through the center of the arroyo and appeared to constitute the stream bed for any ephemeral flow. Short sections of the channel were cut into sandstone.

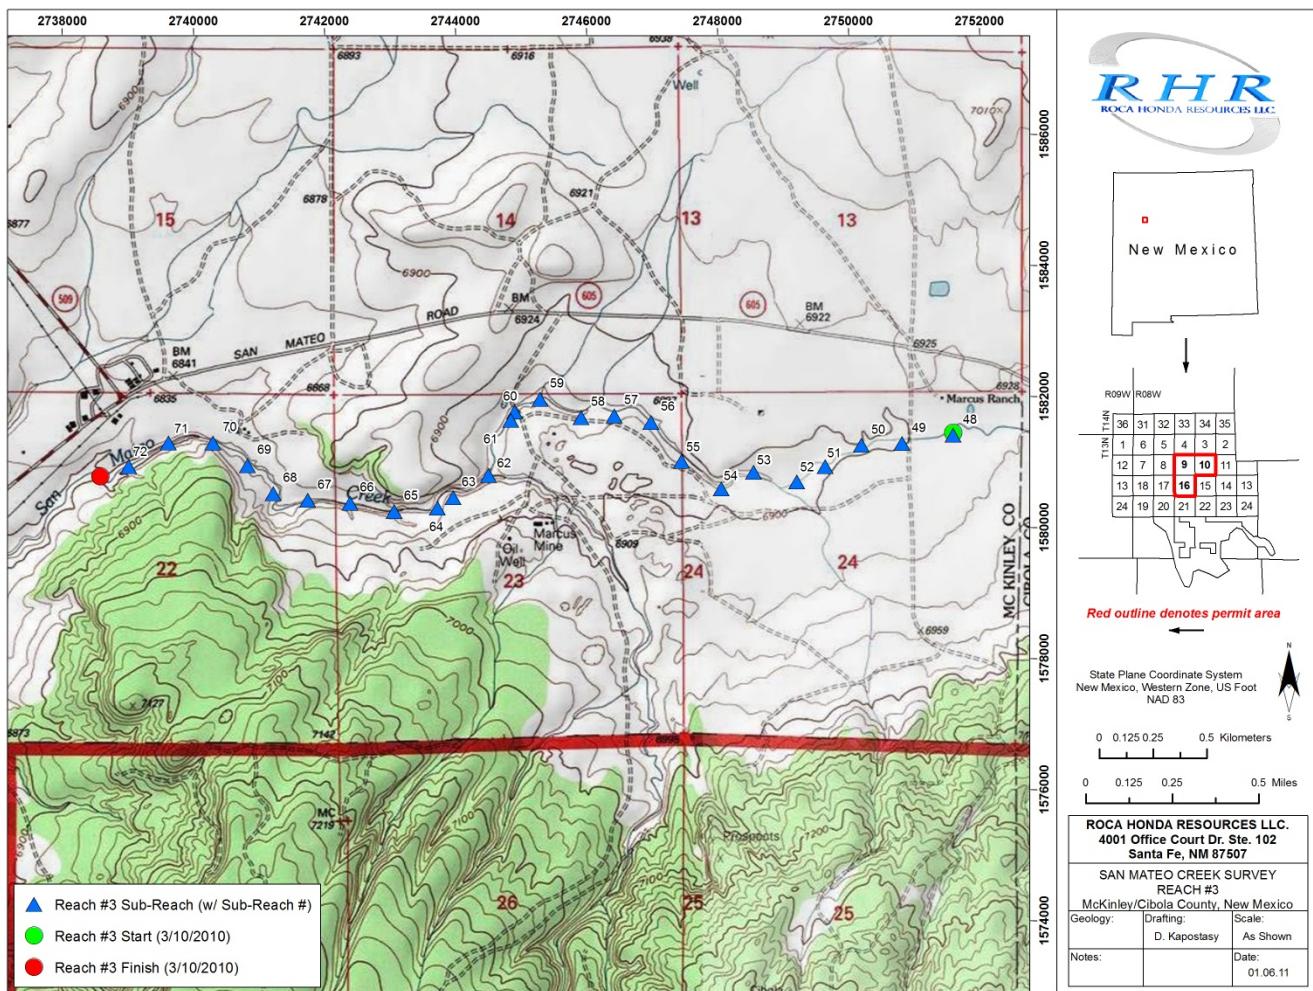
Figure 3. Location of Reach #3 Sub-reaches

The Level 1 Stream Determination of Reach #3 of SMC was performed on March 31, 2010. The surveyed stream section extended from the end of the Reach #2 survey at the Schmitt Ranch in the NE ¼ of Section 24 in T13N, R9W, west 3.5 stream miles down the channel to the point where San Mateo Creek exited a canyon carved in Dakota Sandstone outcrops NW of the NE ¼ of Section 22. Figure 3 shows the locations of the 25 sub-reaches which make up Reach #3 (#48 through #72) and Table 3 identifies each sub-reach location. The work was accomplished during a mostly clear, sunny, windy day. Precipitation had last fallen in the area several weeks earlier as snow, but had entirely disappeared by the time of the survey, leaving the stream channel dry.

No flow water, fish, or other indication of perennial flow was found anywhere in the reach. Reach #3 was determined to be an ephemeral drainage over its entire length. Figure 3 found in the summary section of this document shows the locations of the sub-reaches that make up Reach #3.
