BASELINE DATA REPORT

Section 8.0

Surface Water

Roca Honda Resources, LLC
4001 Office Court, Suite 102, Santa Fe, NM 87507

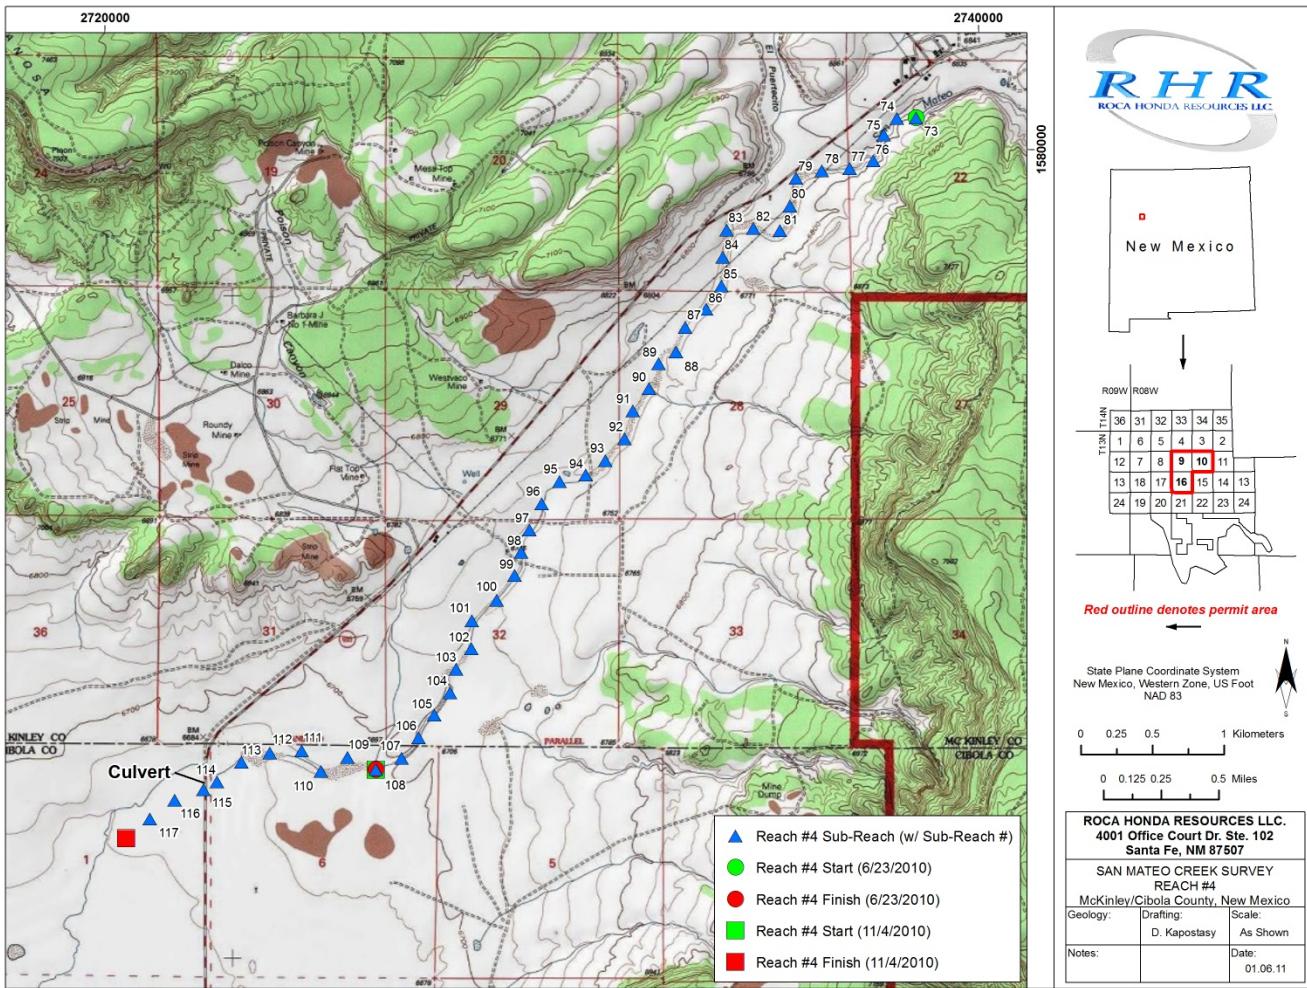
Figure 4. Location of Reach #4 Sub-reaches

The Level 1 Stream Determination of Reach #4 of SMC was performed on June 23, 2010 and extended on November 4, 2010. Reach #4 began where Reach #3 ended, and extended westward approximately 6.5 stream miles to the NE $\frac{1}{4}$ of Section 1, Township 12 N, Range 9 W, at which point the channel of SMC was fairly indistinguishable from the surrounding country. Figure 4 shows the locations of the 45 sub-reaches which make up Reach #4 (#73 through #117) and Table 4 identifies the location of each sub-reach. The work was accomplished on dry, sunny days. No precipitation had fallen for several weeks prior to both field days. The second field day was necessary because of some confusion regarding the correct course for SMC at the lower end of Reach 4. Initially the narrow channel was walked from the end of sub-reach #107 for about another $\frac{1}{2}$ mile south until it disappeared. The USGS map indicates SMC turns west from the end of sub-reach #107 and crosses under Highway 605 before it turns to the south. The survey team walked from the highway culverts along a constructed channel until it intersected with the original SMC channel near sub-reach #107. At this point the creek can continue either south until it changes to overland flow or continue westward via the constructed channel and flow through the culverts into a constructed channel on the west side of Highway 605. This portion of the channel directs any flow to the southwest for three sub-reaches (approximately 2000 feet) until it changes to overland flow.

No water was encountered along this reach of SMC. In general, the valley was a wide, low-banked arroyo cut into unconsolidated alluvial sands and silts. The “active” channel bottom ranged from very sandy, unvegetated, and up to 40 feet wide in the upper part of the reach, to covered with short grasses and four-wing salt brush and only slightly distinguishable from the main arroyo as a narrow cow path in the lower part of the reach. As the channel gradually became indistinguishable from the surrounding countryside in the lower part of the reach, the banks disappeared, the channel narrowed to a cow path, and vegetation grew within the channel. The arroyo and channel ranged from straight to broadly sinuous. Occasional clumps of tamarisk were found, but appeared to be unrelated to any regional high water table system. Figure 4 shows the locations of the 45 sub-reaches which make up Reach #4.

SUMMARY OF SUB-REACHES #73 through #117: Reach #4 began where Reach #3 ended, and extended westward approximately 6.5 stream miles to the NE $\frac{1}{4}$ of Section 1, Township 12 N, Range 10W, at which point the channel of SMC was fairly indistinguishable from the surrounding country.² No water was encountered along this reach of SMC. In general, the valley was a wide, low-banked arroyo cut into unconsolidated alluvial sands and silts. The “active” channel bottom ranged from very sandy, unvegetated, and up to 40 feet wide in the upper part of the reach, to covered with short grasses and four-wing salt brush and only slightly distinguishable from the main arroyo as a narrow cow path in the lower part of the reach. As the channel gradually became indistinguishable from the surrounding countryside in the lower part of the reach, the banks disappeared, the channel narrowed to a cow path, and vegetation grew within the channel. The arroyo and channel ranged from straight to broadly sinuous. Occasional clumps of tamarisk were found, but appeared to be unrelated to any regional high water table system. Figure 4 found in the summary section of this document shows the locations of the sub-reaches.

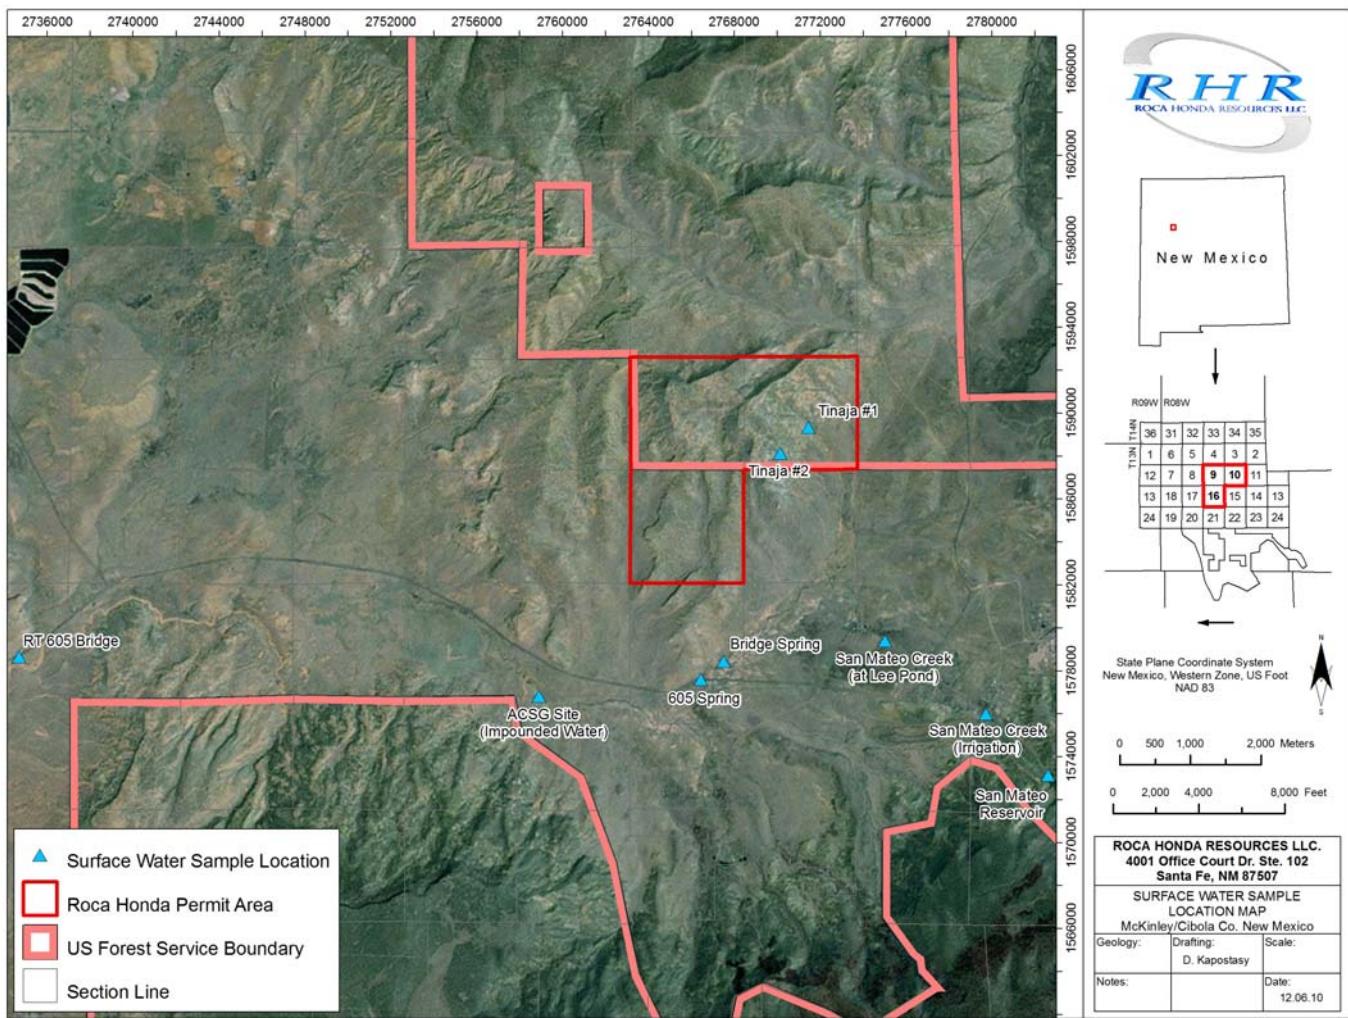
Figure 8-B-1. Surface Water Sampling Locations

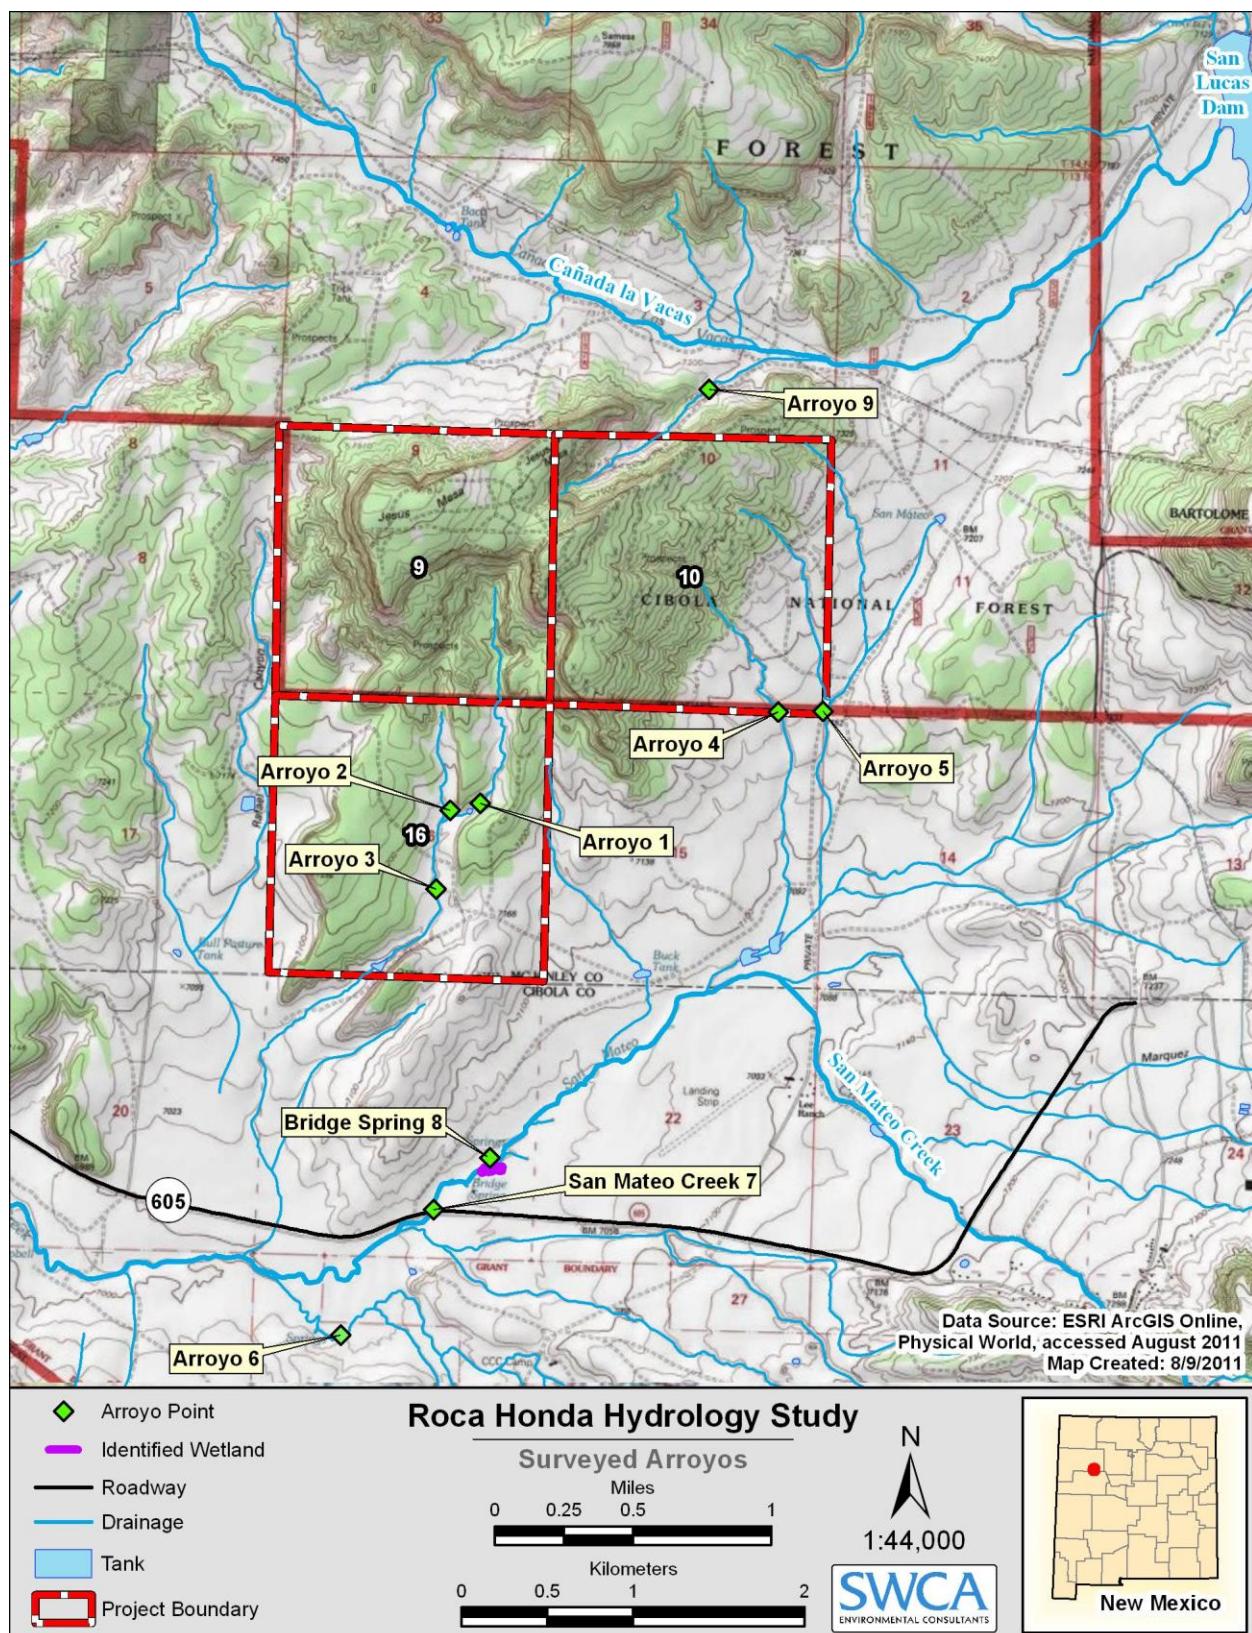
Figure 2. Drainages from the Roca Honda Mine Site.

Figure 2 depicts the drainages identified in the vicinity of the Roca Honda Mine Site. Nine locations (two on San Mateo Creek) were identified and described individually. All observed drainages were classified as ephemeral. One potential wetland was also identified (Bridge Spring).

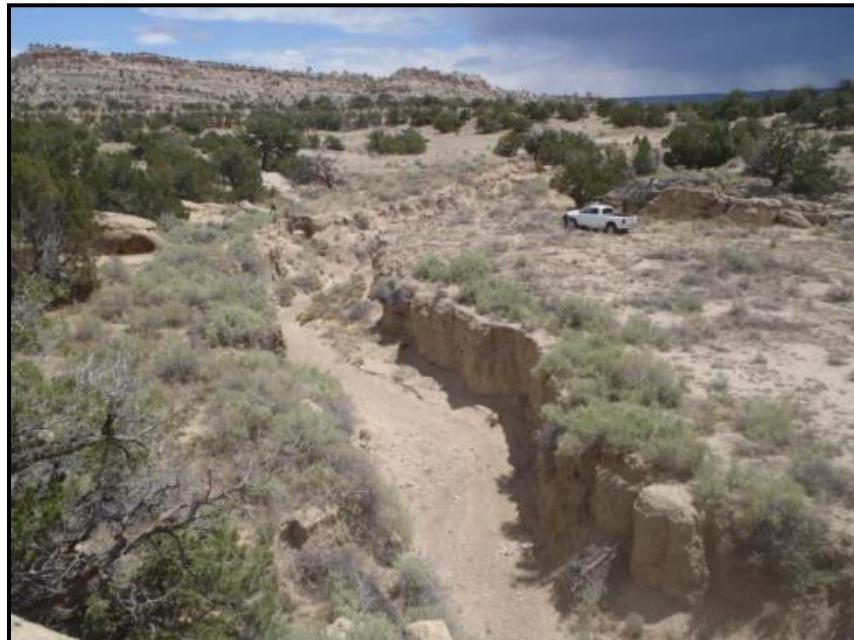
Figure 3. Unnamed Arroyo 1 Looking Up-Arroyo (Northeast).

Arroyos 1 and 2 are ephemeral drainages in the north eastern portion of Section 16. The Arroyo 1 is a deeply incised channel, approximately 20 feet wide and 20 feet deep (Figure 3 and Figure 4). It originates as storm runoff from nearby hillsides in the southeast quarter of Section 9. The Arroyo 2 has smaller incised channels and is somewhat braided. It is approximately 20 feet wide and 6 feet deep (Figure 5 and Figure 6). It originates as sheet flow from nearby hillsides in Section 9, which come together to create the Arroyo 2. These two ephemeral drainages merge in front of a rock formation (Figure 7) and flow south to a man-made impoundment. Arroyo 3 is south of the impoundment. Neither arroyo has an OHWM and no other hydrological characteristics were observed in either arroyo. Dominant plant species include blue grama and fourwing saltbush.

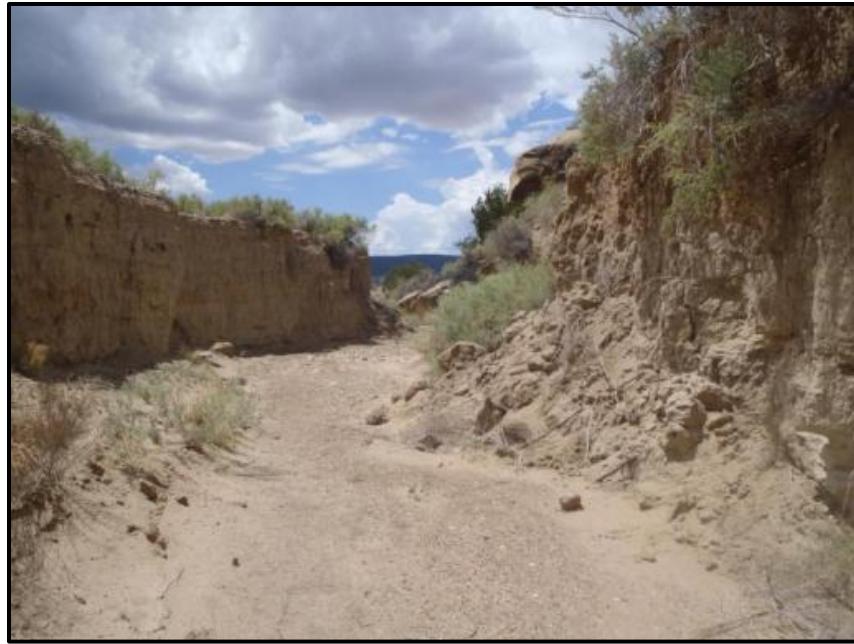
Figure 4. Unnamed Arroyo 1 Looking Down-Arroyo (South).

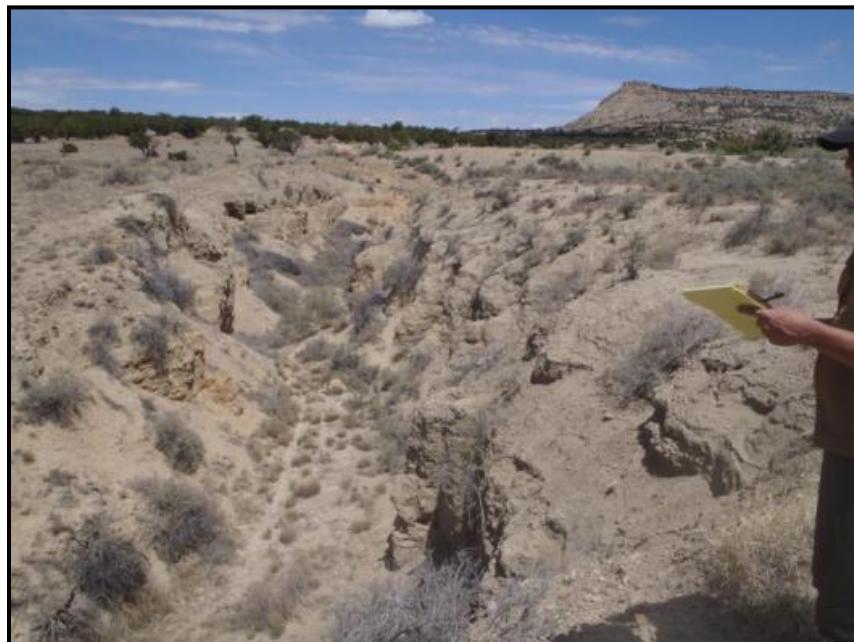
Figure 8. Unnamed Arroyo 3 Looking Up-Arroyo (North).

Arroyo 3 is an ephemeral drainage that is approximately 40–50 feet wide and 30 feet deep in Section 16. This arroyo combines the flows from Arroyos 1 and 2 and continues toward San Mateo Creek. The observation point was south of a man-made impoundment which retained water for cattle. Arroyo 3 flows in a southerly direction and meets San Mateo Creek, south of the project boundary (Figure 8 and Figure 9). There is no OHWM and no other hydrological characteristics were observed. Dominant plant species include fourwing saltbush and pale wolfberry (*Lycium pallidum*).

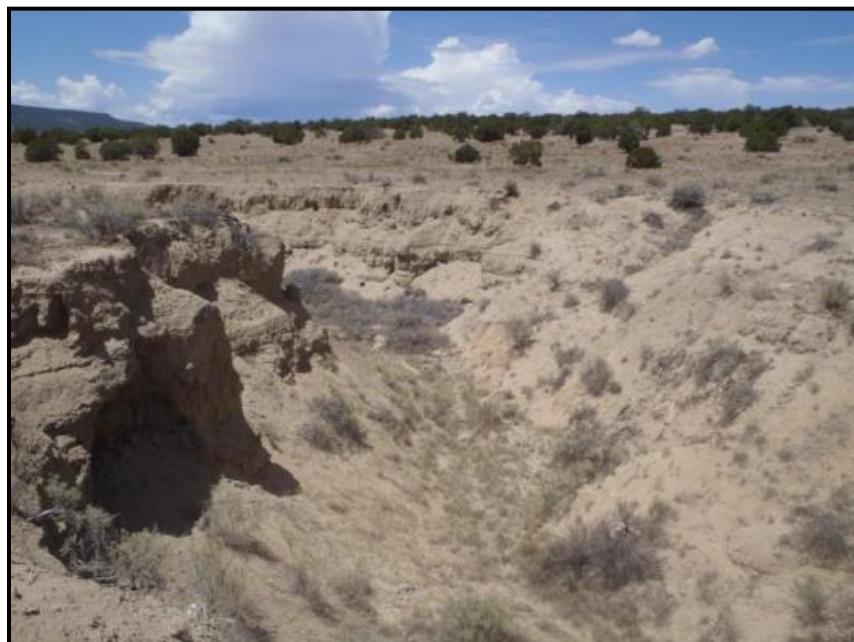
Figure 9. Unnamed Arroyo 3 Looking Down-Arroyo (South).

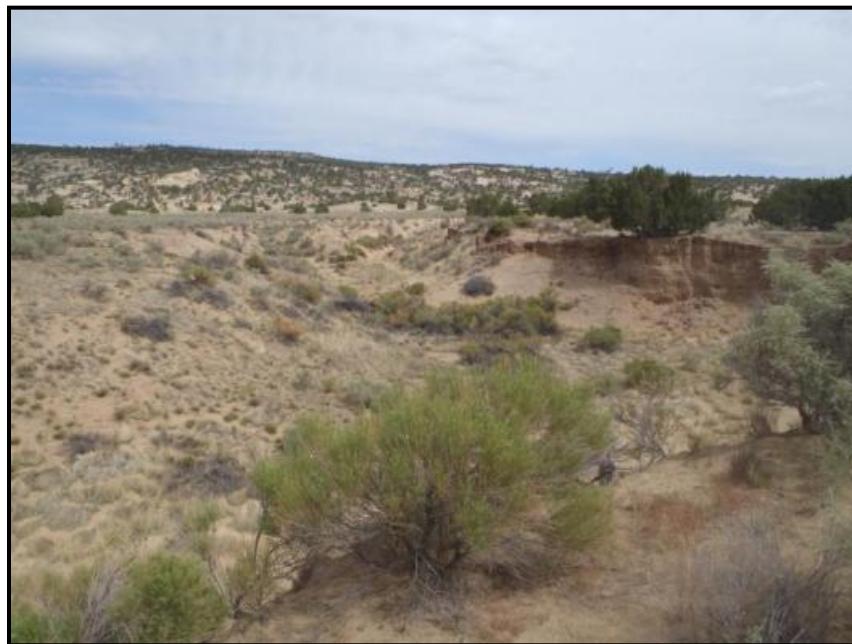
Figure 10. Unnamed Arroyo 4 Looking Up-Arroyo (Northwest).

Arroyo 4 is a deep ephemeral drainage that is approximately 50–75 feet wide and 20–30 feet deep (Figure 10 and Figure 11). It originates in Section 10 and flows south. The arroyo meets San Mateo Creek south of the project boundary after flowing through two small tanks. It is heavily incised. There is no OHWM and no other hydrological characteristics were observed. Dominant plant species include alkali sacaton, Indian ricegrass (*Achnatherum hymenoides*), and fourwing saltbush.

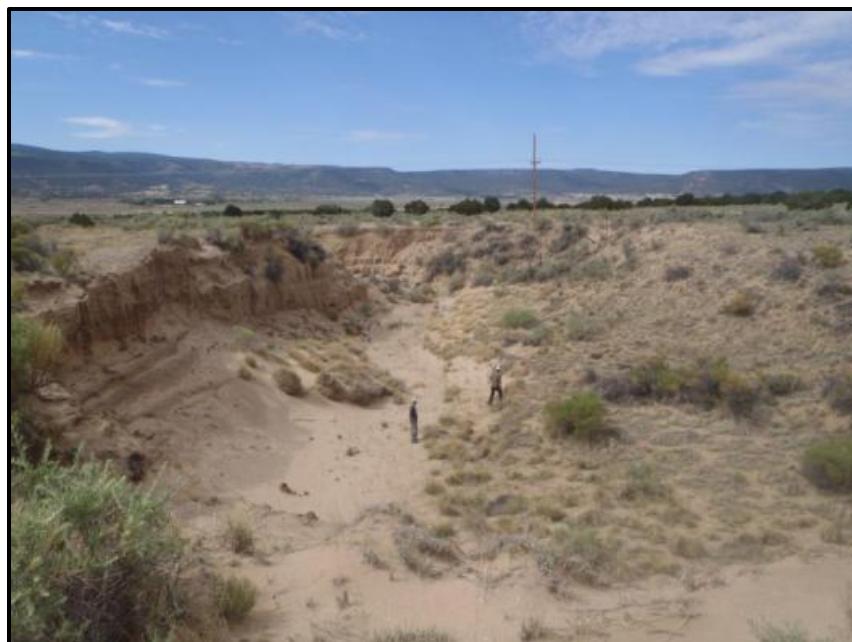
Figure 11. Unnamed Arroyo 4 Looking Down-Arroyo (South).

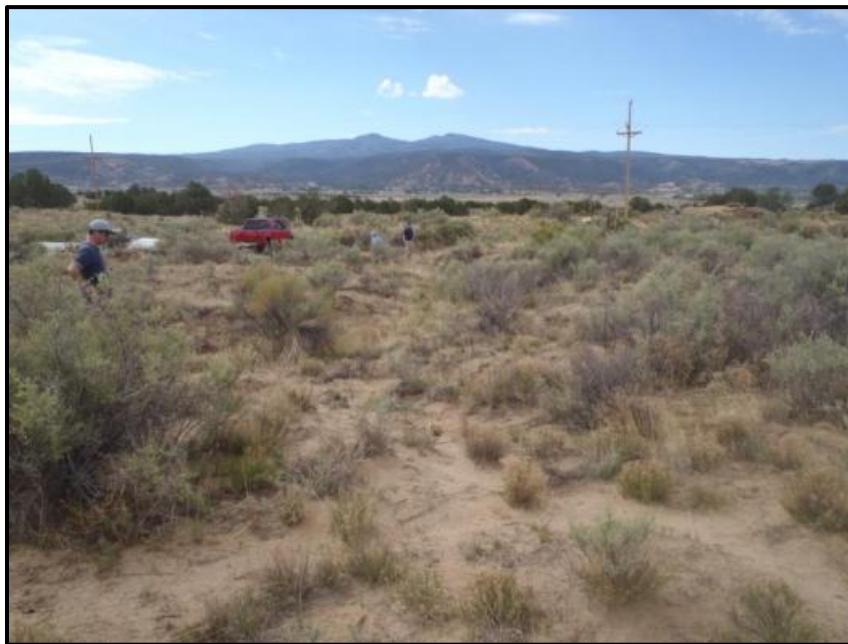
Figure 12. Unnamed Arroyo 5 Looking Down-Arroyo (Southeast).

Arroyo 5 is an ephemeral drainage that originates in the northeastern portion of Section 10 and flows south toward the southeastern corner of Section 10. The drainage flow change to sheet flow approximately 200 yards until it reaches small incised cuts (approximately 10 feet wide), and then flows into an incised drainage/dirt road at the corner of Section 10 (Figure 12 and Figure 13). The arroyo flows into a tributary of San Mateo Creek outside the project area. There is no OHWM and no other hydrological characteristics were observed. Dominant plant species include alkali sacaton, blue grama, and fourwing saltbush.

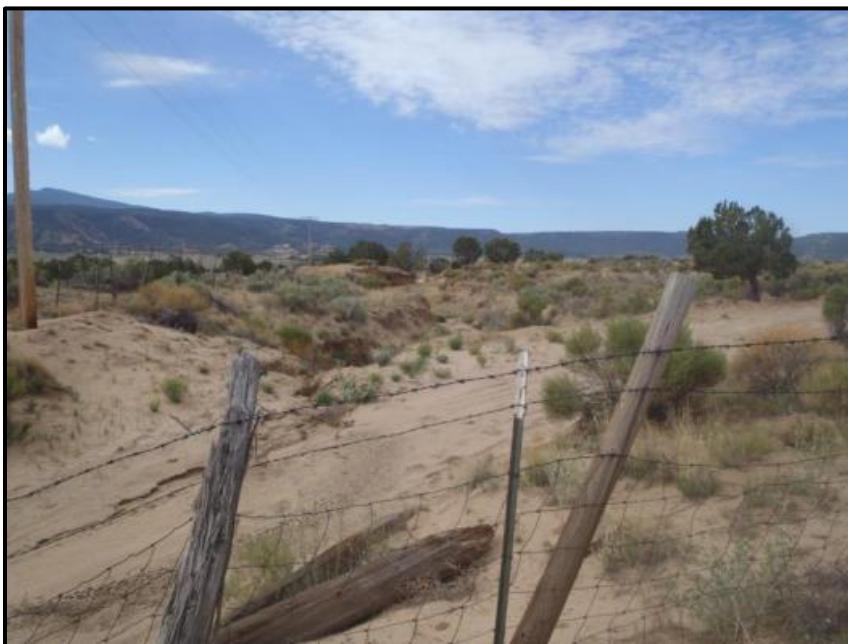
Figure 13. Unnamed Arroyo 5 Looking Down-Arroyo (South).

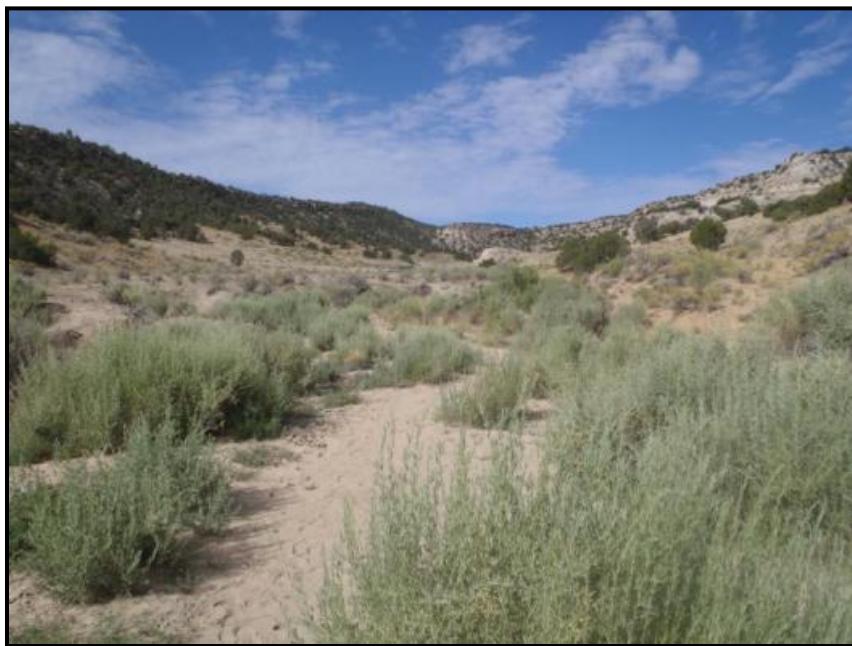
Figure 14. Unnamed Arroyo 9 Looking Up-Arroyo (South).

Arroyo 9 is an ephemeral drainage that originates in the northwest portion of Section 10 and flows northeasterly into Cañada la Vacas. Cañada la Vacas drains into San Lucas Dam, which connects to San Miguel Creek. This location was selected because a small portion of the permit area drains to this unnamed arroyo. The arroyo is approximately 15–20 feet wide with banks less than 2 feet high (Figure 14 and Figure 15). The channel is somewhat incised. There is no OHWM and no other hydrological characteristics were observed. The dominant plant species is fourwing saltbush (*Atriplex canescens*).

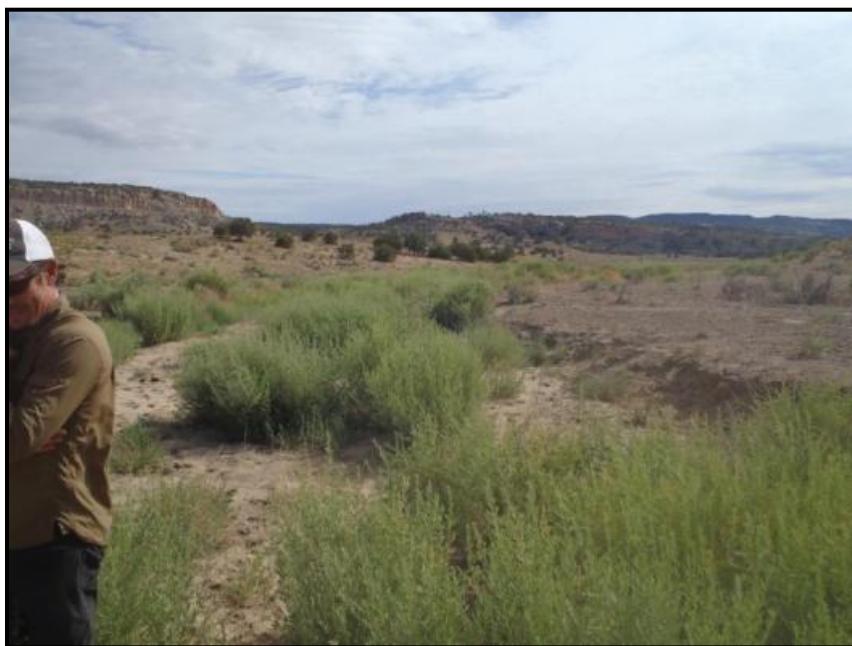
Figure 15. Unnamed Arroyo 9 Looking Down-Arroyo (North).

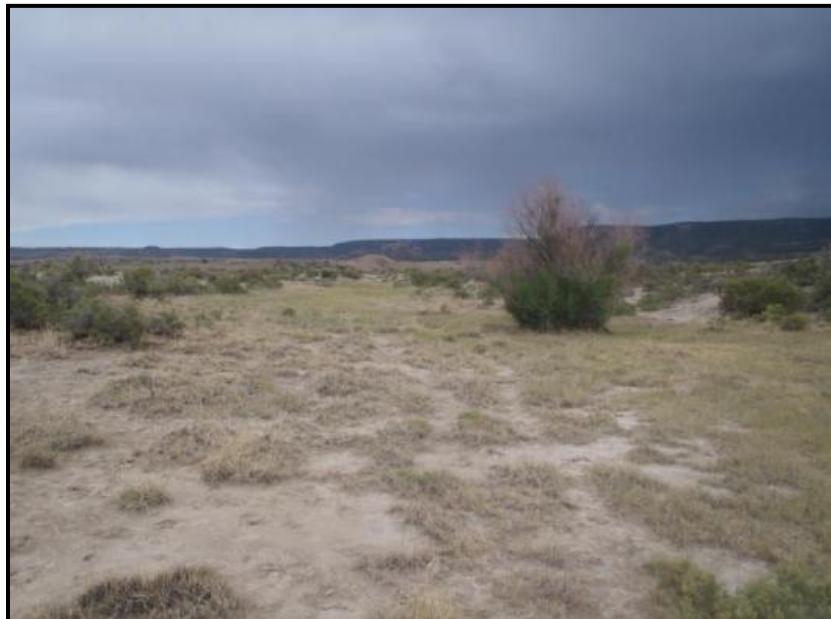
Figure 16. Unnamed Arroyo 6 Looking Up-Arroyo (East).

Arroyo 6 is an ephemeral drainage on the Lee property that flows in a northwesterly direction into San Mateo Creek, south of the project boundary. It is approximately 35 feet wide and 10–12 feet deep (Figure 16 and Figure 17). This location was selected because the USGS maps indicate South Spring is located here. Also, RHR staff have sampled surface water at the location. Cattle tracks were observed in this arroyo. There is no apparent ordinary high water mark (OHWM). Hydrological characteristics include a few surface soil cracks in areas where ponding has occurred from recent rainfall. Dominant plant species include alkali sacaton (*Sporobolus airoides*), blue grama (*Bouteloua gracilis*), saltcedar (*Tamarix ramosissima*), and greasewood (*Sarcobatus vermiculatus*).

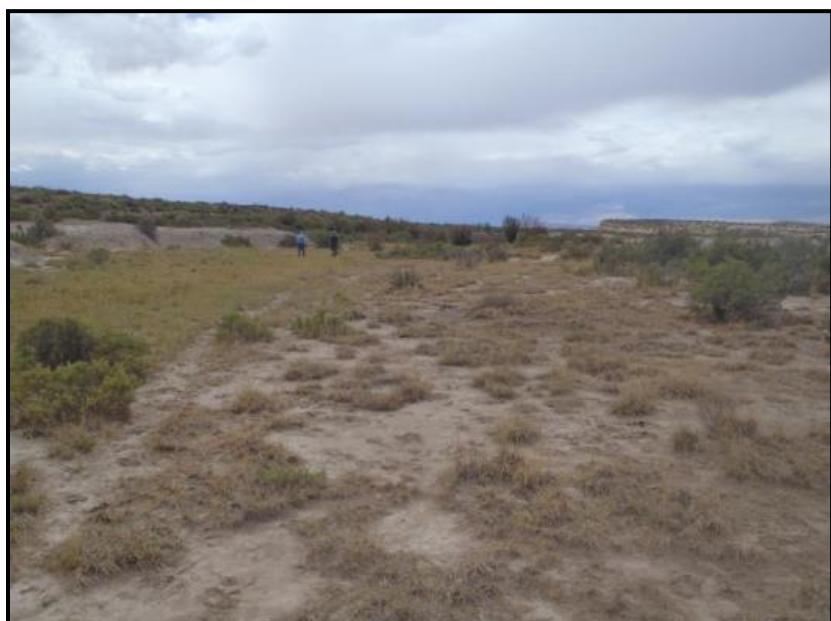
Figure 17. Unnamed Arroyo 6 Looking Down-Arroyo (West).

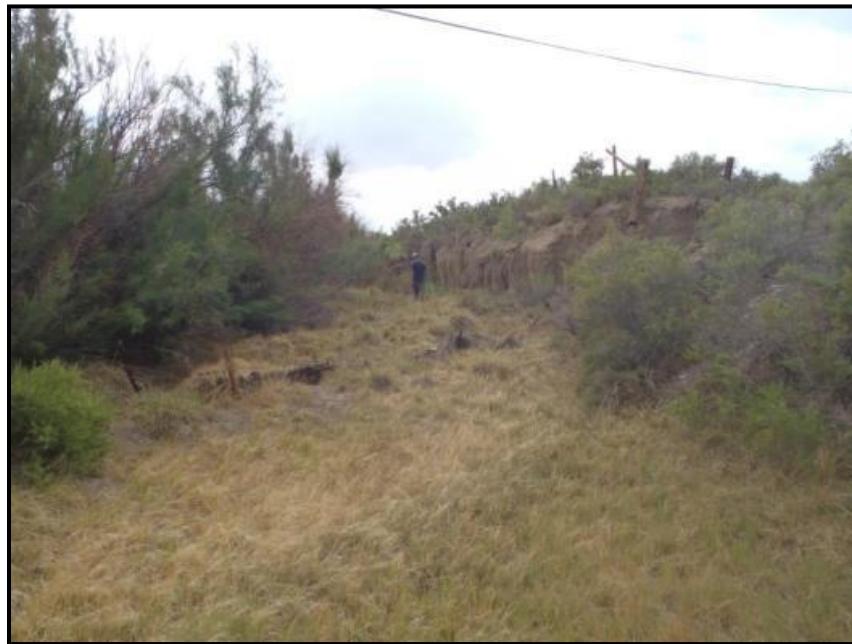
Figure 18. San Mateo Creek at Location 7 Looking Up-Arroyo (North).

Location 7 is a potential spring immediately north of Highway 605 within San Mateo Creek. The area has held water for months and other times it is dry. It is located downstream of Bridge Spring and south of the project boundary in Section 21. The location is approximately 30 feet wide and 10 feet deep (Figure 18 and Figure 19). The channel widens upstream, toward Bridge Spring. There is no OHWM and no other hydrological characteristics were observed. Dominant vegetation includes saltcedar and saltgrass (*Distichlis spicata*).

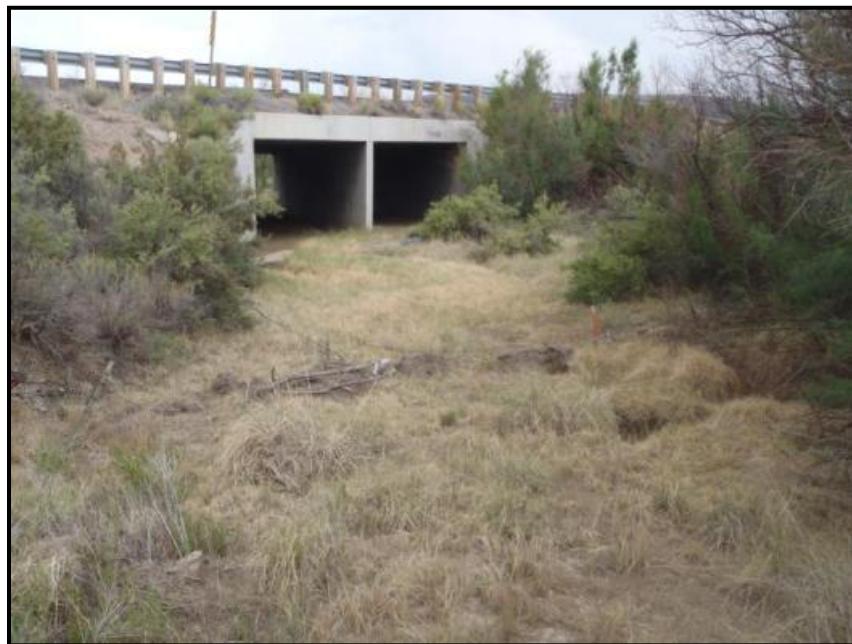
Figure 19. San Mateo Creek at Location 7 Looking Down-Arroyo (South).

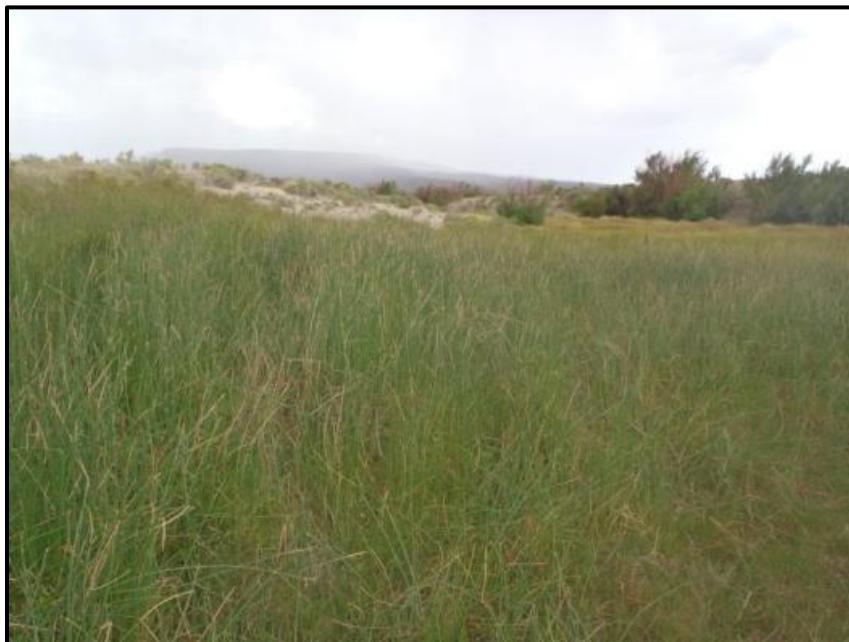
Figure 20. Bridge Spring Looking Down-Arroyo (Southwest).

Location 8, Bridge Spring is a spring-fed wetland area north of Highway 605 within the San Mateo Creek drainage (Figure 20 and Figure 21). It is located south of the project boundary in Section 21. The wetland area is approximately 0.56 acre. This part of San Mateo Creek is ephemeral, but likely flows during storm events. These flows probably also help sustain the wetland. Hydrological characteristics include surface water, wetland obligate plant species, and salt crusts. Dominant plant species include saltcedar, sedges (*Carex* sp), rushes (*Juncus* sp), and bulrush (*Schoenoplectus* sp).

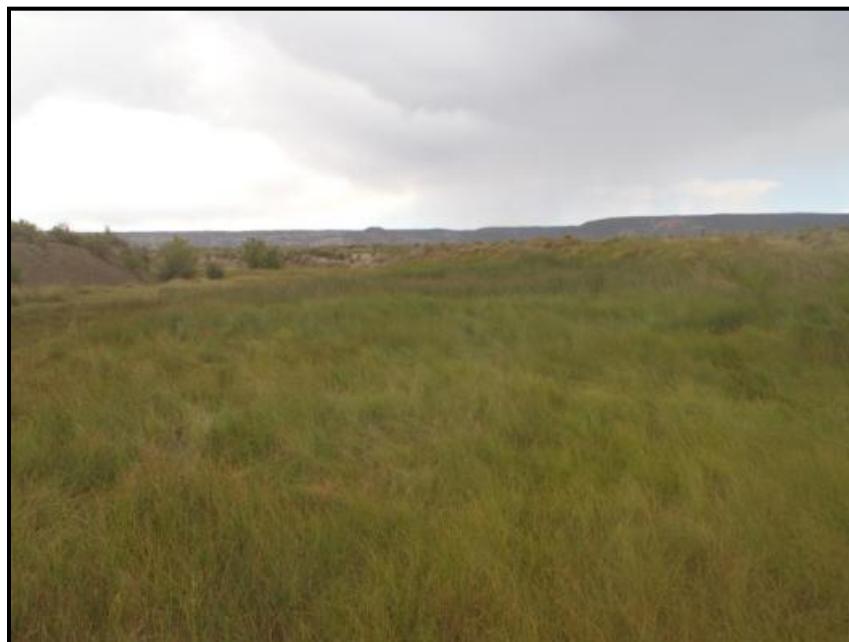
Figure 21. Bridge Spring Looking Up-Arroyo (Northeast).
