RE: Response to Joint Agency Request for Additional Information, Waste Rock Pile Workplan Design Package and 2021 Cover Performance Review, Cunningham Hill Mine Reclamation Project, MMD Permit No. SF002RE and NMED DP-55

Subject: Cunningham Hill Mine Reclamation Project DP-55 Waste Rock Pile Cover

CUNNINGHAM HILL WASTE ROCK PILE IMPROVEMENTS

CUNNINGHAM HILL
WASTE ROCK PILE IMPROVEMENTS
SANTA FE COUNTY, NM
COVER SHEET AND INDEX

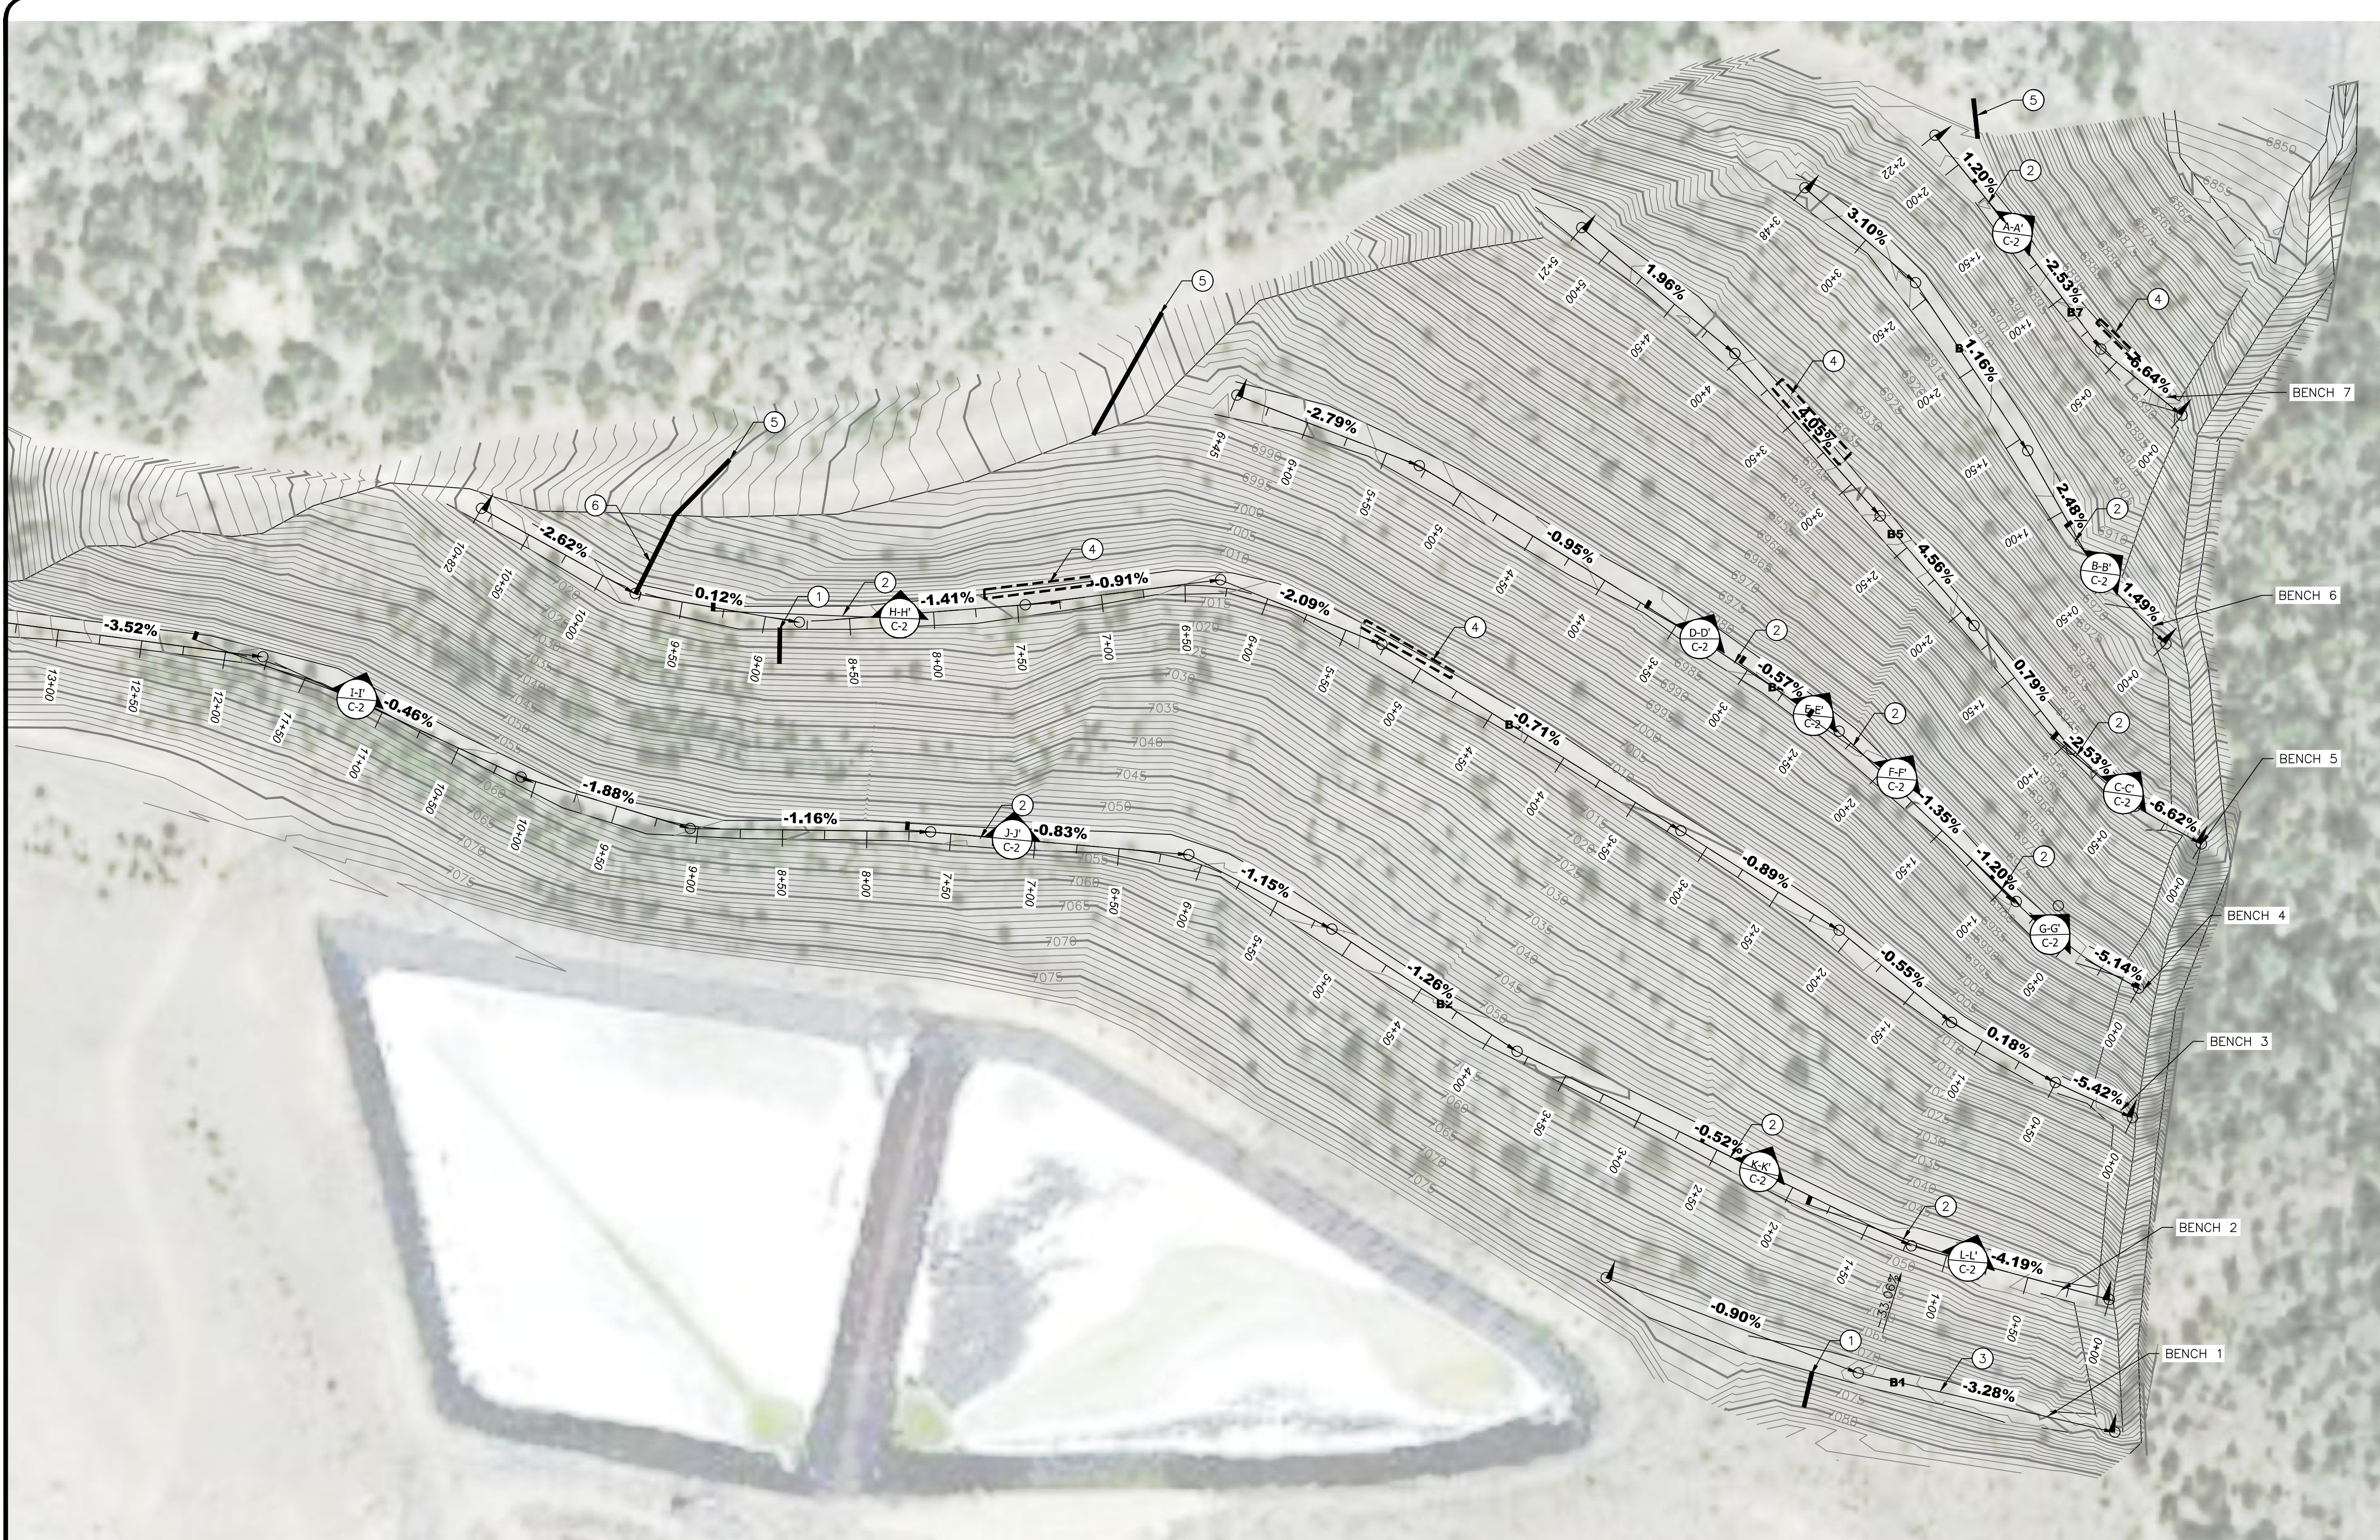
- GENERAL NOTES:**
1. REPAIR RILLS BY PLACING SOIL AROUND EXISTING VEGETATION AND COMPACTING TO 90% OF THE STANDARD PROCTOR (ASTM D698).
 2. GRADING OF 15-FOOT WIDE BENCHES SHALL BE COMPLETED BY COMPACTING SOIL TO 85% OF THE STANDARD PROCTOR (ASTM D698).
 3. SOIL TO BE FREE OF ORGANIC MATERIAL GREATER THAN 3/4".
 4. A GRAVEL ADMIXTURE COMPOSED OF 3/4" GRAVEL SHALL BE MIXED IN WITH SOIL AT A RATIO OF 1:3 BY VOLUME (GRAVEL:SOIL) PRIOR TO PLACEMENT.
 5. ALL DISTURBED AREAS TO BE RE-SEEDED.

- KEY NOTES:**
- ① REPAIR RILLING
 - ② GRADE BENCH TO PROMOTE LATERAL WATERFLOW
 - ③ CLEAR HDPE INLET
 - ④ BUILD UP LIP OF BENCH TO PREVENT STORMWATER FROM RUNNING DOWN THE SLOPE OF THE COVER
 - ⑤ CONSTRUCT/REHABILITATE SWALE TO DIRECT WATER OFF COVER
 - ⑥ CONSTRUCT 18" WIDE RIPRAP CHANNEL TO DIRECT WATER OFF COVER. RIPRAP TO BE PLACED AND COMPACTED INTO THE SOIL COVER.

1. *Page 2, Grading of Benches and IFC drawings, sheet 3 of 5. There are no clear design criteria for the percentage slope on the benches in the Engineering Drawing Issued for Construction (IFC Drawings) in Attachment 1. The IFC Drawing shows numerous bench slope percentages ranging from -6.82 to 3.10 with numerous reaches less than 1 percent, especially on Bench 3. The changes in slope may continue to cause infiltration and deposition of sediment, which will further alter the grade on the benches. The benches need to be designed to convey stormwater off the reclaimed waste rock pile and limit infiltration. Based on the agencies' experience, a minimum of a uniform 2-5% grade on benches is recommended. Please provide a percentage grade expected to be achieved to move water off the benches in addition to any intermediate channels to be constructed across the waste rock pile to reduce infiltration on the benches. In addition, additional design details are needed to show how the benches will tie into the East and West Groin channels.*

The range in bench slope percentages shown in Sheet 3 of 5 of the IFC drawings represents pre-construction site conditions. Design criteria are shown in the profiles on Sheet 4 of 5. A primary goal for this project is to restore the slopes, in accordance with the original design, along areas of the benches where depressions or shallow slopes have developed and are evident. The proposed improvements are consistent with the original designed bench slopes shown in the document titled *As-Built Construction Report for the Cunningham Hill Waste Rock Storage Facility North Slope Bench Regrade and Coversoil Project* (Schafer and Associates, 1996). The improvements will promote positive drainage toward the east and west groins, while minimizing disturbance to the cover, particularly the healthy and
