Re: Freeport-McMoRan Chino Mines Company, Closure- Closeout Plan Renewal,
Mining Act Permit No. GR002RE

Continental Mine Closure/Closeout Plan Update

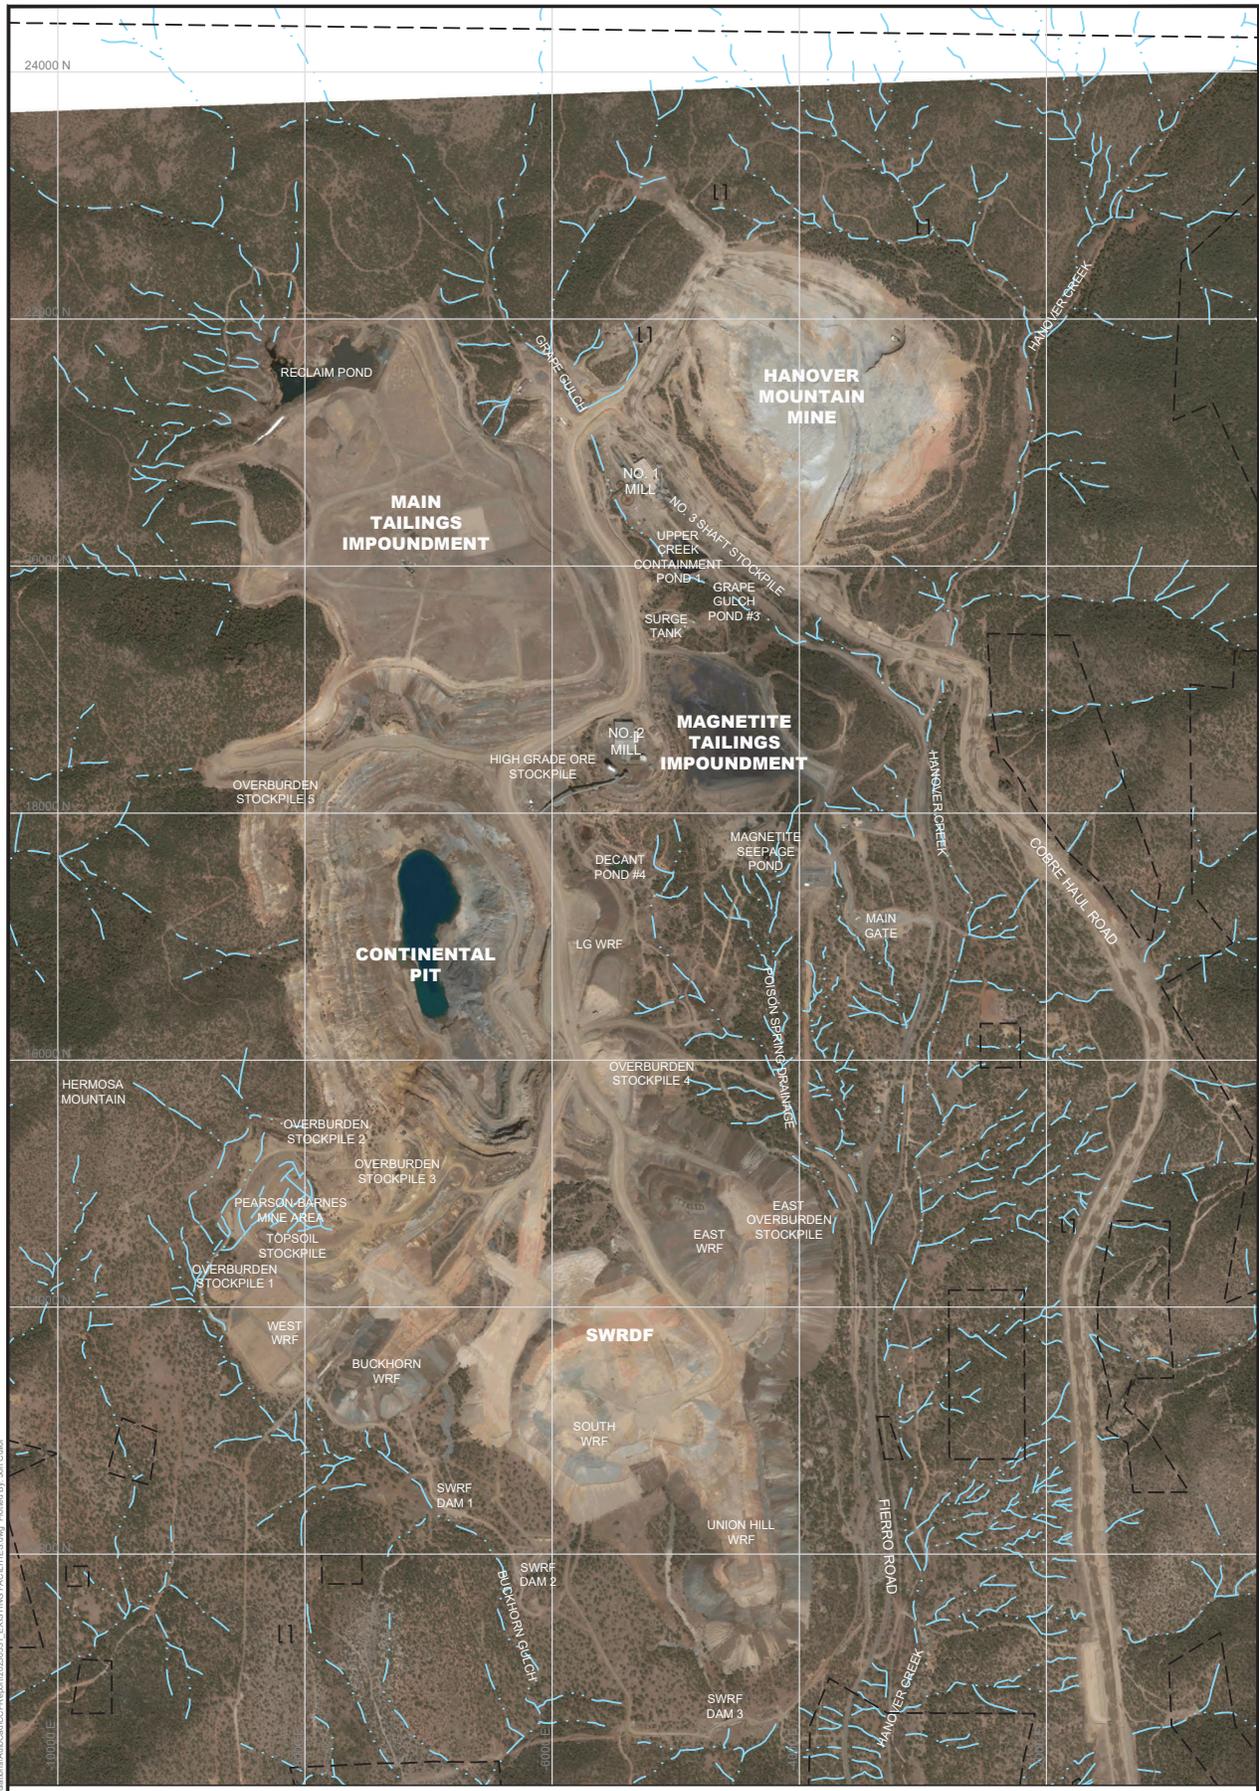
FIGURE 3 EXISTING FACILITIES

- NOTES:**
1. TOPOGRAPHY REPRESENTS SITE CONDITIONS AS OF 6/13/2020 EXCLUDING HANOVER MOUNTAIN MINE WHICH REPRESENTS CONDITIONS AS OF 6/1/2022
 2. PIT LAKE EXTENT SHOWN AS OF 7/2022

The Cobre Haul Road is an approximately three and half-mile long road that connects the HMM to Chino Mines and a one and half mile road that connects the HMM to the SWRDF (Figure 3). The CHR is a 120-foot-wide road flanked by single or dual berms. Berms measure approximately 24-feet wide and 8-feet tall to accommodate the largest haul trucks. Blasted rock faces comprise some of the cut slopes along the haul road corridor. The CHR crosses isolated fragments of BLM land. Stormwater from ephemeral drainages is conveyed under the road through a network of culverts. Ore mined from Hanover Mountain Mine is hauled by truck to the Chino Mine for processing via the CHR.

Stockpiles at the Continental Mine include the (Figure 3):

As shown in Figure 2, Figure 3, and Figure 10 many historical mining shafts and adits surround the Continental Mine. Mining has been the primary land use and economic support for the area for over a century. Surrounding lands have a variety of uses including residential, grazing, timber, aggregate mining, and recreation.

The total drainage area of Hanover Creek is 10.9 square miles, of which approximately 70 percent is located downstream of mining activities (Telesto, 2008c). Figure 3 shows the main ephemeral tributaries within or adjacent to the mine including Grape Gulch, Poison Spring Drainage, and Buckhorn Gulch.

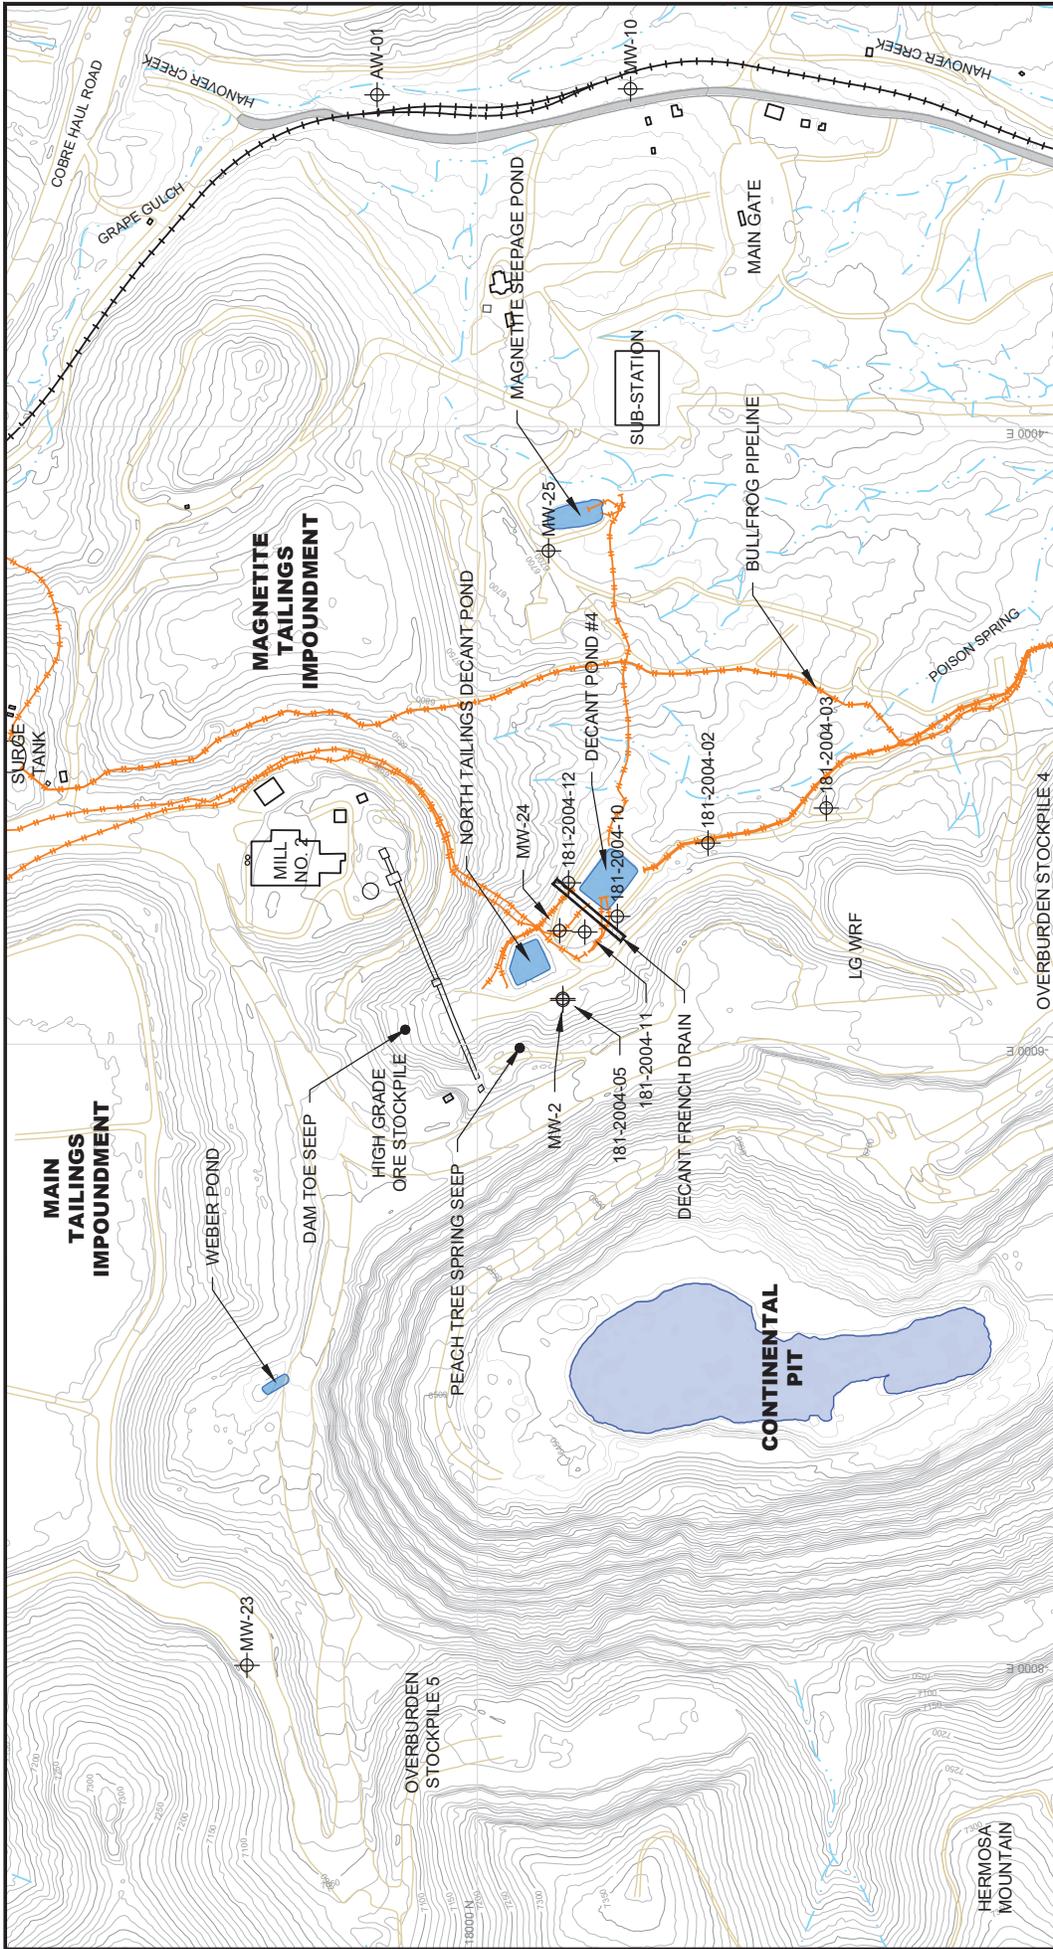
FIGURE 6
EXISTING FACILITIES LOWER POISON
SPRING AND HANOVER CREEK AREA

- NOTES:
1. TOPOGRAPHY REPRESENTS SITE CONDITIONS AS OF 6/13/2020 EXCLUDING HANOVER MOUNTAIN MINE WHICH REPRESENTS CONDITIONS AS OF 6/1/2022
 2. PIT LAKE EXTENT SHOWN AS OF 7/2022

Today, the Continental Pit is approximately 675 feet deep, 0.62 miles in diameter on the north-south axis, 0.33 miles in diameter on the east-west axis and covers an area of approximately 147 acres (Figure 6 and Figure 7). The uppermost level of the pit rim is on the west side at an elevation of approximately 6,950 feet, and the lowest level in the pit is near the north-center of the pit at an elevation of approximately 6,275 feet.

The Continental Mine water management system utilizes surface water impoundments to control stormwater and collect seepage (Figure 5 through Figure 8). Collected stormwater and seepage are sent to Chino through the Bullfrog Pipeline for inclusion in the Chino water management system. A list of surface impoundments with their type and status at EOY 2026 can be found in Table 3.

Tanks, small dams and surface impoundments are described in Table 3 including their status at EOY 2026 and are shown in Figure 5 through Figure 8. Surface impoundment maintenance is included in Appendix D and surface impoundment reclamation in Appendix B.

after facility reclamation as predicted in Condition 83 (Golder, 2009). Seep collection systems locations are shown in Figure 5 through Figure 8.

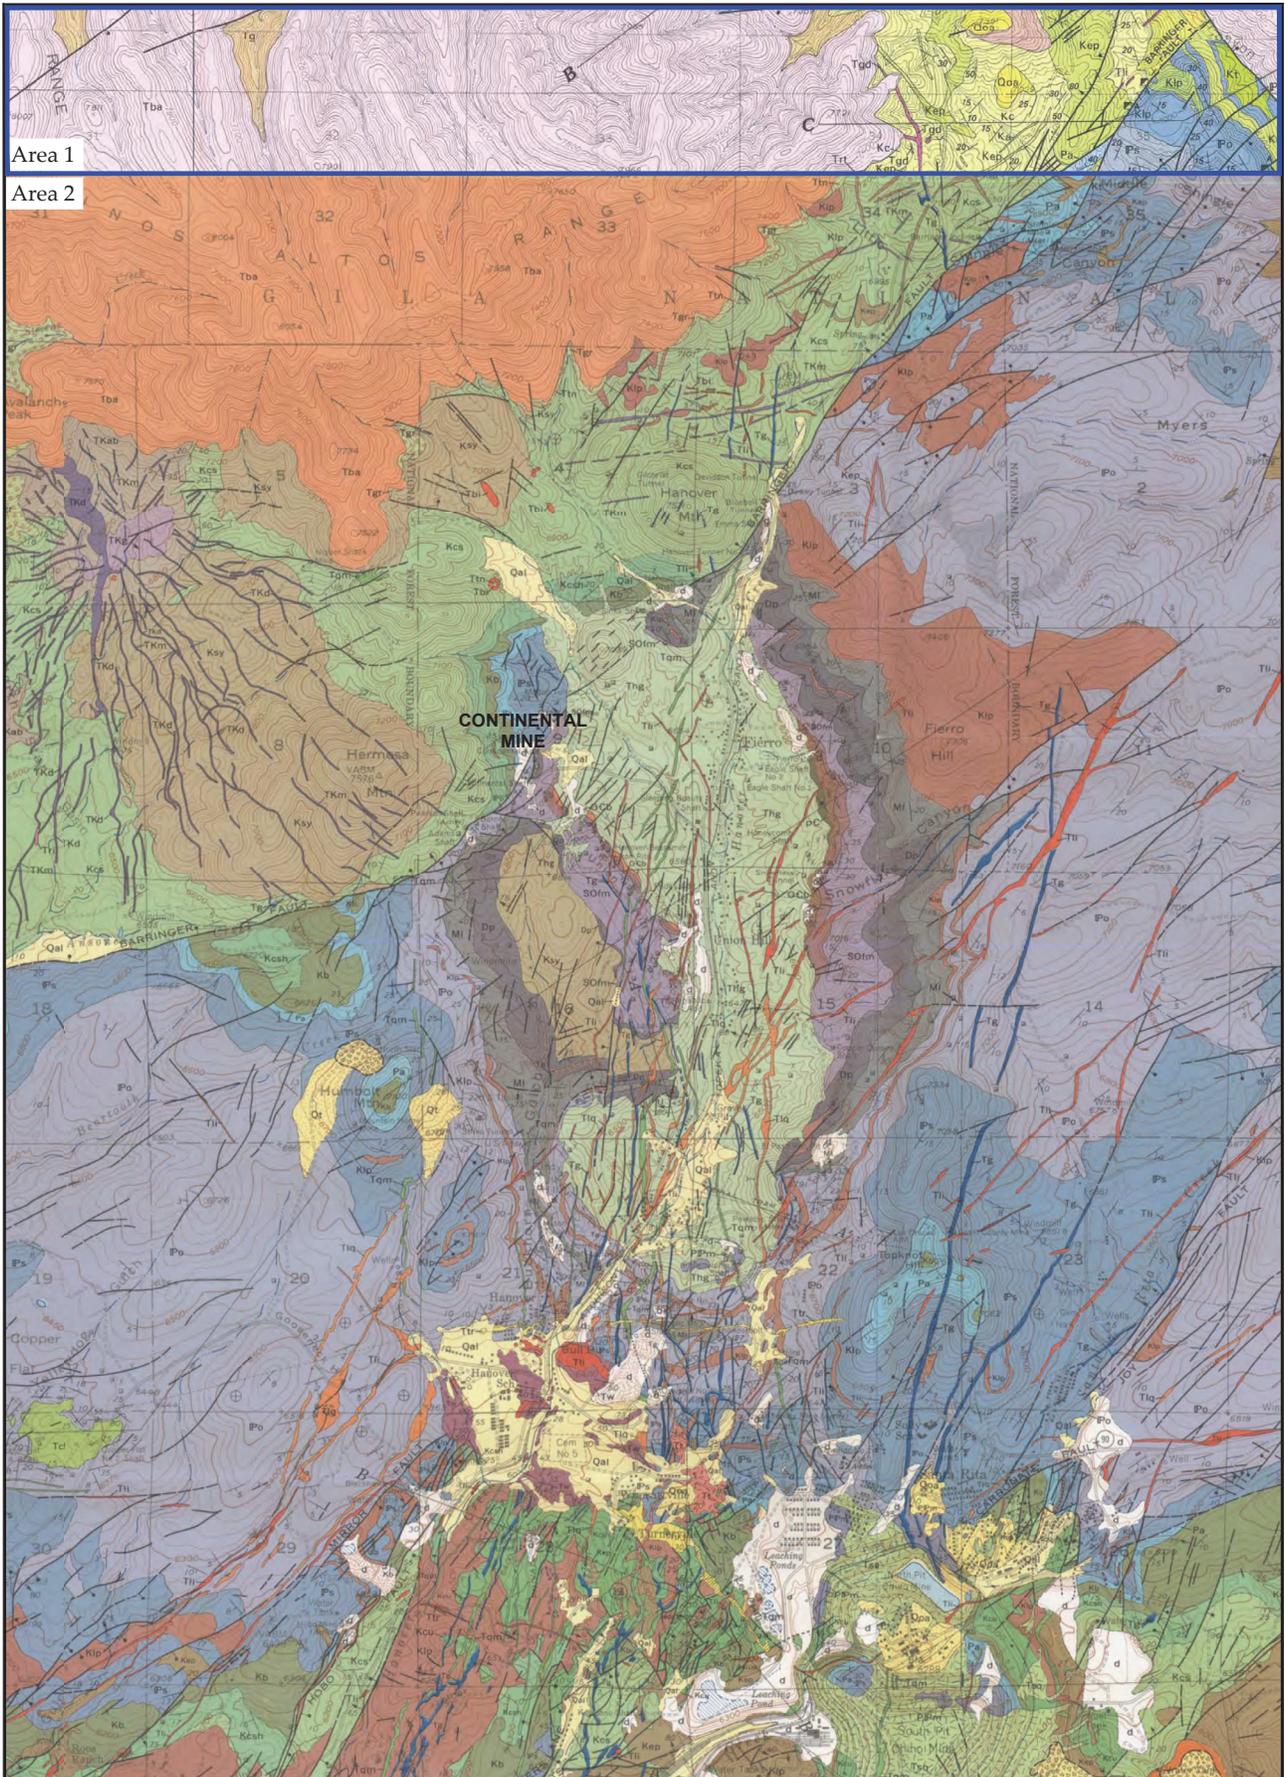
FIGURE 11-A
GENERALIZED GEOLOGY

GEOLOGY LEGEND: See Figure 11-B For Area 1
See Figure 11-C For Area 2

The Continental Mine is located within the Santa Rita Quadrangle, which lies in a broad transitional zone between the Colorado Plateau and the Basin and Range Province (Jones, et al., 1967). To the south and southwest of the quadrangle, Paleozoic to Mesozoic sedimentary rocks and younger volcanic rocks are exposed in northwest-trending ranges. To the north, sedimentary formations thicken and form the broad highlands of the Colorado Plateau (Figure 11).

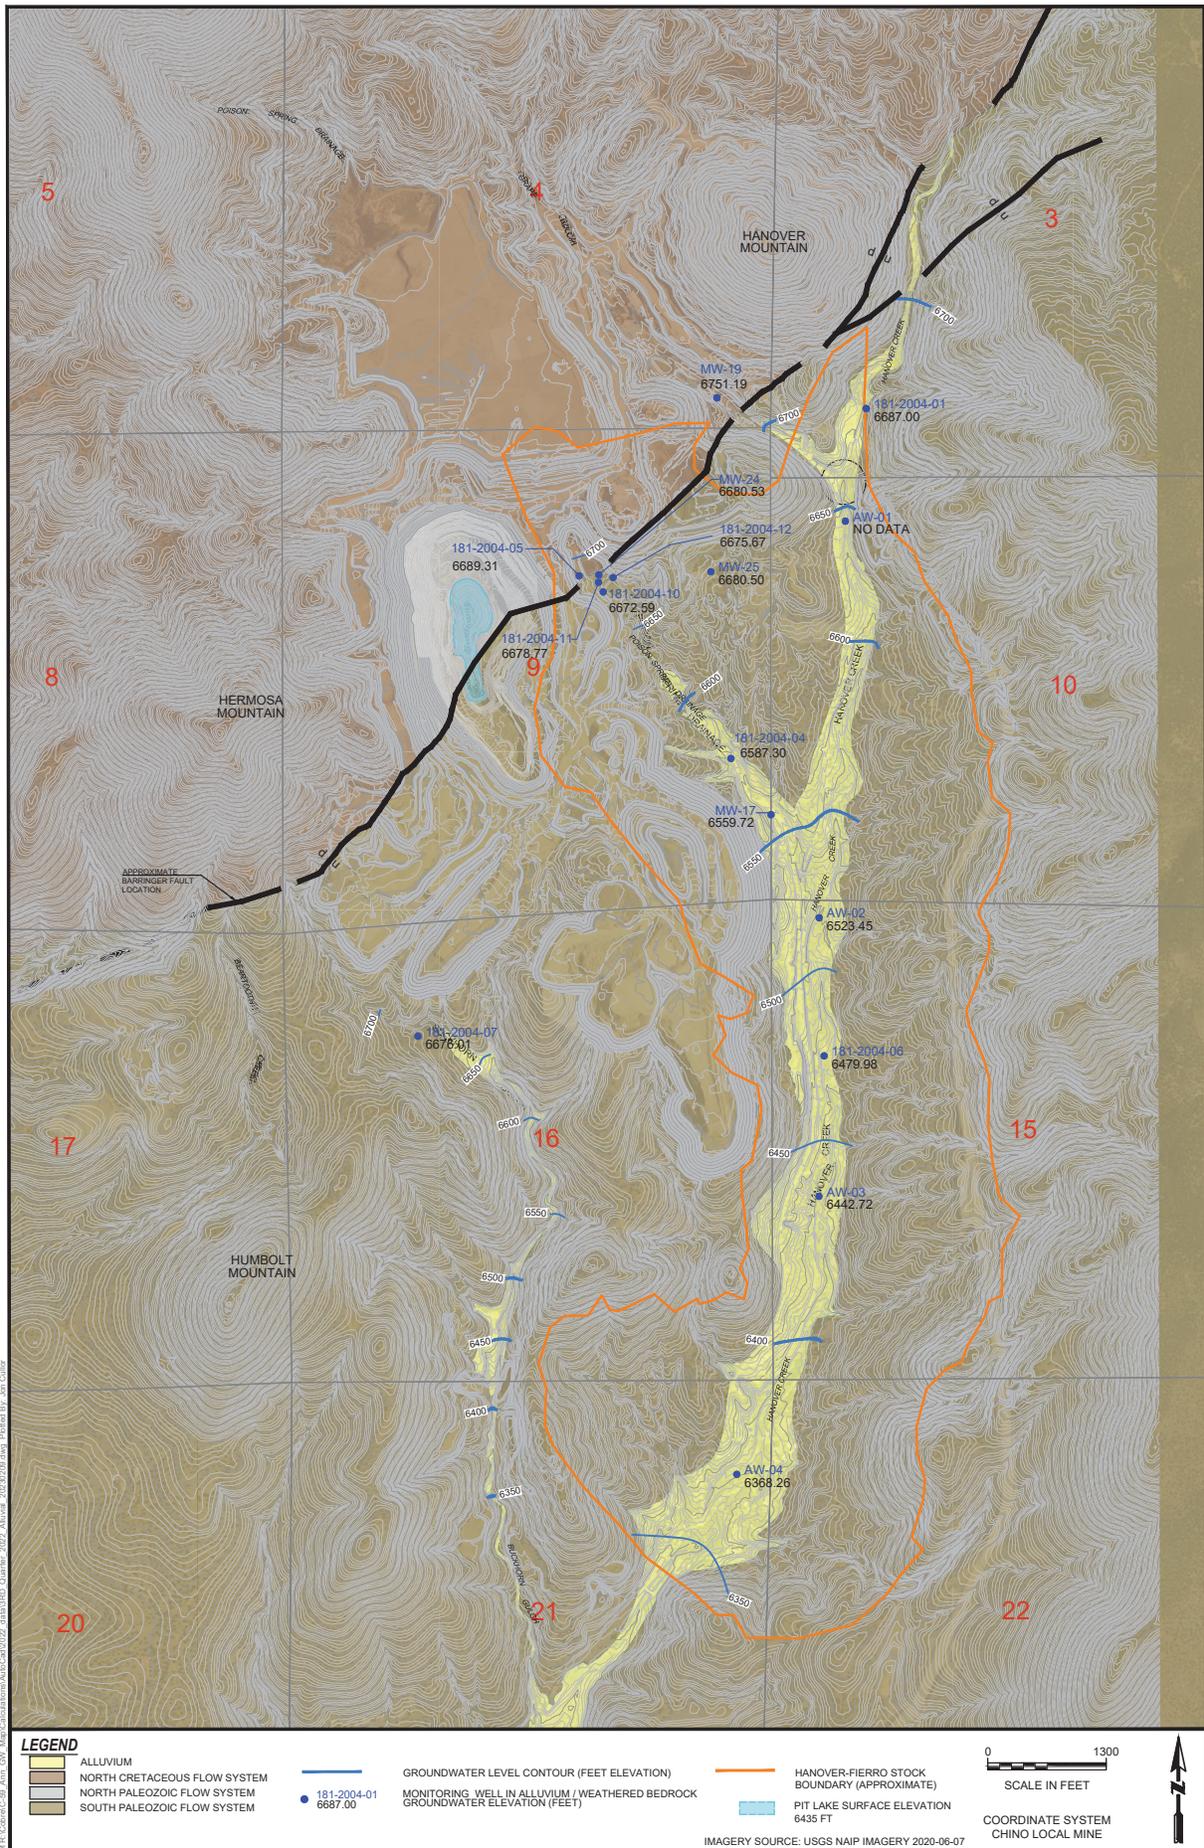
FIGURE 12
THIRD QUARTER 2022 GROUNDWATER POTENTIOMETRIC SURFACE STREAM ALLUVIUM AND UNDERLYING WEATHERED BEDROCK

Figure 12 through Figure 14 provide groundwater elevations projected in the third quarter of 2022 for each of the aquifers.
