HARDING PEGMATITE MINE SAFEGUARD PROJECT - PHASE II DIXON, NEW MEXICO

PROJECT NO. EMNRD-MMD-2022-02

COVER SHEET

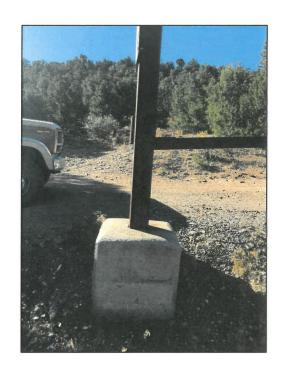
1 GATE 1 RECEIVING POST (EXISTING CONDITION)

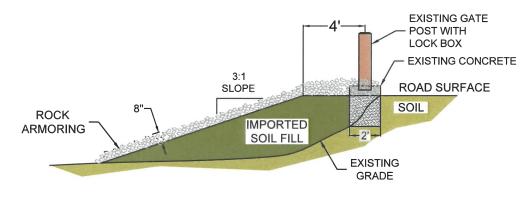
2 GATE 1 POST STABILIZATION SCHEMATIC PROFILE VIEW

- 5. PLACE AND COMPACT FILL MATERIAL IN MAXIMUM OF 12-INCH LOOSE LIFTS. COMPACTION SHALL BE OBTAINED USING A RAMMER/JUMPING JACK COMPACTOR.
- 6. CONDITION FILL MATERIAL WITH WATER FOR OPTIMUM COMPACTION. COMPACTION TESTING IS NOT REQUIRED; BUT LIFT COMPACTION AND FINAL COMPACTION MUST BE TO PROJECT MANAGER'S SATISFACTION.

- 7. ENSURE THAT THE GATE LATCH AND LOCKBOX ON THE POST ALIGN AND INTERLOCK WITHOUT RUBBING OR STRAINING BEFORE PLACING FILL AROUND EXPOSED FOOTING OF THE POST. ROUTINELY CHECK ALIGNMENT DURING FILL PLACEMENT AND COMPACTION ACTIVITIES. IF ALIGNMENT IS LOST DURING STABILIZATION ACTIVITIES, PLACED SOIL SHALL BE REMOVED AND THE POST REALIGNED AT CONTRACTOR'S EXPENSE.

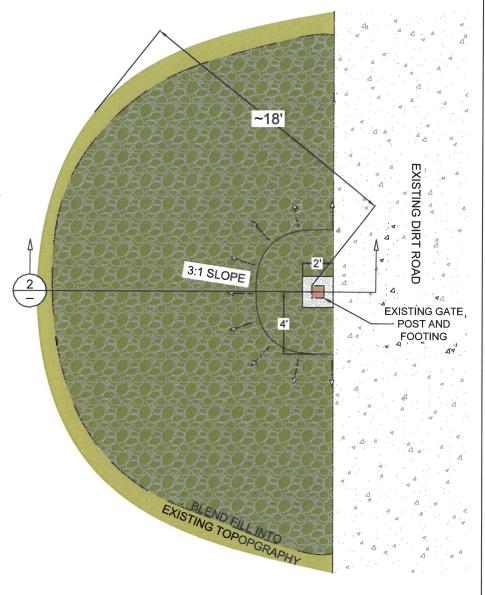
3 GATE 1 POST STABILIZATION SCHEMATIC PLAN VIEW
1" ~ 6"

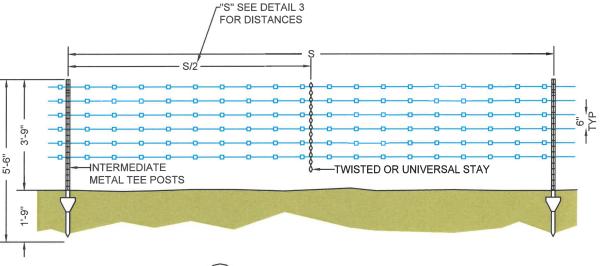
2 LINE PANELS DETAIL NTS

- 2. INSTALL APPROXIMATELY 150' OF SIX STRAND BARBED WIRE FENCE WIRE FENCE AT THE ICEBERG PIT AND REPAIR THE FENCE AT THE OPEN STOPE. THE BARBED WIRE SHALL BE NEW, DOUBLE-STRAND STEEL, $12\frac{1}{2}$ GAUGE OR $15\frac{1}{2}$ GAUGE HIGH TENSILE BARBED WIRE.

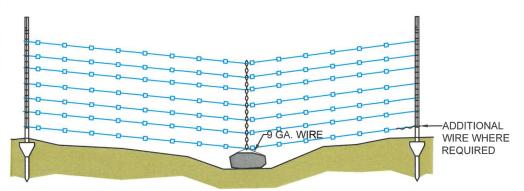
NOTE: ADD ADDITIONAL WIRE AND A ROCK DEADMAN (MINIMUM WEIGH 50 LBS.) WHEN SPACE BETWEEN BOTTOM WIRE AND GROUND EXCEEDS 18 INCHES.

PANEL AT MINOR DEPRESSION DETAIL
NTS

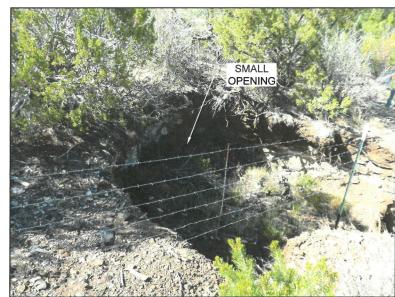
SUB-1 OPEN STOPE - EXISTING CONDITIONS
LOOKING NORTHEAST TOWARDS SMALL OPENING

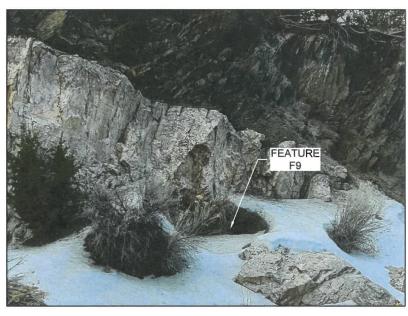
5 FEATURE F9 - EXISTING CONDITION
- LOOKING SOUTHWEST TOWARDS HIGHWALL

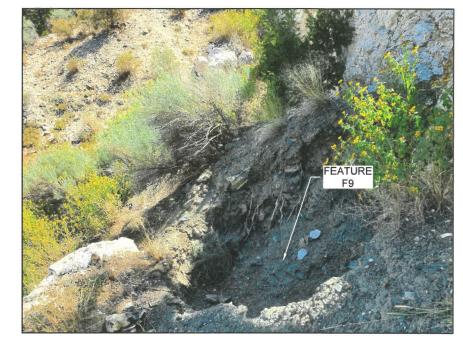
6 FEATURE F9 - EXISTING CONDITIONS
- LOOKING SOUTHEAST PERPENDICULAR TO HIGHWALL

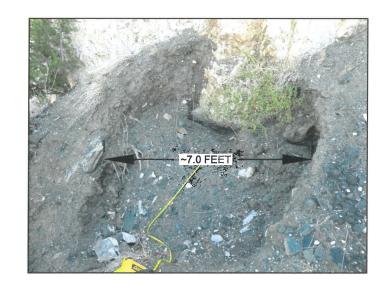
1 FEATURE F9 – PHOTO OF EXISTING CONDITIONS

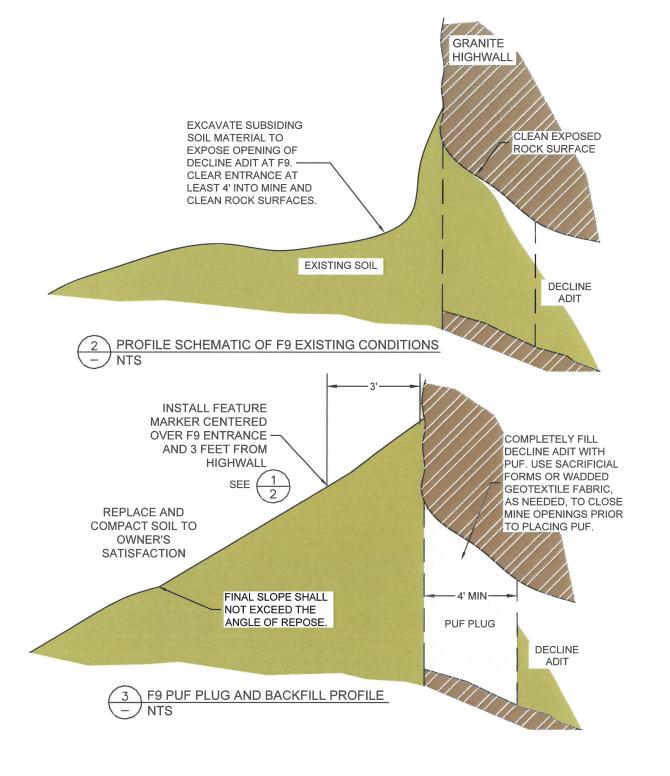
- 1. EXISTING SOIL SHALL BE EXCAVATED TO EXPOSE THE ENTRANCE TO THE DECLINE ADIT. MATERIAL FROM INSIDE THE ADIT SHALL BE REMOVED TO 4 FEET FROM THE ENTRANCE (AS DEFINED BY PROJECTION OF VERTICAL SECTION OF THE HIGHWALL IN THAT LOCATION).

- 7. BACKFILL WITH EXISTING SOIL THAT IS EXCAVATED FROM THE DECLINE ADIT. BLEND SURFACE WITH SURROUNDING GRADE AND LAND. FORM TO SIMULATE NATURAL CONDITIONS.

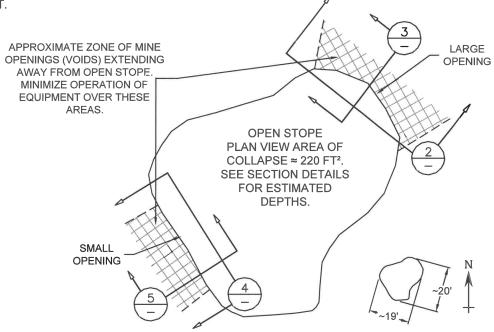
1 PLAN VIEW OF OPEN STOPE NTS

- FEATURE IS A COLLAPSED OPEN STOPE. UNDERGROUND MINE WORKINGS (VOIDS) ARE PRESENT AROUND THE FEATURE. THIN BEDROCK MAY BE PRESENT AROUND THE FEATURE. CONTRACTOR SHALL SIZE EQUIPMENT AND PLAN EQUIPMENT APPROACH ACCORDINGLY.
- 2. SHAPE AND DIMENSIONS ON SCHEMATICS ARE APPROXIMATED BASED ON OBSERVATIONS FROM OUTSIDE THE COLLAPSE FEATURE AND DATA FROM LIDAR SURVEY. CONTRACTOR SHALL VERIFY DIMENSIONS.
- 3. FEATURE SUB-1 IS SECURED BY TEMPORARY CHAIN LINK FENCE PANELS ERECTED AROUND THE FEATURE. THE CONTRACTOR SHALL REMOVE THE TEMPORARY FENCE AND TRANSPORT IT TO THE LAYDOWN AREA IN THE LOWER PARKING AREA FOR REMOVAL FROM THE SITE BY THE AML PROGRAM.
- 4. TEMPORARILY REMOVE SECTION OF BARBED WIRE FENCE OVER THE STOPE WHILE CONSTRUCTING SAFEGUARD MEASURES. REPLACE REMOVED FENCING AFTER FILLING OPEN STOPE IN ACCORDANCE WITH DETAILS ON SHEET 5.

5. FINAL DEPTHS OF OPEN STOPE PRIOR TO FILLING WILL BE DEPENDENT ON AMOUNT OF SOIL AND WEATHERED ROCK THAT IS EXCAVATED DURING PREPARATION FOR PLUG INSTALLS AND PUF PLACEMENT.

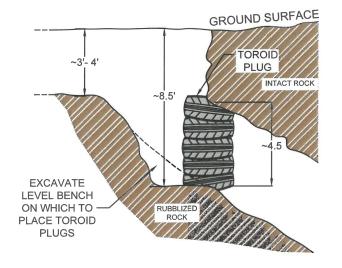
3 SECTION LARGE OPENING - NORTHWEST 10 1" ≈ 5'

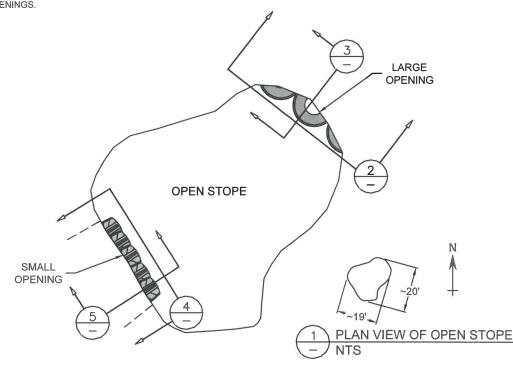
- ONCE TOROID TIRE PLUGS ARE PLACED, COVER THE EXPOSED TIRE SURFACES WITH NONWOVEN GEOTEXTILE FABRIC TO PREVENT PUF FROM ENTERING THE MINE OPENING BEHIND THE TIRES. THE FABRIC SHALL BE PLACED IN A MANNER TO OPTIMIZE THE CONTACT SURFACE AREA OF THE PUF TO THE ROCK WALL. ANY OPENINGS IN THE TIRE PLUGS GREATER THAN 1 FOOT IN ANY DIMENSION SHALL BE SUPPORTED USING WIRE MESH BEFORE APPLICATION OF THE GEOTEXTILE FABRIC. SEE SHEET 10 FOR FABRIC PLACEMENT.

- 7. LOOSE SOIL, VEGETATION, AND WEATHERED ROCK SHALL BE EXCAVATED FROM THE OPEN STOPE PRIOR TO INSTALLING PLUGS OVER OPENINGS.

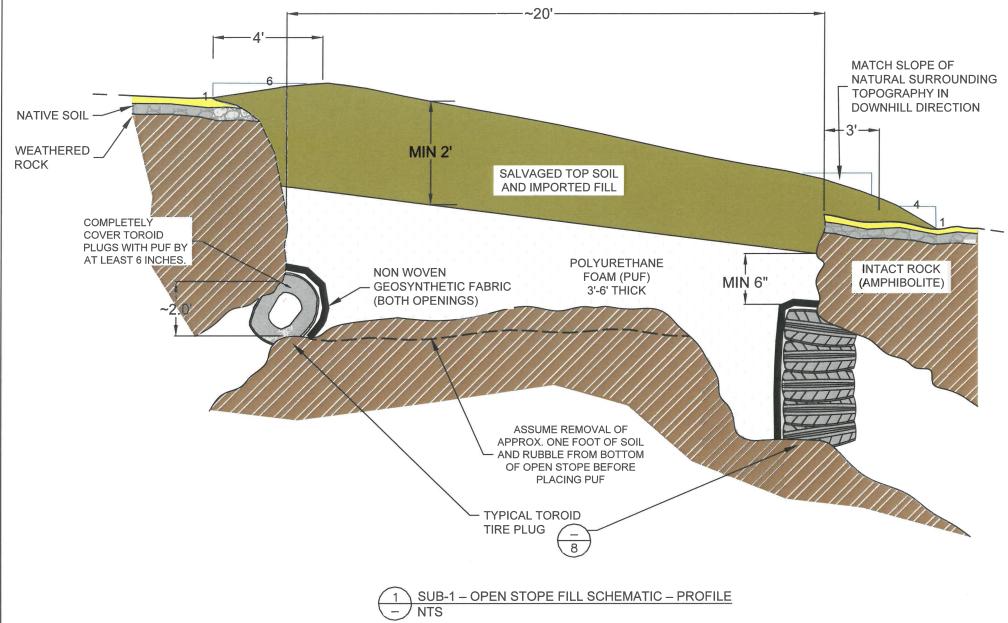
APPROXIMATE FILL VOLUMES

SALVAGED TOP SOIL ≈ 4 CUBIC YARDS IMPORTED SOIL FILL ≈ 25 CUBIC YARDS PUF (CURED-IN-PLACE) ≈ 54 CUBIC YARDS

- 8. USE WATER TO TREAT SOIL FILL FOR COMPACTION. COMPACT SOIL WITH MECHANICAL TAMPER. DO NOT USE WHEELED OR TRACKED EQUIPMENT FOR SOIL COMPACTION. OPERATION AND TURNING OF HEAVY EQUIPMENT OVER THE RECLAIMED OPEN STOPE COULD CAUSE SURFACE COLLAPSE OF OTHER SECTIONS OF THE MINE.

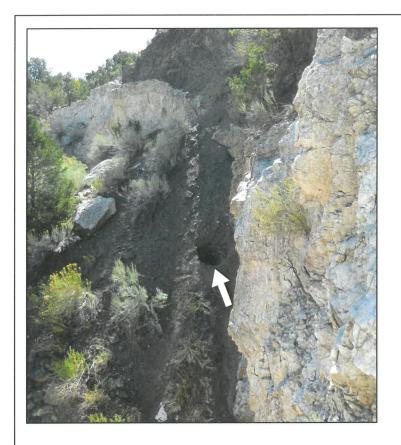
1 PHOTO OF SUB-2 LOCATION EXISTING CONDITIONS
- LOOKING SOUTHEAST

SAFEGUARD MEASURES AT FEATURE SUB-2
INCLUDE THE INSTALLATION OF A MINE
VENT TO ENHANCE BAT HABITAT IN THE
MINE WORKINGS. GENERAL CONSTRUCTION
NOTES FOR SUB-2 SAFEGUARD MEASURES
ARE PROVIDED ON SHEET 12.

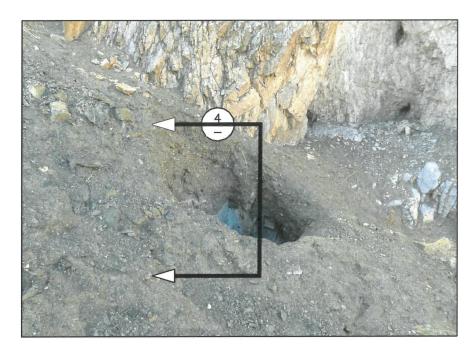
2 PHOTO OF SUB-2 LOCATION EXISTING CONDITIONS
- LOOKING SOUTHWEST

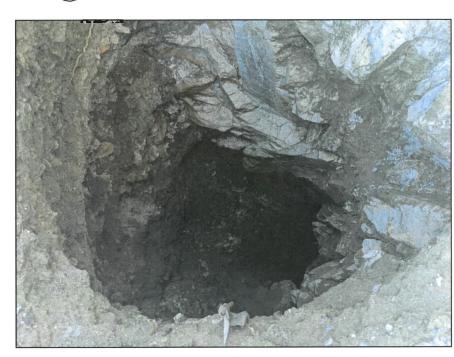
3 PHOTO OF SUB-2 LOCATION EXISTING CONDITIONS LOOKING DOWN INTO OPENING

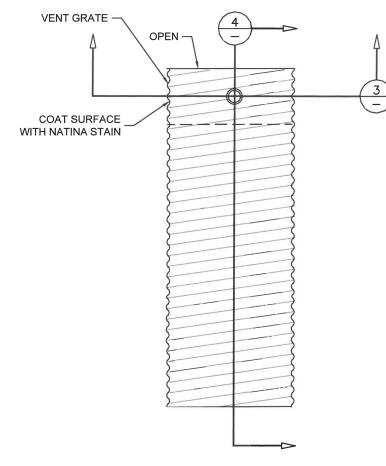
TOP OF PIPE WITH INTERNAL VENT GRATE - PROFILE

- 9. HYDRATE THE BENTONITE WITH CLEAN WATER (NOT AVAILABLE ON SITE) IN 6-INCH LIFTS IN ACCORDANCE WITH RECOMMENDATIONS BY THE BENTONITE VENDOR.
- 10. STEEL PLATES AND SHAPES FOR THE VENT GRATE ASSEMBLY SHALL BE MILD STEEL PLATE. WELD ALL JOINTS. STEEL PLATES, BOLTS, AND NUTS SHALL BE MILD OR STAINLESS STEEL. DOUBLE-NUT ALL BOLTS. ROUND OR CHAMFER ALL EXPOSED EDGES AND CORNERS TO THE VENT GRATE.
